# **The Nalco Guide to Boiler Failure Analysis**

**Nalco Chemical Company**

**Robert D. Port**

**Harvey M. Herro**

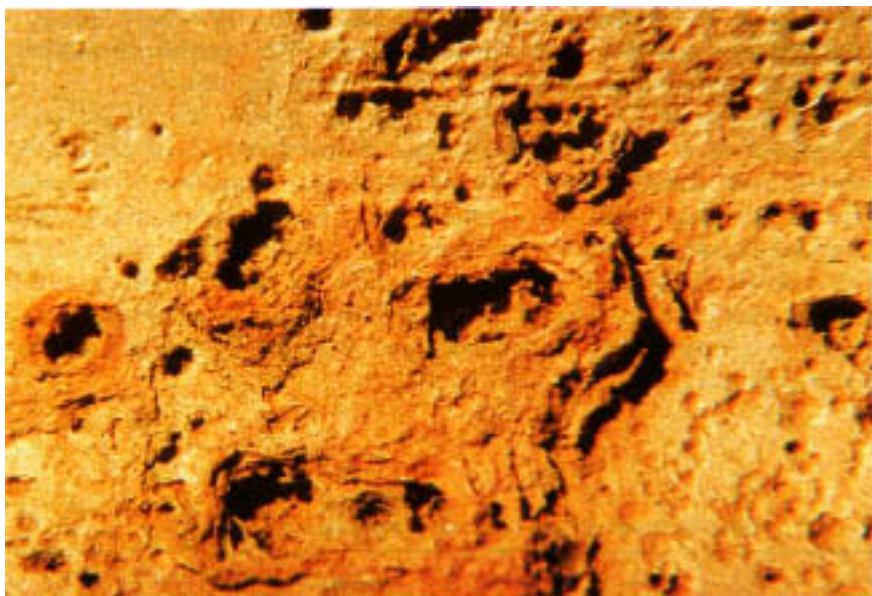
**Figure 1.9** Deposits on turbine blades before cleaning, as in Fig. 1.8. (Magnification: 7.5 $\times$ .)

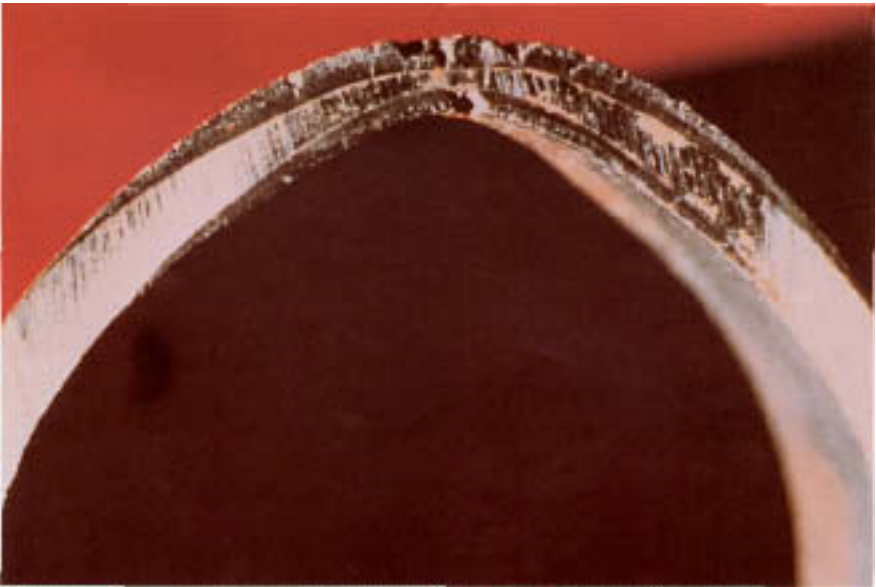
**Figure 2.3** Thick, thermally formed oxide on internal and external surfaces of a bulged wall tube. Thinning of intact metal at bulge is due to both plastic deformation and thermal oxidation.

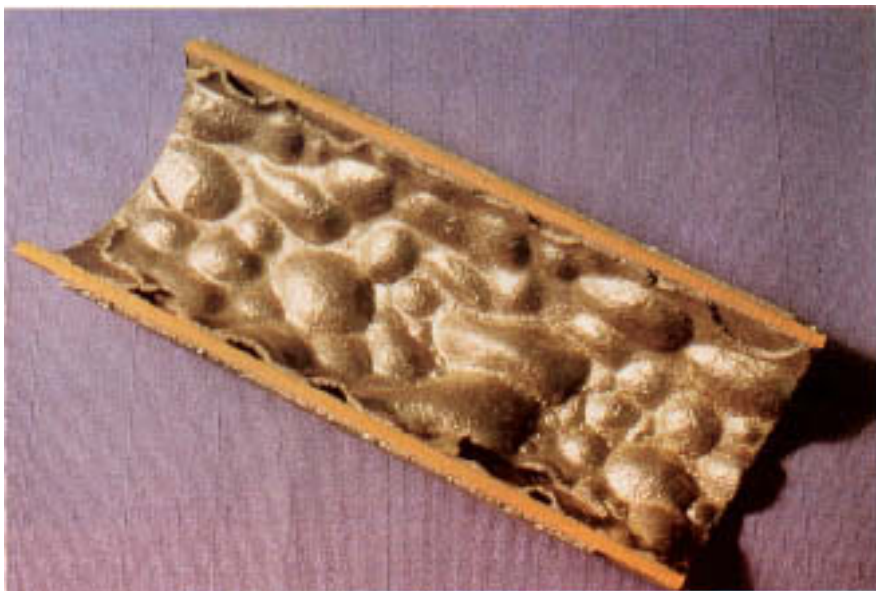
**Figure 2.4** Thick, blistered magnetite layer on internal surface of 150-psi (1.0-MPa) tube. Oxide was formed during dry firing of boiler. Metal temperatures approached 2000°F (1100°C), causing slow, “viscous” flow of magnetite.

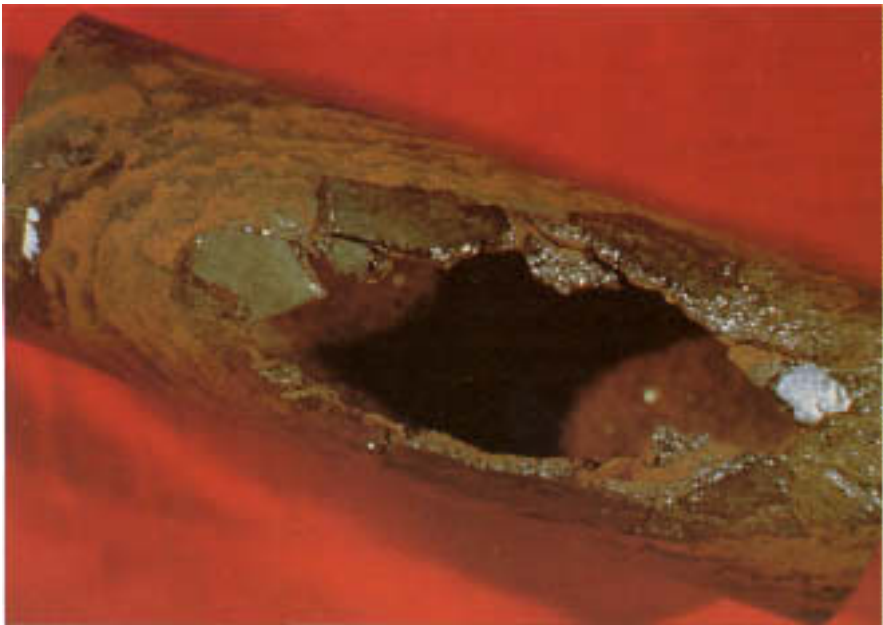
**Figure 2.6** Through-wall oxidation of a tube from a low-pressure boiler. Brittle black magnetite patches still adhere to the rupture mouth. Elsewhere the oxide has spalled. Such through-wall oxidation is most common in low-pressure boilers, where internal pressures are not sufficient to cause premature failure.

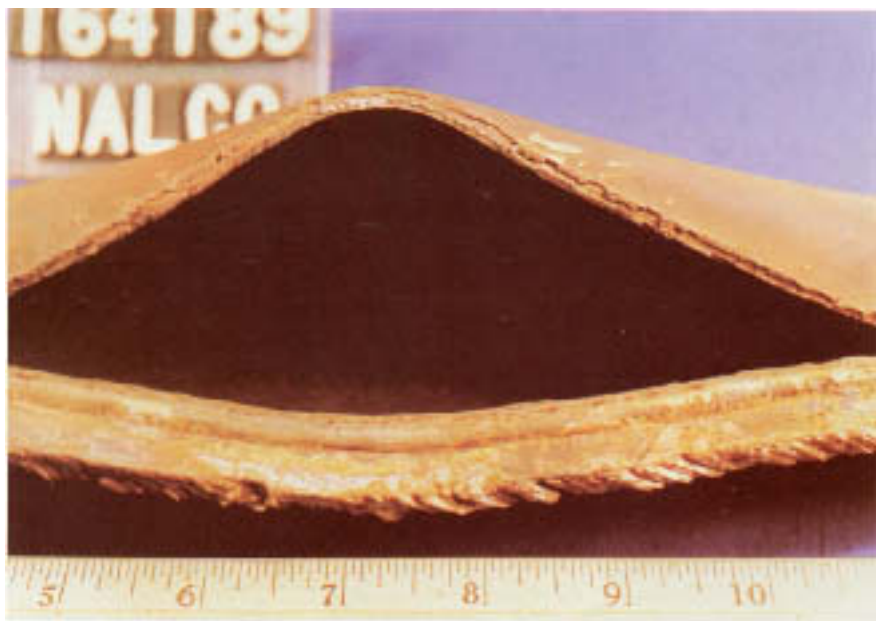
**Figure 2.9** Rupture at longitudinal weld due to chain graphitization. Note the blunt, rough rupture edge. Such failures occur after long-term mild overheating.

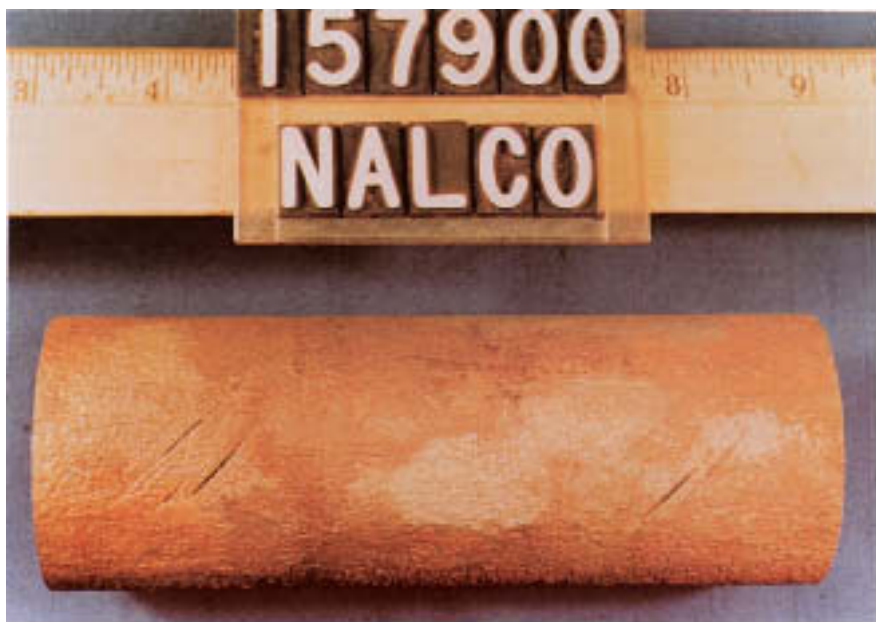
**Figure 2.10** Spiral through-fissures due to chain graphitization. These fissures formed along lines of maximum shear stress.

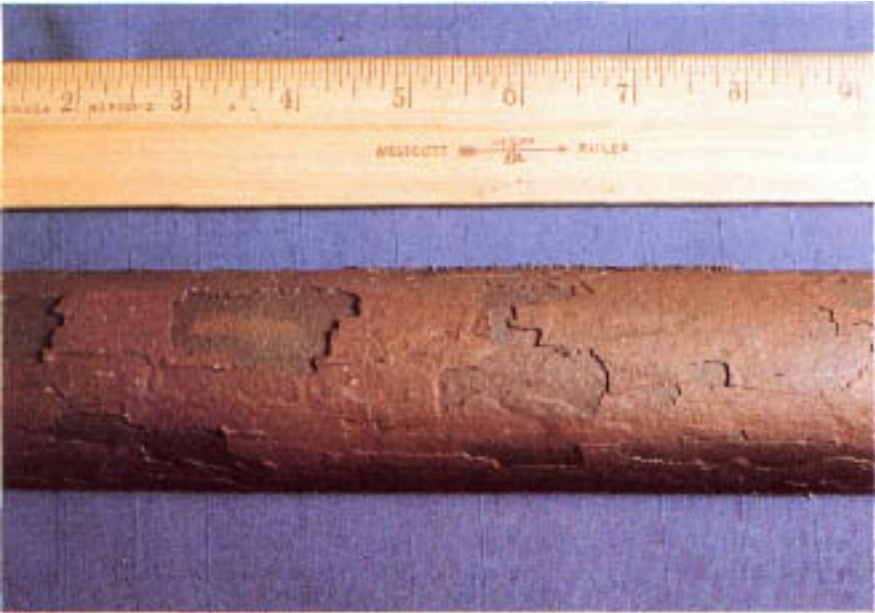
**Figure 2.11** Severe thermal oxidation and spalling of magnetite on external surface. The laminated nature of the scale indicates multiple episodes of spalling and oxide reformation.

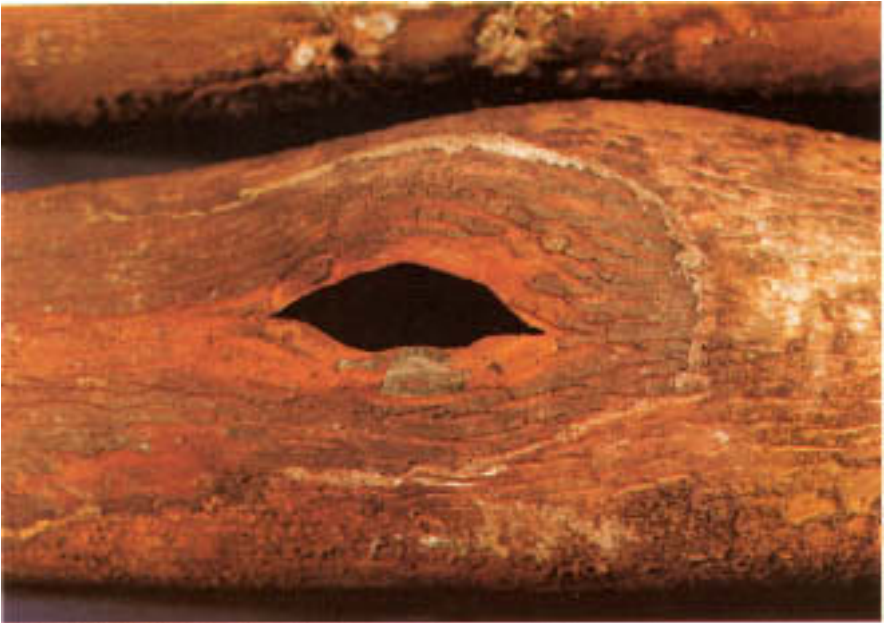
**Figure 2.14** As in Fig. 2.13. Fragmented thermally formed oxide surrounds the rupture.

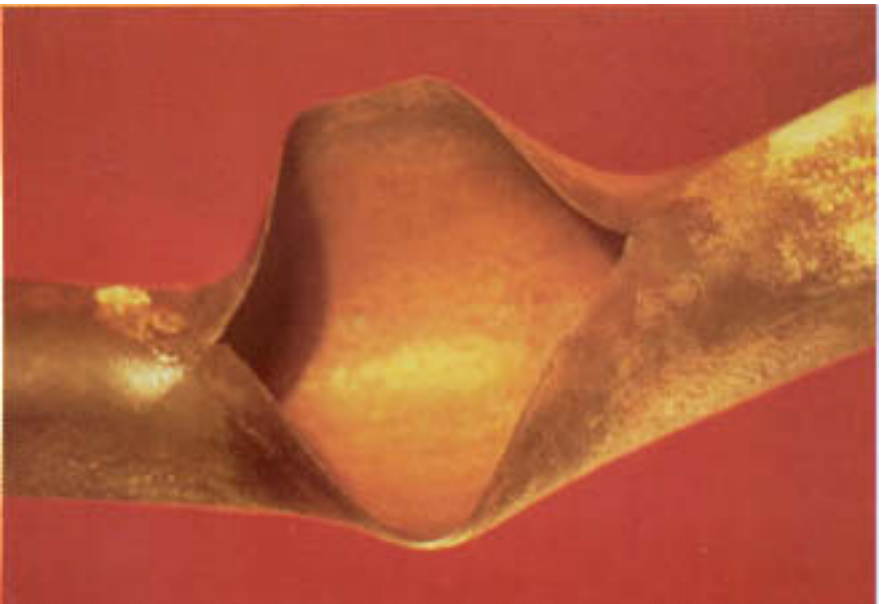
**Figure 3.2** Short-term overheating in which bulging occurred before rupture. Note the chisel-like rupture edges.

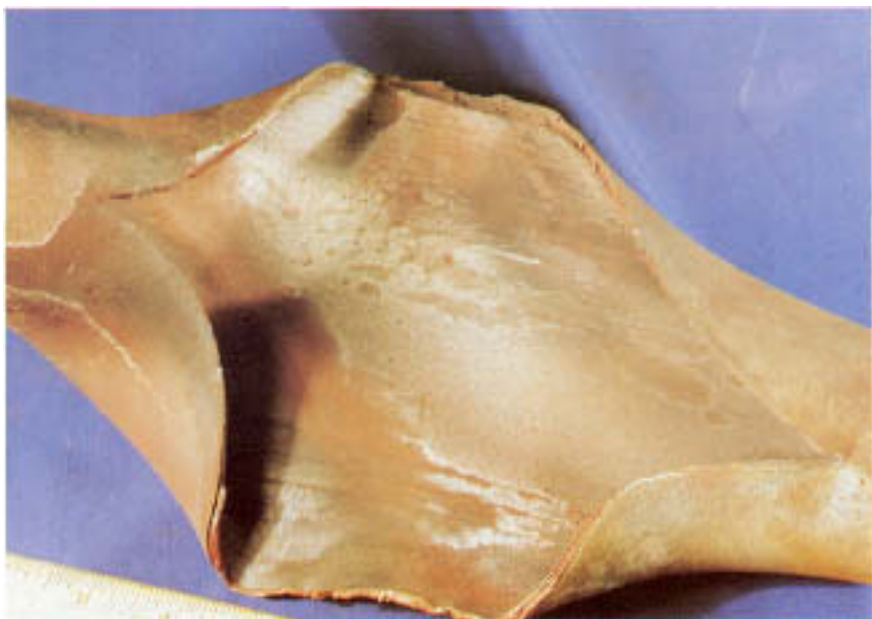
**Figure 3.3** Violent rupture caused by short-term overheating. The tube is bent almost to a right angle, caused by the severity of the burst.

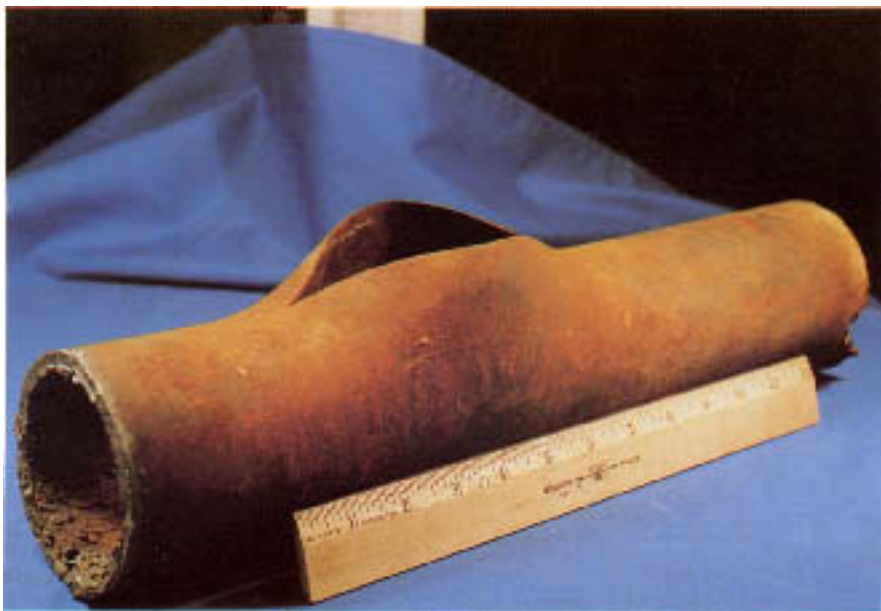
**Figure 3.4** A rupture at a single bulge. The tube had experienced long-term overheating, followed by a brief episode of severe overheating.

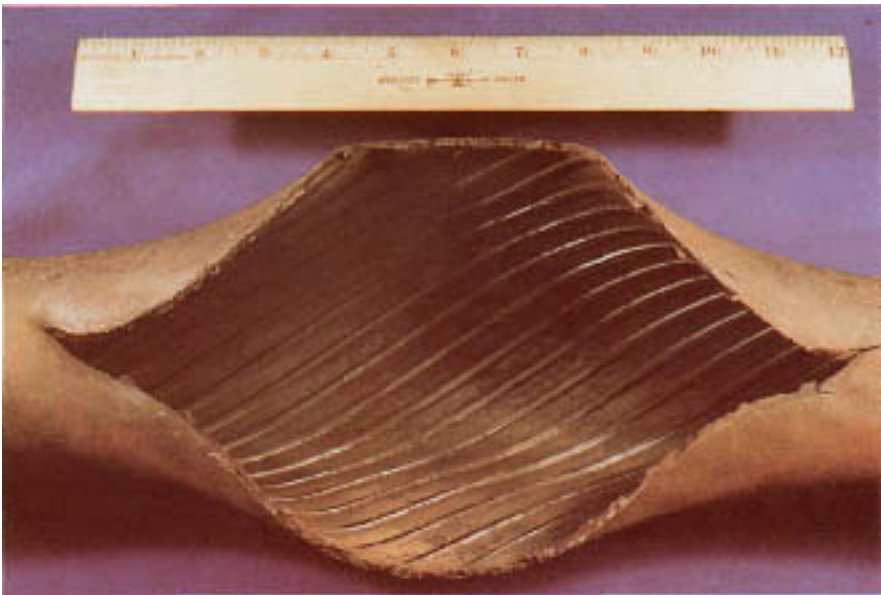
This section of the internally rifled waterwall nose arch contains a large, thick-wall rupture. Rupture edges are 12 in. (30 cm) long and have a jagged contour (Fig. 3.5). Both internal and external surfaces are smooth and are

**Figure 3.5** Large, fish-mouth rupture of rifled nose-arch tube. Rupture edges are thick, blunt, and ragged. Note the absence of significant deposits.

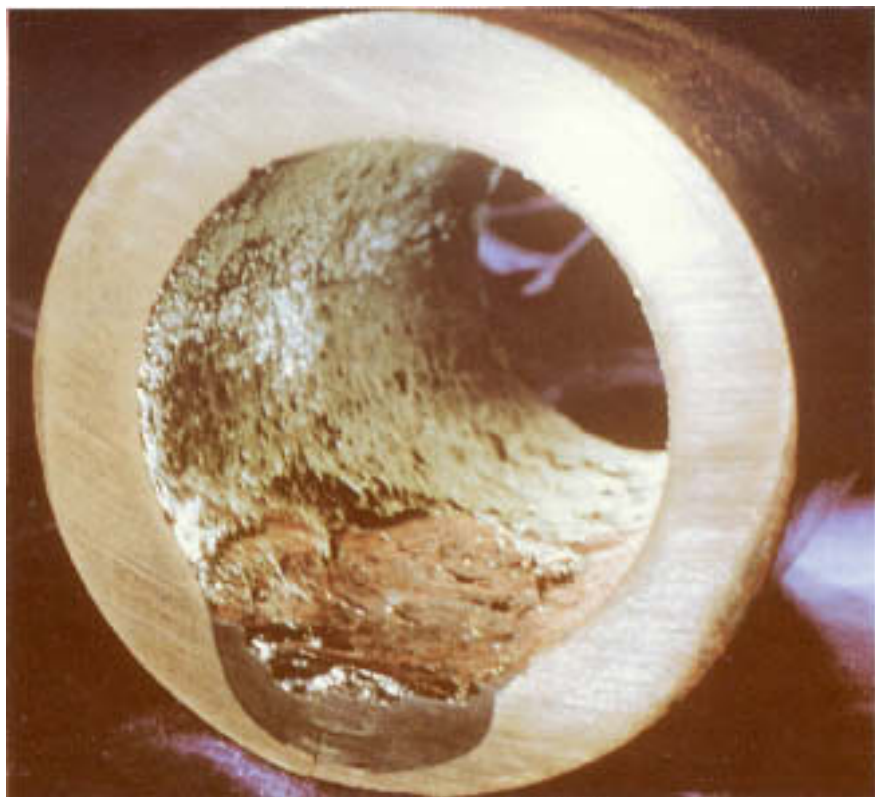
**Figure 4.3** Deep caustic gouging beneath insulating internal deposits. (Courtesy of National Association of Corrosion Engineers.)

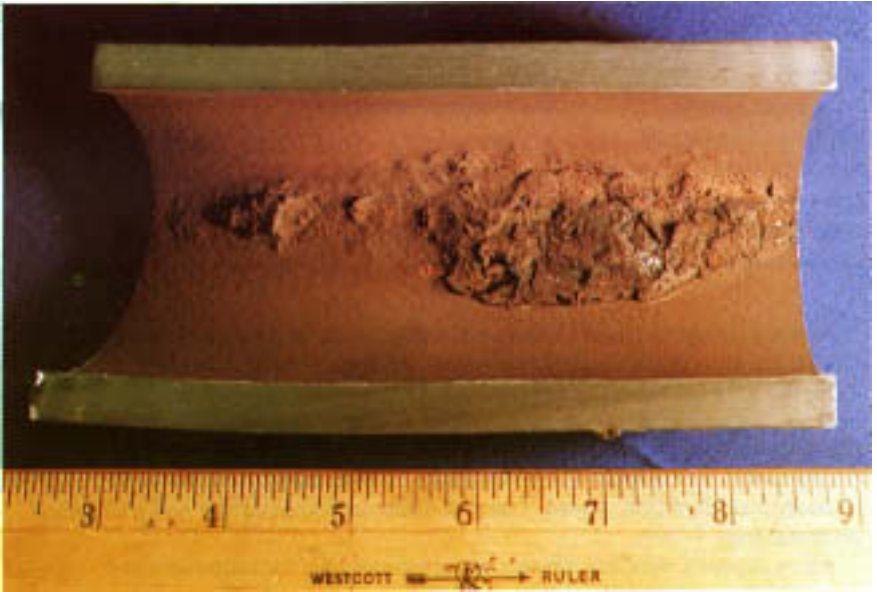
**Figure 4.7** Patch of hard iron oxides on internal surface.

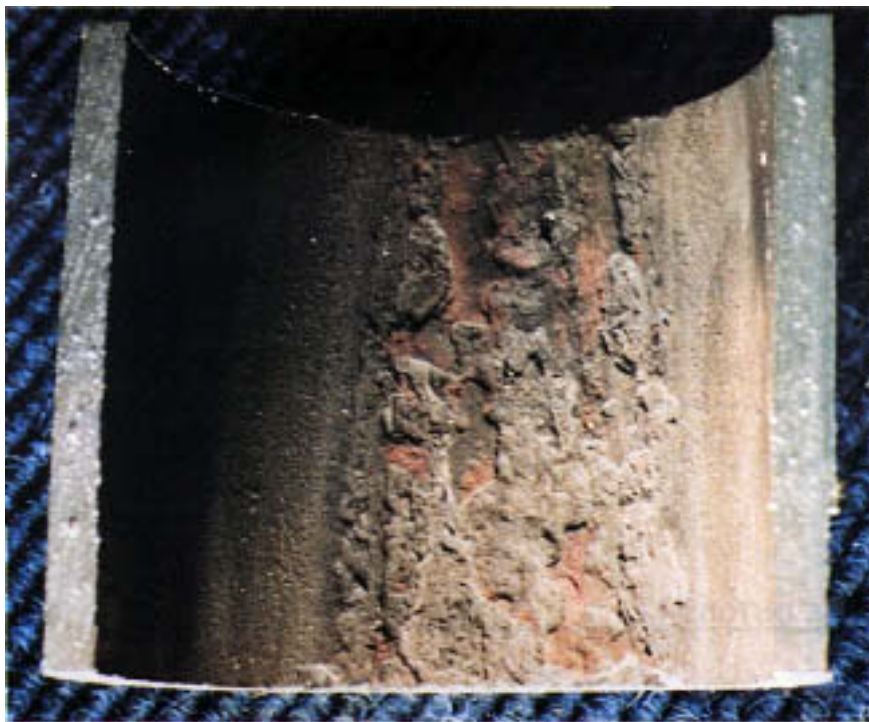
**Figure 4.14** Internal surface showing wasted metal.

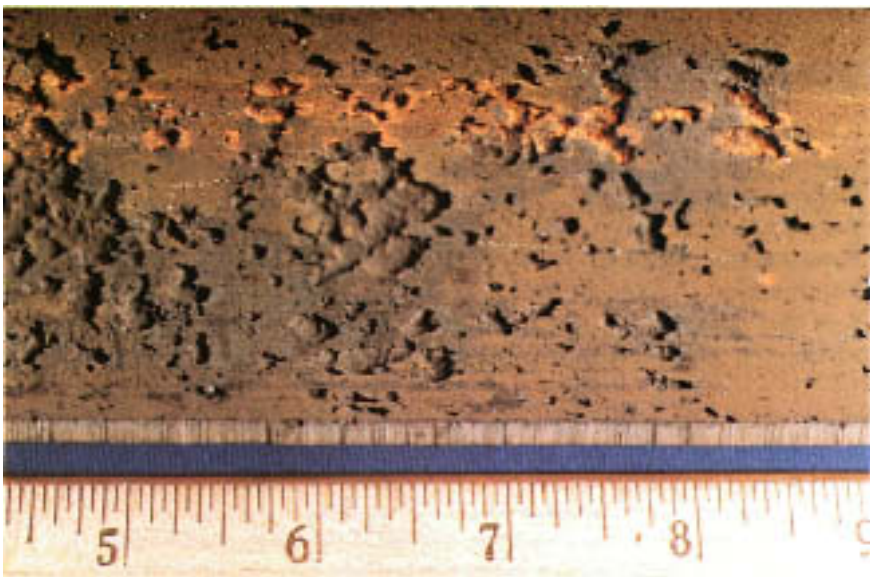
drum, and on the steam-separation canisters. This is evidence that excessive levels of dissolved oxygen were present in the feedwater. The excessive oxygen levels, coupled with the presence of the chelant, resulted in the corrosion observed. The metal loss produced smooth, rolling, wavelike surface contours and islands of intact metal in affected areas (Fig. 5.7).

**Figure 5.7** Internal surface of downcomer tube showing oxygen-assisted chelant corrosion.

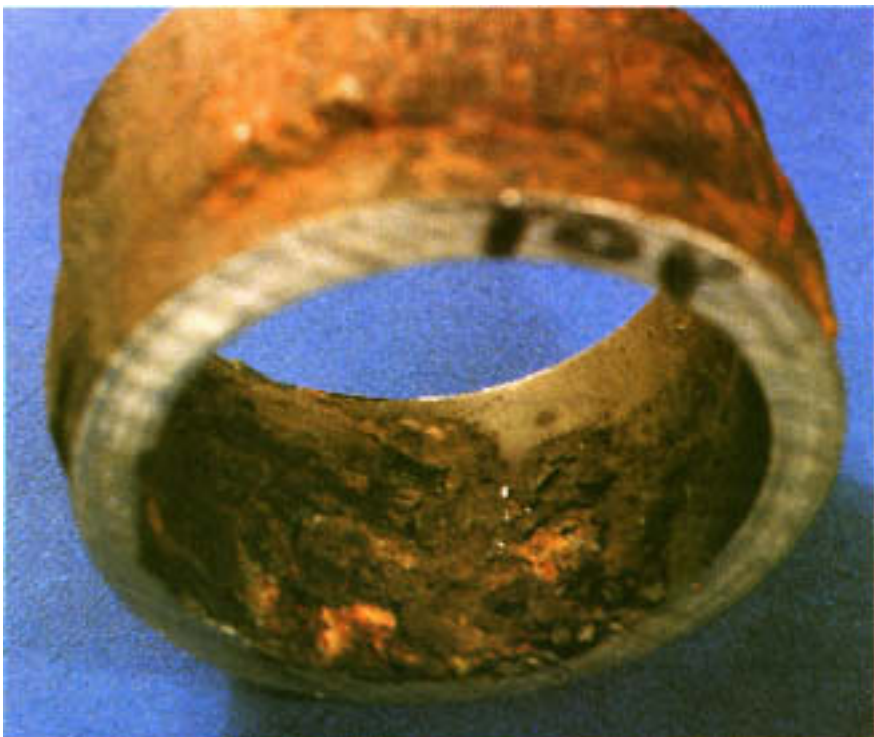
**Figure 6.1** Low-pH gouging.

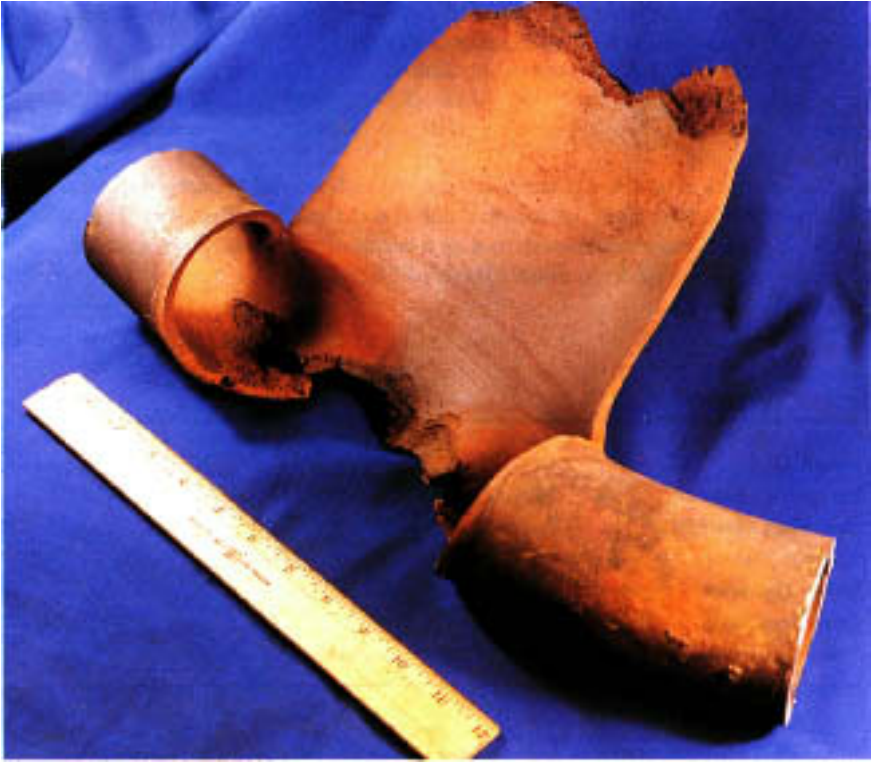
**Figure 6.3** Rupture associated with low-pH gouging.

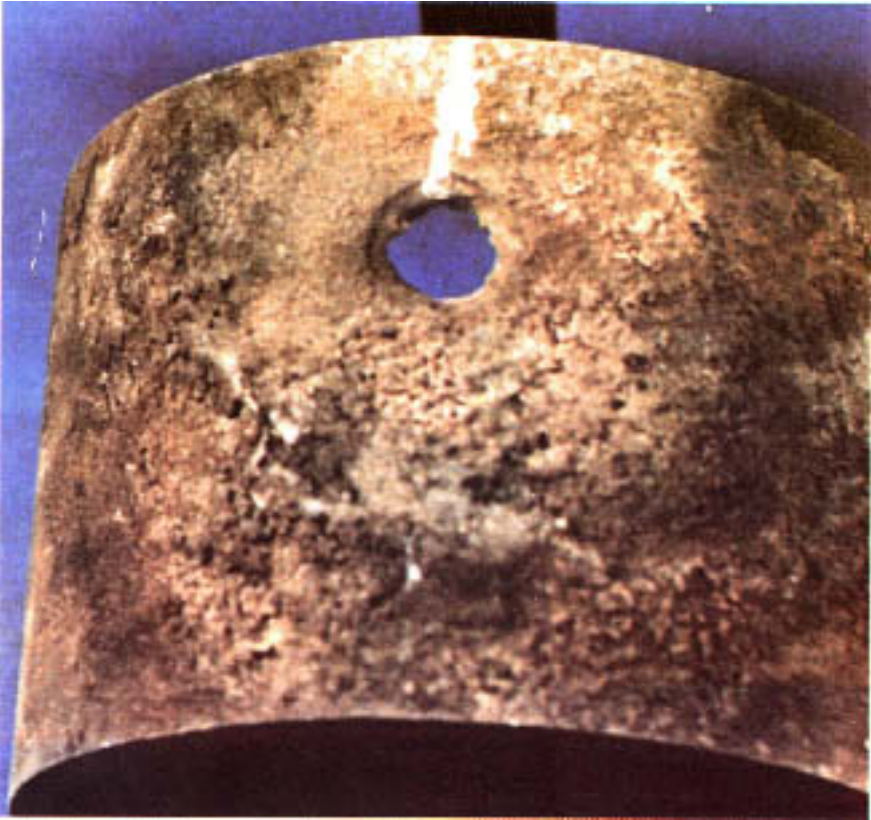
**Figure 6.9** Perforation resulting from corrosion of internal surface.

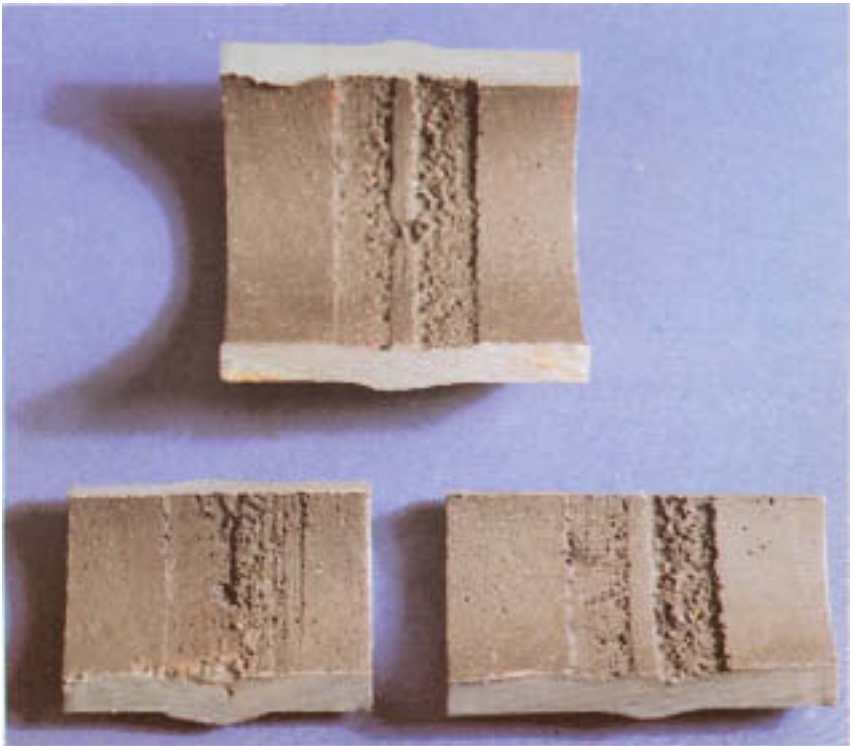
**Figure 7.2** Acid corrosion at weld.

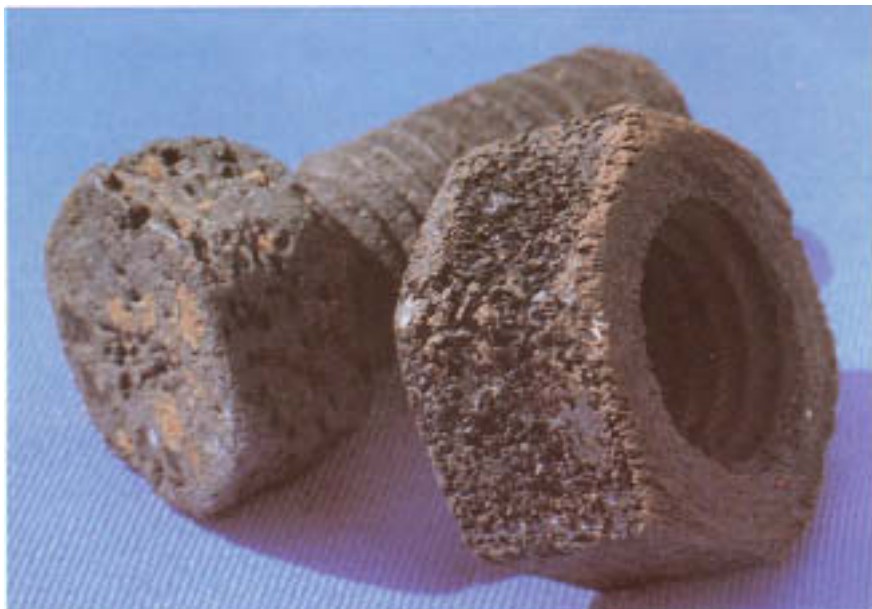
**Figure 7.3** Acid corrosion of attachment hardware.

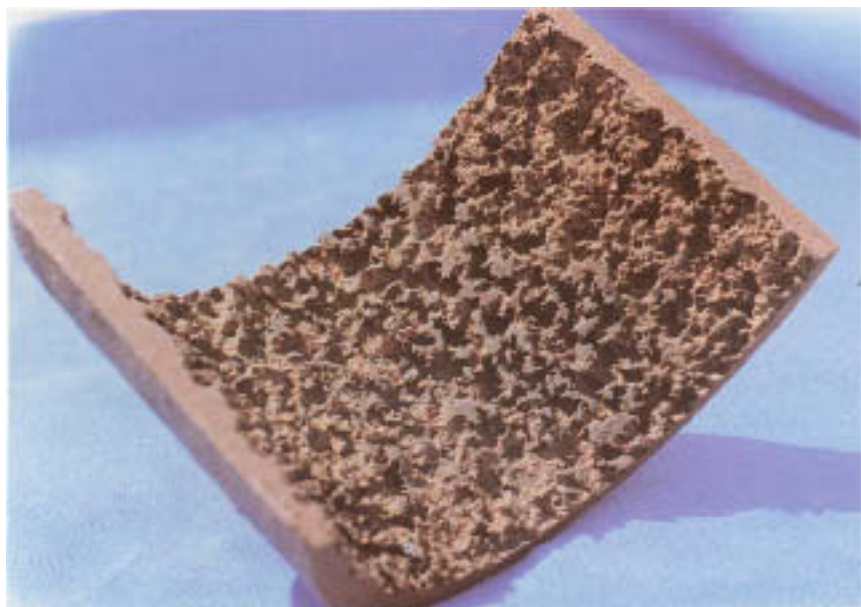
**Figure 7.4** Jaggedness associated with severe acid corrosion. (Courtesy of Electric Power Research Institute.)

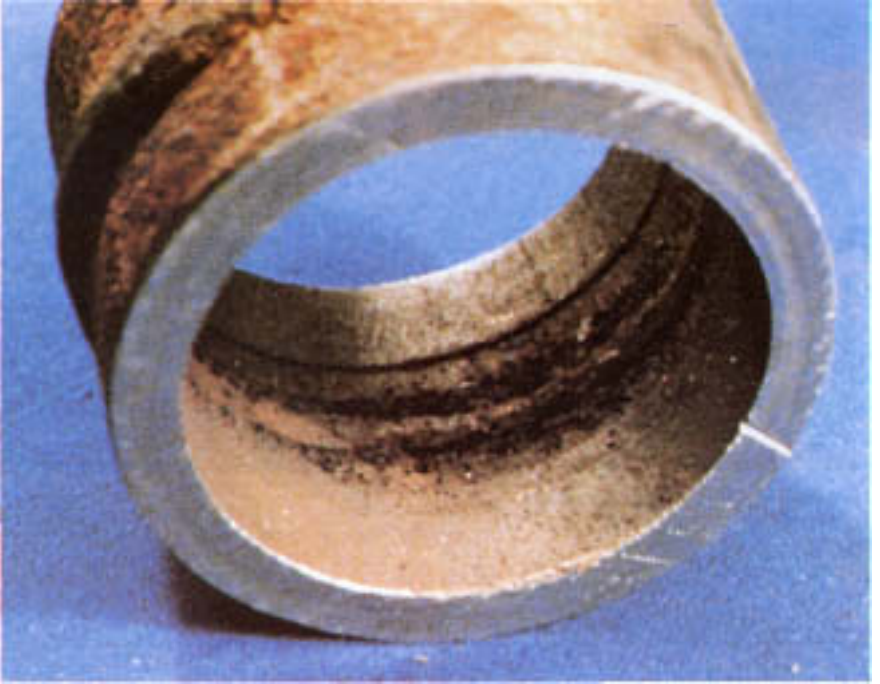
**Figure 7.9** Acid corrosion at weld.

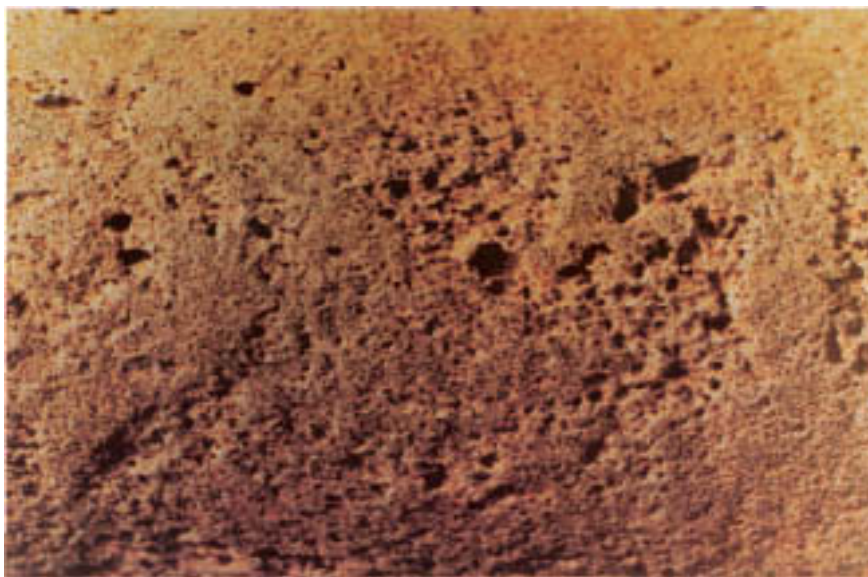
**Figure 7.14** Close-up of external surface shown in Fig. 7.13.

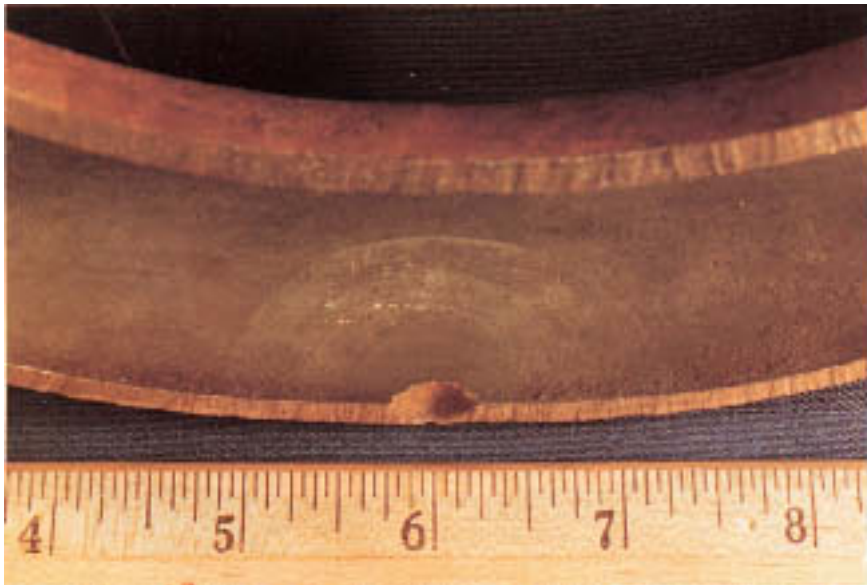
**Figure 8.4** Elliptical water rings surrounding oxygen pit in a U-bend. (Courtesy of Electric Power Research Institute.)

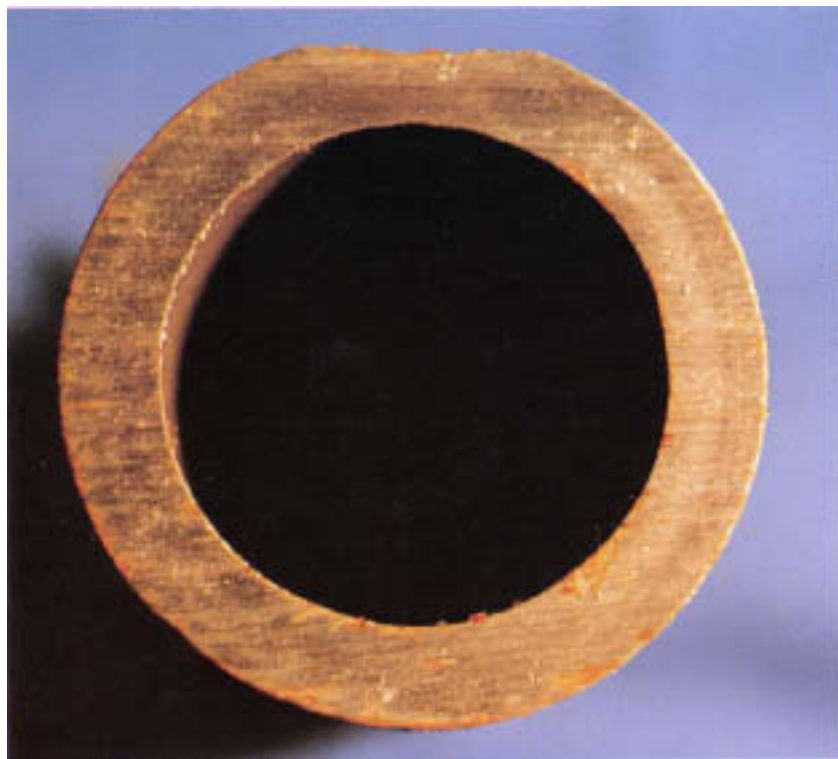
**Figure 10.5** Transverse profile of tube showing metal loss.

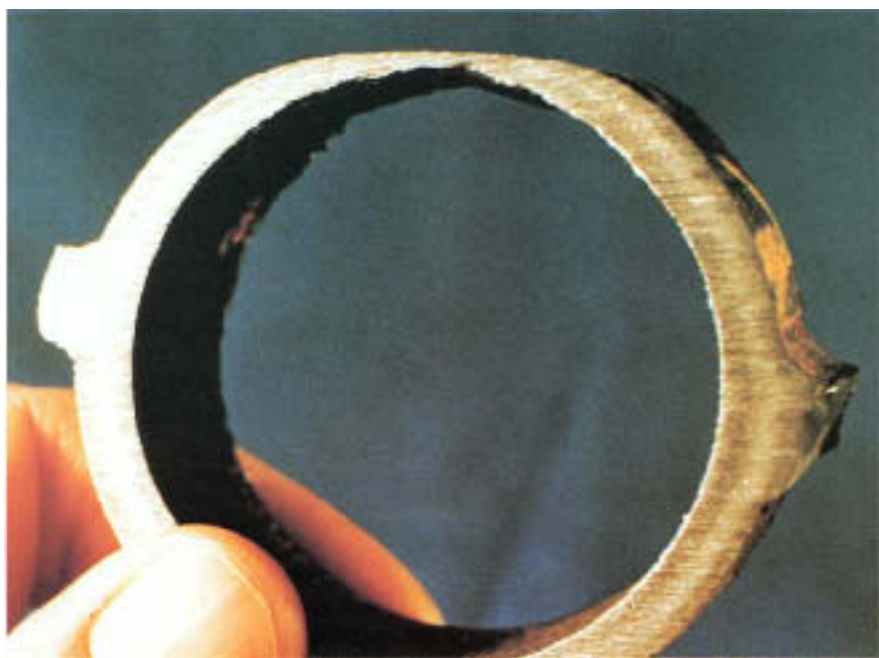
**Figure 11.6** Severe metal loss along crown of tube resulting from exposure to a molten phase.

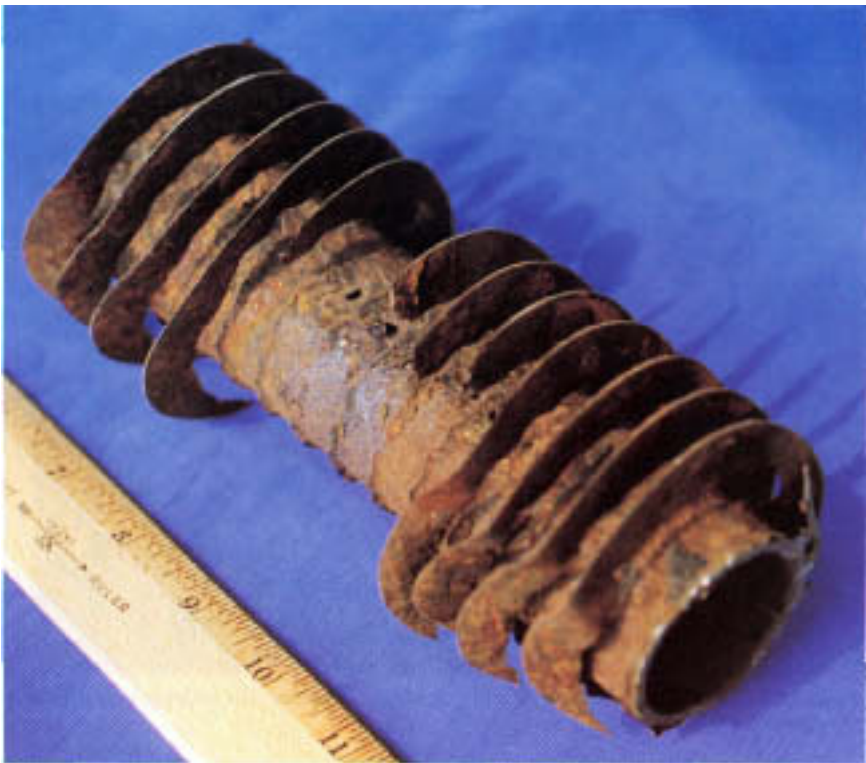
**Figure 12.4** Corrosion and perforations of finned economizer tube resulting from exposure to condensed sulfuric acid. Note detachment of fins from tube wall.

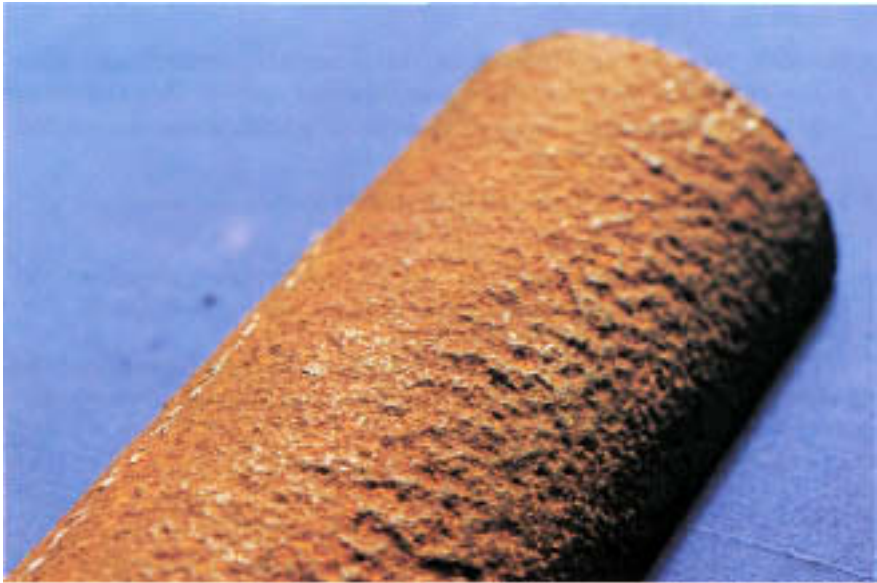
**Figure 13.3** Appearance of the external surface of a screen tube after exposure to moisture and corrosive deposits during idle periods.

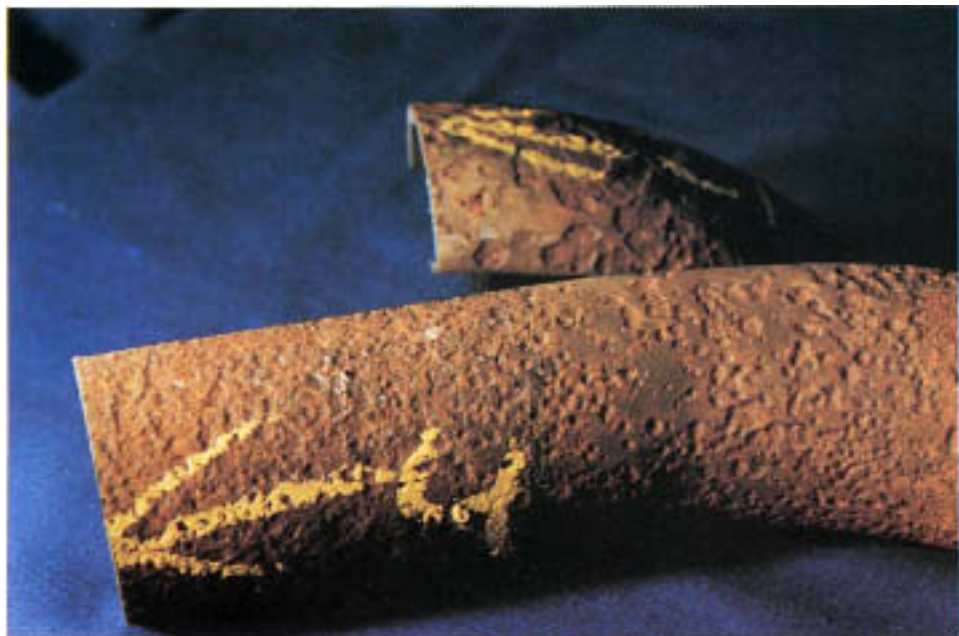
**Figure 13.4** External surface of economizer tube following dew-point corrosion.

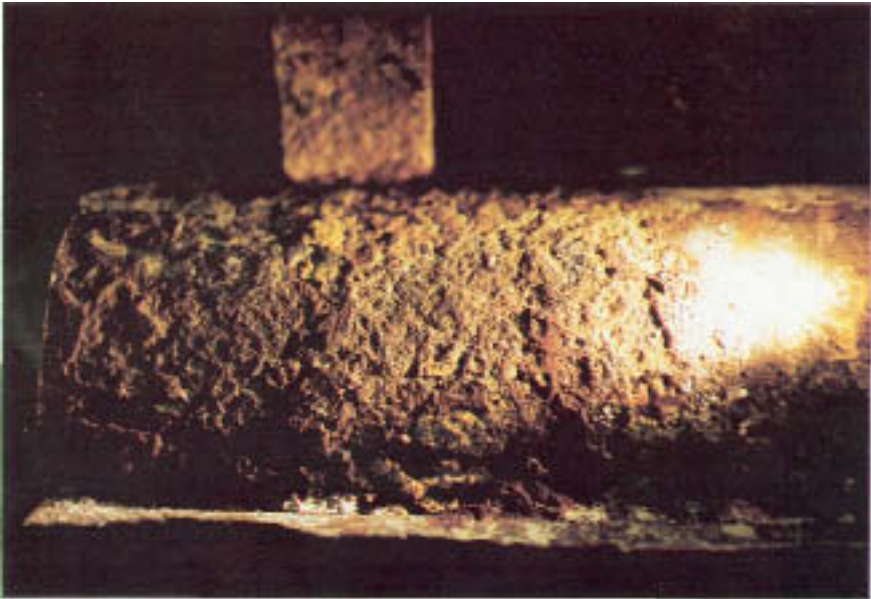
**Figure 13.5** Idle-time corrosion occurring beneath refractory.

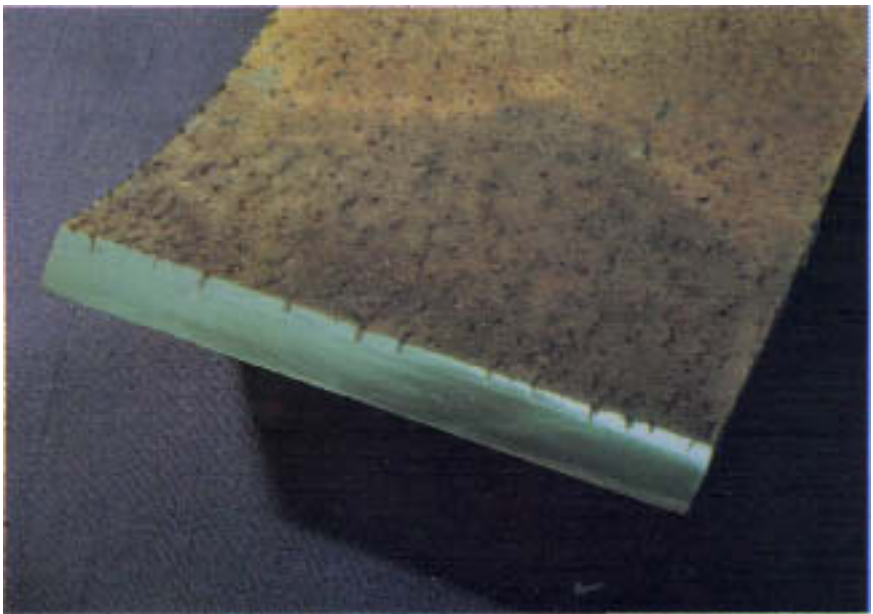
**Figure 15.4** Transverse cracks originating on the internal surface.

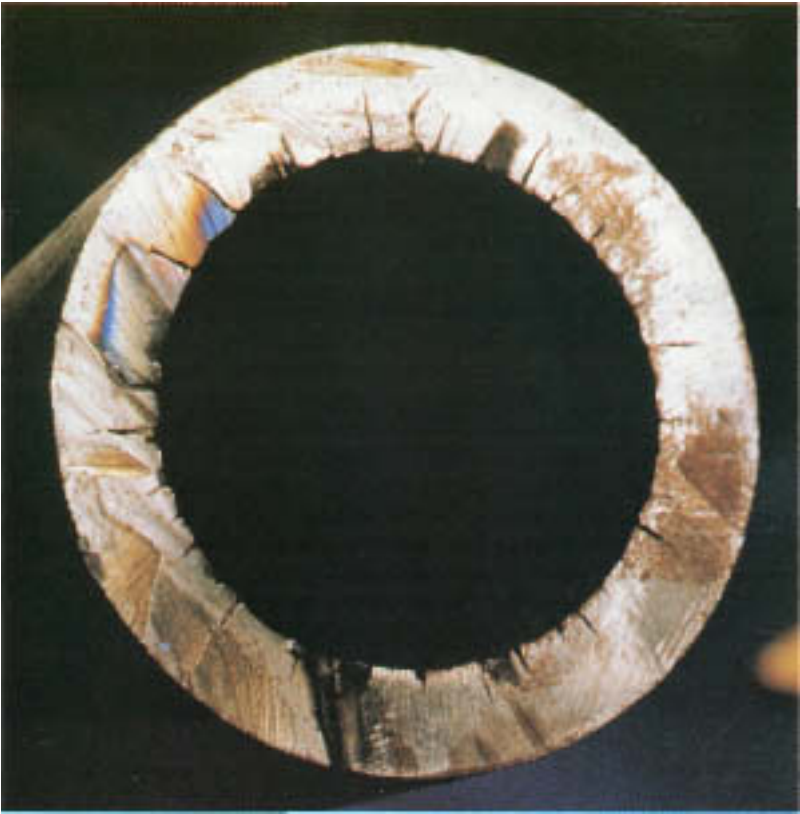
**Figure 15.7** Cross section through cracks.

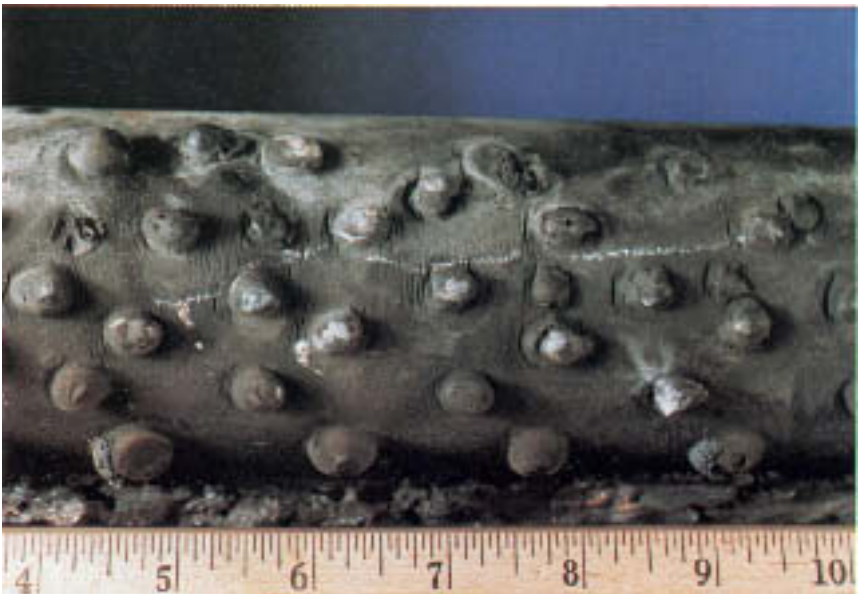
**Figure 15.8** Transverse fissures at and near stud bases.

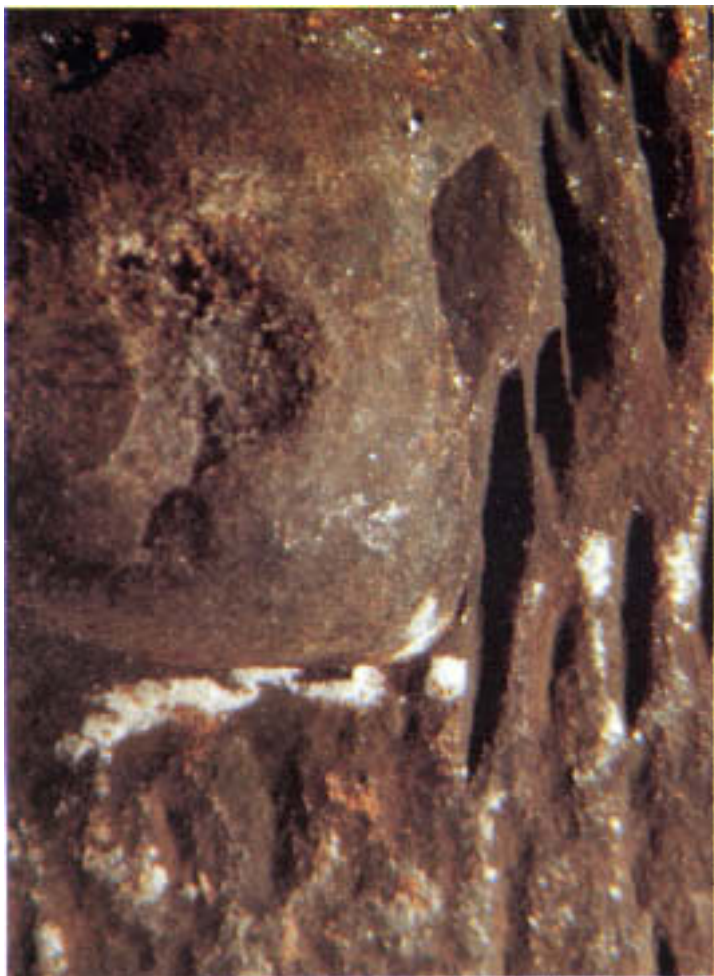
**Figure 15.9** Transverse fissures near stud (center). (Magnification: 6.5X.)

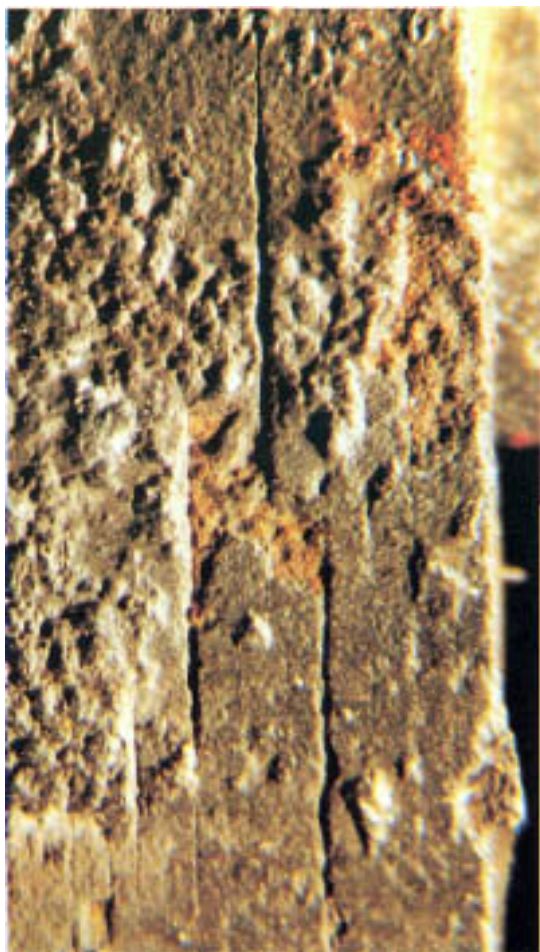
**Figure 15.11** Secondary corrosion-fatigue cracks on external surface. (Magnification: 6.5 $\times$ .)

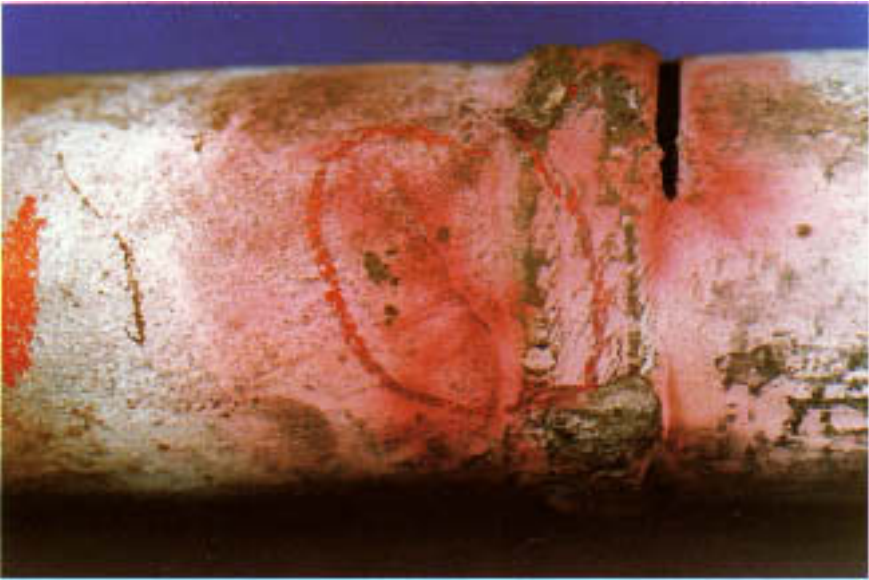
**Figure 16.5** Appearance of stress-corrosion crack on the external surface. Crack is located within the red circle.

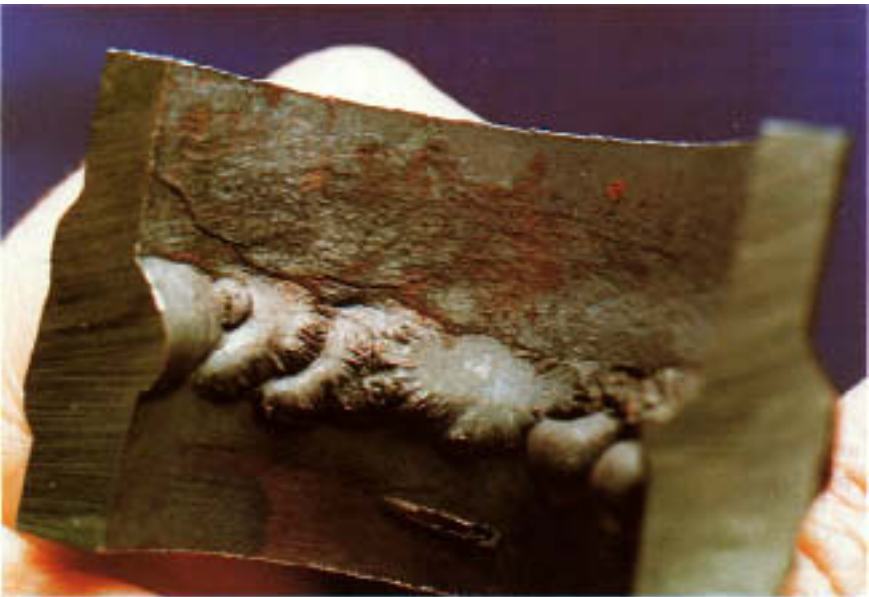
**Figure 16.6** Appearance of crack on the internal surface. Note the branching and proximity to the weld bead.
