# **The Nalco Guide to Boiler Failure Analysis**

**Nalco Chemical Company**

**Robert D. Port**

**Harvey M. Herro**

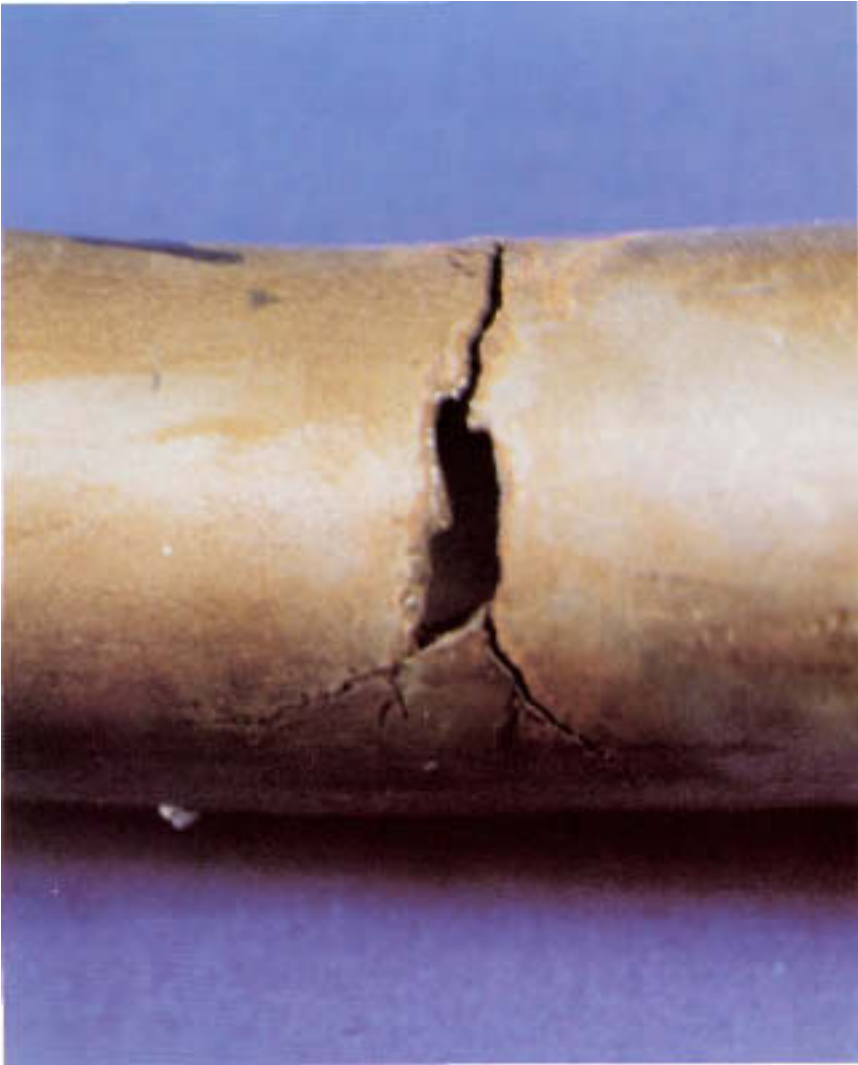
**Figure 16.7** Transverse crack resulting from caustic stress corrosion in a bent stainless steel superheater tube. Note small “window” that has been blown out of the wall.

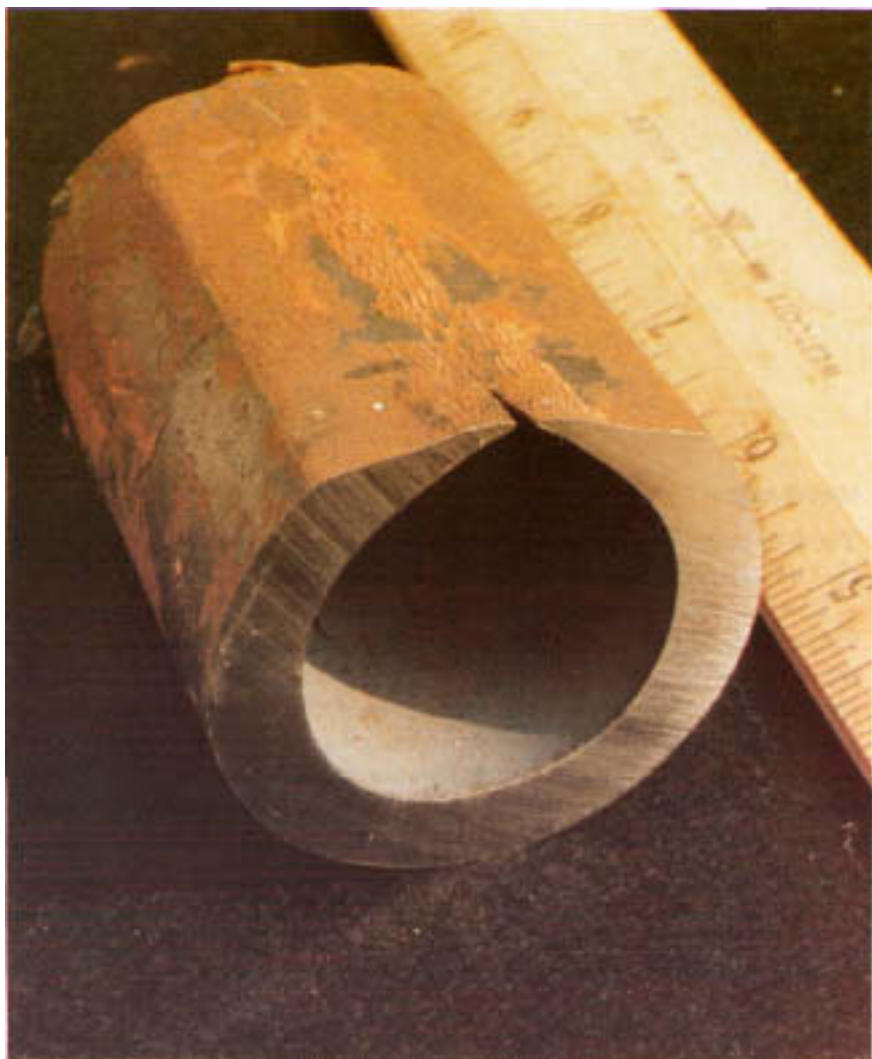
**Figure 17.1** Superheater section thinned by soot-blower erosion. Note the flattened surface. The tube bulged and ruptured on the thinned side. Also, note how the eroded surface color is not dissimilar to unattacked regions, indicating intermittent attack.

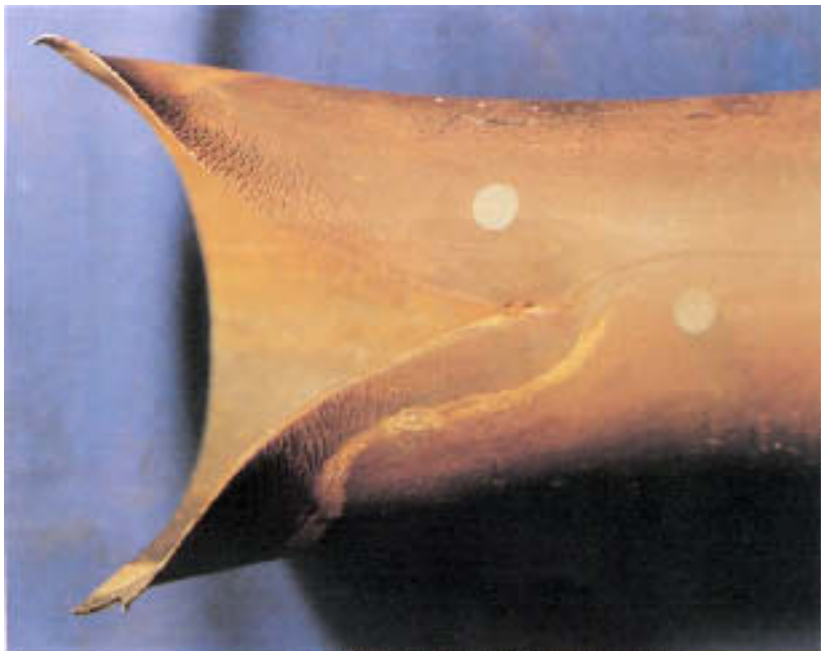
**Figure 17.3** Numerous parallel surface ripples at the edges of an external-surface rupture in a superheater tube. The light circles are regions where acid drops removed the thin oxide layer during laboratory testing.

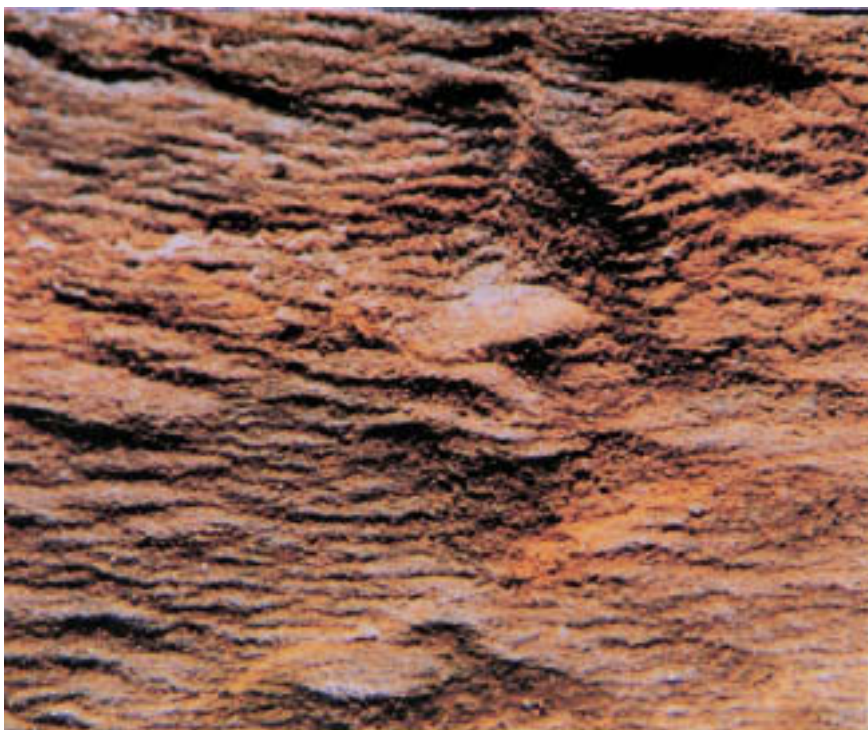
**Figure 17.4** Finely spaced, wavelike, parallel undulations on eroded fire-side external surface of superheater tube. The striations resemble waves viewed from the air and are aligned perpendicularly to the direction of steam impingement. (Compare with Fig. 17.3.)

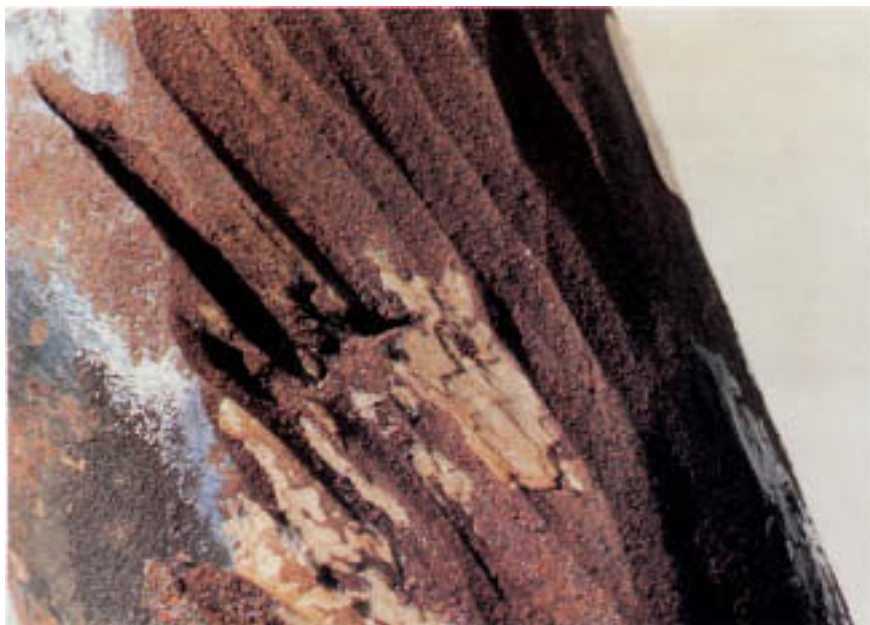
**Figure 17.6** Grooving on pendant U-bend superheater leg caused by steam leaking through a corrosion-fatigue crack at the U-bend. Grooves were rusted after removal from boiler.

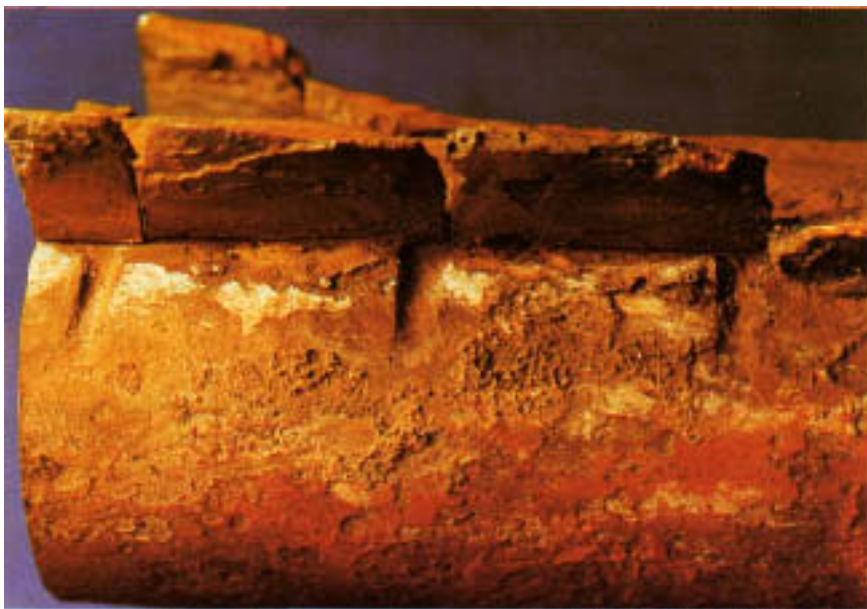
**Figure 17.8** Deep grooves cut into the hot side of a waterwall tube. Grooving was caused by channeling of furnace gases containing entrained fly ash.

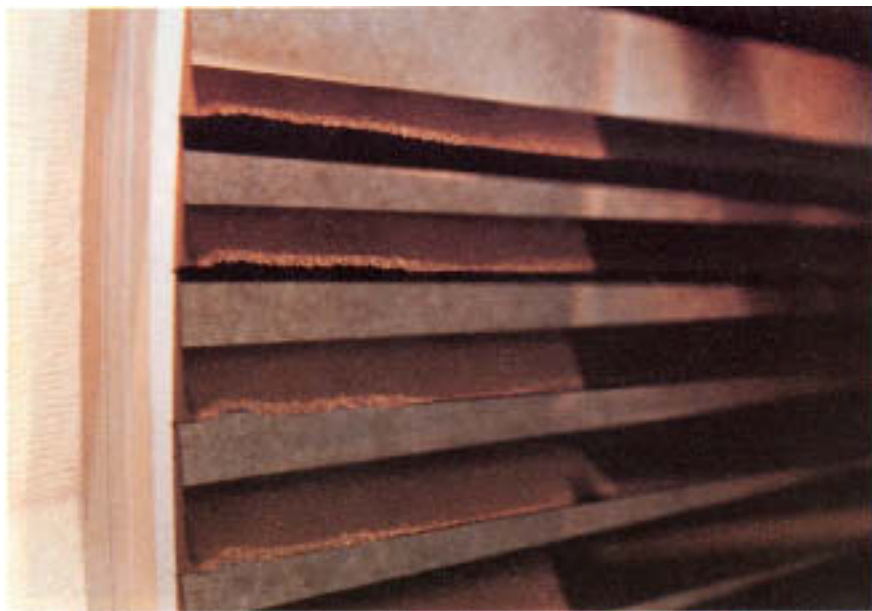
**Figure 17.10** Ragged leading edges of final-stage turbine blades. Damage was caused by water-droplet impingement.

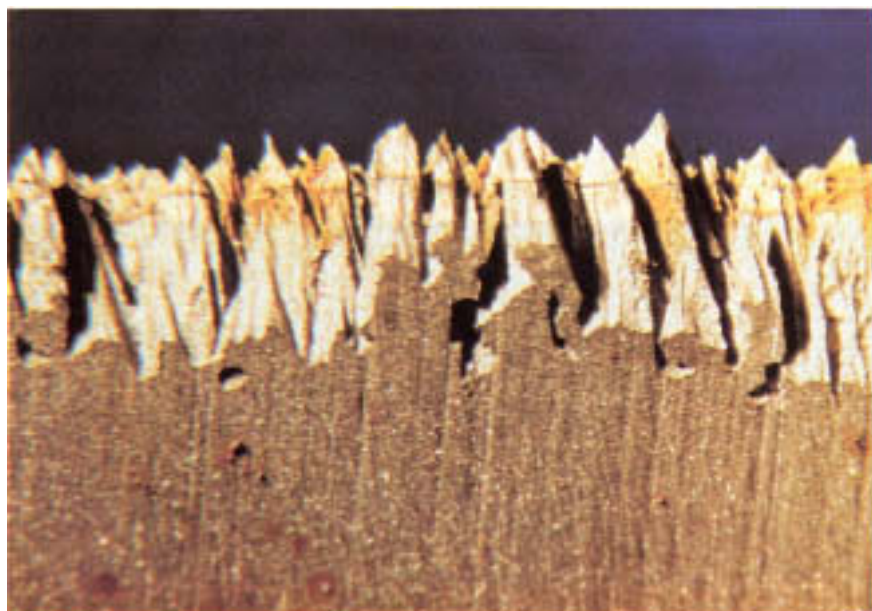
**Figure 17.11** Fine, striated grooves on front face of final-stage turbine blade caused by water-droplet impingement. (Magnification: 7.5X.)

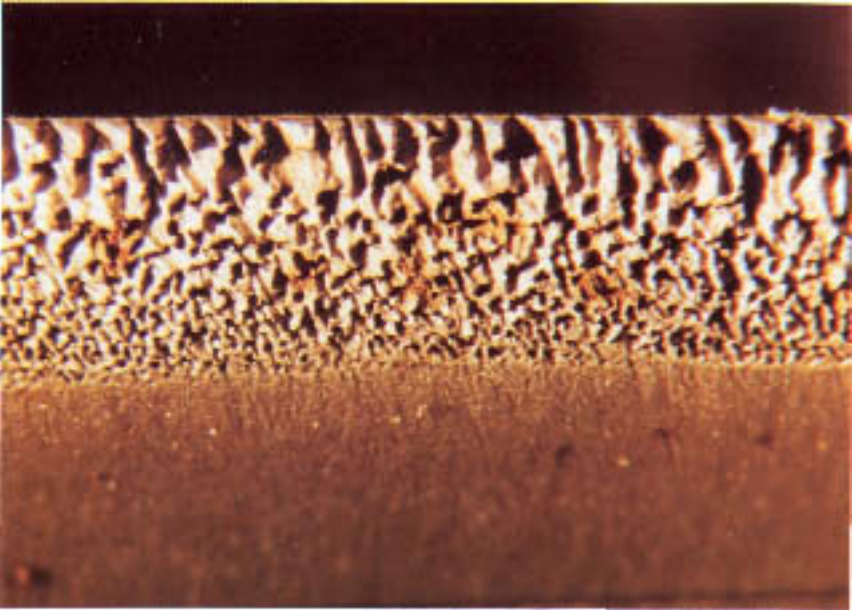
**Figure 17.12** Dimpling of back edge of bucket surface shown in Fig. 17.11.

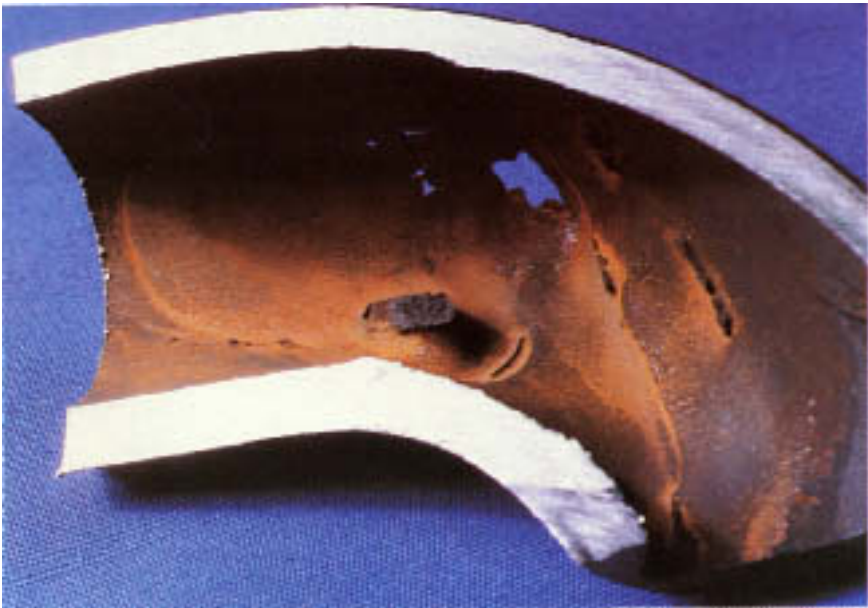
**Figure 17.15** Elliptical metal-loss pattern and intact island of tube metal at perforated superheater U-bend. Erosion was caused by an object left in the tube 10 months earlier.

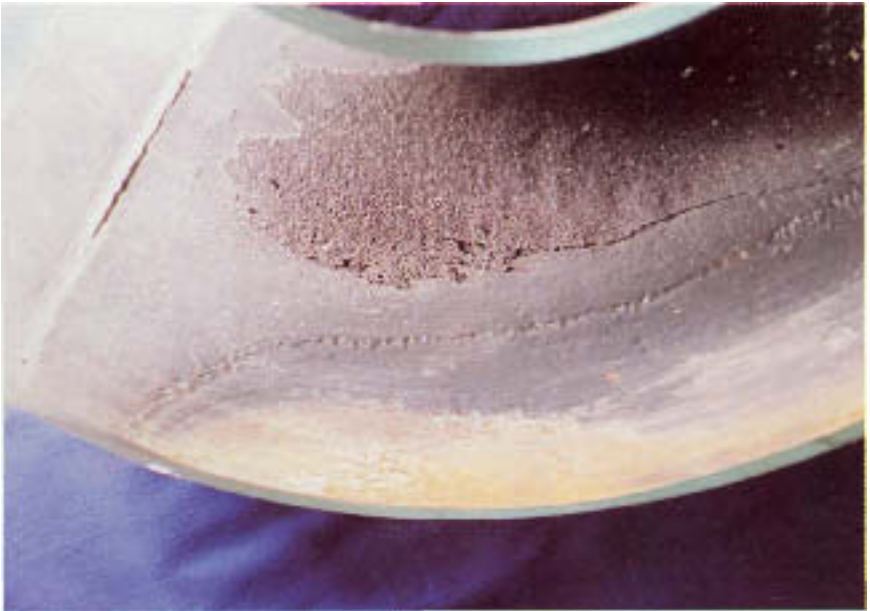
**Figure 17.17** Localized metal loss in a bend of a condensate return header.

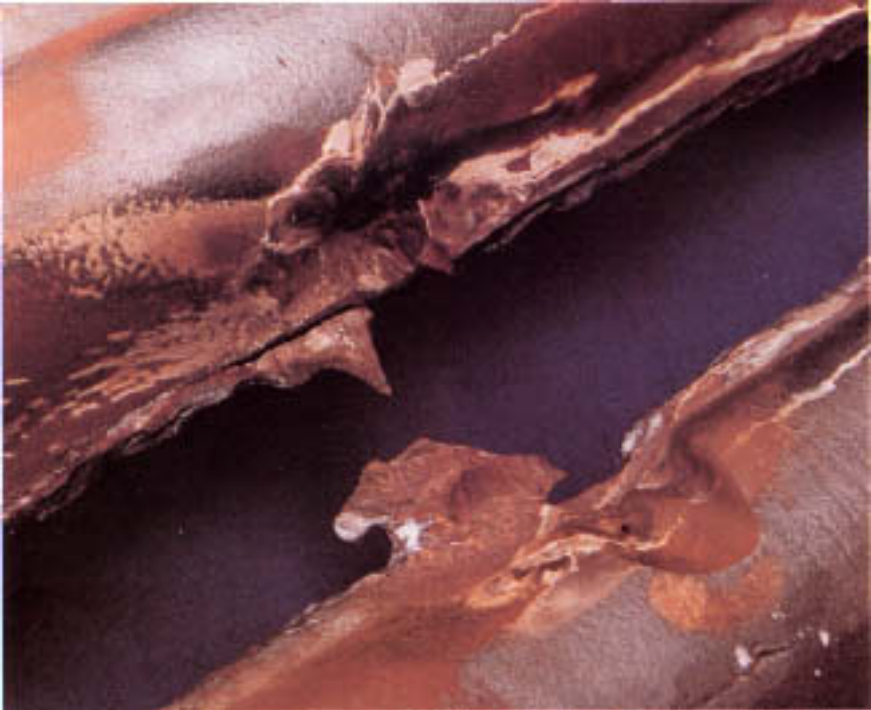
**Figure 17.20** Steam cutting of utility convection tubes. The original failure occurred at a welded support bracket and was due to corrosion fatigue. The adjacent tube was breached by escaping steam from the original failure.

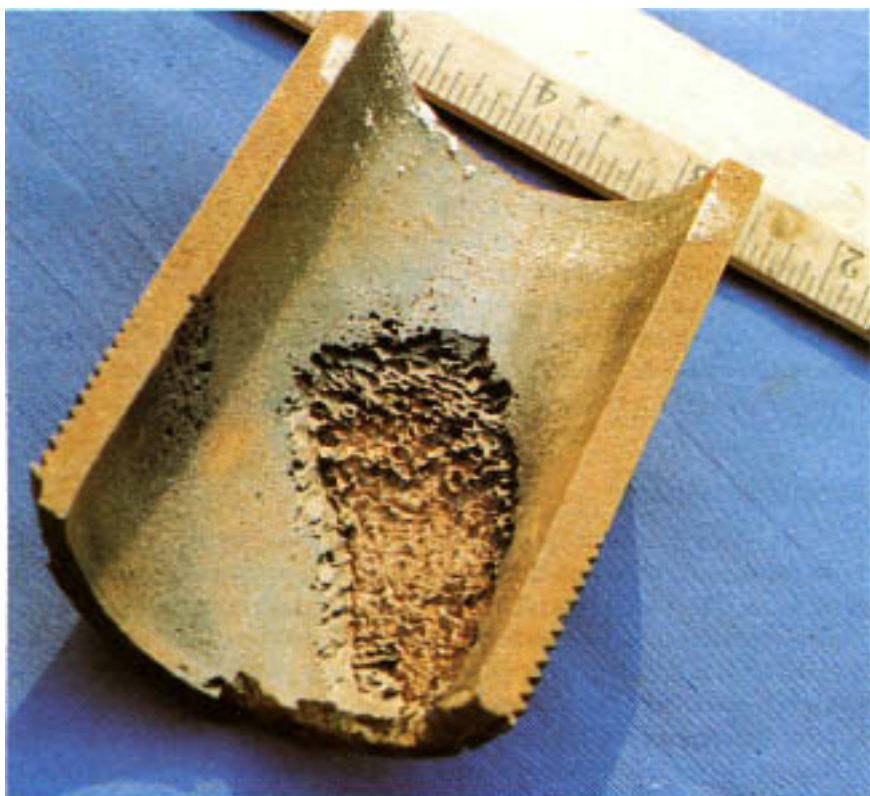
**Figure 18.1** Longitudinally split blowdown line with severe localized metal loss caused by cavitation.

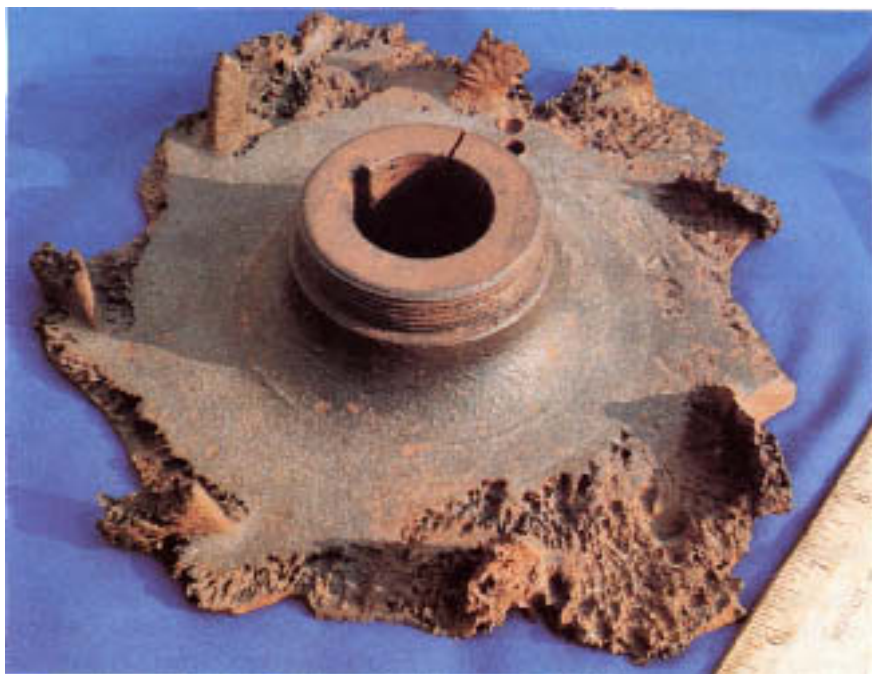
**Figure 18.3** A cast steel feedwater-pump impeller severely damaged by cavitation. Note how damage is confined to the outer edges of the impeller where vane speed was maximum.

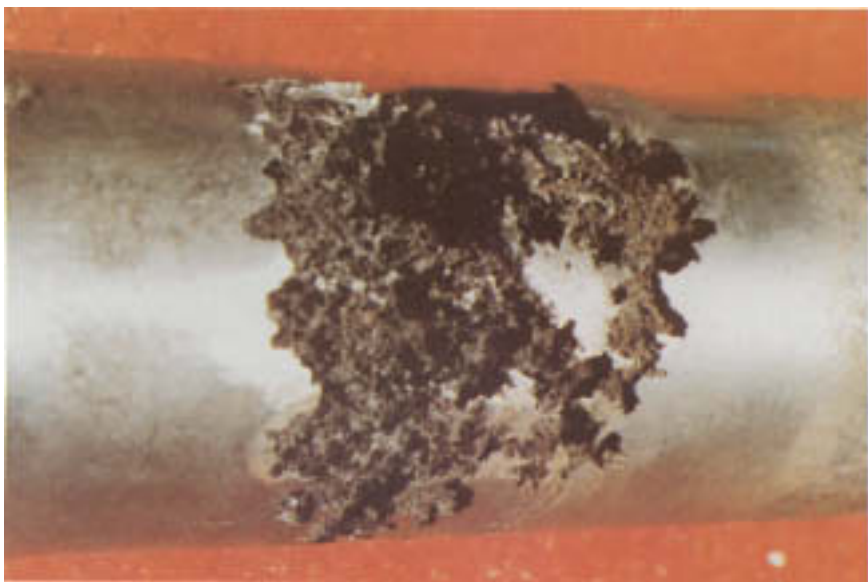
**Figure 18.5** Highly localized cavitation damage on steel feedwater-pump shaft. Adjacent regions are free of metal loss.

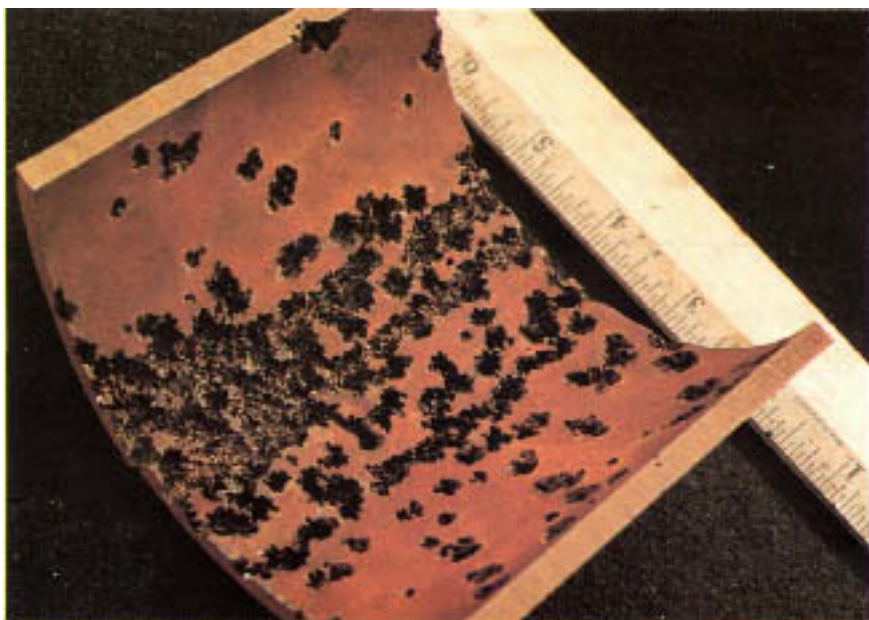
**Figure 18.6** Heavily pitted condensate line. Attack resembles oxygen pitting, but was caused (at least in part) by cavitation.

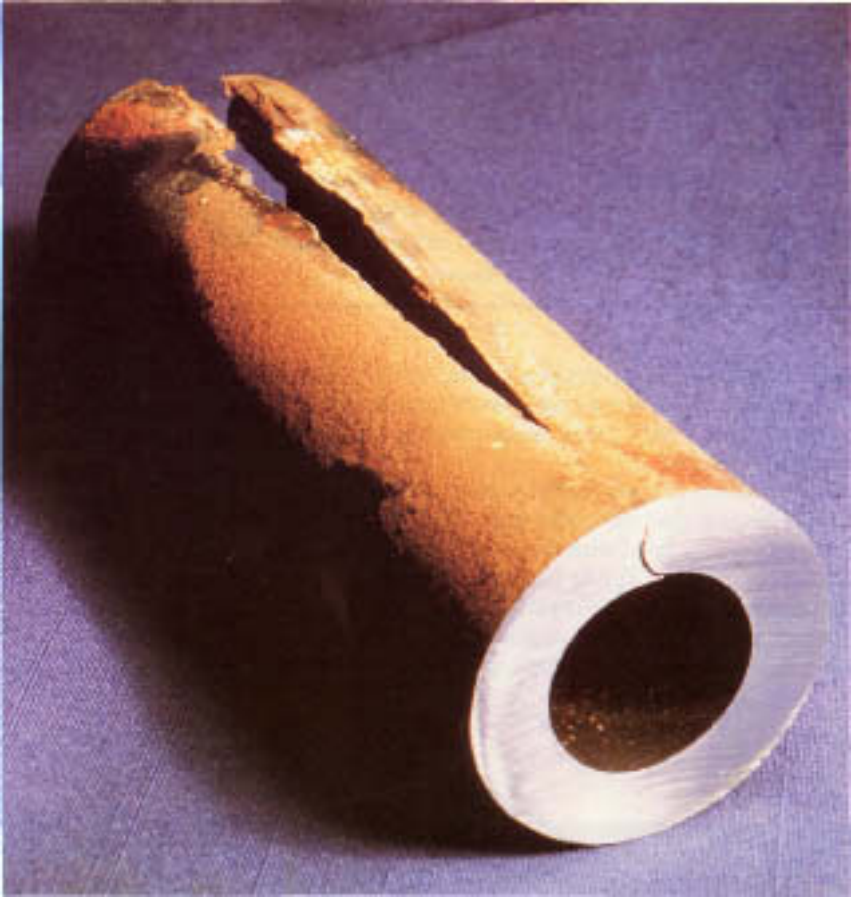
**Figure 19.1** Curved defect originating on the internal surface of a seamless tube. This defect ran for 18 in. (45.7 cm) along the length of the tube. (Courtesy of National Association of Corrosion Engineers.)

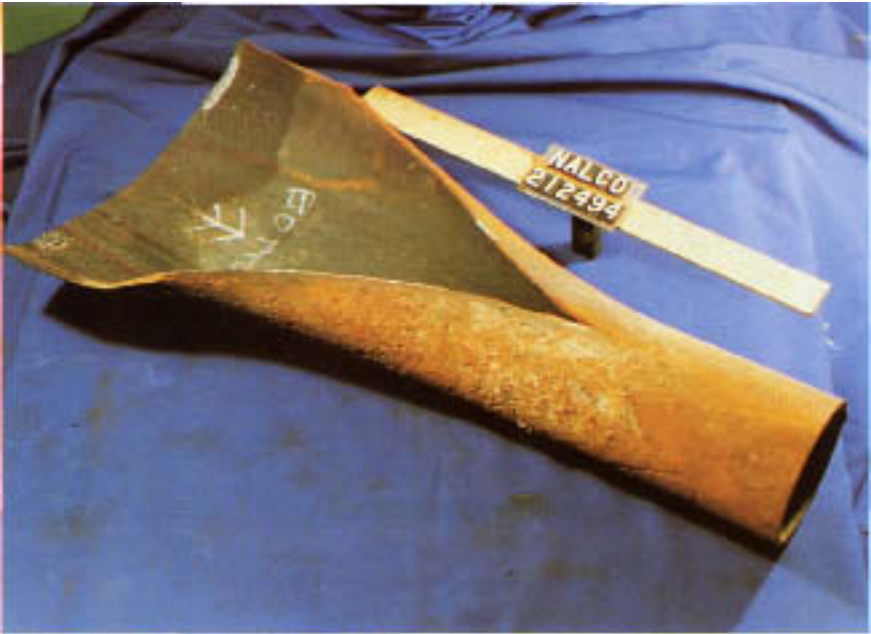
**Figure 19.4** Massive rupture of tube along a weld-seam defect.

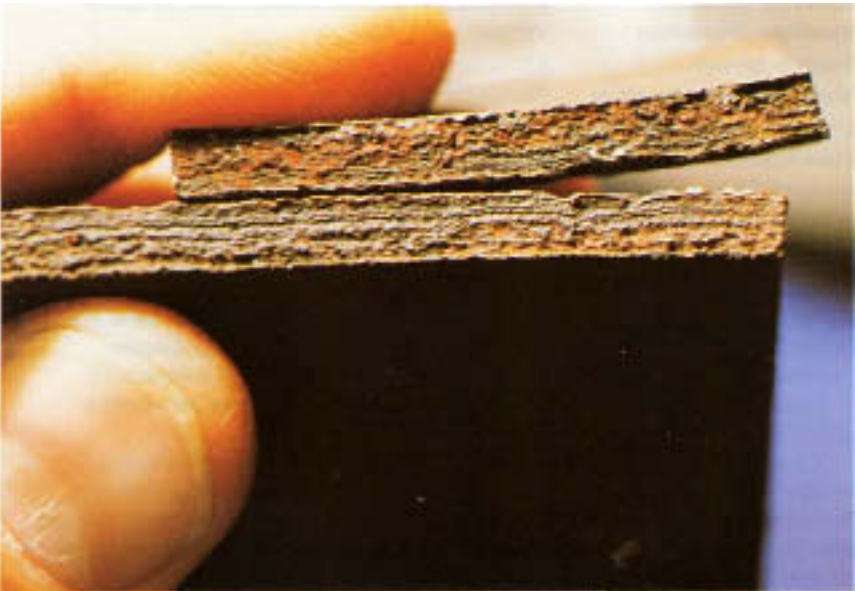
**Figure 19.5** Edges of brittle rupture.

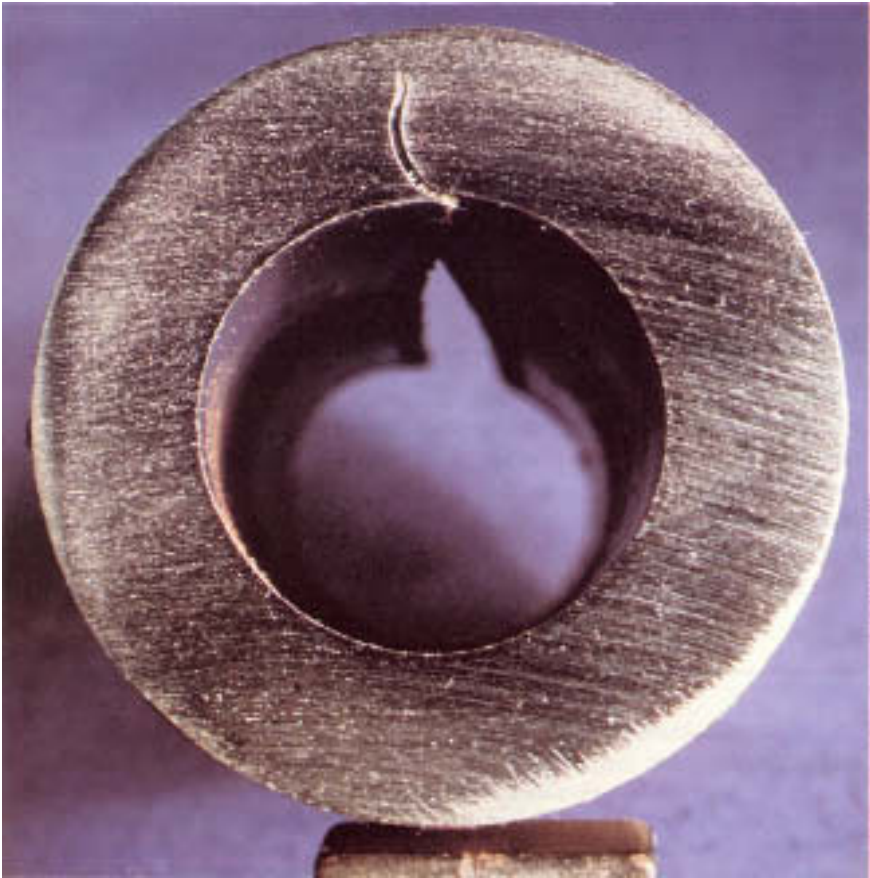
**Figure 19.6** Failure along a massive manufacturing defect in the tube wall. (Courtesy of National Association of Corrosion Engineers.)

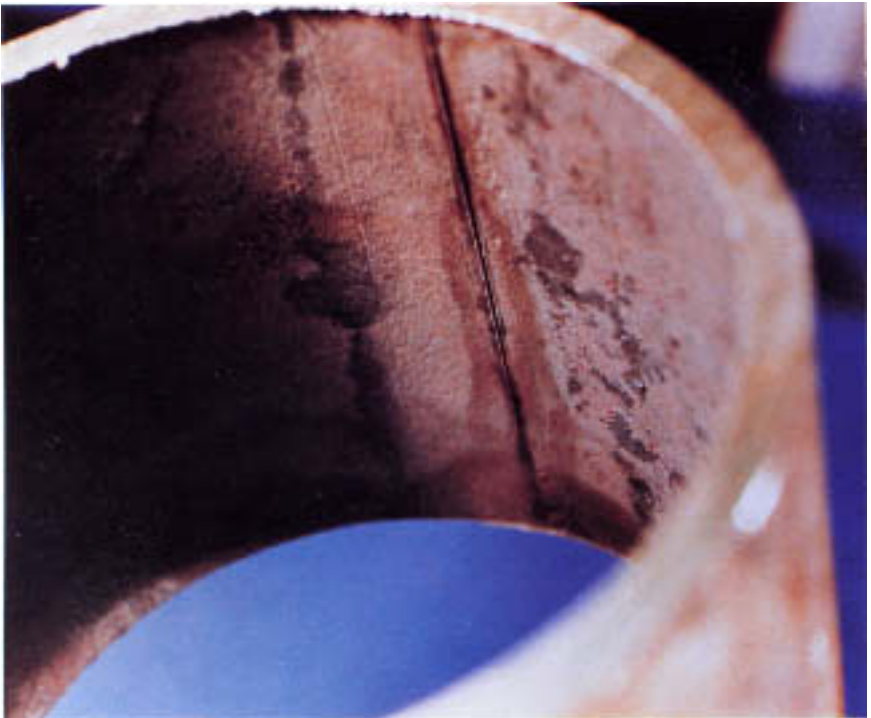
**Figure 19.8** Seam defect in steam line.

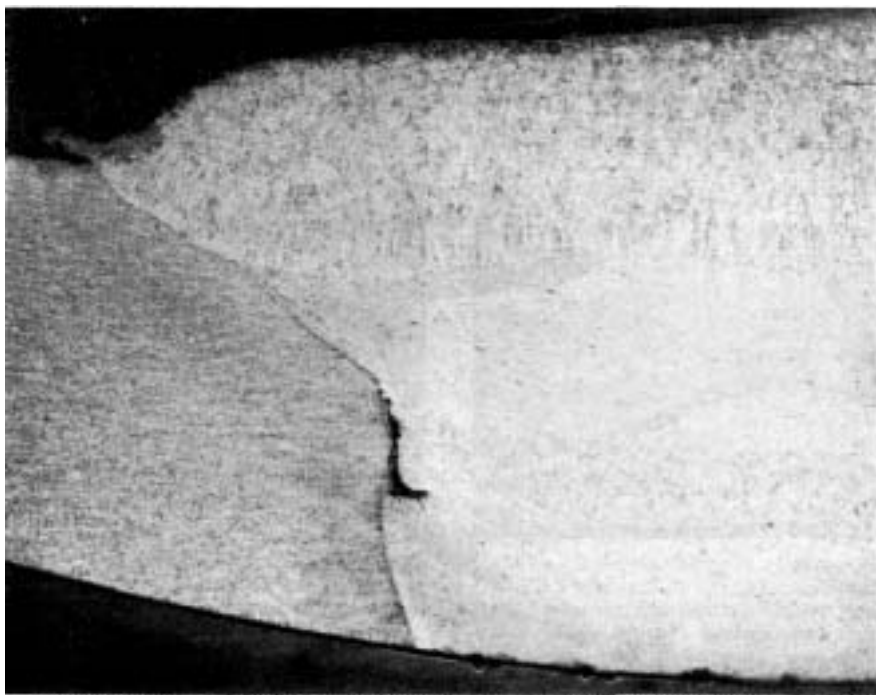
**Figure 20.2** Cross section through a linear slag inclusion. This weld had been in 650-psi (4.5-MPa) service for 25 years. (Magnification: 5X.) (Reprinted with permission from Helmut Thielsch, *Defects and Failures in Pressure Vessels and Piping*, New York, Van Nostrand Reinhold, 1965.)

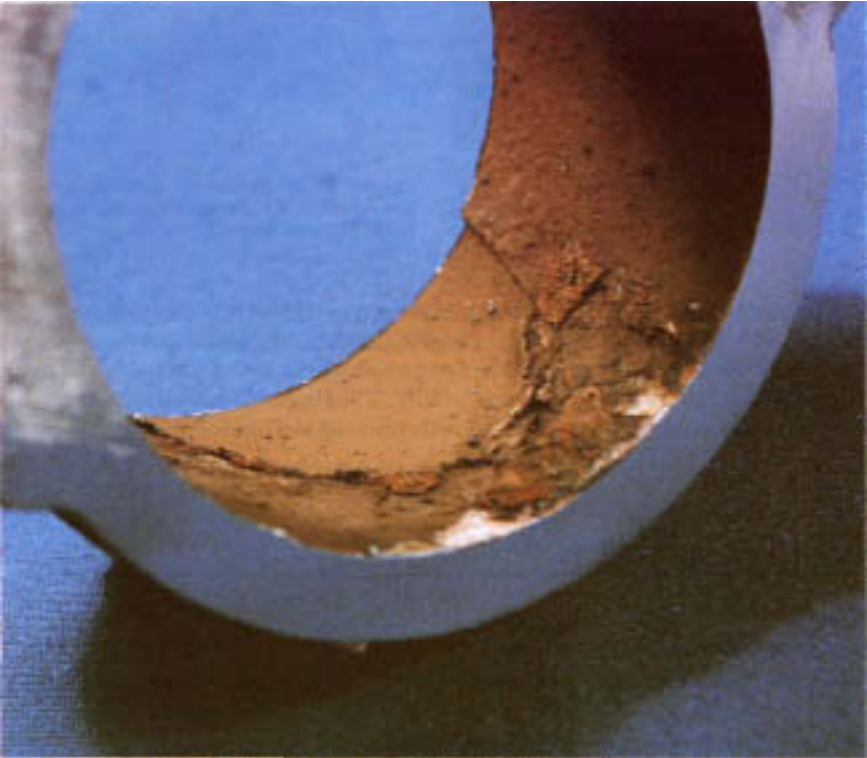
**Figure 20.11** Internal surface of tube showing oval-shaped replacement window welded into place.

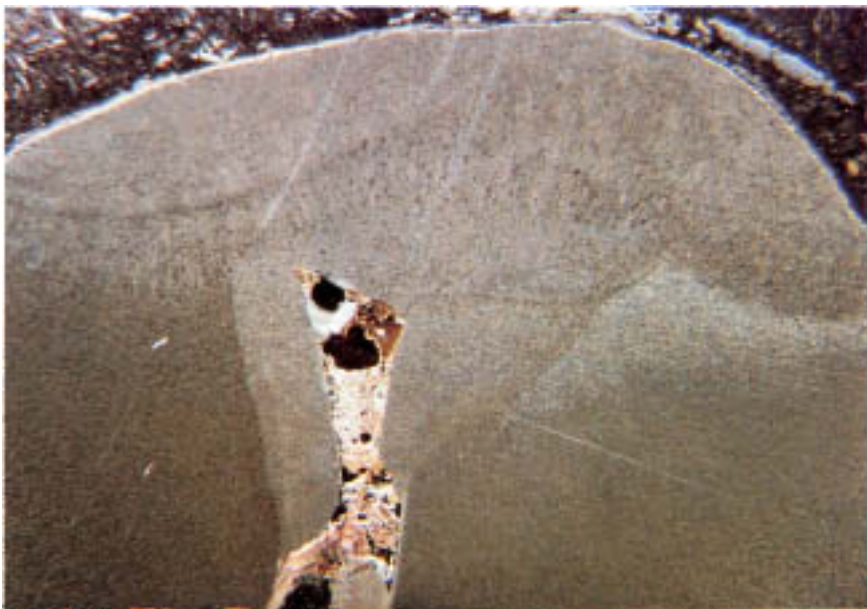
**Figure 20.12** Cross section through window weld showing deep fissure in weld metal. (Magnification: 6X.)

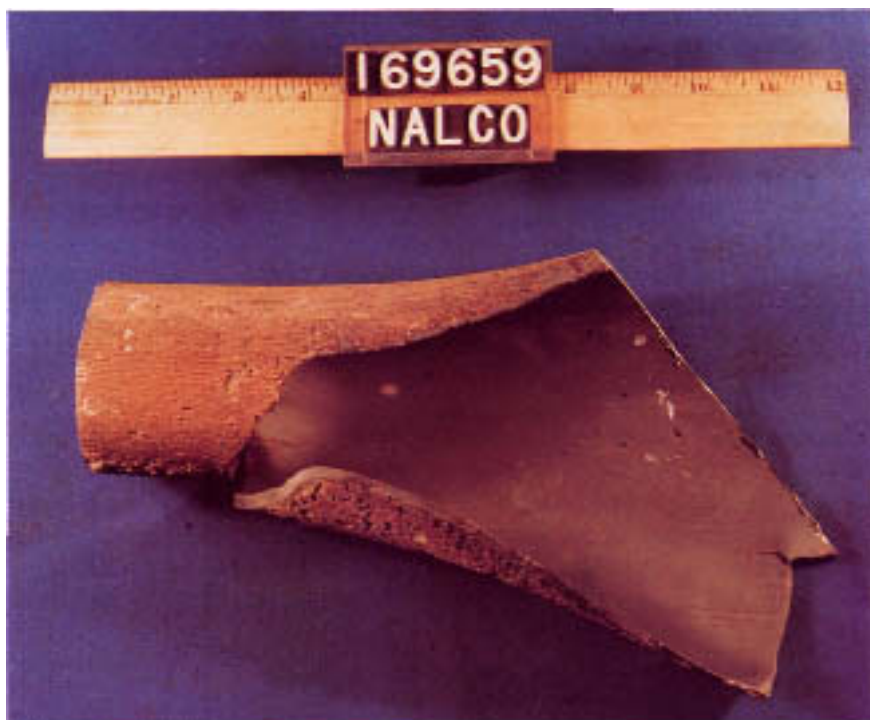
**Figure 21.2** Part of a thick-walled rupture in a superheater tube.

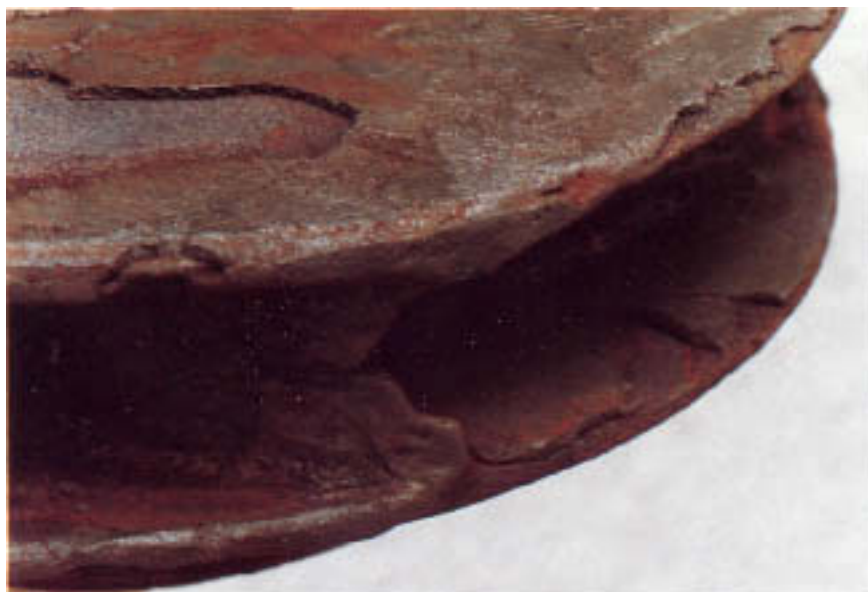
**Figure 22.5** Severe graphitic corrosion of a gray cast iron feedwater-pump impeller. Patches of corrosion product have cracked and spalled, revealing uniform general wastage. Note the fracture in the impeller vane.

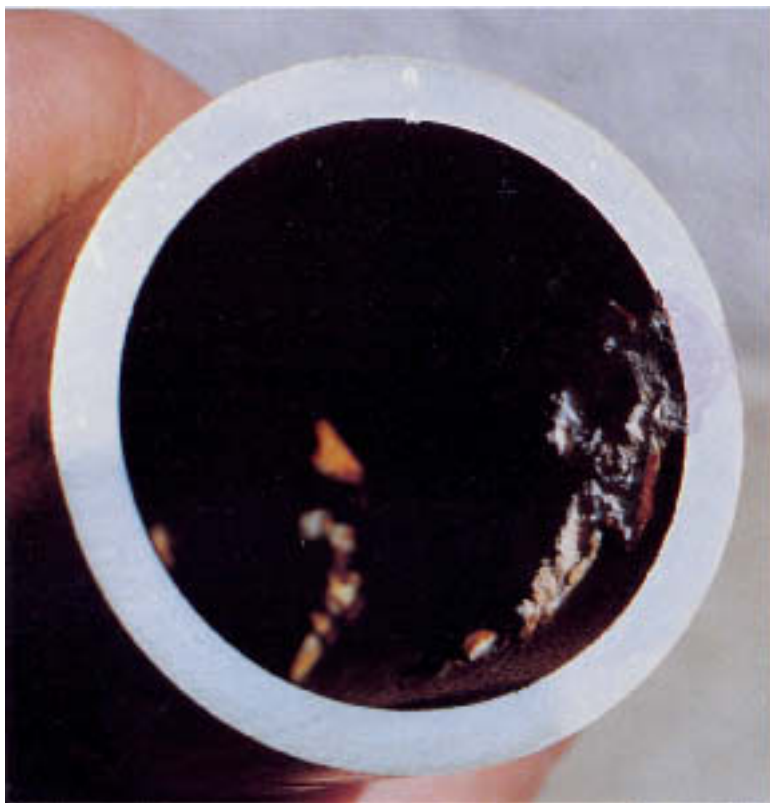
**Figure 23.1** Plug-type dezincification beneath a deposit in admiralty brass tube.

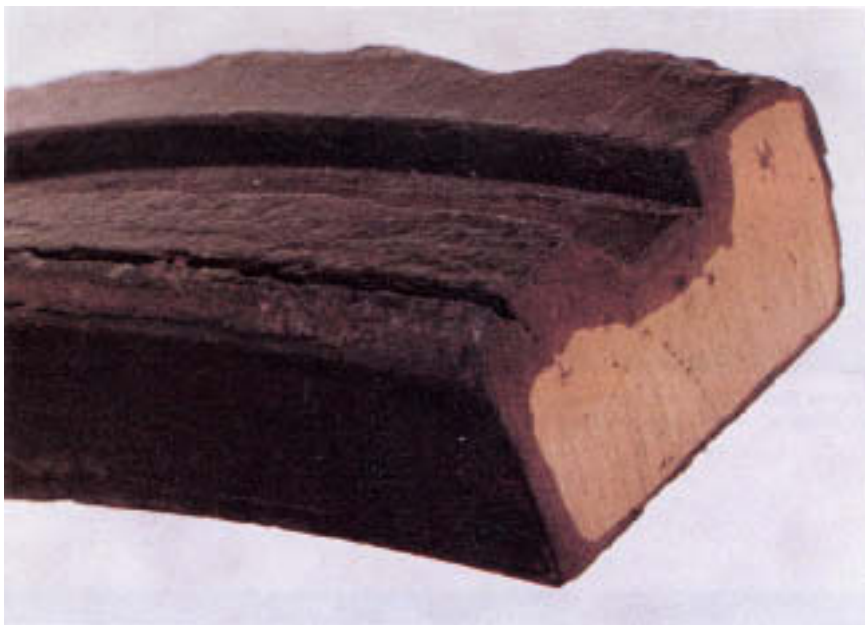
**Figure 23.2** Layer-type dezincification of a brass pump component.

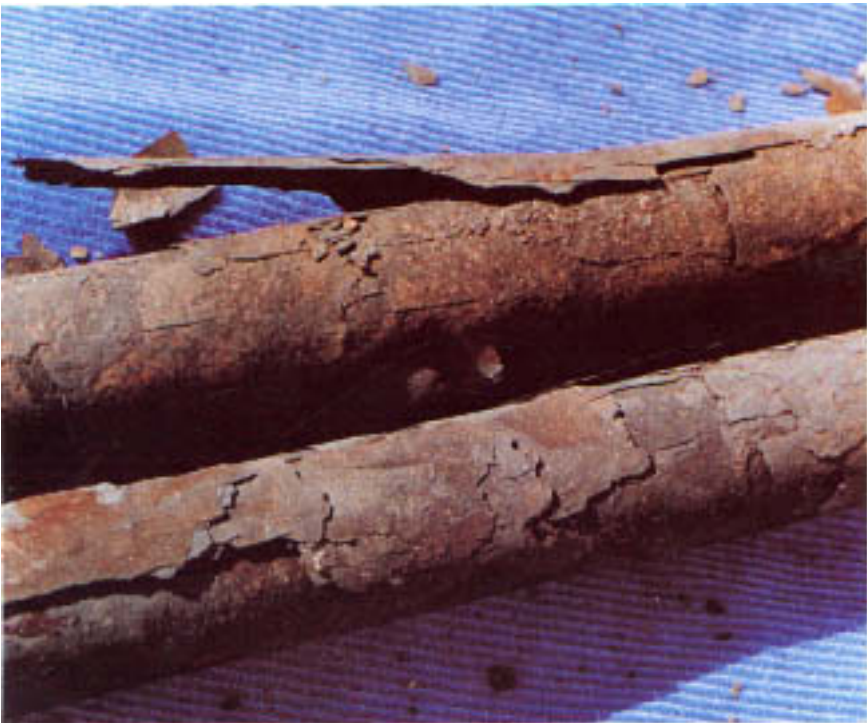
**Figure 23.4** Peeling surfaces on a cupronickel high-pressure feedwater heater tube.
