# Bamboo House

## Auroville Bamboo Research Center and the Auroville Earth Institute

### Introduction

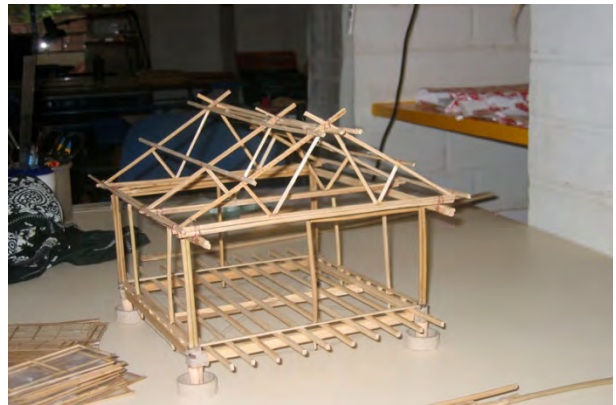
Fig. 1- Model of the structure

The characteristics of the local bamboo were analysed and doubts on its load carrying capacity arose. Therefore, timber (eucalyptus) was chosen for the main beams and the floor structure. The main posts were composed of 3 large trunks bound together. The roof beams were doubled.

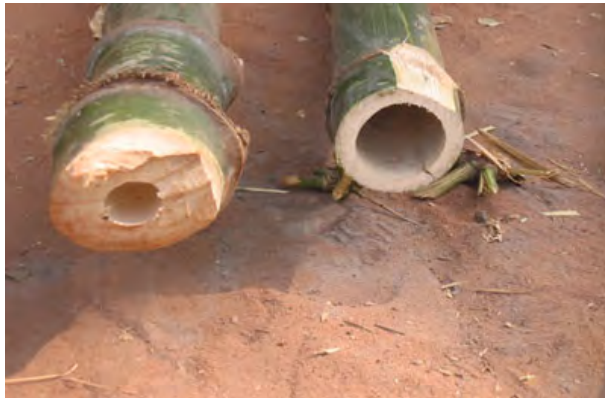
Figure 2- *Dendrocalamus strictus* - upper and lower section of the same culm. Notice variance in wall thickness

Bamboo (which species?) culms tend to be arched. To straighten them, the nodes were heated with a hand-held kerosene burner. The average maximum straightening achieved was 5-8 degrees.

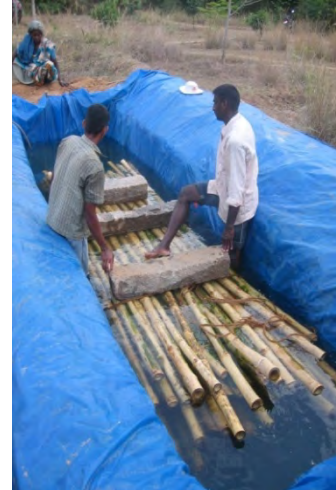
Figure 3- Treatment against insects

Eucalyptus and both species of bamboo (*Dendrocalamus Strictus* and *Pseudoxytenanthera ritcheyi*) were sourced locally. Culms and nodes had to be treated against insect attack. Nodes were sanded, 3mm diameter holes were drilled by every 2 nodes and culms were soaked in a solution of borax and boric acid. Fifty grams of each chemical were added for every liter of water. Soaking time was typically 3 days.

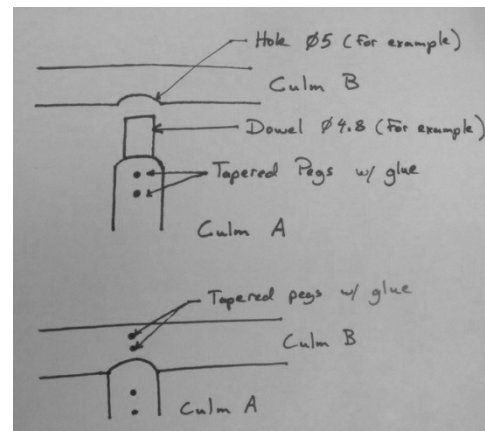
Figure 4- Sketch of a finished fish mouth joint

Walls panels were made using fish mouth joints for the main frame and simple holes with bamboo pegs for bracing members. To the left is a sketch illustrating the fish mouth joint and its construction.

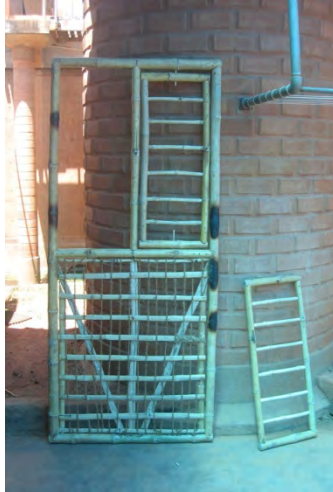
Figure 5 - Finished wattle and window panel

- The smooth side of the bamboo panel was roughly sanded to create a surface that daub could easily adhere to.
- Horizontal components were attached to 2 verticals pieces by drilling small holes where steel nails were hammered and bent over.
- Slots were cut in the bottom horizontal member of the wall frame and the vertical members of the panel were inserted.
- The panel was first nailed only to the centre brace of the wall frame and then it was nailed to the diagonals as well.
- Additional horizontal supports were nailed to the braces, including one small piece at 0.5 cm distance from the wall frame's central piece and another at the same distance from the wall frame's bottom horizontal piece. These small pieces were used to fix rope.
- Rope was tied and woven through the horizontal bamboo.
- The horizontal bamboo was nailed to the diagonal braces.

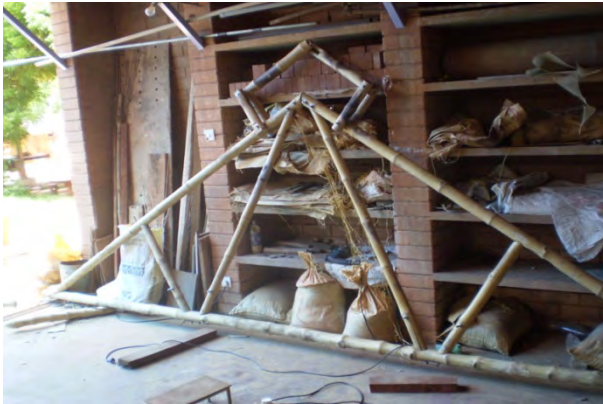
Figure 6 - Truss

Trusses were put together and a very liquid mix of concrete (1:1 sand: cement) was poured into holes at the nodes where joints were made.

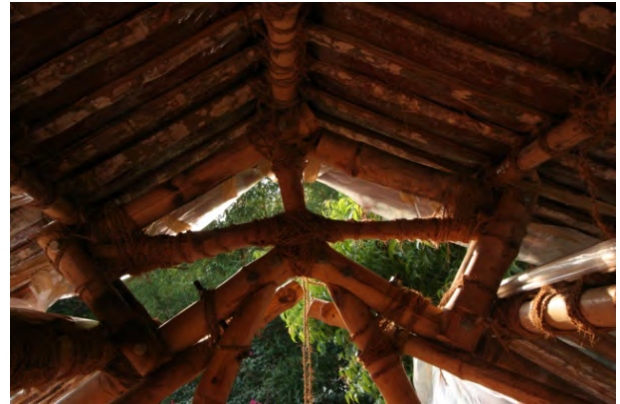
Figure 7 - Truss ridge crown modification

*Note:* After the first layer of plaster was laid on the ridge, the northeast corner sank down towards the main roof. To prevent movement, the top section of the truss (ridge crown) was modified to include vertical and horizontal supports.

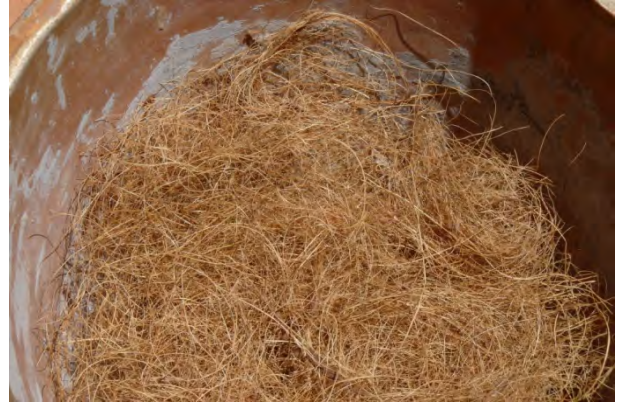
Figure 8 - Coconut fibre density – Fibres are firmly hand compacted and left to rise to level.

3 coats were prepared using different ratios of earth, sand, coconut fibres and fresh cow dung to obtain varying thicknesses. For structural purposes, more binder was used in the first 2 layers. Also, less fibre made the final coat smoother. The cow dung in the final coat further increased the smoothness and acted as an insect repellent.

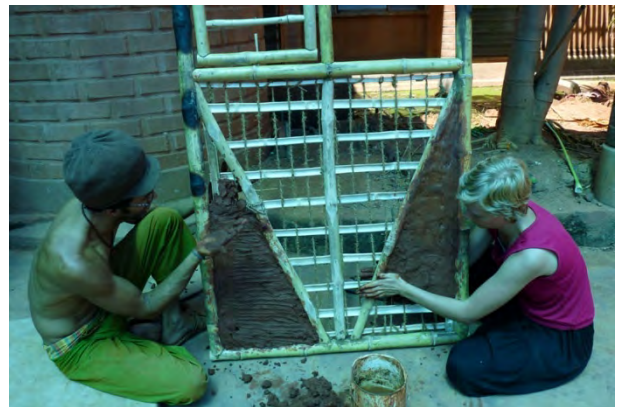
Figure 9 - Applying the first layer of daub

During prefabrication, only the first layer of daub was applied. Adding more would make the panels too heavy and difficult to assemble into walls later. And with all the movement during assembly, cracking was inevitable. However, these cracks are usually inconsequential if only located in the first later of daub. Weight of a 1m<sup>2</sup>, 3cm thick section of earth was approximately 30 - 35kg.

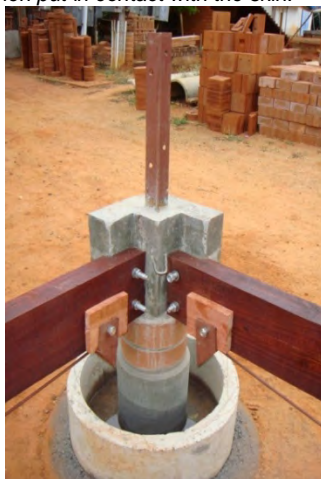
Figure 10 - Floor beams and tension rods added

The eucalyptus floor beams and joists were connected to the pillar foundations. Tension rods were added at the bottom of each beam. All eucalyptus was coated with cashew oil to prevent insect attack. Bison board panels (12mm) were screwed to joists and aluminum channels were placed in the floorboards.

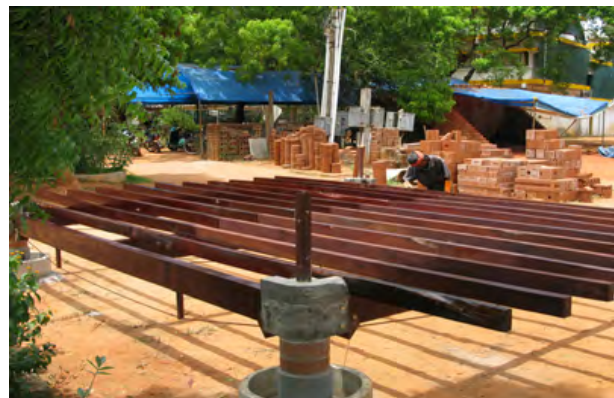
Figure 11 - Floor substructure

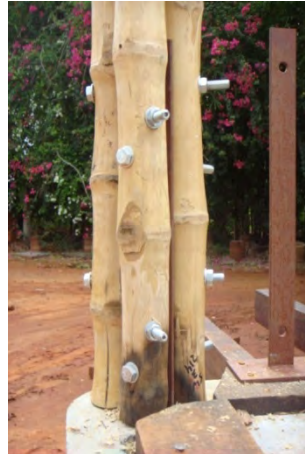
Figure 12 - Posts fixed with bolts

Large diameter (7 - 9cm) bamboo culms were joined (in groups of three) to metal fixings at each corner. Additionally, they were tied together at tops.

*Note: Splitting can occur at the base of the culms with axial load. To avoid this, culms can be tied with rope and glued, or thin metal sheet clamps can be used. Also, here long drill bits are necessary (20 cm) to penetrate at least 2 culms fastened together.*

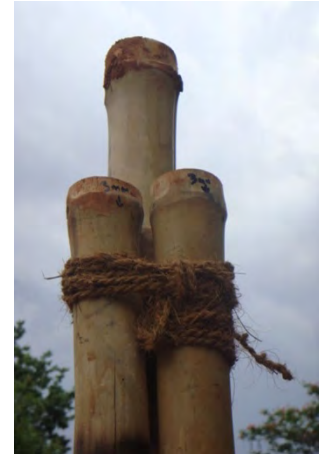
Figure 13 - Post tops tied to align

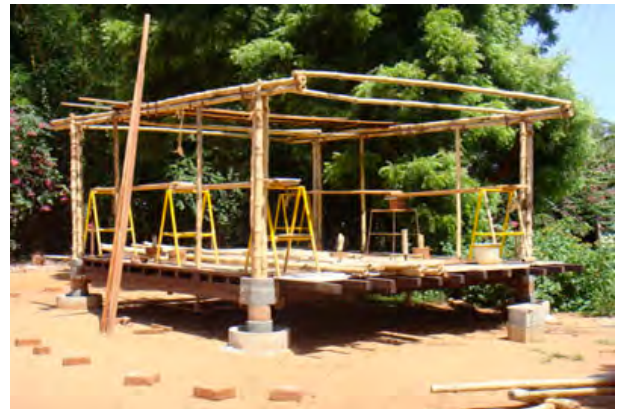
Figure 14 - Posts and beams

2 culms were joined with metal fasteners to form beams and then tied to the tops of the posts.

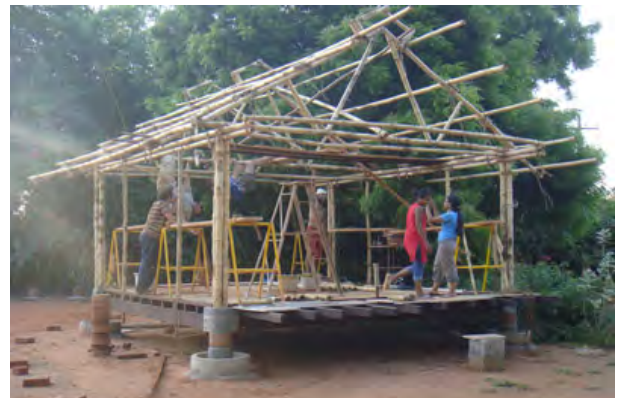
Figure 15 - The purlins in place

The trusses were raised and tied in place. Three people were necessary to lift, hold and tie them. The weight was roughly ~40kg per truss. Purlins were tied to trusses.

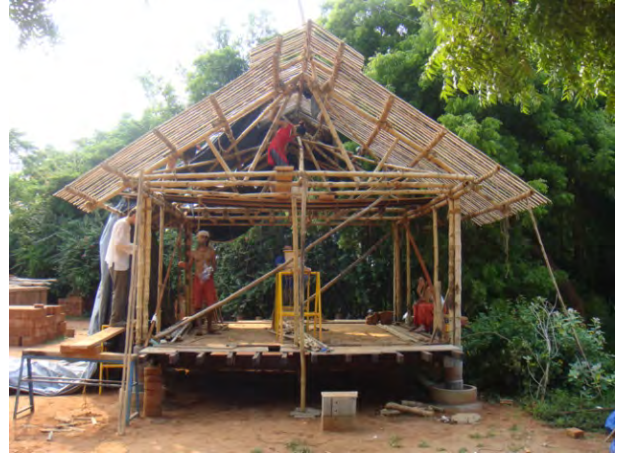
Figure 16 - Roof substructure nearly complete

Rafters of pakamaran (beetle nut wood) were fixed to the purlins with coconut rope at every joint. Mezzanine joists were tied to the trusses

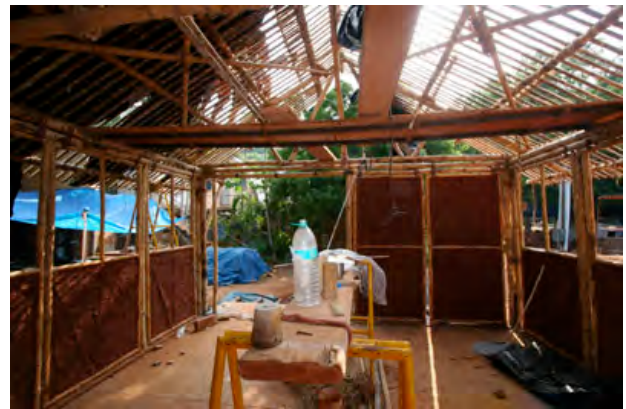
Figure 17 - Panels with one layer of daub placed in the structure

The panels were fixed with small metal plates at the top and bottom of each panel.

*Note: It was very difficult to fit the panels into the structure. This was due to curving members in panel frames and the main beams above them. Often substantial material had to be chiseled or sanded off.*

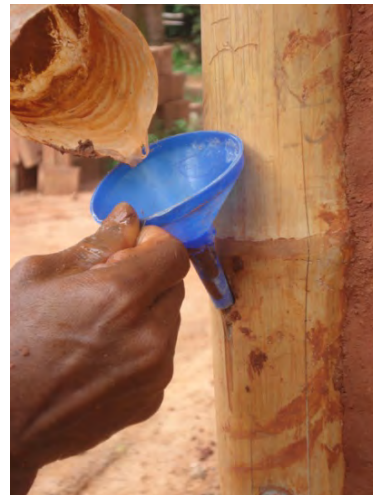
Figure 18 - Cement poured into post. A larger funnel than pictured is recommended

Holes of 10mm for the cement, and 3mm for air were drilled. Cement (mix 1:1) was poured by funnel into the bottom section of each post.

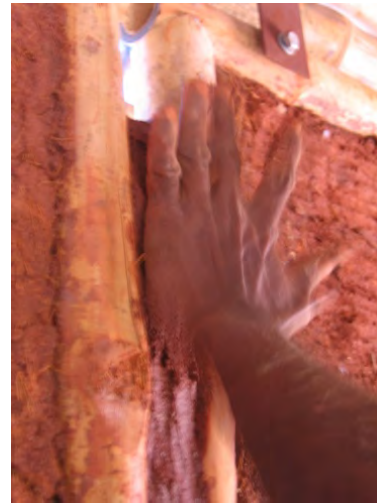
Figure 19 - Filling the gaps

There were many gaps between the panels. Plaster (Mix #2) was applied to fill the gaps. This gave lateral structural support to the house while the roof was being done.

*Note: As the size of the gaps could be large (up to 15cm wide and 5 cm thick), care had to be taken to avoid cracking. In spaces larger than 7cm, a piece of split bamboo was placed in the center to divide the gap. Moreover, the plaster mix used contained very little moisture (only enough to keep it plastic) and was compacted as much as possible in the gaps.*

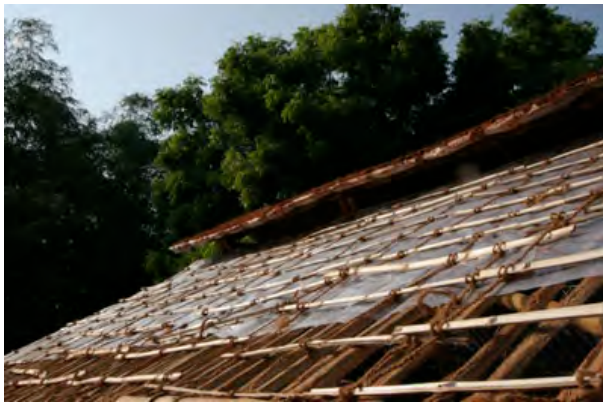
Figure 20 - Plastic sheet and lattice of bamboo and coconut rope

Above the pakamaran (beetle nut wood), a thin (less than 1 mm) plastic sheet was laid. This plastic sheet was supposed to be the waterproofing layer of the roof. Then, a lattice of split bamboo and coconut rope was placed to stop the next layer (earth mix) from sliding down the roof. The composition of this layer was as follows: 8 coconut fibre, 8 coconut coir dust, 3 earth and 3 water (3 water as a starting reference only). Moisture content here was important to ensure cohesion. As a test, moisture should pool around fingers when the mix is compressed.

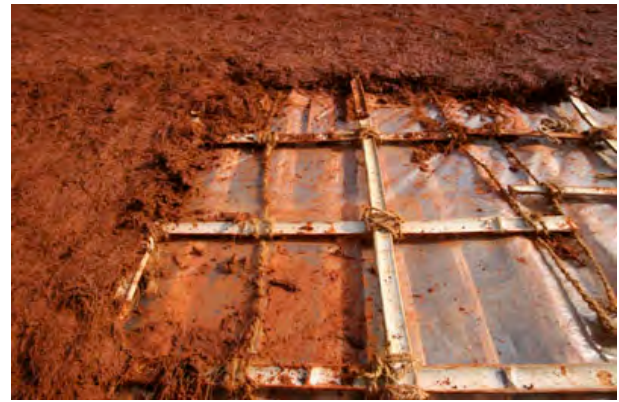
Figure 21 - Mud plaster layer (5cm thick)

The purpose of this layer of earth-coconut layer was to weigh the plastic sheet and avoid getting damages by the UV of the sun. The roof mix was cohesive and formed a mat on which to walk when dry. The dry weight (26 kg/m<sup>2</sup>, 5cm thickness) was slightly heavy for the structure and caused *around 7 cm* deflection in the purlins. One extra purlin was added on each side, just above the originals. Due to the 33° angle of the roof, most water should run off, however ~15% absorption may be expected and the structure must be capable of handling this additional weight.

Finally this roof was not successful as it became too heavy with the first rains. The water absorption was more than projected. The roof, gaining weight with the rain, it sacked even more and cracked some trusses. The latter had to be reinforced. Another problem was that the plastic sheet was punched by the workers, when they walked on it. Therefore the roof was finally not waterproof and leaked. It had to be covered with a tarpaulin, which avoided the roof to leak and to sack more. The roof remained like that, covered with a tarpaulin, until May 2012. During these 3 years the roof went on deforming and the trusses got much damaged. It was not possible to repair anymore these trusses and finally they were replaced by steel trusses and the roof changed for a composite system made of PVC corrugated sheets, polystyrene for insulation and plywood cladding inside. The roof was finally the critical part of this research and totally failed.

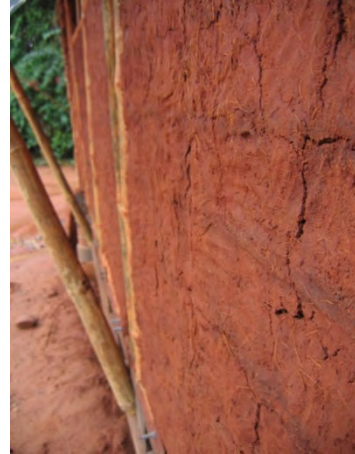
Figure 22 - Cracks appeared and could be filled

Layer 2 was applied to wall panels. Cracks usually formed within 48 hours and were subsequently filled once or twice. The mix for filling cracks had a slightly higher sand content eg: 12:5:2 rather than 12:3:2 (Earth, sand, fibre).

*Note: Here too, wet mixes (with obvious water content without even squeezing) usually caused more cracking. Panels receiving direct sunlight seemed to crack more than those in the shade.*

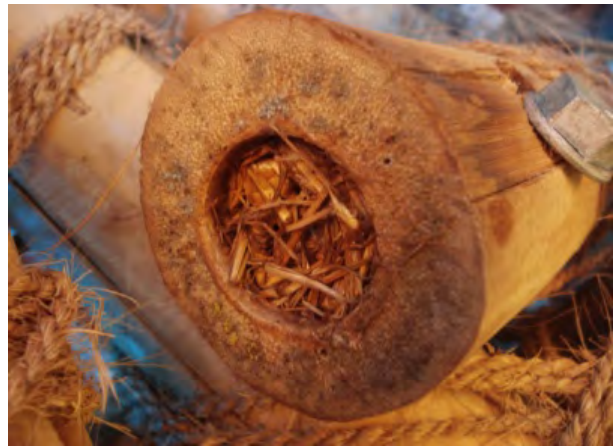
Figure 23 - Ends filled to prevent rodent habitation

As insects and small rodents tend to nest in small spaces, the ends of all open culms were sealed with fevicol and straw.

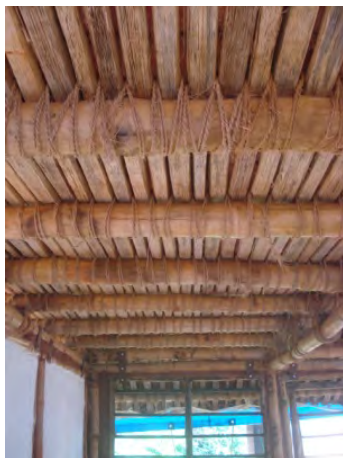
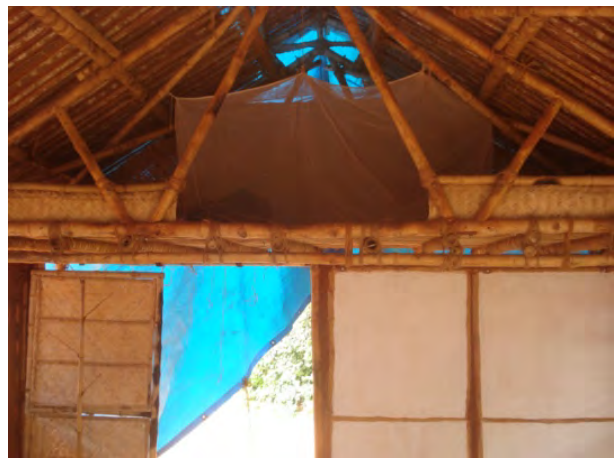
Figure 24 - Mezzanine view

Figure 25 - Mezzanine view

Beetle nut wood was planed to a consistent thickness and tied to the mezzanine joists with continuous ropes down each joist.

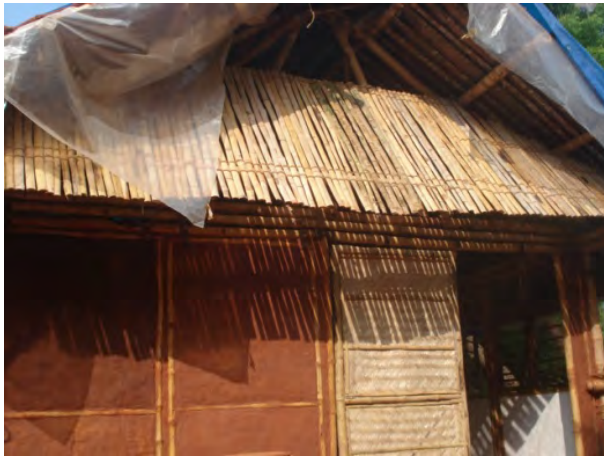
Figure 26 - Eave exterior view

Bamboo was split by hand and tied with continuous ropes to beams.

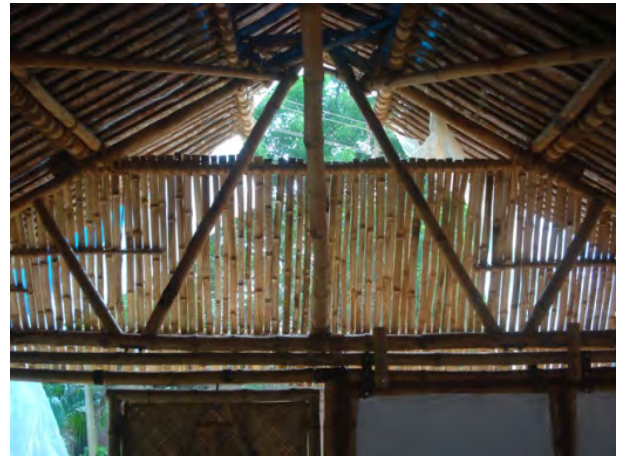
Figure 27 - Eave interior view

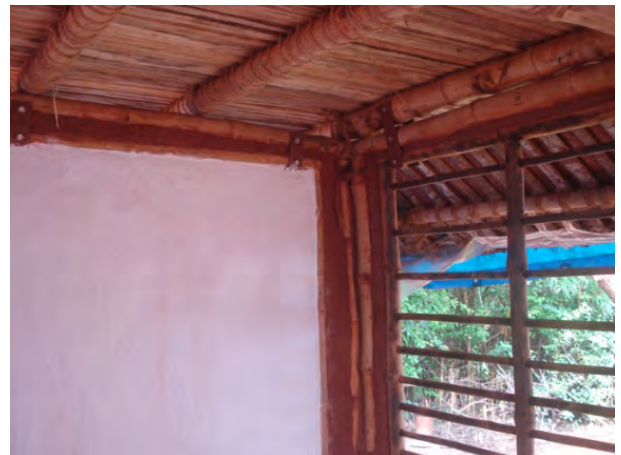
Figure 28 - Finished wall

Layer 3 was applied, and when dry and crack-free, 2 coats of lime wash were applied (mix 1 lime, 1 water, 125 grams fevicol DDL for 4 kg of lime).

*Note: Both the final layer of earth plaster and the lime cracked after first application. Both could however be remedied with simple touch ups.*

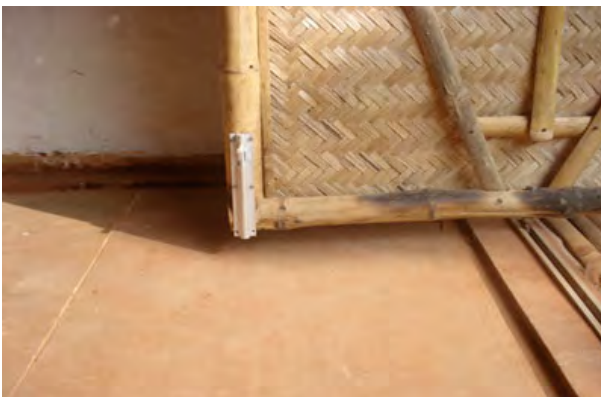
Figure 29 – View of the door

Pivoting-sliding doors were hung, in accordance with the center of mass after all fixings and closing mechanisms were added.

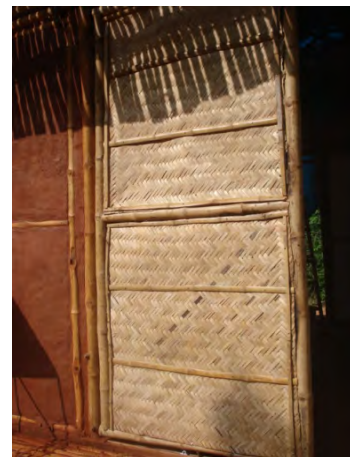
Figure 30 – View of the door from outside

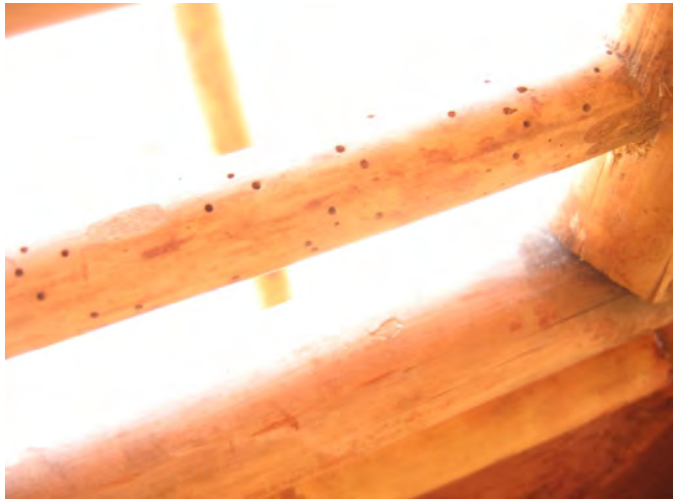
Figure 31 - Borer beetle exit holes

Borer beetle attack occurred in 3 or 4 places on the *Dendrocalamus strictus*, the majority being in the *Pseudoxytenanthera ritcheyi* window bars. This could be because of inadequate treatment, *as this species is nearly solid, and it takes much longer for the chemicals to be absorbed by the vascular bundles.*

To defend against these attacks, all window bars were charred with a kerosene burner. After this, a toxic chemical of unknown composition was applied. The result of these treatments was a drastic reduction in the dust produced when the insects are present in the bamboo. In some cases, as a final step, white glue was applied to cover the insect holes. This seemed to increase the effectiveness of the treatment.

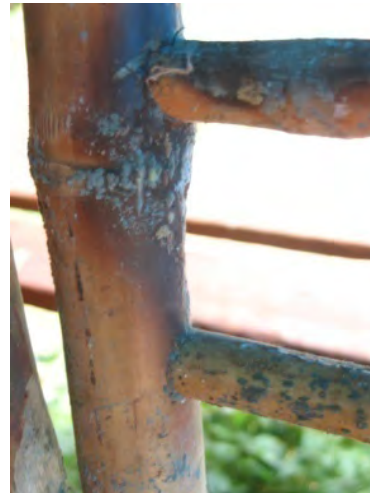
Figure 32 - Mould during the monsoon

During monsoon, mould formed on many culms in both the interior and exterior of the house. In most cases it was simply wiped off, and in severe cases, heat was applied to dry the culm. At the end of the monsoon, it had not reappeared.
