Rammed Earth Conservation

C. Mileto, F. Vegas & V. Cristini

PROCEEDINGS OF THE FIRST INTERNATIONAL CONFERENCE ON RAMMED EARTH
CONSERVATION, RESTAPIA 2012, VALENCIA, SPAIN, 21–23 JUNE 2012

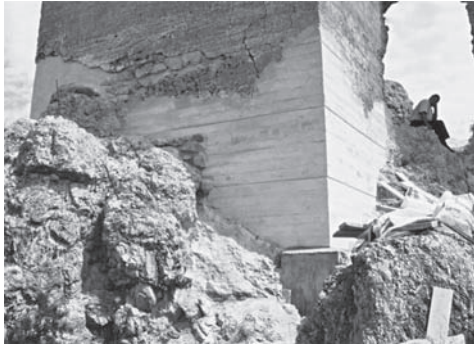
Figure 3. Siyasa. Tower struck by lightning.

It was also in 1992 that a bolt of lightning struck down the south-east corner of the only tower still standing in Siyasa Fortress. The following year the missing corner was reconstructed and a framework was added to tie the four walls together and shelter the interior from rain. The work was performed with a mixed white cement and lime concrete; the characteristic rammed earth formwork technique could not be used because of the location of the intervention.

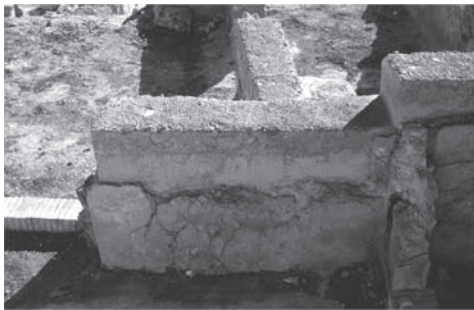
Figure 4. Wall rebuilt with its own rammed earth as Siyasa.

In 1993 work began on the village of Siyasa, the remains of an Islamic medieval town abandoned in the 13th century. A large part of its structures are rammed earth walls (sometimes with a crust, sometimes with *brenchas* (undulated reinforcement), sometimes with masonry repairs or reinforcement, of which only the masonry bases and many incomplete walls remained). In this case, as we have explained on other occasions, an attempt was made, on the one hand, to consolidate with lime wash, that is, to improve the cohesion and adhesion of the materials of the fabrics and, on the other hand, to rebuild walls up to the partially conserved levels using the demolished earth. After these initial works, several others were carried out

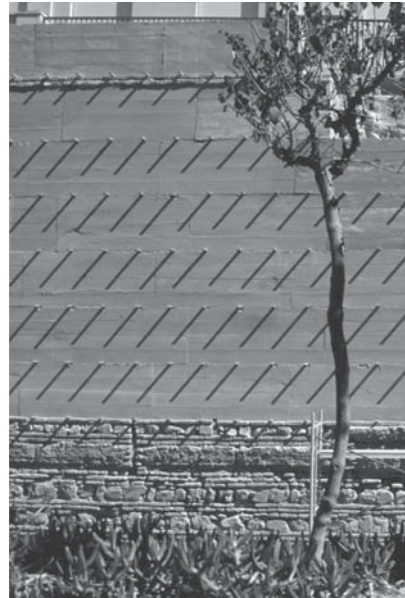
Figure 5. Murcia. Verónicas section of the wall.

The first time that formwork was selected outright and wholeheartedly was in the restoration of the Verónicas section of Murcia City Wall in 1995–1996, as part of a global project of the architect Fernando de Retes with the collaboration of the author of this article. The proposal here was to rebuild longitudinally the half of the wall that had been removed when building a convent and to leave the timber putlogs visible for aesthetic purposes. At the end of the day, all the interventions involve an approach to rammed earth architecture and have a great deal to do with personal experience and discoveries.

It is true that restoration as we understand it today has a didactic function and, in this sense, certain licences can be justified, but construction logic should never be undermined. The Verónicas part of the wall had a sculptural and pedagogical value in a cultural project that was the Legado Andalusi, which was a reason to leave the putlogs, but it is a resource that has been too often used since then. I myself have been unable to resist the banal temptation to leave naked putlogs in places where it was not appropriate, suggesting a provisional state that later became definitive.

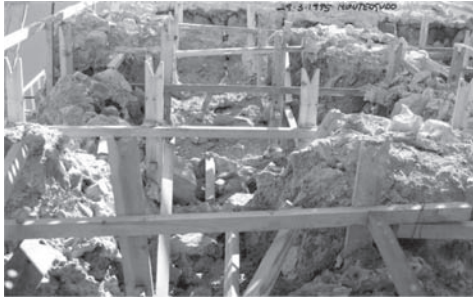
Figure 6. Monteagudo. Putlogs reinforcing the lime concrete.

One year later, in 1996, there was another intervention on the same castle to fill in the gaps with lime concrete rammed earth walls with rubble in a stretch of the wall in danger of collapse. In this case the putlogs were left on view, in the knowledge that they could be removed later, although that has not been the case so far.

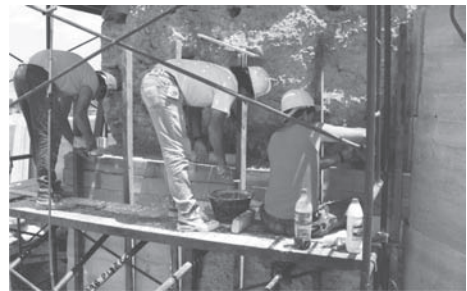
Figure 9. Specifications. Replacement of the crust.

seemed to collaborate. The employment of the rammed earth technique as a restoration method was even rather forced in some instances, such as the completion of the crust in places where the gaps were relatively shallow.

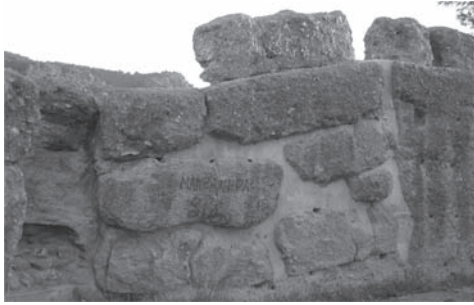
Figure 10. Murcia. La Luz. Rammed earth pieces placed on top of one another.

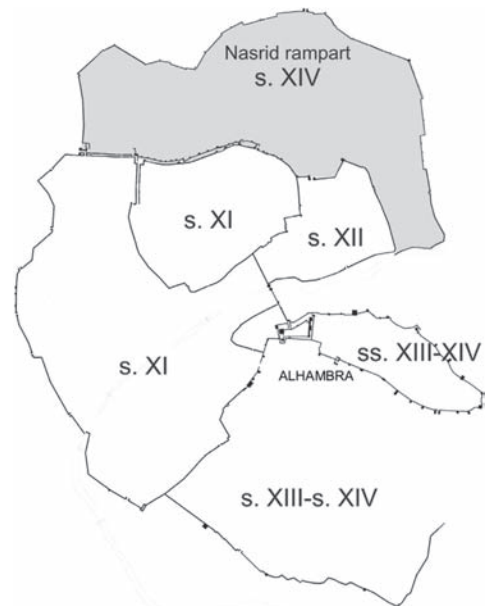
Figure 1. A hypothesis of the evolution of the medieval ramparts of Granada. (Source: author.)

Figure 1 shows a hypothesis of the evolution of the medieval ramparts of Granada according to the consensus of scholars (Seco de Lucena 1975,

García 1996, Orihuela 2001, 2002). The walled nucleus of the Islamic city on the Albaicín hill dates to the Zirid period; by the end of the XIth Century and the beginning of the XIIth it extends to the lower parts of the city and reaches the opposite banks of the river Darro. In the XIIth Century ramparts were expanded and in the Nasrid period, from the first half of the XIIIth Century, two big extensions gave its final shape to the ramparts of the city.

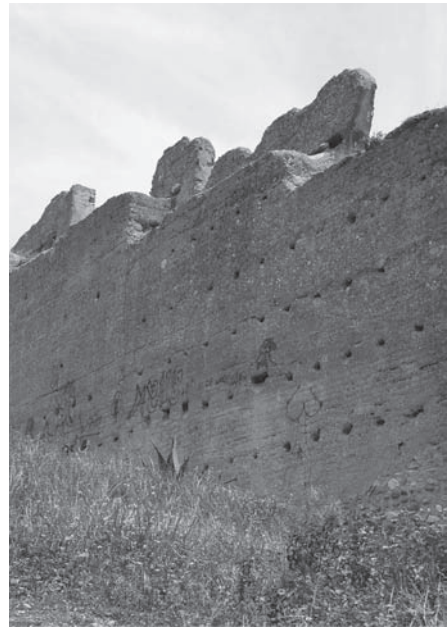
Figure 2. Traces of the crenellated parapet of the Nasrid ramparts. (Source: author).

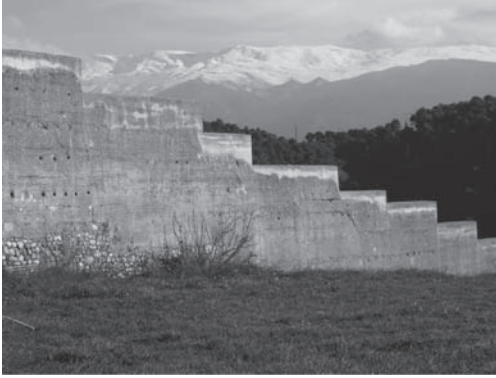
Figure 3. Stepped disposition adapted to the slope of the terrain. (Source: author).

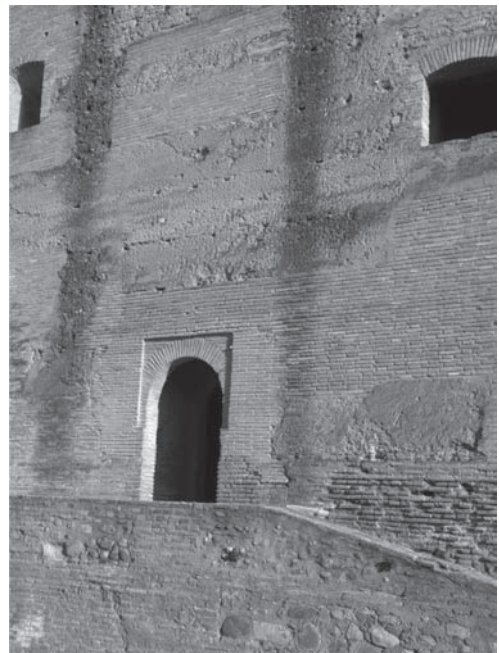
Figure 7. Cavity of the door of the main Tower in the interior with diverse repairs.

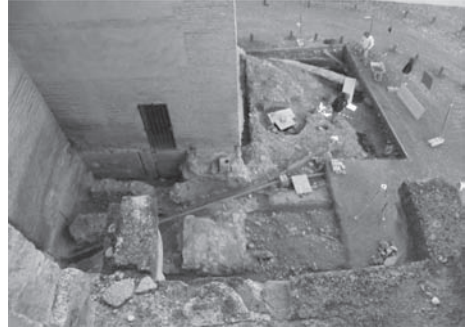
Figure 8. *Tapial* wall corresponding to the oldest phase of the Torres Bermejas fortification.

This survey has allowed us to find evidence about the oldest stage of the Crimson Towers fortification thanks to our analysis of the technique used in building the multi-layered *tapiales*, that is, walls built by pouring a mixture of earth and varying quantities of lime into a succession of wooden molds. We have been able to relate *Torres Bermejas* with the *Alcazaba* (Citadel) of the Alhambra, which has been dated from the XI century in the Zirid period, and which appears in other sections of the city wall such as the one which goes down from the Alhambra to the *Puerta de las Granadas* (Gate of the Pomegranates) and which goes up from there to *Torres Bermejas*. To this period we attribute the original foundations of the three towers which were constructed in a trench dug at ground level. The walls were built in a similar way, and were powerful structures of mortar whose whitish color is due to its high lime content and whose caissons (each row of molds) are separated by lines of bricks which in some cases appear to have been given a careful finish to protect them from the damp. To this day we can see traces of the

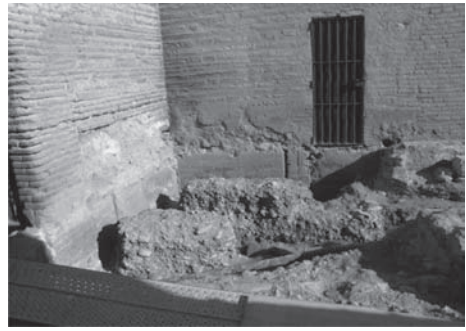
Figure 9. *Tapial* wall conserving the imprints of the construction process, such as the marks of wood and nails. It is noteworthy that on all the walls there are numerous imprints of the *costales* which joined vertically the wood of the frames.

building process of these walls, such as the marks left by nails and beams. It is noteworthy that in all the walls under examination there are numerous impressions left by the struts which vertically

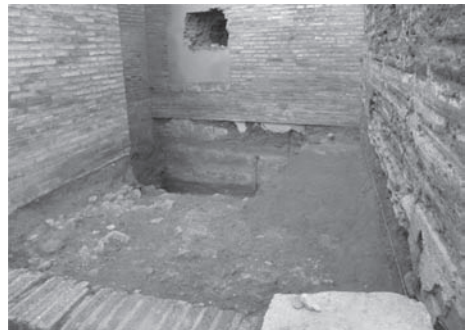
Figure 10. Section in ruins of the wall, constructed in *tapial calicastro*, which was the union of the three towers.

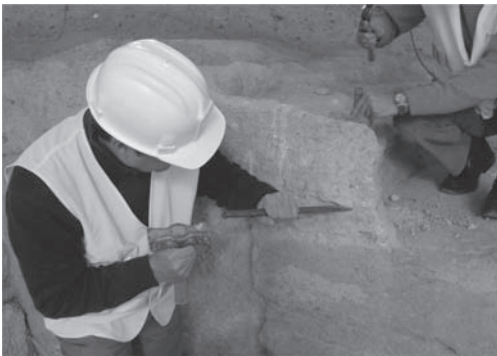
Figure 2. Manual extraction system with chisel and hammer.

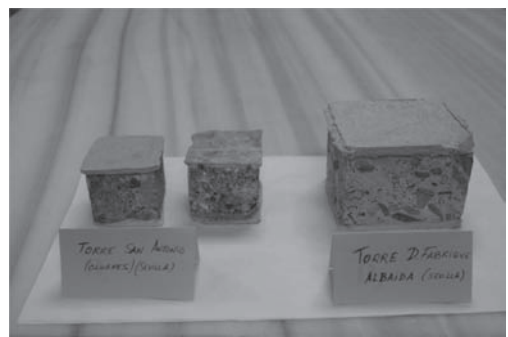
Figure 4. Photographs of three cubic wall cores capped with sulfur.

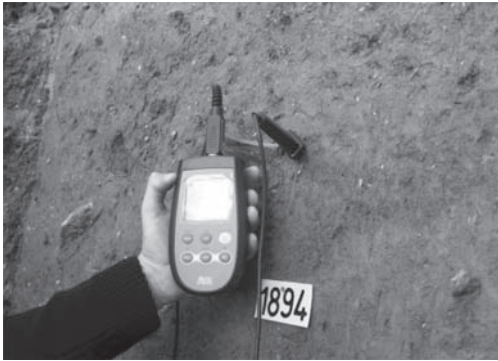
Figure 5. Temperature measurement of pottery fragments embedded in a rammed-earth wall.

b. Thermoluminescence. This method is based on the physical phenomenon of light emission as a result of raising the temperature in a crystalline mineral such as quartz, calcite, or feldspars (minerals accompanying clays in ceramics). These minerals must have been previously exposed to ionizing radiation deriving from the disintegration of the natural radioactive elements such as uranium, thorium, and potassium, whose isotopes are present in rocks in trace amounts. The electron layers bordering the thermoluminescent materials and the electrons released by the method are ionized. Some remain trapped in the crystal's defects or traps and cannot break free unless they are supplied with a certain amount of energy. The electron's stay in the trap depends on several factors, including temperature. As temperature increases, the electron's energy level increases and, at a certain level, it can break free. Once free, the electron can recombine with a "luminescent centre", which is what produces the luminous emission. The intensity of this emission is directly proportional to the number of trapped electrons, which depends, in turn, on the amount of radioactive dose the material has received. That is, the time elapsed since the structure formed or was first heated if the radiation was constant over time (Fernández, 1992; Aitken, 1985). Evidently, to perform this type of dating, there must be ceramic remains in the wall.

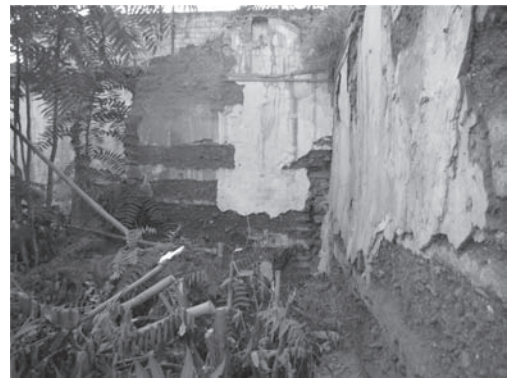
Figure 4. Separation walls alternating mortar joints in ChercHELL. (Aliche, S., 2011).

These walls have layers of mortar of 4 to 9 cm high. The size variation between these layers is about 30 cm (28 to 33 cm). There is an average of 5 cm height between mortar layers. At the angles and sometimes between two lifts, mortar layers increase and appear every 10 cm or in each compaction layer. Mortar is made of lime, sand, soil and gravel. The walls are made of rammed earth composed by earth with loose stones, gravel, pieces of pottery, lime pieces and sometimes, animal bones. The limits of lifts are perceptible with difficulty. Vertical limits where mortar lines stop can be deduced. Horizontal limits are made of one mortar layer out of two. This leads to 70 to 80 cm

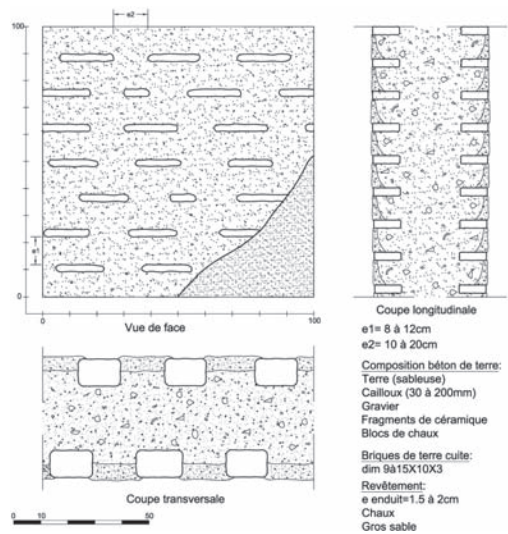
Figure 6. Section of a wall face with alternating layers of brick and lime mortar: plan and sections. (Alliche, S., 2011).

Visible sections of the walls certified that bricks give patterns to the wall. These walls are composed by a soil, full of pebbles with different diameters, gravel, small tiles, broken bricks and sometimes small pieces of lime. There was will for improving the soil mechanic characteristics. High proportion of pieces of earthenware in soil composition would mean that pieces of ceramic from ancient era were numerous, existing everywhere in the city and would have been taken off the soil that was used in construction of rammed earth walls. Some walls have the two different variants on opposite faces. The interior face had mortar layers and exterior face had alternating fired bricks and lime mortar. This arrangement leads to the conclusion

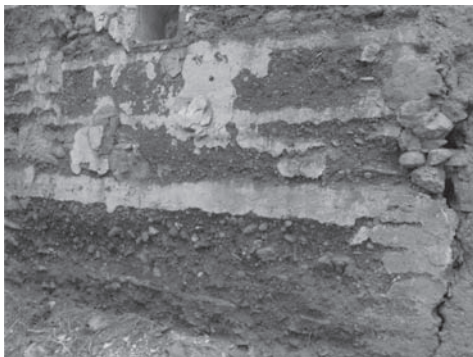
Figure 5. Party wall with alternating mortar layers pattern in ChercHELL. (Alliche, S., 2011).

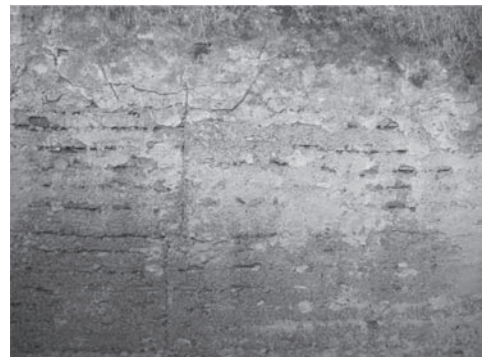
Figure 7. Trace of the formwork side on a wall face with alternating fired brick and lime mortar. (Alliche, S., 2011).

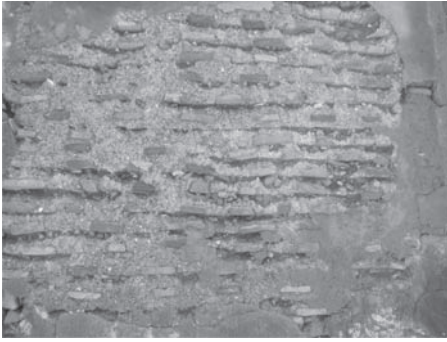
Figure 8. Arrangement of bricks in the wall according to the variant with facing alternating brick and mortar. (Chennaoui. Y., 2007).

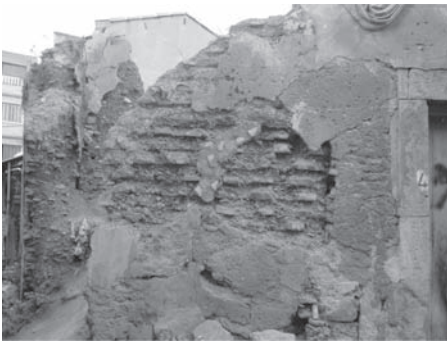
Figure 9. Exterior walls are partially collapsed. (Chennaoui. Y., 2007).

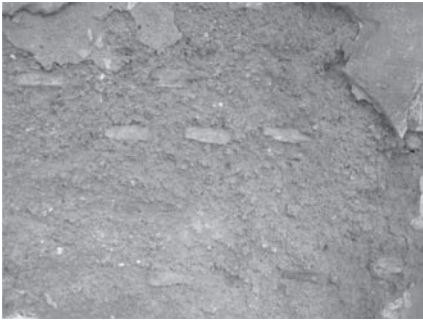
Figure 12. Rammed earth wall with facing made of fired bricks and lime mortar in Koléa. (Alliche. S., 2011).

In the city of Koléa the same variant as in Cherchell and Ténès was found. Rammed earth walls are built on a 60 to 80 cm high stone base, which is sometimes mixed with bricks. Walls are always 50 cm wide. Soil used for the building wall has a thin and silky texture and is full of gravel and pieces of pottery. Bricks are arranged in stretcher bond and have lengths differing between 10 to 26 cm. They are 3 cm thick and between 10 and 12 cm wide. Horizontal spaces between bricks vary between 7 and 20 cm and in some walls until 30 cm. Vertical distances are between 7 to 15 cm, matching with compaction layers. Bricks are alternated in the wall face with lime mortar mixed with thin sand and a proportion of clay.

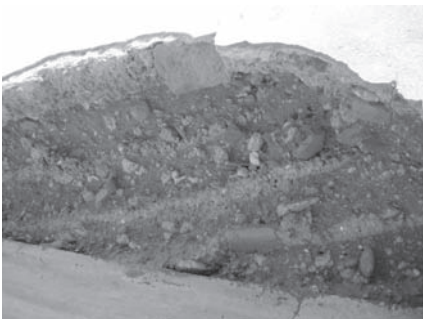
Figure 13. Interior of a rammed earth wall with facing made of bricks and lime mortar in Koléa. (Alliche. S., 2011).

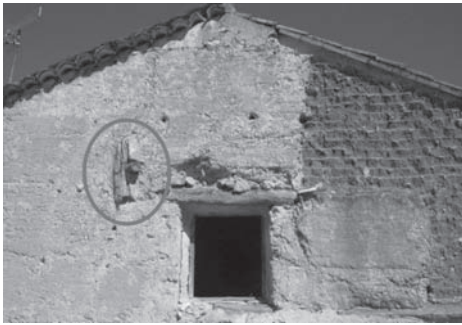
Figure 2. Façade detail of the house with reeled brace.

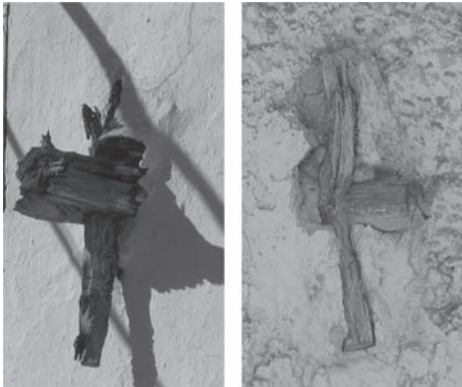
Figure 3. Reeled brace. View from the outside. Cut-out in the axis of the brace. Brace, pin and wedge. Half-lap joint assemble. Brace, pins and iron wedges.

The system is made up of three elements: the brace, the pins or arms which cross to the exterior and the wedge which hold them in place. It consists of reeling the walls together using wooden struts and pins on the exterior of the wall limiting their movement. This was thought up as a way of absorbing traction pressure localised to the uppermost corners of the wall joints where no beams are found, taking advantage of the compression pressure exerted by the brace and the pins.

The wedges are used during construction to fasten the pins into place in the cut-outs, either with one wedge, or with two (one on top of the other crossing over at the points). Throughout the life-span of the construction, either due to weather conditions or just old age, the wood warps and any problems can be avoided by simply adjusting the pins against the walls and adding new wedges. Load bearing wedges are usually used to fix the pins to the half lap joint hooks.

The assemble of the brace and the pin is carried out in a rectangular cut-out or conical to achieve a stronger attachment. This cut-out is found in the centre of the axis of the brace and near the end, but separated just enough to avoid splitting of the heads due to the pressure. This layout is the oldest and most traditional, although previously there came about a type of assembly in a half lap joint on one of the sides of the brace. The half lap joint assemble allowed the use of straight pins which were set in place with iron wedges.

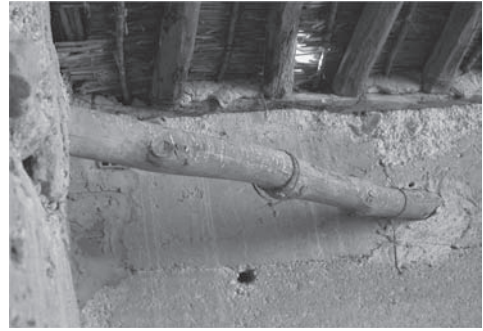
Figure 4. Reeled brace. View from the inside. Brace.

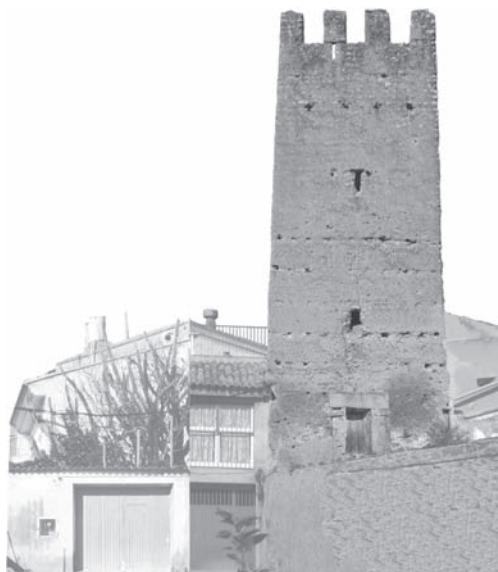
Figura 2. Alzado este. En esta fachada se encuentran la puerta de acceso original en primera planta, las aspilleras en segunda y tercera altura y las almenas rematando la torre. (Autor: realización propia).

En concreto, la Torre de Godelleta es de planta cuadrangular y su parte superior se defiende con parapeto coronado de almenas. Fue construida con muros realizados con la técnica del tapial (piedra y argamasa). Este tipo de fortificación poseía un pequeño recinto amurallado donde se cobijaba la población y sus ganados en caso de peligro. En tiempo de paz se utilizaba como granero comunal. La planta baja es la que daba servicio a estos usos. Siguiendo el esquema general explicando anteriormente, la puerta de acceso se encuentra en la primera planta, bastante elevada sobre el suelo (Fig. 2), llegando a ella desde el adarve del

recinto adosado. La segunda y tercera planta son cámaras de habitación con techos de madera y la cuarta forma la terraza defensiva almenada. En el interior hay una serie de salientes adosados a las paredes que son restos de la escalera que servía para acceder a las ventanas y a las almenas a la hora de prevenir posibles invasiones.

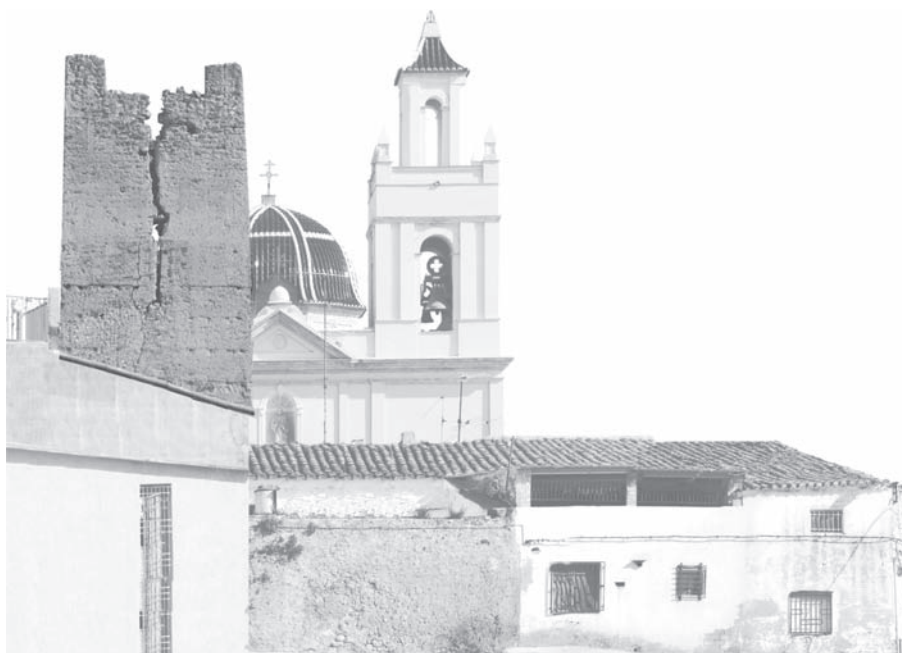
Figura 4. Alzado sur. Vista de la torre en su entorno. En esta fachada se aprecia su deteriorado estado actual con enormes grietas y pérdida de material. (Autor: realización propia).

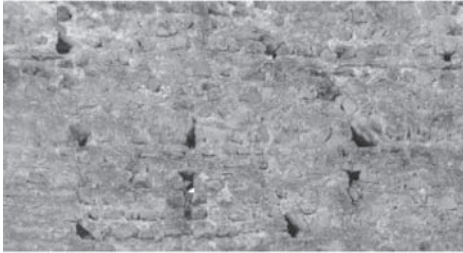
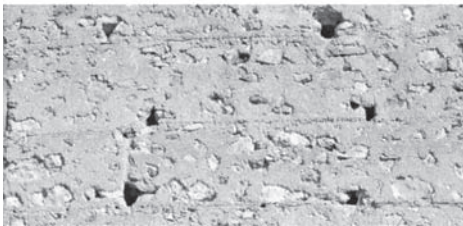
Figuras 6, 7 y 8. Detalle de los paramentos de las Atalayas de Huertas, Torrepedro y Calderones respectivamente.

Por último, en los dos primeros casos (Torrepedro y Calderones) los mechinales se encuentran sobre la tabla de asiento del hilo superior, encajados en la primera hilada de mampuestos (que suele ser más estrecha y regular) y rematados superiormente por otro mampuesto. Esto contribuiría igualmente a facilitar una mejor sujeción de las agujas y por tanto a soportar tapias de mayores dimensiones. En Huertas resulta más difícil determinar esta posición, ya que en algunos casos aparecen rebajados en los hilos y enrasados con la tabla de apoyo del hilo superior.

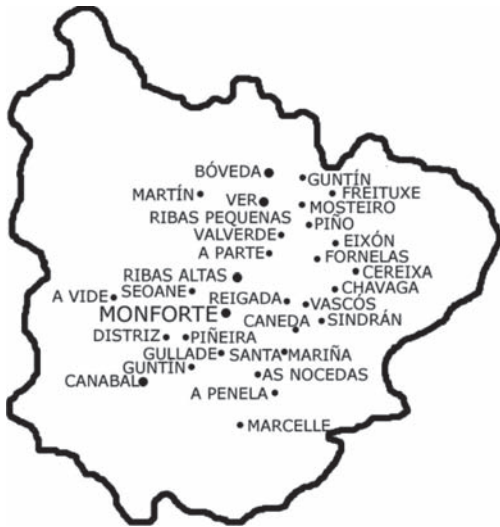
Figure 3. Geographical coverage of rammed earth in Terra de Lemos: Freguesías (parish) with rammed earth constructions.

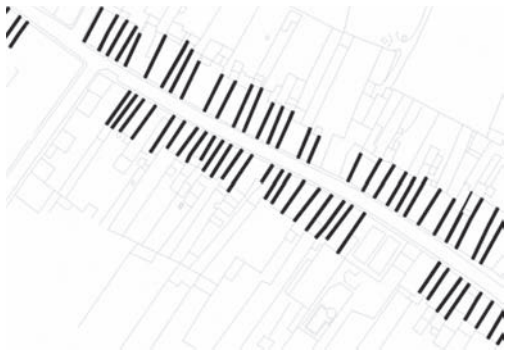
Figure 5. Rueiros structure in Abeledos suburb: Dividing walls in urban housing type1.

- Urban housing—Type 1, with ground floor, first floor with solaina (large balcony) and faiado (attic): It is the oldest type in the town of Monforte, present mainly in both hill and suburbs. It makes sets of long, narrow houses in a row, the *rueiros*. Rammed earth is used for dividing walls with spans of between 4 m and 6 m wide. The front and back part can be rammed earth, of *corres* half timber, or even sometimes *cachotería* on the ground floor, but foundations typically do not rise more than 70 cm.
- Urban housing—Type 2, with ground floor, stone on the front and two floors with gallery and *faiado* (attic): Present in public areas of the old city. These are homes between dividing walls of rammed earth with lights up to 8 m or 9 m divided into two *vans* (supporting space between two walls). The beams support in the middle, in

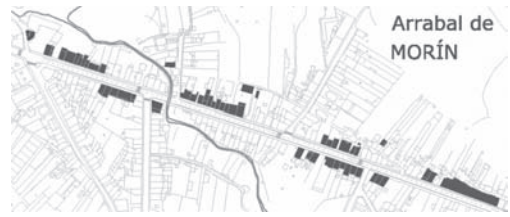
Figure 6. Morin suburb. Urban housing type 3.

- Urban Housing—Type 3, located next to road, it has ground floor, one or two floors and the *faiado* (attic): the latter type is more modern. Presents a typology very similar to Galician road homes, arising from the city growth around roads, probably in the late nineteenth and early twentieth century (they abound in Morin, in the vicinity of the railway station and in the streets out of town). These homes can have only ground floor or adding one or two floors, without *solaina* (large balcony) and galleries. Although sometimes they have small balconies. The walls are rammed earth with foundations of schist. In many of them the front was covered with a concrete structure and brick.

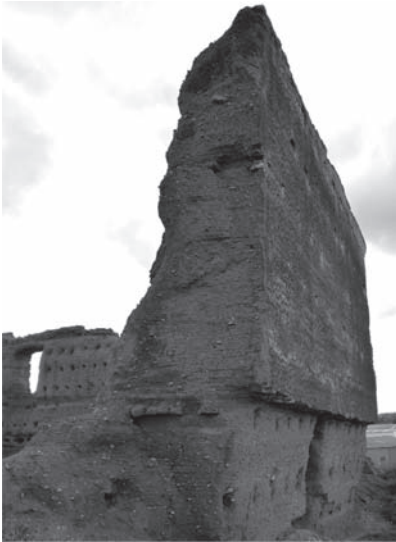
Figure 5. North wall ruins. We can observe the difference of the thickness and the lack of external layer of clay. We can also observe the stones that form the putlog holes in which there were the wood cross ties.

The presence of the putlog holes of the wooden cross ties helps us to reconstruct the process of the walls construction. The distance between these putlog holes to each other is about 70 cm. They pass ever from one side of the wall to the other side. In some of them, the superficial sealing remains. This stopper is made with a fill of rubble, gravel, mud and lime. None of them shows any rest of the wooden cross ties. These signs are the negative of the wooden beams used both as wooden cross ties of the formwork as scaffolding to build the walls. Two wooden cross ties' sizes have been documented. The most common size is rectangular: 8 × 15 cm. The other dimension is square: 10 × 10. This difference of sections may result from use of different sized timber by different crews. Over these putlog holes, stones that form the roof of the putlog hole can be observed. These stones

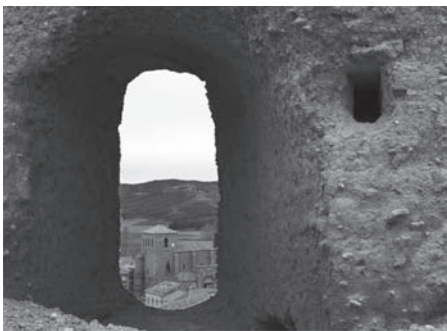
Figure 8. Arrowslit void in the north wall.

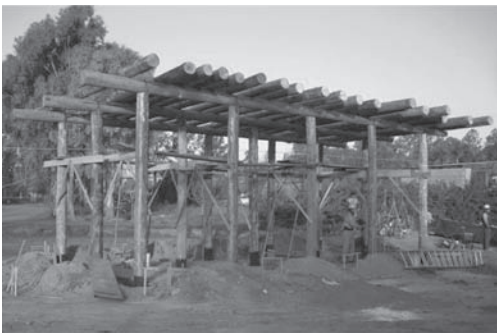
Figura 8. Entramado de madera.

El proyecto consta de una estructura de rollizos de Eucaliptos Grandis (especie maderable que se cultiva en la región), que sostienen un entramado de madera que recibe un entablonado que oficia de plano de apoyo de los elementos que componen el techo verde (Fig. 8). Entre los pies derechos (Fig. 9) de esta estructura se utilizó un encofrado de madera con un revestimiento fenólico, que fue el utilizado por los cooperativistas (en su mayoría mujeres) para realizar los muros (Fig. 10).

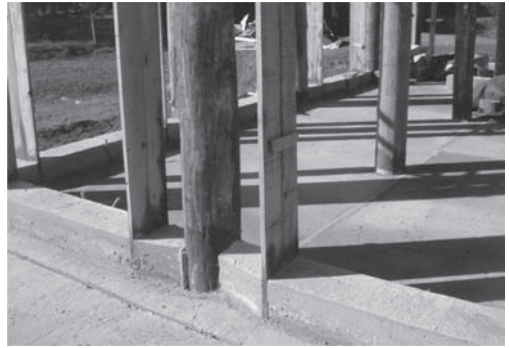
Figura 9. Pies derechos y encofrados.

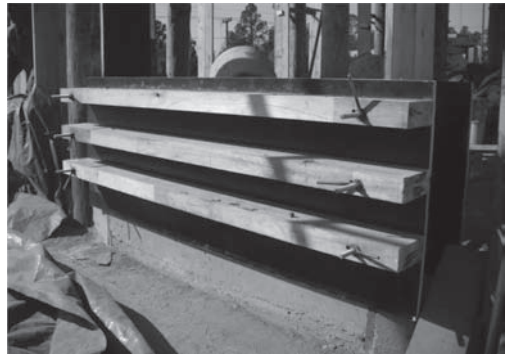
Figura 10. Encofrados utilizados en muros.

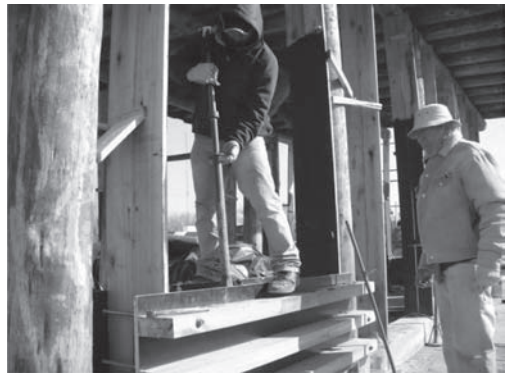
Figura 11. Pisón metálico.

La tierra utilizada se eligió, tras los correspondientes ensayos de clasificación, entre tres locaciones posibles y provino de la apertura de un canal para riego en las inmediaciones. Se utilizó un pisón metálico (Fig. 11) y se ensayó la incorporación de óxidos metálicos (Ferrita) para colorear

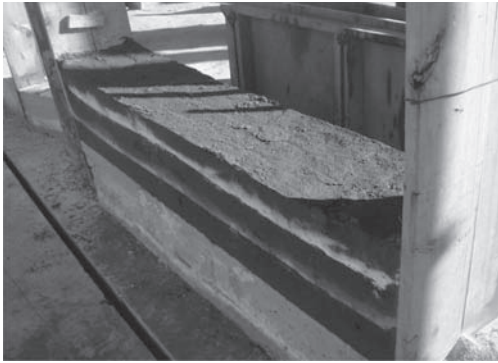
Figura 12. Juntas constructivas coloreadas con ferrita.

las juntas constructivas (Fig. 12). La dosificación empleada incorporó un 8% de cemento y un 2% de cal, especialmente en las juntas entre tongadas.

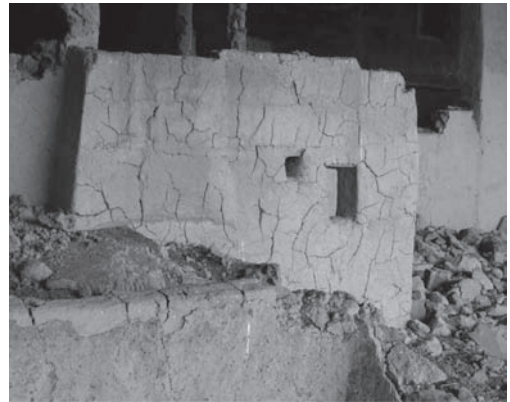
Figure 1. The cracking of the core of the walls suggests that the soil that was used for the construction was excessively moist. Pre-Hispanic houses at *El Embudo Caves*, Chihuahua, Mexico.

Several authors (González, 1995:54; Gamboa, 2001:55; Cano, 2001:84) have stated that the remarkable architecture in the Sierra of Chihuahua, as well as in the archeological zone of Paquimé—both in the North of Mexico—, was made with rammed earth walls. Nevertheless, some elements suggest that the constructive system was based on the use of mud in plastic condition mixed with variously sized stones. This argument is supported by the absence of vertical joints between the building components, as well as, the cracking of the nucleus of the walls.

While, as a matter of fact, molds were used for the construction of walls, the level of soil moisture did not allow its compaction. For this reason, the technique does not correspond to rammed earth building logic, but it is related to the procedure which Doat et al. (1990:103) called “stabilized earth concrete”. (Figure 1).

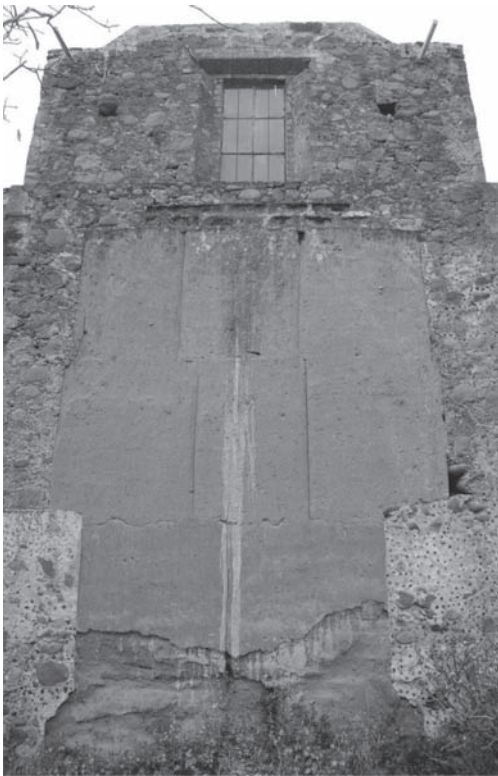
Figura 4. Rammed earth wall with buttress made of volcanic stone and boulders. Chapel of Santa Ana. Calpan, Puebla.

with buttress or “*rafas*”, a name given by Marcos y Bausá (1879: 170), but without horizontal reinforcements (*verdugadas*). These vertical reinforcements were built with volcanic stone masonry and boulders, settled with mortar of lime and sand. In these cases, the walls’ height raises between three and four rows.

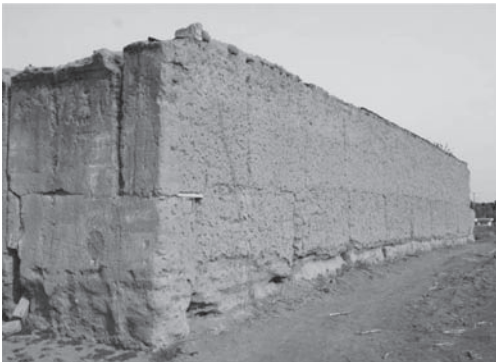
Figure 5. The South façade, to the left of the picture, does not present insects’ boreholes, while the East is crammed with them. Also to be noted is the weathering on the base of the walls by the lack of foundations and plinths.

Another deterioration that was often found in the walls of the region is the presence of multiple perforations caused by colonies of insects known locally as “*tlapipilloles*”. It is a striking phenomenon that they are mainly located in the East wall surfaces and with less intensity in the South walls. On the other hand, the North walls—which are in contact with the prevailing cold wind’s impact and do not receive sunlight-, are not damaged. (Figure 5).

Although deterioration caused by these colonies of insects have a superficial effect, its impact is noticeable and produces collateral damage, such as, the entry of rainwater, and it’s freezing at night and the final disintegration of the earthen surface.

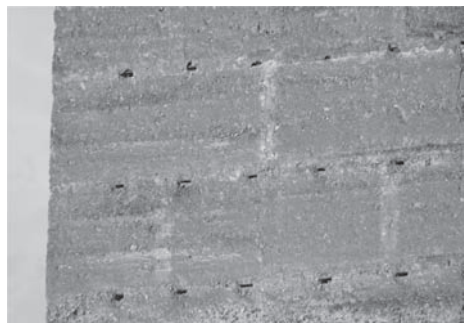
Figura 4. Técnica decorativa en la torre de la Pileta.

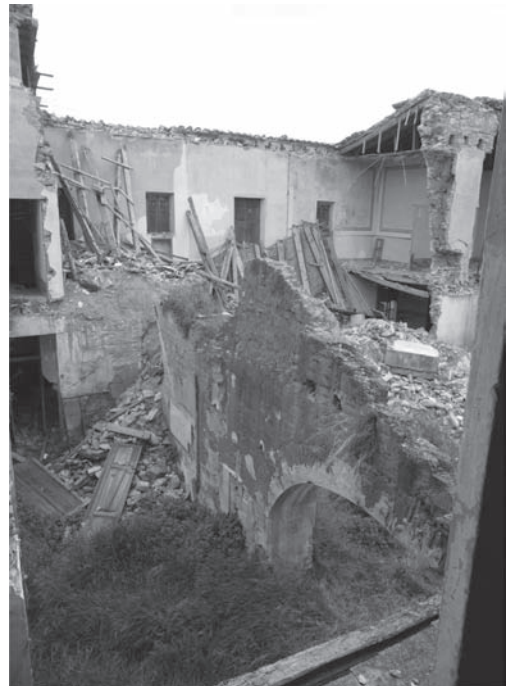
Figure 2. Collapsed *tapia valenciana* walls in a 16th century building (“El Relpá” in Alquerías del Niño Perdido, Castellón).

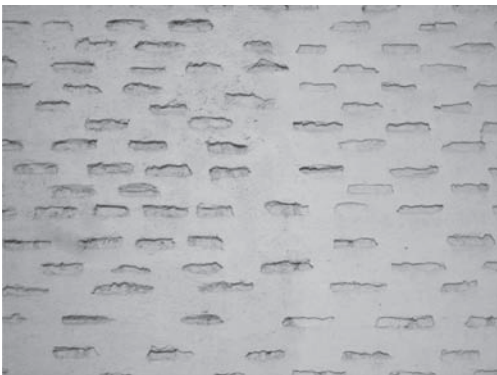
Figure 3. *Tapia valenciana* wall restored with a protective coating (*Almudín*, Valencia). Here two walls from different periods can be perceived.

In the case of the rammed earth wall, furthermore, a protective coating was selected.

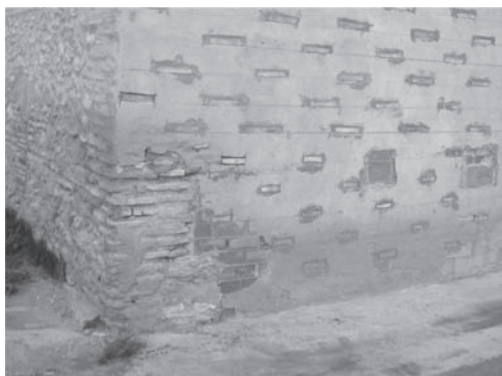
Figure 5. Fake *tapia valenciana* wall: new wall coated with a rendering into which the bricks are inserted (Alquería de Pinohermoso, Burjassot, near Valencia).

In an intermediate line, we might consider the ingenious recuperation of the image of *tapia valenciana* in the Alquería de Pinohermoso, in the town of Burjassot. The building, one of the medieval farmhouses in the Valencian countryside, had suffered a progressive decline throughout the 20th century, and had ended up in a state of ruin. Besides the loss of floor and roof, in recent decades the walls of the main façade had collapsed. Recently acquired by a new owner, its rehabilitation was undertaken to be used as a second residence. In this case, the walls were rebuilt with new material and then “transformed” into *tapia valenciana* with a layer of mortar and bricks -or fragments of brick- embedded afterwards. It would have been preferable to build the wall in the traditional way, but even so, the recovery of the farm, a landmark that was destined to disappear, must be celebrated.

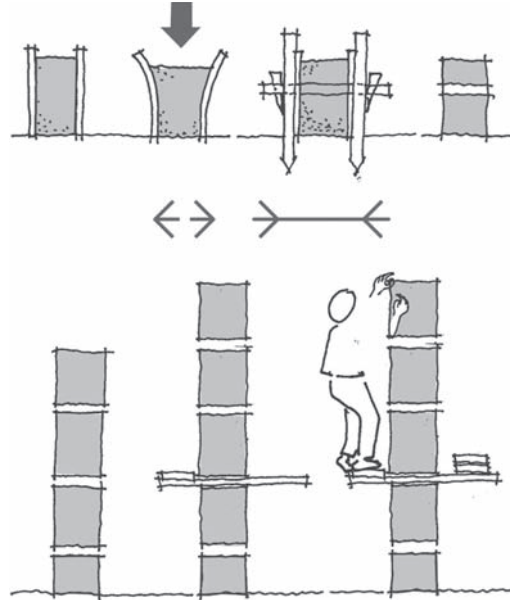
Figure 3. Principle of ramming: pouring in, and squeezing. Construction elements (the holes) are used later for maintaining and repairing.

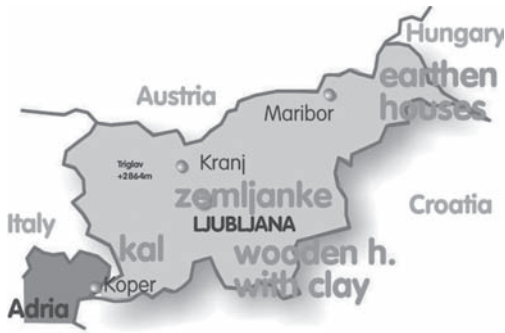
Figure 4. Slovenia and use of clay: in the Karst region it enables the ponds, in the central region it is cut for storing rooms, in the Eastern part it is used in cob and rammed houses, in the South it serves as filling in the wooden constructions.

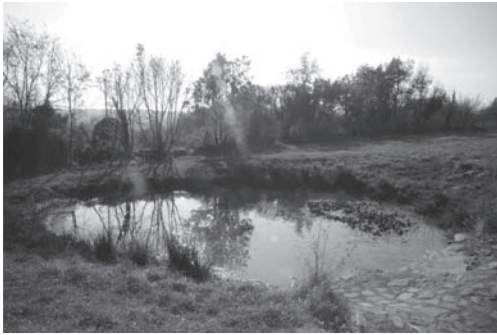
Figure 5. Kal or sort of a pond, used for drinking water over the summer, and for making the ice from December to April.

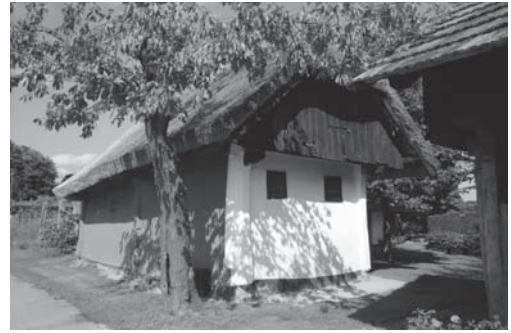
Figure 6. The main façade is white, the back one is darker, brown or red.

The architecture is the same: the houses are at least four metres wide and up to 24 metres long. They are mostly made of wood, and sealed and covered with a clay daub (Juvanec. 2010). On the main façade and in the inner part (toward the inner yard) they are white, the back is coloured red or brown.

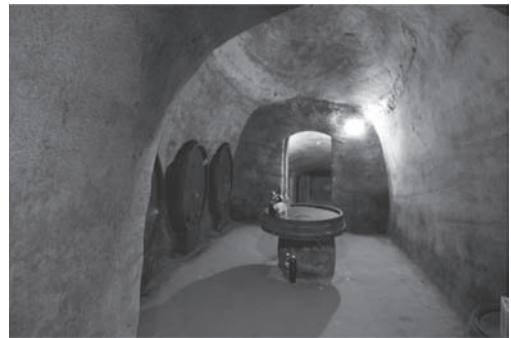
Figure 7. Repnice in Slovenia, artificial caves are cut into the hard, compressed clay. Or is it actually soft stone. photo: Domen Zupančič.

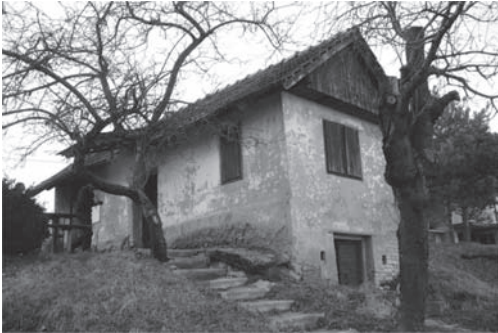
Figure 8. Blatnjača, a cob house, as vine cellar.

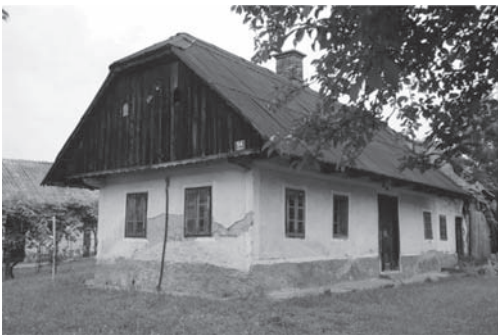
Figure 9. Butanca, rammed construction.

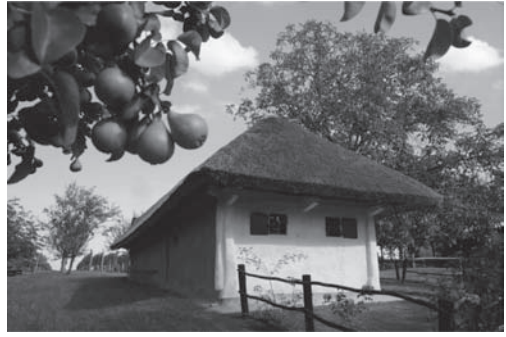
Figure 10. The vintage vine cellar: the windows are somewhere only some cm big.

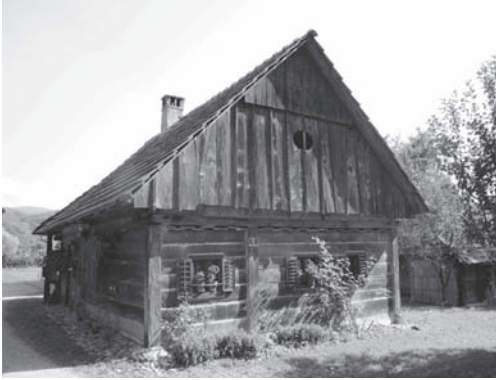
Figure 11. A wooden construction, sealed with clay is useful, successful and decorative. The final decoration in lime is the crosses around the window, made with the fingers.

Wooden constructions with clay daub in Slovenia: The commonest construction in the south—eastern part of Slovenia is a wooden construction, covered and sealed with clay. This is visible as a full cladding or sealing only. The construction itself can be seen at the corners, where the projecting ends ensure the solidity of the construction itself (in Portugal with stones, Correia, 2007:136).

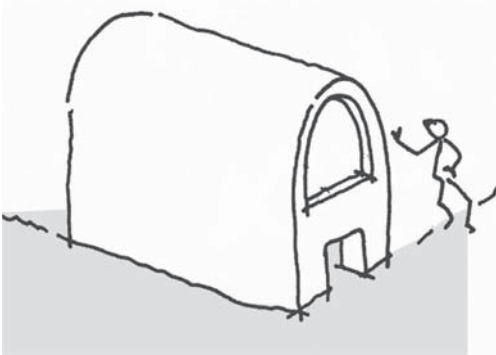
Figure 12. The tomb Campu Lontanu near Florinas, Sardinia is an object in a single piece of stone. Even the internal house fitting is in this stone: the bed for the dead. This is hard to 'build', hard to achieve appropriate material. This is very rare architecture.

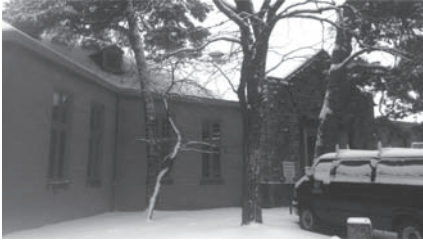
Figure 4. The Mud Hut, Marvin Studios, University of Kansas; built primarily of compressed earth blocks. Photo by author.

In 1941, W.C. McNown, professor of civil engineering at the University of Kansas, set out to build a single story 7000 square foot compressed earth block building for the, then, School of Engineering and Architecture (McNown 1945). Utilizing the labor of teen-aged boys from the National Youth Administration in its construction, Professor McNown successfully built, on a shoestring budget, a building of understated beauty (Alvy 1946). The building still stands today, in near perfect condition, as a testament to the durability of earthen architecture, and as the seeds of a legacy begun at the University of Kansas, albeit one that has largely been forgotten.

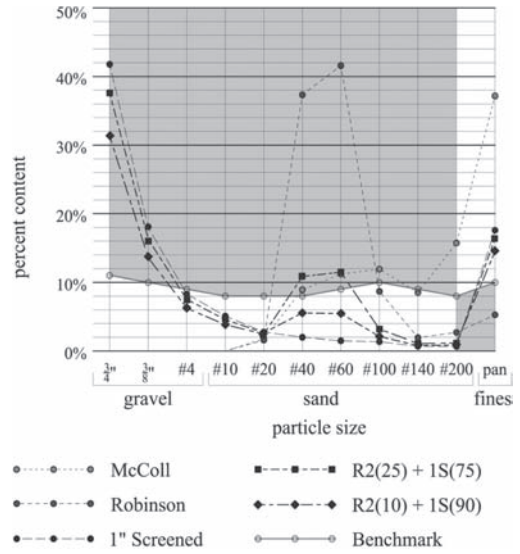
Figure 7. Particle size analysis on soils and soil blends.

In comparing particle size distribution of the soils, a benchmark line was established based on criteria drawn from the North American Rammed

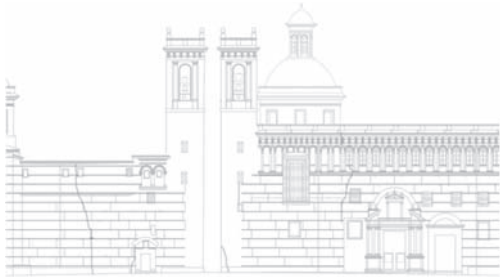
Figure 7. Detail of W and S façades.

On the main southern façade, there are a total of 10 rammed earth wall courses (Fig. 7). On the western façade there are up to 12 courses and on the north-eastern corner, there is a height of 15 courses.

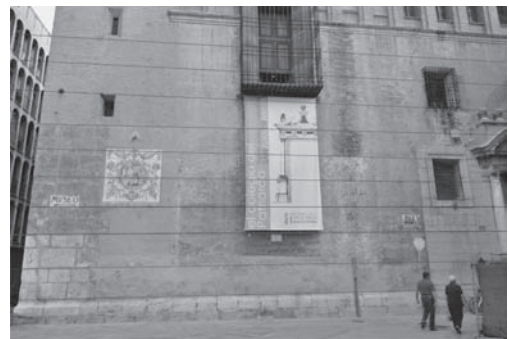
Figure 8. Superimposition of the rammed earth wall courses over a photograph of the southern façade.

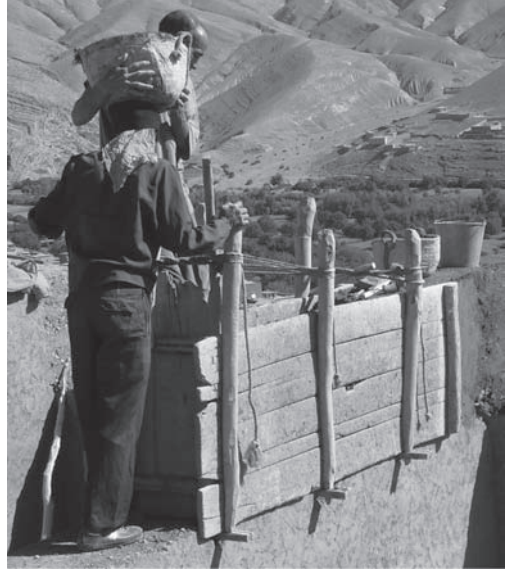
Figure 3. Hauling and pouring the earth.

Basket (*takfift*, pl. *tikfaf*): A basket is used to haul the earth mixture. It had a double rope sewn to its outer surface that formed the handles and lent it some rigidity.

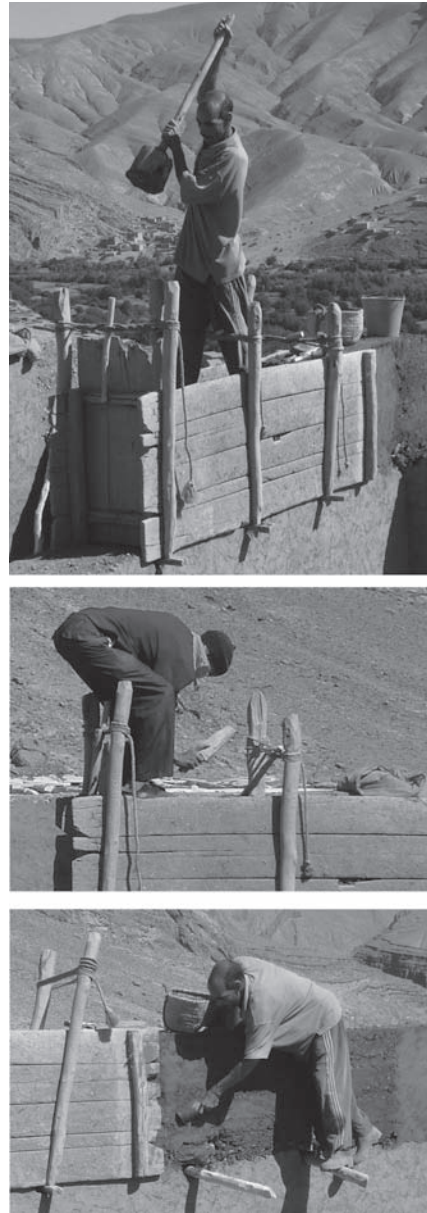
Figure 5. Ramming and finishing a wall section. a. ramming b. hand-ramming c. finishing (*takhbat*).

The first step is moisturizing the surface with a brush, just before applying by hand on selected areas a thin layer of earth partially moist that will cover the holes of the stays and other imperfections. A scraper is used to prepare the surface. A wet, small hand-rammer is used to finish the wall, which means tapping and making circular movements on the surface until it is perfectly smooth, with no evidence of the planks of the form or the joints with the two neighboring sections (one at the bottom, another one on a side). Finishing hides

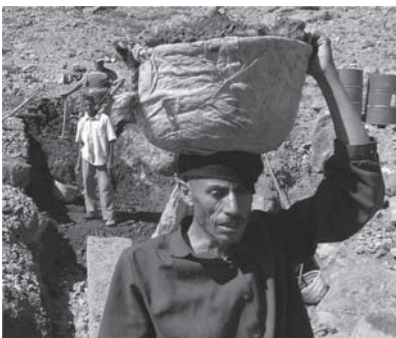
Figure 6. Forefront: Mr. Oukhom hauling the earth in a basket. Bottom: workman in the ditch.

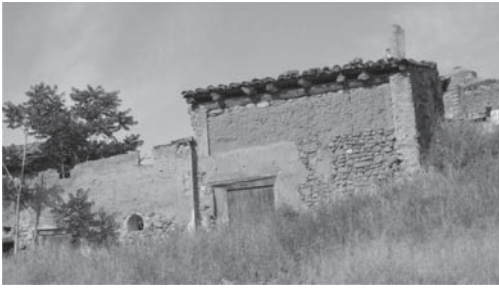
Figure 1. Simple rammed earth wall at Torrebaja standing on a masonry socle between two structural gypsum buttresses that bear a coping girder on which the roof is laid. The presence of the structural buttresses leaves the rammed earth wall free from any structural function (Vegas & Mileto).

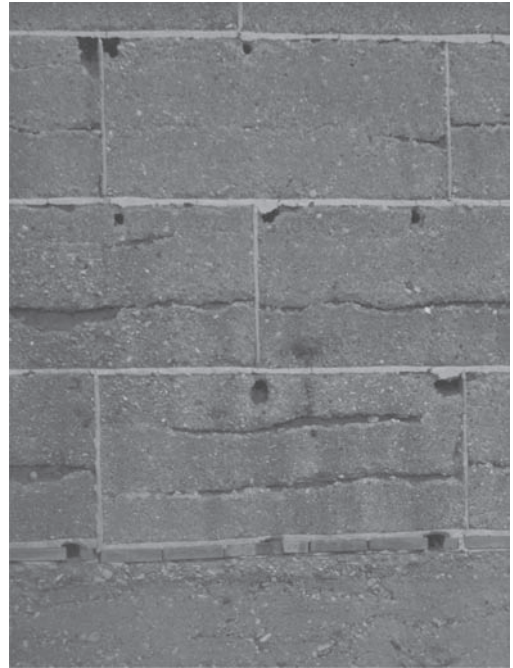
Figure 2. Rammed earth wall with gypsum-reinforced joints in order to protect these weaker points from atmospheric agents (Cristini).

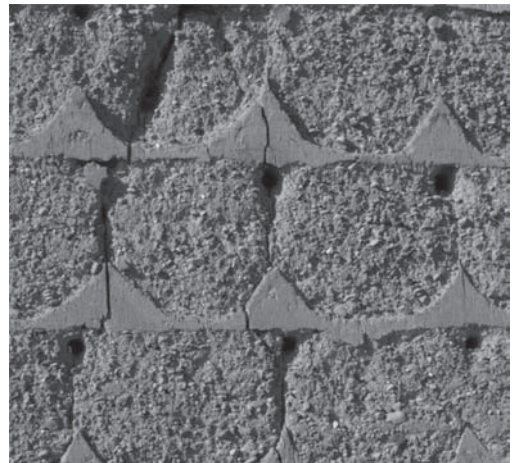
Figure 3. Detail of a rammed earth wall with *brencas* or undulated gypsum reinforcement (Vegas & Mileto).

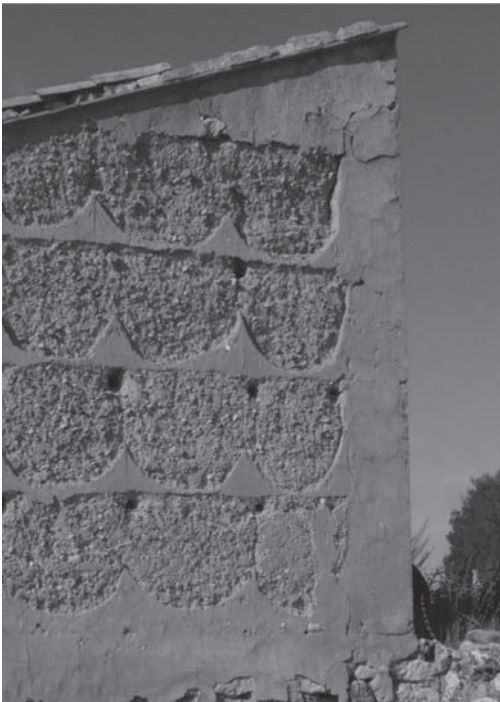
Figure 4. Rammed earth wall with *rafas* or embedded pilasters at the corner (Vegas & Mileto).

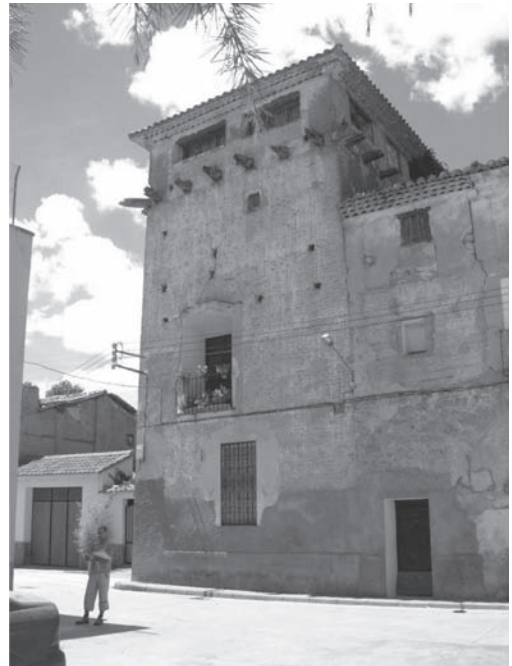
Figure 5. The tower at Torrealta, a typical case of Valencian rammed earth wall bonded in mass and reinforced on the outside with stones, visible on the finished surface (Vegas & Mileto).
