Rammed Earth Conservation

C. Mileto, F. Vegas & V. Cristini

PROCEEDINGS OF THE FIRST INTERNATIONAL CONFERENCE ON RAMMED EARTH
CONSERVATION, RESTAPIA 2012, VALENCIA, SPAIN, 21–23 JUNE 2012

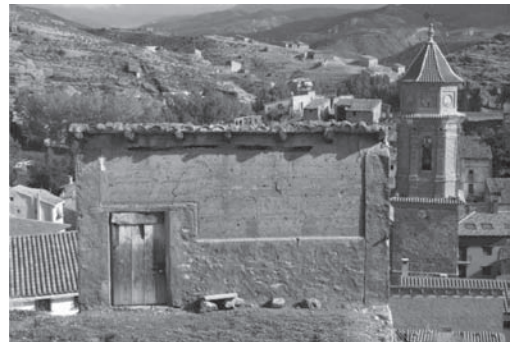
Figure 7. Gypsum thin wall built with formwork between two structural gypsum buttresses in a common auxiliary building (Vegas & Mileto).

The gypsum wall built with formwork is an extreme case on this list, since it shares the plank moulding system with the other techniques but differs from them in the way it is made, which is not by means of compacting, as gypsum does not need to be compacted in order to set and acquire its resistance capacity (Sanz 2009). The gypsum earth wall is very common in the domestic architecture of the parish for the outer walls of the upper stories. They can be planked on one side, reinforced with slabs of stone at the back with a total thickness of about 8–10 cm, or planked on both sides, with a majority of gypsum and a filling small stones and scraps

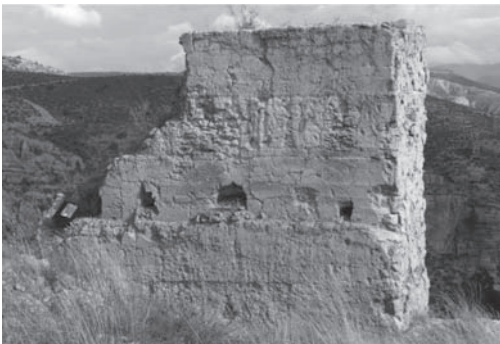
Figure 9. Massive gypsum wall built with formwork for defensive purposes (Vegas & Mileto).

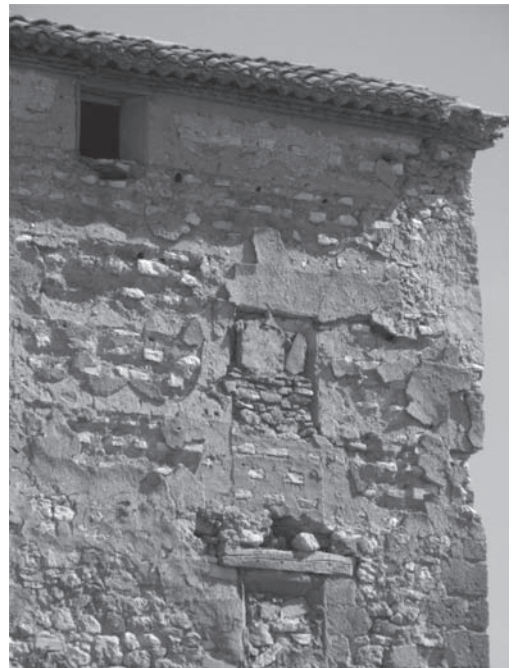
Figure 10. Example of a Valencian rammed earth wall with brenças and rafas damaged by weathering in a gradual process of erosion and loss of material (Vegas & Mileto).

The most common pathologies in this type of wall are not usually connected with the gypsum present in almost all the variants, but rather with the earth. In any case, these walls are seldom found to be in a poor state if periodical maintenance works are performed on them. Problems usually stem from damages in the roof and progressive leaks that seriously harm the wall and even destroy it completely if something is not done about it. If the stone socle is not sufficient, the pathologies can be caused by the dampness of the ground. The surfaces of the walls can also be damaged by weathering in a gradual

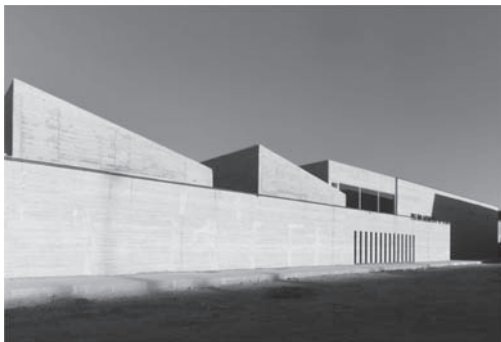
Figure 1. Autor: H. Fernández Santos-Díaz.

Thus, it was designed a sober building, without sacrificing the language of contemporary architecture, trying to link, in a natural way, with the building tradition of the area (Fig. 1).

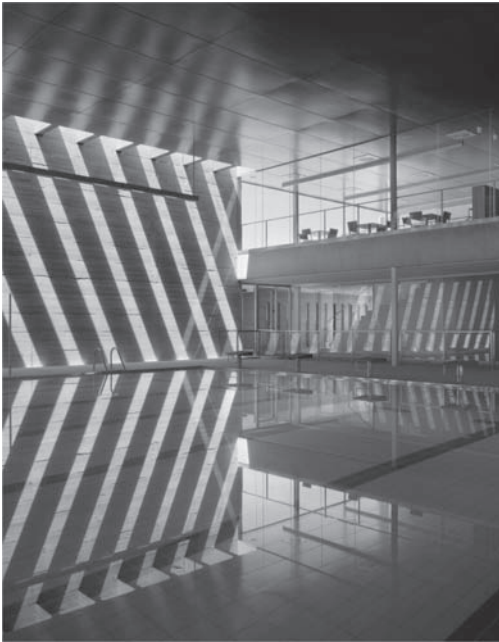
Figure 4. Light and shadows on the rammed earth wall. Autor: H. Fernández Santos-Díaz.

The closed and severe aspect of the building contrasts with the image that appears as soon as one crosses the threshold. The light enters the building through the skylights and courtyards which divide the rooms, but it is in the volume which contains the swimming pool basin where plays the prominent role, generating, at certain times of day, an intense play of light and shadows on the rammed earth walls (Fig. 4).

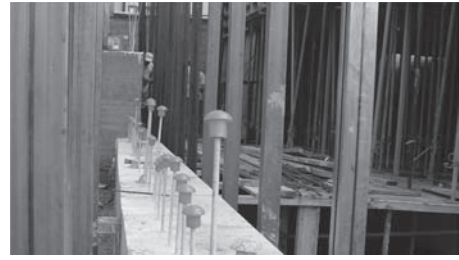
Figure 5. Reinforced concrete foundations with metallic connectors. Autor: Vier arquitectos SLP.

- A. The rammed earth wall was built over reinforced concrete foundations with galvanized steel connectors, above the ground level and the levels of runoff. In all cases, an impermeable barrier consisting on a specific mortar was applied (Fig. 5).
- B. The shuttering panels, with their associated connectors, were placed. The laying and texture of the formwork were carefully chosen in order to fix the appearance of the wall.
- C. The tiers were poured in layers of 10–12 cm thick for a better compaction (Fig. 6). The first tiers were richer in cement and a sealant was added to prevent absorption of water. Each five

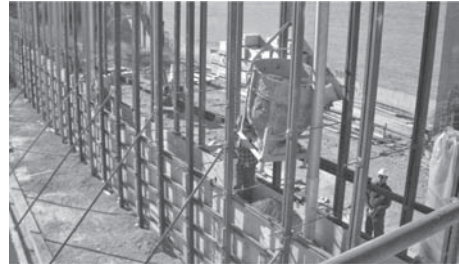
Figure 6. Pouring the earth once placed of the formwork. Autor: Vier arquitectos SLP.

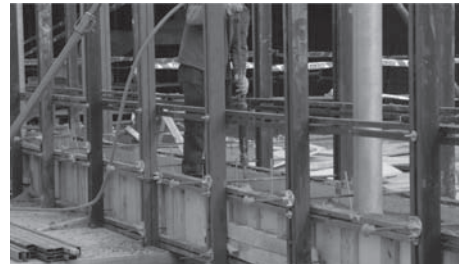
Figure 7. Mechanical manual compactor. Autor: Vier arquitectos SLP.

- ties (50–75 cm), one, rich in lime, was poured as reinforcement.
- D. Compaction. Mechanical manual compactors were used (Fig. 7).
- E. Protection. During the construction, all surfaces of the wall were protected with plastic sheets, particularly the heads (Fig. 8).
- F. Post-tensioning the wall. The most critical zone, in terms of structural requirements and stability, was focused in the hall of the pool basin, due to the significant height (6.40 m), the low permanent load of the roof and the large separation between the shear walls (35.00 m).

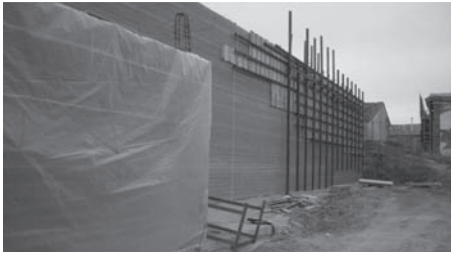
Figure 8. Protection of the wall with plastic sheeting. Autor: Vier arquitectos SLP.

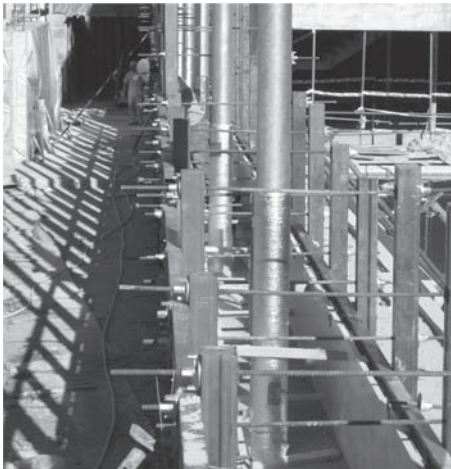
Figure 9. Galvanized steel tube with elastic joint inside the wall. Autor: Vier arquitectos SLP.

The structural solution proposed was based on stiffening the deck and post-tensioning the rammed earth walls to balance the possible lateral thrust, ensuring the stability of the whole enclosure. A concrete beam was placed over the wall to provide the tensioning load. The post-tensioning sheaths embedded in the walls should not transmit undesired loads to them when tightened –steel galvanized columns, embedded in the walls, equipped with an elastic perimeter joint to avoid movements, were chosen to convey solely the effort of tensioning (Fig. 9).

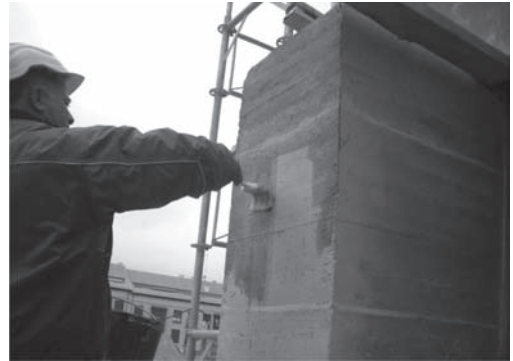
Figure 10. Application of a hydrophobic and fungicide impregnation. Autor: Vier arquitectos SLP.

- G. The wall surfaces were cleaned and repaired, after the application of two layers of a hydrophobic (water repellent) and fungicide impregnation but water vapor permeable, which did not affect their final appearance (Fig. 10). In the process of fissure repairs, injection techniques of pure mud were employed with uneven results, finally opting for the opening of the crevasses, filling and finishing them with clay slurry (Fig. 11).

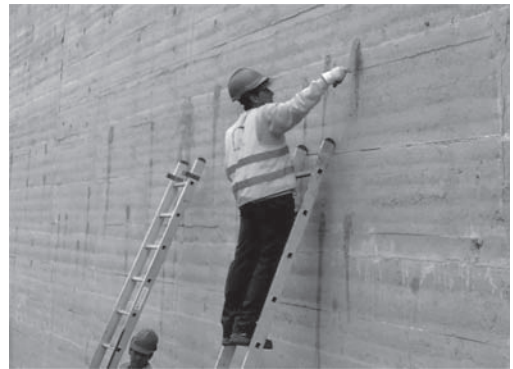
Figure 11. Reparation of small voids and defects. Autor: Vier arquitectos SLP.

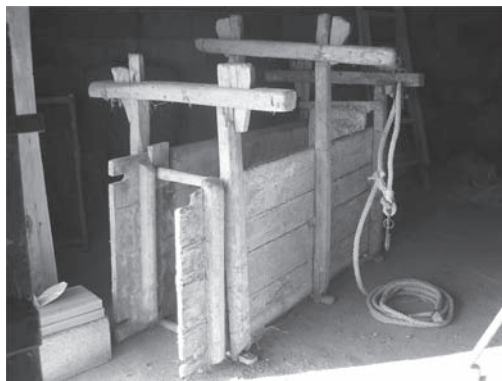
Figura 2. Tapial (con uno de los tableros puesto del revés). Villafranca del Campo (Foto: Félix A. Rivas).

La estructura total del tapial montado (Fig. 2) daba lugar a un volumen interior correspondiente

al módulo básico de tapia y cuyas dimensiones podían variar ligeramente. A partir de las medidas aportadas por los informantes y de las tomadas en muestras concretas de paramentos de tapia en la zona pueden establecerse sus dimensiones más habituales y más extremas en 70 cm de altura (entre 60 y 76 cm habitualmente), 1,5 m de anchura (entre 1,3 y 1,7 m) y 40 cm de grosor (desde 37,5 a 50 cm).

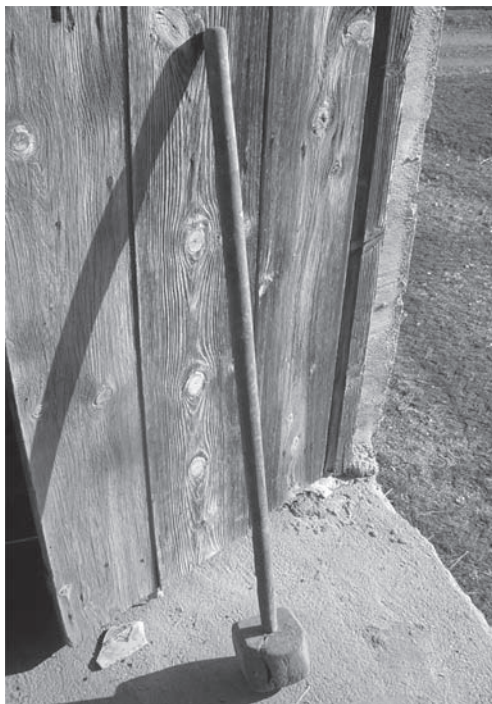
Figura 3. Pisón. Villafranca del Campo (Foto: Félix A. Rivas).

Desde el interior del encofrado, los dos tapiadores arrojaban cierta cantidad de tierra cada vez y la iban apisonando. El pisón (Fig. 3) era una herramienta de madera compuesta por un mango redondo y largo, lo suficiente para que la persona que lo manejara lo pudiera hacer desde una postura erguida, y rematado por una “cabeza” en forma más o menos cúbica aunque algo apuntada hacia su extremo inferior y, frecuentemente debido a su desgaste debido al uso, un poco redondeada en su parte final. Su longitud total podía oscilar entre 1,13 y 1,40 m, y su cabeza tenía entre 10 y 12 cm de anchura y entre 12 y 15 cm de altura.

La cabeza, además, solía ser de madera de carrasca o sabinas para que se desgastara lo menos posible a pesar de su uso. La acción, denominada de manera general “pretar”, consistía en golpear la tierra con el pisón hasta que alcanzaba un aspecto compacto que se juzgaba suficiente.

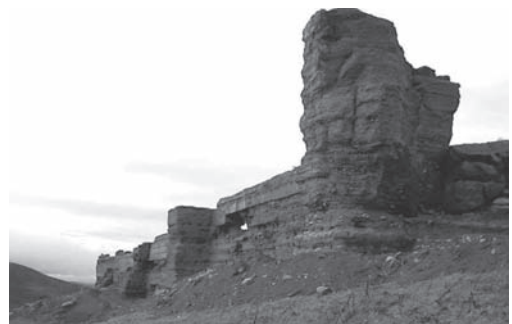
Figure 1. Southwest walls and towers, before work.

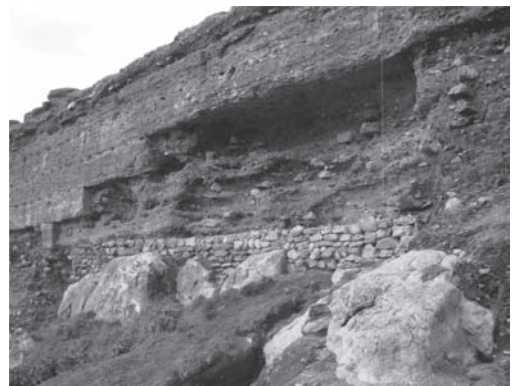
Figure 2. Erosion in rammed earth walls. Here we can see the difference between the two types of raw material used in lower rows and in the upper rows.

In these walls there are two types of material used for the overlapping rows. The first type is located in the lower rows, in some cases very deteriorated. The mass is rich in ceramic but has a low cohesion, due to the small presence of lime as a binder in its core. Mainly presents a high proportion of clay, silt, sand and gravel, along with pieces of pottery and large stones. The soil that becomes part of its composition was probably caught in the same area of construction. Thus, the wall has the same colour as the ground on which it is built.

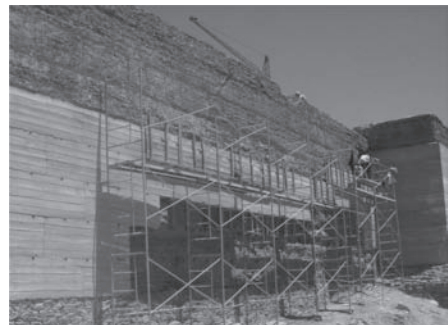
Figure 3. Working zone on southwest wall. Notice the lack of space for scaffolding mount and for machinery work. See the small crane, working from the interior of the wall.

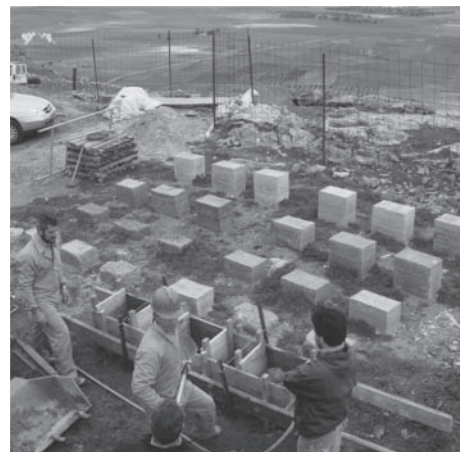
Figure 4. Rammed earth samples, made on site.

It was also very important for us to define the most efficient way to tamp the soil. To achieve this purpose we also used the making of the samples, to test different forms of ramming the earth. We tested manual and mechanical means, electric and compressed air systems, also trying to simulate all possible situations of the work on the wall. Finally, it was decided to do a mechanical compaction with an electric hammer adapted for tamping. However, as some parts of the wall would have to be done with manual compaction, we had

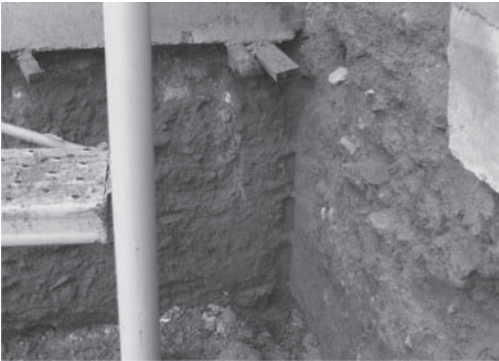
Figure 5. On centre of this photo, it can be seen in a corner of the rammed earth wall, the negative of the five wooden overlapping planks from the original formwork.

Making a review in the rammed earth on the wall, we found areas where we could still see the negative of the original formwork. Based on these data, it was possible to know that the original moulds were made of five wooden planks overlapping in vertical position, reaching the height of 85 cm. Using these same dimensions we have made new boards, therefore perfectly adjusted to the metric of the original construction. It was also possible to collect some original rods that were used to hold the boards. From these we have produced, with the same wood species, *quercus ilex*, new rods identical to the original, and we used them to mount the new formwork. Originally, the rods were set in place with some pieces of wood, small wedges

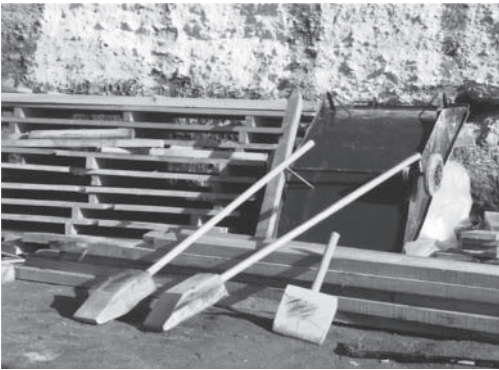
Figure 6. Newly produced formwork and rammers.

to draw and make some wooden rammers adapted to the circumstances that we knew we would have.

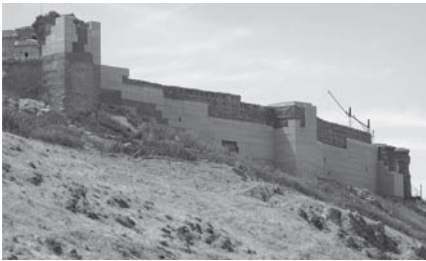
Figure 8. Completion of works on northeast walls and towers.

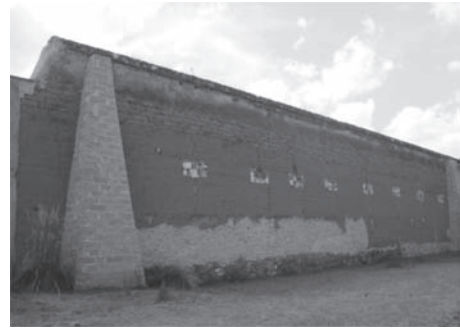
Figura 4. Muro de tapia en la fachada norte de la fachada de la casa grande. Imagen de autor.

La fachada norte (posterior) es casi en su totalidad un muro ciego, únicamente cuenta con un acceso; en esta sección se logra apreciar el muro de tapia con pérdida de aplanados y de policromía.

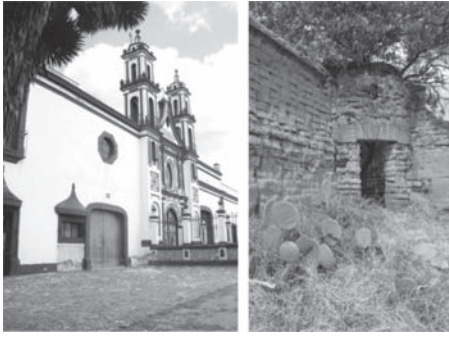
Figura 6. Estados de conservación de distintos espacios componentes de la hacienda. Imágenes de autor.

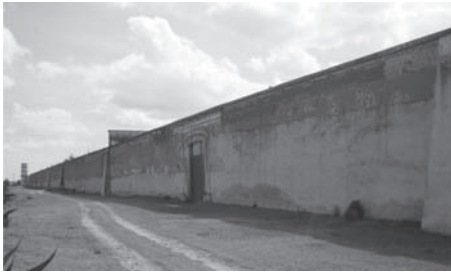
Figura 10. Fachada posterior de la casa grande de la hacienda. Imagen de autor.

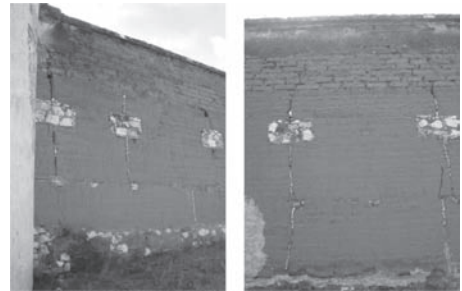
La erosión de estos muros es más evidente en los cerramientos y encofrados en los que se utilizó adobe, es decir, se aprecia visiblemente que el adobe se ha deteriorado más que la tapia, en la que únicamente se nota la pérdida de aplanados y ligera disgregación del material.

El sistema constructivo de tapia empleado en la hacienda fue a base de tierra arcillosa de la región conformando muros con un espesor variable de 0.40 a 0.80 m; en las trojes y graneros se localizan los muros con menor grosor, mientras que en la casa grande y capilla el espesor de los muros es mayor.

Figura 12. Estado de conservación de muros de tapia con cerramiento de adobe. Imágenes de autor.

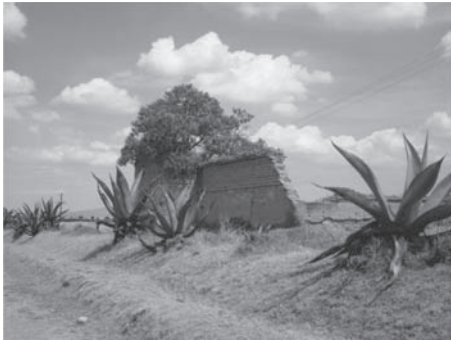
Figura 13. Estado de conservación de muros de tapia con adobe. Imagen de autor.

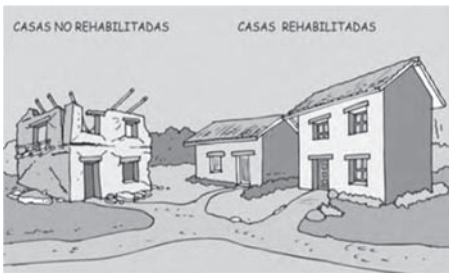
Figura 14. Distintos estados de conservación de construcciones de tierra. Fuente: Manual para la Rehabilitación de viviendas construidas en adobe y tapia pisada, 1999.

El aspecto general en la actualidad permite la lectura del comportamiento de los muros de tapia, mostrando en la realidad una imagen de la publicación colombiana llamada *Manual para la Rehabilitación de viviendas construidas en adobe y tapia pisada*, la cual se muestra a continuación y nos pone como ejemplo la diferencia entre un inmueble que se descuidó y está en total abandono contra uno que se ha mantenido rehabilitándose paulatinamente.

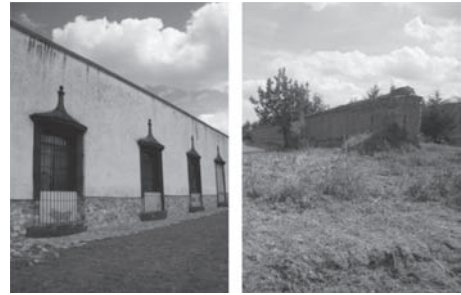
Figura 15. Distintos estados de conservación en muros de tapia de la hacienda Santa Teresa Ixtafiyuca. Imagen de autor.

En la imagen anterior se pueden ver distintos estados de conservación en la arquitectura de tapia, mismos que en hacienda de Santa Teresa Ixtafiyuca están presentes en algunos de los espacios que la componen, mostrando diversas apariencias de este sistema constructivo.

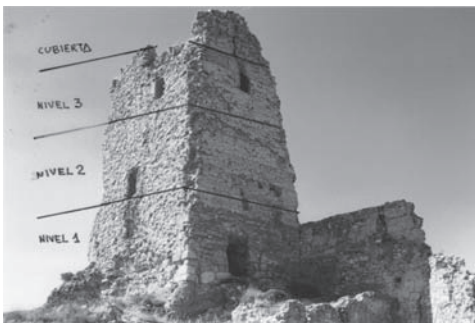
Figura 5. Torreón de tapia de yeso.

El torreón había perdido prácticamente en su totalidad la piel exterior, tenía importantes pérdidas en la masa de sus muros, sobre todo en su parte superior, con grandes grietas que habían roto la unión y continuidad de sus muros, poniendo en riesgo su estabilidad.

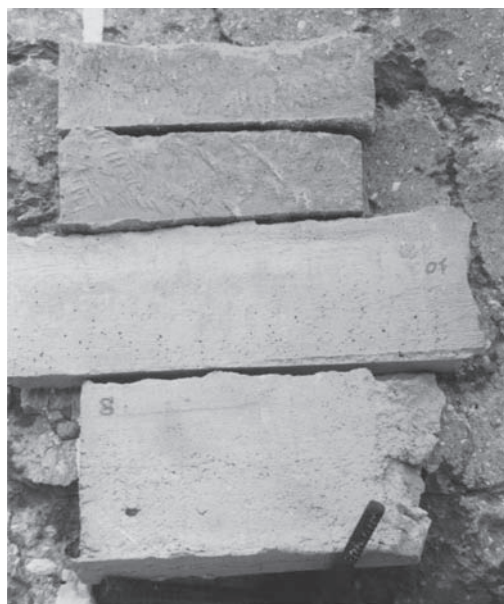
Figura 8. Muestras de yeso envejecido artificialmente.

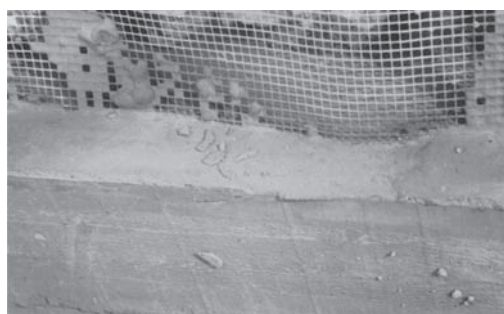
Figura 9. Malla de fibra de vidrio y tapia de yeso nueva.

En la unión de la tapia vieja con la nueva se dispuso una malla de fibra de vidrio anclada con conectores de acero inoxidable como elemento diferenciador de los conglomerantes viejo y nuevo y como armado del nuevo conglomerante para minimizar las fisuras de retracción y facilitar la adherencia entre ambos (Figs. 9–10).

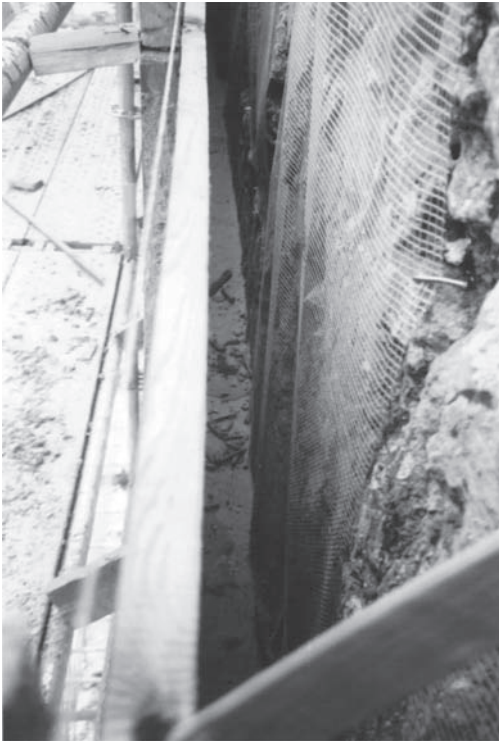
Figura 10. Malla de fibra de vidrio y tapia de yeso nueva.

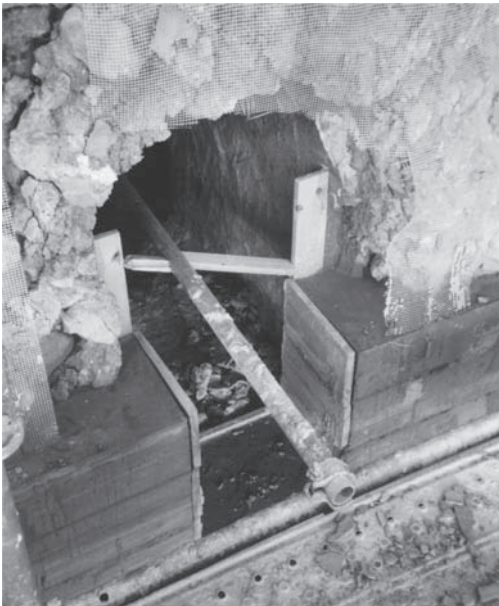
Figura 11. Vano en proceso de restauración con volumen importante de tapia a reponer.

se realizaron varios ensayos físicos y mecánicos para conocer la resistencia del nuevo yeso a utilizar (Figs. 11–12).

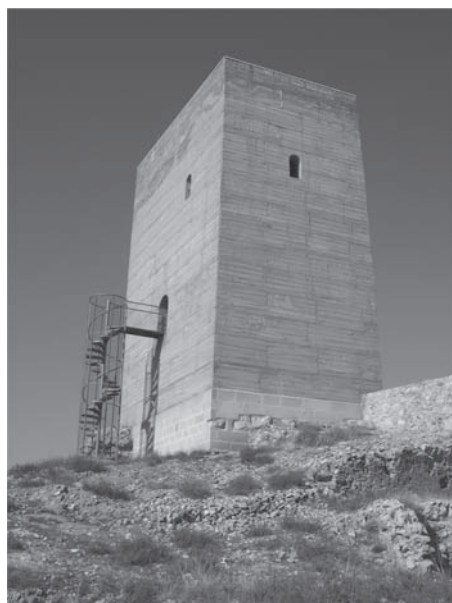
Figura 16. Torreón de tapia de yeso restaurado.

El resultado final una vez realizada la intervención respondió a las previsiones realizadas antes del inicio de las obras (Fig. 16).

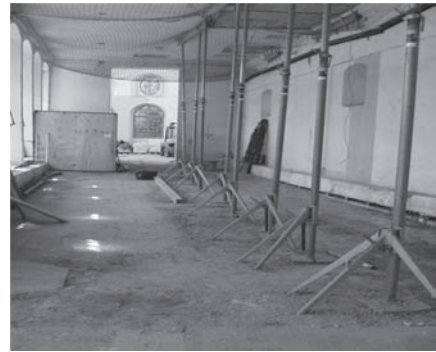
Figure 4. Current situation of the rammed earth floor, northern pavilion and northern oval house, Belvedere Orangerie, September 2011.

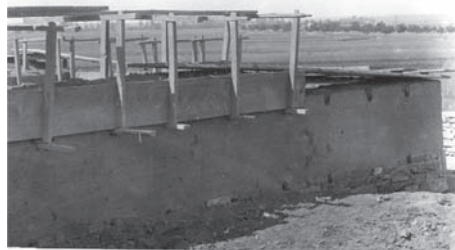
Figure 1. Rammed earth construction in Hroznová Lhota, distr. Hodonín, in 1910 (Karel Chotek).

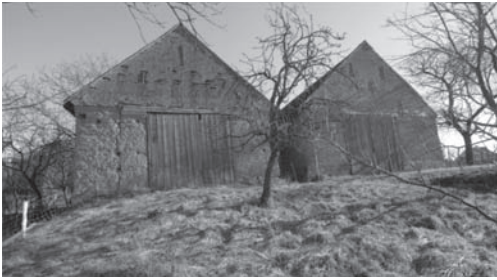
Figure 2. Rammed earth barns in Vnorovy, distr. Hodonín.

In Moravia the rammed earth is gradually used not only for the construction of residential and important farm buildings (Fig. 2), but also the most common small structures as vineyard cabins (Fig. 3). It also penetrates to the upland regions like Luhačovické Zálesí and Moravské Kopanice (Dobiáš 1892, Václavík 1930, Máčel & Vajdiš 1958), where the living tradition of rammed earth survived till the 20th century. One of the last documented newly built rammed earth constructions is that of the house No. 126 in Lopeník from 1925 (Máčel & Vajdiš 1958).

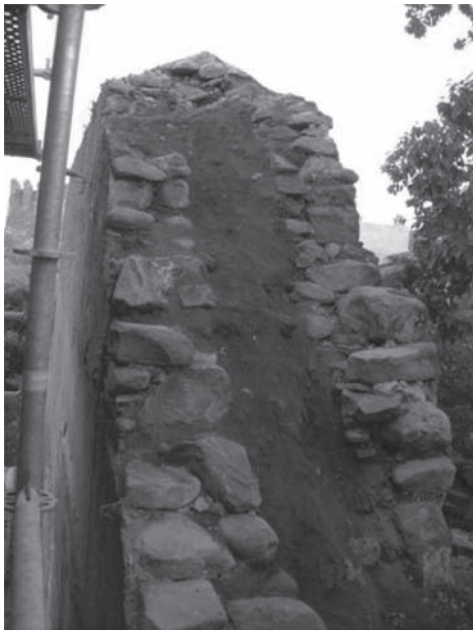
Figure 1. Section of the wall at the rebuilt in 1942 by the Dirección General de Regiones Devastadas.

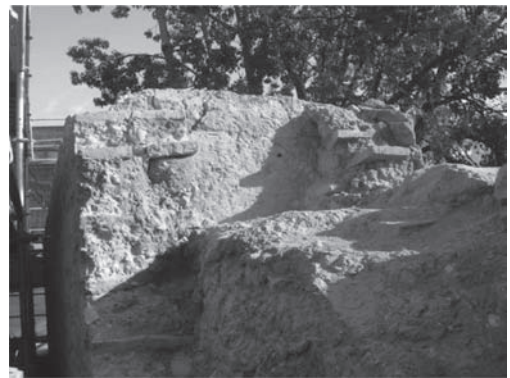
Figure 3. Detail of the original section in the union of two rammed earth walls.

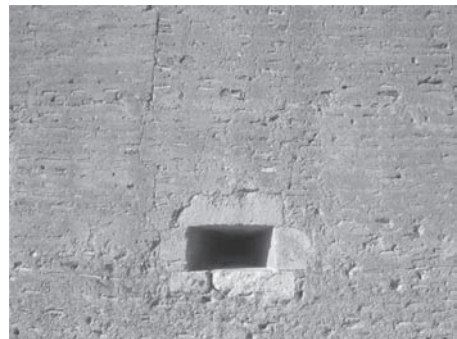
Figure 4. Aspect of the original finish on the tower of the Portal de l'Horta, with the pocket described in the contract.

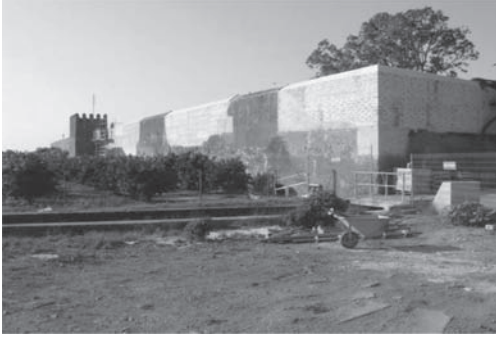
Figure 5. Appearance of finished wall.

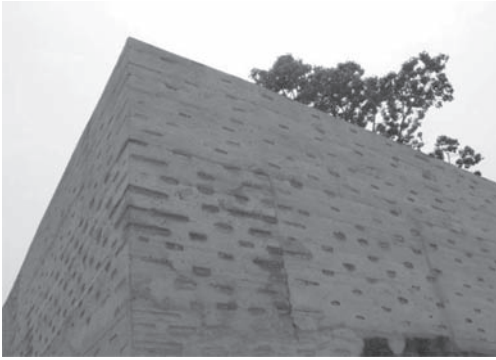
Figure 6. Detail of the wall.

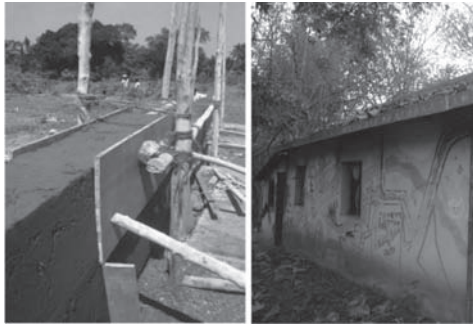
Figure 1. The rammed earth wall and formwork and finished wall in Building 1.

The authors' first experience with Rammed Earth was a garage structure in Mysore, India in 1996, referred to as Building 1. It was made with a simple horizontal form work of wood panels, wooden clamps and wooden inclined supports, all held together with ropes. The available soil was modified by adding quarry dust, and 5% cement was added as a stabilizer. Figure 1 shows the formwork and the rammed earth. This structure has a sloping Reinforced Cement Concrete roof of filler slab with Mangalore tiles.

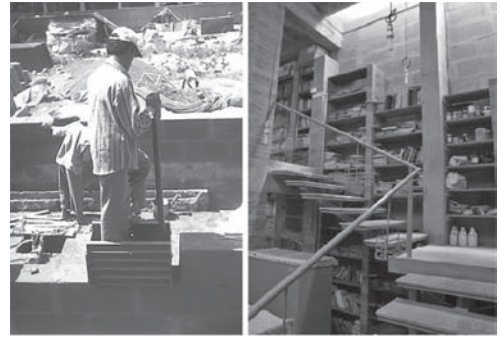
Figure 2. Rammed earth block making and walls in Building 2.

The authors worked with Prof. M.R. Yogananda for their second rammed earth wall in Building 2 for a project in Bangalore in 2003. In this process earth was poured in small MS box formworks. The result was a block like unit.

Up to 2.1 m height, these blocks were made in situ above which workers preferred to make the rammed earth blocks on the ground and lifted them in place. The soil was modified by adding 40% quarry dust and 5% cement. The load tests were conducted on the Rammed Earth Blocks at the Centre for Sustainable Technologies, Bangalore and found to be close to 80 kgs/cm^2 . The surface of these blocks was smooth and well finished. Making the blocks also allowed for the flexibility to redo if the surfaces did not match the desired expectation.

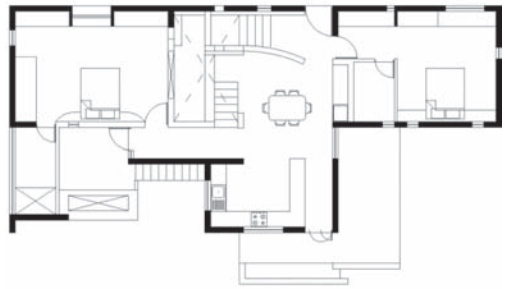
Figure 3. Dark walls indicating rammed earth walls of Building 3.

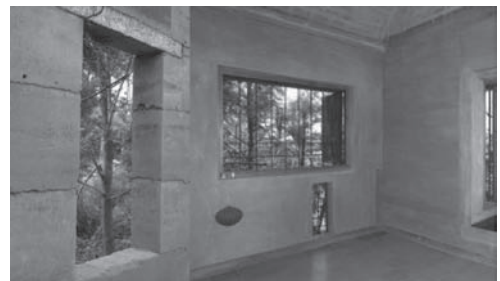
Figure 5. Walls with the visible joints during construction and after rendering.

The internal surface was thus rendered with a stabilized plaster to achieve uniformity and smooth surface, as seen in Figure 5. Externally the surface was left as it is with one exterior wall having a mud cement mural as seen in Figure 6.

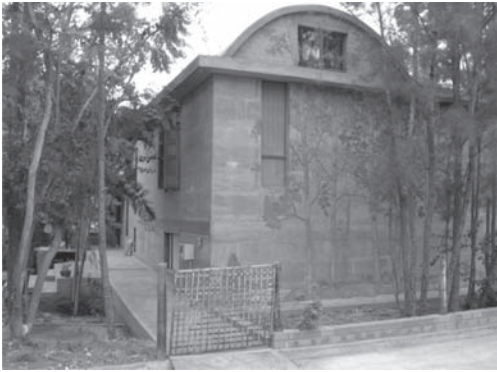
Figure 6. Exterior view of Building 3 with mud cement mural.

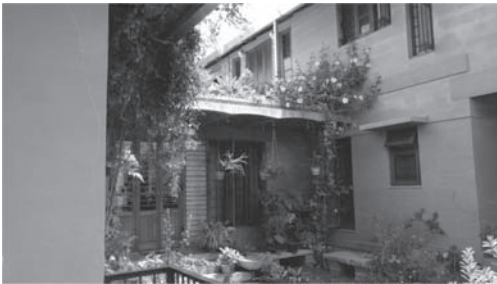
Figure 7. Mud paint rendering on rammed earth walls of Building 4.

Building 3. Here too clients did not appreciate the walls being left un-rendered. Both the internal and external walls were rendered with mud paint as seen in Figure 7.

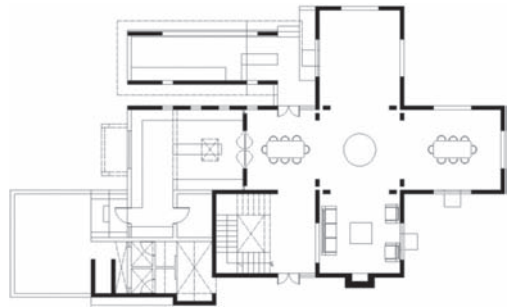
Figure 9. Plan of the admin block of Forsyth Lodge, Building 5. The shaded walls are the rammed earth walls.

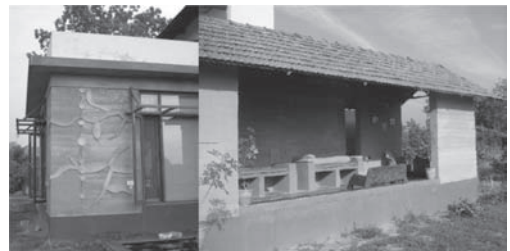
Figure 10. Walls with 90 degree turn and plane panel walls.

The walls were smooth and without issue, except on two occasions when the panels were not cleaned well before setting up for the next stage. In these occasions, the surface peeled off while dismantling. This peeled surface was covered by a mud cement mural. This method of constructing brings about a vertical joint with round holes where clamps were placed. The vertical joints, though of no consequence with respect to the structural stability, were covered by incorporating a mural as seen in Figure 10. Internally, the surface was plastered and painted.

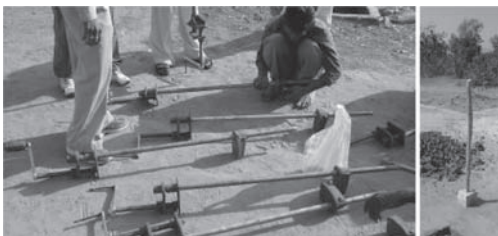
Figure 11. Clamps used in the formwork and wooden rammer, fabricated locally.

The soil was tested at site and found to be sandy enough, not requiring any modification except for 5% stabilization with cement. The formwork was of centering sheets, wood planks and steel clamps. The clamps shown in Figure 11 were simple enough that they could be manufactured in the town nearby. A wooden rammer was also made at the site.

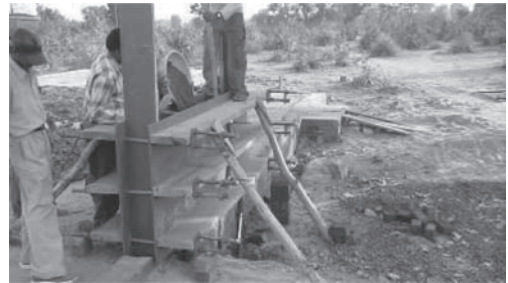
Figure 12. Formwork used in Building 5.

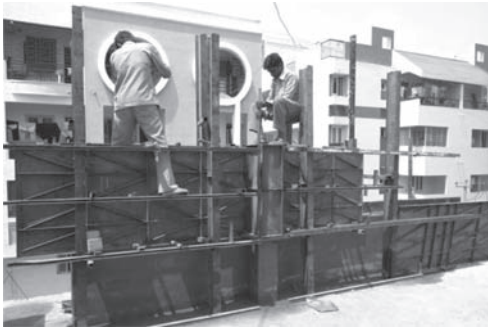
Figure 15. Form work used in Building 6.

It was not possible to build with Compressed Earth Blocks due to lack of space for making them. Rammed Earth construction was the obvious choice, since the walls could be made in situ and also modified structurally to take the load of four floors. The ramming at height was an issue, and was overcome with the design and materials used for ramming. The whole perimeter of the building was divided into six parts, minimizing the joints between the panels. Openings were provided where a joint occurred; making the panel joints a feature, with the design following the construction method adopted. The 2.5 meters of height was rammed in three stages. The material for the continuous formwork was centering sheets for panels and mild steel “I” section supports and metal clamps tack welded together as shown in Figure 15.

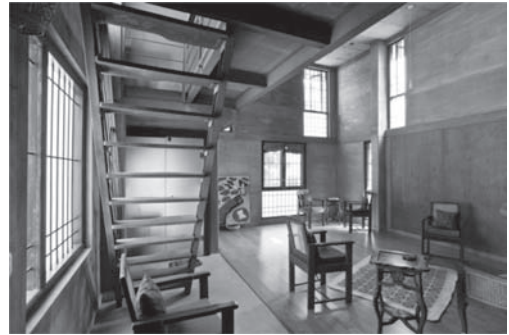
Figure 16. Form work reused for intermediate floor Building 6. Inferences.

In Building 6, it was decided to close the loop with respect to the formwork. The final floor plate was designed to use the formwork I sections as supports for the floor boards, as in Figure 16 and the

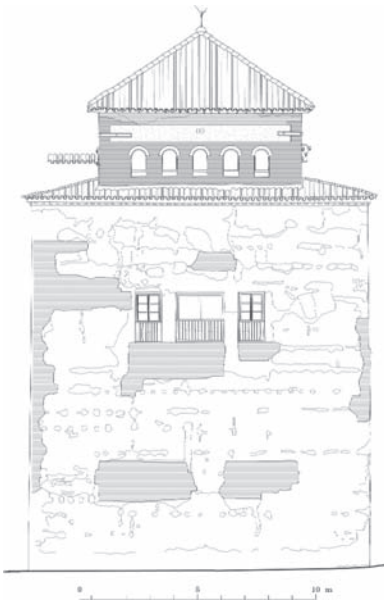
Figure 3. Southern elevation of the tower.

As from 6 m from the floor of the *qubba* the external walls are cut short, and from this height a square body stands out, like a lantern (Fig. 3), sustained on the northern and southern walls and on the header faces of the interior transversal walls. This lantern body has five small arches on each side to light the interior and is finished with a square trough collar-beam roof. Constructively, the way in which this higher body was made, of mixed masonry brickwork and *tapia*, turns out to be very appropriate. Prior to making the lantern, the six satellite spaces were covered with panelled ceilings with beams supported on the eastern and western outer walls and on some thin wooden beams supported on the header faces of the partition walls, and placed very near the wall face of the central hall. Underneath this beam, in the two central wall openings, plaster arches with decoration without any tectonic function were built. The four side wall openings were closed with wooden doors. Over these panelled ceilings the *tapias* were prepared, to continue the construction with rammed earth. To avoid loading the weight of the wall which otherwise would have rested on the previously

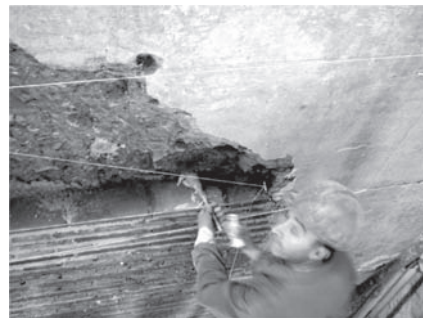
Figure 5. Insertion of the wall ties with plaster and hemp.

The attachment has been made with wood, since that was the material that was used to a great extent in the *tapia*, as we have been able to establish in this building itself and in other places. Therefore, in the constructions in Meknes (Morocco), probably one of the most impressive complexes of *tapia* constructions, with over 30 km of walls built with this technique, we have been able to observe a systematic use of wooden elements set into the mass of the walls to give them greater bonding, in particular in the angles and corners where cracks tend to happen with ease, due to differential settlements or other earth movements. With this experience behind us, we began to take advantage of any opening in the original wall, whether of *agujas* (pieces of wood for sustaining the shuttering), or previous strengthening elements, to introduce pieces of wood covered with plaster and hemp to guarantee good adherence to the masonry and protection of the material. These pieces had sufficient length to reach a few centimetres from the outer face of the walls. In the areas where there were no holes or they were set a long distance away, orifices were opened using an electric drill with a bit and wooden laths were put in, of the type used to make tenon joints in carpentry and which have a high degree of resistance and a fluted surface that improves adherence. They were covered with plaster and hemp like the pieces of a wider section (Fig. 5). All of these attachment elements, placed every 40 or 50 cm and entering 25 cm into the old wall, were absorbed into the brickwork masonry with which we reestablished the openings produced due to the *tapia* having receded or previous repair work having fallen away. This brickwork was made with lime mortar scarce in conglomerates (1:3) and the openings existing behind it were filled in to ensure some adherence with this method.

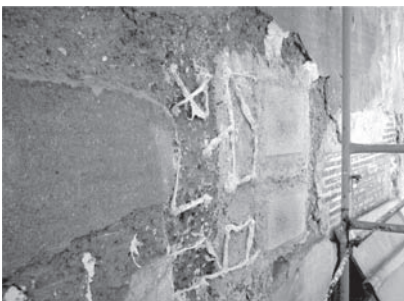
Figure 6. Wall tie elements for rendering.

To repair superficial deterioration a similar method was followed, using wall ties of shorter wooden laths, similarly coated in plaster and hemp joined together with bands of these fibers covered in plaster. Over this mesh the lime mortar rendering was extended, and in this way it was more solidly secured to the wall (Fig. 6). We consider that this simple and economic procedure improves the bonding between the two materials, the restored and the original; by maintaining the methods of traditional restoration, which are certainly not perfect, we must admit that up until now there are not other methods that offer a better guarantee or durability.

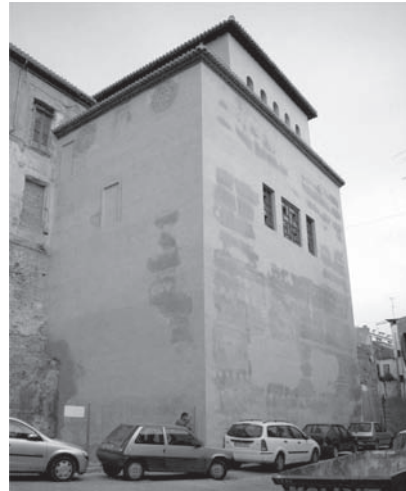
Figure 7. Restored tower of the Cuarto Real de Santo.

atmospheric agents that had taken effect in various ways, therefore it was impossible to achieve an overall tone, nor on the other hand would this have been desirable, since it would have deprived the monument of its original image. Finally, we chose to apply a medium toned mortar and to apply glazes to smooth the differences in those parts that are in contact with old and darker rammed earth parts. As a final result the original areas of wall are clearly distinguishable, while there is a homogenous and coherent image in the wall faces as a whole (Fig. 7).

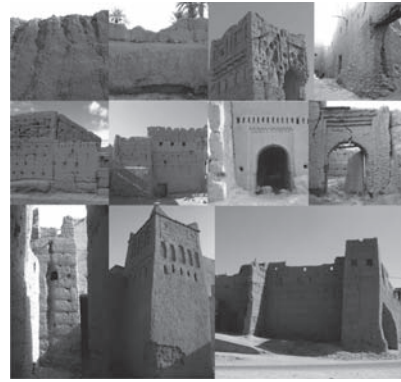
Figure 3. Earthen construction pathologies in the Drâa Valley (credit by CERKAS 2005 and E. Baglioni 2009).

A different class of pathologies are linked to the "limitations" of the construction techniques, related to the specific place, to local cultures, and to the skills of local workers. All these causes influence the construction process (VV. AA. 2009). In analysing the built heritage, it was observed that the rammed earth layers are often built without offsetting the vertical and corner lap joints. This was also noted in the perimeter wall and the partitions—whether in rammed earth or adobe. Both cases are related to economy factors, which tend to minimise the use of rammed earth sub-module. From a structural point of view, in the absence of mutual bonding, the walls work separately. The lack of a perimeter ring beam at floor level prevents the wall sections from creating a "box" that would spread the loads more evenly. Due to the natural joint separation and the weathering action, the walls gradually tend to separate from each other. This phenomenon is affirmed by the presence of recognisable vertical cracks. These processes are accelerated by the sagging or settling of the soil, which often generate rotations of the walls—with overturning tendency—and the onset of "out of plumb". To limit such effects in these cases, stone buttresses are often used against the walls.

Weak elements of the Drâa Valley buildings are also the horizontal structural elements (beams and lintels) made with palm wood, which—due to its fibrous nature—does not guarantee high structural performance. The fibres of the palm trunk, when

under load, tend to work separately and produce a strong deflexion of the timber elements; such repeated action require an adjustment of the wall with the subsequent onset of cracking, mainly visible in the adobe walls.

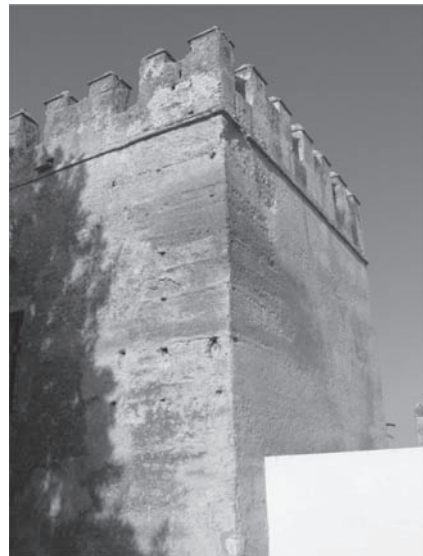
Figure 2. Bell tower.

In both stages, walls were constructed with rammed earth (Fig. 2) of diverse typology, which nowadays can be observed as having been greatly altered by successive consolidation work throughout its history, but especially by those interventions carried out in the early twentieth century by the English archaeologist George Bonsor (1822–1930) who bought the castle and set up his residence there.

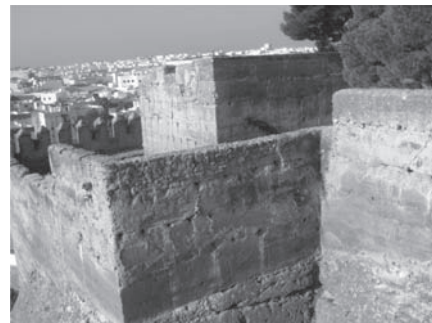
In the composition of the walls, abundant use of “albero” is observed; the typical ochre sedimentary rock of this zone, rich in calcite, poor in quartz and with a variable content of iron oxides in the form of goethite (Fig. 4). This material has been widely used in construction in Seville, since it gives mortars the good qualities of high mechanical strength and a low reduction in volume.

Figure 4. South barbican.

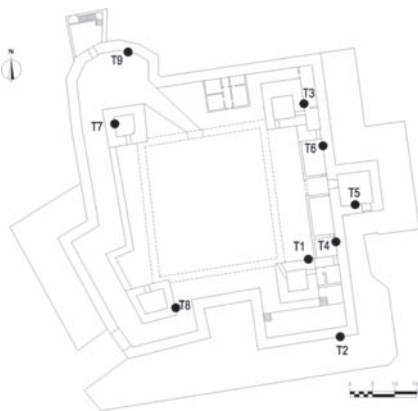
Figure 5. Location of samples.

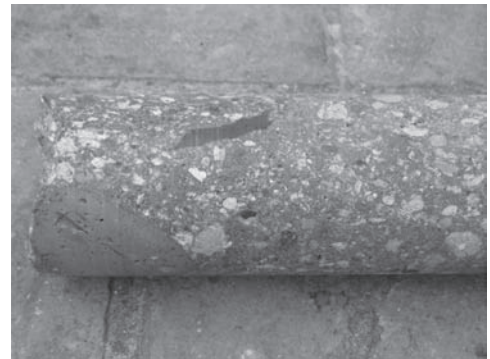
Figure 8. Sample 1.

rest, and detecting a 80–90% of sand, containing a higher quantity of silts and clays than 10% in all samples except for No. 1 (Fig. 8).

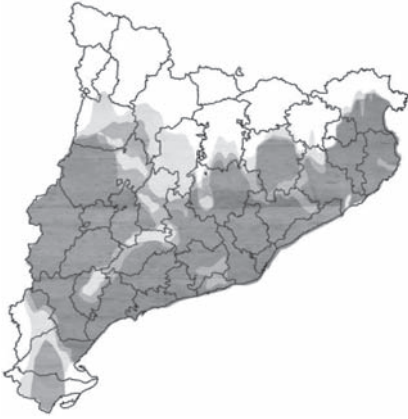
It has been proven the existence of rammed earth buildings in almost all the Catalan territory except for the Pyrenean area, where easy access to the stone, on one side, and the wettest weather on the other, have been determinants in the use of other construction techniques (Fig. 2).

Figure 2. Map of the earth architecture distribution in Catalonia. Source: thesis A. Cuchi.

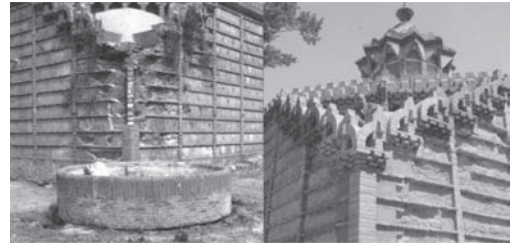
Figures 5-6. Previous and later view of the rammed earth restoration carried out by architect and Professor Joan Bassegoda Nonell, Gaudí Chair director until the year 2000. Pictures: Joan Bassegoda.

Between 1967 and 1980 UPC Professor UPC Joan Bassegoda i Nonell carried out the restoration of the buildings that become the headquarters of the Gaudí Chair until a few years ago. The restoration of the building kept the rammed earth as it was found, since no significant damages were detected. Only in a few areas where the rammed earth sections were affected by erosion caused by water seepage of deck were restored according to the original technique. The original finishes were respected as far as possible. Some decorative paintings were redone on the basis of a sample of the paintings that were in a good condition. In the same way, the precast mortar pieces that were damaged were replaced by new parts from a mold taken in situ (Bassegoda 2000- Andruet 2002). (Figs. 5-6).

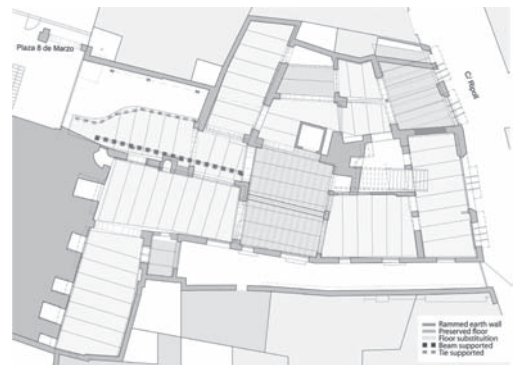
Figure 8. Location of rammed earth walls in the main (first) floor. Picture: S. Bestraten–E. Hormias.

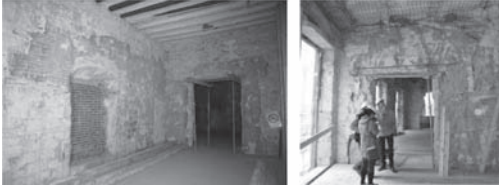
Rammed earth walls found in ground floor date from the 14th and 15th centuries, while the ones in the main floor date 16th century. All rammed earth walls have been made with lime strata rammed earth technique. The general state of the found rammed earth walls is good and they have no major damages. In addition to the identified rammed earth walls, also appear small rammed earth sections that fill small areas between stone walls. (Figs. 9–12).

Figure 9. (left) 15th century rammed earth, facade main floor.
 Figure 10. (right) 16th century rammed earth. Main floor. Perpendicular wall to the romantic garden. Pictures: S. Bestraten–E. Hormías.

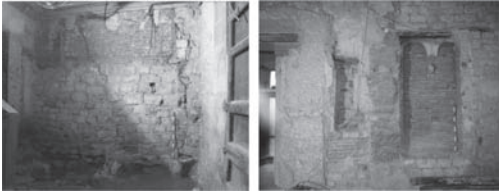
Figure 11. (left) 14th century rammed earth, perpendicular wall to Ripoll facade.
 Figure 12. Rammed earth from the 14th century, main floor. Facade Hostal En García. Romantic garden. Pictures: ATICS.

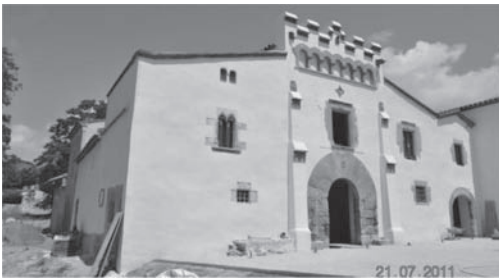
The case of Can Falguera (Fig. 14) is a good solution when using lime or bastard mortar to let internal rammed earth perspire, avoiding a moisture inside. But there are commonly found situations using portland mortars which don't have a good behavior in long term with the rammed earth wall, since their different stiffness and its impermeability cause plaster detachments.

Figure 14. Restoration of Can Falguera. Facade rendered with lime mortar. Architect: David Lladó, DAC Arquitectura.

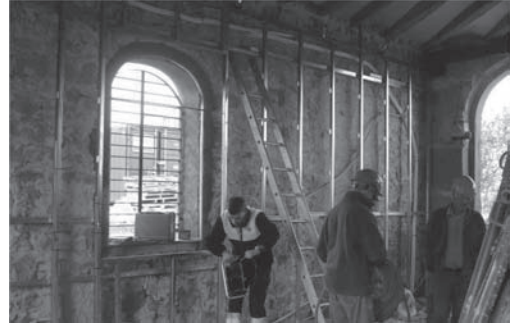
Figure 15. Intervention in Can Muscó. Vilanova del Camí, in the proximities of Igualada (Barcelona). Example of conservation of the bearing function and later new wall. Architect: Josep Vendrell.

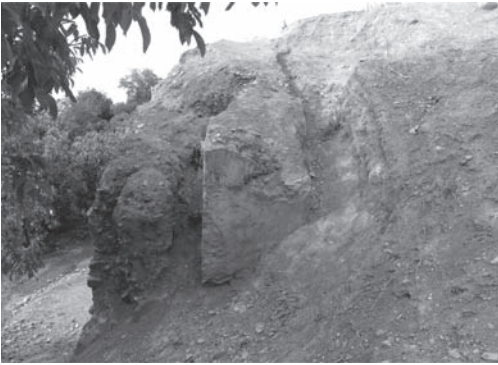
Figure 2. South end of the wall before the intervention, seen from the south.

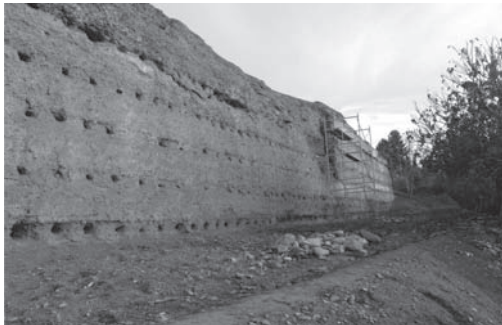
Figure 5. The wall before the intervention. The slope conceals the height of almost two rammed earth sections.

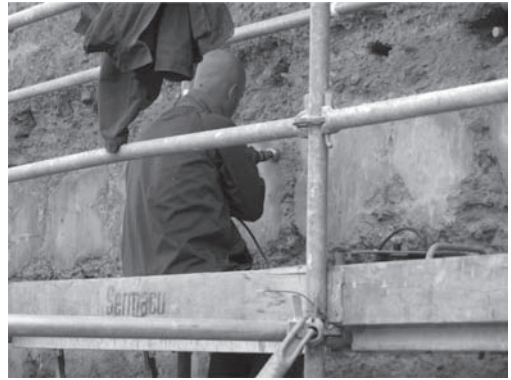
Figure 6. Mechanical cleaning of the crust conserved.

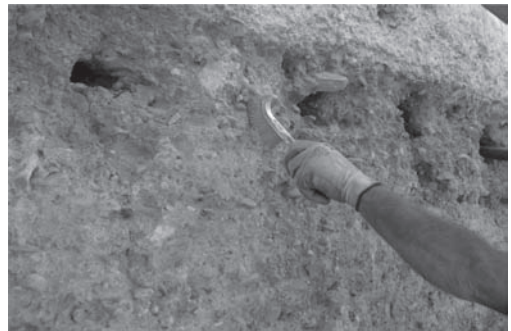
Most of the cleaning was carried out by means of a dry procedure. General consolidation was performed with lime wash and ethylene silicate was used only for the most seriously damaged parts.

Figure 7. Hand cleaning of the wall with no crust conserved.

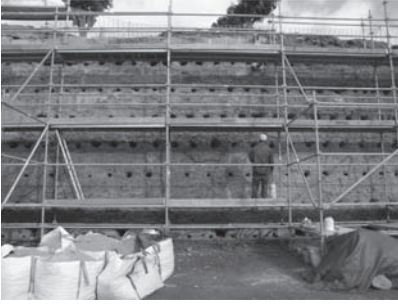
Figure 8. Irrigation with lime wash.

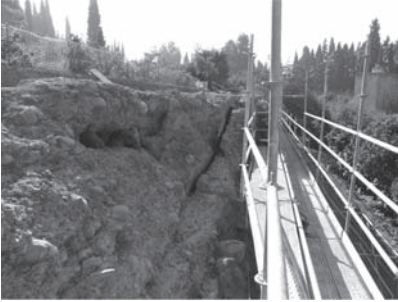
The current deterioration of the structure made up of the two walls seems to have been caused mainly by the overgrown vegetation, whose roots have undermined and separated the two walls in search of the interface.

Figure 9. View towards the south. Separation between the two walls. V.

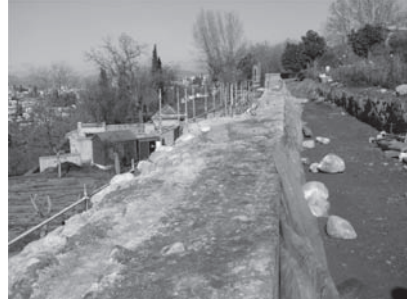
Figure 11. View towards the north. Filled interface.

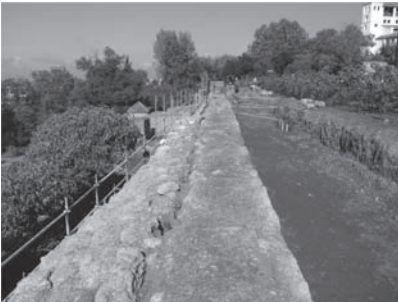
Figure 10. View towards the north. Half-filled interface.

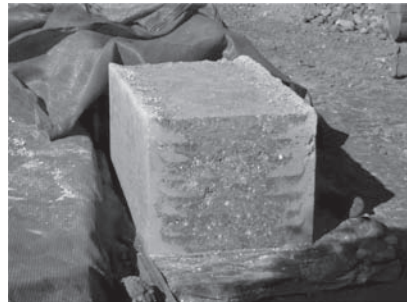
Figure 12. Essays of walls with different crusts.

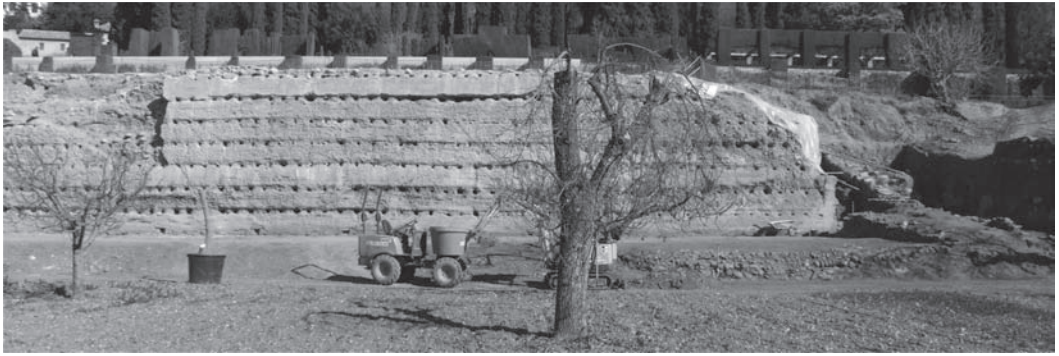
Figure 14. View from the west. South end with remains of the ramp.
