Rammed Earth Conservation

C. Mileto, F. Vegas & V. Cristini

PROCEEDINGS OF THE FIRST INTERNATIONAL CONFERENCE ON RAMMED EARTH
CONSERVATION, RESTAPIA 2012, VALENCIA, SPAIN, 21–23 JUNE 2012

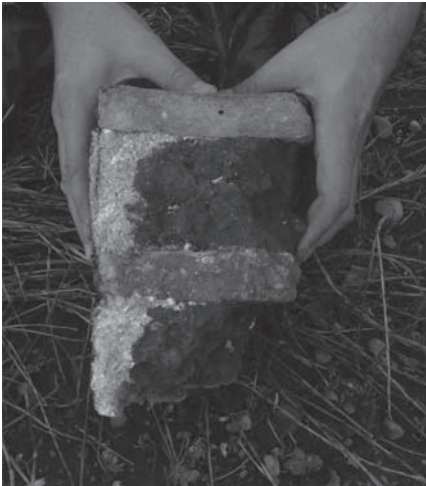
Figure 2. Mortar core, ceramic connectors and crust. Three detached parts of a *tapia valenciana* wall. (Authors: Cristini & Ruiz Checa).

the heterogeneity of the raw materials is not unintentional. In this case, the bricks' function is more that of connecting the strata rather than traditional brickwork masonry. Because of this, it is possible to identify three detached and well defined parts that form a *tapia valenciana* wall: a rammed earth and lime mortar core, a few ceramic connectors and finally a lime crust (Fig. 2).

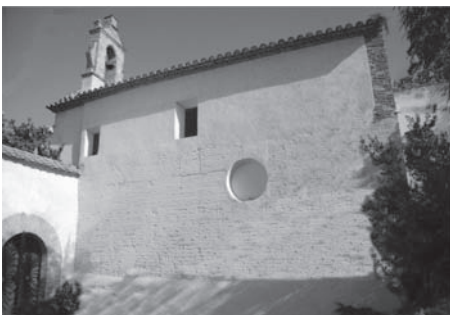
Figure 4. Whitewashed surface of *tapia valenciana* wall, *Ermita de S. Jaume de Fadrell*, Castellón (Authors: Cristini & Ruiz Checa).

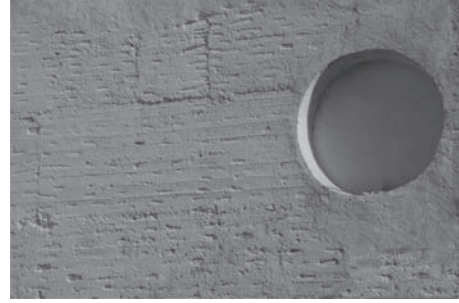
Figure 5. Whitewashed surface detail, *Ermita de S. Jaume de Fadrell*, Castellón (Authors: Cristini & Ruiz Checa).

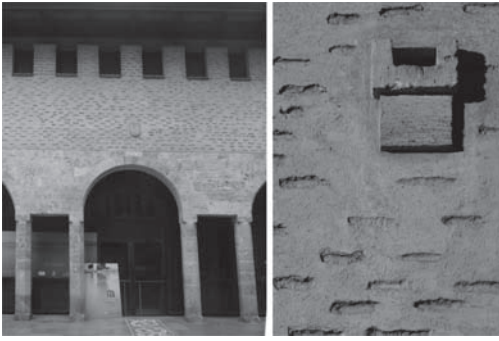
Figure 6. A surface detail, simulating header bricks. *Almudín*, Valencia (Medieval Granary) (Authors: Cristini & Ruiz Checa).

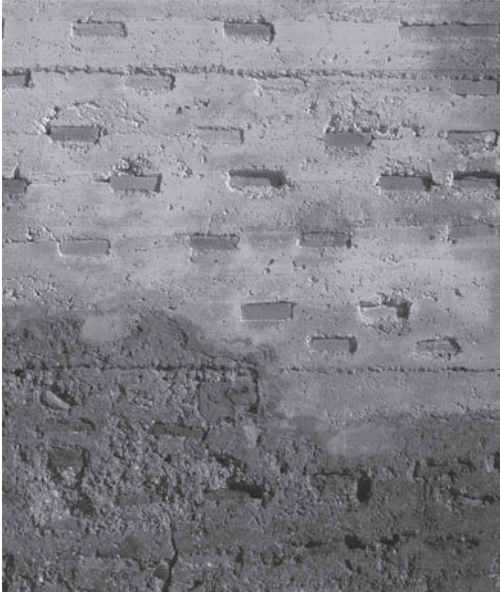
Figure 9. Example of *tapia valenciana* volumetric reconstruction. Mascarell city wall, Castellón (Author: Cristini & Ruiz Checa).

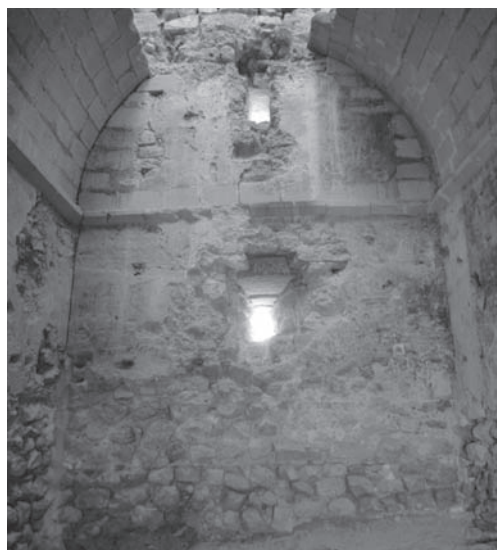
Figura 6. Vista interior de la Torre. Se aprecia el deterioro del acabado interior de los muros y el desprendimiento parcial de la bóveda de cañón.

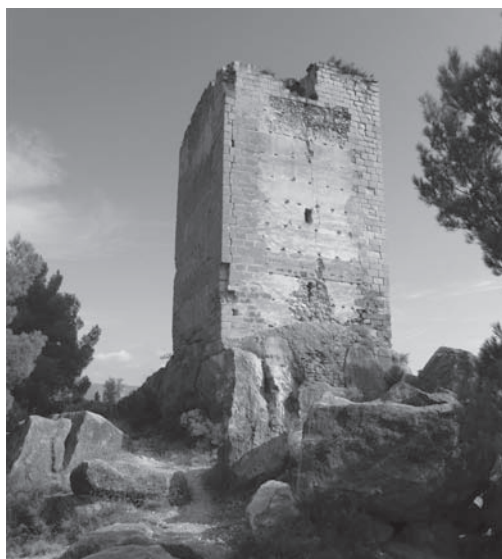
Figura 7. Vista de la fachada sur. Se aprecia la técnica mixta de tapia y sillares reforzando las esquinas.

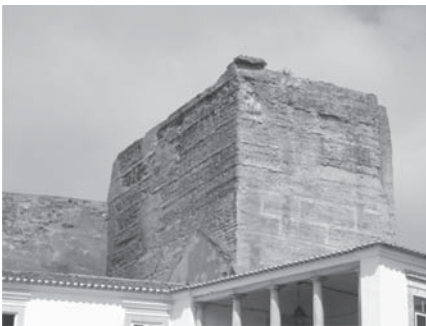
Figura 1. Reparaciones de 1995 en la torre de tapia militar. Castillo de Moura. Imagen de 2003.

Esa primera intervención de consolidación con doble paramento de albañilería piedra no afectó a muchas murallas de tapia consideradas islámicas y contrarias al espíritu simbólico de conquista católica de la fundación de Portugal (Fernandes, 2005). Ejemplos como las fortificaciones de Moura (Fig. 1), Elvas (Castelo de Elvas, 1997), Mértola

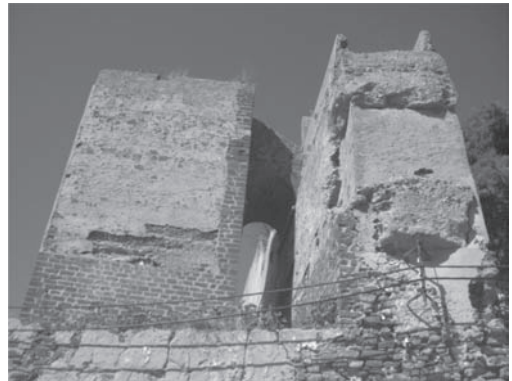
Figura 2. Intervenciones de los años 80 y 90 en las murallas de Silves, Portugal. Imagen de 2012.

(Castelo de Mértola, 2007), Serpa (Muralhas de Srpa, 2003), Beja y Silves (Fig. 2) fueron parcialmente restauradas en modo “neo medieval revisitado” únicamente porque contaban con castillos del periodo de la fundación en la cumbre de la correspondiente ciudad fortificada.

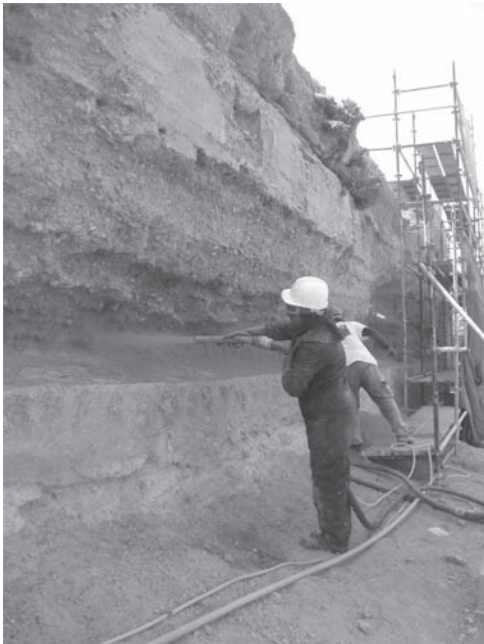
Figura 3. Tierra proyectada para colmatación de lagunas en las murallas del castillo de Paderne, en Albufeira. 2005.

Con el desarrollo del conocimiento científico referente al comportamiento estructural de las tapias, así como de los materiales constituyentes, se han llevado a cabo experiencias de reconstrucción/protección con tierra proyectada (Fig. 3), así como inyecciones en las tapias antiguas (Luso et al., 2007). Paderne, un castillo construido durante el período *Almorávia—Almoáda* (Bruno, 2005a) y que prácticamente no había sufrido intervenciones de restauración, fue un verdadero laboratorio de prácticas donde se aplicaron todas esas técnicas, con resultados estéticos absolutamente innovadores en Portugal (Costa et al., 2007).

La experiencia con tierra proyectada demostró ser algo ineficaz debido a las retracciones visibles en muchos de los paramentos. A día de hoy (pasados seis años de la intervención) y en comparación con otras experiencias como las de Moura (Fernandes, 2005) y Elvas (Muralhas e obras, 2006), se puede constatar que las intervenciones con morteros de cal y tierra en lagunas dan mejor resultado que las proyecciones con tierra y aditivos.

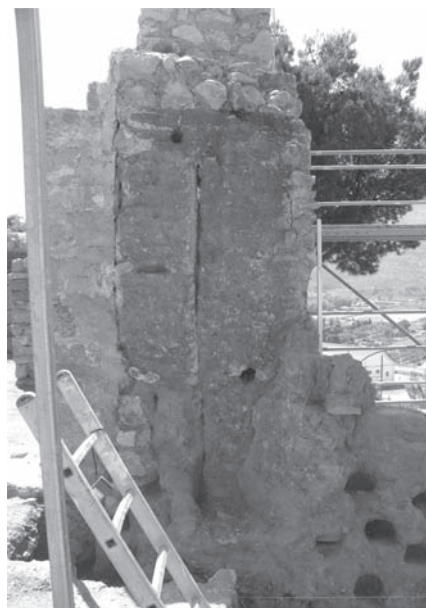
Figura 3. Las dos hojas en el entronque con la torre de tapia.

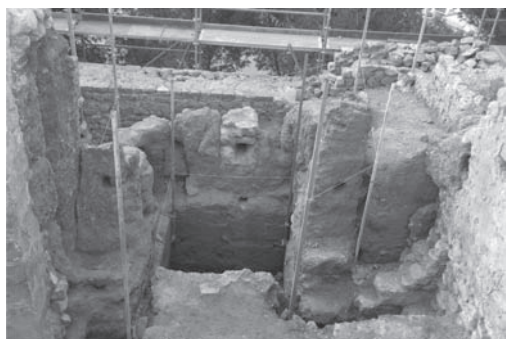
Figura 4. Interior de la torre. Se aprecia el elevado grado de deterioro de las tres últimas hiladas.

Se sacaron a la luz un total de cinco hiladas, todas en mal estado e incompletas, particularmente las tres últimas (Fig. 4). Pese a su grado de deterioro, aún se han podido determinar algunas de sus características, que nos aportan valiosa información sobre los procedimientos constructivos empleados y que, además, nos serán de gran utilidad para acometer los trabajos. Así pues, sobre los muros de la torre original, podemos decir lo siguiente:

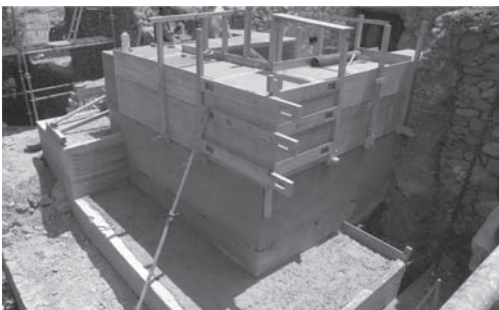
Figura 5. Levantando la última hilada de la torre original de tapia con los dos restantes muros a distintos niveles.

Para favorecer la lectura del conjunto se levantaron los tres muros a distintos niveles, de forma escalonada los dos exteriores, quedando el de mampostería en la cota más baja. Se completaron las tres hiladas superiores de la torre elevando una nueva sobre estas, hasta enrasar con el nivel superior del muro de tapia del lienzo de lado oeste, con el que se trabó (Figura 5). Así pues la fábrica de tapia y la de mampostería, desde distintos niveles crecen escalonadamente desde el lado oeste de la torre hasta el lado este, donde alcanzan sus cotas máximas.

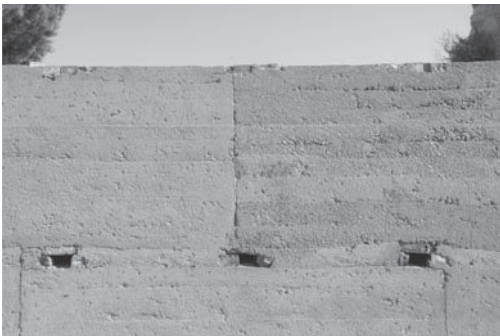
Figura 6. Paramento calicostrado cepillado con los mampuestos vistos y las marcas verticales de las tapiadas.

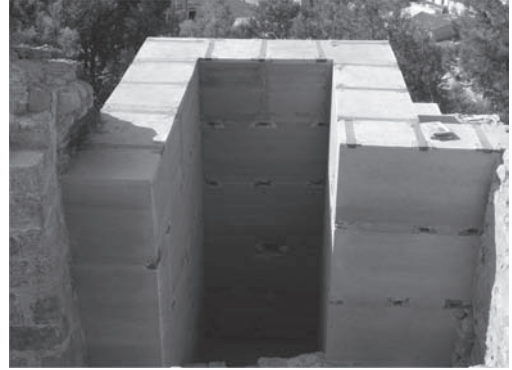
Figura 7. Obsérvense las maderas en el remate en la torre terminada. Compárese esta imagen con la de la figura 4.

- En la coronación de la última hilada dejamos alojadas maderas en las posiciones necesarias para un posible recrecido futuro. De momento sirven para romper la continuidad de la coronación y controlar posibles fisuras por dilataciones térmicas (Fig. 7).

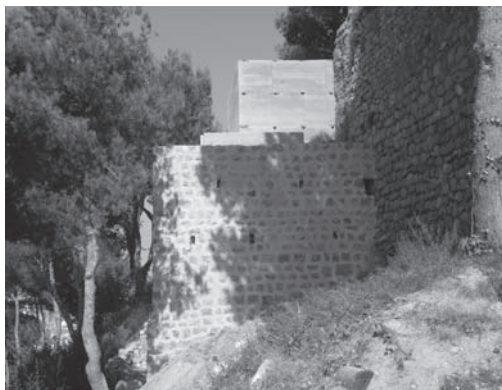
Figura 9. Vista oeste de la torre norte al finalizar los trabajos. Compárese esta imagen con la de la figura 1.

En el primer caso, si es la propia tierra por la pérdida de las costras la que ha de soportar directamente la acción del agua, difícilmente podremos asegurar plenamente su preservación mediante impregnaciones consolidantes o soluciones similares, solamente la protección de la intemperie, si es que es posible, o la calidad de la propia fábrica, pueden permitirnos conservar la fábrica original asumiendo, eso sí, determinados niveles de deterioro. Lamentablemente, al igual que ocurre en tantos aspectos relacionados con la construcción con tierra, las consolidaciones del material es todavía un campo a explorar en profundidad (Castilla, F.J. 2011 *Informes de la Construcción*, nº 523: 143–152.). La restitución de volúmenes, como en el caso que nos ocupa (Fig. 9), conlleva

inevitablemente la ejecución de paramentos lisos, tersos y con aspecto de recién construidos que, normalmente, atraen en exceso la atención.

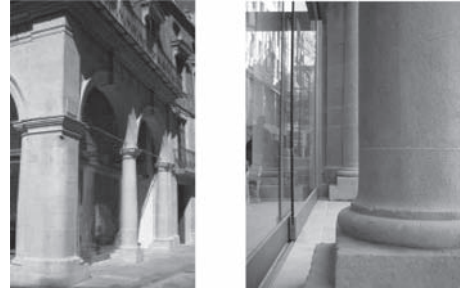
Figures 3 and 4. Corner arcade of the *Llotja*. Detail of column and wall texture.

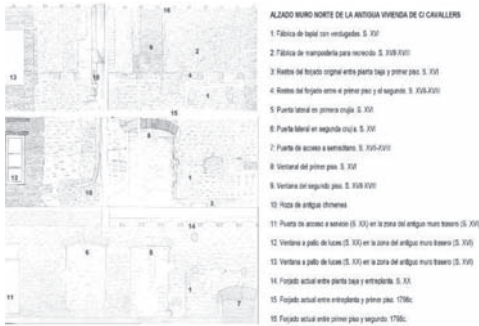
Figure 8. Stratigraphy of the wall of the building on Caballeros Street. Extract from the archaeological report.

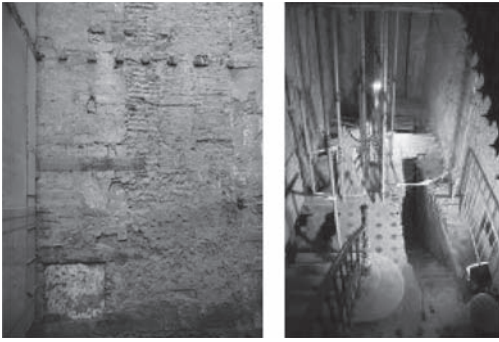
Figures 12 and 13. Condition of property division walls. Access to the air-raid shelter.

Other remarkable circumstances were the scarce (sometimes inexistent) foundations of the building, and also the huge cavities found in the sub-soil (2 big septic tanks and an air-raid shelter from the Civil War in Spain during the 30s), which converted the sub-soil into a huge *Gruyère* cheese. The new status of the loads resulting from the new uses and the pathologies detected made the following interventions necessary.

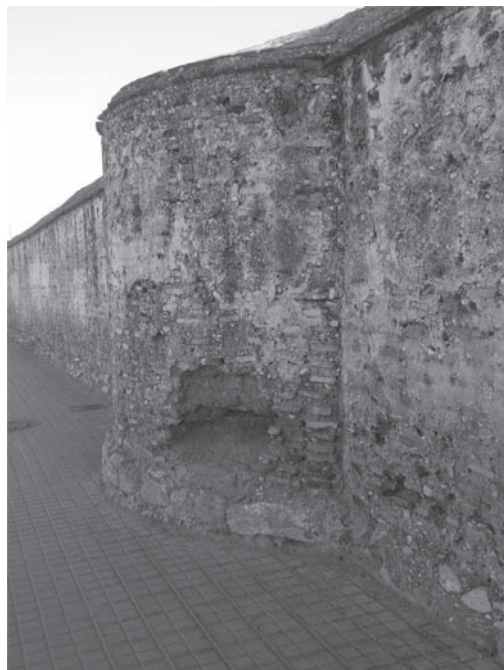
Figura 1. Monasterio San Miguel de los Reyes, Valencia. Partes diferenciadas de una *tapia*.

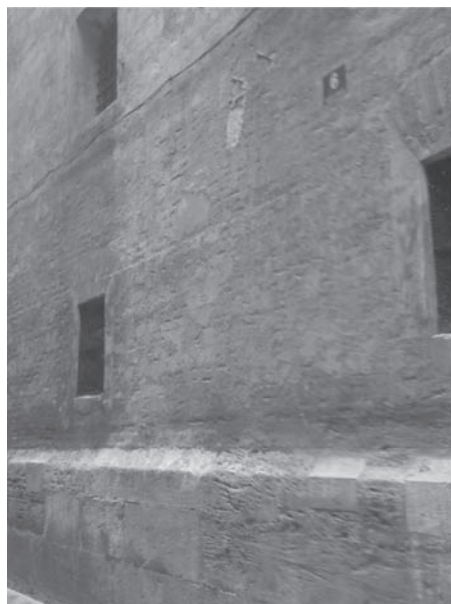
Figura 2. Colegio Corpus Christi de Valencia. Potente zócalo de sillería.

El procedimiento que más ha llegado hasta nosotros, sobre todo en edificios de una cierta entidad monumental, es aquel en el que el *zócalo* se hace de sillares de cantería, y luego sigue la tapia (Fig. 2).

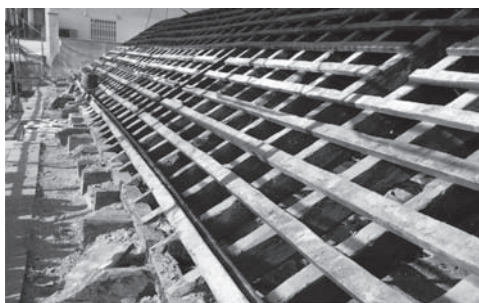
Figura 3. Capilla del Rosario. Iglesia del Pilar, Valencia. Coronación del muro de fachada con rafe independiente, sin albardilla de sellado.

Es este uno de los puntos que mayores patologías provocan en las obras, debido a que, en general, su ejecución en las cubiertas se realiza en dos unidades totalmente independientes: por una parte, la albardilla, cuya función se confía exclusivamente a las propias tejas; por otra parte, el rafe con su estructura independiente. Por eso, deberá exigirse una atención especial la solución de este detalle (Fig. 3).

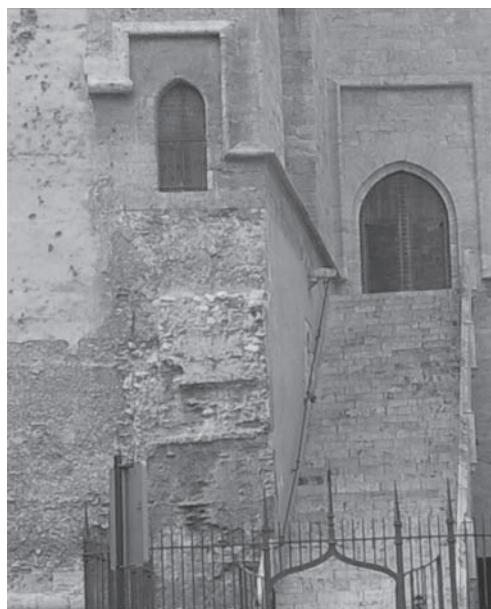
Figura 4. Sección de la antigua muralla cristiana de Valencia. Tapia valenciana. Albardillas de protección de los distintos hilos.

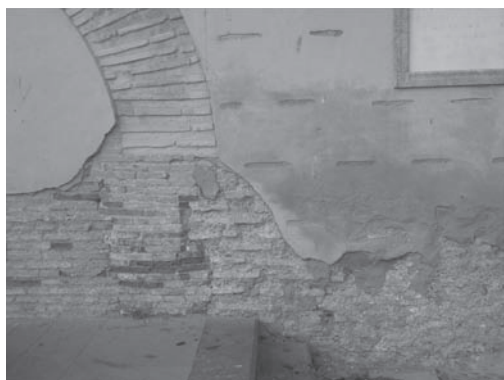
Figura 6. Sede Gremio de Carpinteros de Valencia. Deficiente restauración de la tapia. Humedades de capilaridad por falta de puntido, desconchones en el enlucido y anárquica distribución de las hiladas.

El aprovechamiento de la posible *carga estética* (tercer supuesto), nos puede llevar a intervenciones totalmente kafkianas, y más si no se sabe actuar correctamente (Fig. 6).

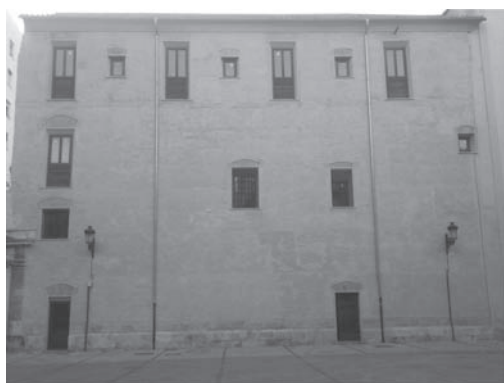
Figura 7. Capilla del Rosario. Iglesia del Pilar, Valencia. Restauración mediante la consolidación de las distintas fábricas.

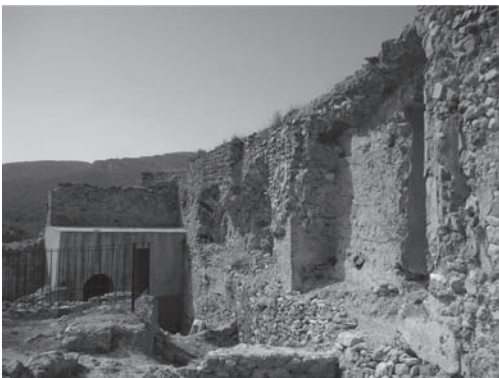
Figure 2. Original view inner side of the wall.

This second core has lost a big part of the wall mass, risking becoming a dangerous spot given the continuous partial demolitions due to the poor quality of the mortar and the disappearance of the original materials. Humidity and the disaggregation of walls caused by the rainwater flow collected from the same walls in the parade ground are the responsible of this ruin, added to massive burials done in the castle walls during the time in which it was a village cemetery.

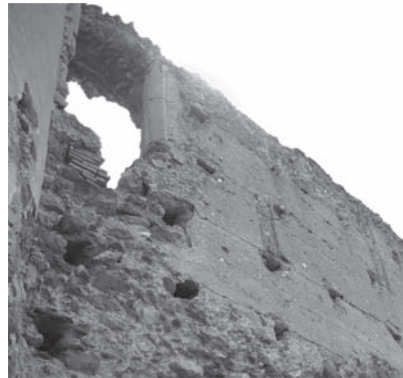
Figure 3. Original view of the outer face of the wall.

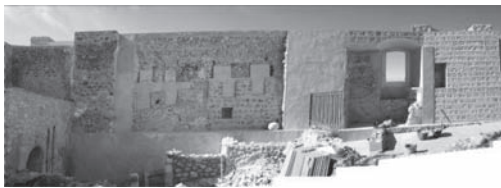
Figure 7. Inner side of Western Wall.

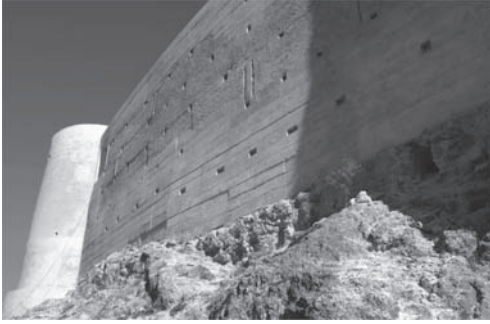
Figure 8. View of the outer face of the wall.

parts of it, caused by the lack of consistency of the original mortars. It shows a wide range of kind and periods of interventions, we can observe the first line of defense of the castle, in its original Islamic height, and the following enlargements built over the years, in height and width.

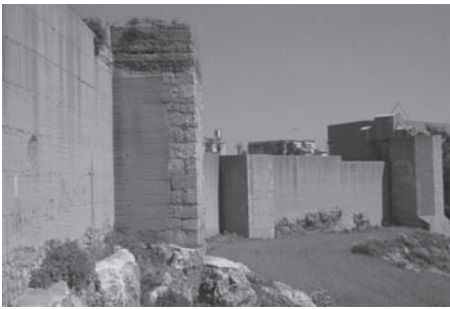
Figure 6. General view of the Niebla city walls after restoration (Huelva, Spain) (Vegas & Mileto).

In some interventions reconstructions are seen as partial volumetric restitution, as Ismael Guarner González writes when speaking about his intervention on the walls of Niebla in 1980 (Fig. 6). “Restore the monument while striving to endow it with a more defined image more like what it once used to be, without having to reproduce the original volume” (File PI 0102.09 of the IPCE archives).

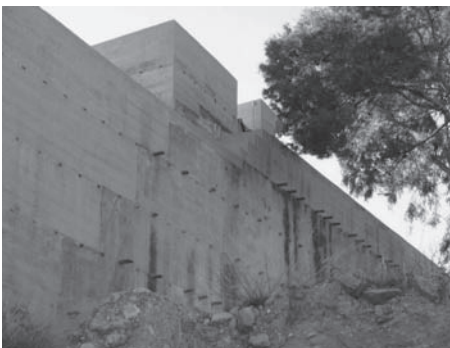
Figure 7. Part of the external wall of the castle of La Mola (Novelda, Alicante, Spain) with the regularization of the volumes (Vegas & Mileto).

This criterion can also be seen in the intervention on the Castillo de la Mola (Novelda) in 1983 (Fig. 7), where Ramón Valls Navascués stated, “This project is aimed at consolidating the existing ruins, arranging the current volumes in such a way that by completing the shapes which can be deduced from the existing parts, the appearance, the colour, the well-known romantic character of this type of building and this one in particular will

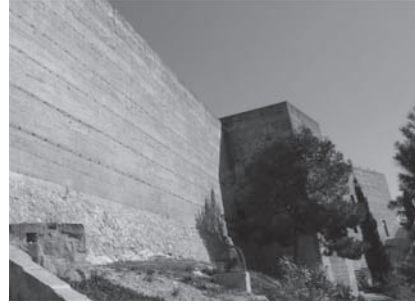
Figure 9. Restored wall of the castle of Petrel (Alicante, Spain) (Vegas & Mileto).

The connection between the original material, rammed earth, and the new material, concrete, depends on the construction detail proposed in each case, but the detail proposed for the Castillo de Petrel in 1982 is common: “Restoration of the surface of the wall with mixed cement and lime concrete, with timber planks fixed with wire, which will be cut off when the planks are removed and the putlog holes will be left visible. Dovetail profiles will be used to attach the rammed earth wall to the existing fabric” (File PI 0988.03 of the IPCE archives) (Fig. 9).

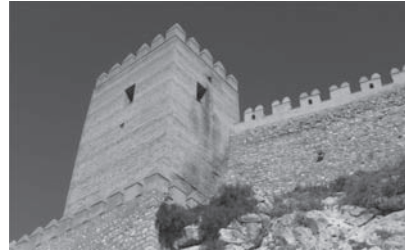
Figure 10. South wall of the Islamic castle at Almería (Spain) (Vegas & Mileto).

Puig Álvarez suggests “consolidating with masonry in the existing gaps, first proceeding to clear away the rubble at the base of the wall, to which will be added the rubble from chipping off all the false rendering and plaster in order to restore a stony appearance to the wall, which, even if it is not quite the original Arabic rammed earth, would be more appropriate than all the Christian reconstructions” (Fig. 10) (File PI 0001.01 of the IPCE archives).

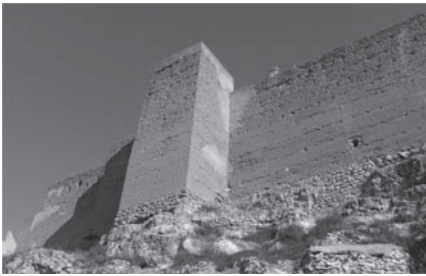
Figure 12. Restored wall of Jorquera (Albacete, Spain) (Vegas & Mileto).

chosen also depend on the original building techniques. For example, in the intervention on the walls of Jorquera in 1982 (Fig. 12), they said “as the building material is not stone but mortar, we do not think the solution is to clamp the cracks. Therefore we prefer to fill them in with lime mortar, stone and local soil, to which formwork will be applied in the places where it is deemed necessary and a finish similar to the original will be applied” (File PI 0363.03 of the IPCE archives). In other cases, such as the intervention on the church in Écija in 1983, since it is rammed earth confined between brick buttresses, the solution proposed is completely different: “the surface is cracked just between the two vertical joints that define the rammed earth walls. We propose to consolidate this wall by clamping these cracks by means of toothers or brick repointing” (File PI 0157.04 of the IPCE archives).

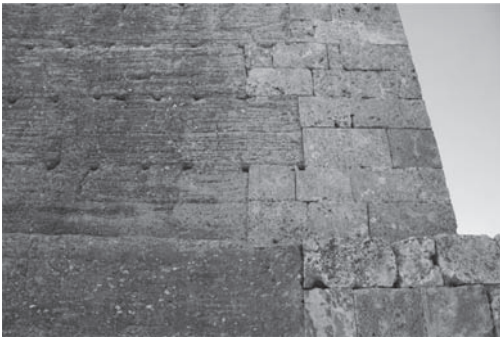
Figure 3. NW wall of the tower (A. Graciani).

The tower was built of mixed rammed-earth and stone masonry (Fig. 3). The chain was carried out with coursed ashlar of local stone and some pieces were re-used. The courses have a height ranging between 0.88 to 0.90 m and are separated by a 0.03 m thick layer of lime. It is executed with overlapping formworks creating 6–7 meter sections of continuous rammed earth between the stone chains. Its NW face, towards the plain, must have housed its original entry point, of which there is currently no evidence.

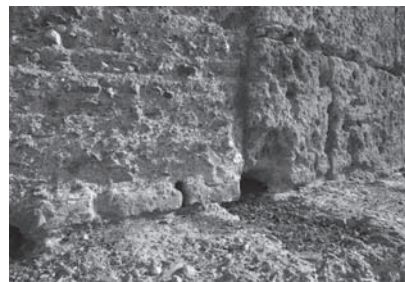
Figure 4. NW face of the tower (detail) (A. Graciani).

However, there is a certain trend to higher hazard in material damage (erosion), evidenced by a somewhat higher hazard level due to the lack of protec-

tion (roof and covering), to the high exposure, and to the lack of regular maintenance. Therefore, it is advisable to apply certain preventative measures in the medium or short term to reduce the hazard of existing erosion progressing. Otherwise, what is currently superficial loss of mass and stains could degenerate with a certain degree of probability into more serious damage.

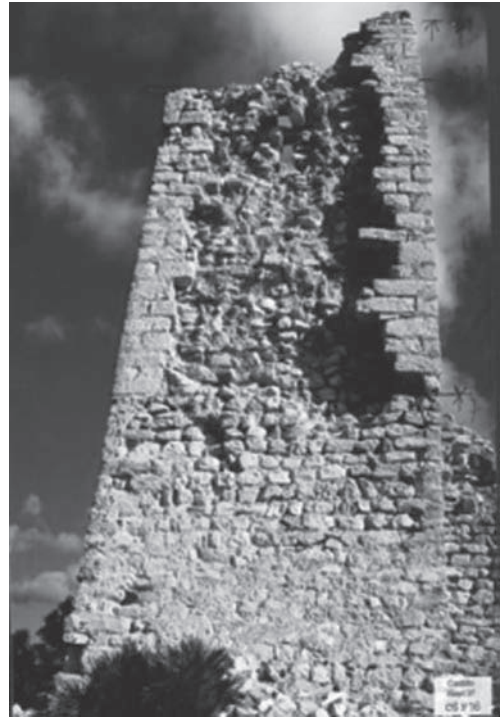
Figura 1. Paramento oeste de la torre. Muro de mampostería encofrada reforzada en las esquinas por piedras careadas de mayor tamaño.

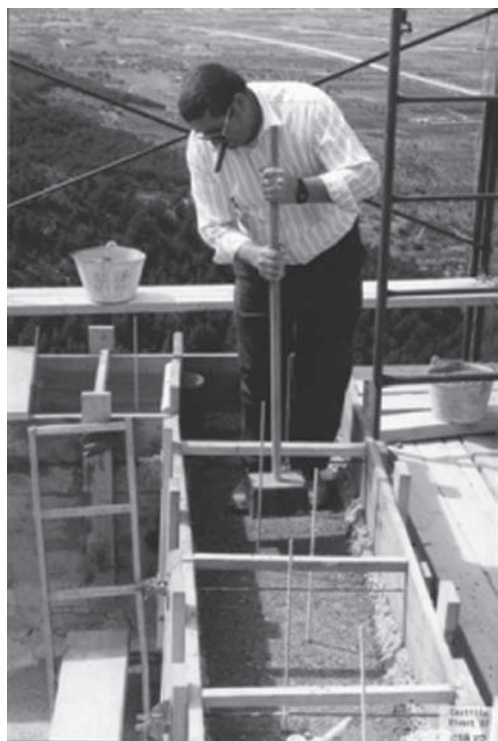
Figura 2. Restitución de tapial calicostrado, armado, para unirlo al resto de la fábrica.

se realizó en los paramentos S, N y sobre todo en el temible paramento O. El proceso se efectuó según la altura del encofrado en módulos de 80 cm (dos codos). Uno de los primeros pasos fue la colocación de varillas de acero. Puede parecer que el armado de fábricas es un hecho ajeno a la construcción antigua. Por este motivo buscábamos paralelos en la arquitectura preislámica, concretamente en el espacio geográfico del cercano oriente. Ya el tratadista griego Filón de Bizancio dedica unos escritos al armado de fábrica de murallas con madera o con parrilla metálica. Del mismo modo se armaban edificaciones en Siria preislámica, posterior sede del califato Omeya. En Xivert también tenemos ejemplos con zunchado y refuerzos con mader.

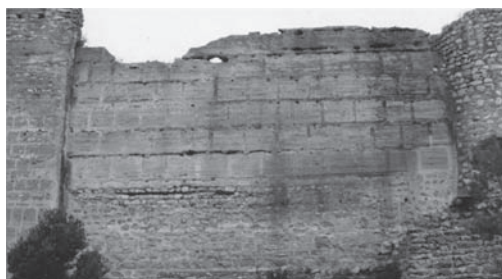
Figura 3. Muro de tapial calicostrado, decorado con sillería fingida, que se eleva sobre un zócalo de mampostería encofrada asentada directamente sobre la roca.

Aquí destacamos sólo el componente al exterior del recinto, o sea el muro de tapial calicostrado, decorado con una sillería fingida. Este tapial calicostrado, que por su composición material es auténtico hormigón medieval, se eleva sobre un zócalo de mampostería encofrada asentada directamente sobre la roca. El muro lleva una inscripción realizada, igual que las juntas de sillares fingidos, en fino mortero de cal y dice en letra arábiga *al-fatih Allah*. La traducción es *La victoria la trae el Dios*, y la realizó durante la restauración la profesora

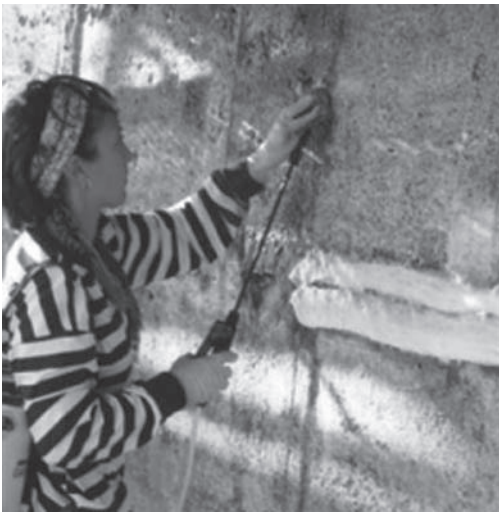
Figura 4. Limpieza de tapial calicostrado.

El siguiente trabajo, precedido por la aplicación con pinceles de varias capas de biocida para la neutralización de líquenes, se centró en la limpieza del tapial. El objetivo de este complejo proceso era la eliminación, con agua desionizada y cepillos finos, de la gruesa capa de tierra y de los restos de líquenes neutralizados, ambos depositados en la superficie.

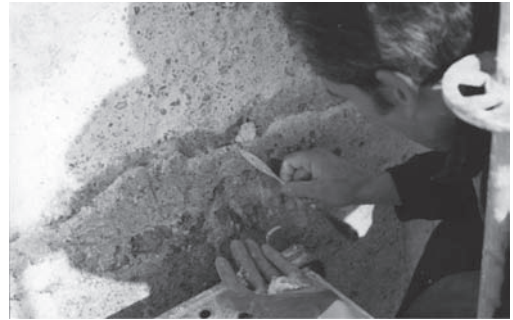
Figura 5. Sellado de sillares fingidos.

Al terminar la limpieza del paramento se sellaron los desprendimientos de la sillería fingida. Otros trabajos complejos, realizados al mismo tiempo, fueron tres reintegraciones: de tapial, de calicostrado y de juntas ilusorias.

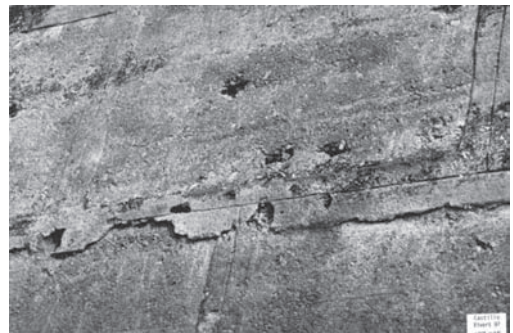
Figura 6. Desprendimiento de juntas en sillares fingidos.

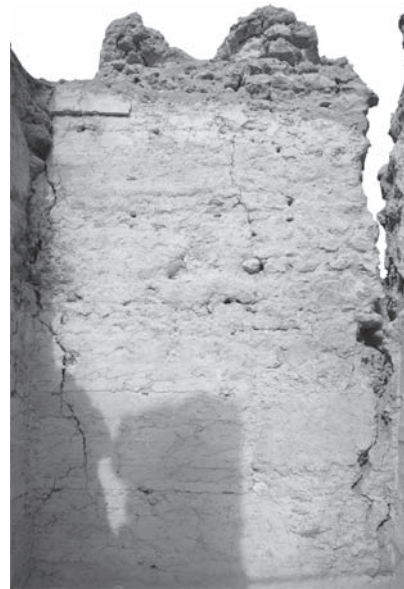
Figure 2. Tower number 2 showing formwork marks.

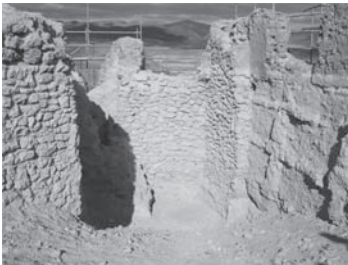
Figure 3. Three types of walls built up with gypsum in different state (stone, binder) and proportion among them, in the northeast angle of the “Castillo Mayor”.

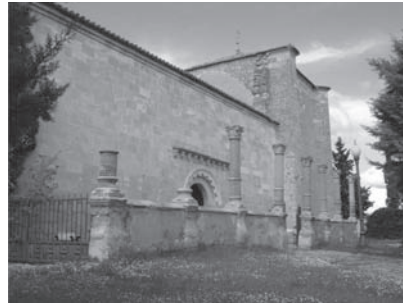
Figure 1. Church of 'San Nicolas de Bari'. State before last intervention. The stone facing from 1965, covering the original rammed-earth wall, is visible. (Pinés & Jové-Architects).

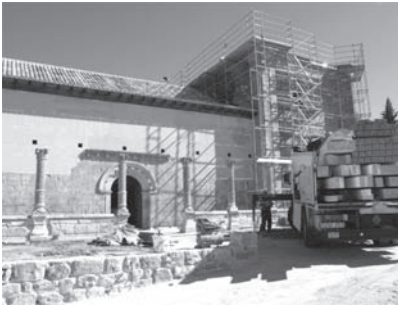
Figure 2. Restoration work. Recuperation of the rammed-earth wall built on top of the remnants of the 13th century wall (Pinés & Jové-Architects).

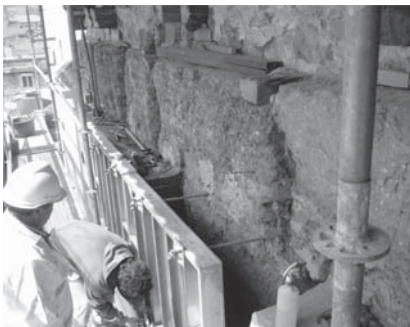
Figure 5. Restoration work on the rammed-earth walls. Church of 'San Nicolas de Bari'. (Pinés & Jové-Architects).

This scraping, which is done manually with a trowel, makes the surface rough, thus improving contact between the two materials. Next comes the filling of the gap using a circular compactor of small diameter which allows for the correct compacting of the edges against the existing wall,

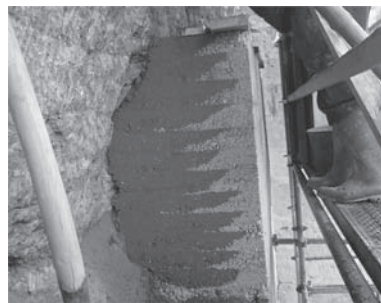
Figure 6. New rammed-earth section. We can see the limed mortar line after ramming. Work of reintegration wall. Church of 'San Nicolas de Bari'. (Pinés & Jové-Architects).

The building process was as follows: after placing and levelling the formwork, the first layer of limed mortar was laid down, with a volumetric proportion of one part lime to six parts sand and low humidity, equivalent to that of the earth mixture. Using the trowel, the mortar is pushed up against the casing so that the mixture generates a natural inclination that corresponds with the internal friction angle \emptyset of its components. Then the earth is laid down, levelling off the thickness of the layer up to an approximate height of about 15 cm. The level is obtained by inserting a trowel with a mark indicating the desired height. The layer of earth almost totally covers the previous layer of limed mortar, leaving 2–3 cm of lime in sight against the formwork.

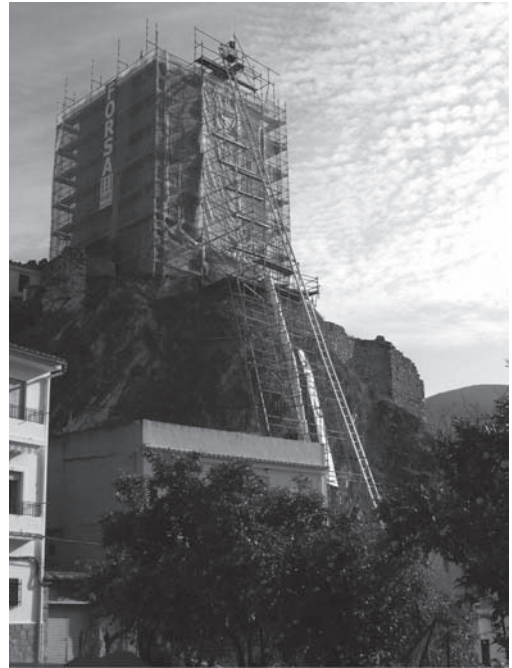
Figura 3. Vista del andamio y del montacargas en el inicio de las obras.

Finalmente, se optó por una solución novedosa, considerada como la más sencilla, viable y segura, que consistió en la instalación de un montacargas inclinado hasta la plataforma auxiliar en voladizo ubicada al pie de torre. Esto permitió un suministro sencillo y constante de materiales y elementos auxiliares de la obra.

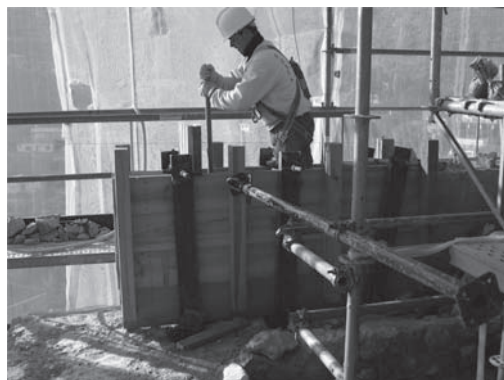
Figura 4. Compactación de la masa de la tapia.

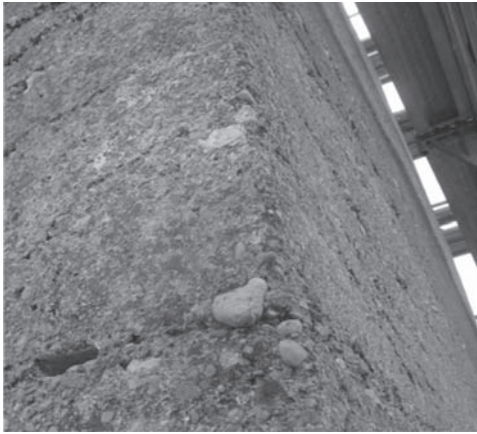
Figure 2. Corner of the tower that shows the continuity of the rammed earth wall (Vegas & Mileto).

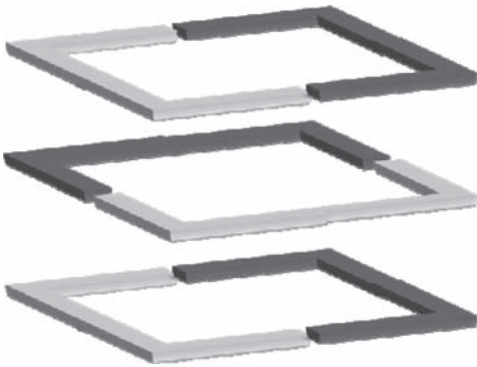
Figure 3. Building system used alternating the available U-shaped formwork (Vegas & Mileto).

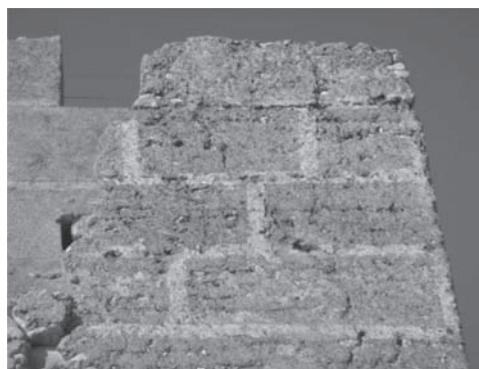
Figure 9. Tower crown with consolidation and reintegration treatments (Vegas & Mileto).

At the crown, in order to secure the surfaces in danger of immediate collapse in the north side and the merlons in the east and west sides that had lost stability due to erosion at the base, several possibilities were considered. Finally, it was decided to use the same procedure as to fill in the gaps because it ensured bonding and adherence, instead of more theoretical methods, which did not offer so much durability. The intention was not to restore the tower to its original shape, so these gaps were filled in up to the adjacent historic level and the degraded crest of the coping was respected in the areas where material did not need to be added to secure or stabilize the fabric (Fig. 9). Any attempt to outline the original shape of the upper edge was avoided at all costs, even where it was clearly the original coping, in an attempt to achieve the appearance of a hypothetical second-last course.

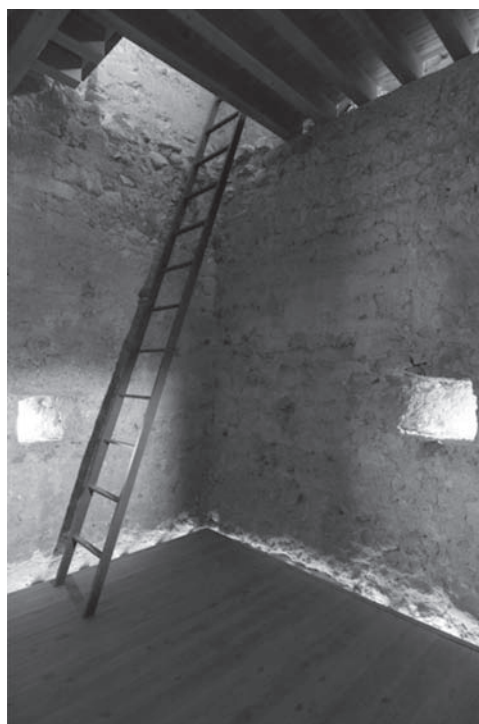
Figure 10. New floors and ladder in the interior of the tower (Baeza).

to the rhythm marked by the traces on the historic walls, like the staircase (Fig. 10). It would have been logical to look for olive girders or joists or girders and joists from some wild tree like holm oak to imitate them if any of them were missing. In this case, as there were no remains, the framework was fashioned out of traditional materials like timber but with contemporary grammar.

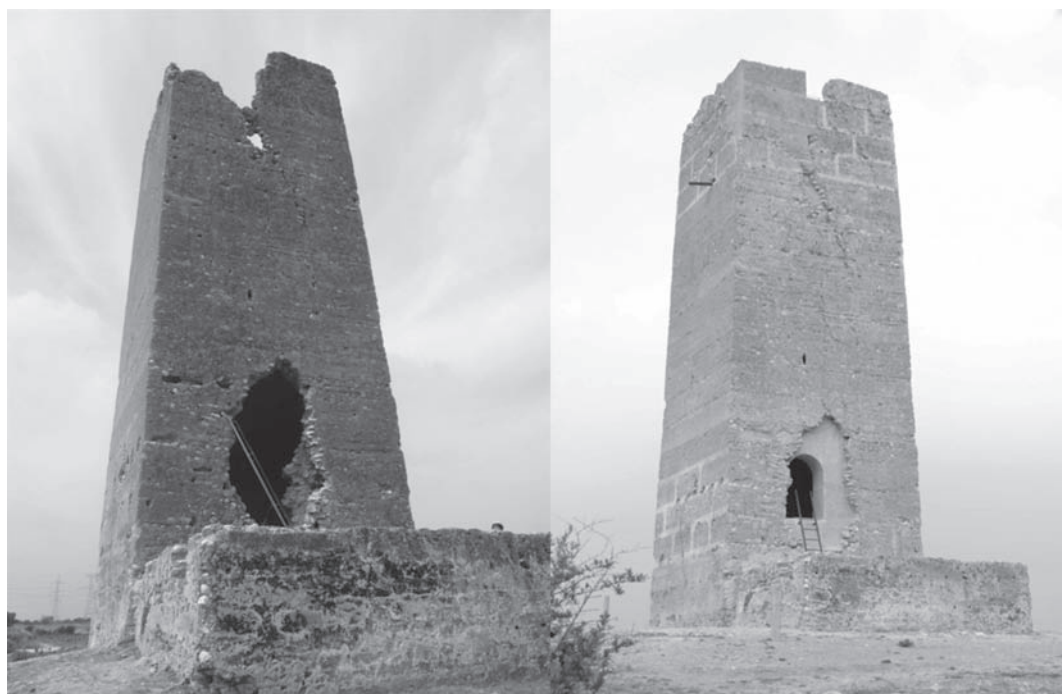
Figure 11. Bofilla Tower before and after the intervention (Vegas & Mileto/Baeza).

On the other hand, as described above, contextual integration was performed on the exterior, seeking to harmonize with the degree of degradation, patina and color of the preexisting adjacent areas to better guarantee the integration of the parts added to the building, which the authors have always given the central role in the intervention. When examined in detail, the additions have the appearance of *rigatino* in a historic painting, so that distinguishability had been guaranteed at the same time as the historic image and the value of the age of the building have been safeguarded.

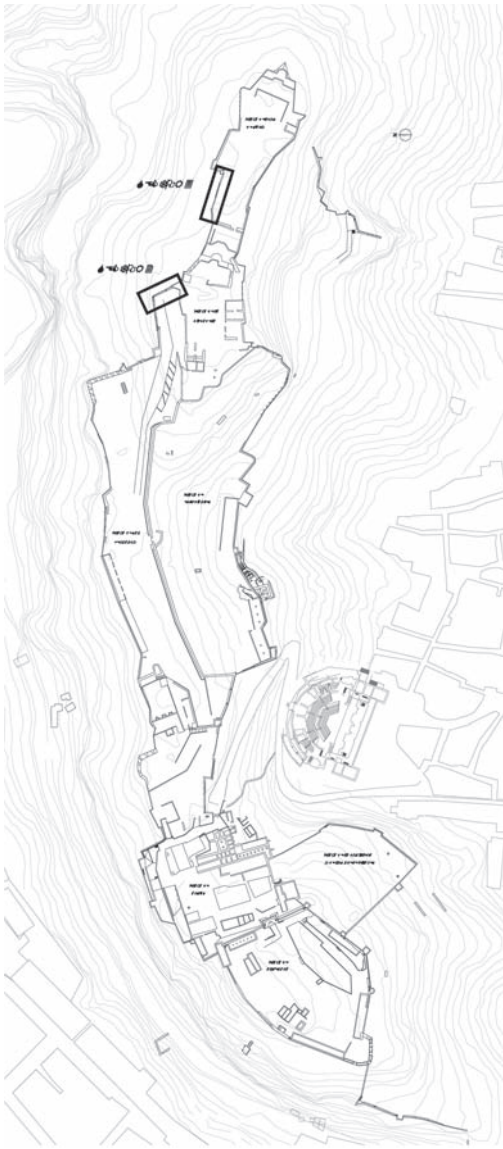
Figure 1. Planta del Castillo de Sagunto. Emplazamiento de los sectores 2 y 3.

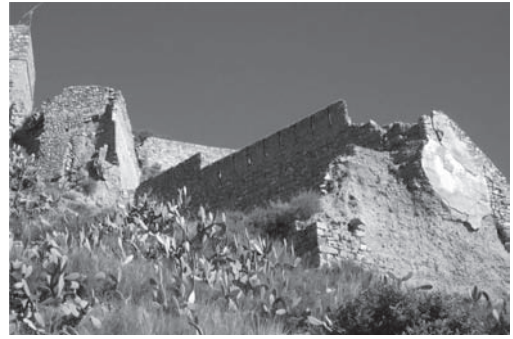
Figure 2. Estado previo. Alzados exteriores del sector 2.

un pequeño resto de la costra de la cara interior, ambas en la zona inferior del sector 2. La última pista la daba la huella de la sección de un muro de tapia de gran potencia que se podía apreciar entre las fábricas de mampostería en forma de uve, en la parte alta del sector (Fig. 2).

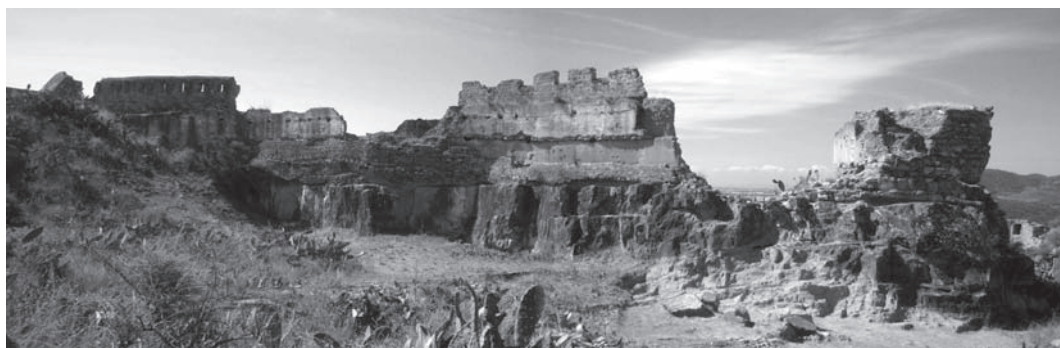
Figure 3. Estado previo. Alzado norte, interior, del sector 3.

El sector 3 se trata de un tramo de muralla con la base ubicada sobre una cresta rocosa cuya cara sur se encuentra a 12 metros del suelo y el alzado norte (interior) a 3 metros de un suelo de cantera resultado de la extracción de roca. Es un tramo zigzagueante en planta, de unos 42 metros de longitud que comienza en el extremo oeste de la plaza de la Ciudadela y finaliza en los restos de un cubo o torre maciza. Se trata de un lienzo muy complejo dadas las distintas fases constructivas que se han ido superponiendo en cada época (Fig. 3).

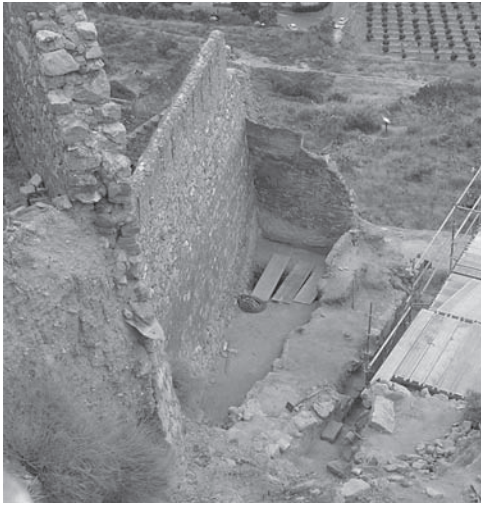
Figure 5. Alumbramiento del trazado medieval en el sector 2.

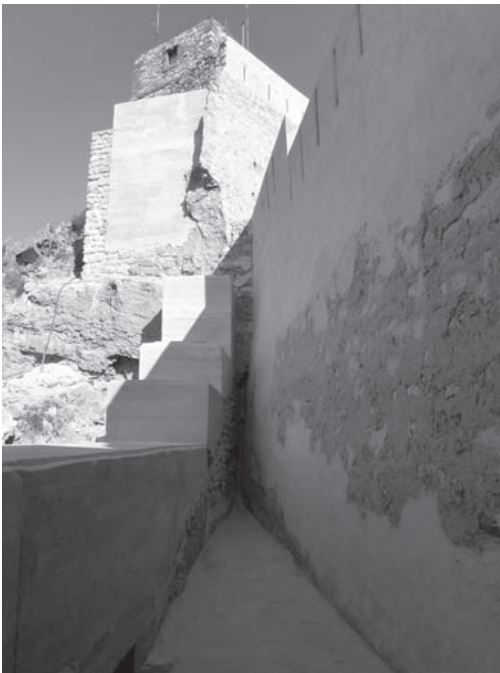
Figure 6. Alzados exteriores del sector 2. Consolidación de los restos del trazado exterior de la muralla medieval de castillo.

En el caso del lienzo de fábrica de tapial del denominado sector 2, el valor histórico y constructivo a restaurar principalmente era el de testimoniar la presencia de un trazado que rebasa el límite del lienzo actual. Los trabajos de restauración se enfocaron hacia la consolidación de los restos de ese nuevo trazado hallado, alcanzando mayor sentido la propuesta del proyecto que ya planteaba recuperar con una materialidad distinta la zona de intersección entre el muro medieval islámico y el muro de mampostería del siglo XIX, con el propósito de dar a entender la lectura de la adición posterior del segundo de los muros a la planimetría medieval del conjunto (Figs. 6 and 7).

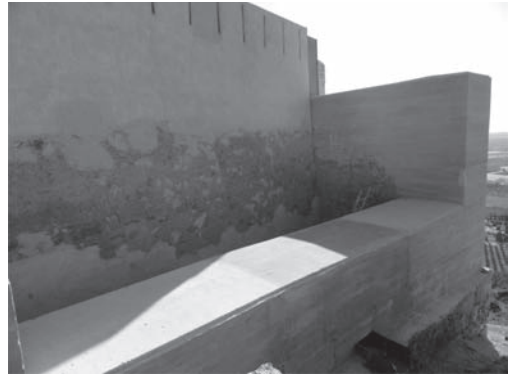
Figure 7. Alzados exteriores del sector 2. Cambio de materialidad en la zona que conecta los dos muros.

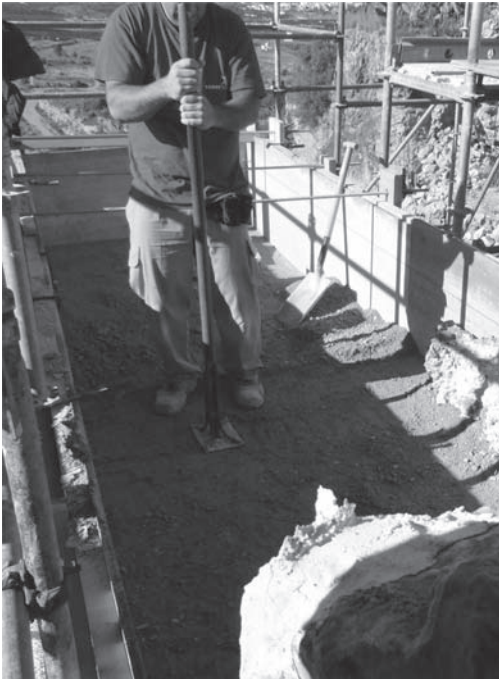
Figure 8. Compactación manual de la nueva fábrica de tapial.

El apisonado de la masa se realizó mediante una primera pasada con pisones de madera y metálicos y posteriormente con una compresión mayor en las zonas exteriores mediante una madera de 5 cm y un apisonado directo con el martillo. De esta forma se conseguía una mayor compresión en las zonas exteriores que estarán a mayor exposición de las condiciones atmosféricas adversas

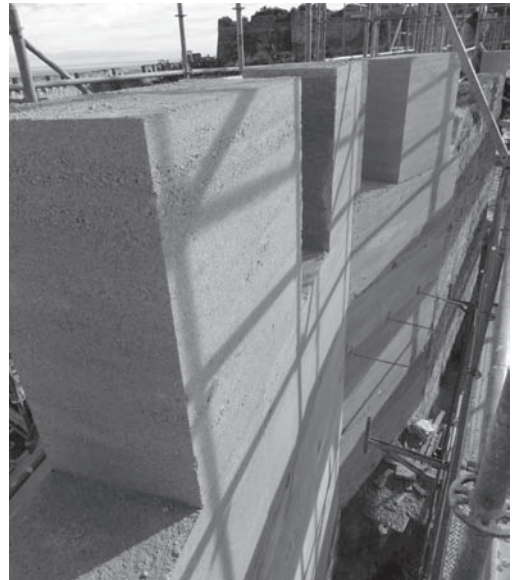
Figure 9. Agujas de madera y varillas roscadas necesarias para apretar los costales de las tapialeras.

madera de 7 x 7 cm. con una muesca en la parte inferior de forma que permitiese la extracción de la varilla roscada que se utilizaba para apretar los costales, abandonando en el interior del tapial, la aguja de madera (Fig. 9). Posteriormente estas agujas de madera, al estar seccionadas en los extremos, eran extraídas de la fábrica sellando dicho alojamiento de la aguja con un mortero de cal de forma que, de cerca, pudiera evidenciar la situación de la aguja, o bien reconocerse cuando pasado un tiempo se desprenda ese sellado como ocurre, sin ninguna intención estética original, en las fábricas de tapial antiguas otorgándoles ese aspecto tan característico.

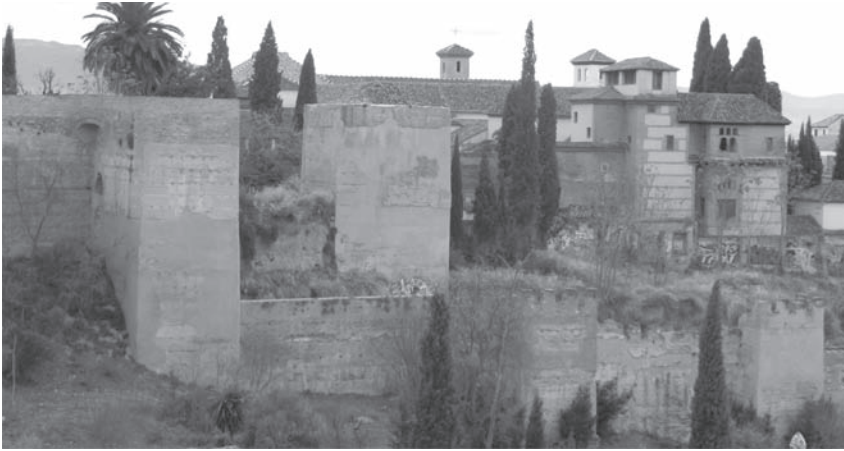
Figure 4. View of the central section after the restoration.

The small agujas holes that had grown larger due to the action of groups of animals, as mentioned previously, were filled up sufficiently to hinder them nesting, but not completely, to avoid any radical change in the previous image of the wall. Nevertheless, the large anthropic cavities in the wall faces were totally blocked up. The caves excavated under some panels were also filled in using heavy stone lime concrete (Figs. 4–6).

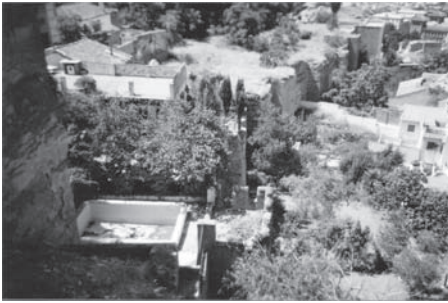
Figure 5. View from tower 8 to tower 14 before the restoration.

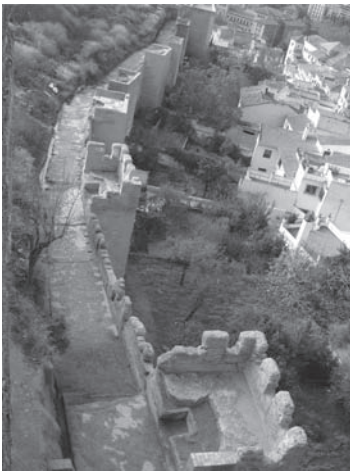
Figure 6. View from tower 8 to tower 14 after the restoration.

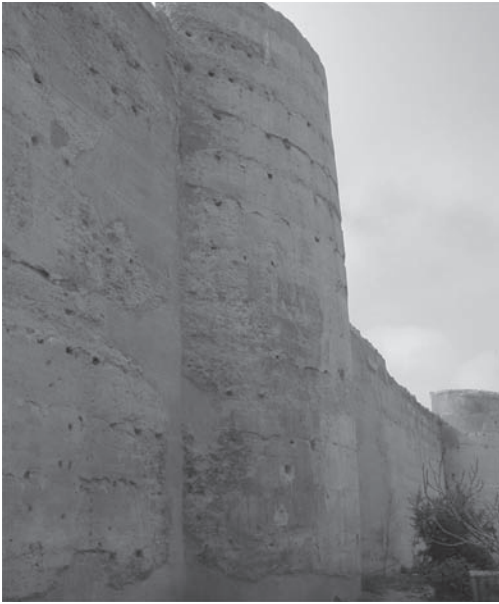
Figure 7. View of towers 2 and 3 after the restoration.

It was important that the thickness of the coats of reintegration mortar was not more than 1 cm, since due to the characteristics of this material a greater thickness would mean its cracking and becoming detached because of lacking sufficient air for carbonization. These coats were laid by throwing them gate would stick on to it. The edge of each of the coats was gate would stick on to it. The edge of each of the coats was well closed on top of the previous one and on the base of the material (Fig. 7).

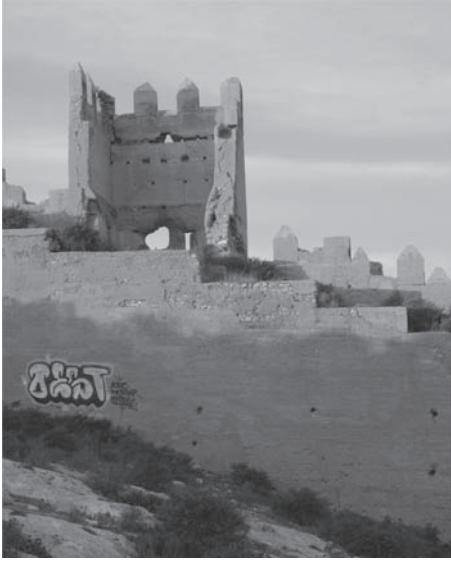
Figure 2. Walls of the San Cristóbal, Almería (2012).

The result of the intervention would be a slipform stone wall, flush with the original, with concrete formwork over irregularly spaced wooden planks, period, in which the discipline of restoration was

clearly visible on the wall surface, with the intention of conserving the structure of the building reproducing here and there the holes that housed the temporary stays used to support the formwork during ramming. The surface color blended with the existing aged wall color more than the interior of the earth wall, as the original finish of the lime-reinforced rammed earth used was a whitish lime mortar.
