Rammed Earth Conservation

C. Mileto, F. Vegas & V. Cristini

PROCEEDINGS OF THE FIRST INTERNATIONAL CONFERENCE ON RAMMED EARTH
CONSERVATION, RESTAPIA 2012, VALENCIA, SPAIN, 21–23 JUNE 2012

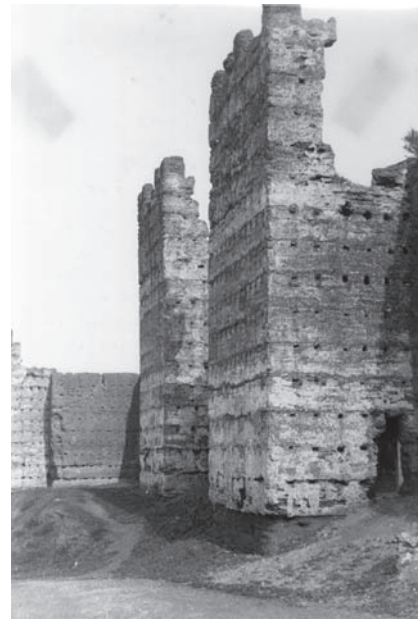
Figure 4. Fortified walls of Ceuta (1967) Fuente: Ministerio de Cultura. Archivo General de la Administración. Fondo Cultura, IDD (03)116, Caja 26/113.

The interventions would be carried out on the walls and towers in poor condition, with the following notable actions: on the towers of the Puerta de Fez gate, the lost merlons were rebuilt with cyclopean concrete, filling in the cracks and fissures of the walls and sectors with loss of the original crust with lime and cement mortar. Finally, the bases of the towers were buttressed with concrete with sections of brick.

The first of the towers to the north of Puerta de Fez was buttressed in the same way, while for the second a fallen section was reconstructed in cyclopean concrete. In one of the towers in the southern sector of the wall, the most deteriorated, a new concrete lining was laid between the walls, sealing the cracks and fissures with stone and then plastering with lime and cement mortar. At the top of the tower a reinforced concrete tie beam and brick merlons were also added. In some cases the concrete elements conserve the courses of the original rammed-earth wall sections and display the holes of the temporary stays. The concrete and mortars used present a rough textured finish and are designed to blend with the present earthy colour of the fortifications.

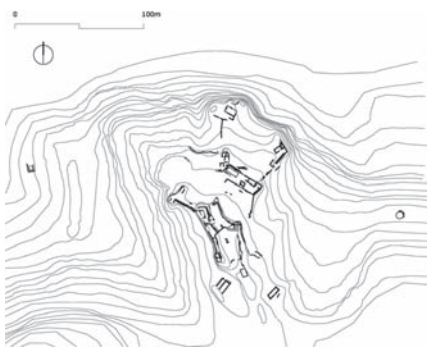
Figure 1. General plan of the fortress.

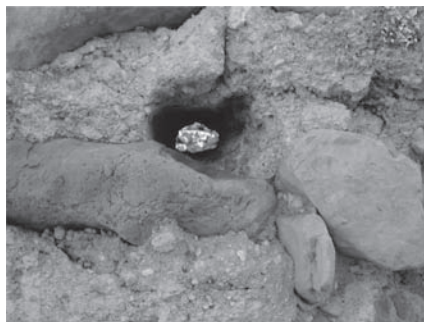
Figure 3. Lime mortar and rough stone with the trace of a putlog in a ruined *tapia*.

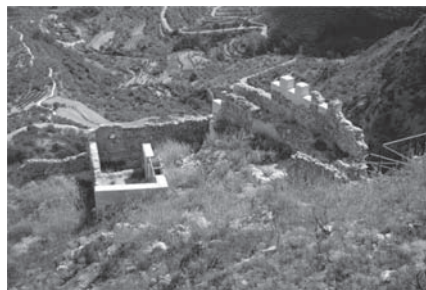
Figure 4. View of the lower *albacar* after restoration.

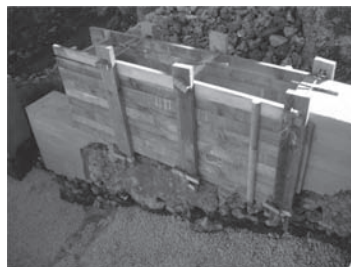
Figure 7. *Tapia* formwork used for restoration.

carbonated. To avoid this problem hydraulic lime incorporating a small proportion of white BL32.5 N cement was used to improve the initial resistance. Ground ceramic was also used for crowning the walls. Following the studies, the bonding mix for rough stone had a dosage of 1:2, that is to say, one measure of bonding agent to two of sand and aggregate.

In order to overcome the limitations of the laboratory tests, various lengths of *tapia* were constructed on site using rough stone, gravel, sand and lime. Instructions were given regarding the process of compacting and removing from the mould. Careful attention was paid to the way in which they were broken, the positioning and union of the rough stone, behaviour of the mortar joints, thickness of the outer layer, marks of the boards and texture and colour of wall faces. In addition, some fragments from the breakages were collected and used to create test samples. These were tested for breakage by compression and the results at 8 days were above 4.2 N/mm². With the variety of information obtained from the test *tapia* walls, small corrections were implemented in order to carry out the final execution. During the intervention controls were carried out on the execution of the *tapia* walls and breakage by compression tests were carried out with satisfactory results. It should be remembered that the hardening process of lime mortars is extremely slow compared with cement mortars, but on completion of the process the resistance is almost the same.

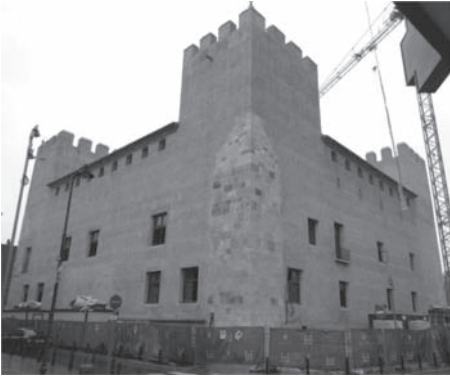
Figure 1. View of the castle in the final processes of the restoration works. In this image we can notice the extension of the of the valencian rammed-earth in the walls.

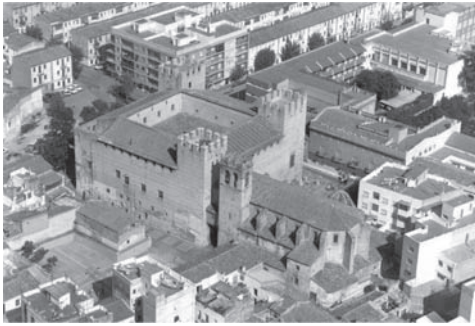
Figure 2. Air view of the castle before starting the restoration works, where can be noticed the northwest tower inexistence.

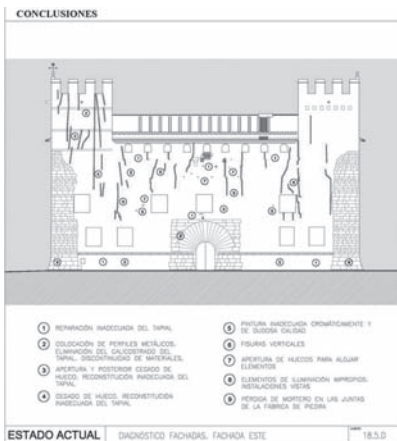
Figure 3. Plan of the previous study included in the Master plan.

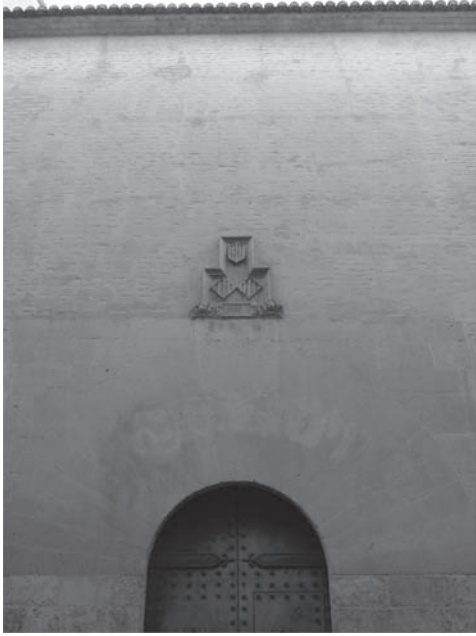
Figure 4. Xàtiva's Almudín façade, in which the valencian rammed-earth wall can be seen, built on the ashlar brickwork.

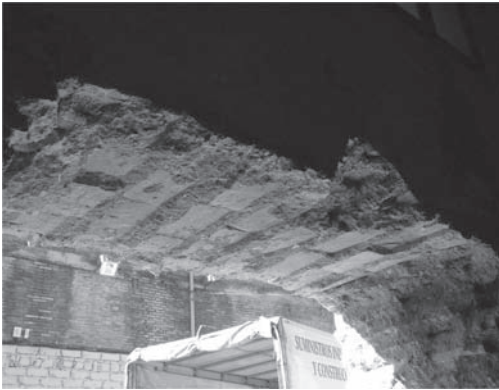
Figure 5. Hollow horizontal section done in the rammed-earth wall of the Alaquàs castle where can be seen the traces of the bricks internal disposition.

The structural walls of the Alaquàs castle obeyed to a logical distribution according to the structural scope to be resisted. Generally speaking, they followed the disposition of placing ashlar at the four corners in such a way that the most exposed points to the changing weather conditions and even to the enemy's attack were made with a more resistant material. This stonework, usually, is composed of two sheets of regular ashlar placed in courses from between 25 and 45 cm height. Inside, there's a mortar rich in lime and arid completing the space in between the two sheets in such a way that consolidated enormously the corner giving to it an eminently structural function.

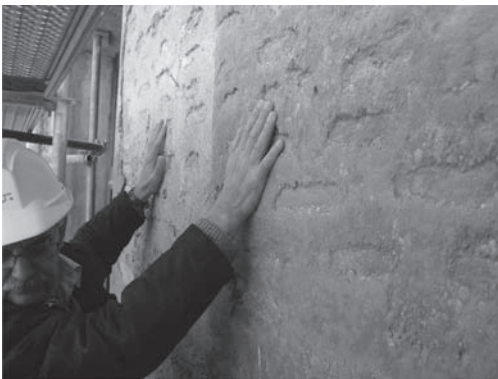
Figure 6. Cleaning tests to remove the existent painting by means of aluminium silicate projection.

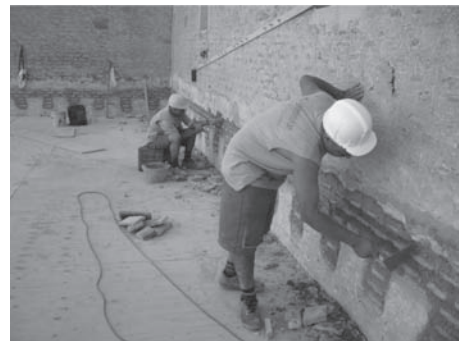
Figure 7. Reintegration of the rammed-earth wall in those areas with hollows of the former supports of the wooden beams.

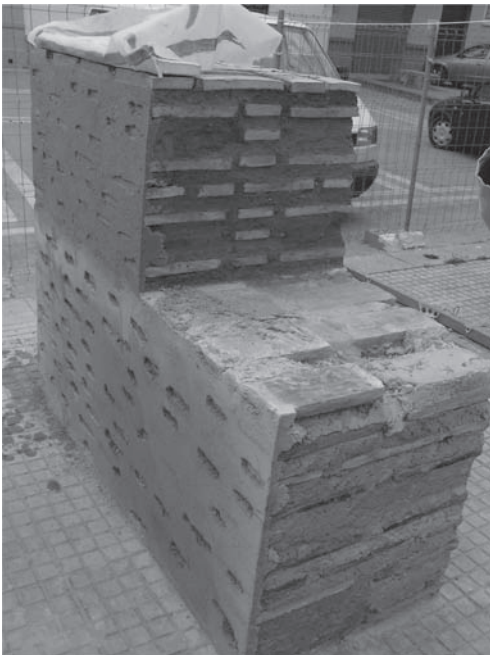
Figure 8. Tests carried out to build the valencian rammed-earth wall.

The proposal raised as suitable for this kind of intervention was to build up a brickwork wall with solid brick courses measuring $28 \times 14 \times 3$ cm and a lime mortar with dosage 1:4, using the arids of the area to get a good integration with the existing brickwork. According to the location of the face to recompose, the different courses followed a cadence alternating 3 or 4 header courses and one stretcher course. The horizontal joints were about 6 to 10 cm thick, being the horizontal joint from 2 to 3 cm thick.

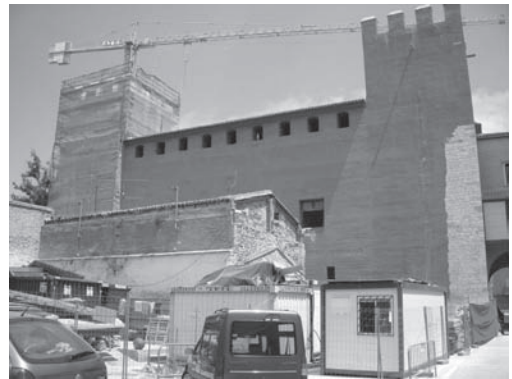
Figure 10. Image of the fourth tower during the reconstruction process.

The reconstruction of the fourth tower was, with no doubt, the work to which more time was devoted to the decision of the carrying out and the selection of the materials. The decision adopted was to use bricks with similar dimensions to the existing ones and rounded arid for the lime mortars. The rhythms of the bricks disposition were studied and a template to be used as a model was prepared. Over the existing rammed-earth wall a brick course was placed marking the difference between the intervention done and the existing wall.

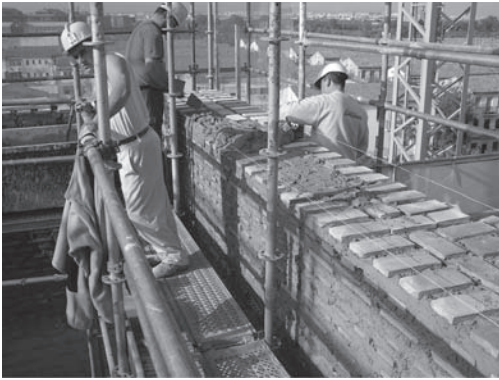
Figure 11. Image of the process of placement of the brick course in the brickwork of the fourth tower during the reconstruction process.

the walls was not followed as we lacked the proper formwork of this technique that formworked the front parts of the wall faces in such a way that when tamping, the mass would flow around the bricks giving them their characteristic aspect. Due to this, the adopted solution in the reconstruction of the fourth tower can be considerate as a brickwork to the image of the valencian rammed-earth wall.

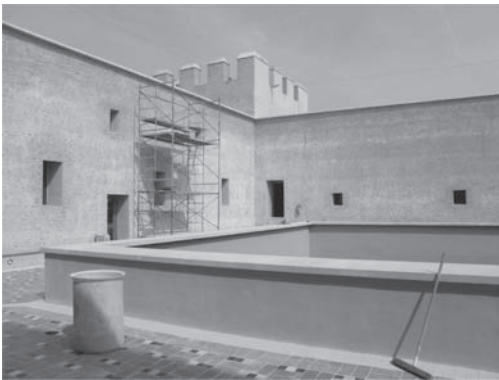
Figure 12. Image from the courtyard during the reintegration and reconstruction works of the fourth tower.

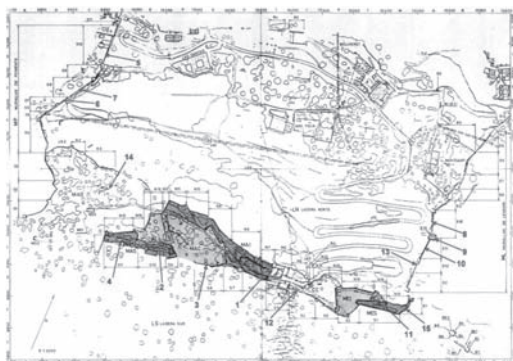
Figura 1. Plano del Castillo de Xàtiva donde se indican los puntos de intervención entre los años 1990–2011.

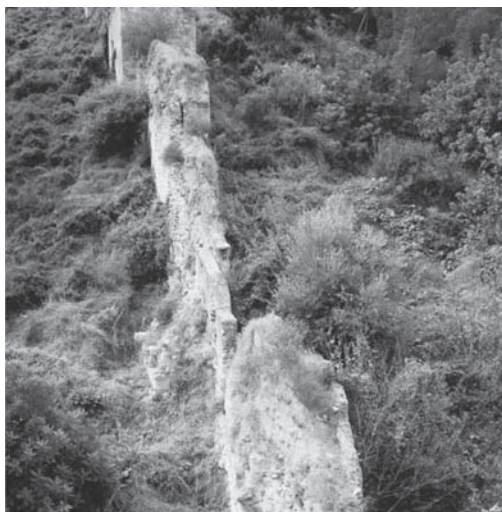
Figura 3. Tramo E11 de las murallas de levante antes de la intervención.

Estas obras se contratan y ejecutan en el año 1996. En el año 1997-1998 se ejecutan las obras de reparación del tramo O7 de la muralla de poniente. Entre los años 1998 y 2001 se realizan las obras de consolidación y reconstrucción de la Torre del Sol y tramo de muralla adyacente E10. También, entre los años 1998 y 2001 se realizan las obras de consolidación de la bóveda y muros exteriores de la Nevera, completadas con las obras de adecuación del túnel de acceso. En noviembre de 2008 finalizan las obras de restauración del torreón-escalera del tramo E11 de las murallas de levante.

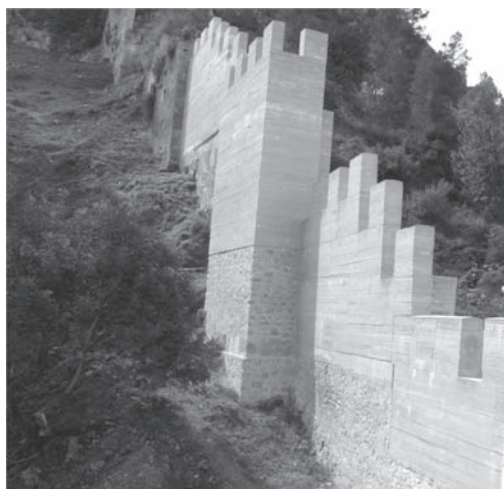
Figura 4. Tramo E11 de las murallas de levante después de la intervención.

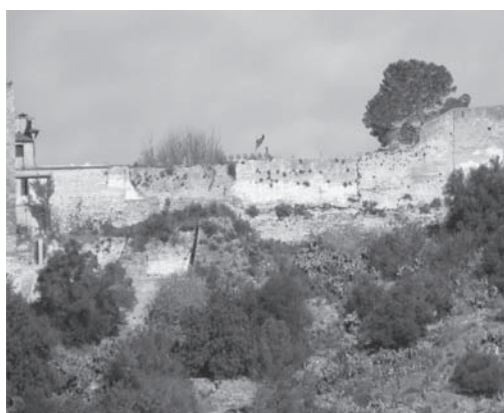
Figura 5. Tramo S4 de las murallas del patio de armas antes de la intervención.

Recientemente, junio de 2010 y agosto de 2011, finalizan las obras de restauración del tramo de muralla S4, y reposición del lienzo y torreón primitivos del mismo tramo situado en el patio de armas. También recientemente, por parte del Ajuntament de Xàtiva, en el año 2009, el desarrollo de un Taller de Ocupación ha permitido restaurar los aljibes situados en la Devesa del Castillo Mayor. En la actualidad, existen dos proyectos pendientes de actuación, la restauración del tramo E12 de las murallas de levante, y la restauración del tramo E1, extremo este del Castillo Menor (Torre de l'Esperó).

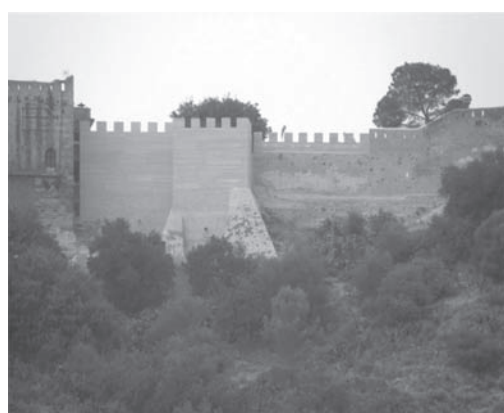
Figura 6. Tramo S4 de las murallas del patio de armas después de la intervención.

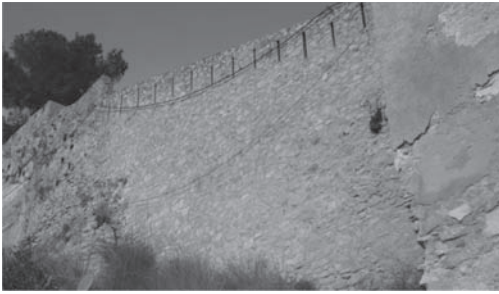
Figura 10. Vista frontal del tramo intervenido.

Codificación: FT/TT/CC → FT/TT/MO.

Datación: Por la modulación del tapial que constituye el vuelo y calidad de la fábrica del zócalo, podemos considerar que su origen es cristiano. La hoja externa se repuso con fábrica de mampostería, posiblemente en la primera mitad del siglo XIX, que es la que se vuelve a derrumbar en la actualidad (1990).

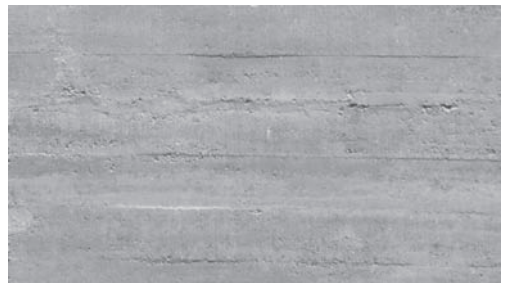
Figura 12. Tapia del siglo XII.

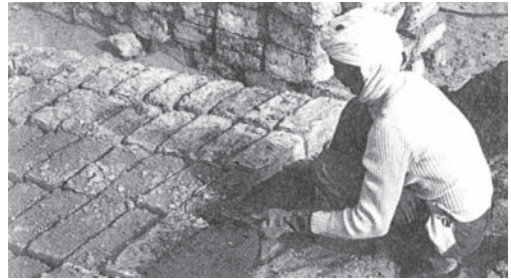
Figure 4. Manufacture of earthen bricks or "Touba" (adobe). N. Abderrahim Mahindad.

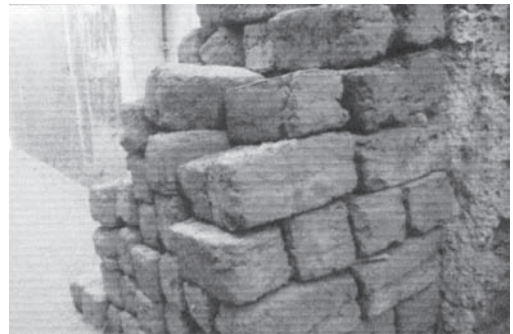
Figure 8. The adobe walls. N. Abderrahim Mahindad.

- The stone walls: They are made of stones of different sizes placed on a bed of mud mortar. There are two types of stone walls according to their fitting: stone walls of sand (Tafsa) placed on fields revealing the polygonal face and walls of stones laid in fish bone shapes at 45°.
- The builder starts with the outer walls and then those inside independently from previous ones, this is why the interior walls are never harped to the outer walls.
- The clay used as a binding material is kneaded with the feet. It is then used to coat the walls to get a smooth finish.

Once completed, the walls are coated with slurry of clay, used to seal joints in order to avoid the water infiltration into the structures in case of rain.

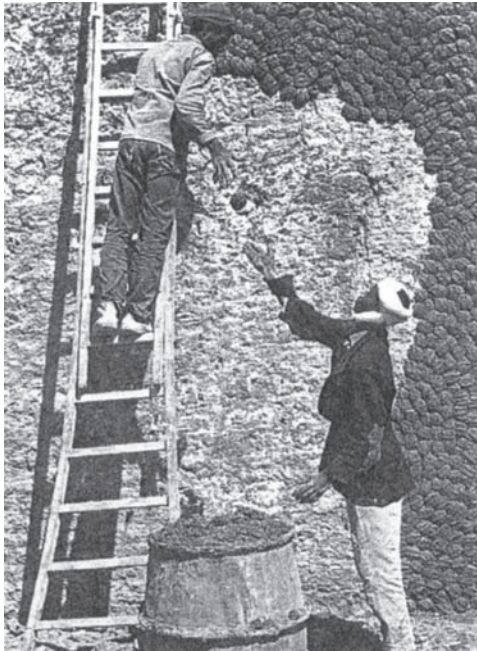
Figure 9. The finish coat. S.Haoui in “For the preservation of the architectures Ksouriennes in raw earth. Example ksar of Timimoun, Algeries”.

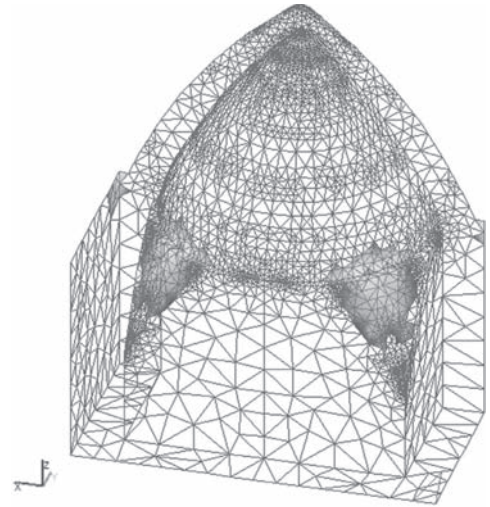
Figure 7. Model of damage resulting from own weight load. Alonso A. (2009).

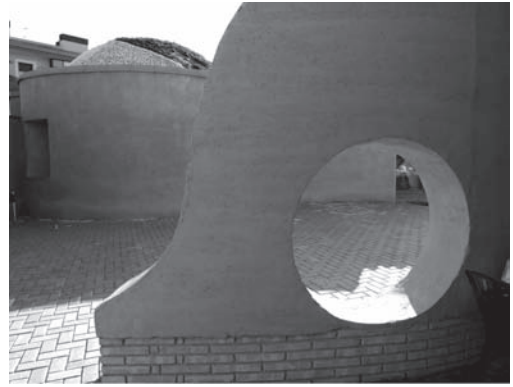
Figure 5. Rammed earth with reserve for a hole.

Despite the ease of construction with CEB, and even greater ease for curved walls (Fig. 5), it was decided to also use earth from the site as an ecological gesture. Using earth from the excavation site to build walls is certainly one way to minimize the impact of construction. Also, reviving the rammed earth technique seemed like a good option given

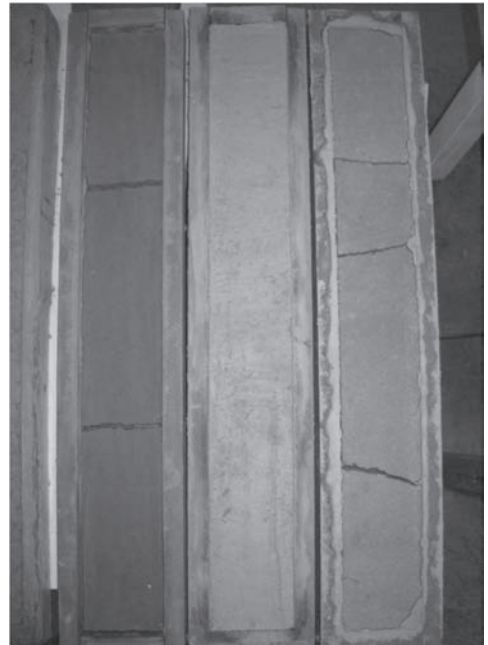
Figure 6. A linear shrinkage test with different dosages.

- 10% lime.
- 12% cement, 7% perlite and 24% brown fibers.
- 12% cement and 7% perlite.

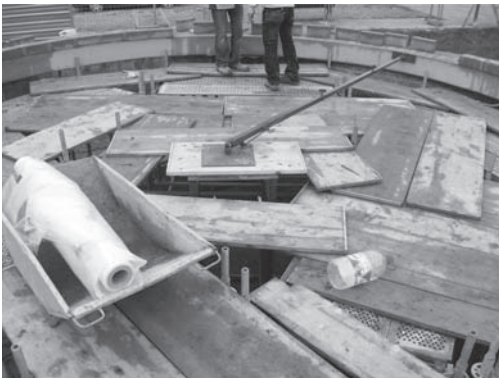
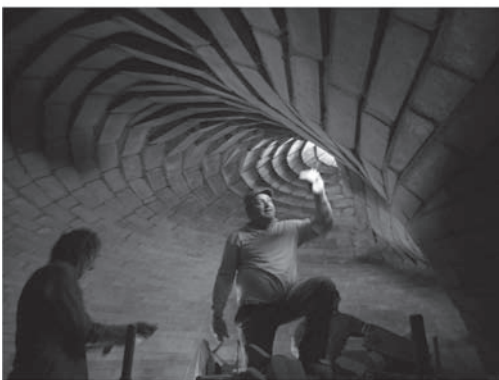
Figure 7. Building Nubian domes without formwork.

domes, due to the great flatness of the last rows of CEB and, despite using the construction system block Nubian offset to the radius of the track, decided to use a fast natural cement brand named “Marfil” from the local company “Cementos Collet”.

The resulting polygon conditioned us to increase the section in the lower area of the dome, filling it with concrete to prevent tractions and the use of steel reinforcement.

The linear thrust obtained was 634 Kp to be added to the seismic thrust in order to determine the amount of steel reinforcement in the hexagonal perimeter hoop. During the construction of the

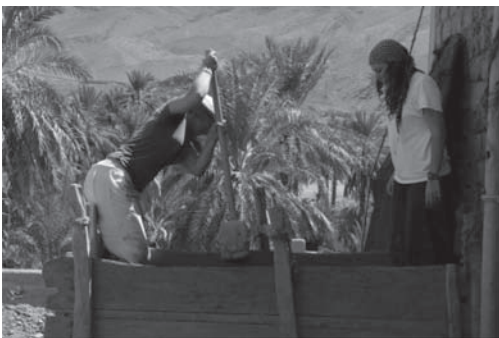
Figura 1. Apisonado de tierra.

Los encofrados de madera que se utilizan en esta zona son de $0.50 \times 1.70 \times 0.70$ m y en ellos se vierte la tierra por tongadas de unos 10 cm. y se compacta con un pisón de mano. La tierra tiene que estar húmeda, sin llegar a ser barro y limpia de piedras excesivamente grandes, solo la gravilla.

La tapia se suele construir sobre un zócalo de otra fábrica, que le protege de la humedad, generalmente de mampostería. Sobre este zócalo se montan los moldes (tabiyyas o tapiales), siendo la separación entre los tableros el espesor que va a tener el muro.

Además los listones de la base que unen los tableros verticales, son cubiertos con piedras sin dejar que la tierra los oprima y una vez terminada la ejecución del cajón de tapial, se puedan retirar con facilidad.

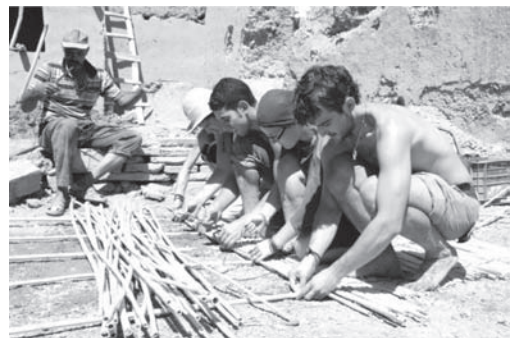
Figura 2. Ejecución del cañizo.

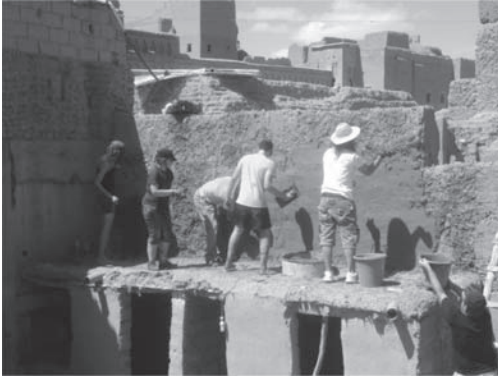
El revoco está compuesto por arena, paja triturada y agua (2 de arena, 1 de agua y 1 de paja). Siendo éste de una consistencia plástica con el que

se revisten paredes. Este revestimiento es ideal para encalados a posteriori.

Figura 3. Ejecución de revoco.

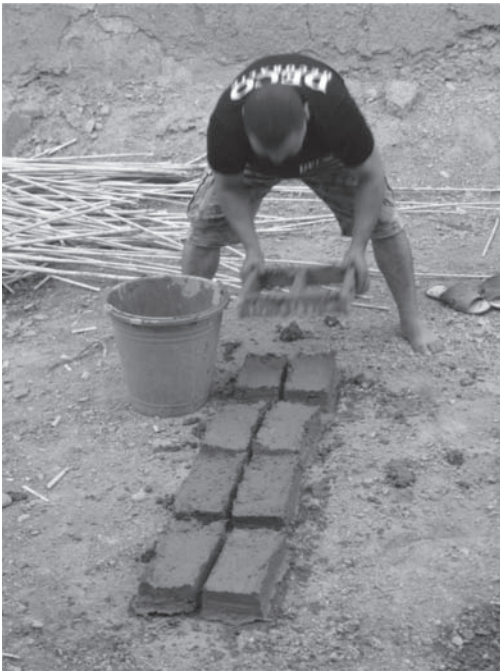
Figura 4. Haciendo adobes.

Para obtener la forma de prisma rectangular se utilizaron moldes de madera de $10 \times 11.5 \times 30$ cm que se rellenan y se dejan secar.

Además de revestimiento, la tierra del revoco sirve para la fabricación del ladrillo de adobe. Estos ladrillos se utilizan para la continuación de muros donde el tapial resulta muy difícil de ejecutar o para aligerar el muro en los puntos más altos donde la carga es mucho menor.

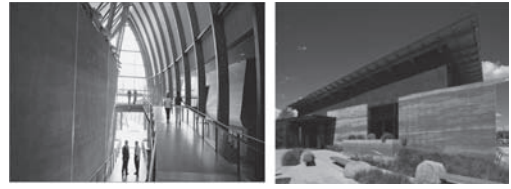
Figures 3 and 4. (Left) National Wine Centre, Adelaide, Australia. Source: University of Adelaide. (Right) Sublette County Library, Pinedale, Wyoming. EEUU. Source: Carney Architects.

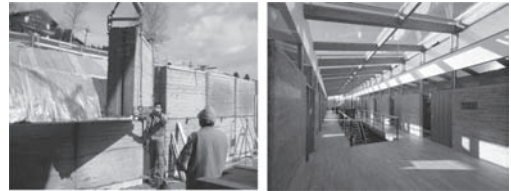
Figures 5 and 6. Prefabricated rammed earth building wall. Printing Gugler. Melk, Austria. Source: Martin Rauch.

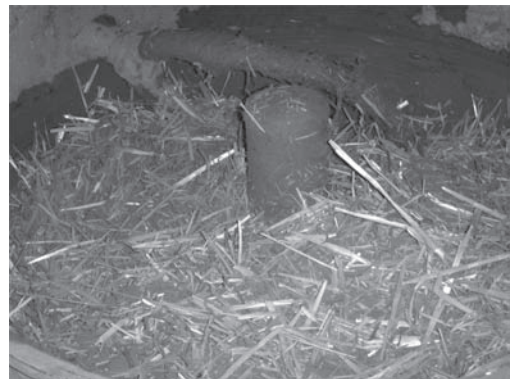
Figure 1. The kneading machine used to prepare the first hand-made samples (photo: G. Bollini).

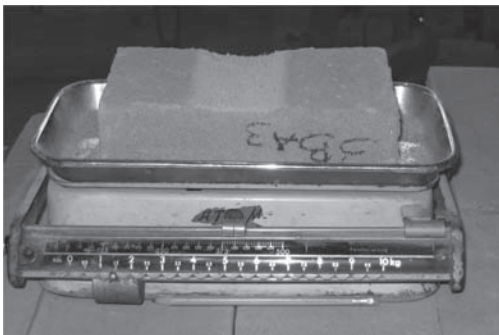
Figure 3. Abrasion test (photo: G. Bollini).

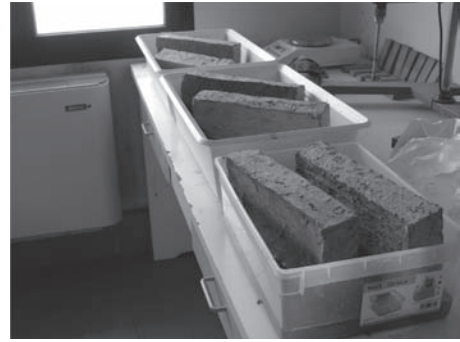
Figure 4. Water absorption test.

One such example was the decision to omit the test for water absorption by imbibition as required by UNI 771-1 but to continue with the most significant test of absorption of atmospheric moisture, conducted in accordance with the internal procedure defined by LTM technical; this made it possible to see (Table 1) the quality of our earth bricks against high fluctuations of moisture in the long term.

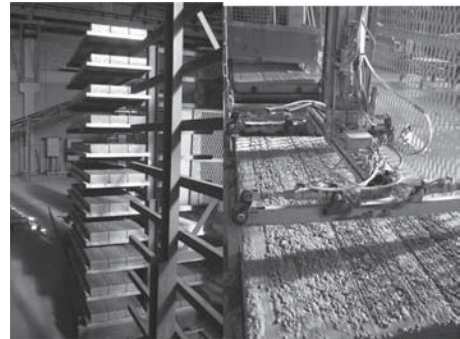
Figure 5. The industrialized adobe production line (photo: M. Brioni).

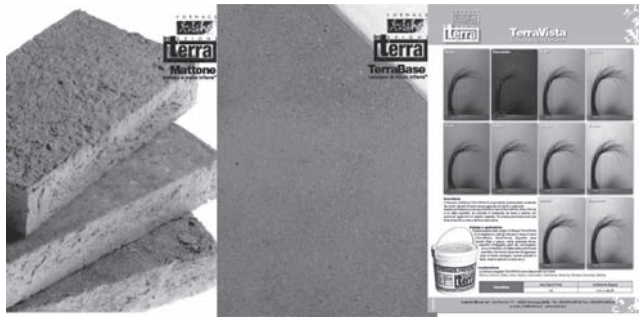
Figure 7. The inTerra™ range of products (folder).

There are 3 types of adobes (30 × 15 × 5.5 cm), varying in density and thermal behavior (ρ 1450 Kg/m³, λ 0.47 W/mK and μ 8; ρ 1200 Kg/m³, λ 0.40 W/mK and μ 7; ρ 800 Kg/m³, λ 0.18 W/mK and μ 5), earth mortar (ρ 1500 Kg/m³, 1.57 N/mm² as compressive strength and 2,8% as shrinkage) and earth plasters (Fig. 7). The performance of all the in Terra™ products are downloadable from the website www.matteobrioni.it, *Products* section, along with building and item specifications.

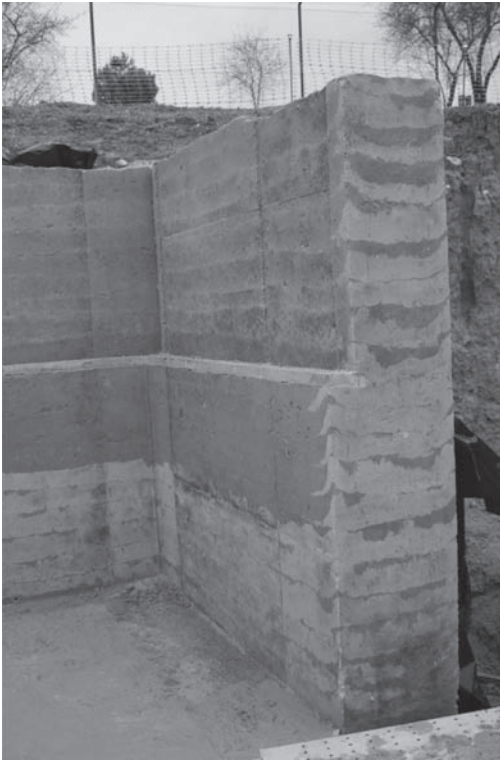
Figure 4. Wall calicostrado. Lime mortar surface finish.

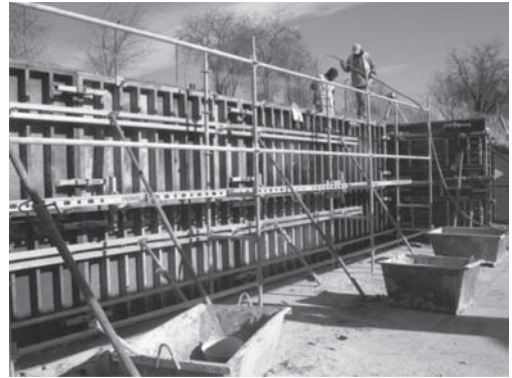
Figure 5. Usual formwork in the construction of concrete walls.

The formwork system with metal panels, stretched and top and bottom stud fastening that allow free soil compaction, secured with braces and anchored to the ground with wedges, becomes, within the current market proposals, as the best option. Surely not represent the most appropriate (for example, difficulting the elimination of excess water during drying), but aids to lower costs and to use common tools bringing earth construction to a conventional choice.

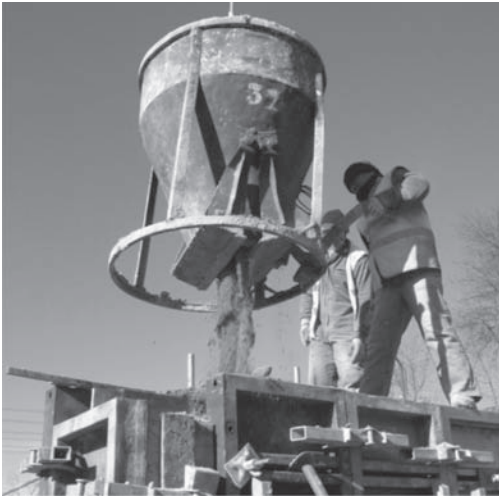
Figure 6. Lifting and pouring earth mix.

The mixing of soil, with the proportions of additives already referred to, and subsequent mixing, is made by mini dumper machine (bobcat), that allow both the displacement of the earth from its place of storage to the point of preparation, and perform works of incorporating additives, even leaving a finest mixing to workers. Soil with additives was used immediately to preparation, being discarded that which was not poured during the job. At night, the soil to be used during the following

day, which already had the right humidity, was protected with canvases from rain or accidental weathering. The ready mix was lifted to the formwork by a shaker driven by a transportable crane.

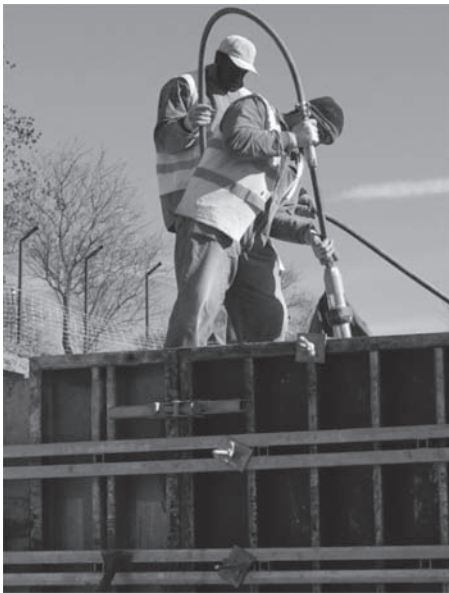
Figure 7. The compactor Sullair F18.

of technique is concerned. Mechanical compaction, despite entering some uncertainties, gets much higher values in the cohesion of the wall and therefore their mechanical performance, reducing execution time and therefore use of aids. Finally, we chose the compactor Sullair F18, weight of 17.5 kg and a height of 126 cm, very manageable, able to work with a frequency of 500 beats per minute and with a 14.5 cm diameter ram, very suitable for the small scale on which we work.

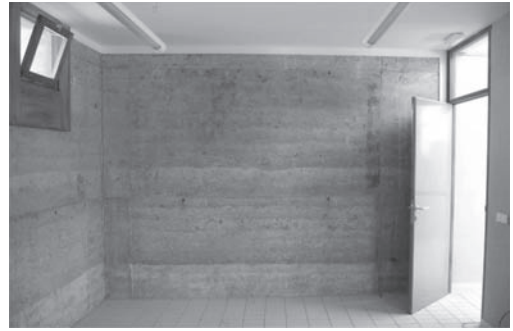
Figure 8. Finished rammed earth wall in library room.

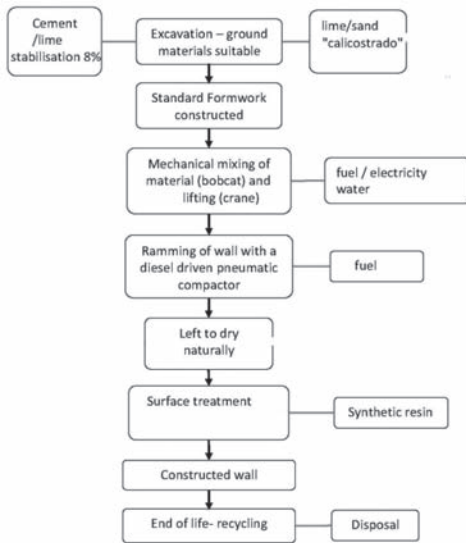
Figure 9. Process diagram for rammed earth wall LCA (adapted from Lax, 2010).

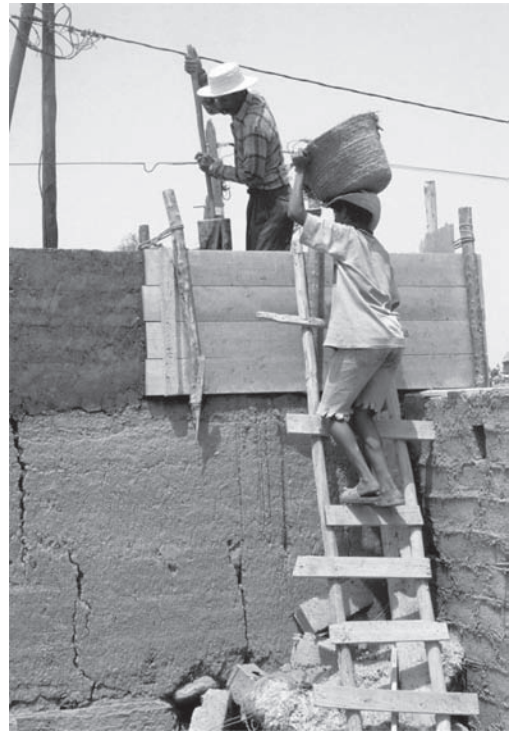
Figura 5. Técnica del Tapial.

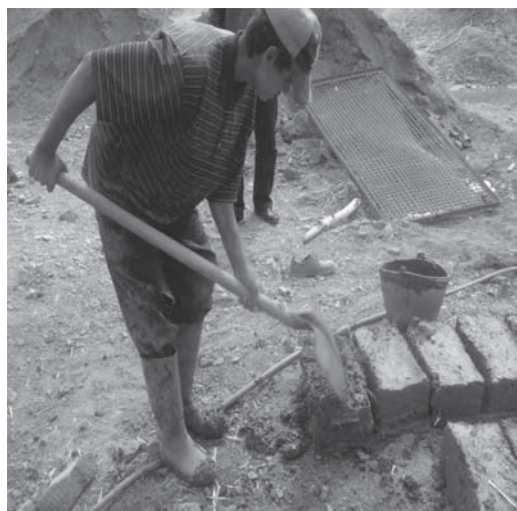
Figura 6. Técnica del adobe.

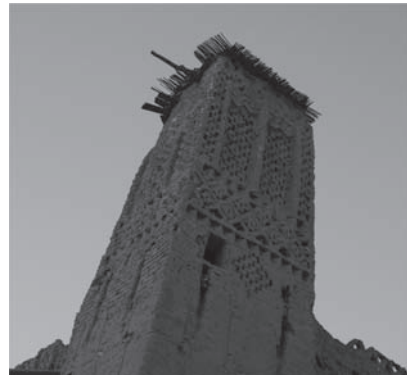
Figure 7. Detail of one adobe decorated tower of Bou Taghrar's Kasbah. Picture: Alberto Montiel Lozano.

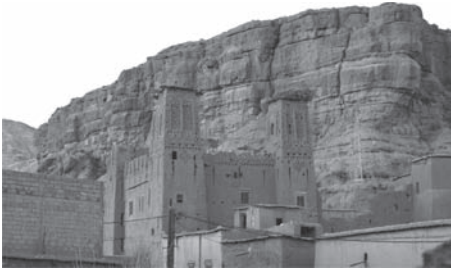
Figure 4. Type I: Tighremt in Bou Taghrar.

- The presence of towers with a talus (high T/t relationship).
- Towers are tall and lean (high T/t relationship).
- Towers protrude over the walls.
- The top of the walls and towers is built in adobe (between 1/3 and 1/4 of the total height).
- Towers are narrow compared to the walls.

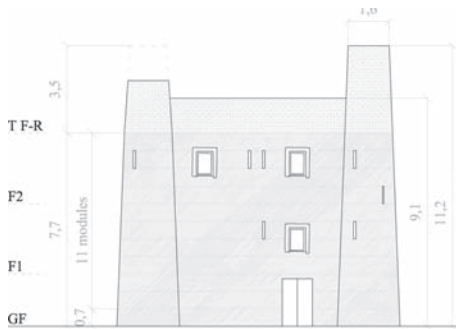
Figure 5. Elevation of the *tighremt* shown in Figure 4. Height is given in meters and in number of wall sections.

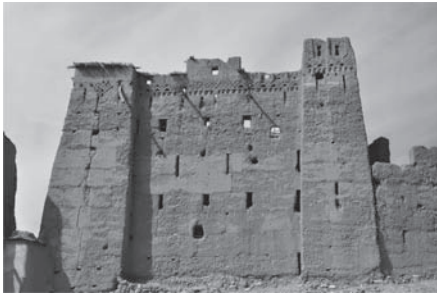
Figure 7. Type I: *Tighremt* in Bou Taghrar, not far from the building shown in Figure 4.

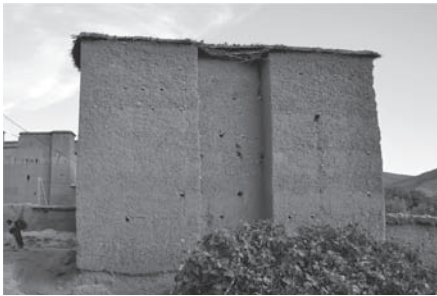
Figure 8. Type II: *Tighremt* in Aït Khalifa.

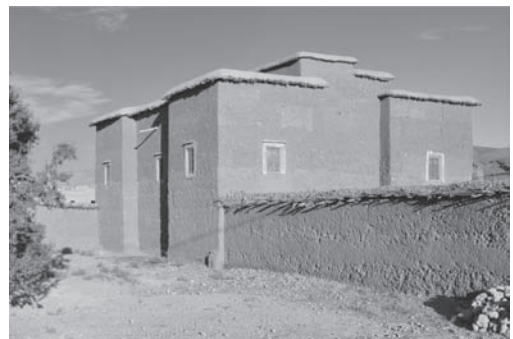
Figure 11. Type II: *Tighremt* in Aït Khalifa, not far from the building shown in Figure 8.

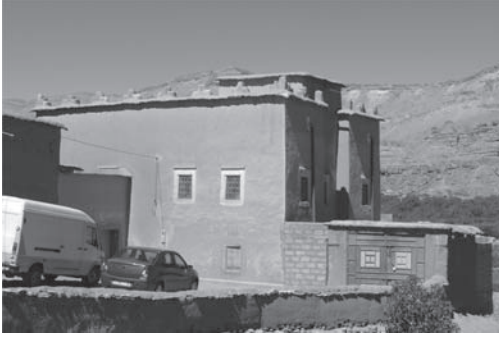
Figure 12. Type III: House in Hdida.

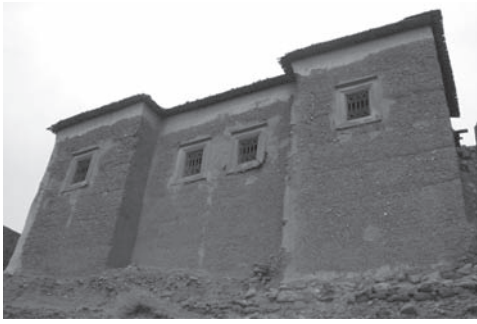
Figure 15. Type III: House in Ait Youb.

- The talus of towers, present in Type I, is gradually lost. Type III does not exhibit it anymore.
- Towers, originally lean, become larger as a result of changes in its function (being used for lodging instead of for stables.)
- Type I towers, taller than the walls and protruding over the façade, have a symbolic defensive character. Towers are gradually lost in the process of simplification.
- On the constructive side an evolution takes place as well. Type I exhibits adobe on the top third of the towers and walls, forming ornaments and

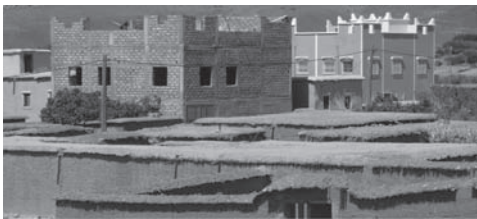
Figure 16. Reinforced concrete house in Alemdoune.

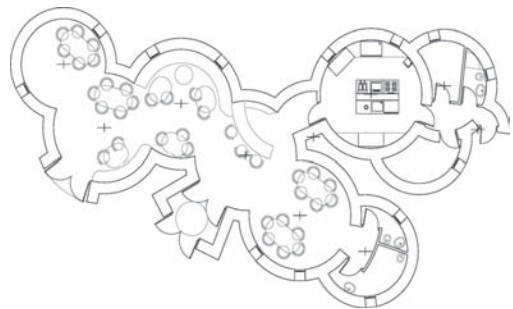
Figura 1. Planta del restaurante.

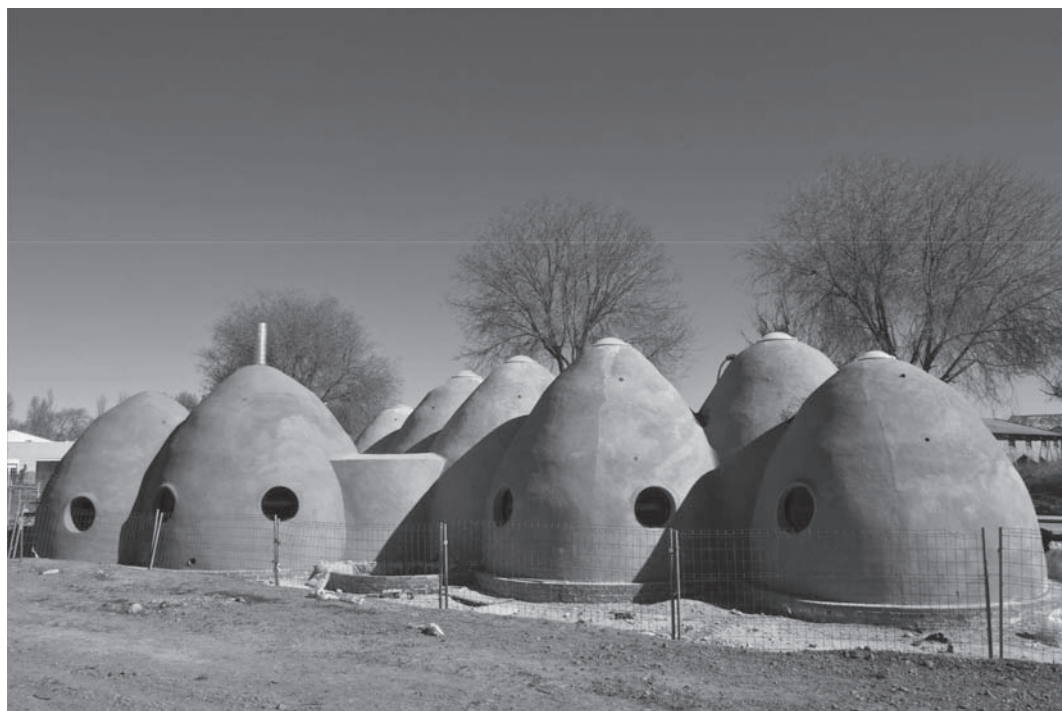
Figura 2. Vista trasera del edificio. (Autor: M. Macho).

y ampliarse indefinidamente, pero utilizando únicamente dos tamaños, dos medidas de diámetro interior: 4.80 m y 4.00 m (Figs. 1 and 2).

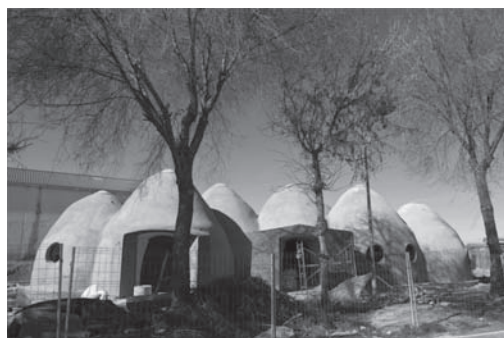
Figura 3. Vista de la fachada principal desde el pueblo. (Autor: M. Macho).

Una macla de cinco cúpulas configuran el comedor, estas giran sobre sus centros abriendo un juego de visuales transversales en el espacio interior que evita la repetición espacial y la existencia de un solo eje visual. El acceso principal se sitúa en la segunda cúpula y se gira respecto al eje de la calle principal desde el pueblo (Fig. 3). También desde

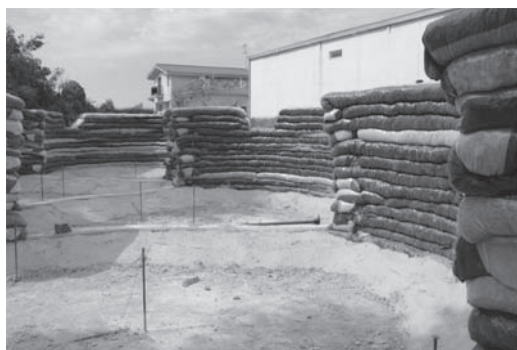
Figura 4. Vista sobre los centros de los arcos. (Autor: P. Diez Rodríguez).

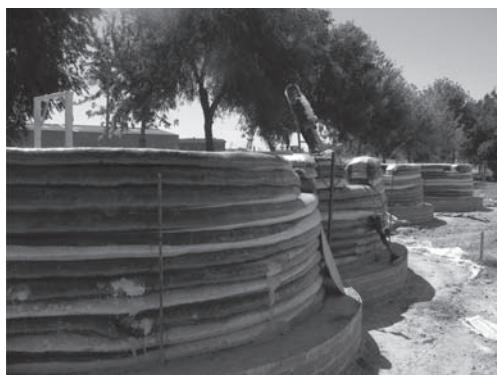
Figura 5. Proceso de construcción. (Autor: P. Diez Rodríguez).

El momento más peligroso de la construcción es precisamente cuando llegamos a la altura de los hombros de la bóveda, el voladizo es muy grande y los empujes no están completamente equilibrados, las hiladas superiores podrían volcar hacia el interior y es necesario apuntalar por seguridad.

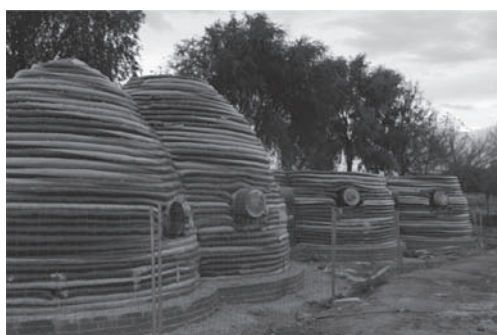
Figura 6. Proceso de construcción. (Autor: P. Diez Rodríguez).

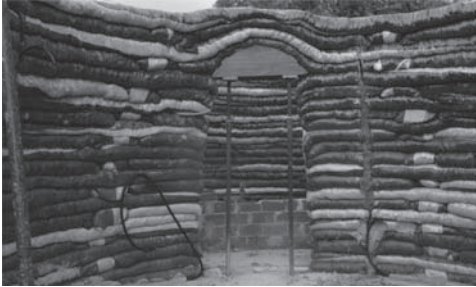
Figura 8. Colocación de cimbras para huecos de paso. (Autor: P. Diez Rodríguez).

Los cargaderos de ventanas y puertas de paso se resuelven mediante arcos de descarga, una vez más sigue siendo la forma la que trabaja. (Fig. 8).

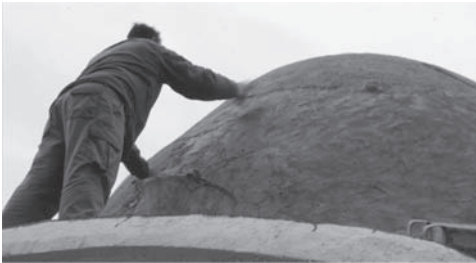
Figura 9. Proceso de revoco exterior. (Autor: P. Diez Rodríguez).

Una vez cerradas las cúpulas se realizan los revocos exterior y al interior utilizando fibra para evitar las fisuras. Se aplica una primera capa o trullado para regularizar los bordes y canales entre sacos y se realiza una segunda capa de acabado final, en la que se introduce la fibra. (Figs. 9 and 10).

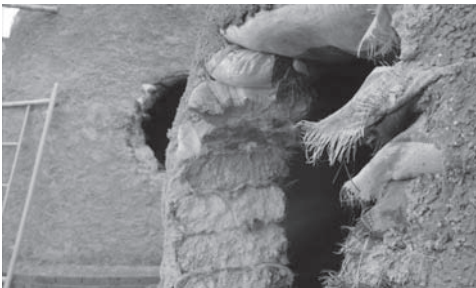
Figura 10. Detalle del muro. (Autor: P. Diez Rodríguez).

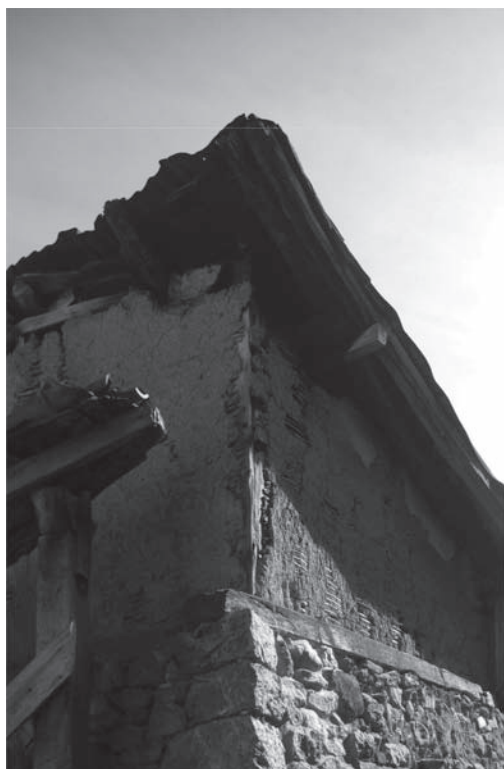
Figura 1. Encestado revocado en Cantabria.

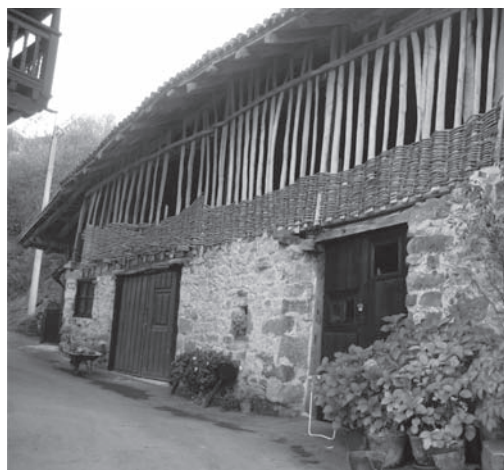
Figura 2. Encestado sin revocar en Potes.

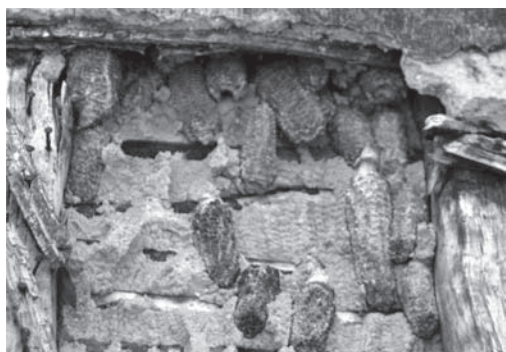
Figura 3. Pared de listón y mazorcas.

El manejo más rápido de los listones consigue muchas aplicaciones. Lo encontramos en los fondos de los balcones y en sus laterales, así como en tabiques sencillos o dobles, colmatando entonces el vacío entre las hojas con variados materiales como desechos de construcción y agrícolas o mazorcas desgranadas, siendo éstas las más características de varias zonas asturianas donde el *taruco* es un distintivo peculiar, mientras que el relleno de paja y barro, conocido como *palla-barro*, es más utilizado en Galicia y en El Bierzo, tanto para llenar el espacio hueco del tabique doble como para cerrar las ranuras que quedan entre los listones una vez clavados en sus bastidores.

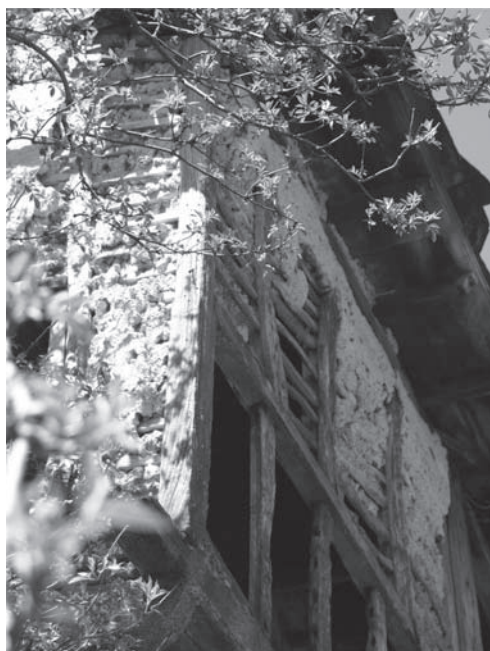
Figura 5. Pared exterior de varillas y trenzas de centeno revocadas en El Bierzo.

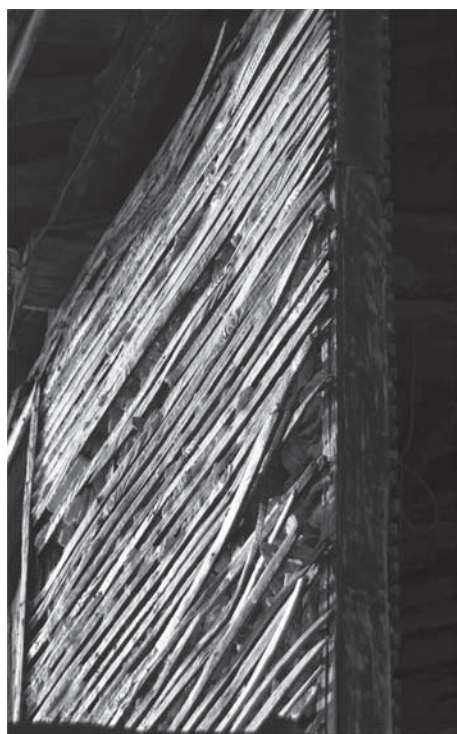
Figura 4. Pared exterior gallega de palla-barro.

Caamaño, en su obra sobre la arquitectura gallega nos recuerda que la *palla-terra* es un modo habitual de realizar el *banzado* con el que forman las campanas de las chimeneas.

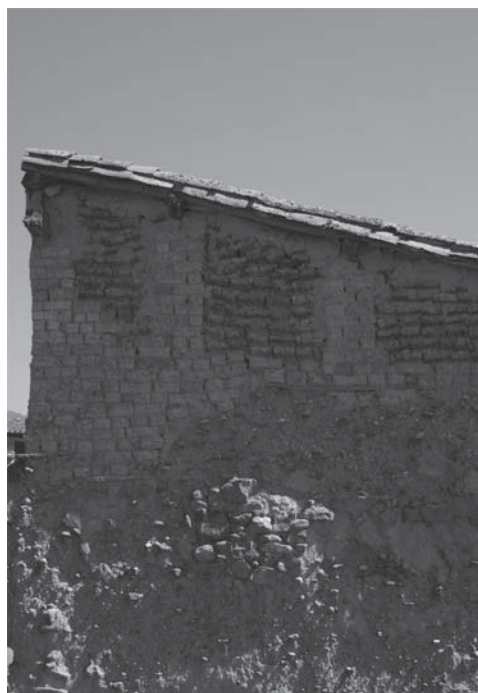
Figura 7. Tepes de turba sobre muro de tierra en el Valle de Vidriales.

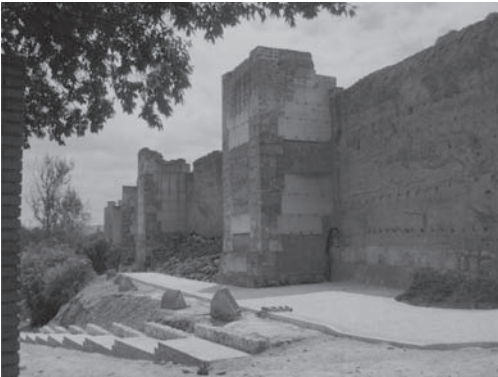
Figure 2. East sector view of City Walls of Niebla, Huelva. (González Serrano, 2009).

Distinctions are embodied as iconographic traces according to the technique employed in a particular historical period. Combinations with basements, chained stone or ceramic brick underline the Roman and Arabic heritage (Fig. 2).

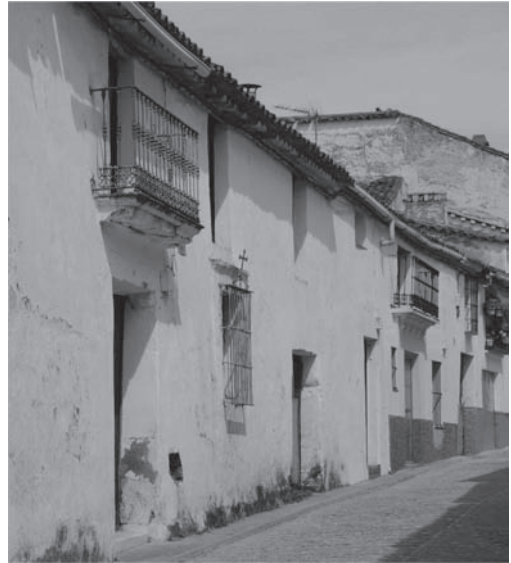
Figure 3. Limes wash façade on andalusian popular architecture. Aracena, Huelva (Rodríguez García, 2011).

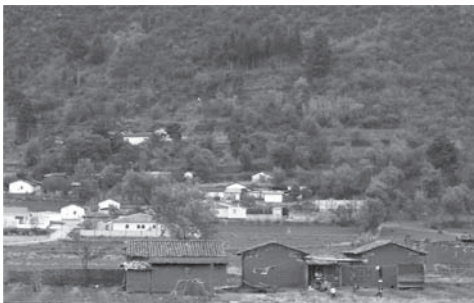
Figure 1. Adobe houses in the Highlands, Totonicapán, Guatemala. Girón, R. 2006.

Small houses with walls of adobe and with corrugated zinc sheets or thatched or tile roofs are part of the landscape in rural areas of the country (Fig. 1). The indigenous pre-Hispanic house, as well as the contemporary one, is built with the same materials; also the design for activities inside is very similar. Generally, the house has a stone foundation, one room, and plastering of mud or lime.

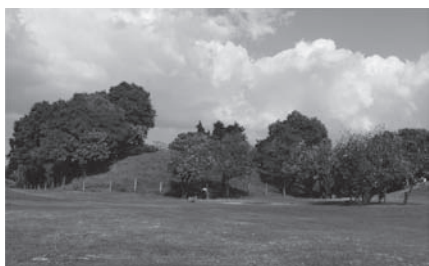
Figure 4. Kaminaljuyú's mound. Gordon, T. 2012.

It has been discovered that beneath the vegetation-covered mounds are ancient pyramids, stone sculptures, jewelry, and several tombs with skulls and ceramic offerings. Most of the mounds have two or more construction stages. Usually the final construction stage has been lost due to erosion and weather damage, and the only remnant is the soil layer of the mounds. This last stage of

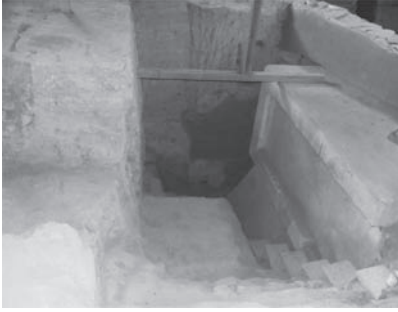
Figure 8. Detail of a slope-panel, talud-tablero, in the Acropolis building. Gordon T. 2012.

The slope-panel is the architectural system formed from an inclined basal wall (the slope) on which stands a rectangular element (the panel) (Villalobos 2006). This system is repeated on each platform. To summarize, the slope is the inclined sustaining element and the panel is the rectangular element supported.

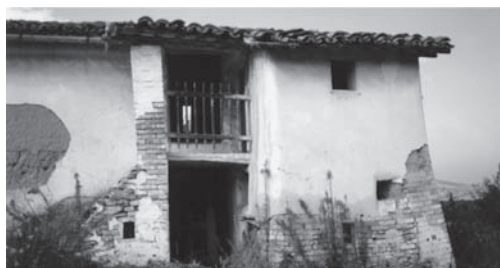
Figure 1. Casalincontrada, a loggia built with baked bricks.
