Rammed Earth Conservation

C. Mileto, F. Vegas & V. Cristini

PROCEEDINGS OF THE FIRST INTERNATIONAL CONFERENCE ON RAMMED EARTH
CONSERVATION, RESTAPIA 2012, VALENCIA, SPAIN, 21–23 JUNE 2012

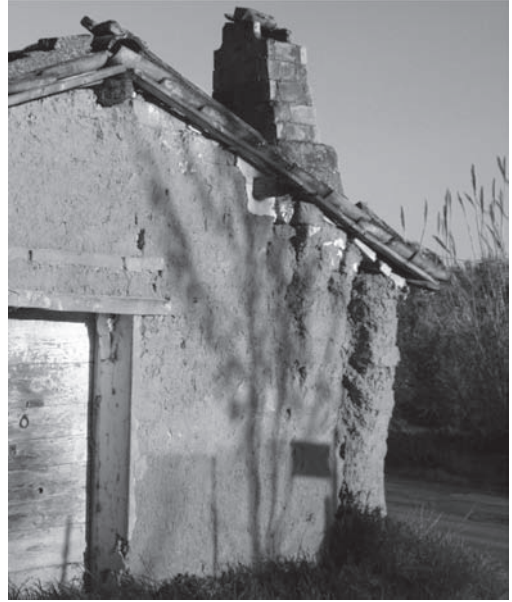
Figure 3. Moscufo, rural building in Contrada Colle di Giogo: the chimney corner.

Nevertheless, the use of different materials don't always cause any problems (Fig. 2), so in other cases these materials help improving the stability and the duration of the structure (Fig. 3). In the same manufacture of Moscufo we can find horizontal rows of baked bricks put at a certain height over the wooden element (Fig. 4): the bricks that are more water-resistant than the earth, allow a better conservation of the wooden structure.

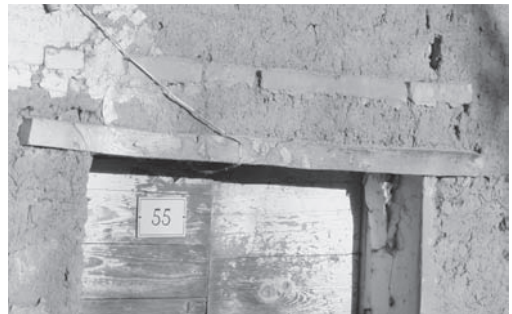
Figure 4. Moscufo, rural building in Contrada Colle di Giogo: horizontal rows of baked bricks.

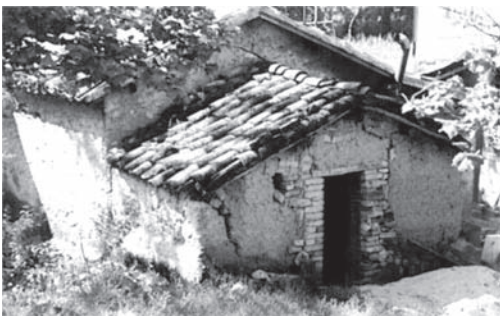
Figure 5. Manoppello, rural building in Locality La Fornace: door reinforced with baked bricks.

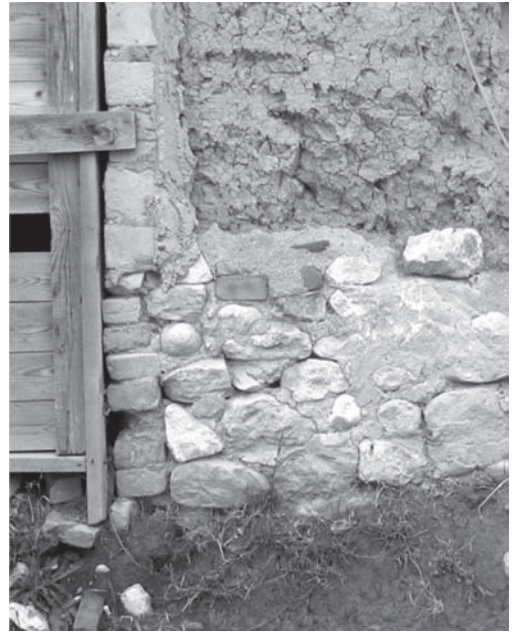
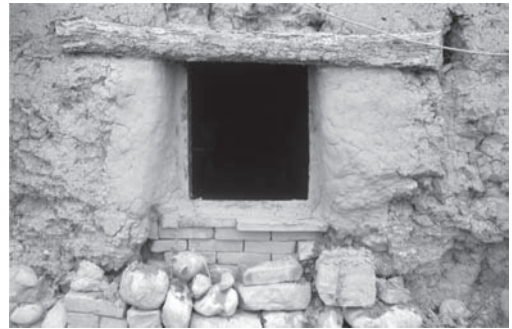
Figure 6. Casalincontrada, rural building; basement created using more resistant materials.

Figure 7. Casalincontrada, rural building; basement created using more resistant materials.

The great deal of these structures in this area show that the presence of the basement allows a better conservation of such a structure along the time (Graham Mchenry 1984). In some buildings the basement is very high and reaches the shutter of the first floor: they belong to the mixed technique group because of the use of the cob doesn't point up all the structure (Figs. 6 and 7).

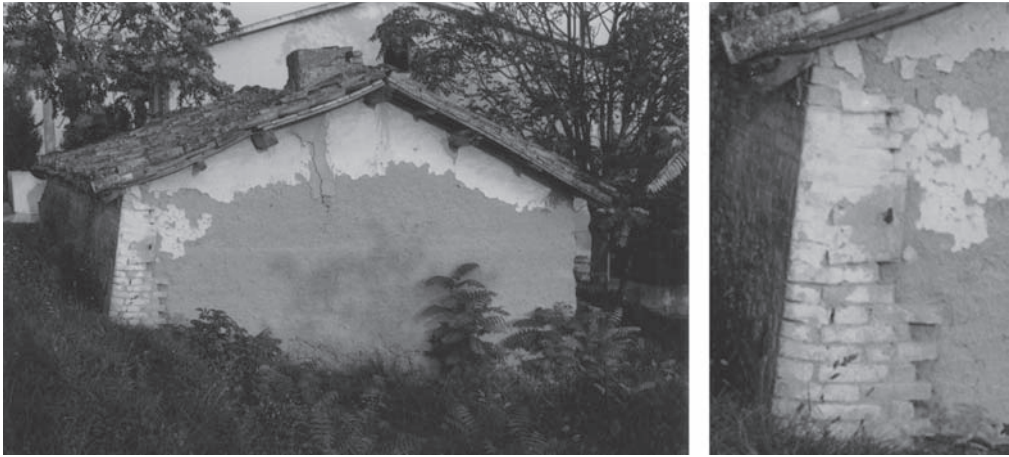
Figure 9. Casalincontrada, rural building; surface covered with a brick wall.

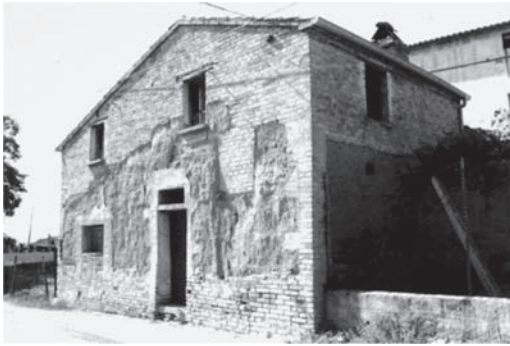
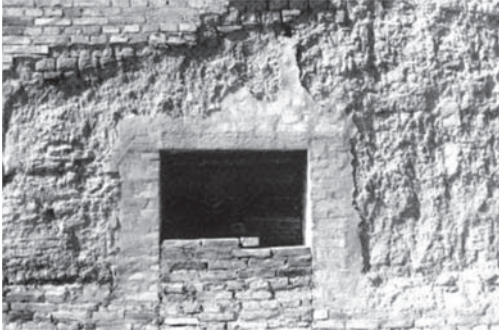
Figure 10. San Omero, building in Locality Case Alte: the original earthen building is increased by a brick raising.

Figure 11. San Omero, building in Locality Case Alte: the original earthen building is increased by a brick raising.

Near Teramo [San Omero, Case Alte] there is a two-storey building, with four rooms and an internal stairway; the original building increased by a brick raising (Figs. 10 and 11).

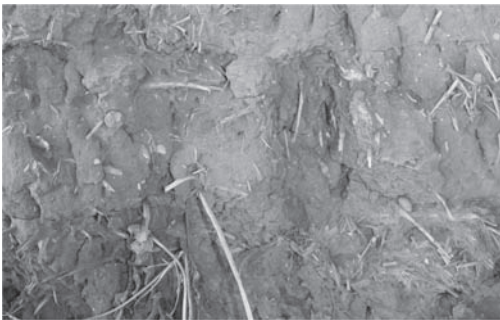
Figure 3. Sample of cob (Pastor, 2012).

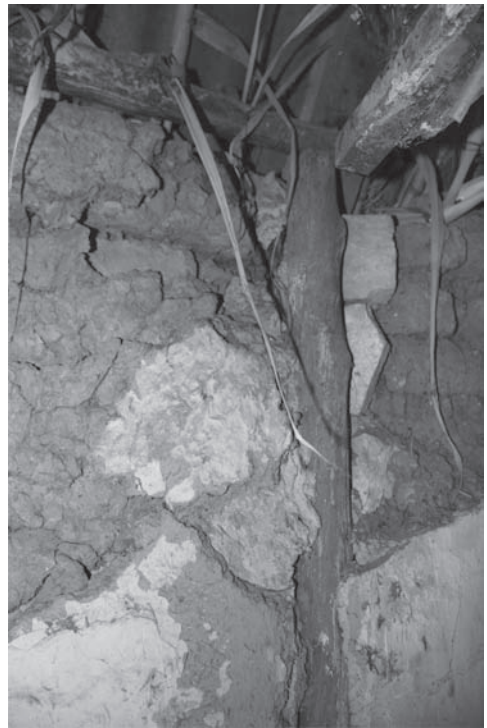
The resistant walls built with adobes are reinforced sometimes with mulberry tree logs stuck into the ground and embedded in the wall (Fig. 4), they support the roof trusses (Guarner 1957, 18).

Figure 4. View of a wall reinforced with logs (Pastor, 2012).

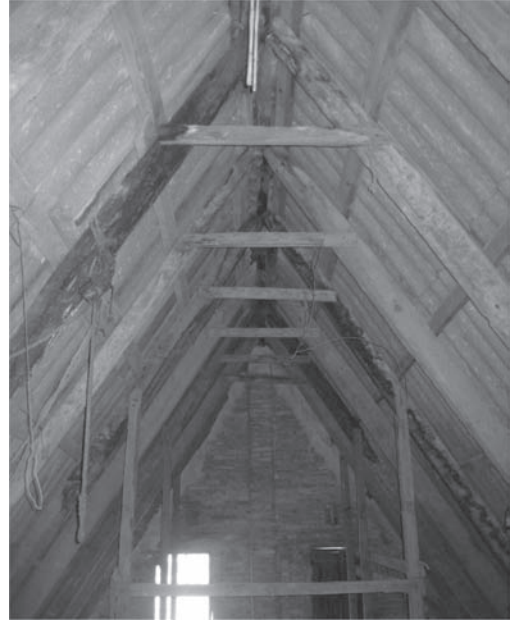
Figure 6. Interior of the *andana* (Pastor, 2011).

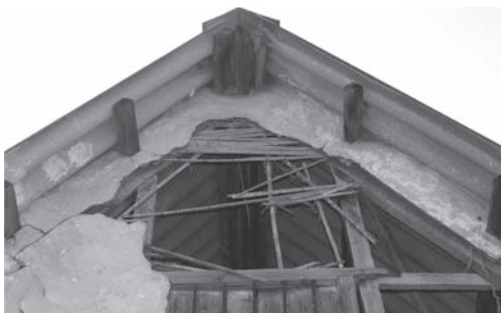
The upper part of the front and rear façades operates as an enclosure. It is built with reed mat covered on the outside with clay and fastened to three studs which end in the roof structure. In order to provide light and ventilation to the interior space some narrow holes are made in this enclosure (Fig. 5).

Figure 5. Upper part of the façade made of reed mat (Pastor, 2011).

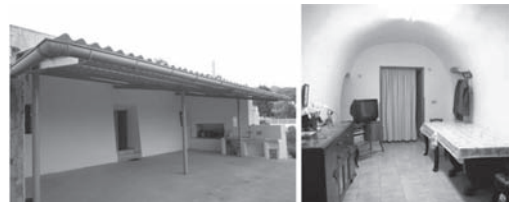
Figure 3. Outside and inside view of an excavated house in the CAVE typology. Images of the author.

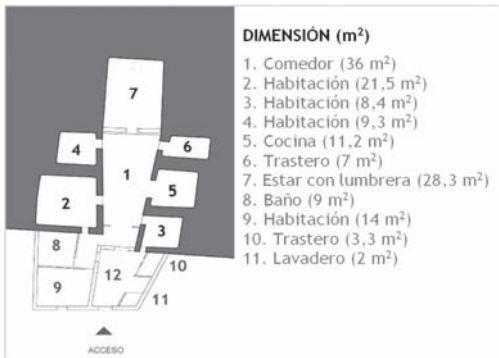
Figure 6. Main floor of an excavated house in the HOUSE + CAVE typology. Image of the author.

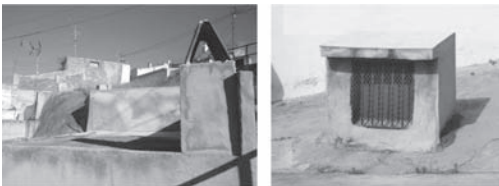
Figure 9. Left image. General view of a traditional chimney. Right image. General view of a traditional “lumbrera”. Images of the author.

It is approximately 1.5 m high and it is usually covered with flat tiles; it has commonly small windows protected by wire mesh on both sides that allow the air exchange and the regulation of temperature and humidity within the cave.

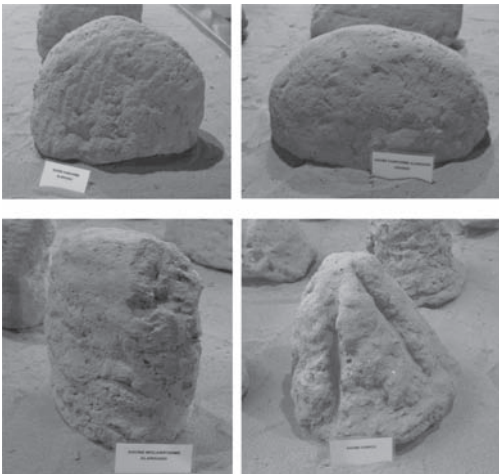
Figure 2. Examples of “molar” shaped adobes, “loaf” shaped adobes, prismatic or conical adobes. Museo Antonini, Nazca. (Authors: Cristini & Ruiz Checa).

With regards to the lumps, these, along with the adobes with a prismatic shape, are typical of the Ventarrón-Collud Civilization (Aprox. 5000–1800 b.C.). Their dimensions change substantially from one region to another, but in all cases they are characterized by dimensions which are greater than the standards found in European archaeological sites.

Thus it is possible to observe the presence of modules more than 50 cm long, and almost 20 cm high. These pieces are manufactured in response to the use of archaic patterns and the easy molded manual process. It’s interesting to highlight that on some models the producers’ marks are visible, like trading stamps. These pieces most likely correspond to different production workshops, as has been proven in adobe studied in Northern provinces (such as La Libertad/Trujillo). Adobe is also the main raw material found in the archeological sites surrounding Lima. In this case the bonding is characterized by header/stretcher bonds or *librilla* bonds (a soldier brickwork with a few centimeters of looseness between the pieces-Fig. 3), forming sloping walls, built using a process similar to a basic trench system (Cardenas Martín 1998).

Other, perhaps less elaborate pieces are made in loaf, molar and conical shapes. These can be found in the more recent Chimú, Moche or Nazca civilizations. In this case, the trapezoidal section of the building constructive elements responds even more specifically to earthquake movements.

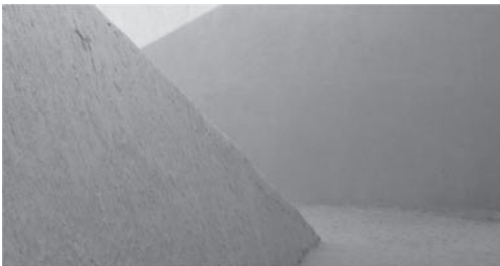
Figure 5. Example of sloping wall, in *Huaca Arcoiris* archaeological site, *Trujillo* Province. (Authors: Cristini & Ruiz Checa).

Whether the basis of these foundations are large ashlar masonries bonded with by mortar (Andes Mountain System/ Sacred valley-Samanez Argumedo 1983) or adobe in its simplest form (desert or coastal regions), they always follow the same design. Frequently the bases of the walls which were built in the Colonial era come from older sloped Pre-Columbian foundations, always displaying a certain inclination in terms of the vertical line (Figs. 5–7). The trenches corresponding

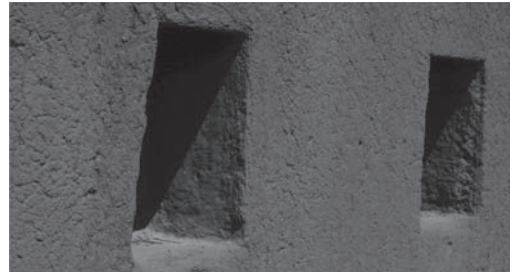
Figure 6. Examples of trapezoidal opening in rammed earth stores; *Huchuy Qosco* archaeological site, *Cusco* Province (Cristini Ruiz Checa).

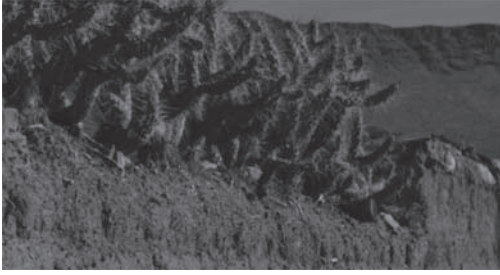
Figure 8. Example of constructive continuity: contemporary earthen architecture in Colca Valley, Arequipa Province. (Authors: Cristini & Ruiz Checa).

There is certain continuity between the Pre-Inca constructive skills and those of the following civilizations (Inca or Viceroyalty). The “Constructive Grammar” does not change drastically through the centuries (Fig. 8).

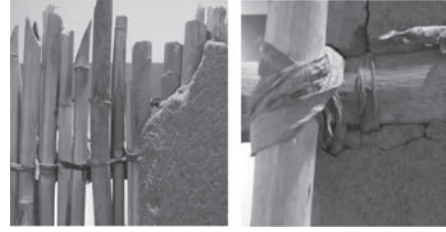
Figure 9. Detail of a *quincha* dividing wall, M. Antonini, Nazca (Authors: Cristini & Ruiz Checa).

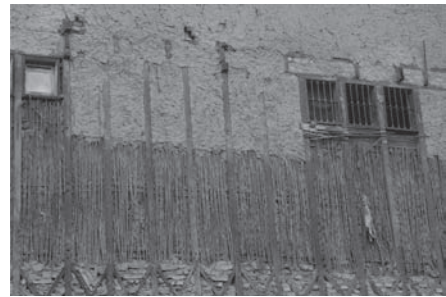
Figure 11. Details of the wicker screens, filled with earth, in a *quincha* wall, Lima (Authors: Cristini & Ruiz Checa).

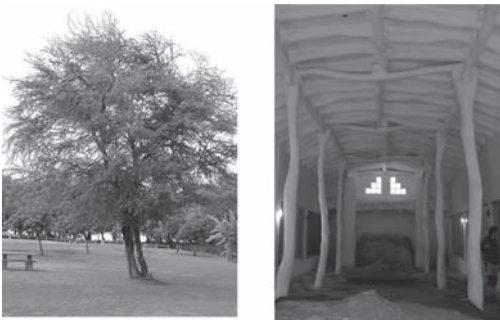
Figure 14. *Guarango* tree and a covering structure, made with this timber. (Authors: Cristini & Ruiz Checa).

Finally, in the Northern area of the Country another autochthonous binomial constructive technique, based on earth and *guarango* timber, can be found (Fig. 14).

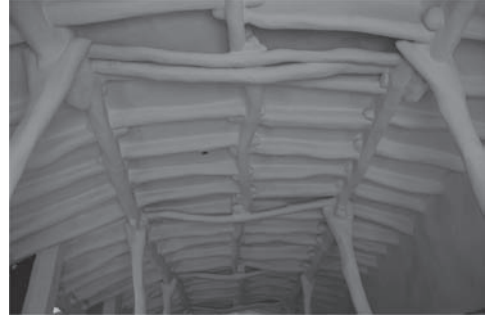
Figure 15. Example of contemporary house in Tucume, Chiclayo Province. A *Guarango* structure, with daubed earth and straw layers, lately whitewashed. (Cristini & Ruiz Checa).

These timber trunks combined with earth can be found in vertical structures (posts or pillars, Fig. 15) or in horizontal systems (ceilings or covers), based on daubed earth and straw layers, extended over the wood surface and subsequently whitewashed.

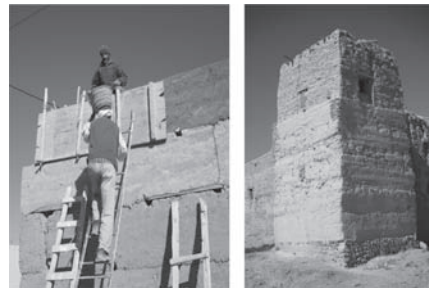
The rammed earth walls of the Outat Valley have variable dimensions, ranging from 0.45 to 0.90 m.

Figure 6. Left: foundations, rammed earth wall and adobe. Right: executing the rammed earth wall.

in thickness, to 0.825 m in height, with a variable length of 1.50 to 2.05 m.

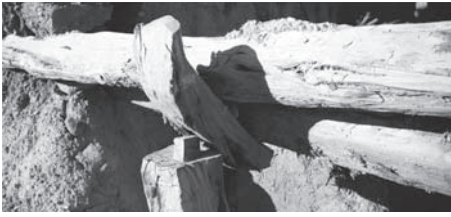
Figure 7. Column, capital and beam.

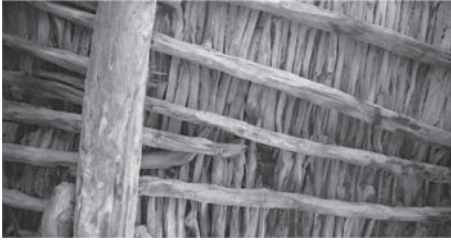
Joists, approximately 10 cm in diameter, appear with a maximum spacing of 40 cm. The space between them is covered with slabs or wood branches of varying lengths. Above them a layer of esparto is placed, locked or not, which makes an insulating layer and prevents the loss of lands of the upper layer. This last layer is put in place while still damp, having an average thickness of 20 cm after its compaction.

Figure 8. Bottom view of the floor.

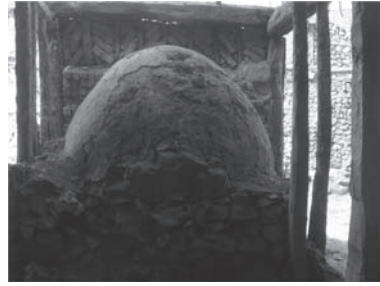
Figura 1. Cedillo de la Torre (Segovia), horno de adobe semiesférico.

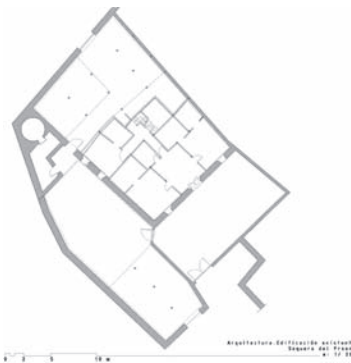
La edificación se distribuye a través de un pasillo central que da acceso a distintas dependencias de servicio situadas a derecha e izquierda del mismo (cocina, despensa, secadera, escalera que conduce al sobrado...) y que comunica el acceso del edificio con el fondo de la edificación, donde suelen ubicarse las cuadras.

Figura 3. Planta de vivienda, Sequera de Fresno (Segovia).

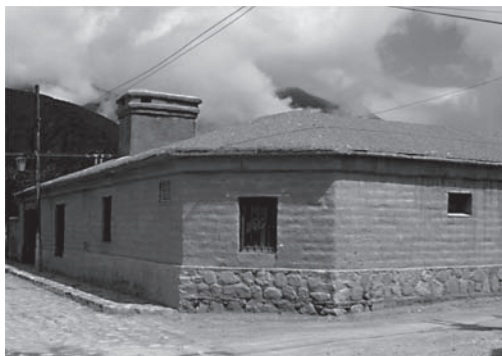
Figura 1. Vivienda en el poblado de Tumbaya. Jujuy.

La tierra también es utilizada en otros componentes constructivos de la mampostería. El cimientado y el sobrecimiento se materializa con piedra y mortero de barro y, dependiendo de la región y de su emplazamiento, sea en el poblado o en el campo, las construcciones populares pueden o no presentar sobrecimiento o llevar un zócalo, con tomado de junta con barro o cal y cemento (Fig. 1).

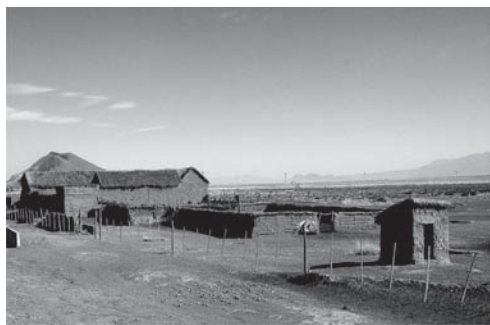
Figura 2. Cerco en tapial, la puna de Jujuy.

El tapial, técnica conocida también como tierra apisonada o tierra comprimida, no fue utilizada en la construcción de edificios. Se utilizó tanto en la puna, quebrada y puna como cerco divisorio, para delimitar terrenos o cerrar los conjuntos residenciales del hábitat rural, como es común observar en la puna (Fig. 2).

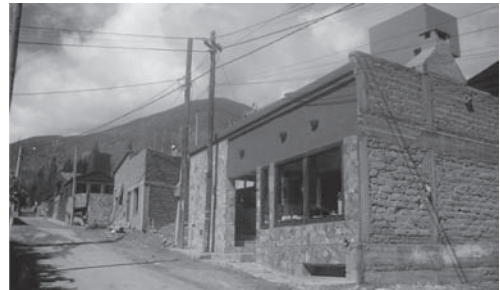
Figura 7. La nueva construcción con estructura de hormigón armado.

La reglamentación de estructura sismo resistente (encadenado de columnas y vigas de hormigón armado) exigidas por las municipalidades de toda la región para las edificaciones actuales, ha contribuido a que el adobe sea utilizado y se suponga tiene el mismo comportamiento al de un ladrillo cerámico. (Fig. 7) Viviendas, locales comerciales y hoteles, se construyen con grandes aberturas, con superficies vidriadas que permitan visuales; el muro de adobe cumple sólo la función de cierre y con el predominio de vacíos sobre llenos, la capacidad térmica que caracteriza a la tierra pierde todo sentido. Volúmenes de dos y tres niveles con ventanales, planos de techos en voladizos, luces superiores a 5 m entre apoyo, marcan indiscutiblemente la complementariedad de la tierra como material de construcción en las nuevas edificaciones.

En obra privada, la vivienda del poblador, que en la mayoría de los casos es autoconstrucción, la estructura sismo resistente no siempre está presente; en algunas resoluciones sólo se construye una viga solera o collar sobre la que apoyará la estructura del techo. En la vivienda de veraneo, barrio de viviendas del estado y obras de servicios: bares, restaurantes, hoteles, en la cual puede participar un profesional de la construcción, las edificaciones son con estructura de hormigón y adobe o bloques de hormigón para cerramiento. (Fig. 7).

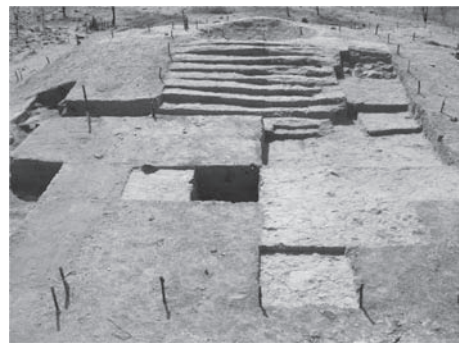
Figure 2. View of the Altar Mayor (High Altar) of the church. UPM-UDEP.

The use of this building as a church has been confirmed thanks to the discovery of a wide Altar Mayor (High Altar) that appeared at the eastern end. The access was through an elegant stairway of seven rammed earth steps covered with lime mortar (Fig. 2). A differentiated space has been documented next to this structure at the back of the altar. This space could have been used as a sacristy. Another high mound located at the south western end of the old temple could have been the base of a *espadaña* or a belfry. The general typology of this temple recalls the previously studied Túcume Viejo church (Vela Cossio 2007). Similar to that church, it might have been organized in three aisles separated by timber studs supporting a wooden roof, though in the interior of the old temple we have only found traces of this last structure and none of the studs. At the same time, several burials with liturgical orientation were exhumed in the interior of the nave during the excavations.

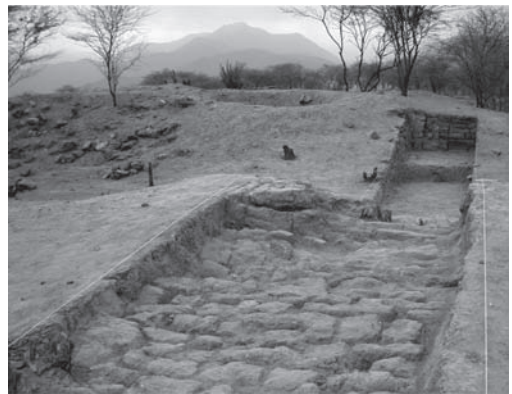
Figure 3. Excavation detail where the remains of the church ruined adobe walls can be seen. UPM-UDEP.

It has also been archaeologically stated that the building collapsed towards its interior. In fact, the ruined walls present a surprisingly good conservation status and this has provided enough data to confirm that the walls are made of adobe with earth mortar enriched with some lime bonds (Fig. 3). The footing of these walls was protected by an irregular masonry base, four Castilian feet high and similar section (approximately 1.10 m). This masonry was made of quartzite stone from the hills nearby. The stones have no cutting traces, but they have been carefully arranged to constitute faced walls. Attending to their irregular dimensions, the bigger ones have been used to create the exterior faces of the walls which were filled up with smaller ones and well-compacted mortar. These footings form the foundations of the walls, but rise considerably above the street level. Similar configurations can be currently found in the traditional building techniques used in the same region.

collapsed. The adobe bricks are parallelepiped prisms of variable dimensions, ranging from 0.46 m × 0.22 m × 0.12 m to 0.36 m × 0.18 m × 0.10 m (Rodríguez Rodríguez & Campos Napán 2010). However, these variations could have been a consequence of their deformation after its ruin. Traces of its primitive exterior coating have been found, consisting on a simple layer of lime mortar. Analogous walls, with the same masonry footings and identical dimensions of three or four Castilian feet wide (approximately 0.90 m or 1.20 m), can be identified on the surface of a wide area of the site. It can be said that it is the most common constructive typology in most documented structures, but especially among those clearly related to the Colonial urban layout.

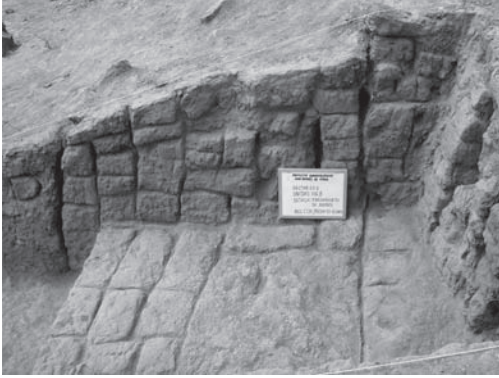
Figure 4. Particular of the adobe structures identified as traditional pre-Hispanic platforms. UPM-UDEP.

the 1st and 7th centuries (Alva 2004: 183–184; Sondeguer 1998: 242). Its singular shape makes them easily identifiable, as they are made up, not by continuous horizontal courses, but by a series of adobe square-section pillars attached to each other. This type of discontinuous structure, showing constructive joints periodically arranged, has been analyzed by many authors as a defensive mechanism from the important earthquakes which have frequently affected the country. Once more, no evidences have been found to confirm that these structures were built prior to the Spanish foundation of the city, but this fact will be clarified in future archaeological campaigns. These works will also help in estimating the chronology, extension and frequency of use of this kind of pre-Hispanic elements as a base for the buildings forming the urban layout of old San Miguel de Piura.

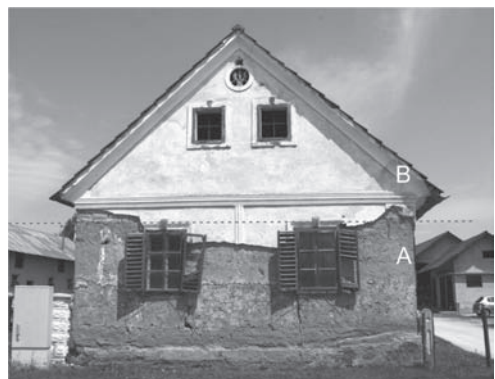
Figure 1. A house in the village of Bukovci: walling construction of rammed earth is exposed. A—wall made of rammed earth; B—gable end wall made of bricks.

Gable end is constructed with bricks, the solution is following the idea of economics in architecture. Bottom part is made of thick walls of rammed earth (approx. 45–50 cm of thickness); upper part consists of bricks (single or double layered bricks of 6/12/24 cm) and wooden roof construction (see Figs. 1 and 2). The upper part (area B, C and D in

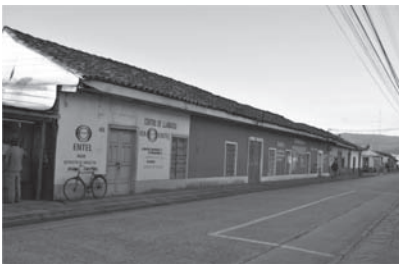
Figure 1. Cobquecura's main street view (Jorquera N., 2011).

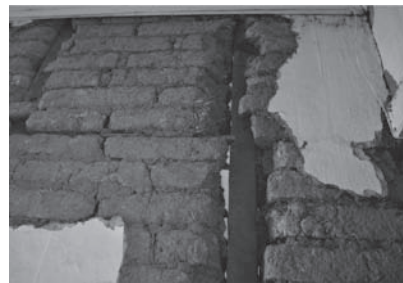
Figure 4. Adobe masonry “confined” inside a wooden structure (Jorquera N., 2011).

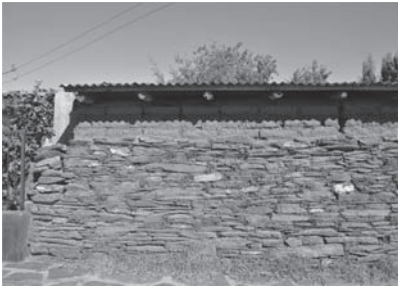
Figure 5. The slate stone base (Jorquera N., 2011).

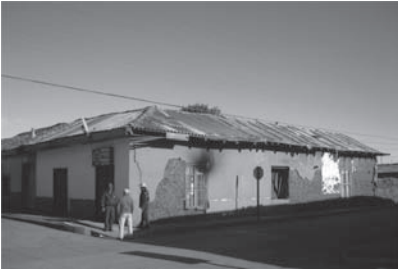
Figure 6. Damages example in Cobquecura (Baglioni E., 2011).

- big angle cracks or even the whole separation of adobe walls in the angles, due to deficient wall toothing;
- separation of perpendicular walls, in the union of different techniques (adobe masonry, confined adobe masonry, wooden frame fill with earthen mortar);

- roof collapse due to the bad state of conservation of the wooden beams, that reduces the structural capacity of bearing the overload of the tiles cover and the earthen isolation layer;
- slate stone wall collapse, because of original construction defects (walls set without mortar and without toothing or ties) that make the wall not to be able to resist the horizontal seismic thrust.

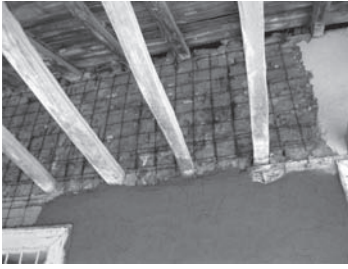
The structural reinforcement technique used consist in the application of a metal greed in both facade of the same wall, joined with metal connector insert into the adobe masonries, with a distance between them similar to the wall thickness (Fig. 7). These metal greed are superimpose to guaranties the union between them, and are applied in all perimeter of the "restoration" area. This reinforcement technique was created in the old legislative context, where just industrial (and certified) materials were allowed.

Figure 7. The structural reinforcement technique used by the Chilean architecture studios Arias Arquitectos and Marcelo Cortes (Baglioni E., 2011).

The constructions process begin with the removing of all the wall plasters, so if the masonries present structural cracks, they could be closed with a earthen plaster (of an earth with similar

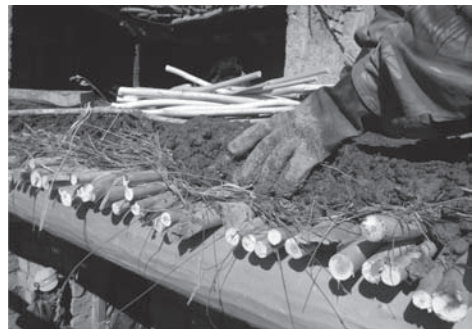
Figure 1. Traditional realization of the roof.

The vernacular flat roofs have a first structure, generally consisting of round section poplar trunks, which support a second structure of wooden boards, small branches, or cut willow sticks (Fig. 1). Successive layers of earth and *markallak* are spread on that second structure, in order to form a stratum of insulation and surface protection.

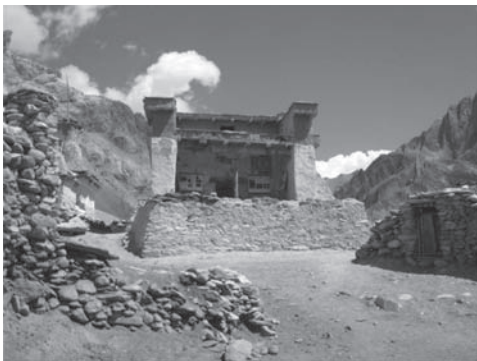
At the time of conservation work on Kanji temple it was possible to observe certain phenomena strictly connected to the degradation induced by atmospheric agents on the earthen structures of the village and particularly on the small temple (Fig. 2).

Figure 2. Tsuglag-Khang, the small Buddhist private temple in Kanji.

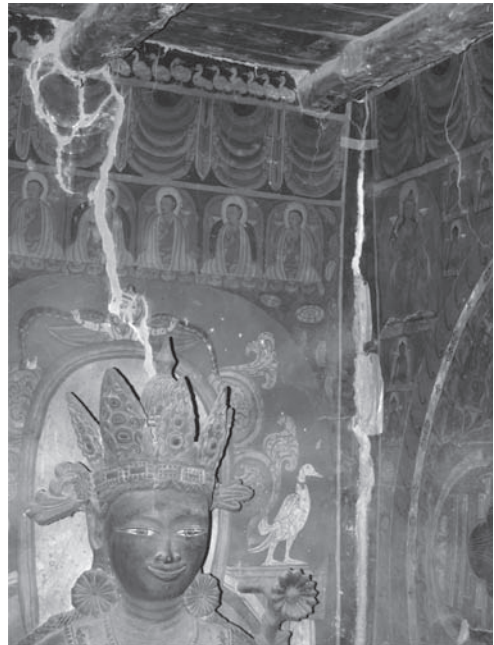
Figure 3. Degrading action on the earthen wall decorations caused by infiltrations of water inside the temple.

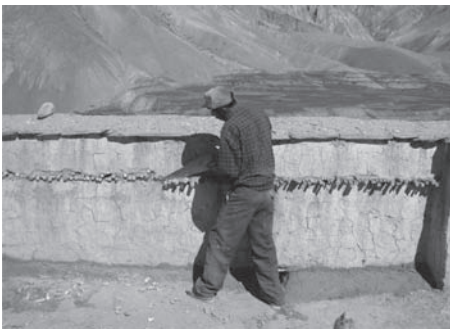
Figure 4. Cutting the protruding wooden elements along the perimeter wall.

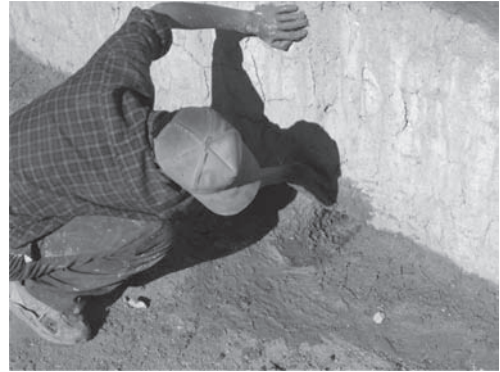
Figure 6. Creation of the improved joint using *markallak* mixture and finely chopped straw with stone joint cover.

Further we realized an “improved roof plane-wall joint”, preparing a dedicated mixture of *markallak*, containing finely chopped straw, able to resist the phenomena of contraction-expansion connected to the frequent freeze/thaw cycles. On top of the layer of *markallak*, another layer of flat stones was created. The final phase of this interventions consisted in covering all the surfaces of the vertical parapets and the flat roof with earthen mortar (Figs. 5 and 6). Another intervention was carried out in order to protect the upper edge of the vertical earthen walls. It consisted in realizing a sacrificial layer for the top of the roof-terrace parapets, adding flat stone slivers and another layer made by earth with a curved section (Fig. 7).

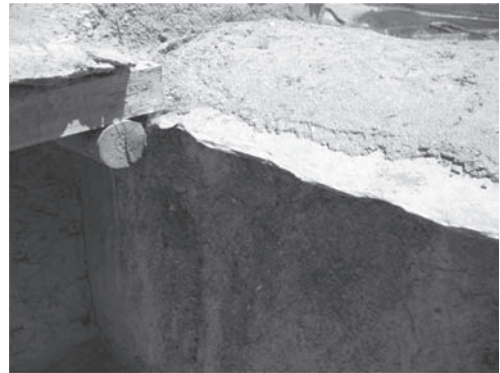
Figure 7. Creation of the protective stone cap.

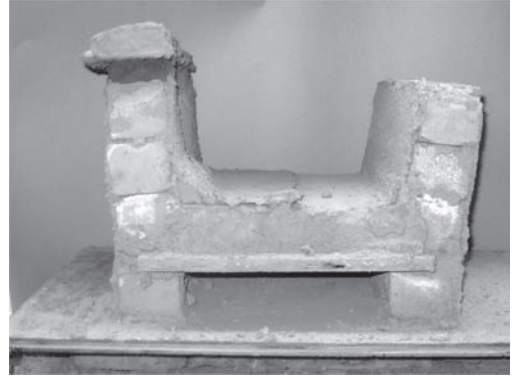
Figure 9. The reduced scale model and the sacrificial layer on the top of the parapets.

On the roof surface of the reduced scale model of the temple was spread a mixture of *markallak* and finely chopped straw in order to reproduce real conditions (Figs. 8 and 9).

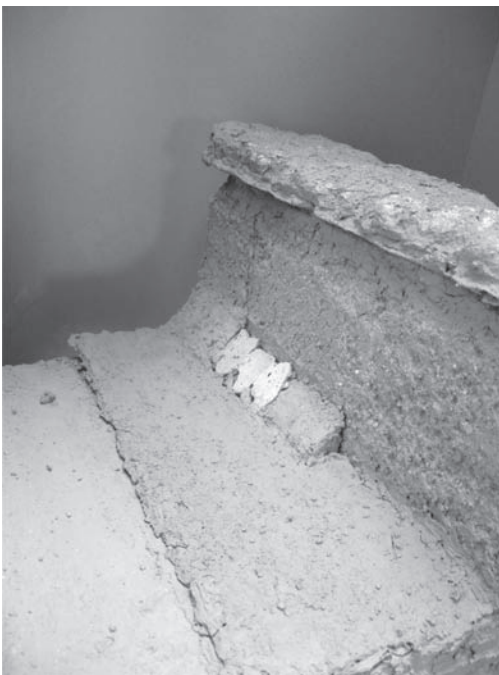
Figure 8. The reduced scale model of the private temple.

The model was then submitted to a set of five freeze/thaw cycles ($-20^{\circ}/+5^{\circ}$) by means of insertion in a dedicated freezer for frost tests. The commonly used test of freezing and thawing at the temperatures -20°C and $+20^{\circ}\text{C}$, was adapted to the reality to make the test more "appropriate" to understand of the behavior of the earthen structures during the late winter-early spring season in Ladakh, when the

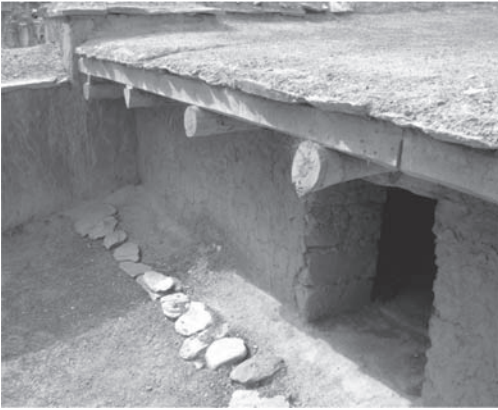
For this reason, the team decided to build a second protective roof (Fig. 10). This choice certainly limits the possibility of obtaining “authenticity of form” related to traditional conservation interventions.

Figure 10. The second roof above the old one.

On the other hand, this intervention presents a character of “reversibility”, providing additional protection. This second roof, even in the absence of ordinary maintenance, can guarantee complete safeguarding of the structure.

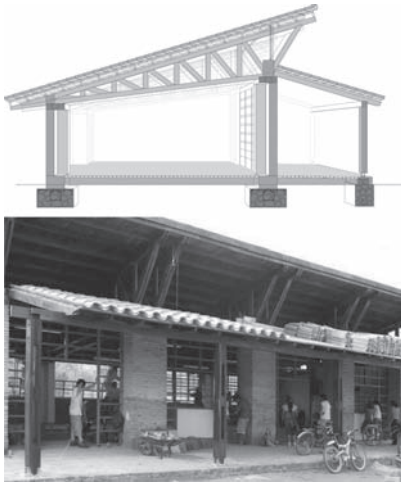
Solution is based on the fired brick pilasters placement of 1×0.60 m separated 4 m between axes. This pilaster has U shape and supports two large Tajibo wood trusses. To ensure continuous support on the brick, three perpendicular wood lintels are placed into the arms of the U, where trusses rest.

Apart from collaborating in the load distribution, the U shape gives the pilaster some stability against compression buckling or the possible bending moment generated by the deck.

Figure 6. Fired brick pilasters. Second module of the Facultad Integral Chiquitana, USF, San Ignacio de V. Bolivia. (Picture: USF).

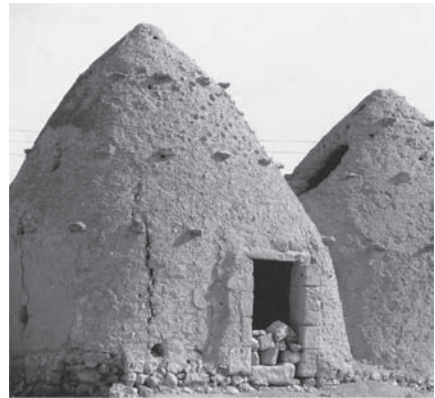
Figure 4. Domes in a poor state of conservation (autor: Dipasquale, L. 2009).

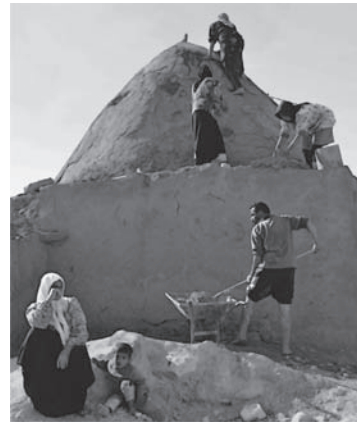
Practices such as the remaking of the plaster coating every year after the rainy season (Fig. 5),

Figure 5. Traditional practice of plaster maintenance (autor: Lupi, L. 2009).

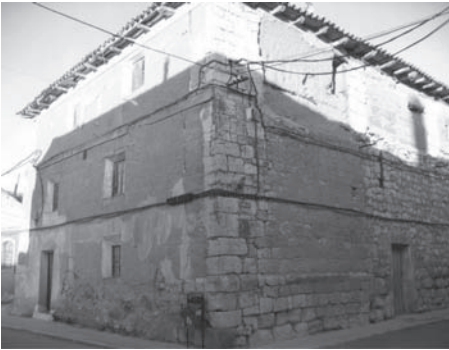
El segundo cuerpo se adosa al original y en él está instalada la vivienda antigua (Fig. 2). En la calle lateral y en la esquina está ejecutada con sillares de mejor factura, pero el frente, la entrada principal es más confusa, alternándose con zonas de tapial revocado al exterior y con huecos muy pequeños. Por encima de la puerta una grieta muy pequeña pero extrañamente curvilínea delata la posible presencia de un arco. El interior es lúgubre, muy húmedo y con estancias de muy poca altura. Por una escalera se accede a las plantas superiores. En la primera planta una grieta parece marcar la traza del arco que se aprecia desde la cuadra, cortado aquí por el forjado.

Figura 2. Fachada a la entrada principal. (Autor: M. Macho).

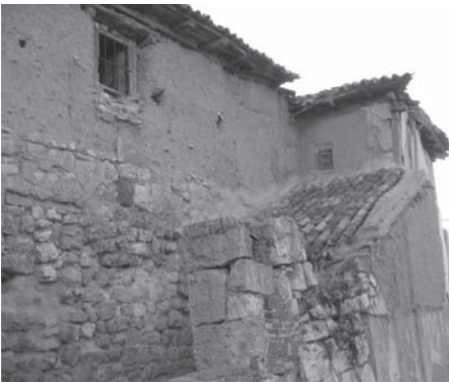
Bajo la escalera en la planta baja se sitúa la entrada de la cocina, en un lugar de paso de acceso al patio lateral de la casa (Fig. 3). La cocina se sitúa en otro cuerpo añadido a la construcción primitiva,

Figura 3. Fachada lateral al patio. (Autor: M. Macho).

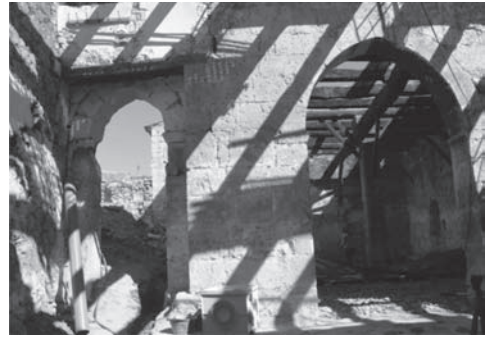
Figura 6. Arcos de acceso. (Autor: M. Macho).

Al eliminar la vivienda delantera y las construcciones de la cuadra aparece un arco gótico de 3 m. de altura que da acceso al recinto prácticamente rectangular de la fortaleza. El arco está intacto (Fig. 6) y tiene una marca de cantero que coincide con las que aparecen en los sillares de los arranques de la parte más baja. Estas marcas de cantería coinciden con la Abadía de Husillos, muy cercana, con lo que podemos datar la construcción de la torre en el s. X periodo en el que se produce un asentamiento de población en esta zona cercana a la Iglesia.

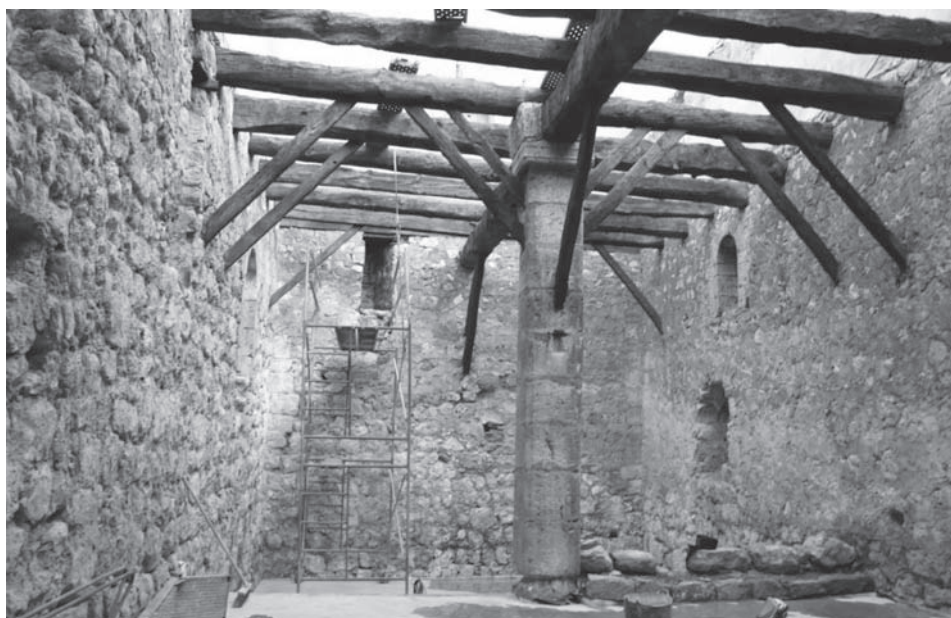
Figura 8. Interior de la fortaleza. (Autor: M. Macho).

Posteriormente a la torre se le adosa un muro, que como el pilar del interior son del s.XIV. Este pilar soporta la estructura de madera del forjado de la primera planta que también es la original (Fig. 8). Cercana a la base se encontró el arranque de una columna que podría haber sido el soporte original.

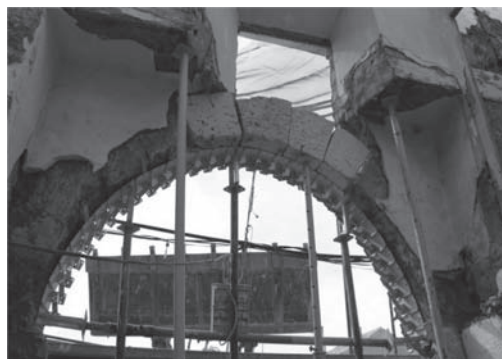
Figura 9. Restauración del arco de entrada. (Autor: P. Díez).

En la planta baja una vez eliminada la parte delantera de vivienda aparece otro arco de tres metros de altura, le faltaba la clave y algunas dovelas, que se reponen para conservarlo (Fig. 9).

Habían sido cortadas para abrir una ventana en la planta primera. Esta fachada está muy dañada, los muros de sillar al exterior en el interior son de tapial y existen grietas entre las hojas.

Probablemente se derrumbó una parte que después se rehizo solamente con tapial. El agua que ha ido entrando aumentó el tamaño de las grietas, se retacan y se traban reponiendo posteriormente los morteros de protección y acabado, se utiliza mortero de cal y las esquinas se cosen con varillas de acero inoxidable de hasta 1 m de longitud.

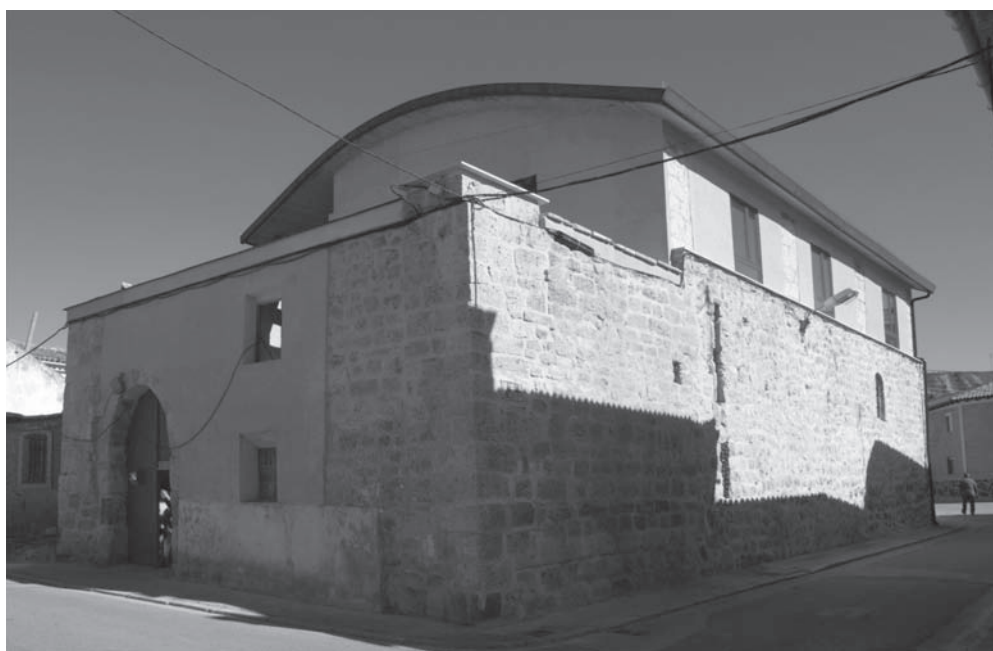
Figura 10. Fachadas exteriores restauradas. (Autor: J. Muñoz).

La solución de la cubierta es un ejercicio de innovación y experimentación, buscando por un lado reducir los costes lo máximo posible y por otro un efecto plástico necesario para solucionar la estética del edificio. Se proyecta una cubierta curva que cubra de una forma asimétrica el interior de la vivienda que se sitúa en la planta de arriba y el patio cubierto donde se sitúa la escalera de acceso. (Figs. 10 and 11).

Está realizada con panel de madera contralaminado de 13 m. de longitud curvados in situ para adaptarse a la forma deseada, el montaje de todo ello ¡2 días! con tres personas. Las prestaciones térmicas de la cubierta se mejoran añadiendo aislamiento térmico (lana de roca) y una lámina impermeable difusora del calor. Por último el material de cobertura es acero corten que se adapta a la curvatura y se pliega para resolver los remates laterales y el canalón.

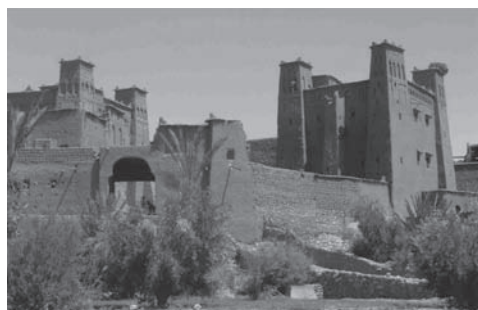
Figura 9. *Ksar Ait Ben Haddou*. Barrio aristocrático. (Pepa Martínez Barranco, 2010).

plantas y el segundo aristocrático formando por diferentes *tighrematin*. Las viviendas del barrio popular son de un tamaño considerable comparadas con las de otros valles. Cuentan con una superficie aproximada de 200 m². En ocasiones poseen patio central. El techo suele ser de cañas apoyadas sobre vigas de álamo. Diferentes callejuelas comunican las diferentes edificaciones.

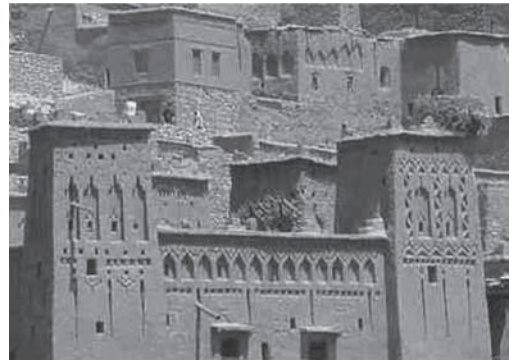
Figura 12. *Ksar Ait Ben Haddou*. Remate *tighremt*. (Pepa Martínez Barranco, 2010).

Las cubiertas se realizan del mismo modo que los forjados pero con una cierta inclinación para la evacuación de las aguas.

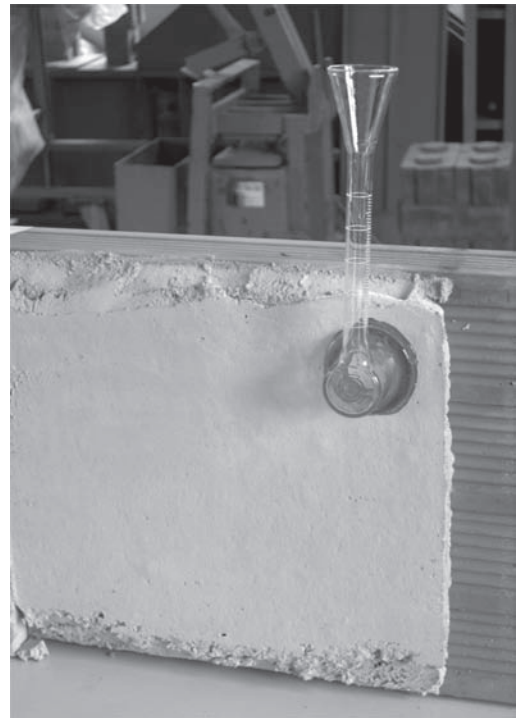
Figure 2. Water capillary absorption tests.

It can be concluded that: (i) the water absorption coefficient increases with the percentage of binder; (ii) there is not a clear or significant influence of the fibers on the capillary absorption coefficient; (iii) the highest results of the water absorption coefficient were observed for the Portland cement binder, when compared to the mortars with the same content of other binders, both with and without fibers.

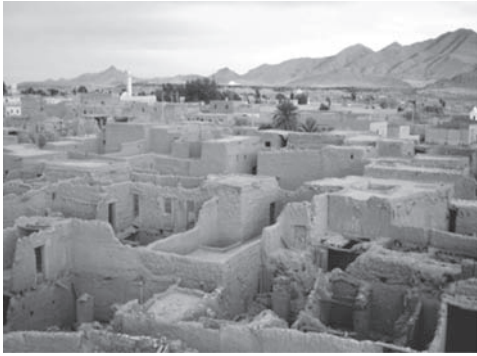
Figure 3. The traditional tissue of earthen architecture, Ksar of Bousemghoune (Mebarki 2009).

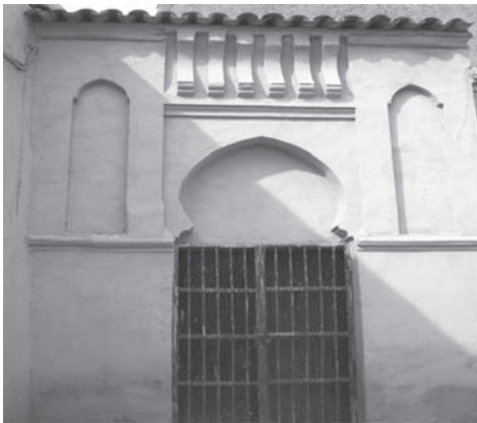
Figure 4. The façade of house with the earthen architecture, Ksar of Tiout (Mebarki 2009).

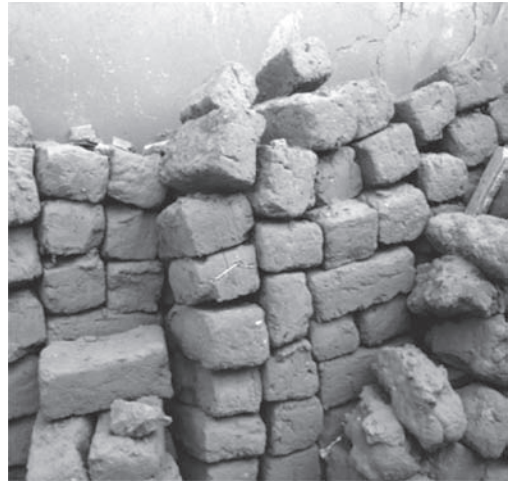
Figure 6. The Adobe materials of construction and restoration, Ksar of *Tiout* (Mebarki 2006).

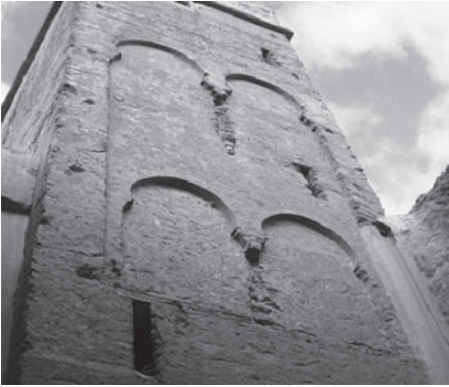
Figure 7. The minaret of restored mosque, Ksar of *Bousemghoune* (Mebarki 2009).

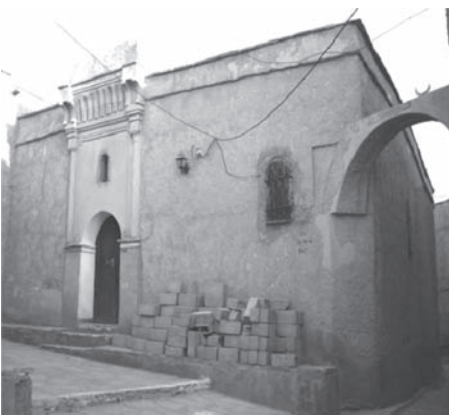
Figure 9. Façade of a restored mosque, Ksar of *Tiout* (Mebarki, 2009).

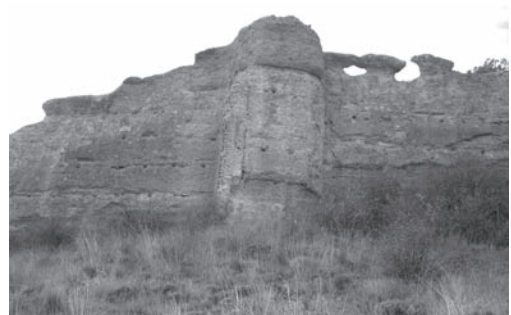
Figura 2. Tramo de muralla erosionado.

Está constituido por lienzos, que tuvieron una altura aproximada de 8 m, de tapia de tierra calcostrada con mortero de cal de espesores variables que oscilan entre 1.00 m y 1.70 m, y con torreones cada 20–25 m, del mismo material con unas dimensiones aproximadas en planta de 3.00 por 3.00 m (Fig. 2). Los muros se coronaban con un paso de ronda y almenas.

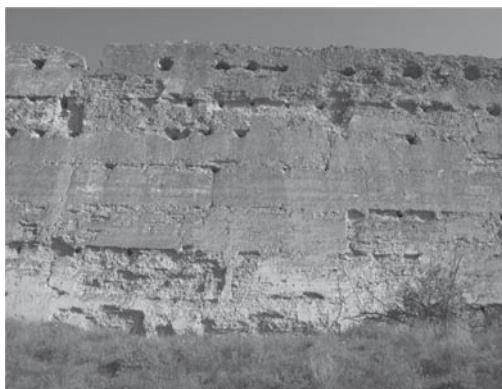
Figura 4. Muro mejor conservado con agujas pasantes.

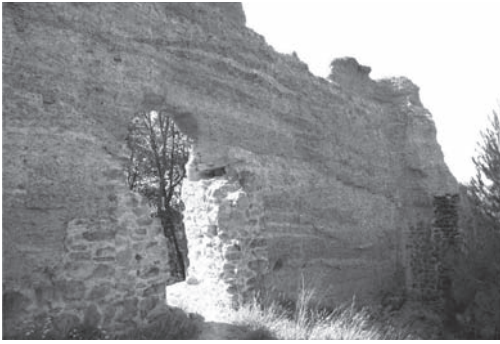
Figura 5. Muro peor conservado con semiaguas.

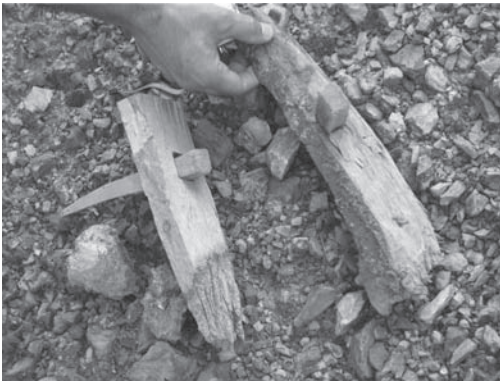
Figura 6. Restos de medias agujas.

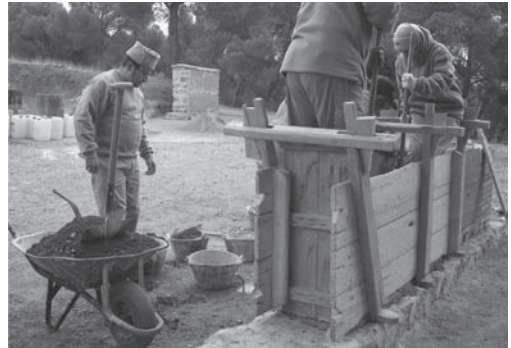
Figura 7. Fabricación de tapia de pequeño espesor.

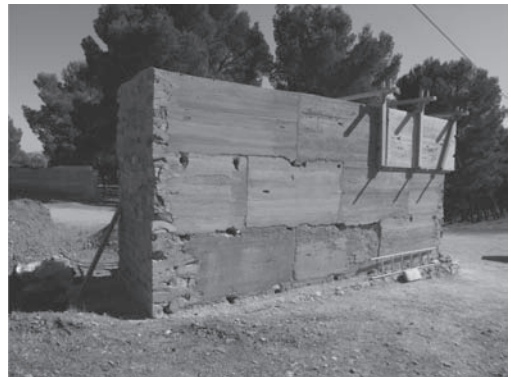
Figura 8. Fabricación de tapia del espesor de la muralla.

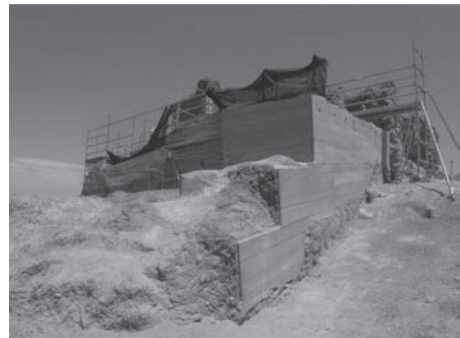
Figura 10. Tapia regularizada con fibras en la calicostra.

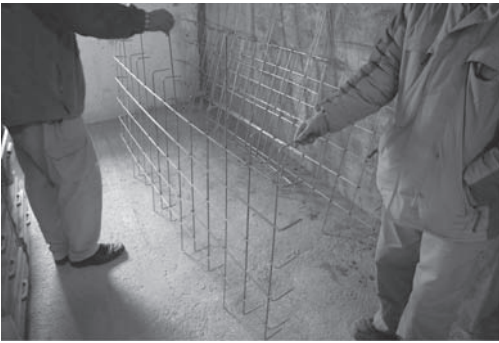
Figura 11. Mallazo de acero inoxidable.

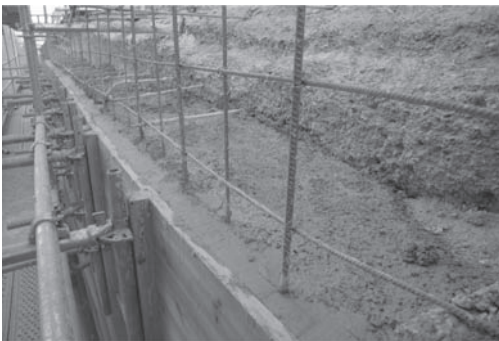
Figura 12. Tapia de cal con mallazo de acero inoxidable.

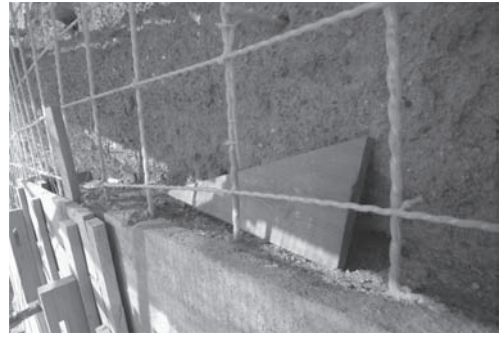
Figura 13. Tapia de cal con mallazo de fibra de vidrio.

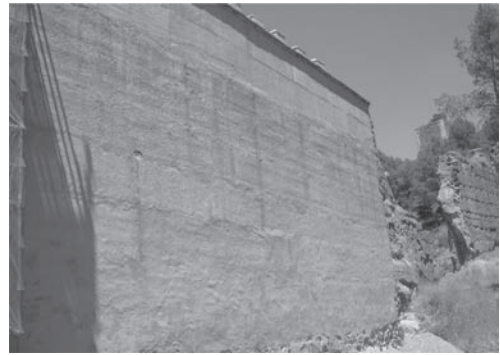
Figura 14. Pruebas cromáticas del hormigón de cal.

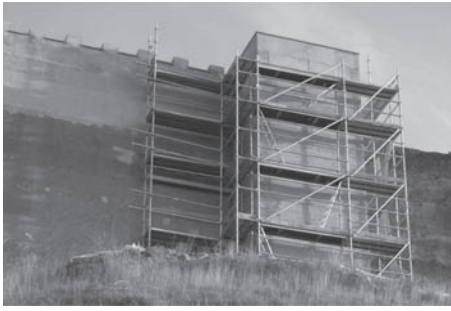
Figura 16. Muro de hormigón de cal con calicostra.

Otra prueba consistió en utilizar el hormigón de cal sin ningún tipo de tratamiento cromático y disponiendo exteriormente una calicostra de mortero de cal semejante a las conservadas. Para ello se hicieron diversas pruebas con distintos tipos de arena para lograr una integración cromática adecuada (Fig. 16).

Esta prueba tiene el valor añadido de que al tener una costra exterior de mortero de cal, su

textura superficial es semejante a la de las calicostras antiguos, y también permite jabelgas posteriores. Su ejecución es más lenta que la anterior.
