Rammed Earth Conservation

C. Mileto, F. Vegas & V. Cristini

PROCEEDINGS OF THE FIRST INTERNATIONAL CONFERENCE ON RAMMED EARTH
CONSERVATION, RESTAPIA 2012, VALENCIA, SPAIN, 21–23 JUNE 2012

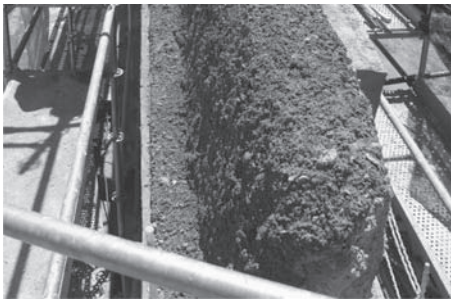
Figura 17. Consolidación como ruina de coronación de muro.

Se realizó mediante el extendido sobre los restos de tapia de tierra saneada de una capa de mortero de cal con fibras de polipropileno y una malla de fibra de vidrio en su interior, y sobre ésta todavía fresca se echó tierra de la tapia ligeramente apisonada y humedecida para adherirla al mortero (Fig. 17). Se trata de un tipo de intervención de rápida ejecución que puede ser adecuada para pequeñas superficies, pero que para intervenciones de mayor entidad requeriría realizar alguna prueba previa de mayor superficie antes de tomar la decisión final.

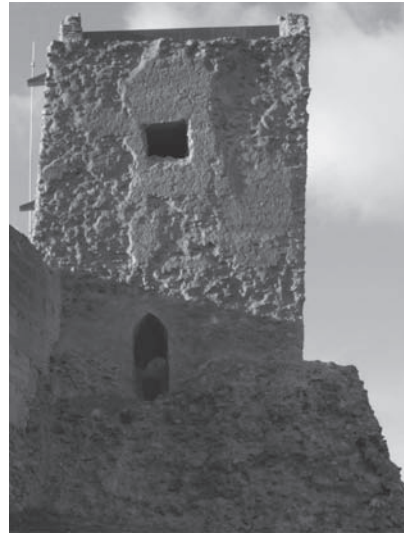
Figura 18. Consolidación de muro de tapia de piedra.

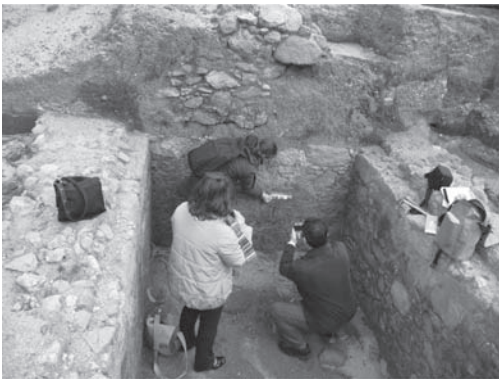
Figure 2. Collecting samples for laboratorial analysis, Forte da Feira, Mafra, 2011 (Ana Catarina Sousa).

In order to confirm soil composition, origin and compaction, a number of soil boring tests were conducted in ramparts and traverses. Preliminary results provide information about the process of restoring and consolidating such structures.

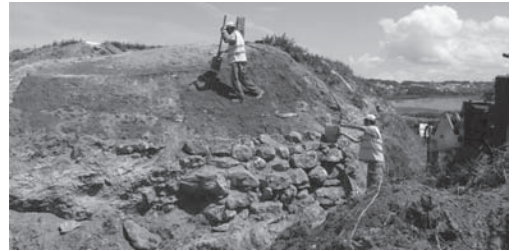
Figure 4. Ramparts: volume repositioning sediment compaction, Forte do Zambujal, Mafra, 2009 (Ana Catarina Sousa).

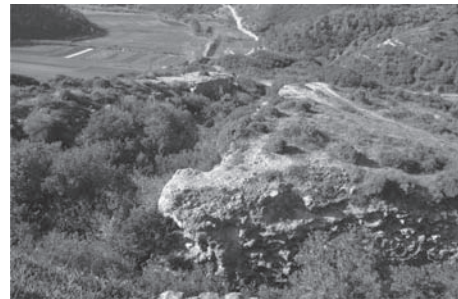
Figure 6. Access to the battery before and after enhancement works, Forte do Zambujal, Mafra, 2008 (Ana Catarina Sousa).

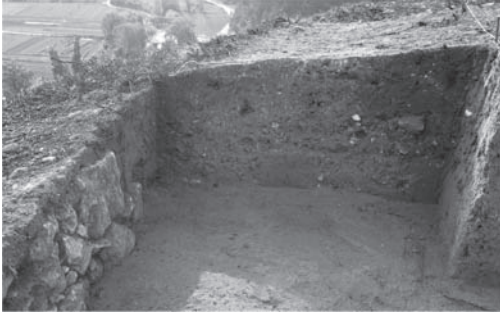
Figure 8. Earthwork cross section (traverse); Forte do Zambujal, Mafra, 2009 (Ana Catarina Sousa).

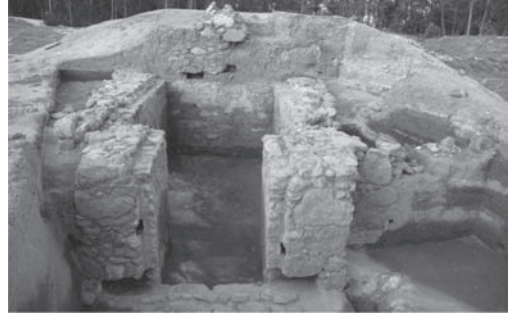
Figure 10. Aspects of the magazine before and during the intervention; Forte da Feira, Mafra, 2008/2011 (Ana Catarina Sousa).

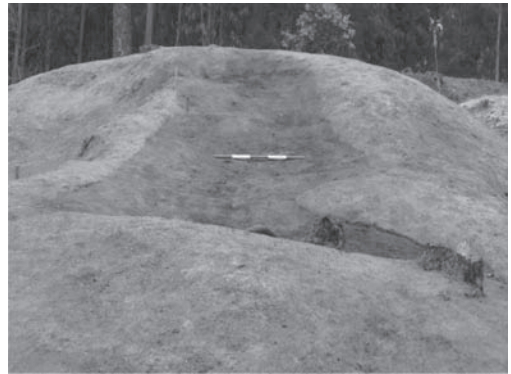
Figure 11. Aspects of the magazine before and during the intervention; Forte da Feira, Mafra, 2008/2011 (Ana Catarina Sousa).

that is accessed by a tunnel. This is one of the most complex structures of the 2nd Line. A scrub vegetation cover extended to 90% of the whole structure thereby affecting its integrity.
