Cave and Karst Systems of the World

Cave Exploration in Slovenia

Discovering Over 350 New Caves During Motorway
Construction on Classical Karst

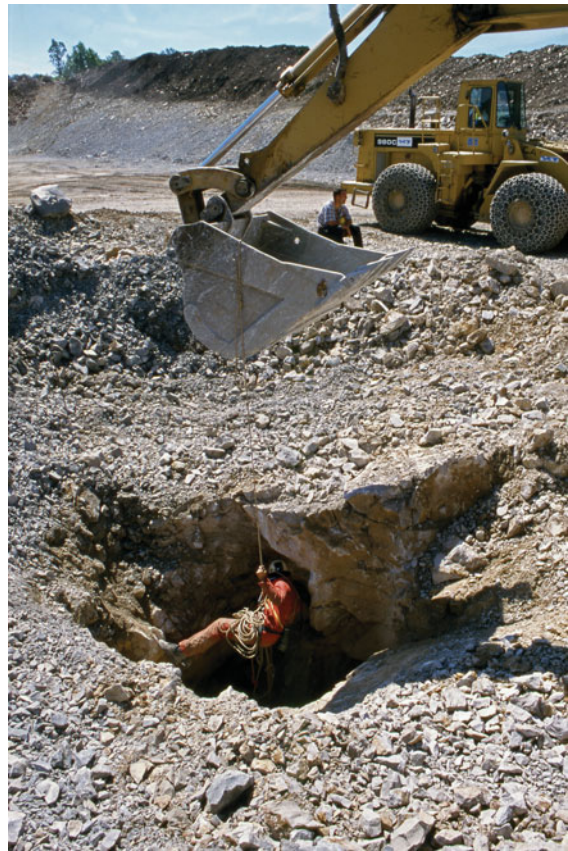
Fig. 1.2 Exploring the cave with a collapsed roof due to the mining during construction of the motorway Klanec–Sermin

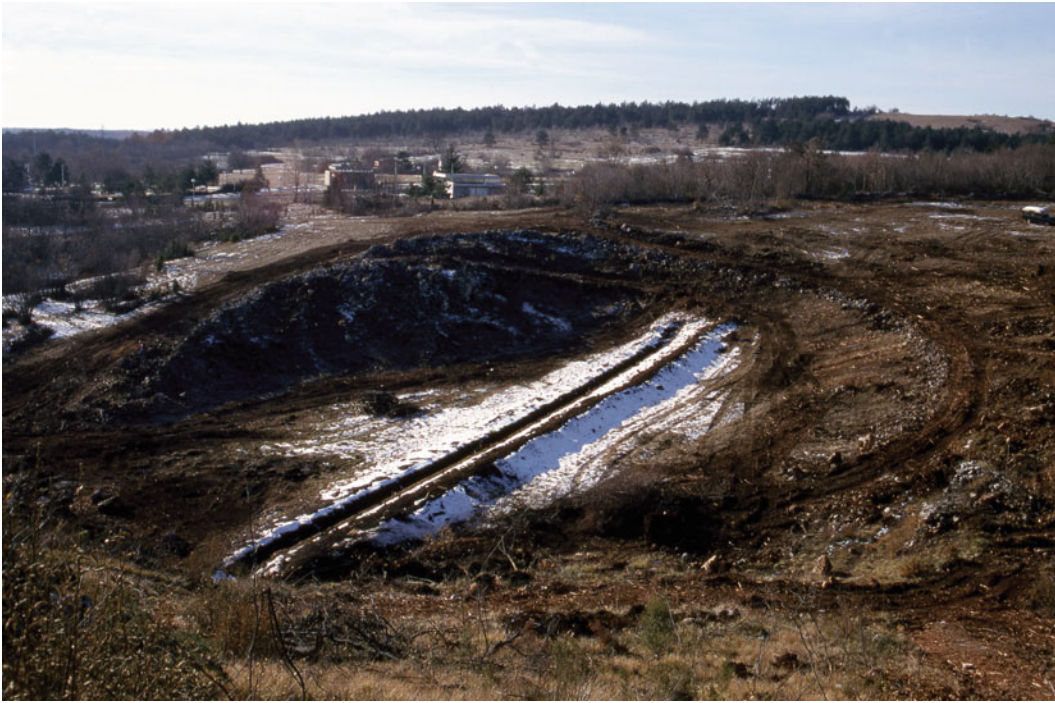
Fig. 1.3 Dolines dissect karst surface

The karst surface is dissected by dolines (Fig. 1.3) and unroofed caves (Fig. 1.4). Today, dolines reflect the way the surface is shaped by precipitation water which percolates vertically through it, passing through the non-flooded part of the aquifer down to the groundwater. Dolines are filled up with soil, some more prominently than others. Doline floors feature shafts and crevices which drain away the water. First, the dolines must be cleared from the soil and next the floors must be reinforced with rocks stacked into arches (Fig. 1.5), since the mouths of shafts are often

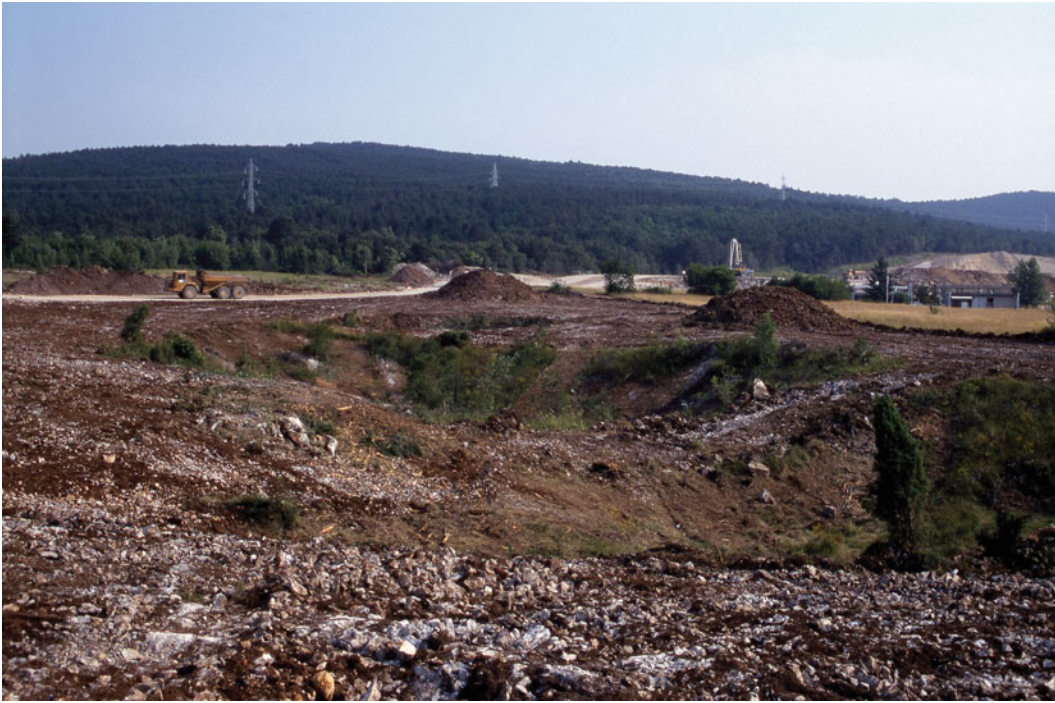
Fig. 1.4 Karst surface dissected by an unroofed cave

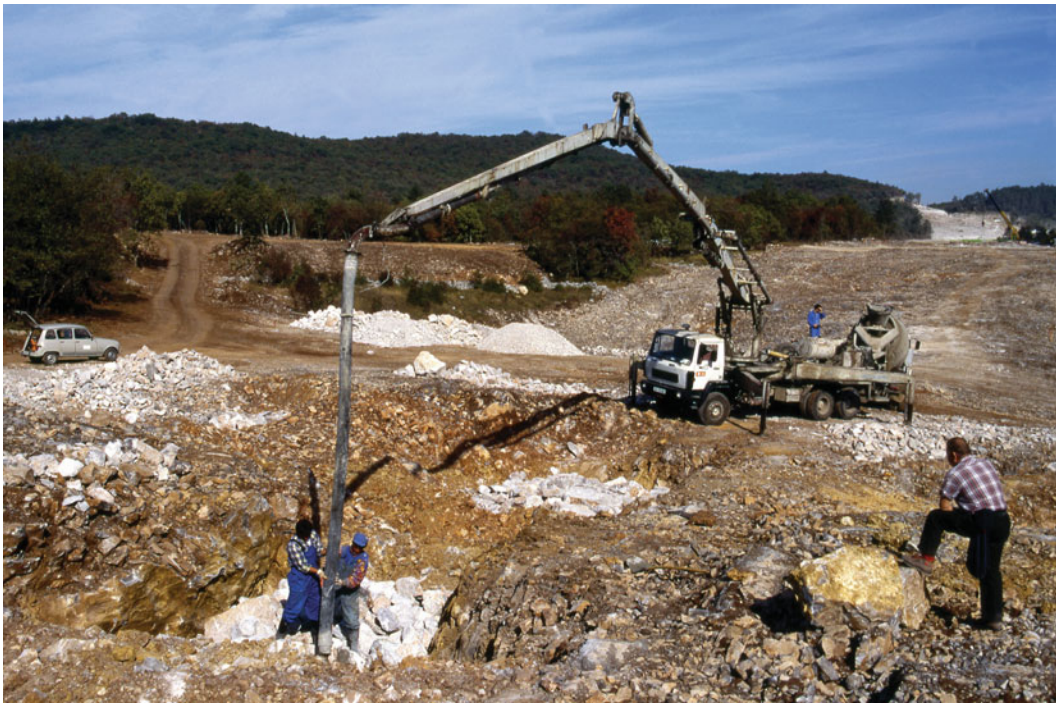
Fig. 1.5 Closing up a fissure cave

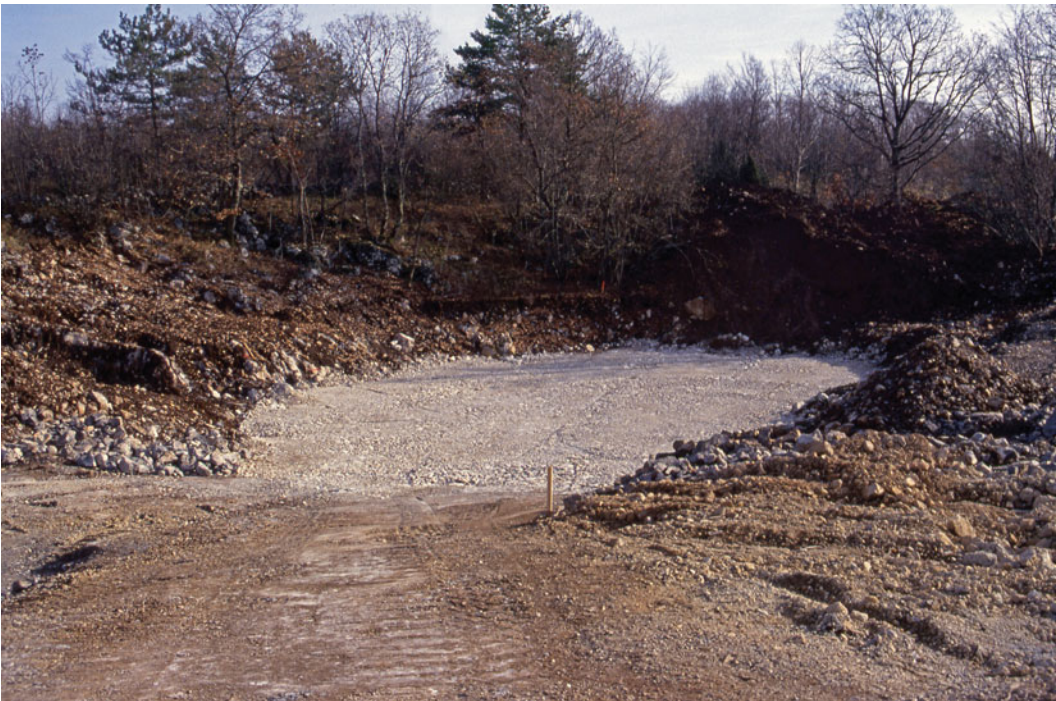
Fig. 1.6 Filling a doline (which now lies below the motorway) with rubble

smaller than the nearby cavities beneath them. Next, the dolines must be filled up with layers of rubble (Fig. 1.6). The unroofed caves are of similar shapes or more elongated. They are old caves that emerged to the surface due to the lowering of the karst surface, i.e. they no longer have the upper parts of the rim. In this case too, it is necessary to clear away the fine-grained fillings, which happen to be old cave sediments, and then fill up the caves with rocks and rubble. Otherwise, water could gradually carry away these sediments and subsidence could occur on the surface in response.

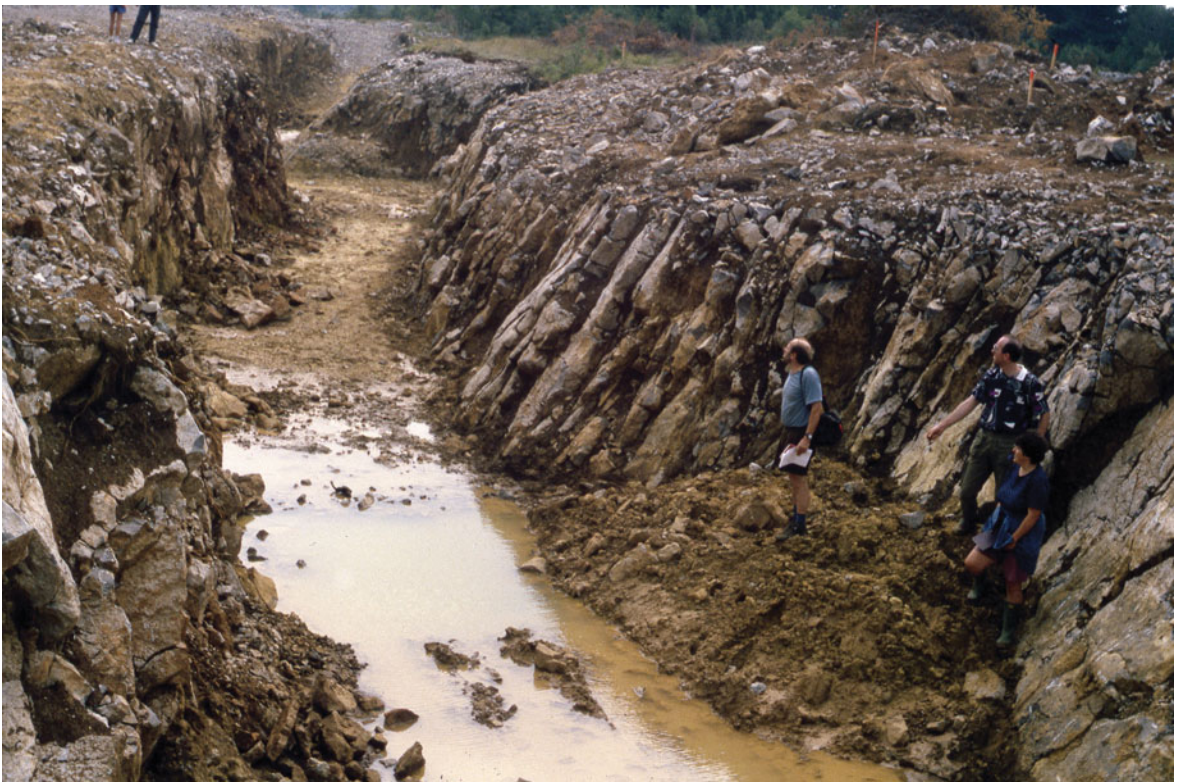
Fig. 1.10 Brezstropa jama unroofed cave near Povir

A peculiar and common karst feature is the unroofed cave (Fig. 1.10). This surface karst feature, which bears relevance still today, is a rather familiar phenomenon, which, however, has not been subject to any comprehensive studies until now. In fact, it was pretty much neglected up until now when it turned out that the number of such surface features is much greater than originally presumed. The number of papers published on unroofed caves correlates with the construction of new motorway sections (Knez and Slabe 1999a, b, 2000, 2001c, 2002a, 2004a, b, 2005, 2006a, 2008, 2009b, d, 2010b, c, d, f, 2011, 2012b; Knez and Šebela 1994; Knez et al. 2012; Kogovšek et al. 1997; Mihevc 1996; Mihevc and Zupan Hajna 1996; Mihevc et al. 1998; Slabe 1996, 1997a, b, 1998a; Šebela and Mihevc 1995; Šebela et al. 1999). The shape of an unroofed cave is the result of the type and shape of the original cave and of the development of the karst aquifer and its surface under various geological, geomorphologic, climatic and hydrological conditions. The distinctiveness of the surface shape of an unroofed cave is dictated by the velocity with which the sediments

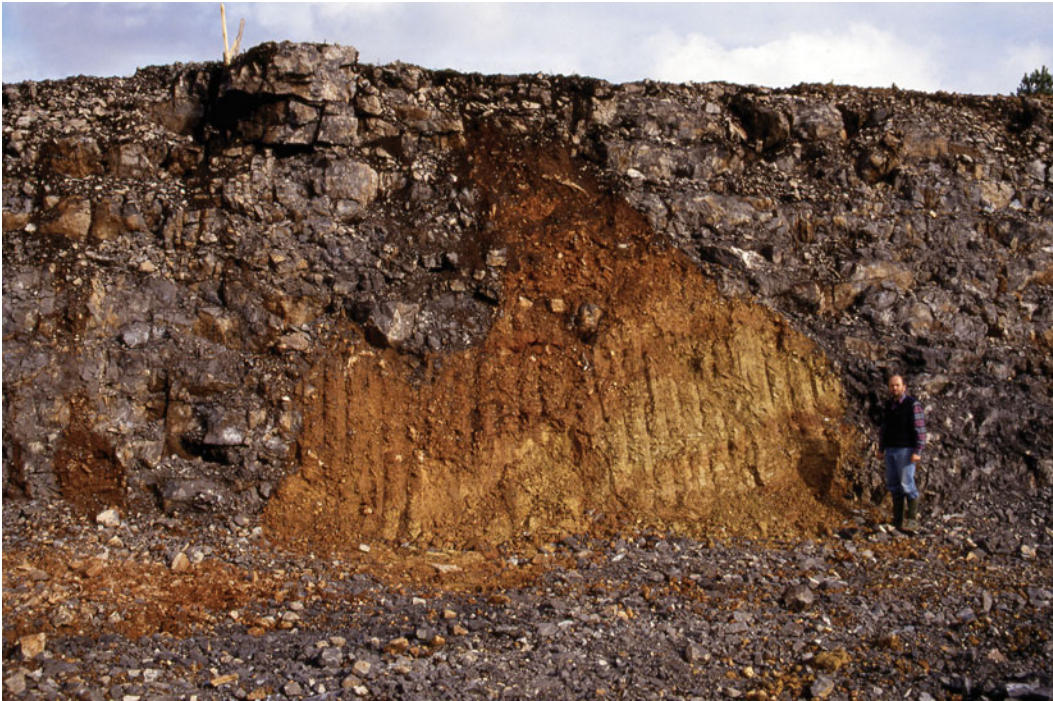
Fig. 1.11 A cave that revealed in a roadcut and has been completely filled with sediments

A great portion of the caves was filled up with sediments (Fig. 1.11). In most cases it is fine-grained flysch alluvium with interbedded gravel. We also took samples of sediments for palaeomagnetic research. It was

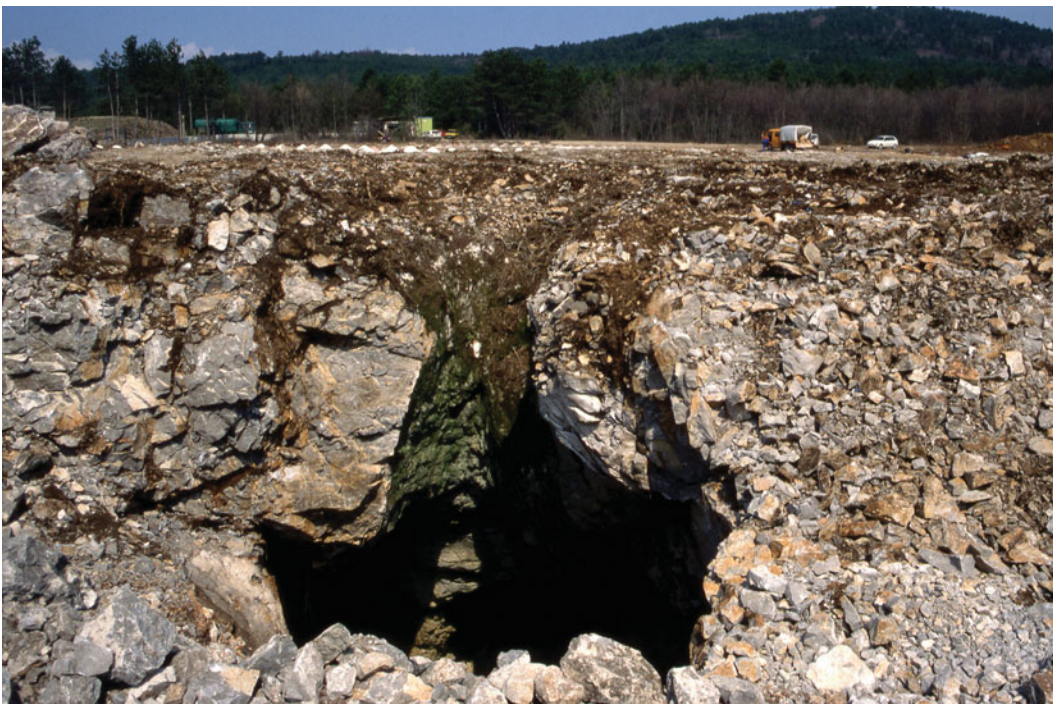
Fig. 1.12 Roof of a cave which collapsed during construction

Motorway construction in the Karst region is heavily influenced by the cavernosity of this landscape (Fig. 1.12). In the Slovenian Karst region, which is strongly marked by very lively tectonics and lithostratigraphic diversity, coupled with diverse development, it is hard to predict where or when a cave will

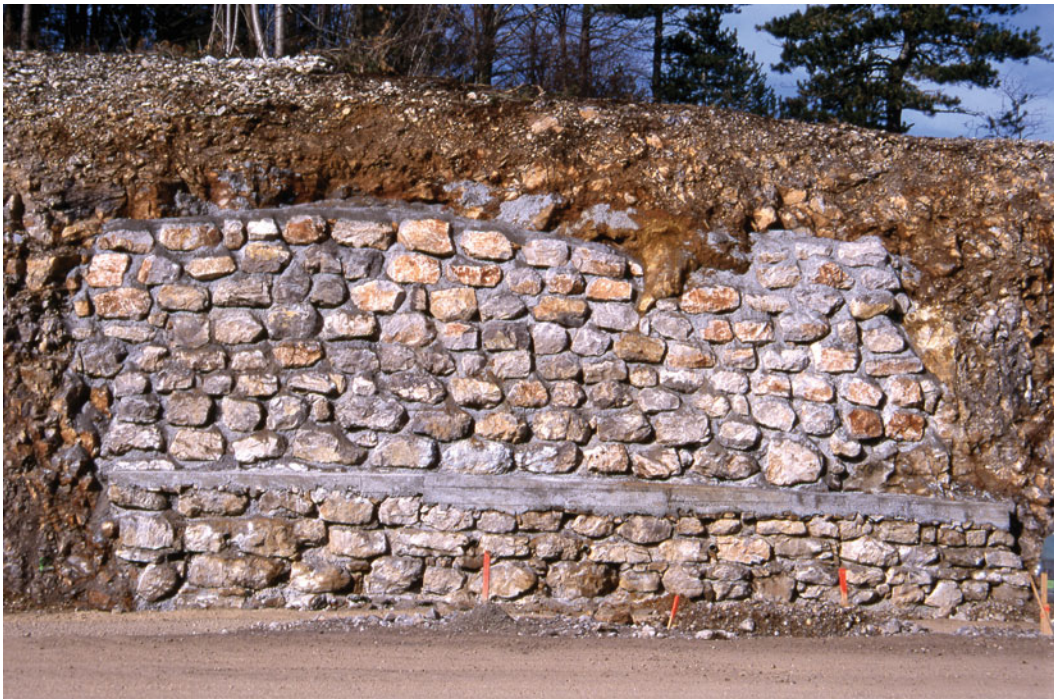
Fig. 1.14 Closing a cave in the embankment of a roadcut

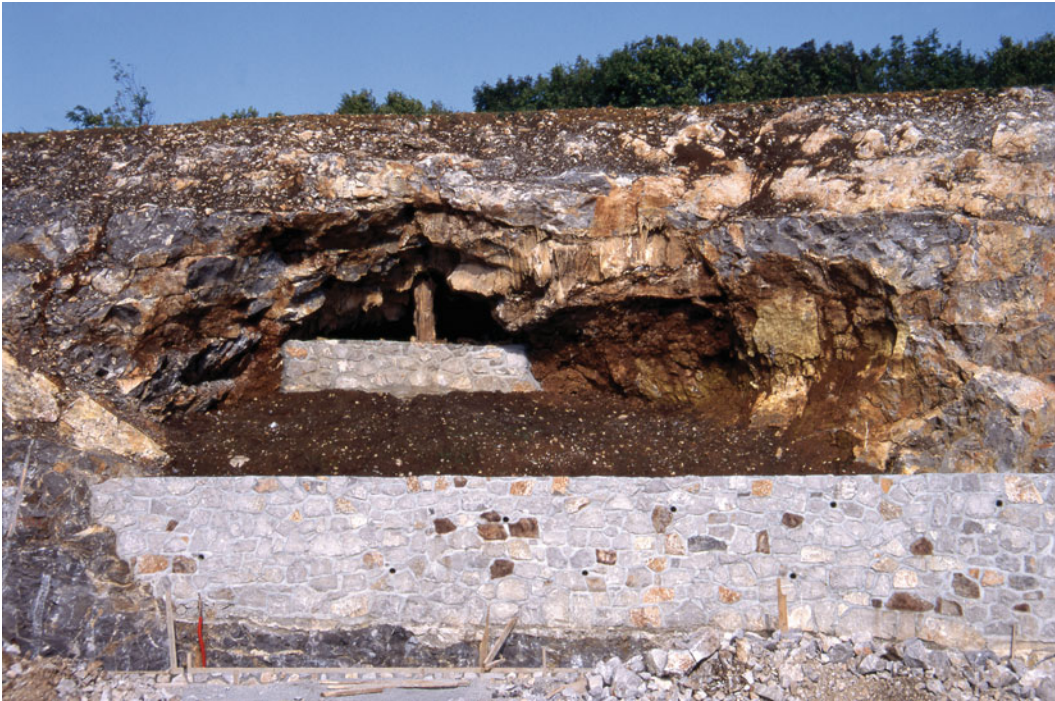
Fig. 1.15 A cave that has remained open before the Fernetiči border crossing

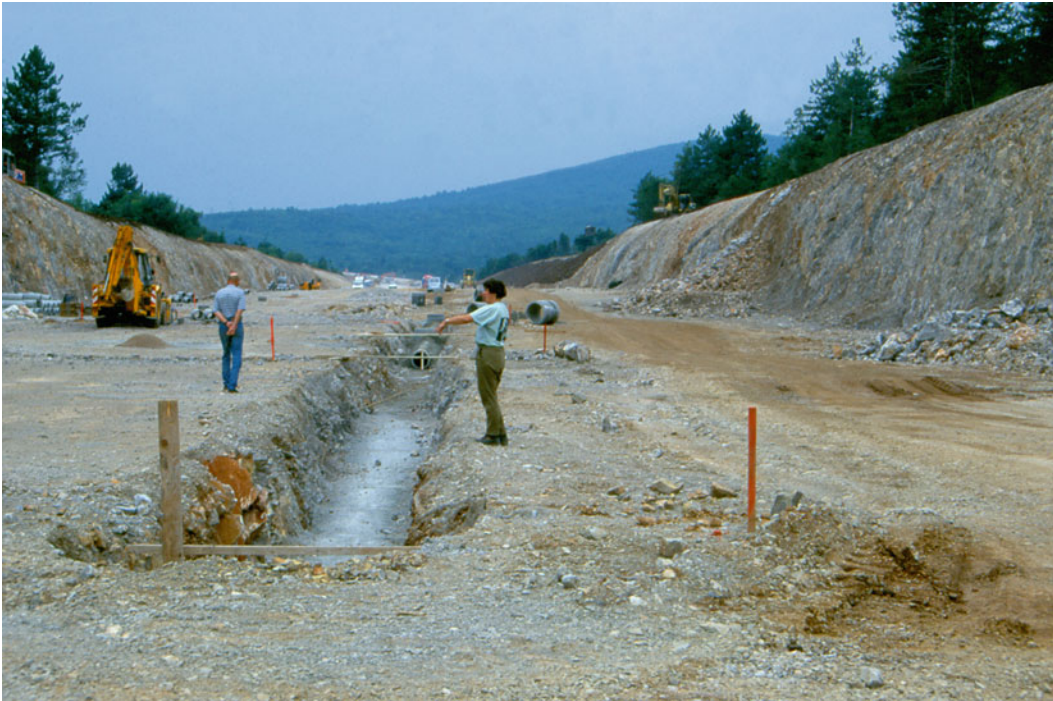
Fig. 1.17 Preparation works for laying pipes for road drainage

surface (Kogovšek 1993), and mineral oils were found in stagnant waters in caves next to the roads (Knez et al. 1994). As a result of these insights and our relentless efforts, motorway designs aim at providing impervious road surfaces. Pipes (Fig. 1.17) and drains (Fig. 1.18) are provided along the road, leading down to wastewater separators (Fig. 1.19). Ideally, untreated water does not reach the permeable karst surface. However, the technical aspect of the drainage system must be brought in line with our wishes. As it is, separators are often too small, and heavy rainfall can flush the sediments out.

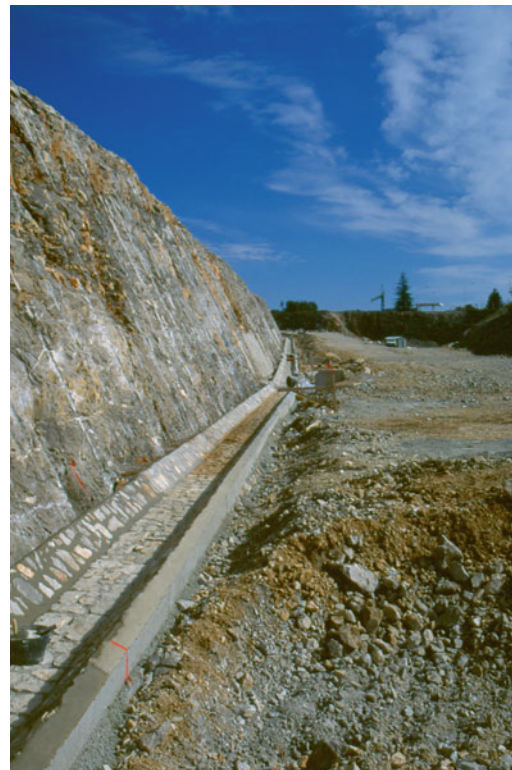
Fig. 1.18 Drainage channels at the side of the road

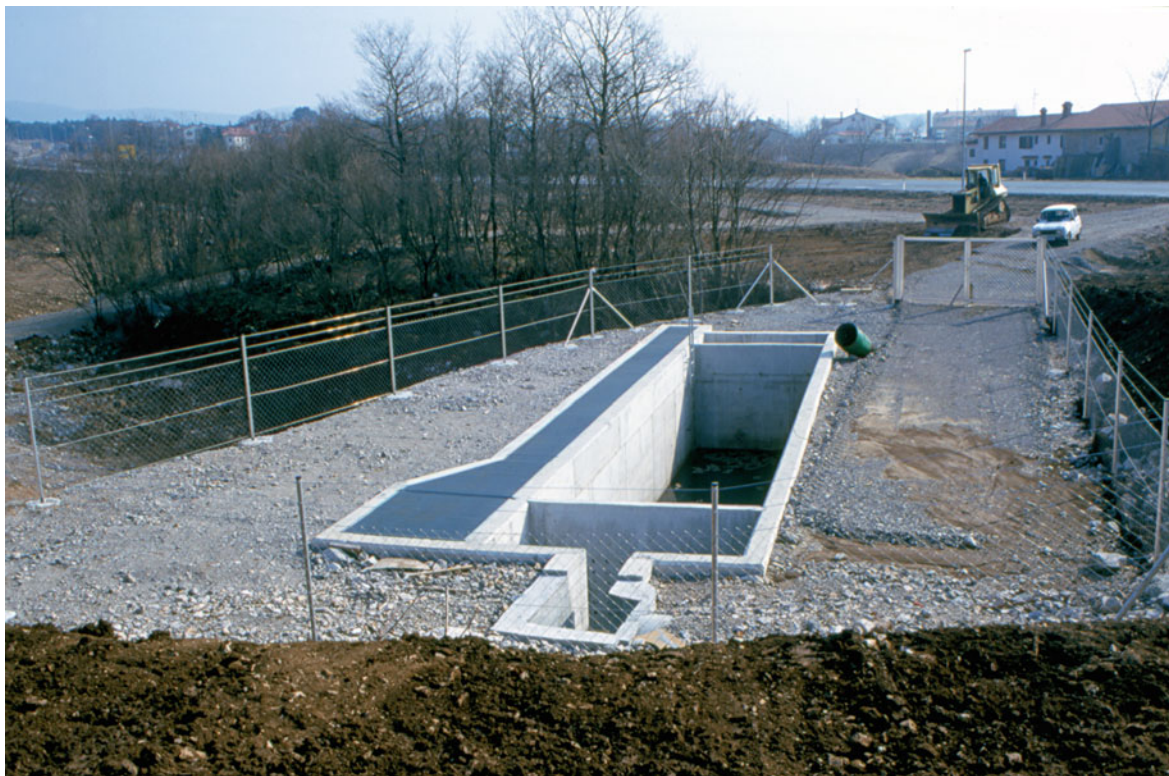
Fig. 1.19 Construction of an oil separator

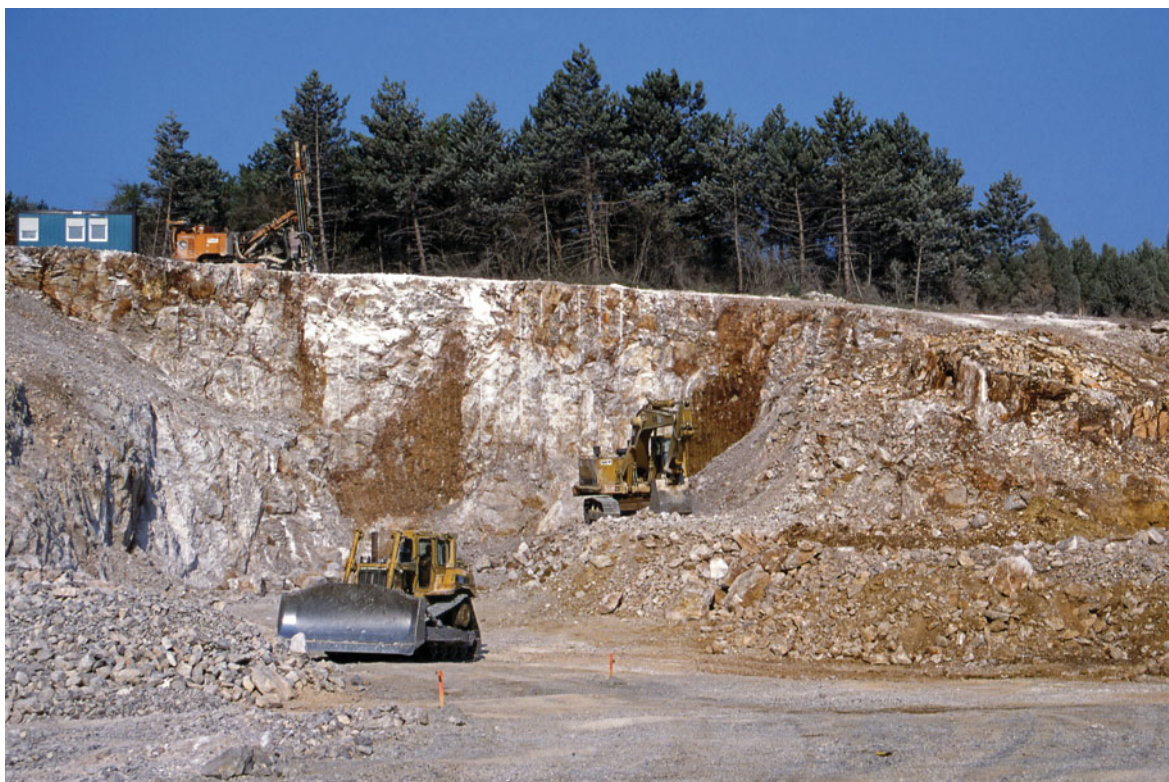
Fig. 2.3 Walls of a cave network that was filled with alluvia and flowstone

A larger system of caves opened on the eastern side of the south entrance to the Kastelec tunnel. A part of the system was already missing the roof, one part consisted of hollow passages, and the other part was filled with sediments and flowstone (Figs. 2.3, 2.4 and 2.5). The rim of the passages had been characteristically reshaped above the sediments (Slabe 1995). From the largest passage, 18 alluvium samples were collected for palaeomagnetic study (Fig. 2.6). With regard to the location within the region and the development of this part of the Karst region, it was established that the deposits, much like other cave deposits in the immediate vicinity, consist of flysch deposits (Bosák et al. 2000a, b). The uppermost part of the profile is made up of a 3 m thick rubble layer. Below lies a 2 m layer which is sandier, whereas the

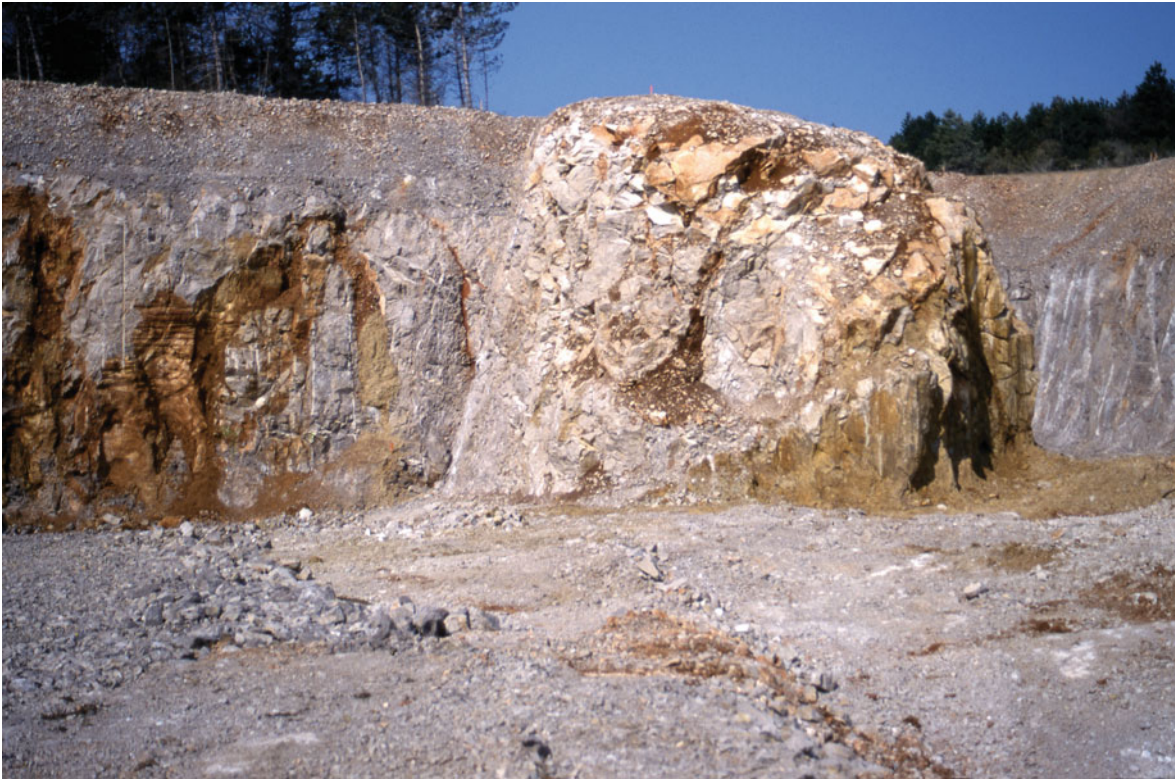
Fig. 2.4 Section of the cave network that was filled with alluvia and flowstone

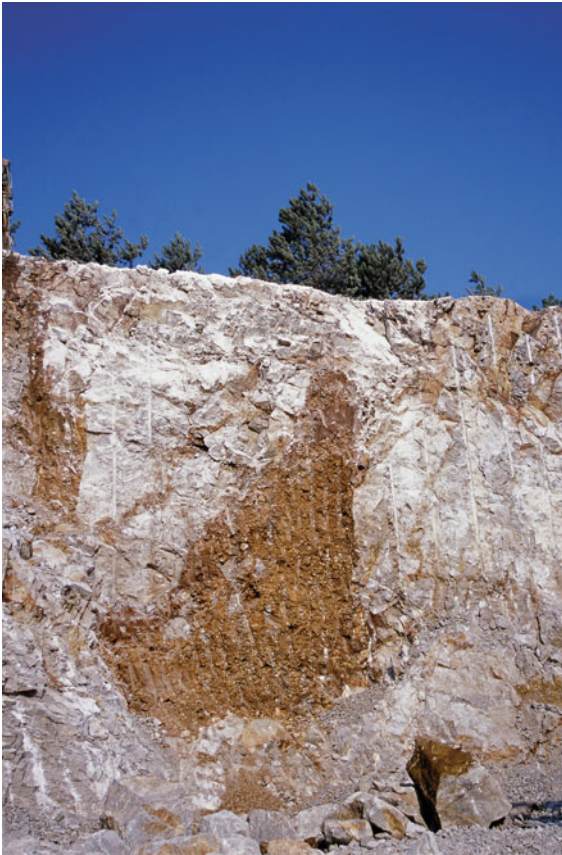
Fig. 2.5 The wall of the passage that has formed along the alluvium, with the passage being filled with fine-grained alluvium

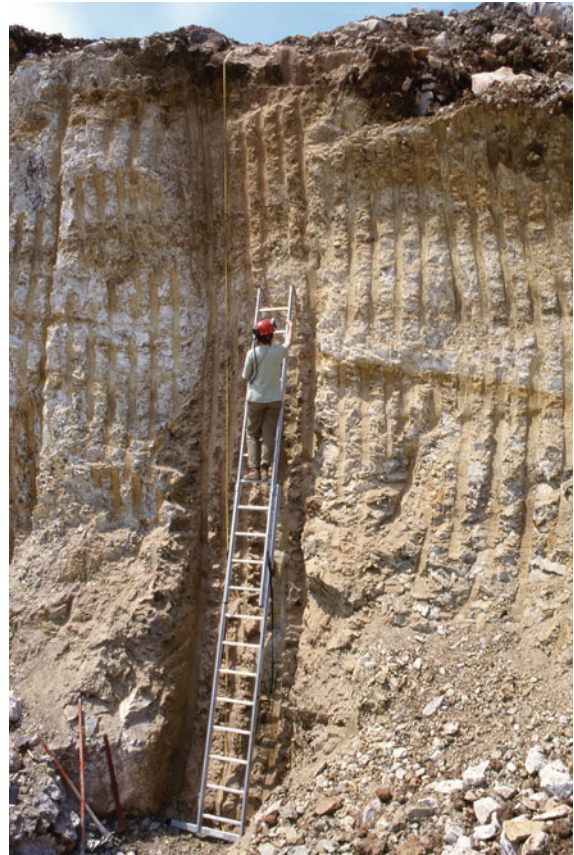
Fig. 2.6 Alluvia in an unroofed cave

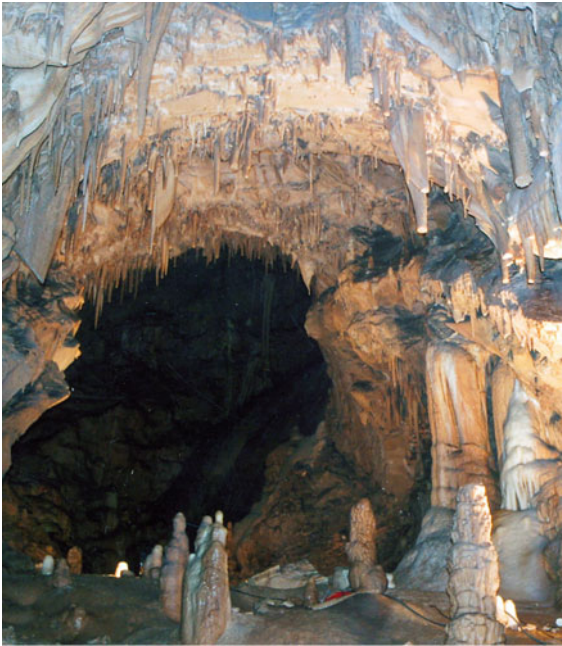
Fig. 2.7 A cave that was uncovered during the tunnel digging (Photo Feruccio Hrvatin)

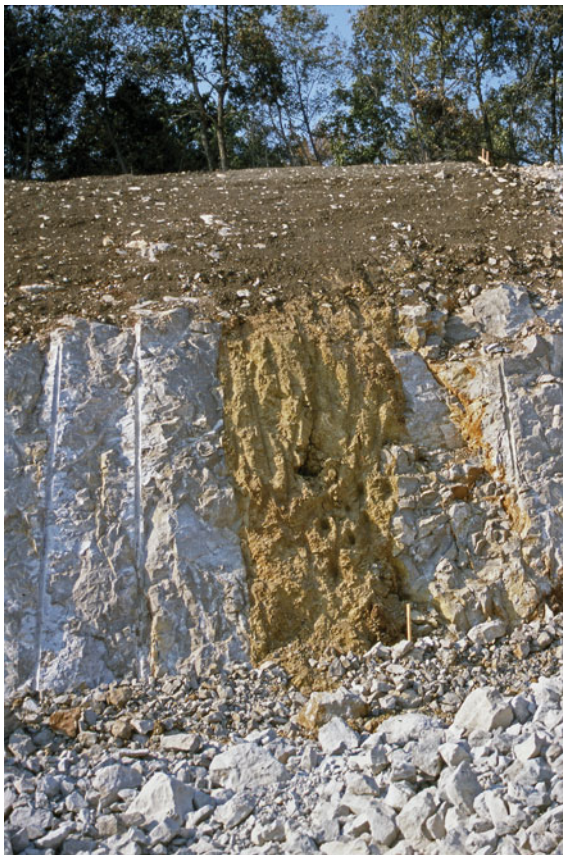
Fig. 2.10 An old shaft filled with fine-grained alluvium

In addition, there was a shaft with a diameter of 4 m located within the perimeter of the described cave system, before the tunnel (Fig. 2.10). It was completely filled with fine-grained alluvium. Its walls showed traces of percolating water and were only occasionally reshaped under the alluvium.

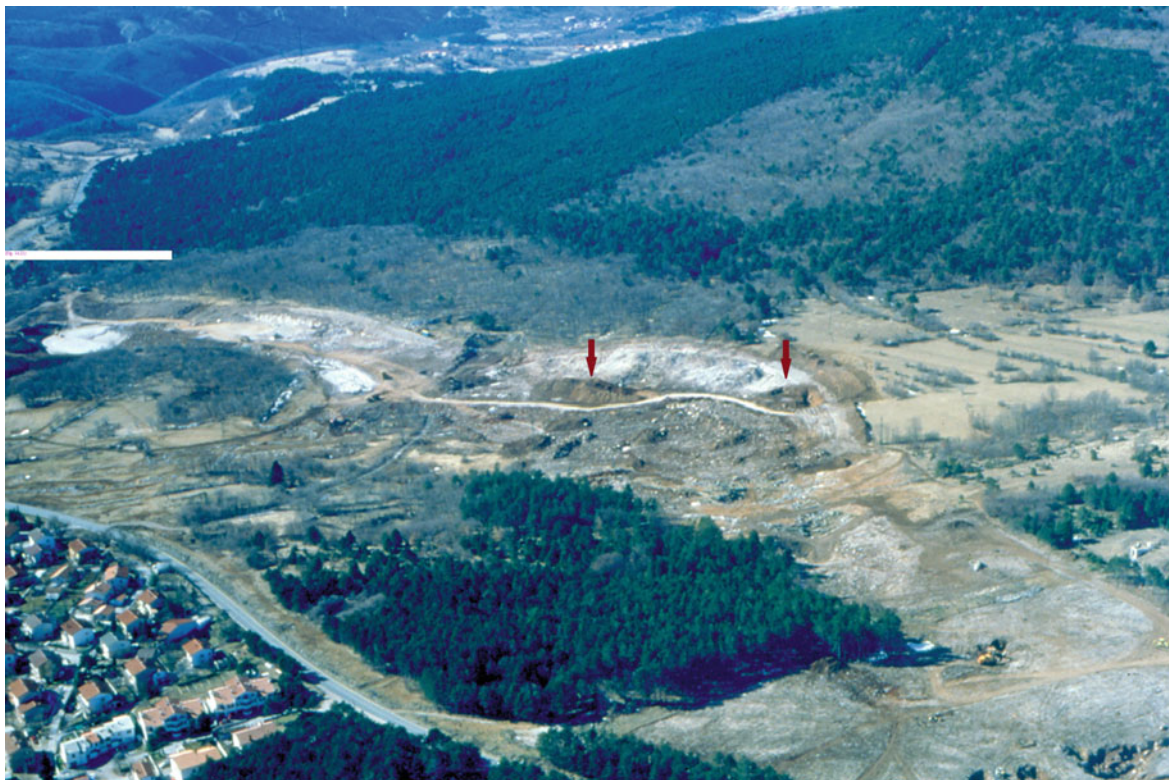
Fig. 3.1 Unroofed caves at Kozina (Photo Alma Bavdek)

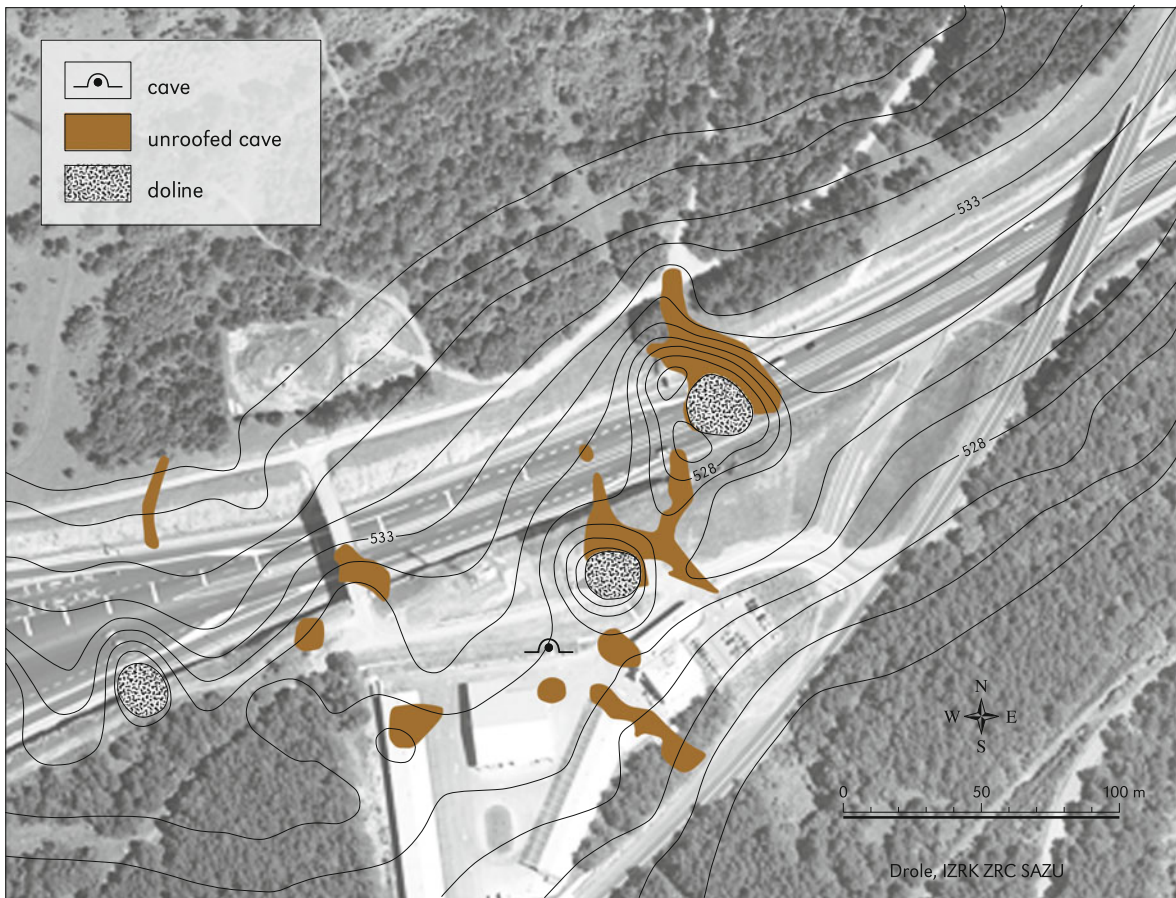
Fig. 3.2 Karst surface with unroofed caves and dolines

The largest cave system (Figs. 3.2, 3.4 and 3.5), which was unearthed at the new, beginning section of the route, stood out on the surface as a network of more or less prominent notches, the most prominent ones dotting the slopes of the dolines and connecting dolines, and of smaller, relatively shallow dolines. The cave system was made up of unroofed sections as well as a smaller hollow passage which we had known about before initiating earthworks, and roofed passages. To a large extent the cave was filled with fine-grained alluvium and pebbles (Fig. 3.6). The bottom of the southwestern part was almost completely covered with heaps of flowstone, stalactites and stalagmites. Even flowstone was covered with fine-grained alluvium. Coarse rubble (Figs. 3.7 and 3.8) occasionally covered the surface or filled the

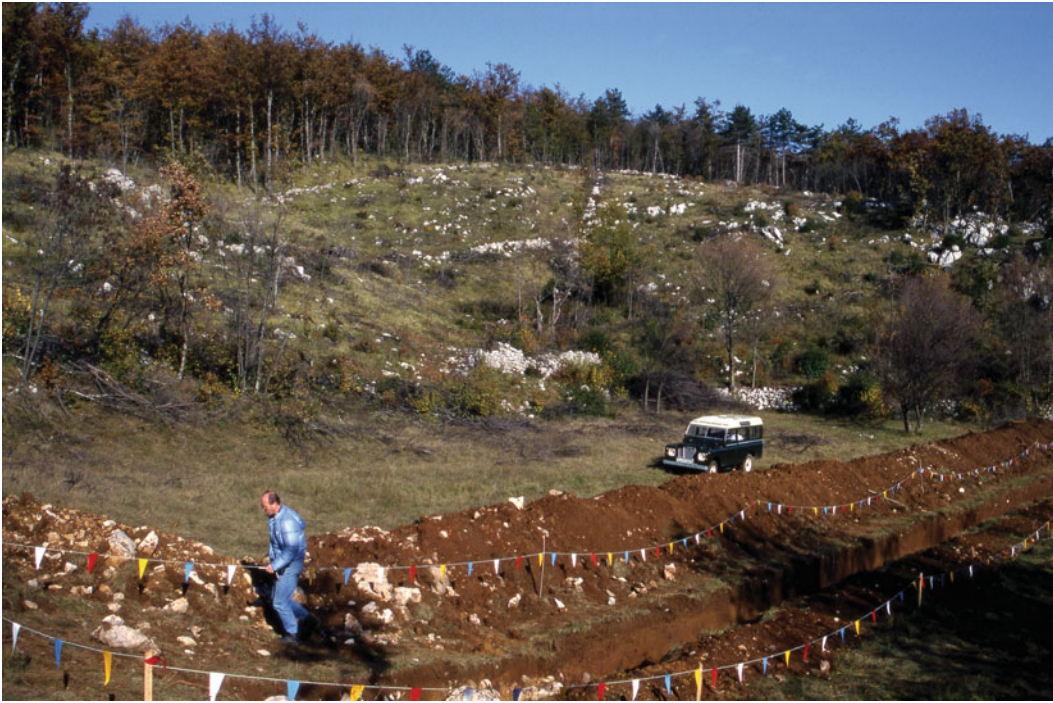
Fig. 3.3 An unroofed cave—an elongated indentation in the karst surface

As early as the planning stage for the motorway route, we had identified the notches that dissect the slopes of the dolines, stretching several tens of metres around, as unroofed passages (Fig. 3.3). Most of our assumptions were confirmed by earthworks.

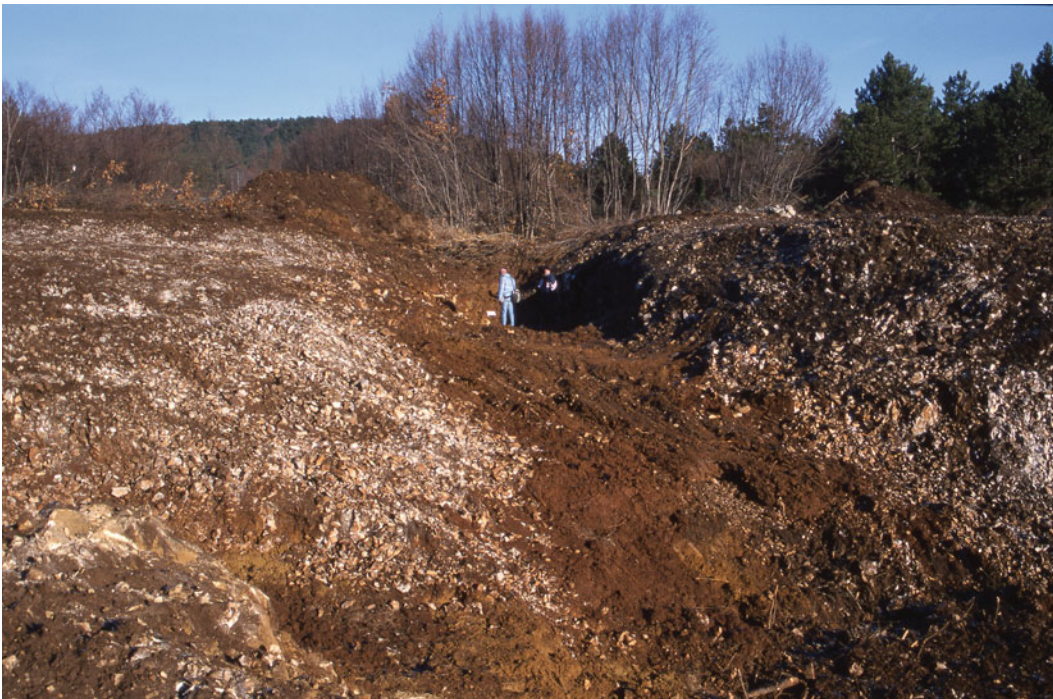
Fig. 3.4 An unroofed cave at Kozina

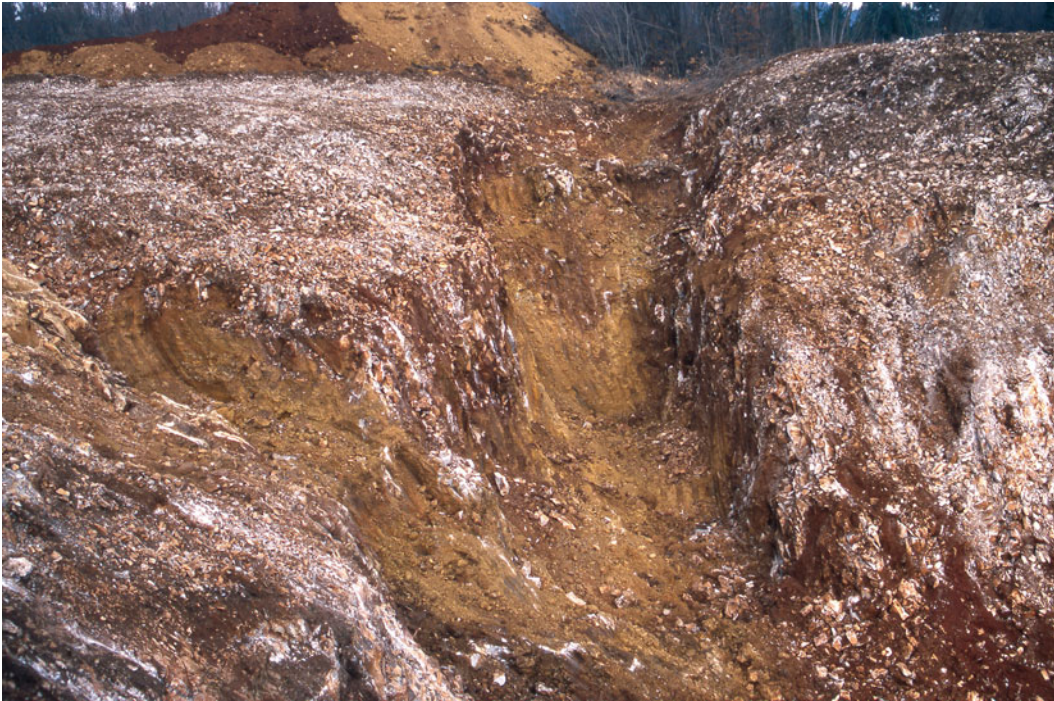
Fig. 3.5 An unroofed part of a cave network after clearing out the alluvia

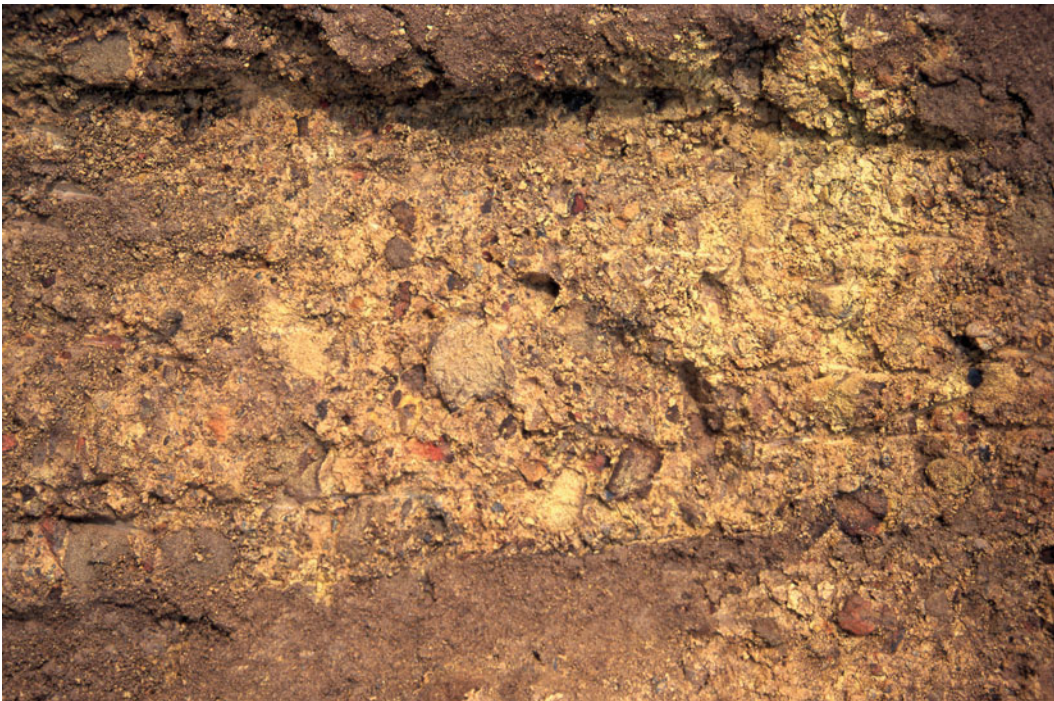
Fig. 3.6 Gravel alluvium in an unroofed cave

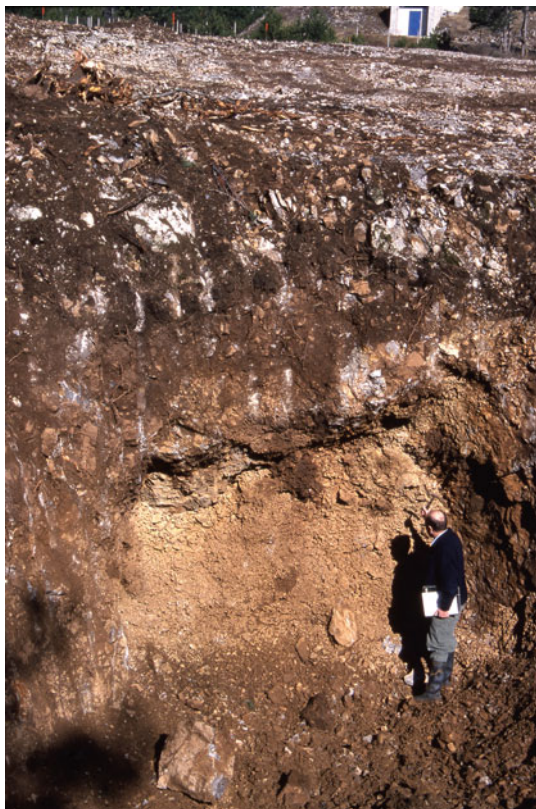
Fig. 3.7 A rubble-filled cave

caves; it was commonly overlaying old alluvial deposits or filling the space below the shelves which were created in the beginning section of passages. The rubble came about as the result of rock disintegration during the cold Pleistocene epoch. The bottoms of the two larger dolines that had formed at the perimeter of the old cave system were covered with layers of brown and red soil a few metres deep. Their rim featured rock formations suggesting notable water percolation. Also at their bottoms were entrances into narrow vertical shafts. More distinct notches develop from unroofed caves, if the high water velocity facilitates sediment transport from the surface, often the result of another doline being located close by.

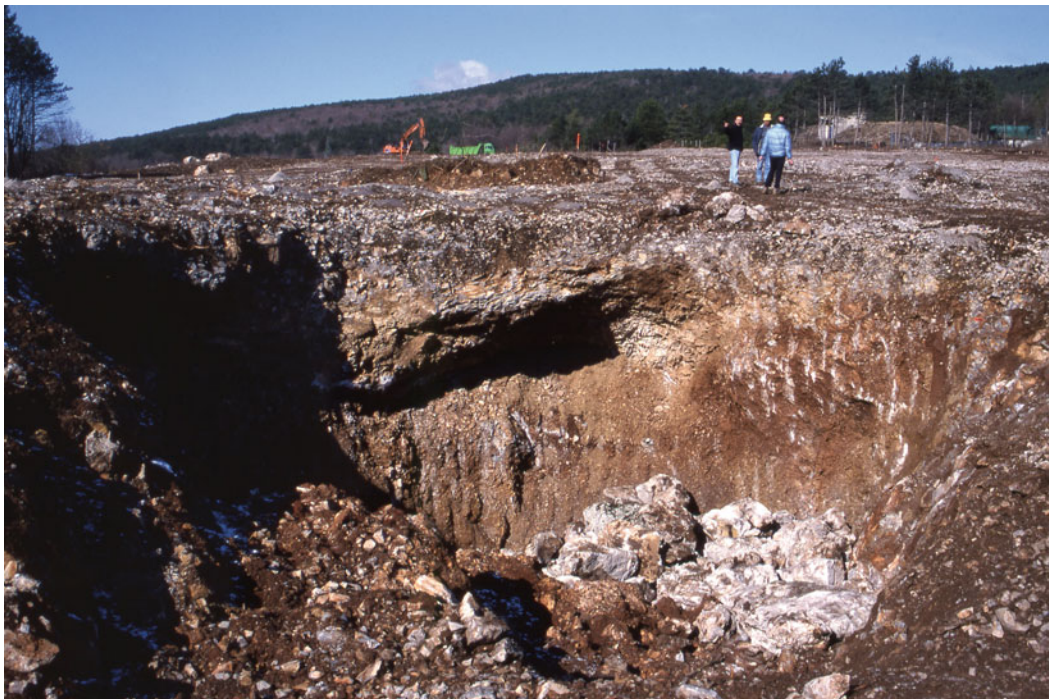
Fig. 3.8 An old rubble-filled cave

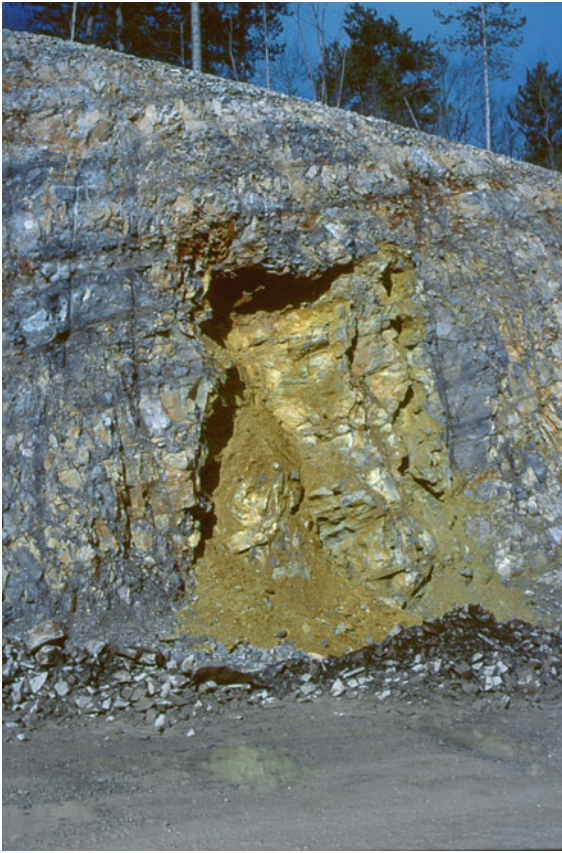
Fig. 3.9 A cave filled with gravel, fine-grained alluvium, and flowstone

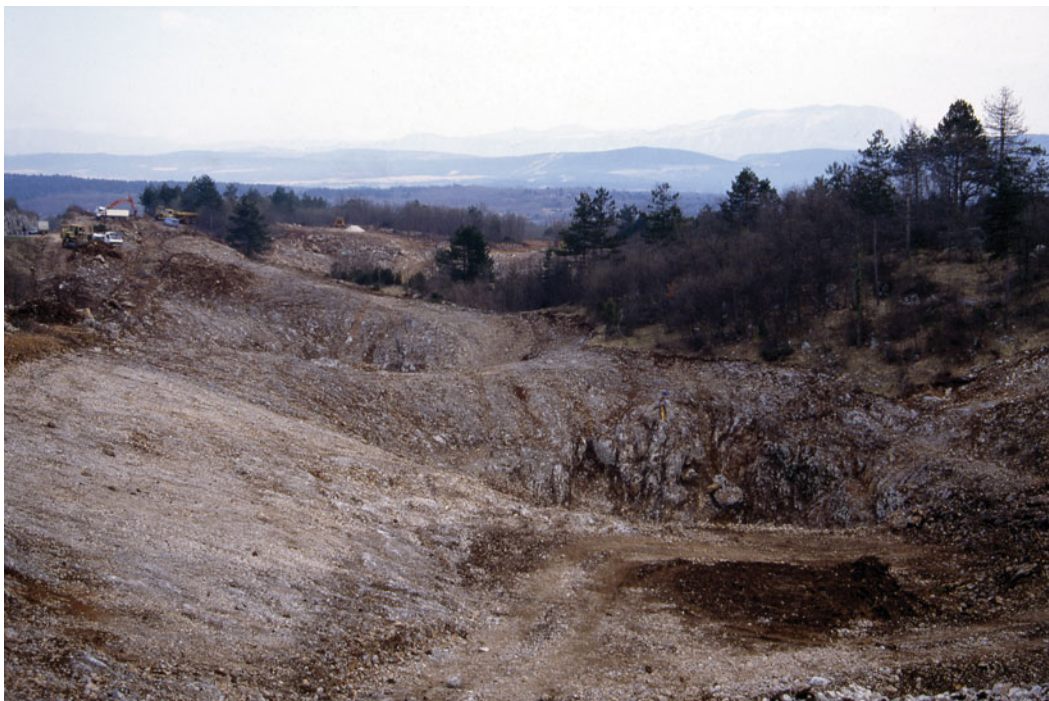
Fig. 4.2 Doline-covered surface

The surface of this area was dotted by dolines (Fig. 4.2). The largest dolines have a diameter of 200 m and a depth of 35 m. The bottoms of some cultivated dolines featured fields. Old cultivated dolines were revealed in the course of archaeological excavations. The doline bottoms often displayed rocks and stones covered with a layer of soil; alternatively, the soil was overlying thick layers of loam that showed no indication of human intervention. We proceeded with measurements as to the amount of soil that was transported into dolines after humans have begun interfering in this setting. It was established that a 0.14 m thick layer of soil was transported from the surface down into the dolines. Macroscopic descriptions of sediments in the dolines were carried out and the sediment layers were sampled for mineralogical analyses.
