Cave and Karst Systems of the World

Cave Exploration in Slovenia

Discovering Over 350 New Caves During Motorway
Construction on Classical Karst

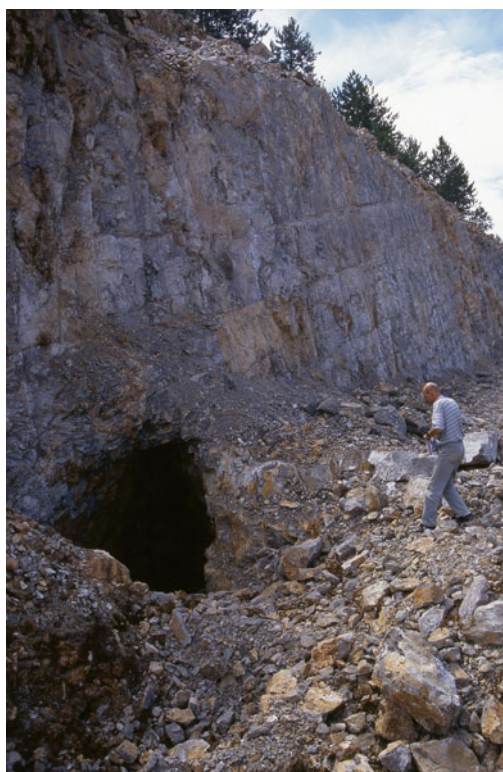
Fig. 4.4 The entrance into an old cave

Caves can be divided in old caves, mostly horizontal or inclined, and in shafts which are shaped by water percolating from the surface downwards. At one point, old caves were characterized by through-flowing water (Figs. 4.3, 4.4 and 4.5), however the drop of underground water meant that they would eventually dry out. There are also some old shafts that were either shaped by percolation water or that make up a part of bigger cave systems. The latter are depicted as old hollow caves on the map (Fig. 4.1) which illustrates the distribution of typical caves found along this particular motorway route.

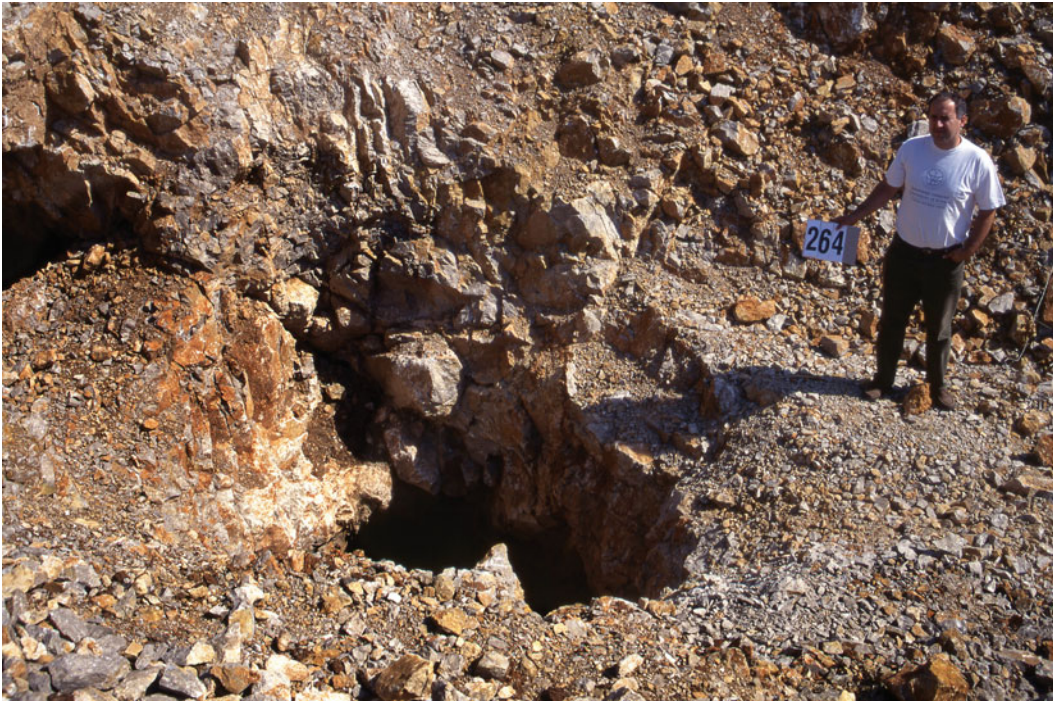
Fig. 4.5 Collapsed roof in the old cave

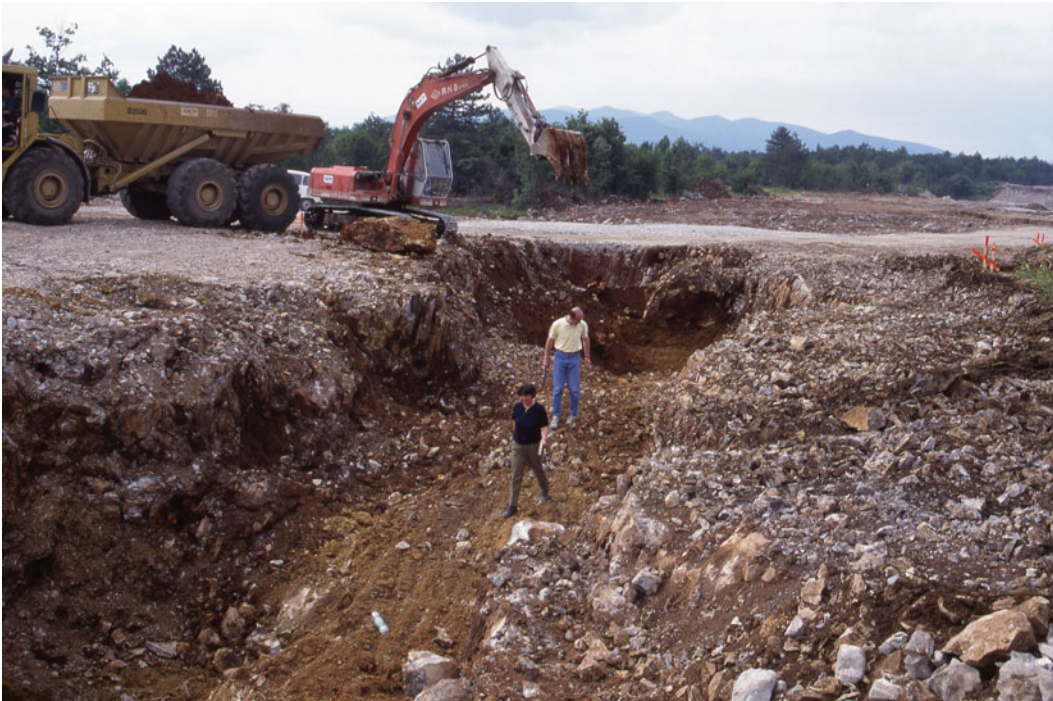
Fig. 4.7 An unroofed cave

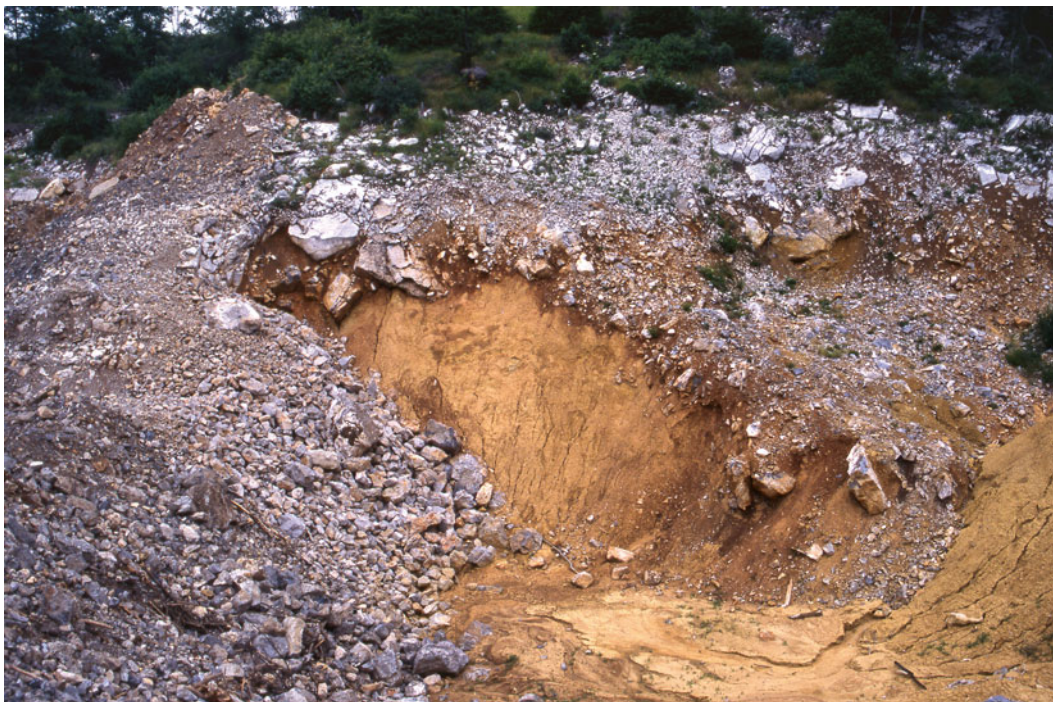
Fig. 4.8 The cross-section of the old cave filled with fine-grained alluvium

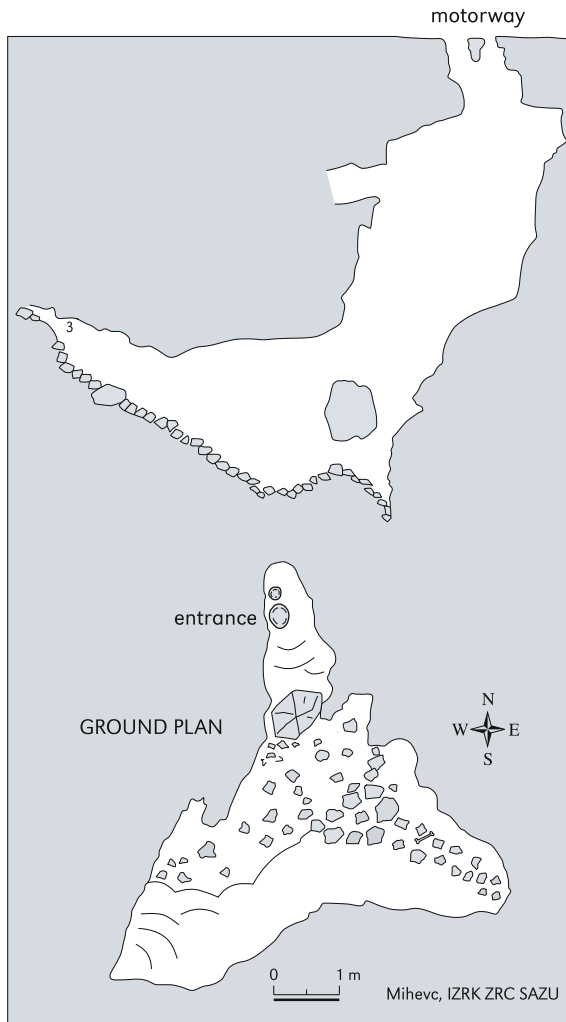
Fig. 4.11 A preserved old cave under the road

West of Divača, a fascinating 14 m deep old cave (Fig. 4.11) had opened. Its bottom is characterized by a small hall which is 12 m in length, 10 m in width and 5 m in height. Its roof displays several chimneys. The

bottom is covered by rocks and loam. Fractured rock, the result of blasting, occurs only in the first metre of the cave below the surface. We proposed that this cave be preserved. It is accessed via a concrete tube that reaches to the lip of the underpass. It is now covered by a concrete lid.

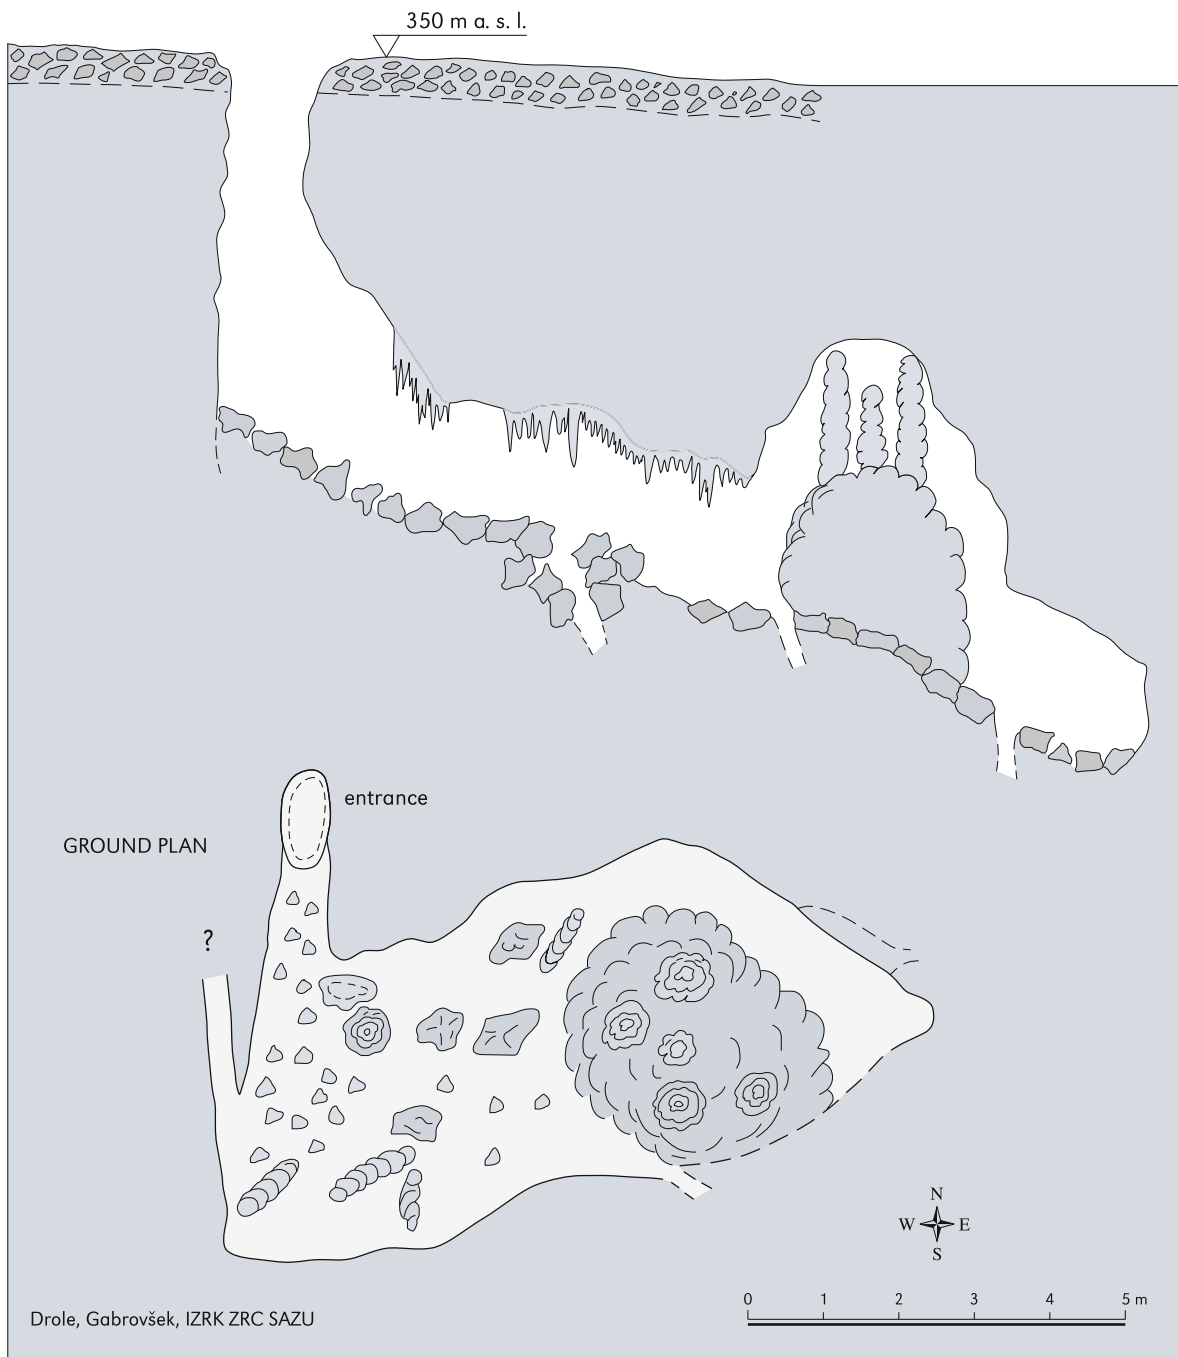
Fig. 5.2 A cave whose roof collapsed during gravel reinforcement works on the route

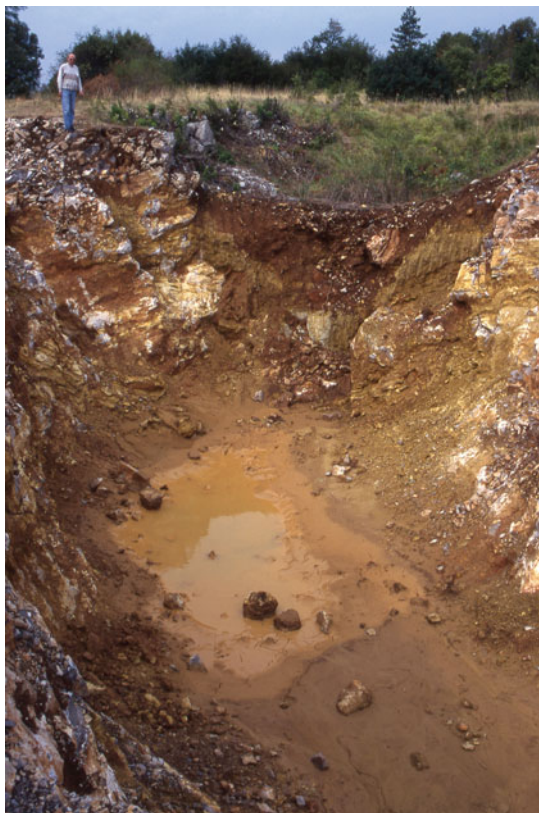
Fig. 5.3 An unroofed cave at Fernetiči

Many old caves which are filled up by fine-grained alluvium are already marked with an absence of roof (Figs. 5.3 and 5.4). The passages wind across the karst surface as shallow notches. It is therefore possible to make them out in the landscape even before commencing earthworks. In roadcuts and tunnels, the passages which are filled up by fine-grained sediments, may be accessed via their cross-sections. The caves are filled up by layers of yellow loam and sand, frequently consolidated; overlying are usually red loam and brown soil. The speleothems and flowstone heaps are covered with sediments, but the sediments are only rarely covered with flowstone. Small scallops were found which are relatively rare indications of faster water flows; in contrast, there were no pebble deposits found in these caves although they are a frequent occurrence in the old caves dotting the motorway routes around Divača. The passages of old caves are frequently cut off by shafts, and the sediments are, as a result, removed in a funnel shape. In addition, old caves may also be intersected by dolines. Percolation water cut out meandering grooves in the bottoms of some, usually smaller, passages. In some locations, patches of flysch remained on the surface for a longer period of time, acting as a layer from which runoff drained into the limestone.

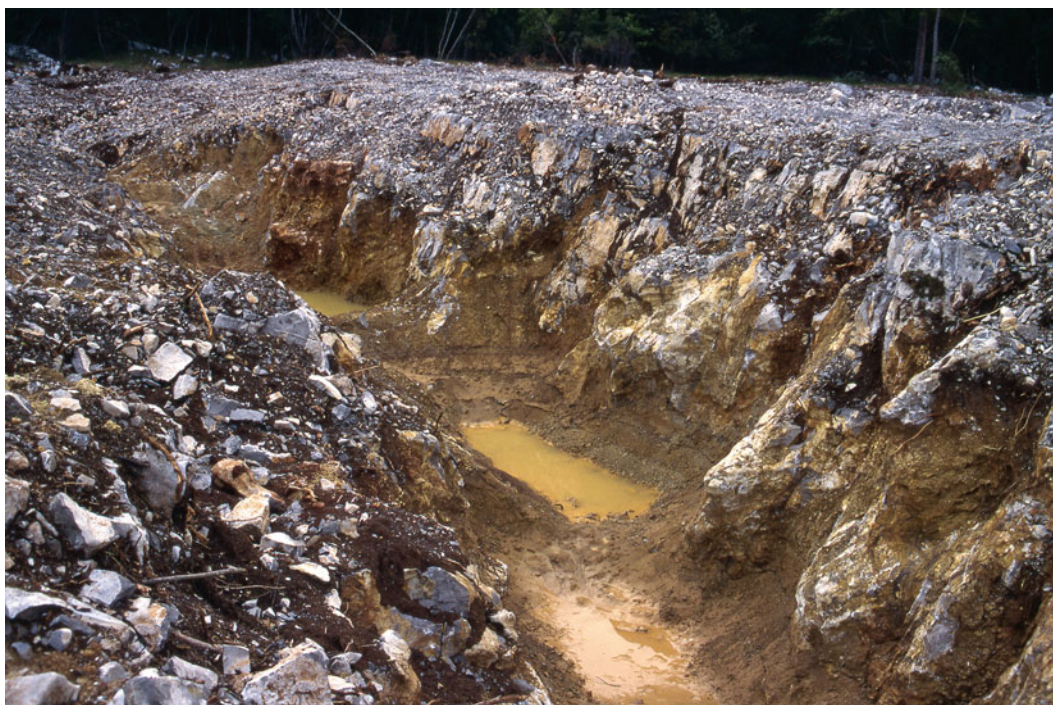
Fig. 5.4 A winding passage of an unroofed cave near Sežana

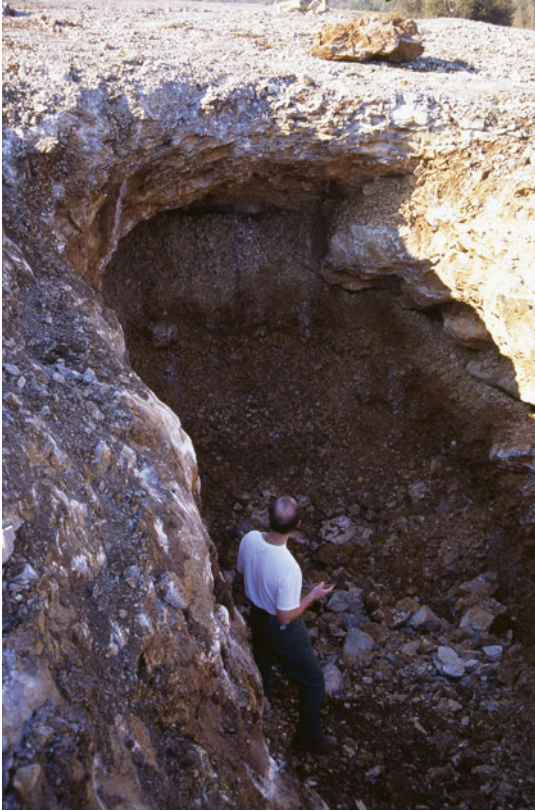
Fig. 5.5 A rubble-filled cave

Parts of newly discovered passages are filled up by coarse rubble (Fig. 5.5). Rubble, with a diameter ranging up to 5 cm, occurred as the result of the disintegration of the karst surface in the cold Pleistocene periods. It generally accumulated in such parts of caves, which were conducive to the transport of fine-grained sediments due to high vertical permeability of the aquifer, and where the thin roof caved in

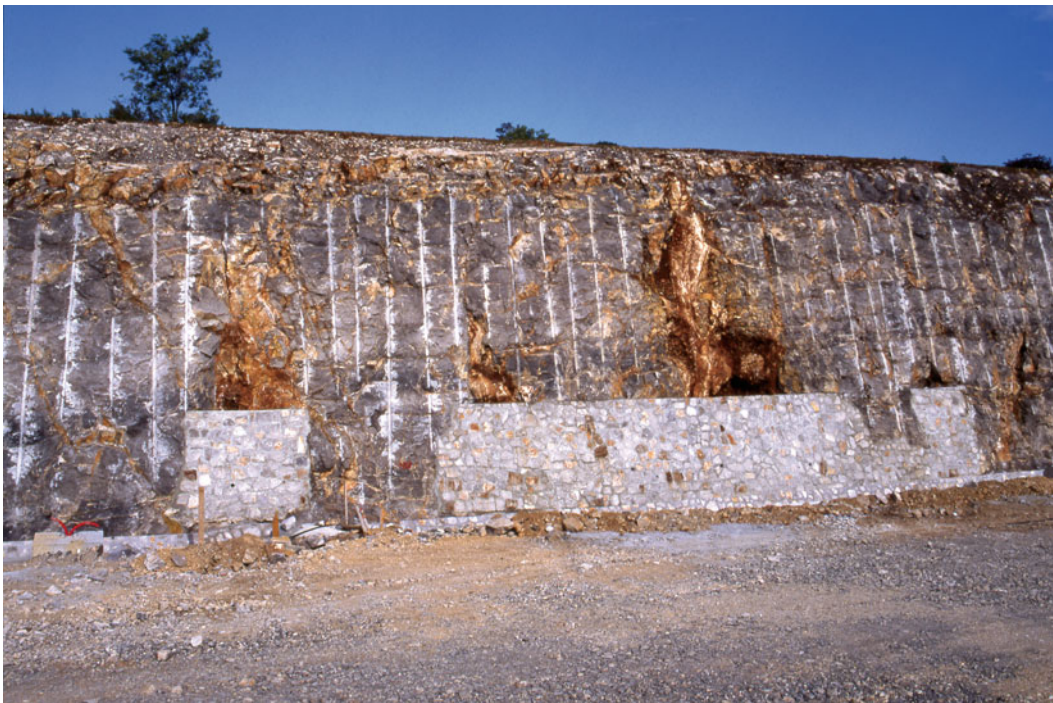
Fig. 5.6 Caves in the embankment of a motorway roadcut that were closed with rock walls

Fine-grained alluvium was washed out onto the route from old caves which were located in the embankments of roadcuts. For this reason, the caves had to be walled up (Fig. 5.6).

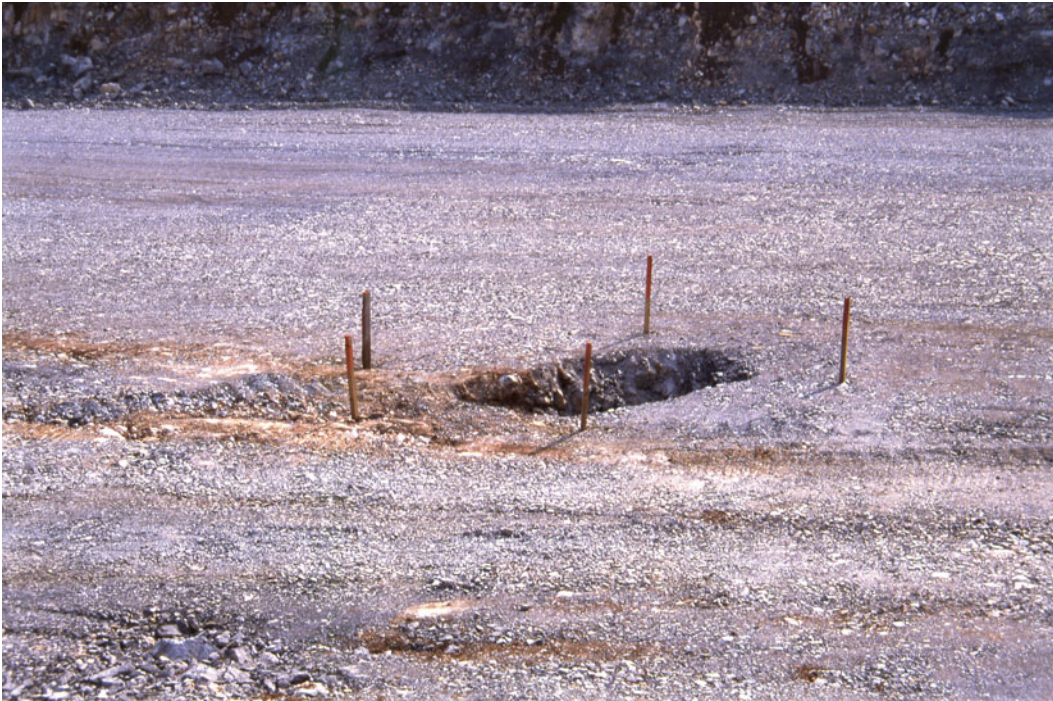
Fig. 5.7 A subsidence in the motorway

One of the most reliable indicators of permeability, the great cavernosity characterizing this area, reminds us how delicately and carefully we must proceed with the construction and subsequent use of this motorway. The vibration roller used to consolidate the rubble on the roadway led to the emergence of subsidence (Fig. 5.7) and the collapse of roofs over smaller caves. However, considering the great cavernosity in this section, it is quite possible that other caves, even larger in scale, are hidden below the surface. It may be concluded that ground-penetrating radar surveys are an essential tool for road safety.

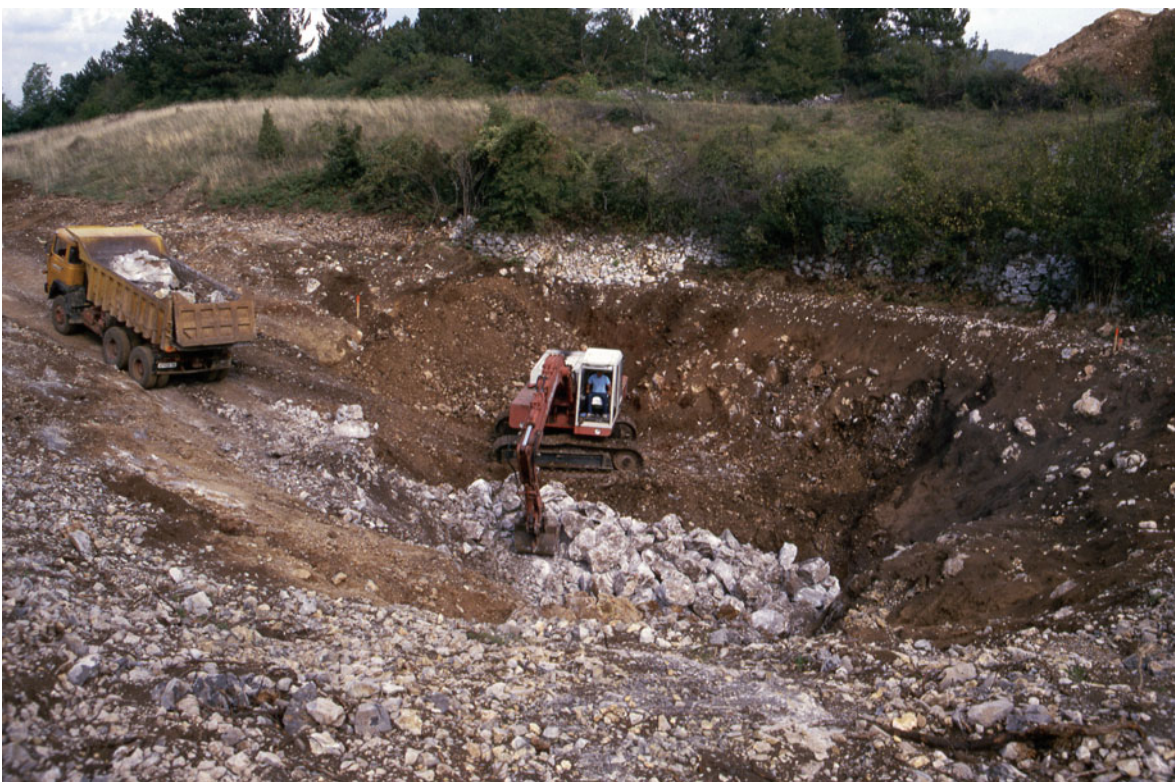
Fig. 6.1 Removing soil and sediments from a filled up doline

The motorway construction works required that we remove the alluvium from the filled up dolines (Fig. 6.1). The results obtained in the course of the preceding research, which included drilling into the doline alluvium, were thus confirmed. Frequently, we found considerable amounts of older, mostly flysch alluvium in the dolines. In one doline situated in the Divača–Dane section the layer of flysch gravel almost reached the surface. But it should be pointed out that there are many filled up dolines within alluvium-filled old caves that had lost their roofs at one point. Shafts were formed under passages which once had through-flowing water. This water flow deposited flysch loam and sand in the last distinctive stages of the development of the passages. Later, in the dry periods flowstone was deposited. These passages and shafts are permeated by infiltrating water which feeds the underground flows. Today, the underground flow runs deep below the surface. Funnel-shaped notches, filled with brown and red karst loam and rubble, were formed in the flysch alluvium rain-washed by the surface water.

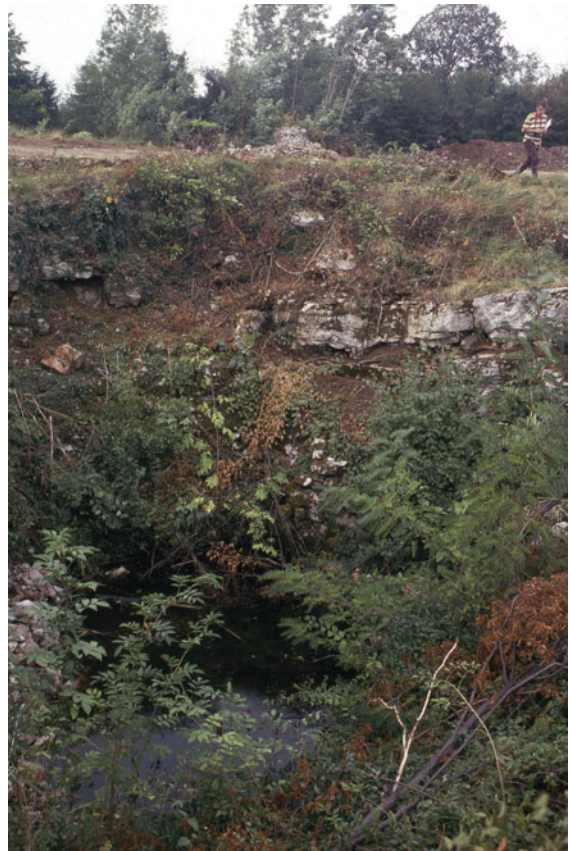
Fig. 6.2 A pond with water

Near the town of Povir, a pond (Fig. 6.2) was created in a sinkhole, which was surrounded by partly man-made walls, because water had collected at the bottom and could not drain off. The pond was located on an elevation, on top of the anticline. The elevation had to be cut through, and we were unable to preserve the pond. The excavation in the pond confirmed our assumption that the water was prevented from draining by an impermeable layer of loam, which was deposited in the old passage, the floor of which was covered by a large heap of flowstone (Fig. 6.3).

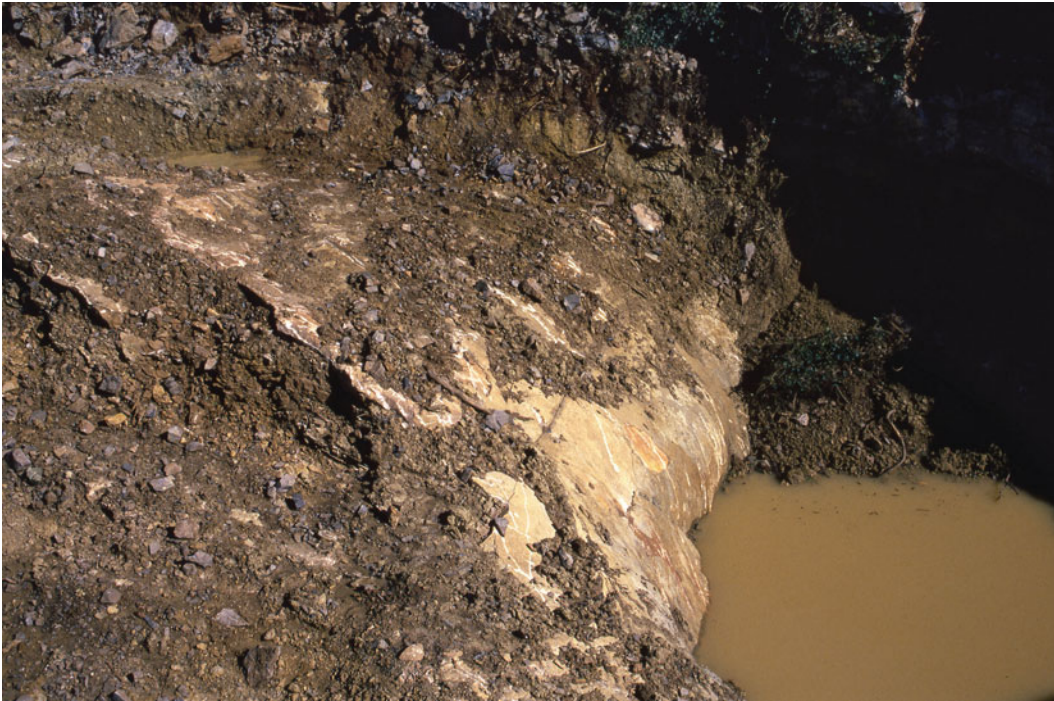
Fig. 6.3 Flowstone and alluvia under the pond

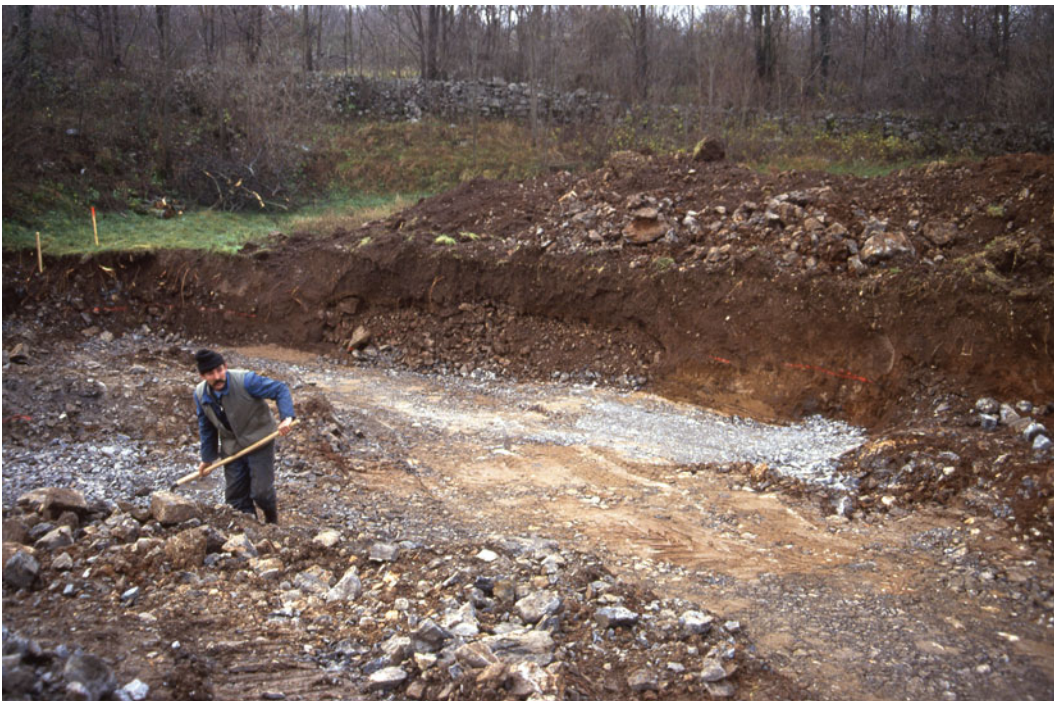
Fig. 6.4 Uncovering of an artificial doline

collected while clearing out the doline and the adjacent karst surface (Fig. 6.4). The people transferred rocks and stones to the excavated doline and later covered them with soil. This method was used to obtain more flat arable land.

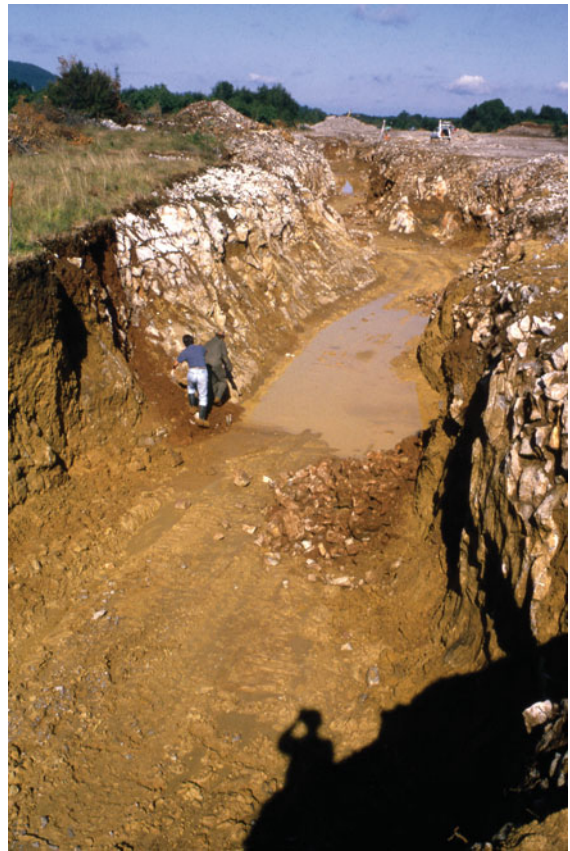
Fig. 6.6 Exploring an unroofed cave at Povir

Alluvium-filled caves are a far more common find. These types of caves have lost their roofs (Figs. 6.6 and 6.7) and are now meandering as furrows over the landscape. Alternatively, the filled in passages can be seen in the cross-sections in the banks of roadcuts (Figs. 6.8 and 6.9). Cave passages vary in size, at times exceeding a diameter of 5 m. Cave walls are frequently covered with flowstone, their bottoms displaying large flowstone heaps. Flysch and limestone gravel, flysch loam and sand are deposited in caves. In the biggest of caves, we found flysch beds over 5 m thick. Alluvium-filled caves can be tracked along the entire route Čebulovica–Divača–Dane. We sampled several sediments and applied X-ray diffraction, mineralogical,

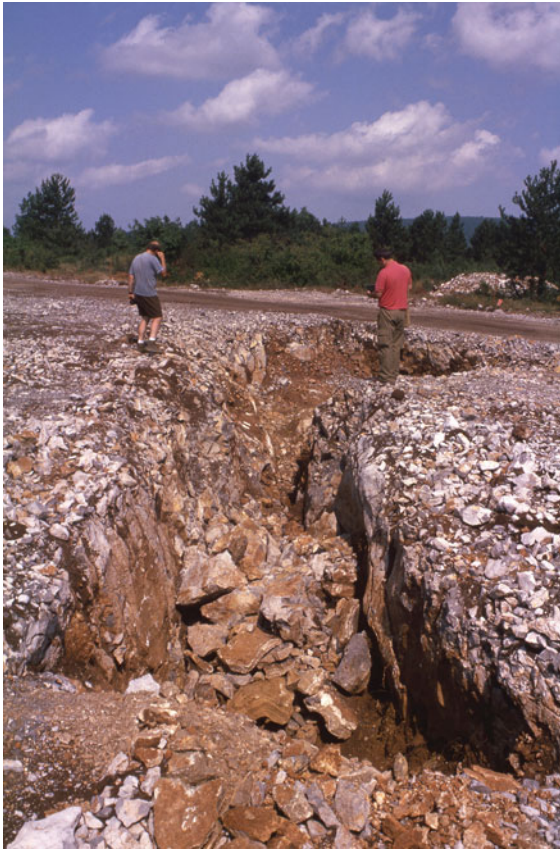
Fig. 6.7 Preserved walls of an unroofed cave

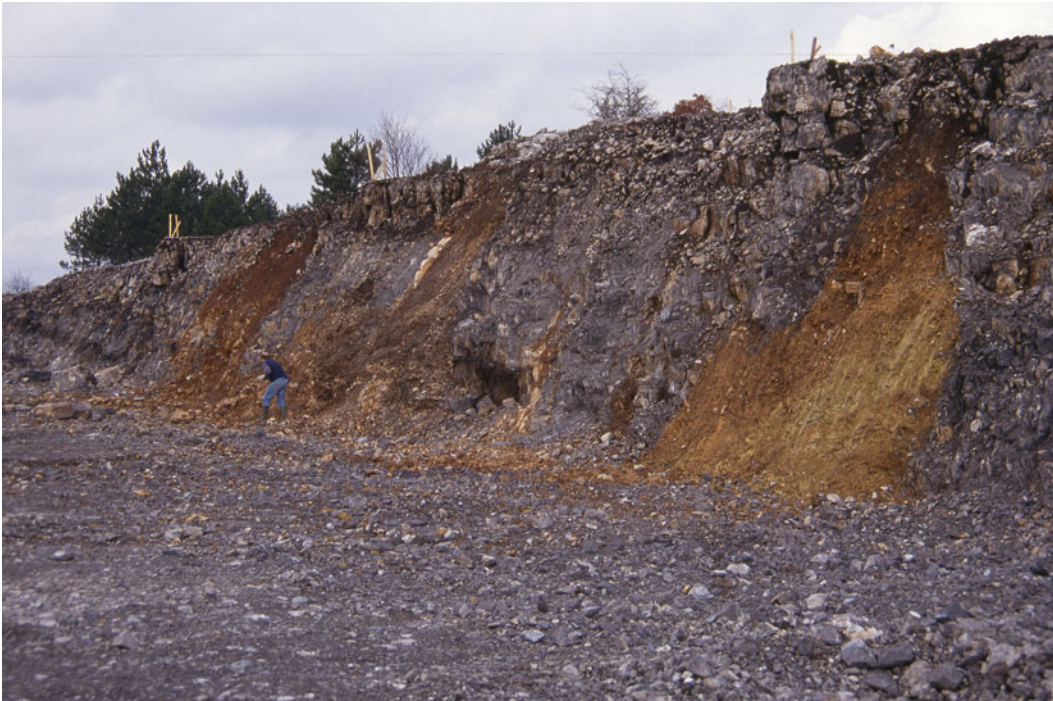
Fig. 6.8 Caves filled with alluvia in the embankment of a motorway roadcut

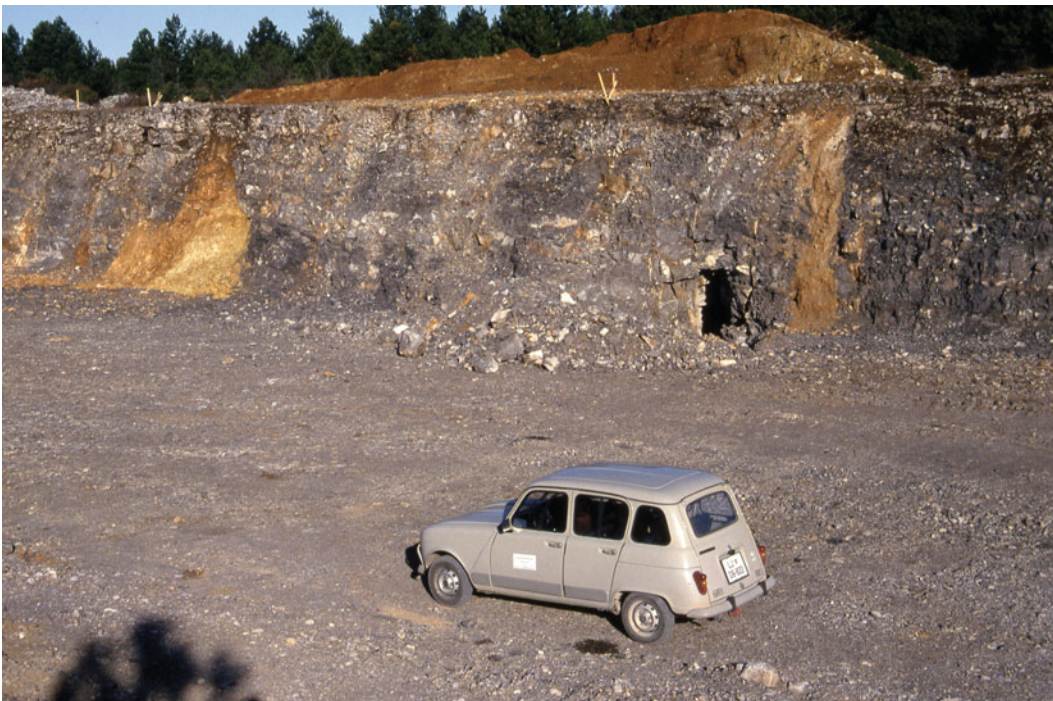
Fig. 6.9 Hollow and alluvium-filled caves uncovered during excavation works for the motorway roadcut

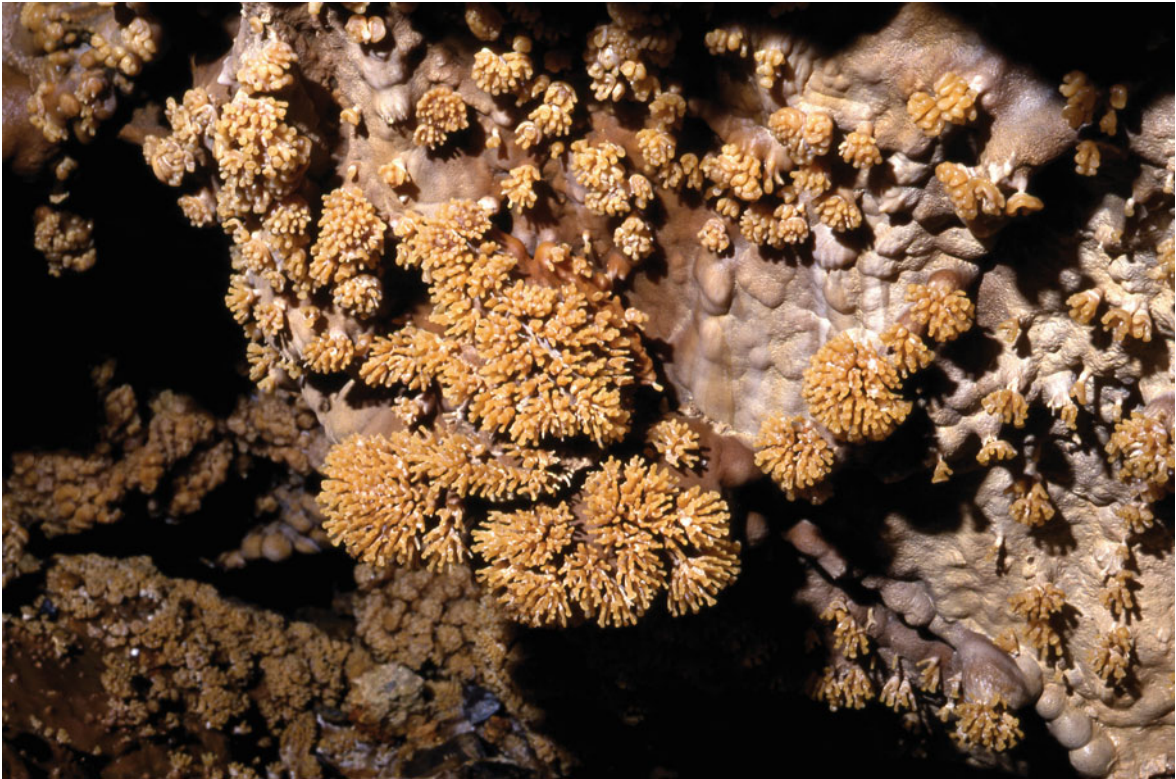
Fig. 6.12 Aragonite crystals on the walls of the shaft

The motorway route revealed several small entry shafts and several deeper stepped shafts. The deepest shaft reached 109 m deep (Fig. 6.11). In this part of the Karst region, water flows are very deep below the surface—200 m and over. For a longer period, they have been infiltrated by precipitation water. Additionally, water carved its way along the fissures. The less prominent fissures, which allowed smaller drainage of water, meant that large caves could be formed only on more open sections. The walls in fissured caves are already partly covered with flowstone (Fig. 6.12).

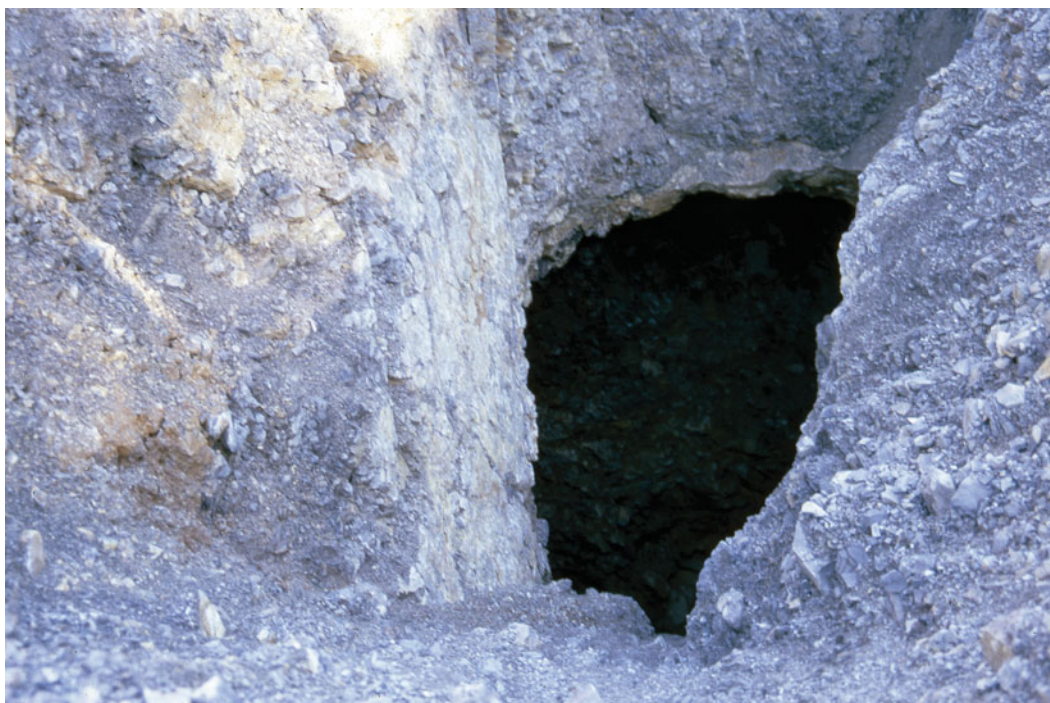
Fig. 6.14 Cave roof which collapsed along the fault

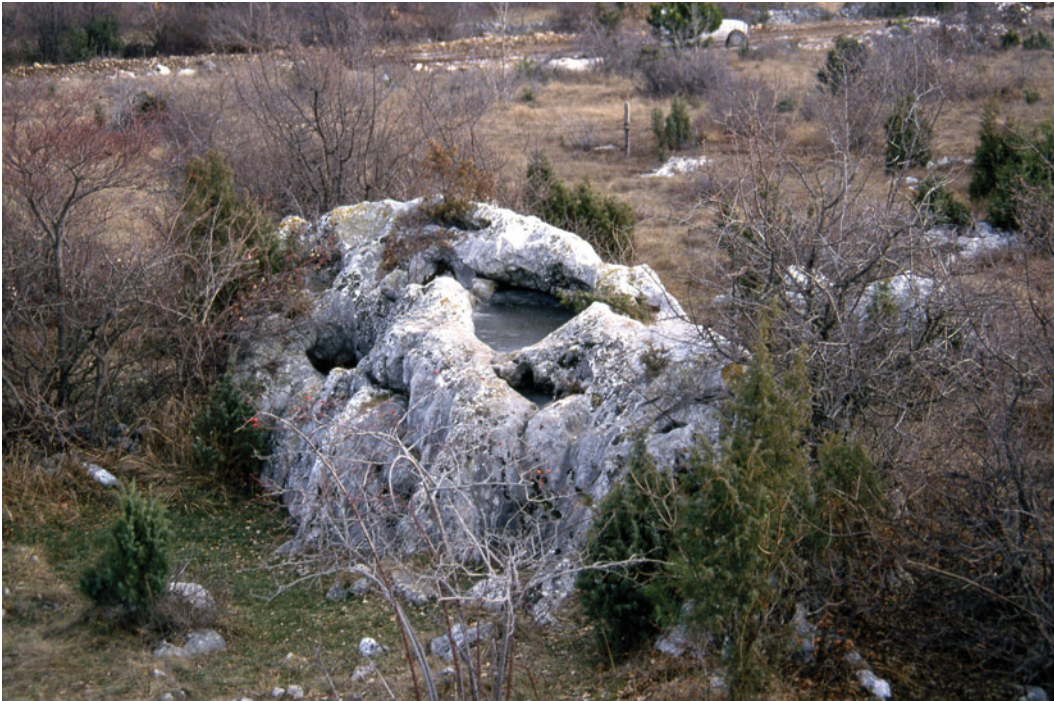
Fig. 6.15 Solution pans

Caves that were opening up in the motorway route were examined as the construction went on. The more important or attractive caves in speleology terms were treated with special care. The fundamental research was augmented with the analysis of the rock hosting the caves and flowstone. It may well be that different carbonate rocks display different cavernosity density patterns, nevertheless they are rich in caves, regardless the rock type. This was corroborated by the Palaeocene limestone which is slightly cavernous near Čebulovica hill, but highly cavernous near Povir. All types of limestone and dolomite feature old caves, shafts and surface rock forms—solution pans (Fig. 6.15). The largest share of shafts is perforating Cretaceous

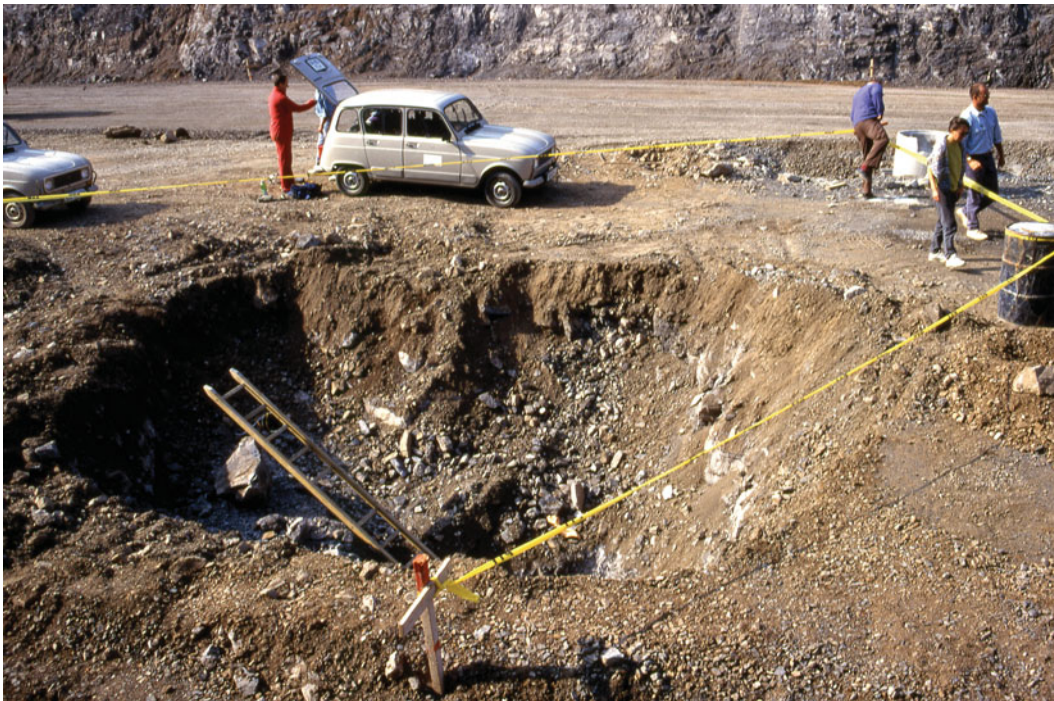
Fig. 6.16 A road collapse

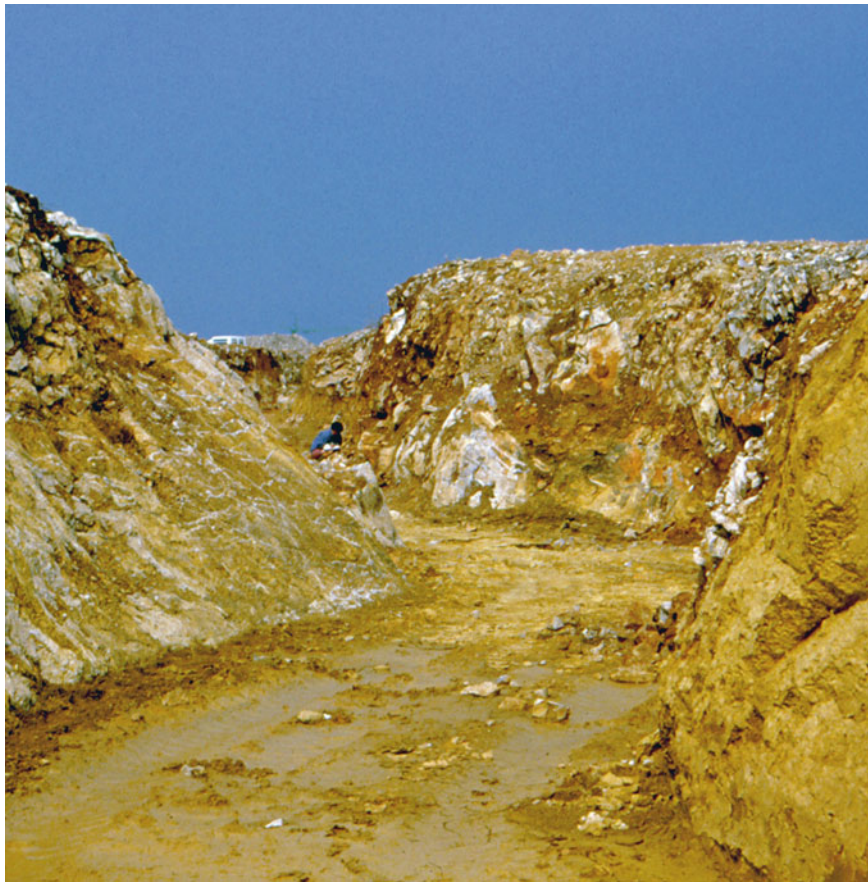
Fig. 7.1 An unroofed cave

Unroofed caves (Fig. 7.1) are old caves that were revealed on account of the lowering of the karst surface. They are preserved by their infill—mostly alluvium and flowstone. We were able to identify their most typical incarnations and their significance for the research of the karst aquifer cavernosity, the epikarst and topography.

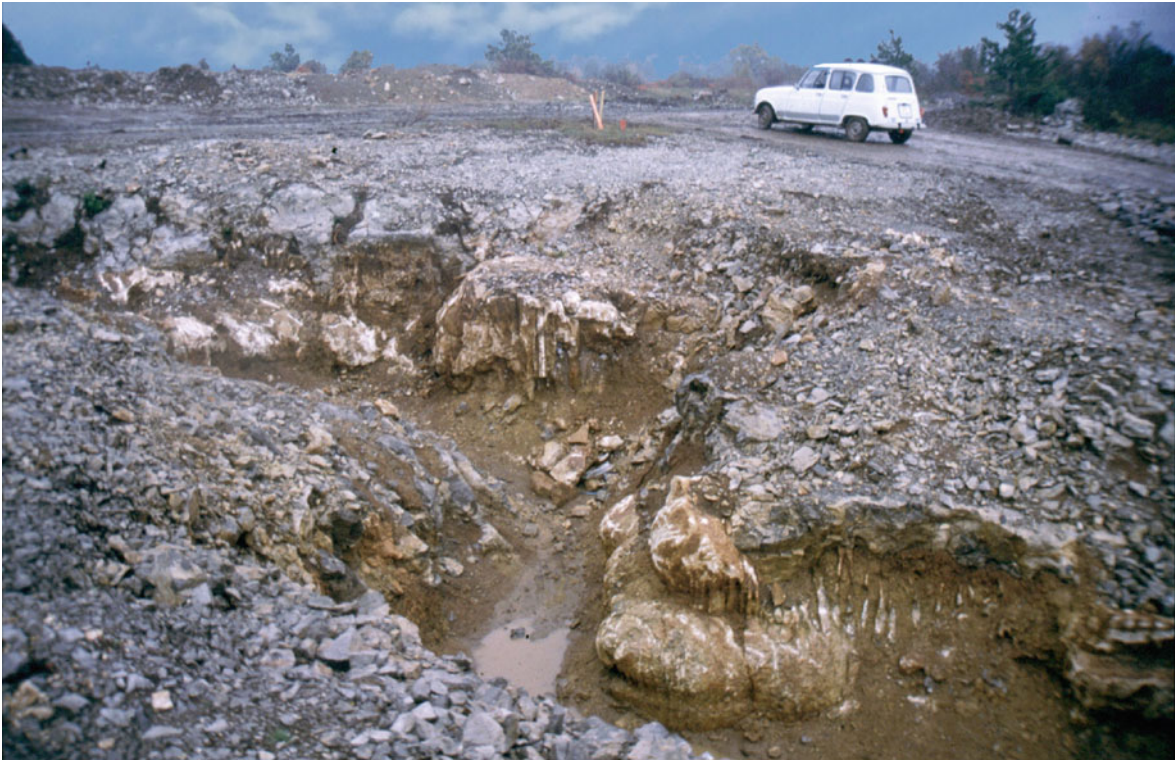
Fig. 8.1 Unroofed cave Brezstropa jama near Povir after the excavation of cave sediments. Remnants of flowstone and stalactites are still visible on the walls of the passage

with karst loam. The next step was to excavate the loam down to the supporting bedrock (Fig. 8.1). After the sod, the top layer of soil and of red loam, and the remaining sediments were stripped down by the construction crew, it became clear that this was an old cave passage. Outside of the doline, the passage, now slightly narrower, continued along the route for about 100 m, and then left the route (Fig. 8.2). The form and contents of this cave and its location at an elevation of about 400 m are important for our understanding of the development of this part of the Karst region. We therefore proceeded by measuring the cave and taking several sediment samples for further analyses.

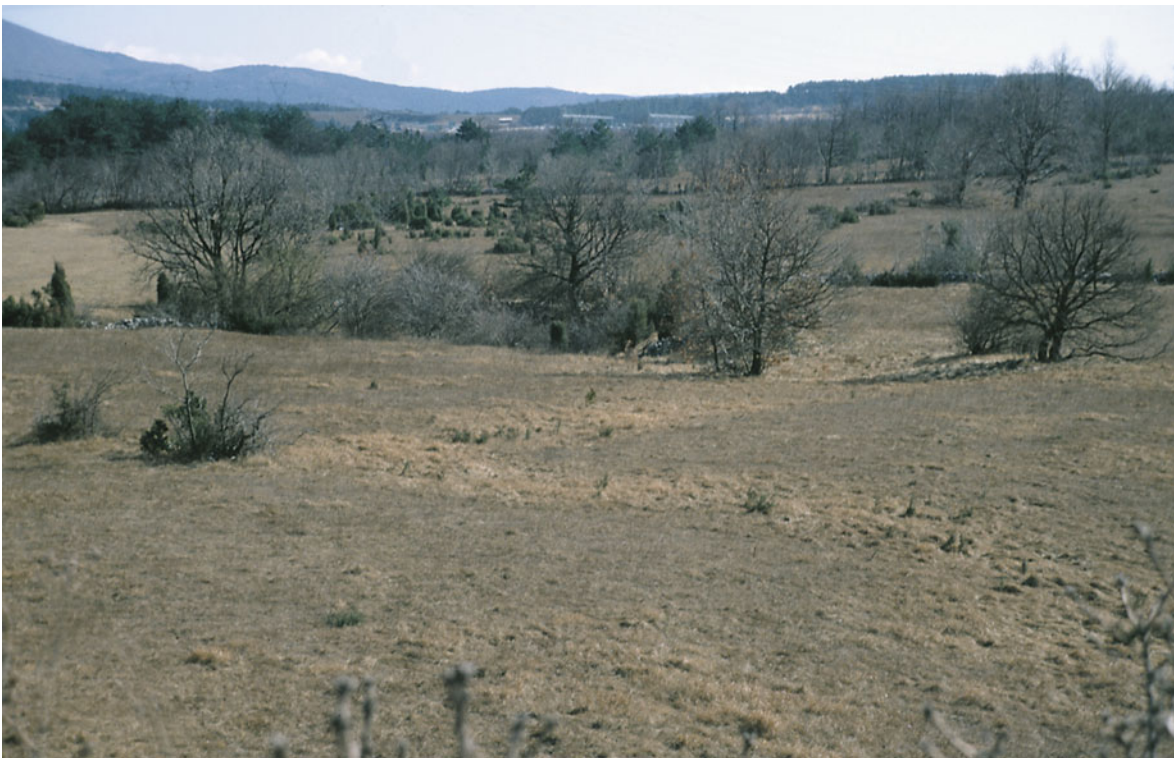
Fig. 8.4 A flat surface at an altitude of 398–400 m a.s.l. A winding unroofed cave lies in front of it. It is separated from the rest of the surface by various vegetation. This unroofed cave was not damaged during motorway construction and was thus preserved

Before the motorway construction started, this particular stretch was barely perceivable as a shallow sag. However, the aerial photographs (Fig. 8.3) made in the infrared part of the spectrum in black-and-white (cyclic filming of Slovenia in 1980) show a well expressed band of brighter, i.e. warmer ground, while a part of the passage is marked by a band of shrubs on thick soil. Similar traces of cave passages can be found on deserted pastures nearby, and some off the route (Fig. 8.4).

Fig. 8.3 On aerial photographs in an infra-red technique the unroofed cave **a–b** is visible as a zone of brighter, i.e. warmer ground. The section of the cave that has been preserved **c** can be seen in Fig. 8.4

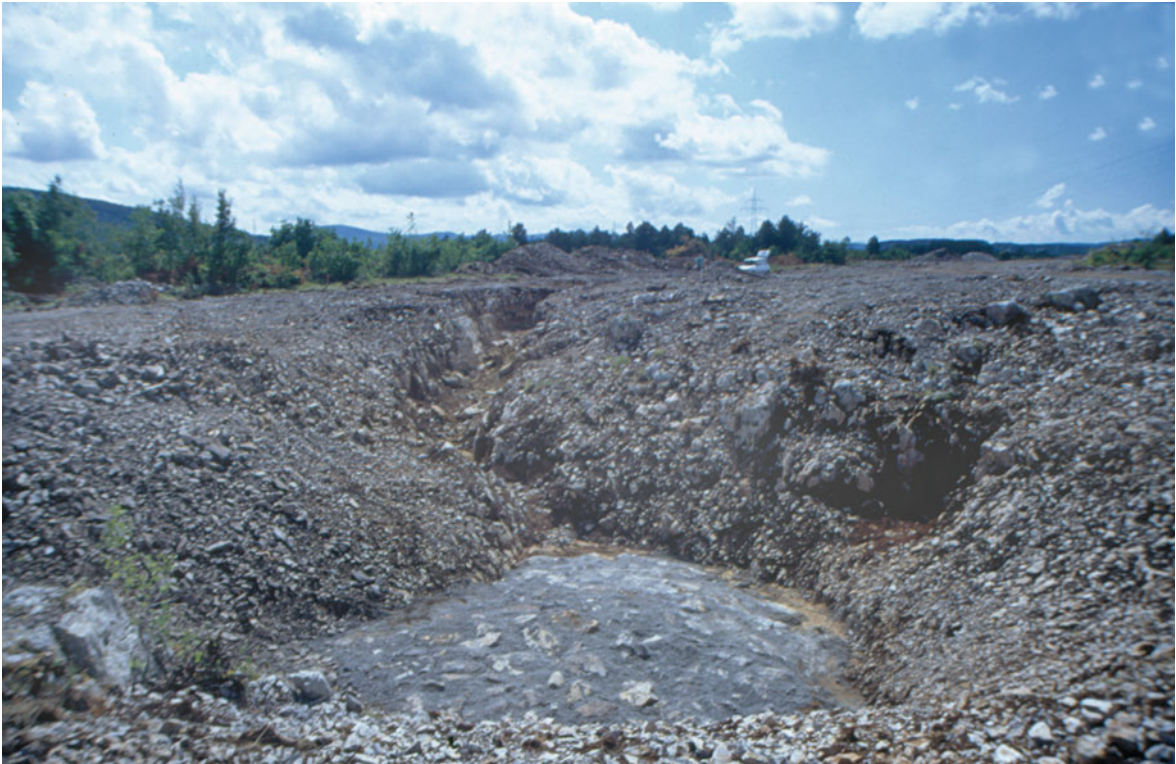
Fig. 8.5 A small corrosion doline which formed in the Brezstropa jama unroofed cave
