Cave and Karst Systems of the World

Cave Exploration in Slovenia

Discovering Over 350 New Caves During Motorway
Construction on Classical Karst

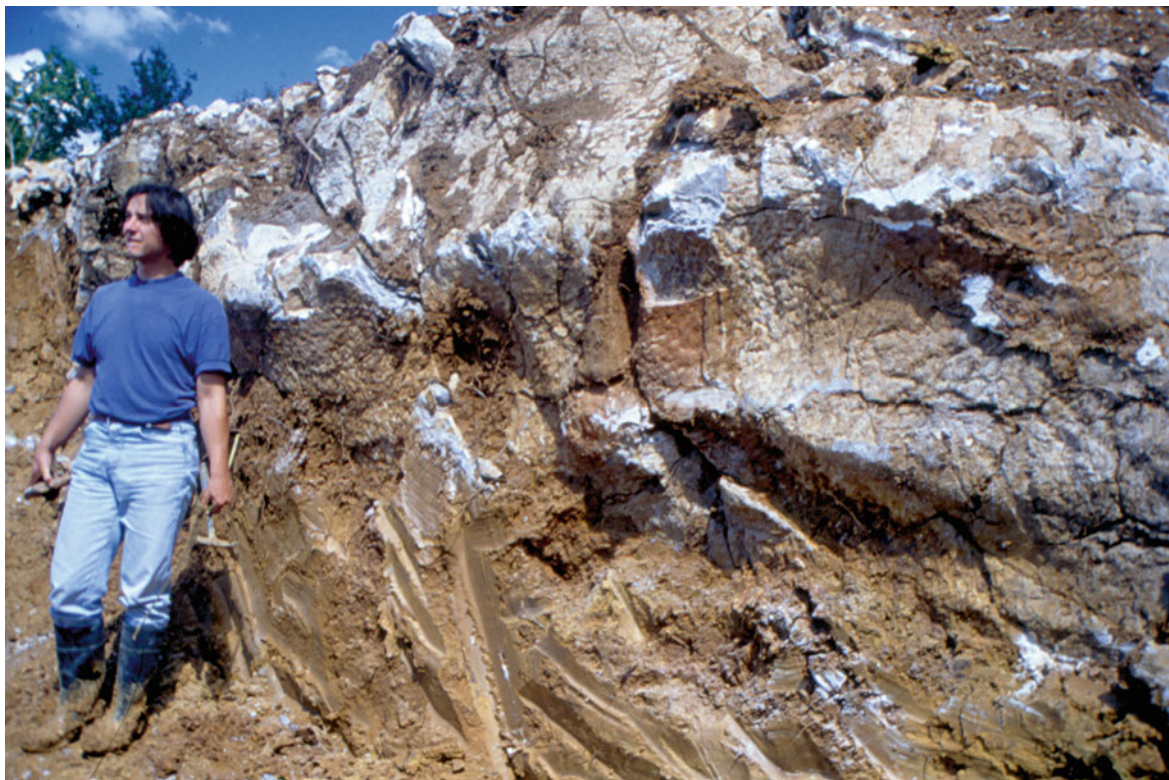
Fig. 8.6 Nicely visible in the wall of the excavated Brezstropa jama unroofed cave are wall flutes and the characteristic colour of the sediment, which next to the wall changes into a reddish

colour. Traces of epikarst decomposition of the walls are only visible in the *top part* of the cave walls

semicircular channels, along the water level line, and along the line of sediment deposits in the cave (Fig. 8.6). Similar notches, slanting in the direction of the water flow, can be found in sink caves transporting gravel.

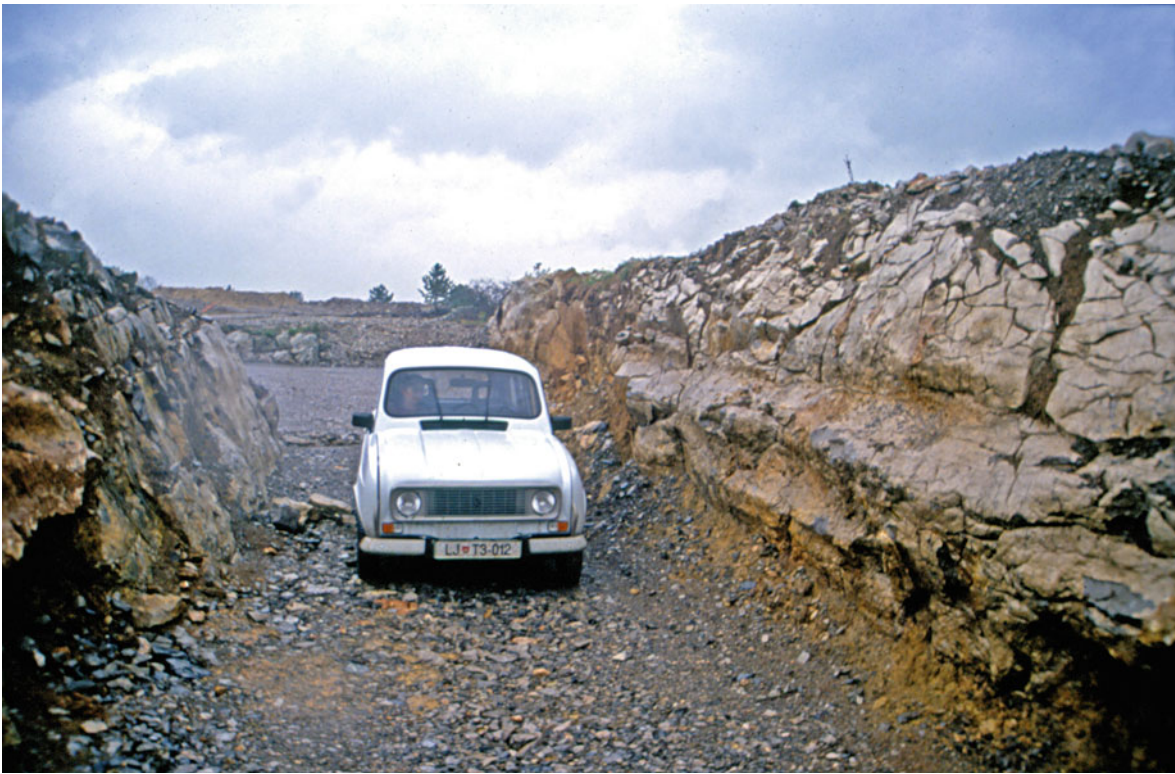
Fig. 8.7 View of the Brezstropa jama unroofed cave after its bottom was already filled in and fortified. Wall flutes are visible on the walls of the passage and in the *left part* of the photograph, in front of the car, also a remnant of an eroded flowstone heap

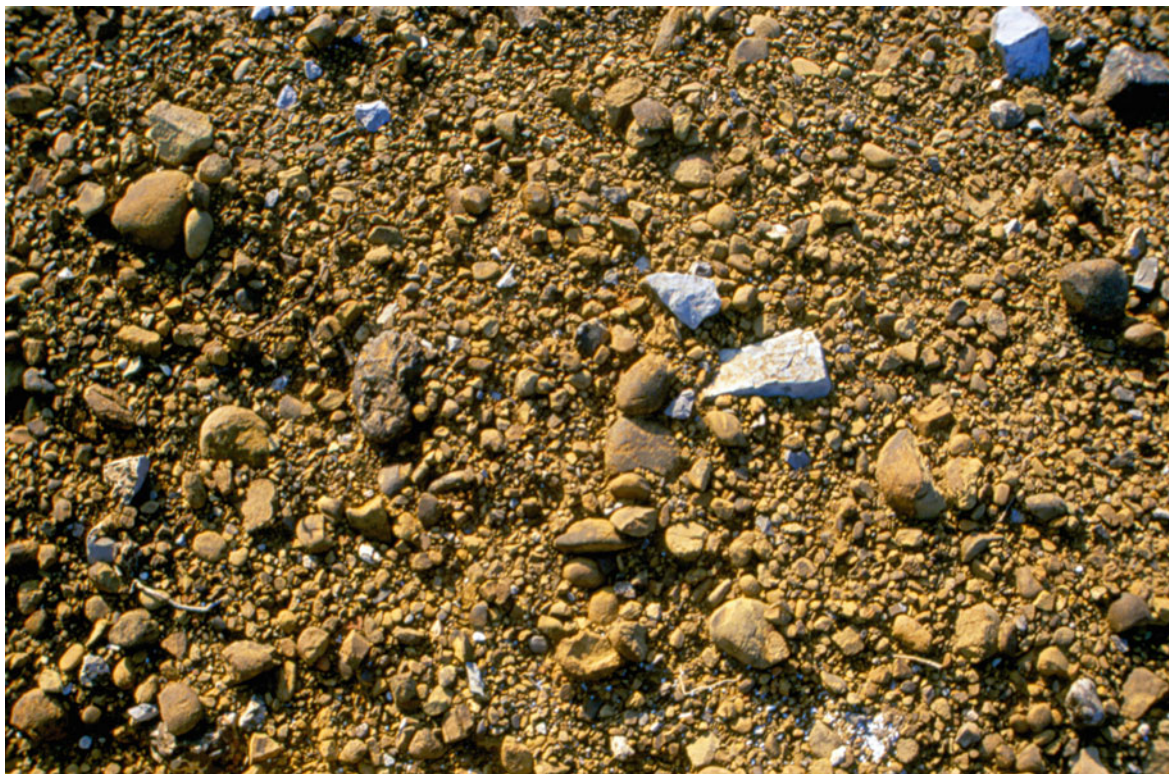
Fig. 8.8 The typical sediment in the cave are flysch sandstone gravel and carbonate gravel, in which a reduction occurred

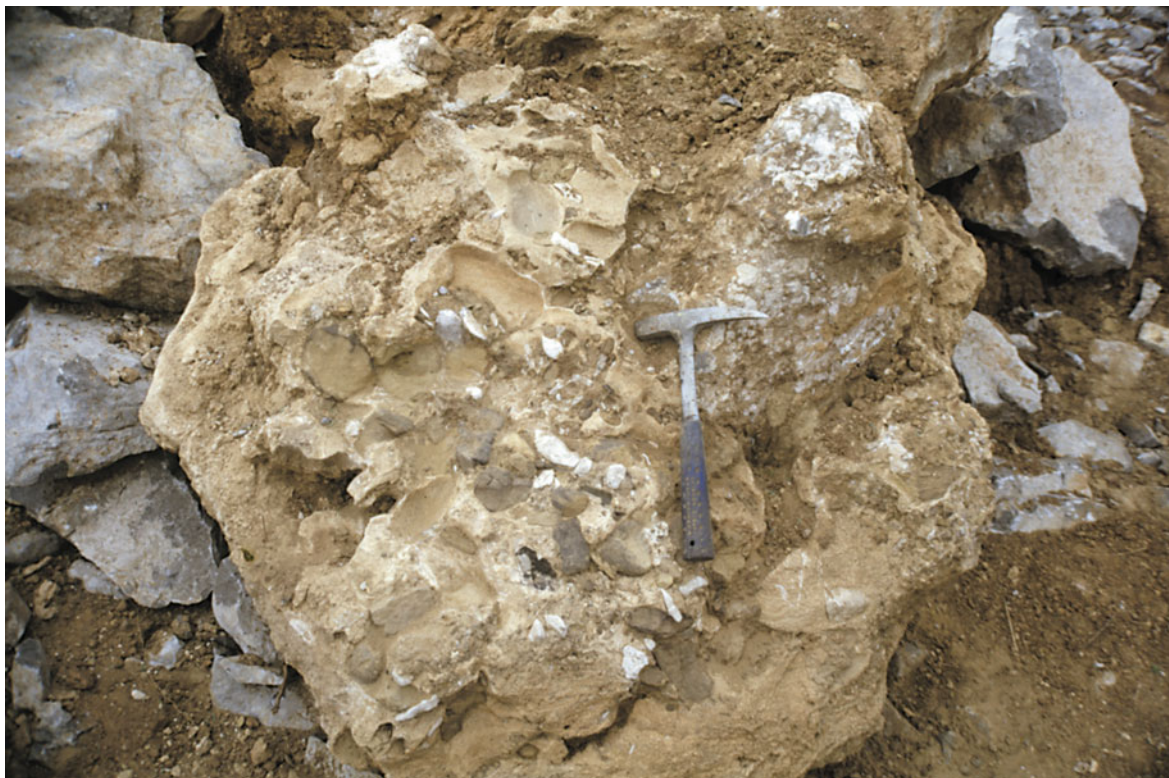
Fig. 8.9 The conglomerate, created beneath the flowstone heap, has also preserved carbonate pebbles in the sediments due to the carbonate-saturated water

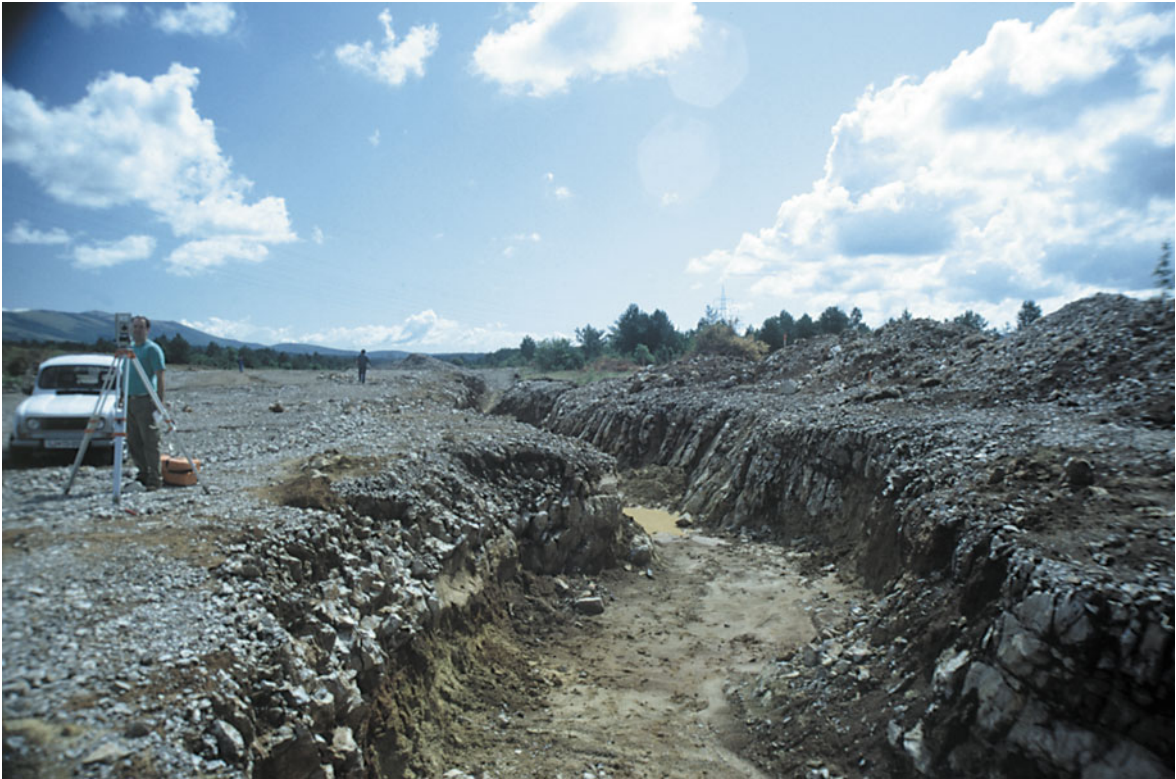
Fig. 9.2 Uncovered cave Brezstropa jama near Povir. View of the cave after the excavation of cave sediments

Most sediments are from the adjacent non-carbonate area. The sedimentation conditions in the passage changed in short-distance increments. The lenses of sand and gravel disappeared and transitioned into thinner fractions. Occasionally, the gravel was cemented in a base of massive flowstone heaps. The deposit layers were heavily folded, indicating that the sediment moved after it had been deposited in the cave. The most characteristic types of sediments were sampled. Figure 8.2 demonstrates the ground plan of the cave and the sites of the individual analysed samples. We were mostly interested in the origin of clastic sediments and how they would compare to the sediments from other sites from the route of the motorway. A reconstruction of the sedimentation conditions in the passage was not possible because of the rapid changes in granulometry and the damage caused due to machine excavation (Fig. 9.2).

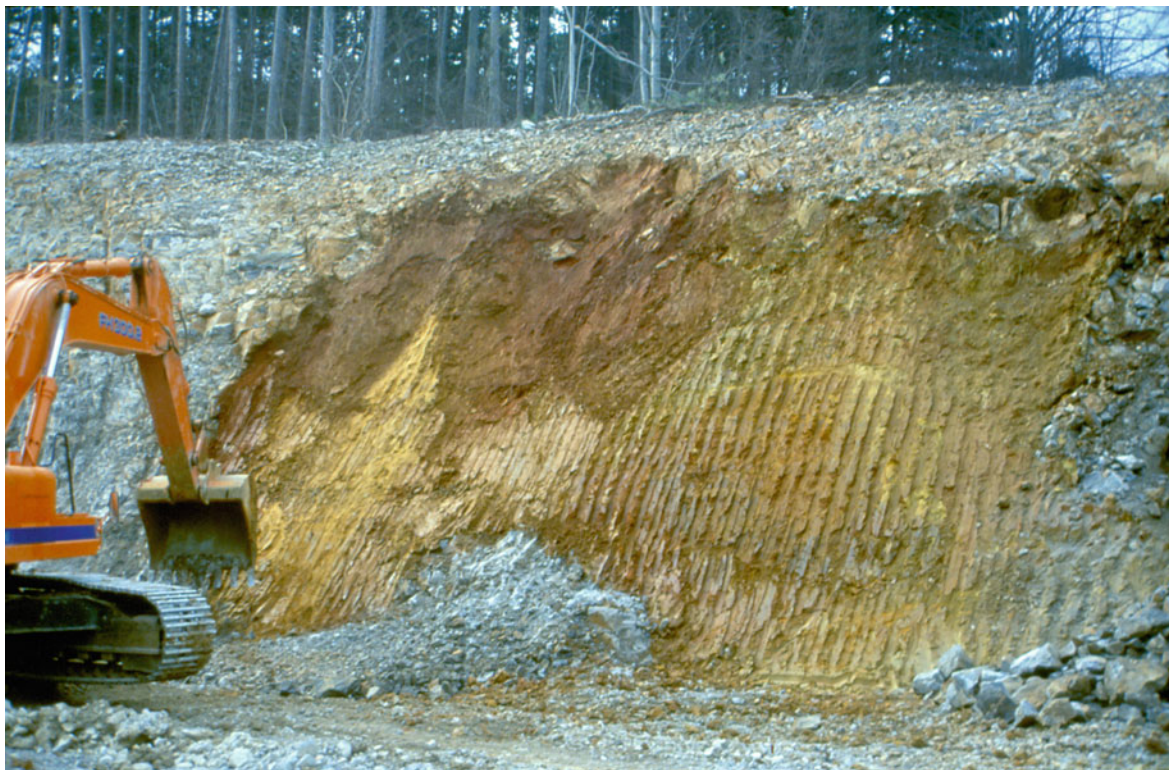
Fig. 9.11 View of the profile of the big passage filled with loam sediment in the Divaški hrib

in a roadcut in the Divaški hrib Hill there was a large cavern which was cut through at an elevation of 450 m. Inside the roadcut, it appeared as a 4 m high and 10 m wide infill of red and yellow-brown loam (Fig. 9.11). The cavern featured a preserved roof about 2 m thick. The cavern was filled up by laminated, strongly kneaded yellow loam with lenses and layers of sand, and macroscopically similar loam of red colour. Layers, lenses and laminas were kneaded and folded. It was overlain by more rubble which has been intensively dyed by red loam. The roadcut cut through the cavern, leaving us unable to establish its shape and size. It is fairly obvious though that the sediments have been significantly displaced. In one part, the cave sediment came into contact with the loam through vertical percolation, down-washing and transport of rubble into the fossil infill, becoming red in response. Two samples of the infill were analysed.

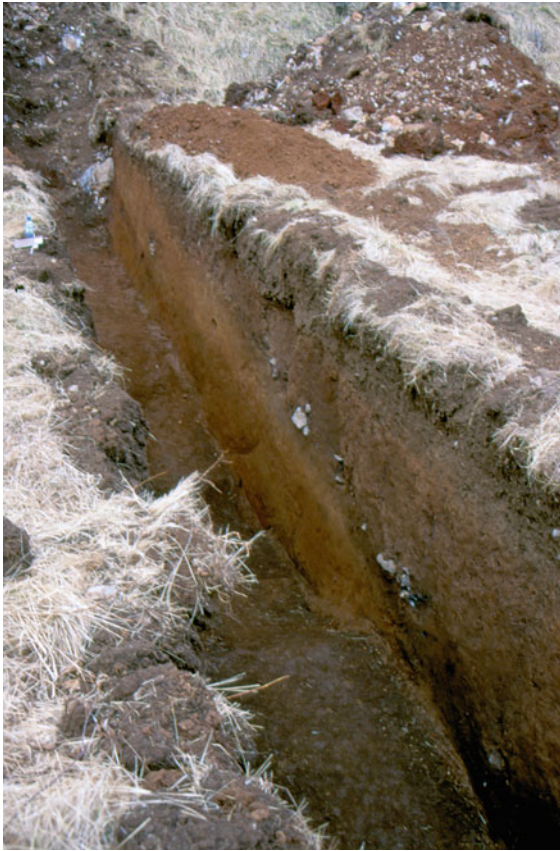
Fig. 10.4 Profile in the doline V2. Visible in the *bottom* are the layers of *red* and *yellow* loam from which two samples were taken for mineralogical analyses

Applying the method of x-ray diffraction, we analysed the V2/1 red loam sample and the V2/2 yellow loam sample (Fig. 10.4). The V2/1 sample, red loam featuring 2.5YR 3/4 colour, comprises 76 % of quartz, 12 % of chlorite, 5 % of muscovite/illite, 3 % of kaolinite, 3 % of plagioclase and 2 % of hematite. The V2/2 sample, yellow loam with 7.5YR 4/6 colour, comprises 73 % of quartz, 13 % of chlorite, 7 % of plagioclase, 4 % of muscovite/illite and 3 % of microcline.

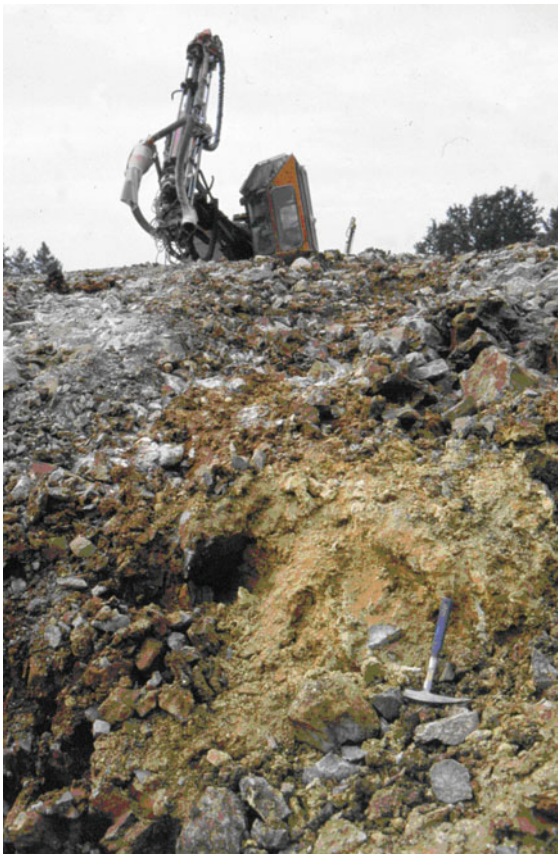
Fig. 10.7 A cave filled with a yellow clastic sediment in the motorway route Divača–Kozina, from which a JSED sample was taken for analysis

One of the caves was completely filled with yellow sandy sediments (Fig. 10.7), among which there was a large heap of disintegrating white flowstone. The sample JSED, yellow sand with the 10YR 6/6 colour, comprises 57 % of quartz, 16 % of muscovite/illite, 15 % of chlorite, 4 % of calcite, 4 % of microcline and 4 % of plagioclase.

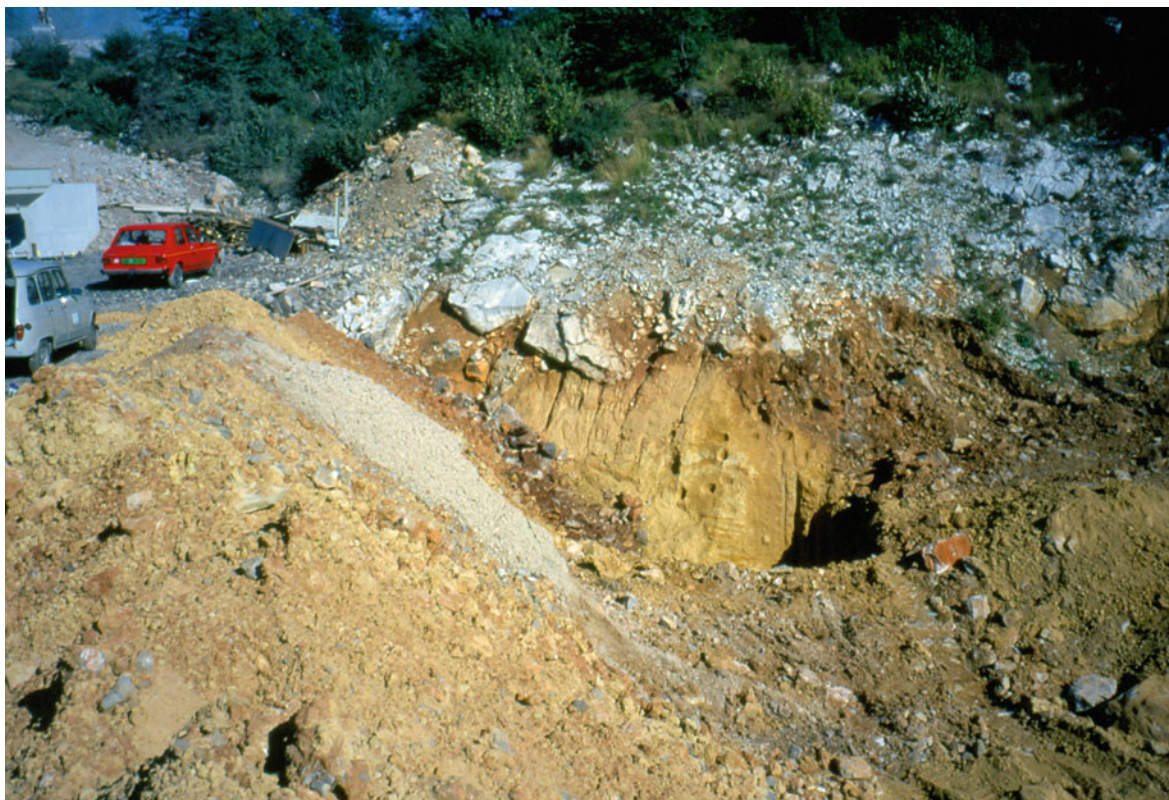
Fig. 11.1 A filled cave south of Divača in a doline on the eastern edge of the construction site of the motorway section Divača–Kozina

The infilled cave passage (Fig. 11.1) was located in the southern slope of a larger doline ($x = 5058400$, $y = 5420100$, $z = 453$ m). The cave was developed in the Lower Palaeocene limestone, with layers dipping by about 10° to the south.

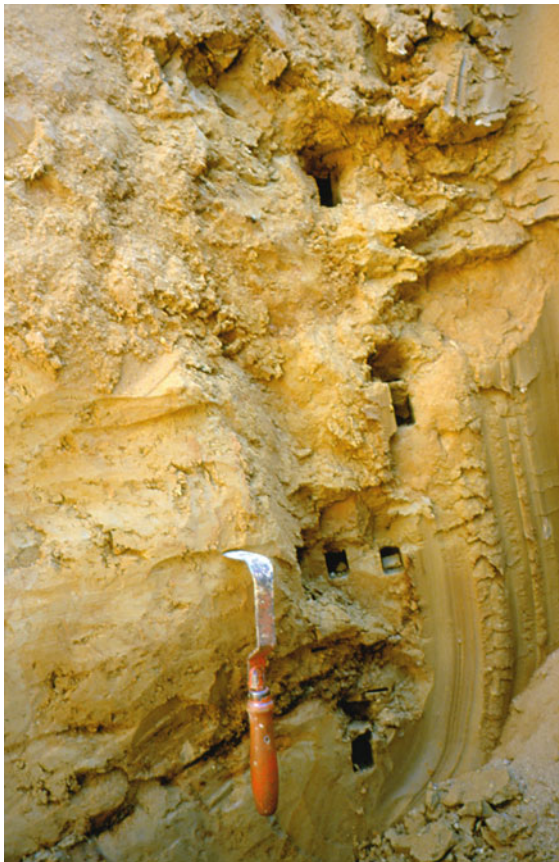
Fig. 11.2 The figure shows the sequence No. 1 in the lower section of the profile which ends with a limonite crust (along the scraper's handle), and the sedimentation of the sequence No. 2 above the crust

The fluvial cave sediments in the profile were divided into four sequences. The lower sequence, No. 1, is separated from the sediments lying above it by means of a thicker limonite crust (Fig. 11.2) that consisted of various layers of clay and silty clay, with

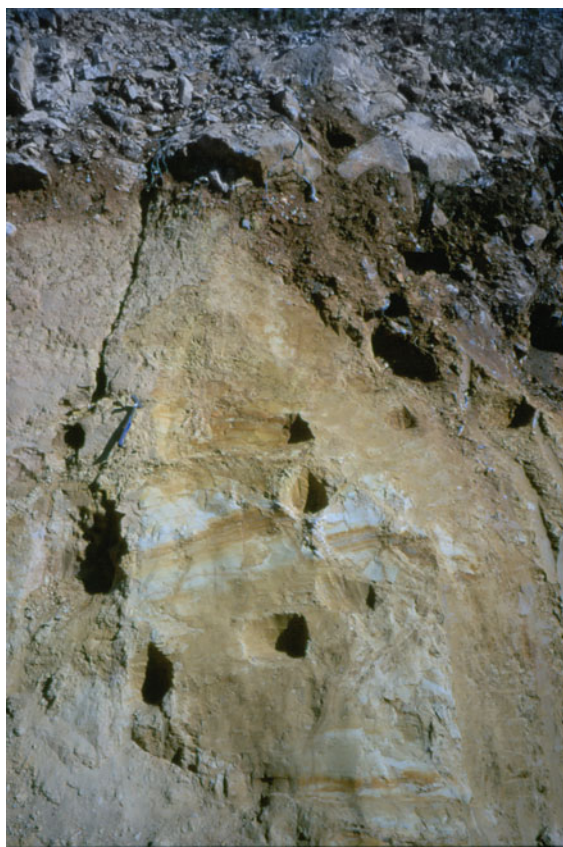
Fig. 11.3 The figure shows the sequence No. 3 in the bottom segment of the figure and above it the *red loam* of the sequence No. 4. The cave was filled up to the roof. The limestone above the cave sediments crumbled into single blocks

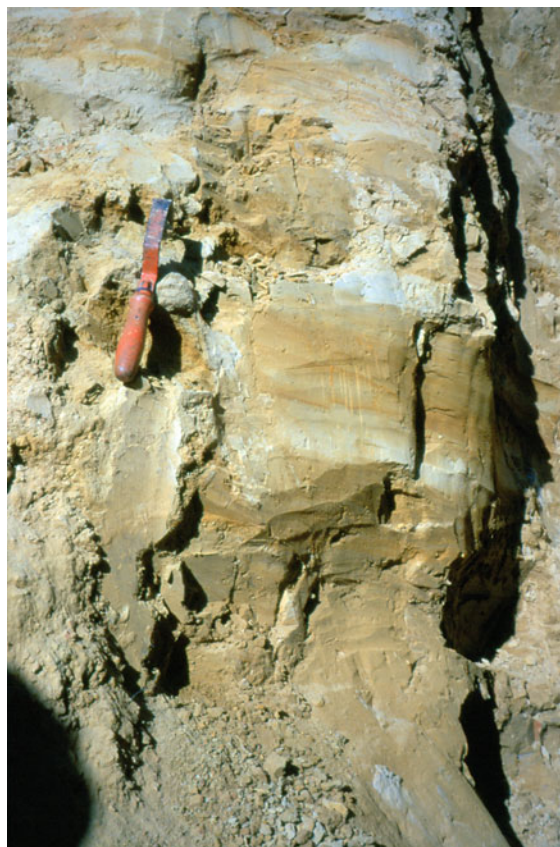
Fig. 11.4 Harder, cemented areas of the sediment protruding from the profile were located in the sequence No. 3

The sediment profile is shown in Fig. 11.5. The individual sediment areas were partially connected, i.e. cemented into irregularly shaped bodies, with a sharp contact with unconsolidated sediment. Cementation occurs especially in white and greyish-brown sands which indicate the contact type of carbonate cementation (Fig. 11.4). Some parts are heavily cemented with calcite crystals measuring several centimetres in length.

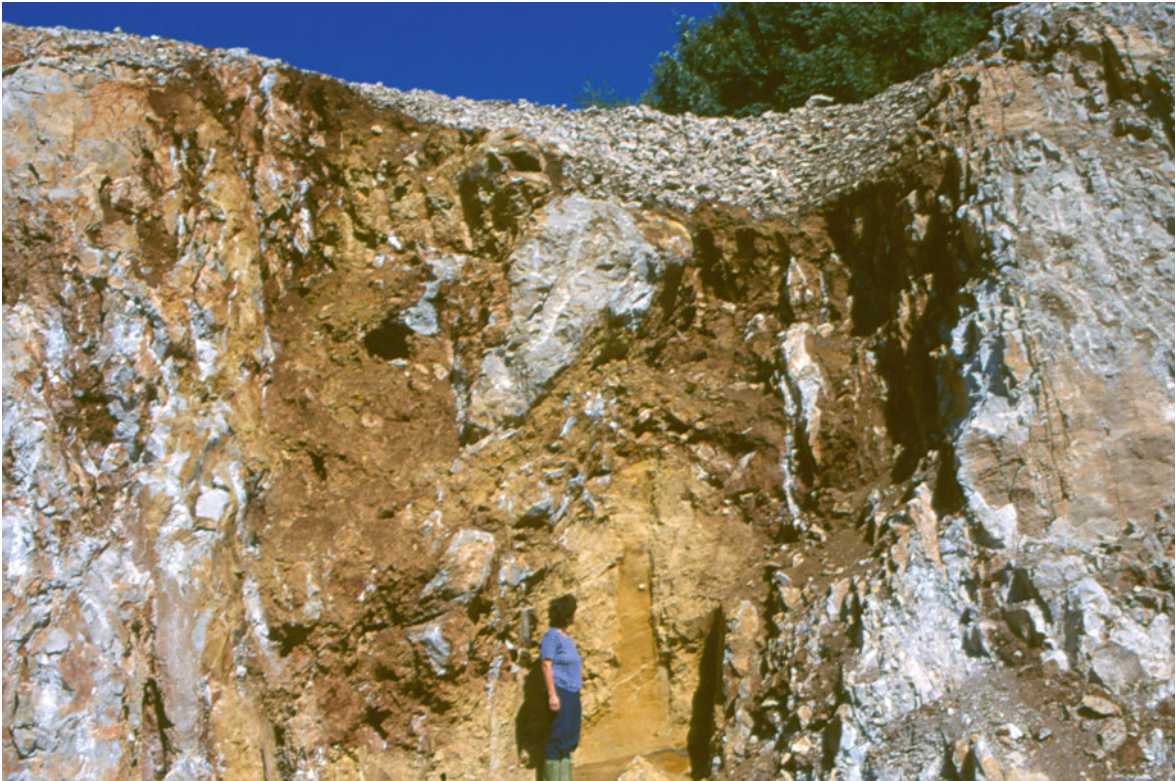
Fig. 12.4 The entire profile in the roadcut near Kozina

The sampled profile is shown on Figs. 12.3, 12.4 and 12.5. The entire profile consists of more than 5 m of alluvium. The bottom was uncovered. The fill comprised two main sequences. The lower sequence comprised

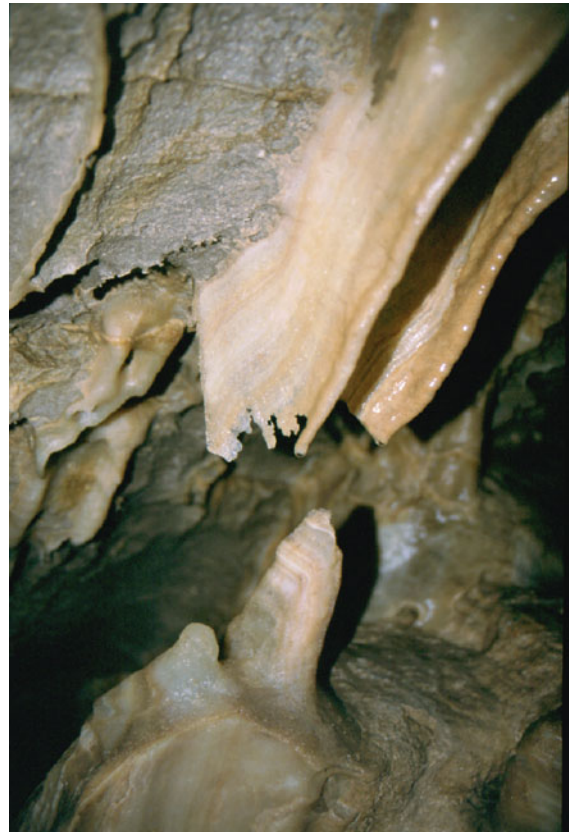
Fig. 13.2 Corroded flowstone (a curtain and a stalagmite) in the midsection of the cave

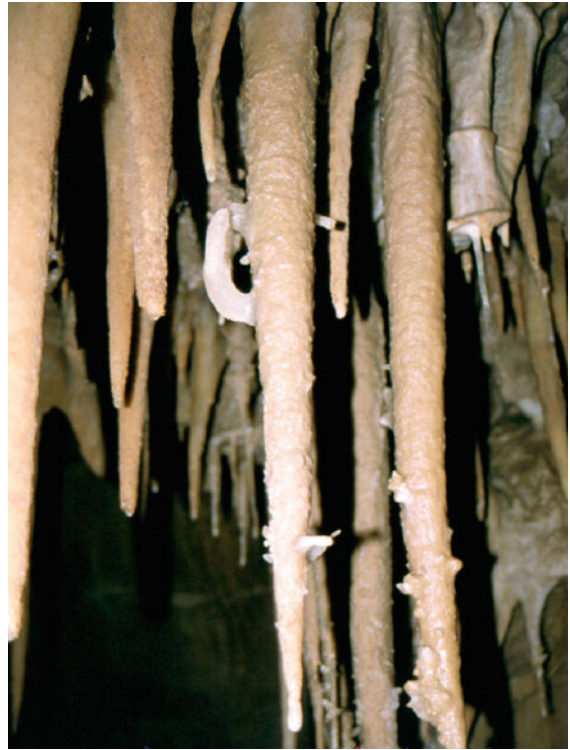
Fig. 13.5 Helictites growing out of stalactites in all directions

In the upper part of the cave, translucent multi-shaped and multi-oriented helictites are growing from the ceiling, walls and stalactites (Fig. 13.5). Helictites are a less frequent form of flowstone and grow from capillary water that trickles through thin channels, usually through transverse fissures in stalactites. The growing helictites follow the principles of crystallization rather than gravity. Colourless, white or yellow, they come in various shapes, with two being predominant, namely thin, long straws that turn in different directions while growing, and short, thick-set monocystals similar to smaller horns.

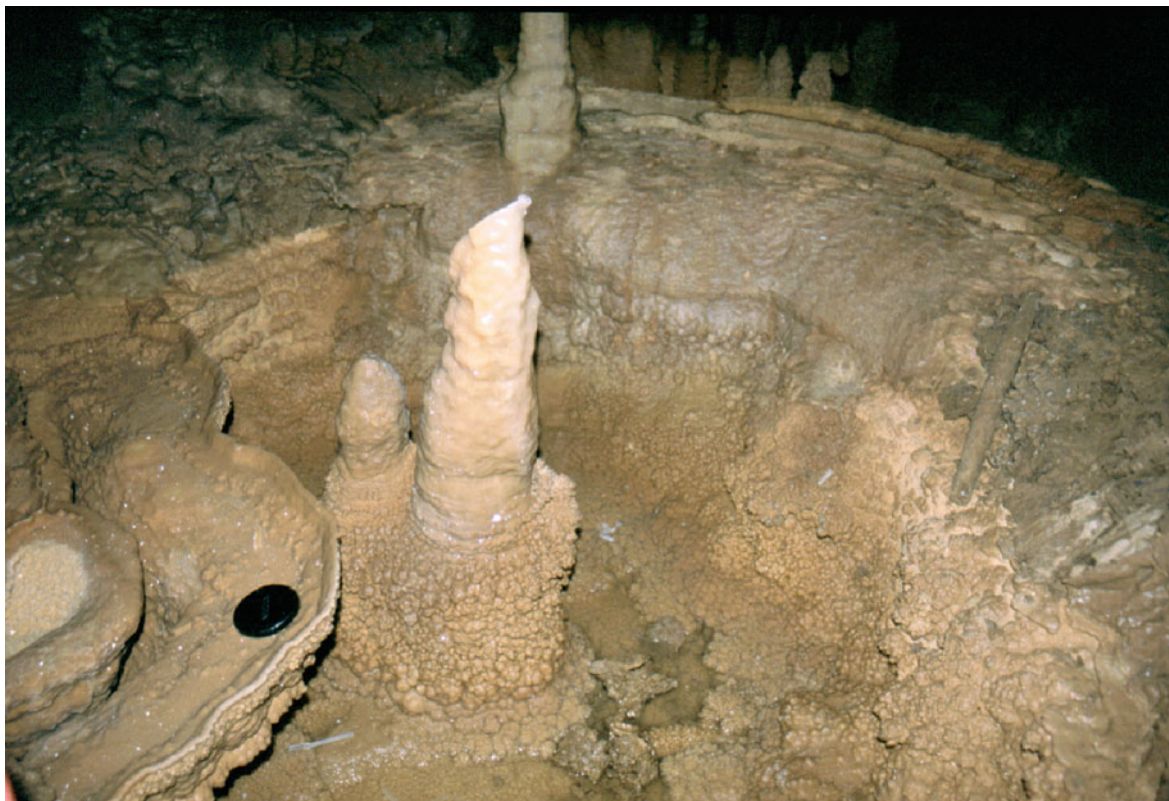
Fig. 13.6 Dry pools in which stalagmites with a triangular cross-section grow

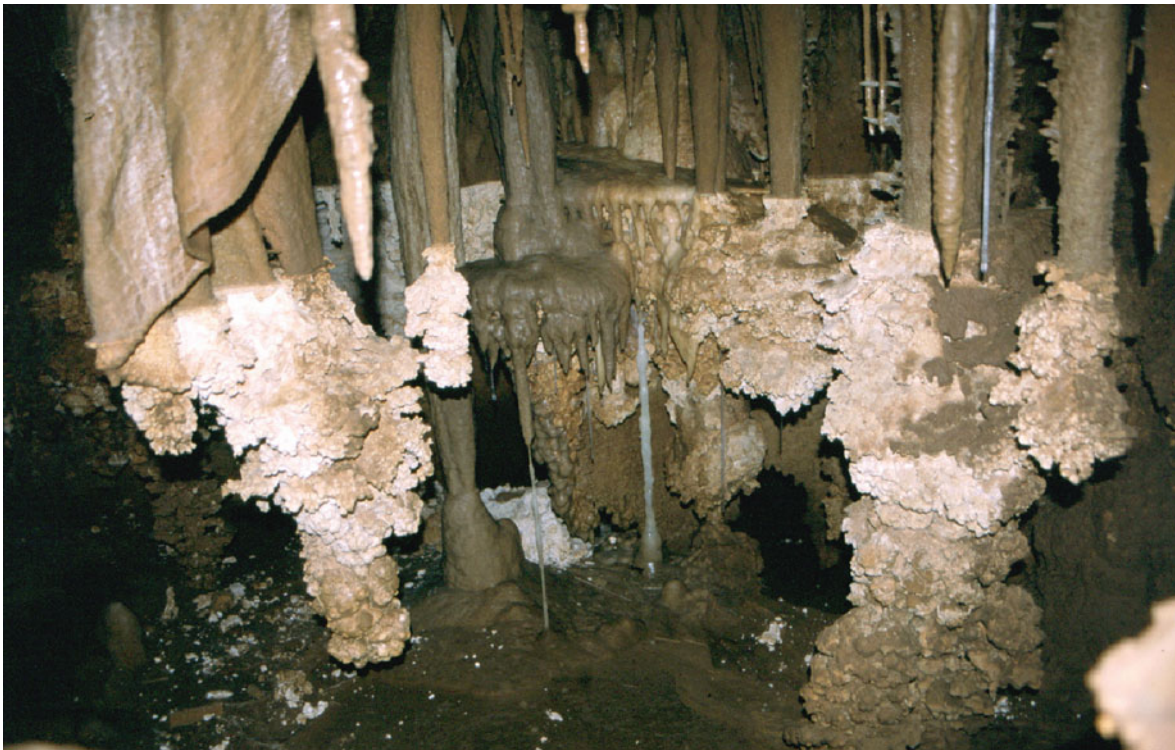
Fig. 13.8 Various types and colours of flowstone above the now dry pool in the upper section of the cave and inside it

The upper part of the cave features a large pool, in and around which flowstone was secreted in various forms and in the course of several generations (Fig. 13.8). It was secreted into the pool and above it in the following order of sequence: (1) growth of stalactites, (2) growth of pools, (3) growth and thickening of stalactite points under the water level,

Stalactites grow into this pool; they feature a special lower part and their onion-like points have grown under the water level (Fig. 13.8). Fibrous calcite was deposited on them, looking like fine crystals of cave milk. Cave milk is secreted in the form of a micro-crystallized white and soft matter on walls and flowstone, containing up to 70 % of water between the mineral crystals; it is rather crumbly when dry. The mineral composition of cave milk can vary but mostly comprises calcite or aragonite; alternatively, it can also contain non-carbonate minerals. It is formed through chemical precipitation from over-saturated solutions and with the help of microorganisms. Upon the lowering of the water level, individual floating calcite crusts (Fig. 13.9) adhered to these onion-like points of stalactites covered in cave milk. The floating calcite crusts grow from the water trapped in puddles and pools, and are secreted on the surface due to the

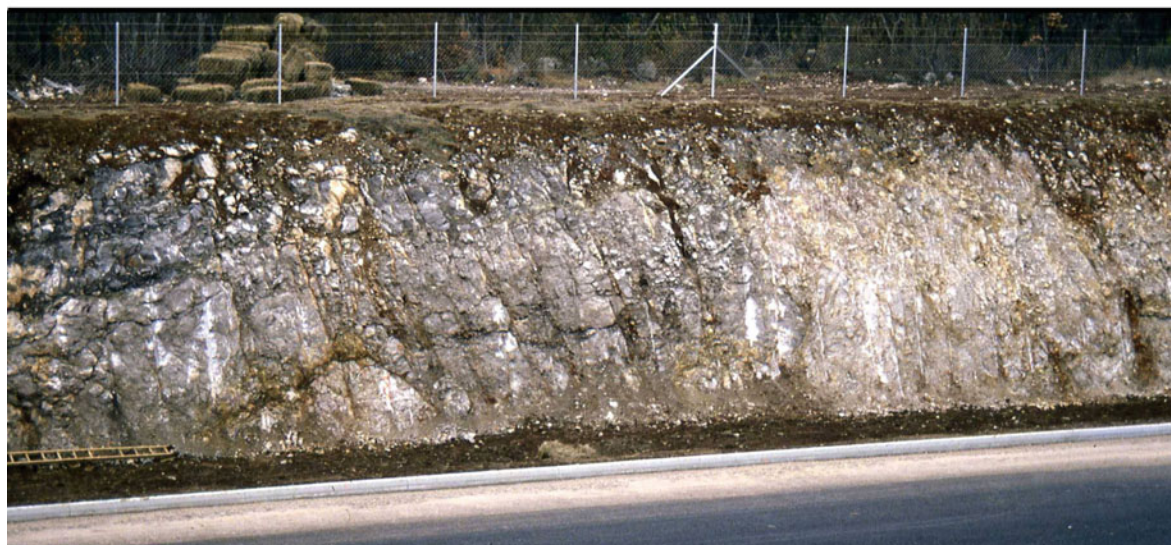
Fig. 14.1 The profile along the Divača-Kozina motorway section. *Legend* 1 limestones of the Lipica Formation (Upper Santonian); 2 bottom red horizon; 3 upper red horizon, direct base of the paleokarst surface; 4 series of horizontal centimetre-to decimetre-scale cavities, filled with brown silt; 5 paleokarst surface, contact area between the altered limestones of the Lipica Formation and the weathered zone; 6

paleokarst surface; 7 weathered zone: bauxite, calcite-bauxite-clayey sediments and breccias; 8 limestone of the Liburnia Formation, lithofacies of brackish closed bays/lagoon; 9 micro-paleokarst surface in the Liburnia Formation; 10 pedogenically modified palustrine limestone (pseudo-microkarst features); 11 present karst surface and soil

Traces of subsurface paleokarst features occur just below the paleokarst surface, in the Upper Santonian shallow-marine subtidal limestones of the Lipica Formation; in some places, they are manifested as three sub-horizontal reddish belts measuring up to 1 m in height, with secondary dissolution vugs (Fig. 14.1). The millimetre- to centimetre-scale vugs were later filled with several generations of meteoric cements alternating with muddy to silty sediments (Figs. 14.2 and 14.3). Directly under the paleokarst surface and even on it, remains of larger caves filled with sediments or flowstone can be found. Flowstone (Fig. 14.4) indicates precipitation in the vadose zone, while the frequent presence of floating calcite (Fig. 14.5) and, in some places, of cave pearls points to the precipitation from the cave pools of the epiphreatic or vadose zone. The karst surface approaching to the phreatic caves is also seen in the intense filling of caves with soil products (ferruginous-bauxite material), selectively leached cements, fossils and flowstone as well as carbonate micrite and silt (Fig. 14.6). Cave sediments also occur

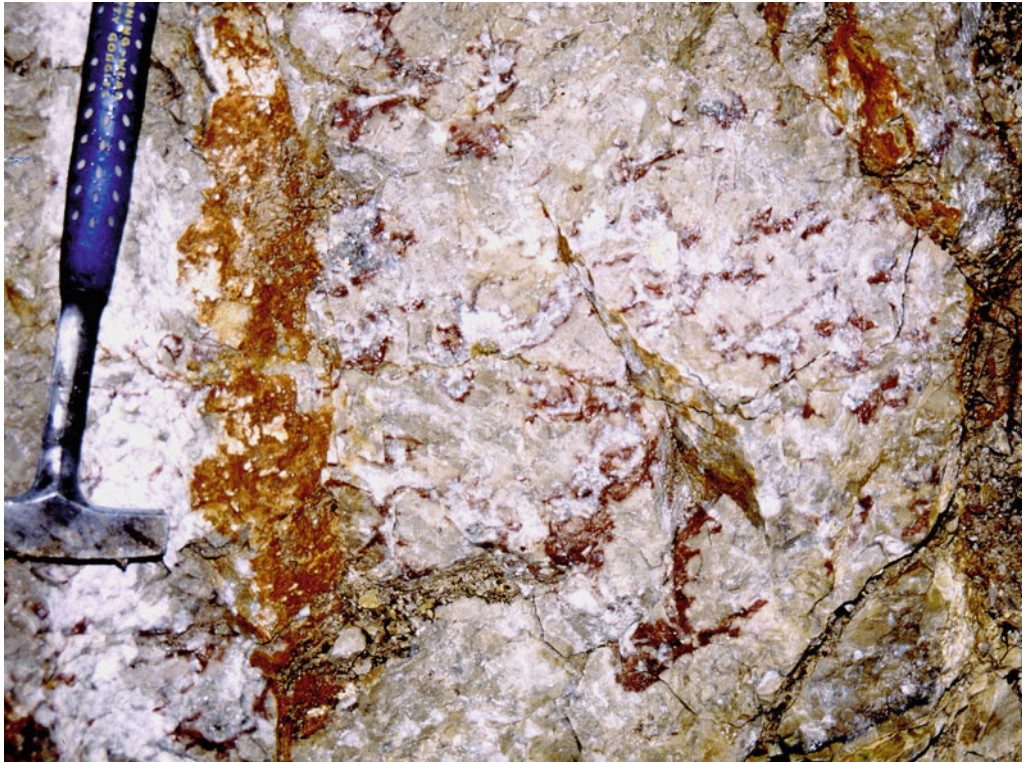
Fig. 14.2 The intertwined system of small channels/vugs created through non-selective dissolution of diagenetically immature limestone is filled by geopetally deposited red micrite and coarse-grained sparite

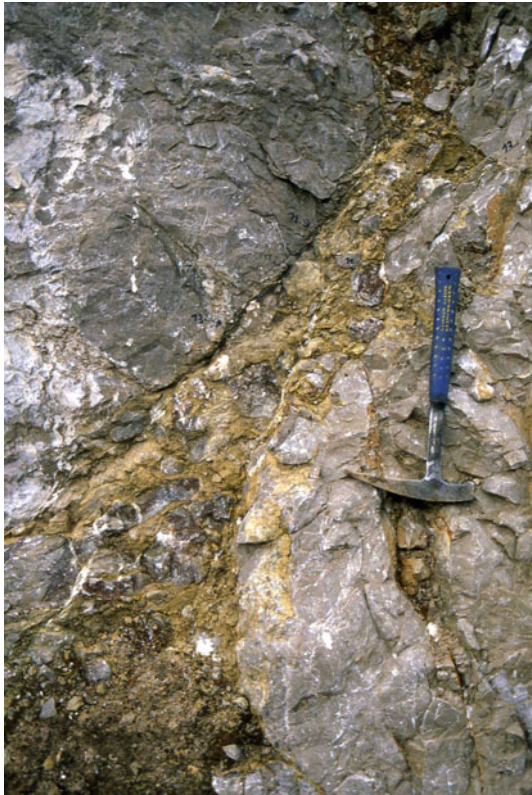
Fig. 14.7 Weathered zone, pedogenic-karstic breccia: altered limestone clasts of the Lipica formation and of flowstone embedded in the calcite-bauxite-clay matrix

frequently as clasts in paleokarst breccias (Fig. 14.7) deposited at the bottom of paleokarst depressions.

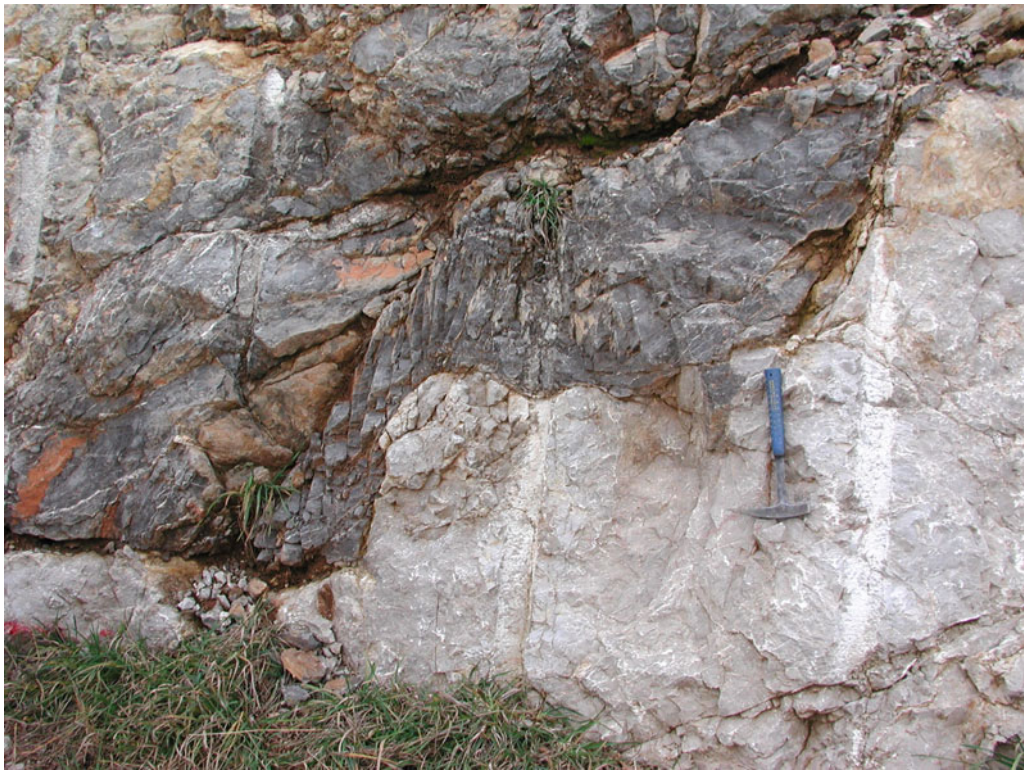
Fig. 14.8 The undulating paleokarst surface separates the Upper Santonian limestone of the Lipica Formation from the Maastrichtian limestones of the Liburnia Formation

In two-dimensional motorway cuts, the paleokarst surface is manifested in the form of pocket-like and gently undulating depressions measuring a few decimetres to several metres. (potholed paleokarstic depressions and hummocky paleokarstic depressions; *sensu* Vanstone 1998) (Fig. 14.8), and larger, distinctly irregular depressions and shafts measuring a few metres (Fig. 14.9) to as much as several tens of metres in size.

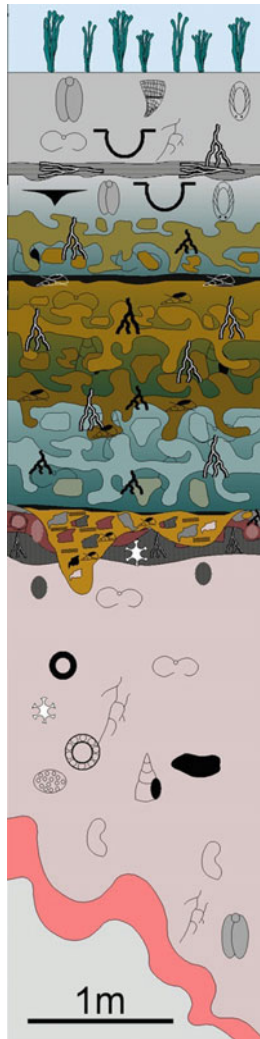
Fig. 14.12 A short geological profile of the direct cover of the paleokarst surface (*bottom left corner*) shows micrite limestones which, together with foraminifera in the *bottom part*, show at least a limited influence of seawater in a depositional environment. Higher up, the micrite limestones underwent several phases of pedogenic modification, and at least one rather prominent paleokarst surface interrupts them

over the markedly uneven karst surface, change quickly in the lateral direction (Fig. 14.1). The oscillating transgression over the paleokarst surface is indicated by the sedimentary succession arranged in the shallowing upwards cyclical parasequences (Fig. 14.12). The limestone is frequently interwoven with pseudo-microkarst voids (*sensu* Freydet and Plaziat 1982) (Fig. 14.13) that show the breccia-like and “pseudo-breccia-like” texture (Fig. 14.14). In the bottom few metres of the succession, only one cycle with a “true” paleokarst surface (Fig. 14.1) covered with regolith (Figs. 14.14 and 14.15), which also includes karst pockets that are up to a few metres deep (“pit cave” or “dissolution pit”; *sensu* Mylroie and Carew 1995) (Fig. 14.16) occurs.

The quick lateral and vertical alteration of the facies of the lower part of the Liburnia Formation (Figs. 14.12, 14.13, 14.14, 14.15 and 14.16) can be explained by the oscillating transgression over the

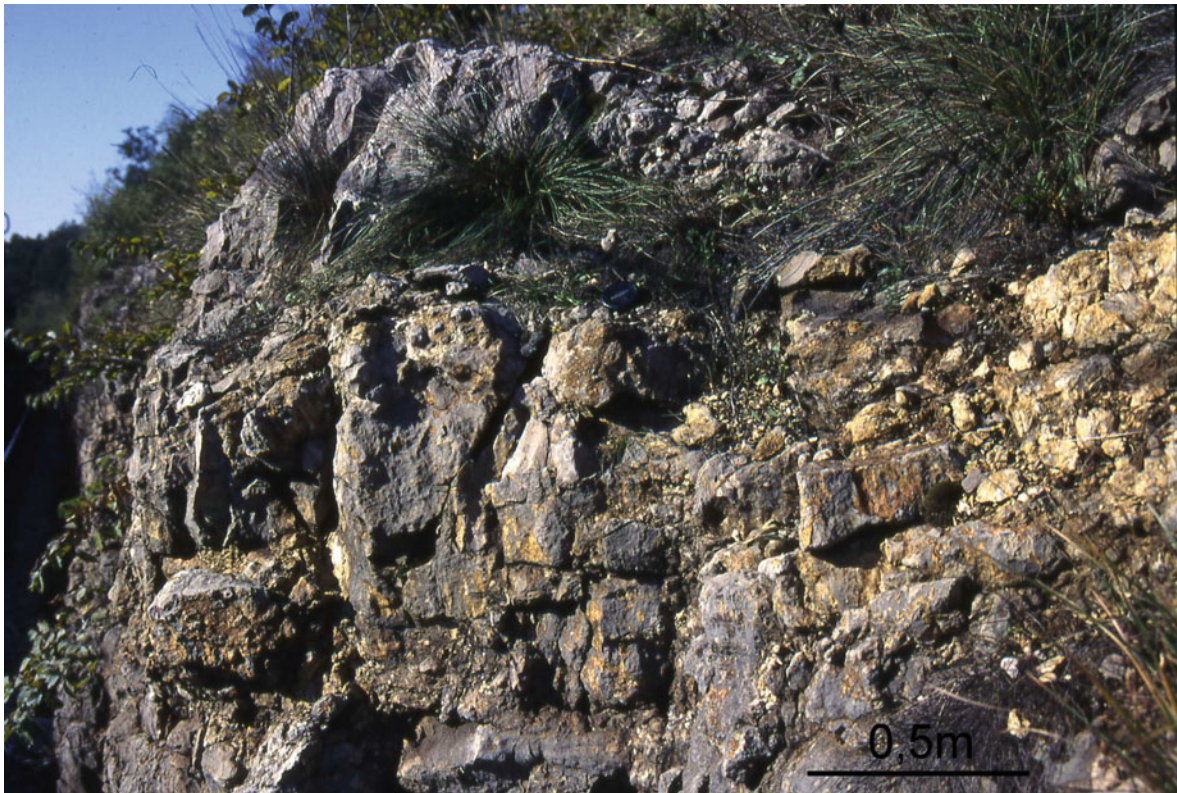
Fig. 14.15 Regolith, which matrix, in addition to the calcite grains, is abundant in kaolinite (>40 wt.%), but does not contain bauxite minerals, covers the paleokarst surface in the *bottom*

part of the Liburnia Formation, only a few metres above the main paleokarst surface

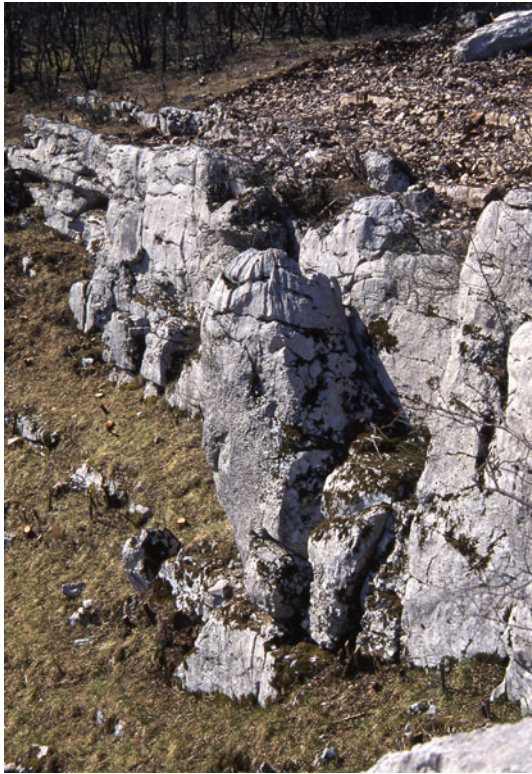
Fig. 14.19 In the upper part of stone teeth measuring over 1 m in height, rain flutes were carved out by rainwater

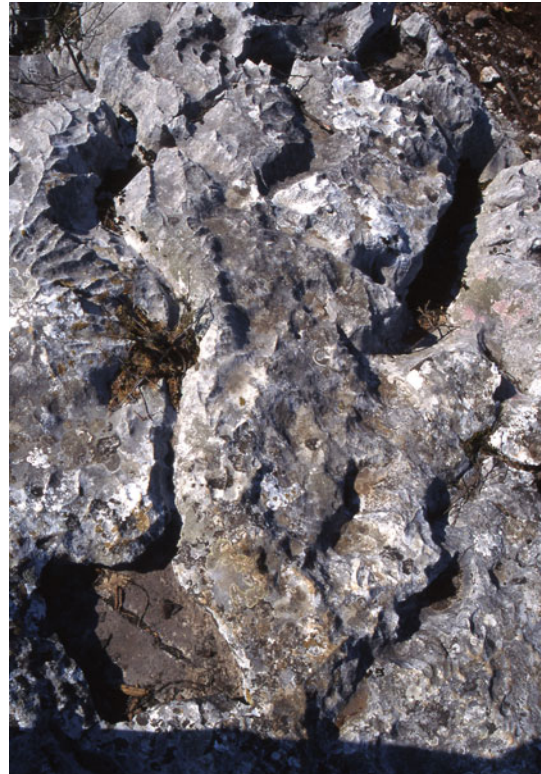
Fig. 14.20 Rain flutes and solution pans were carved out by rainwater (app. image width 0.75 m)

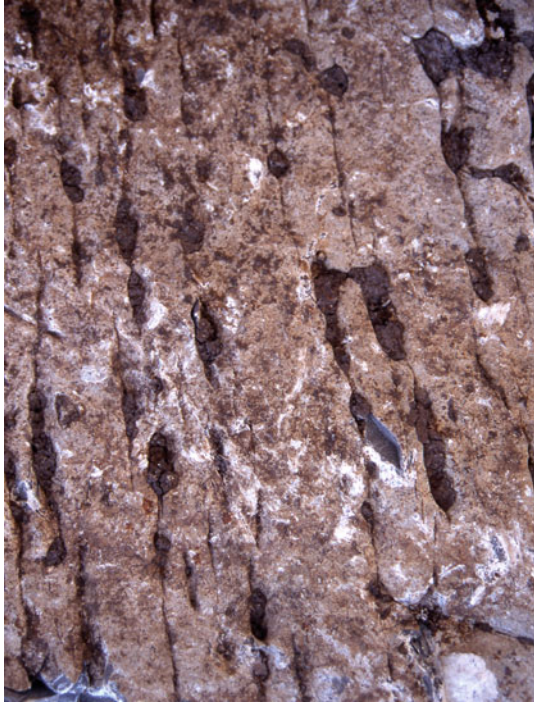
Fig. 14.21 Subsoil hollows on the freshly uncovered rock surface (app. image width 0.75 m)

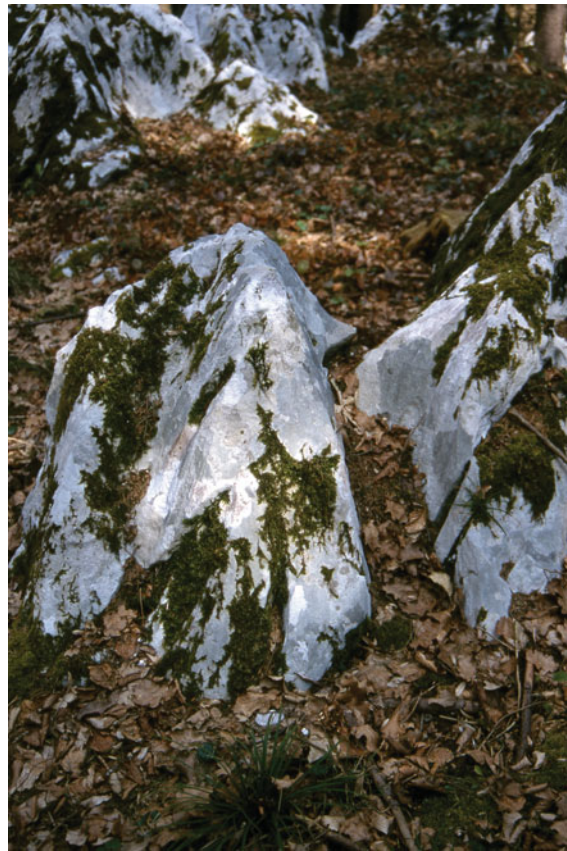
Fig. 15.3 Subcutaneous stone teeth

reach several metres and the rock shape between is reminiscent of subsoil teeth developed in a heavily crushed rock (Fig. 15.3). In places where fissures are more thinly scattered and the rock is more corrosion resistant, genuine stone teeth with pointed or blade-like tops have developed, while some places even feature smaller stone forests (Knez et al. 2003) (Fig. 15.4). They are dissected by subsoil channels. Underground, their surface is typically corroded; it is relatively smooth on the uniform and fine-grained rock, and rougher on diversely structured or crushed rock. Prior to the removal of the soil, only smaller karren or pieces of rock were jutting out to the surface which was overgrown and often covered in moss. There were also solution pans, indentations and partly reshaped subsoil formations (Fig. 15.5), channels and notches (Slabe 1998a). The latter are indications of slow soil erosion.

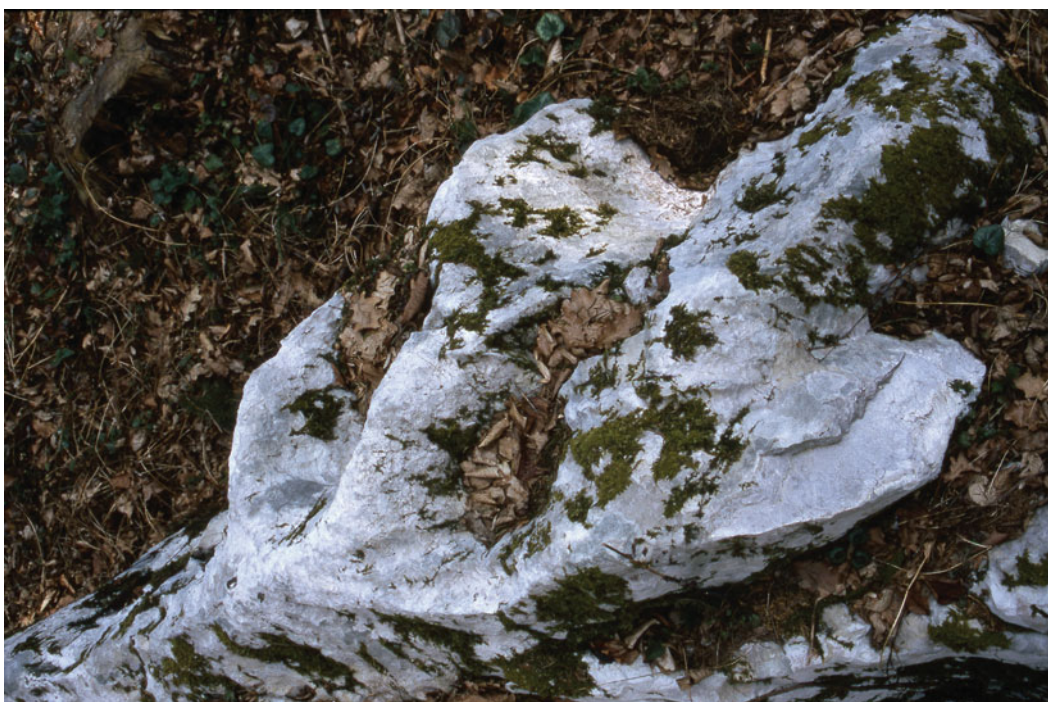
Fig. 15.5 Subsoil indentations on karren
