Cave and Karst Systems of the World

Cave Exploration in Slovenia

Discovering Over 350 New Caves During Motorway
Construction on Classical Karst

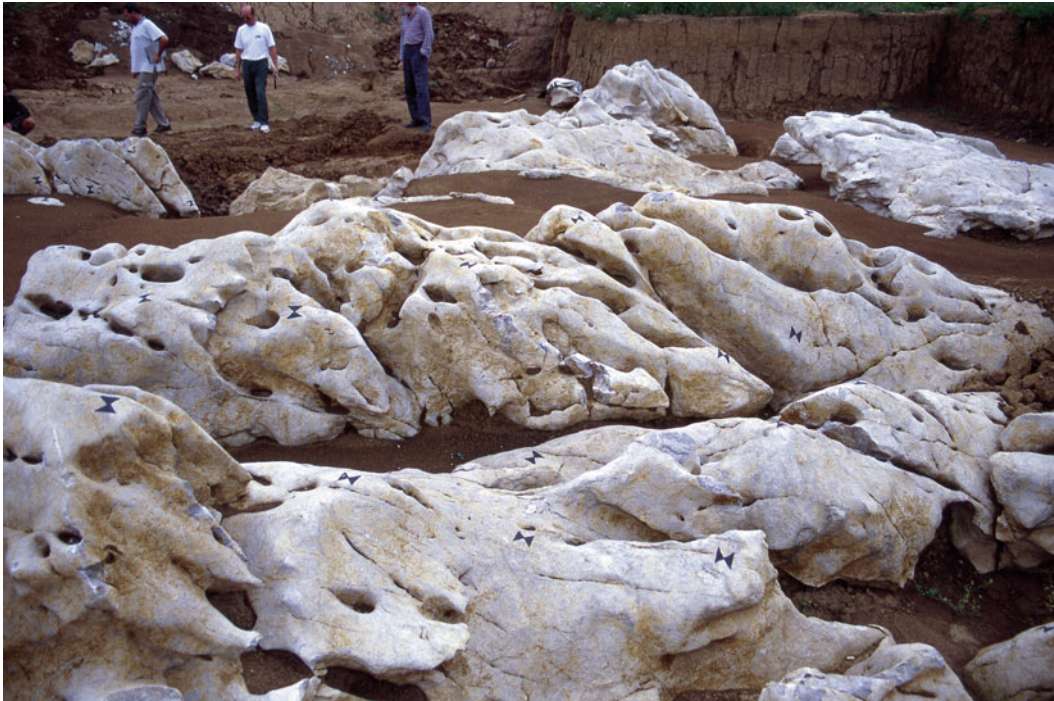
Fig. 15.6 Karren near Bič that were uncovered during archaeological excavations

lowland near Bič (Figs. 15.6, 15.7). They were formed entirely underground. In some places, the layer of sediment and soil is relatively thick; in other places, the karren almost reach the surface. They feature sharpened tops and an interesting rock relief that conveys a lot of information. The upper part prevails in a relatively smooth rock typical of subsoil formation and fine-grained sediment. The most distinct feature of the lower part of the karren are subsoil notches. Larger and horizontal notches reach one metre in diameter, while the smaller ones are placed on top of one another. Semi-cylindrical notches represent the ends of vertical subsoil channels formed along the most conductive ways. Some of the tops of the subsoil teeth located above the most prominent notches are mushroom-like. The subsoil channels on these karren can be divided into vertical and horizontal ones. The former are the conduits of fluctuating water flows along the most conductive ways. The latter criss-cross the more gently sloping rocks, including larger ones, and are co-shaped with moisture which stays in them for the longest time, even after the level of the underground water decreases. Formed along flaws in the rock, which mostly occur in the form of small fissures, are subsoil solution cups

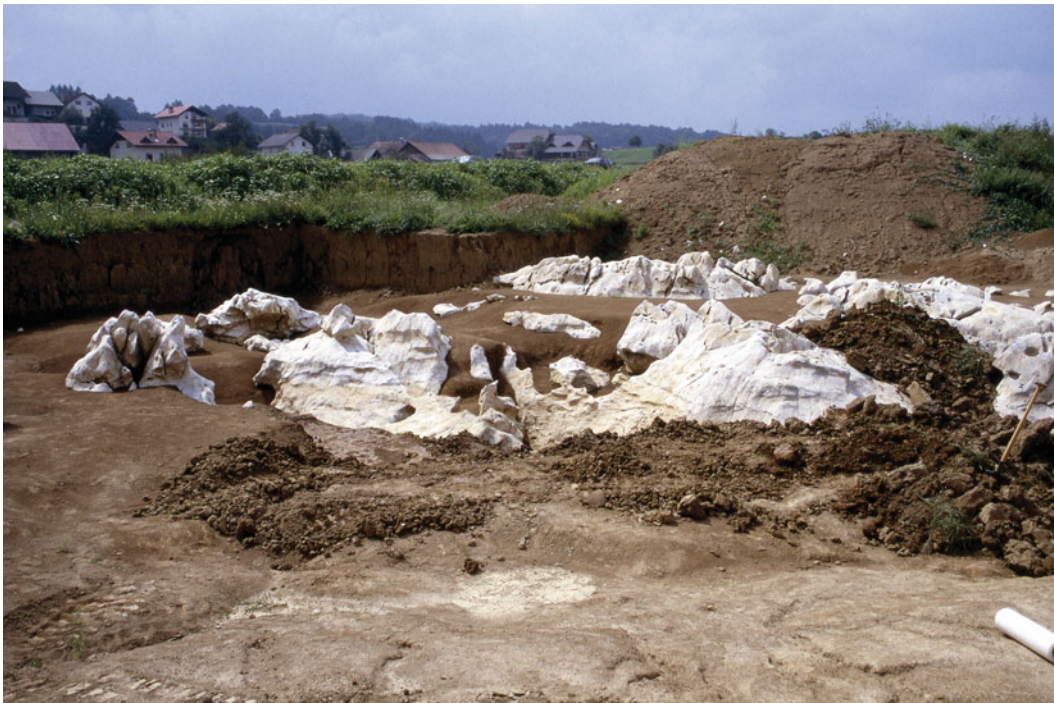
Fig. 15.7 Occasionally flooded subsoil karren near Bič

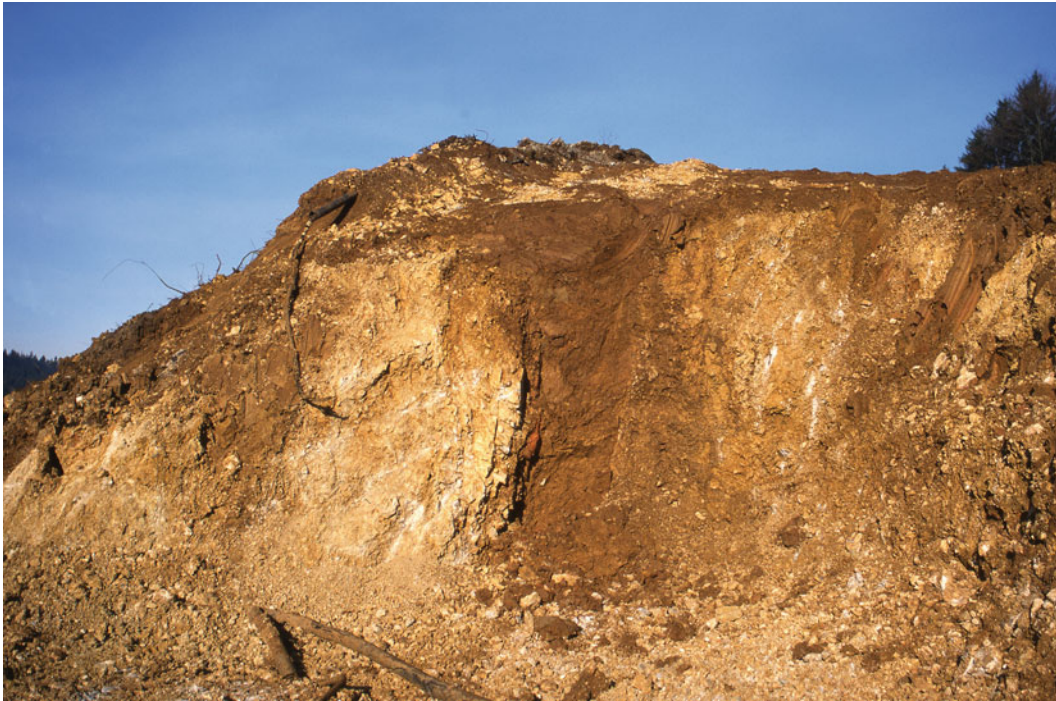
Fig. 15.8 A cave filled with fine-grained alluvium

sediment (Fig. 15.8), while some shafts were hollow (Fig. 15.9). The largest passage, the walls of which were covered with a heap of flowstone, measured 5 m in diameter, while the diameter of others ranged from 1 to 2 m. The rocky circumference of passages was transformed at the contacts with the sediment. The fracturedness of the rock is most often reflected in the position and shape of passages. Fissure caves represent a special type of caves which were formed along the more prominent upright fissures and faults, and at intersections of layers and tectonic deformations. In the cross-section, they are more or less vertical, sometimes also meandering. In all cases, they conform to the lithotectonic state of the rock. The width and volume of filled spaces in the rock correspond to the local fracturedness of the rock. Such caves often follow narrower fault zones from which the interior fault zone material was transported underground and was replaced with superficial sediment. On the walls of these caves, whose width does not exceed 1–2 m, there are still visible traces of the last movement of rock blocks. Vertical circulation of water did not take place at one point alone, but alongside the entire spread of the fault or alongside the equivalent fracturedness of

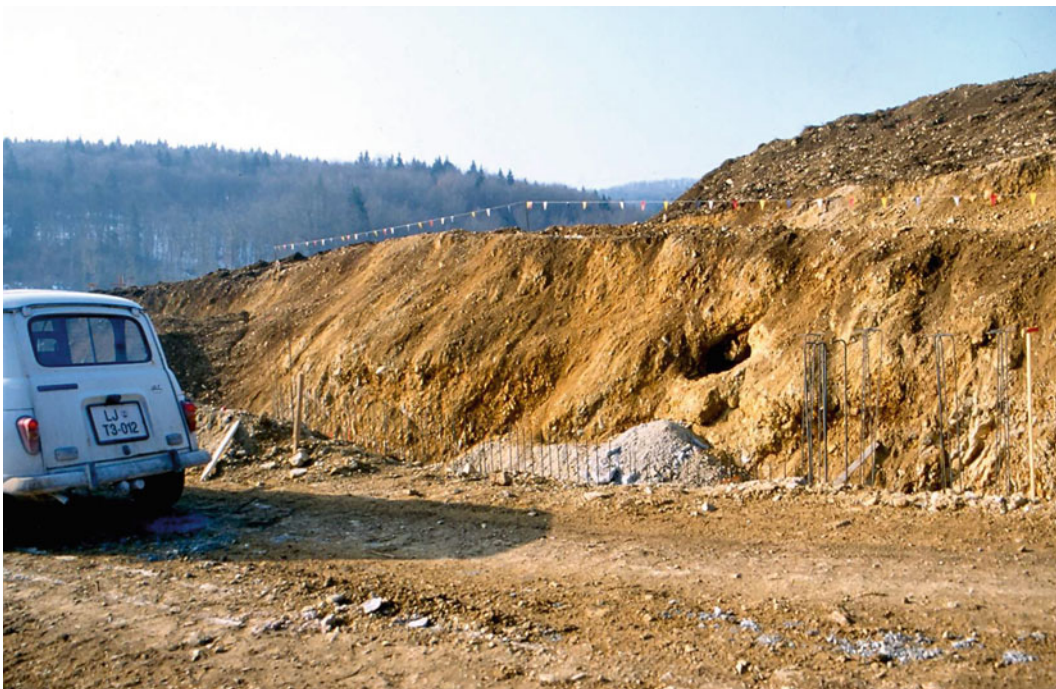
Fig. 15.9 Entrance to the shaft in the cutting of the Mali Medvedjek hill

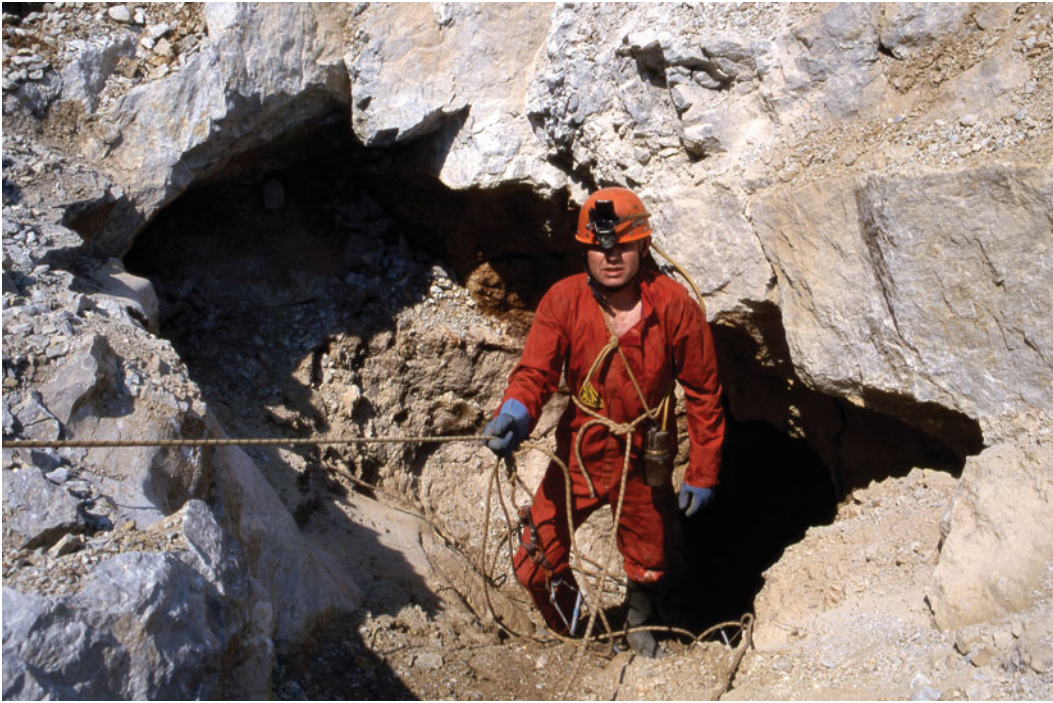
Fig. 15.10 A cave in brecciated rock

the rock. Their shape indicates a somewhat specific evolution pattern. It seems that they formed as sub-sedimentary caves. Smaller caves also developed in a markedly fractured and partly brecciated rock (Fig. 15.10), which explains why their circumference is very rough.

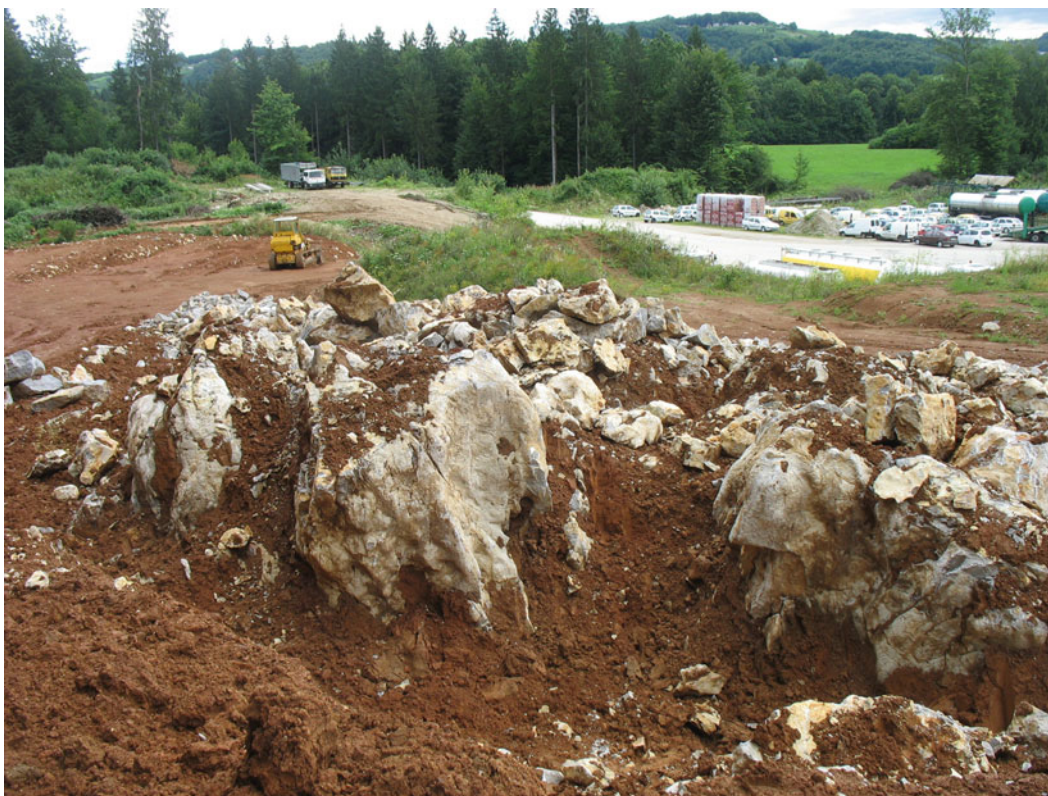
Fig. 16.1 Subsoil stone forest on the Pluska–Ponikve motorway section

In the lower-lying parts of the route and the lower part of the slope surface, in places covered with thicker layers of alluvium and soil, there are subsoil stone forests (Fig. 16.1), while the steep parts of the slope and the dolomitic surface feature subsoil karren (Fig. 16.2).

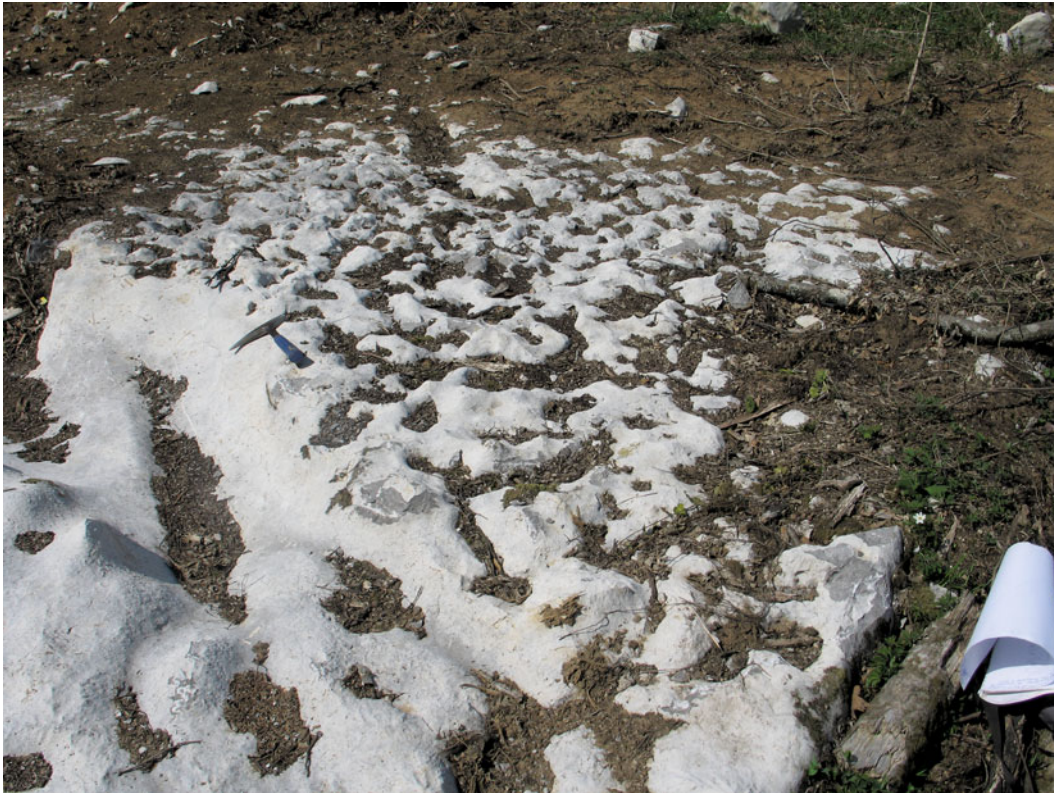
Fig. 16.2 Subsoil karren on the Pluska–Ponikve motorway section

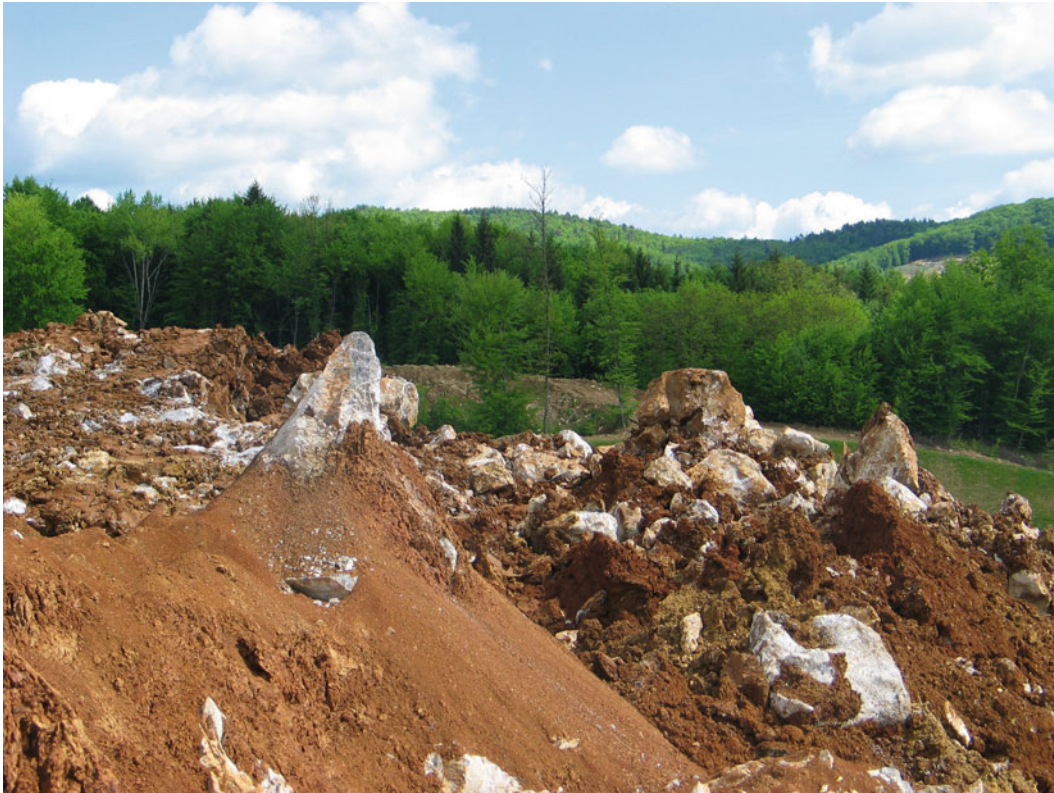
Fig. 16.3 Pointed tops of stone teeth

already prior to the earthmoving work and were partially reshaped by rainwater and biocorrosion. The subsoil and uncovered tops are typically pointy (Fig. 16.3).

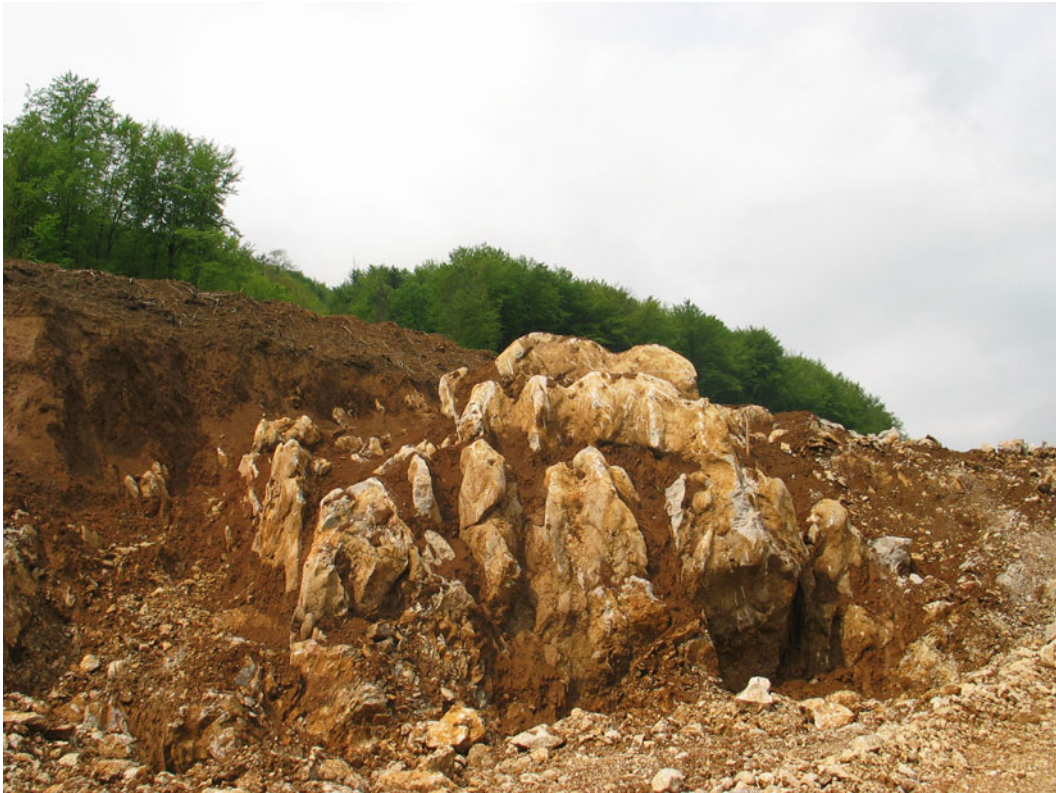
Fig. 16.4 Larger stone columns

Near Ponikve some of the subsoil tops are relatively horizontal or, rather, only slightly rounded and formed along a bedding plane. This area is criss-crossed with a thinly scattered network of upright fissures, which is why the stone columns are large and expansive, and their peaks are dissected by a network of funnel-shaped notches (Fig. 16.4). The cracks between the stone columns are also relatively narrow, giving the stone forest its typical shape. It would seem that the pointy tops were removed while the field was cultivated, and the stones were used to form a path. During construction work, the tops along the bedding planes were also the first to be removed.

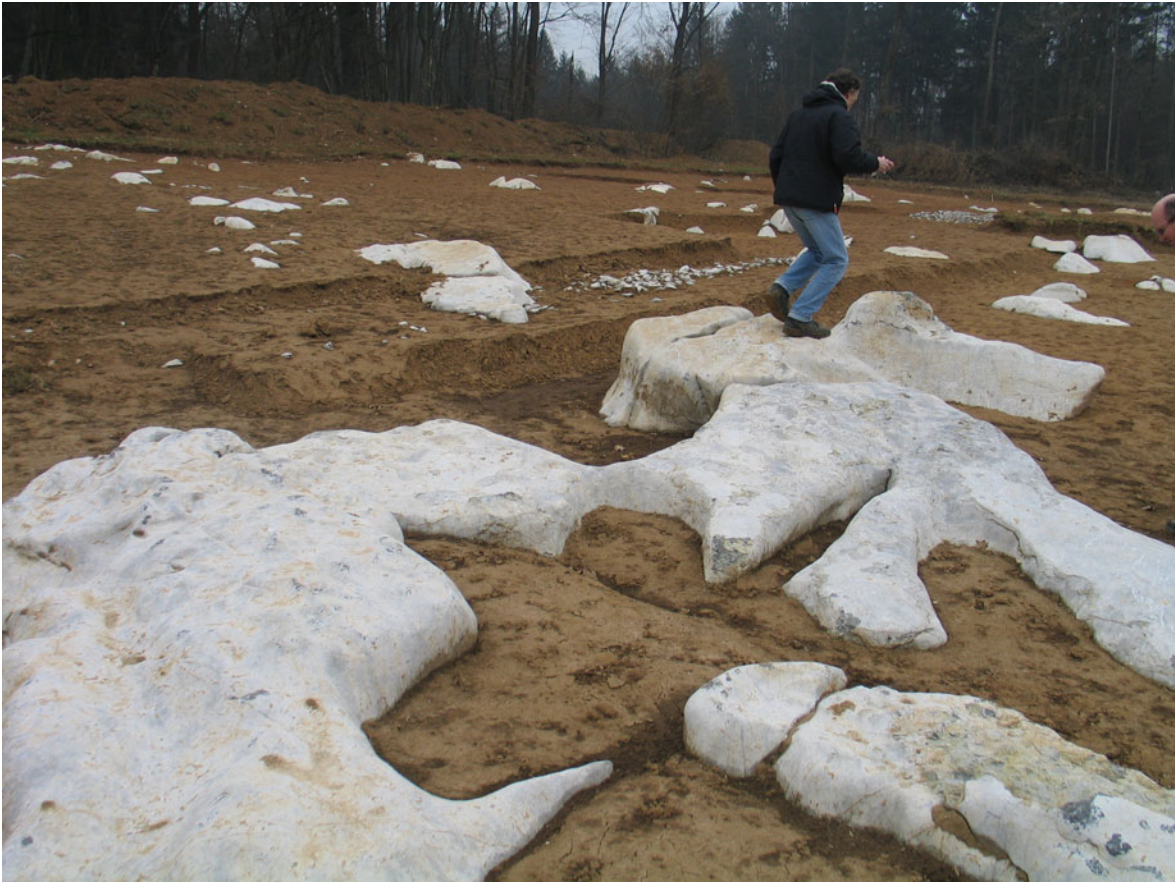
Fig. 16.5 Stone karren

In places covered with a thinner layer of alluvium and soil, usually on steep sections of the slope as well as on the dolomitic rock, the rock surface is less prominently dissected, mostly into subsoil karren. The transverse strips of the karren tops measuring up to 10 m in diameter dissected the construction surface, while other parts were covered in alluvium and soil, therefore featuring rounded shapes (Fig. 16.5). The latter were frequently uncovered in the form of stone teeth and forests in the course of construction works. The tops of karren were mostly located in the forest and therefore bear a typical shape. The denuded

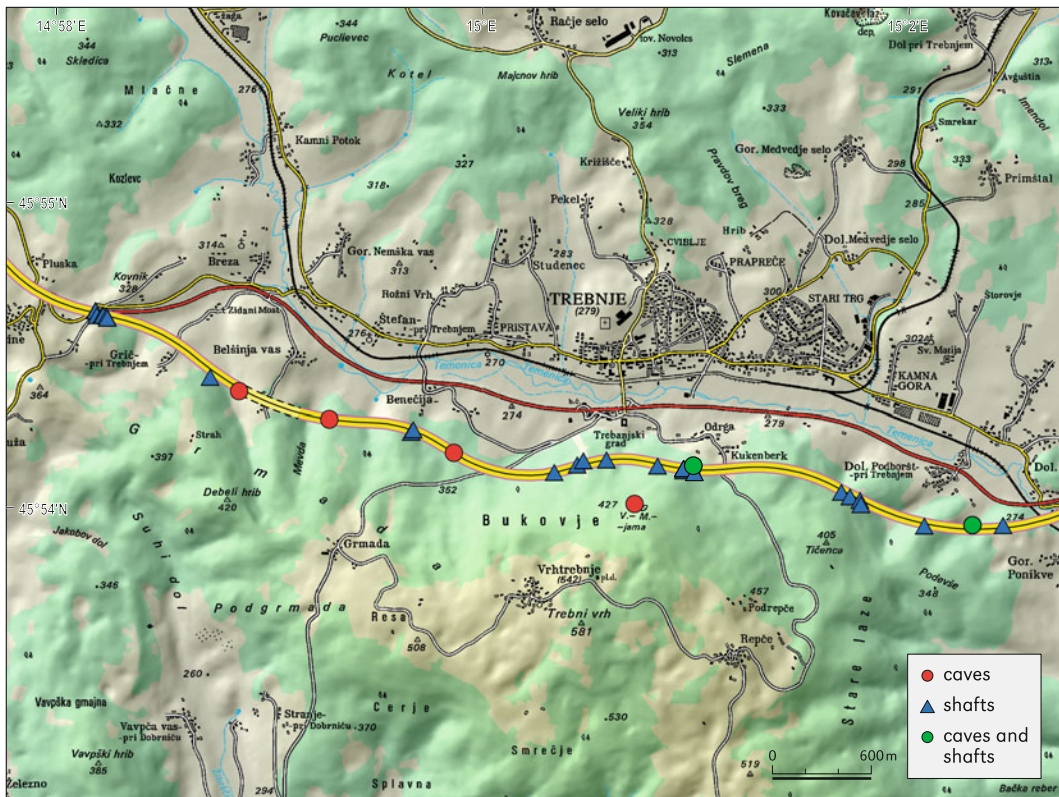
Fig. 16.6 Caves uncovered on the Pluska–Ponikve motorway route

As many as 22 caves were opened in this motorway section during construction (Fig. 16.6). Four of them were formed due to the flow of water streams or flood waters, while two of them were filled with alluvium. Others are shafts which developed on account of water percolating from the surface.

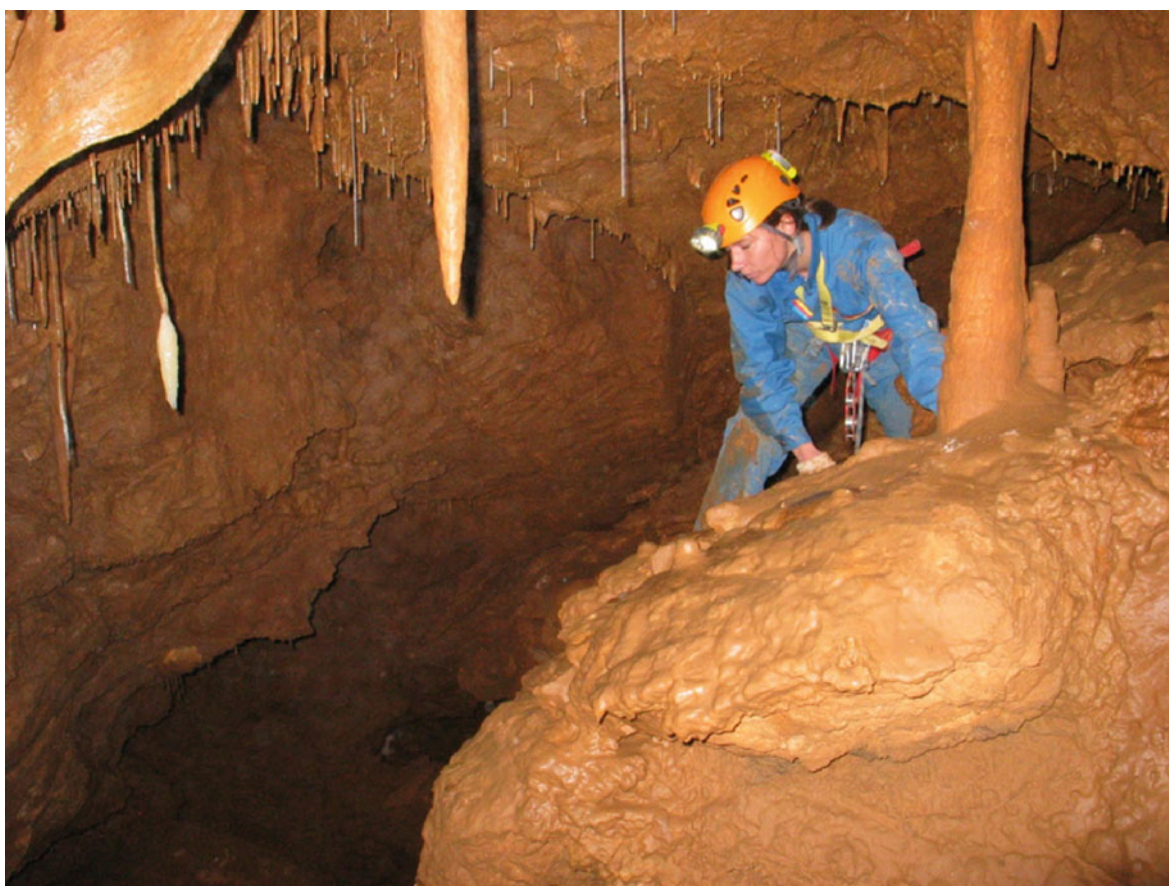
Fig. 16.9 Flowstone formations in the Igorjeva groza Cave

In the road-cut, at the altitude of 333 m, an entrance opened into a cave that is 65 m long and 25 m deep (Fig. 16.8). It is a network of smaller passages connected by fissured shafts that are wider in their lower part. The floor of the bottom part of the cave is covered with alluvium and flowstone (Fig. 16.9). The alluvium indicates the occasional fluctuation in the underground water level or flooding in the bottom part of the cave. The cave is connected with the northern slope of the motorway embankment by means of a concrete tube (Fig. 16.10).

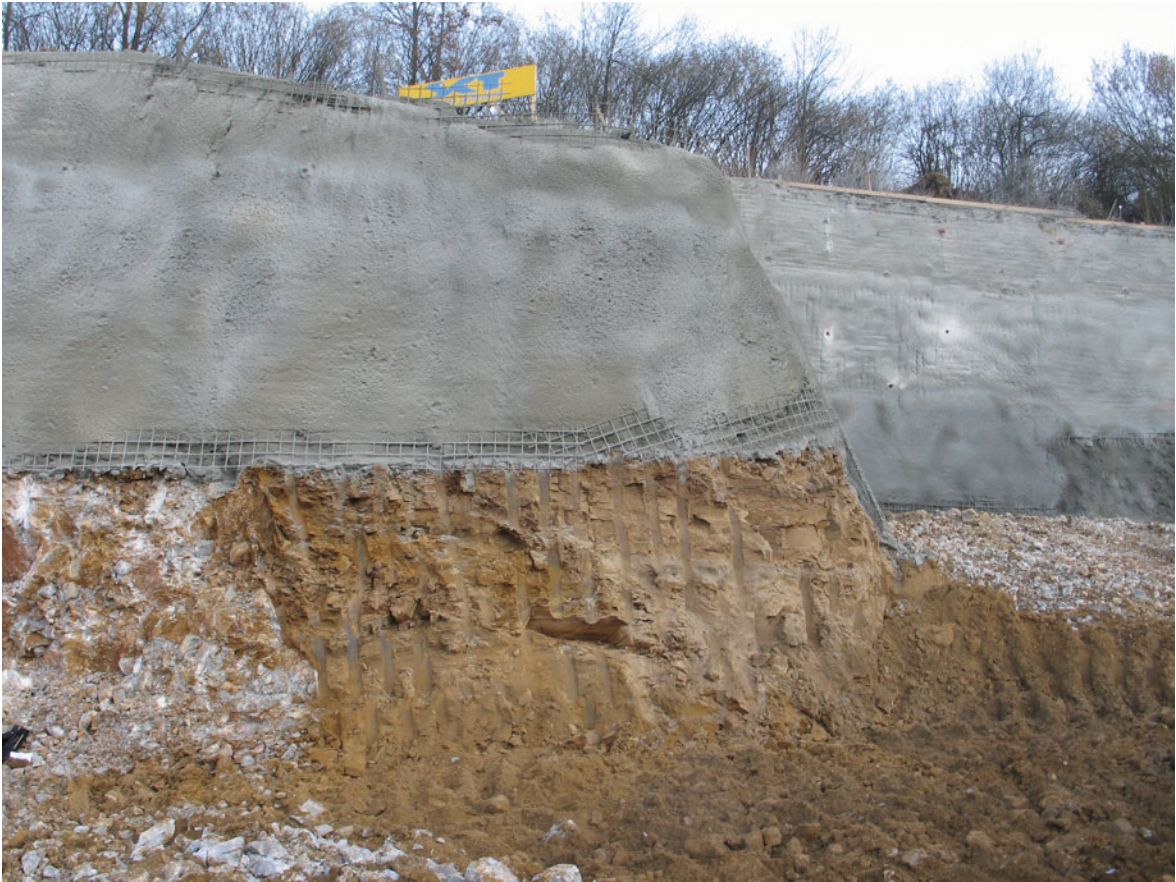
Fig. 16.11 A cave completely filled with fine-grained alluvium

In the course of excavating the tunnel in the middle of the hill's slope, at the altitude of 302 m, a cave opened up, measuring 5 m in diameter and completely filled with fine-grained silicate alluvium (Fig. 16.11). The surrounding surface was formed subcutaneously.

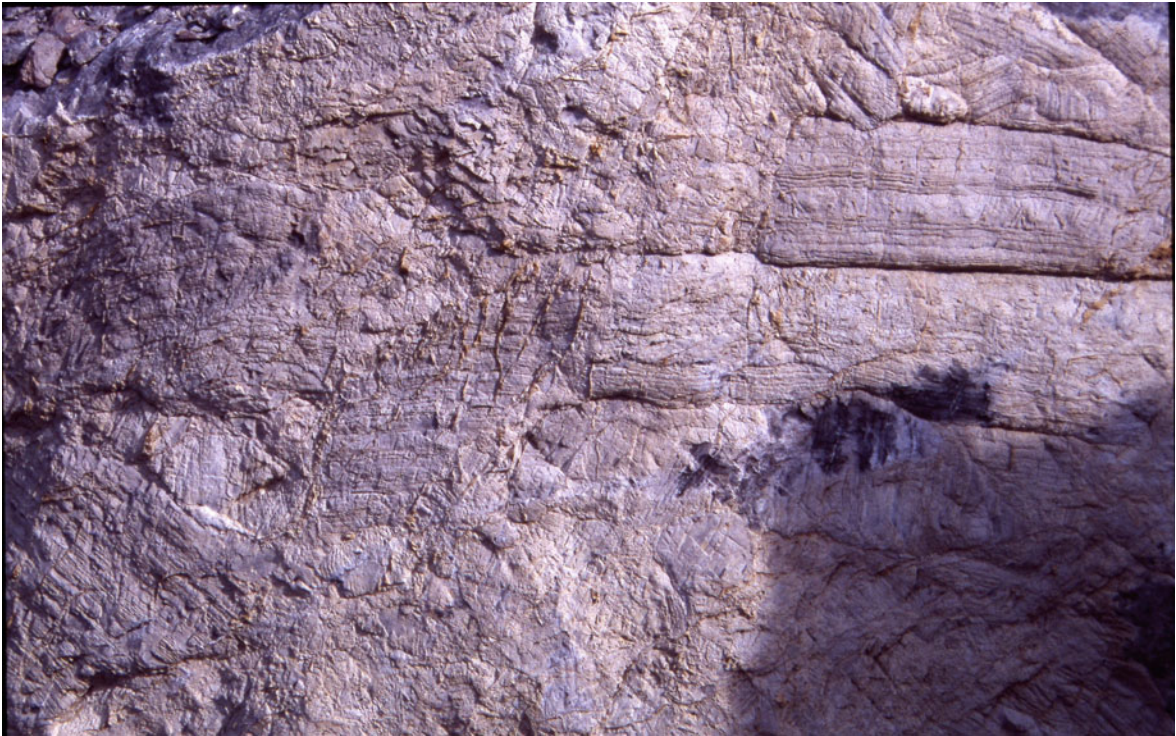
Fig. 17.2 Rocky surface on breccia

Breccia is internally non-homogeneous and exhibits no apparent internal stratification, while clast orientation is chaotic (Figs. 17.1 and 17.2). The clasts are poorly sorted and either touch one another or float in the breccia matrix. The size of clasts varies greatly, ranging from a few millimetres to several decimetres, but they most frequently measure a few centimetres to a little over 1 decimetre in diameter. They come in various shapes, but the slightly oblong clasts are the most frequent. Clasts are mostly coarse and poorly rounded, with only smaller grains featuring slightly less sharp edges. The clast structure reflects the lithology of the surrounding dolomites or dolomitized limestone of inner-shelf sedimentary facies.

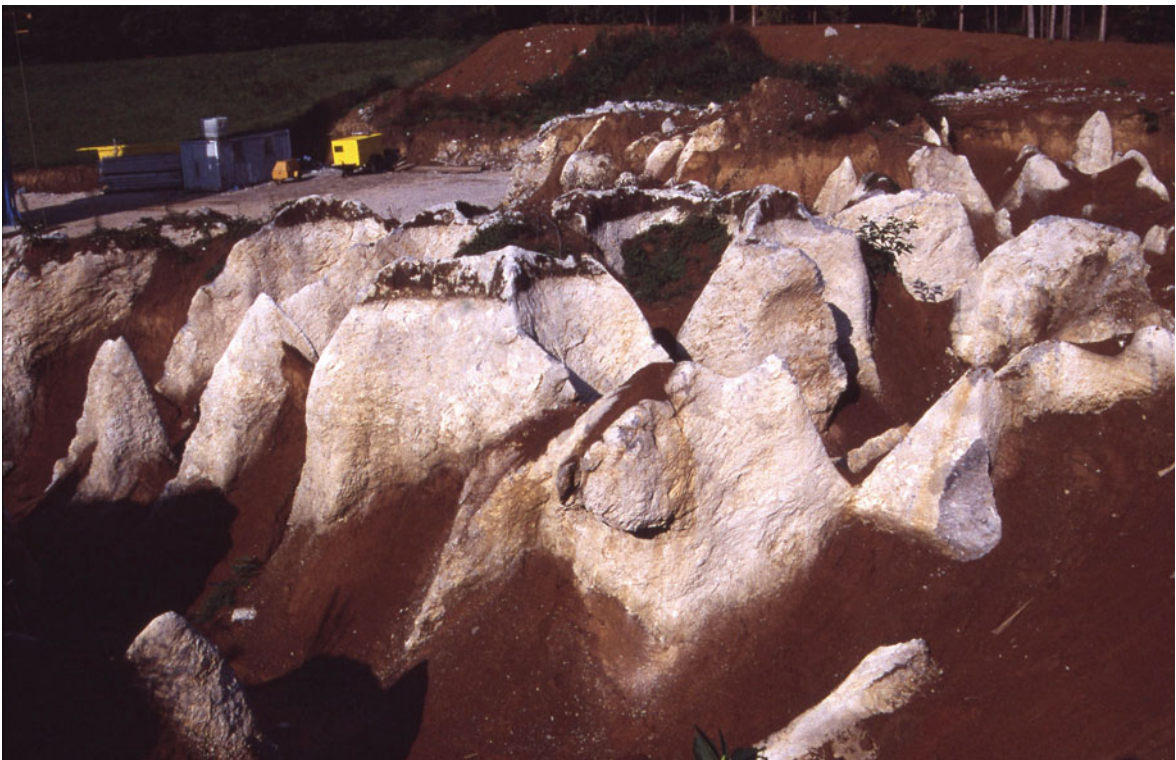
Fig. 17.3 Subsoil stone forest

Although only 1000 m² of the stone forest (Fig. 17.3) have been uncovered, it is possible to infer its main characteristics in terms of form. The subsoil columns, both larger and smaller, are relatively close to one another and are positioned into strips. Their peaks are mostly at the same level.

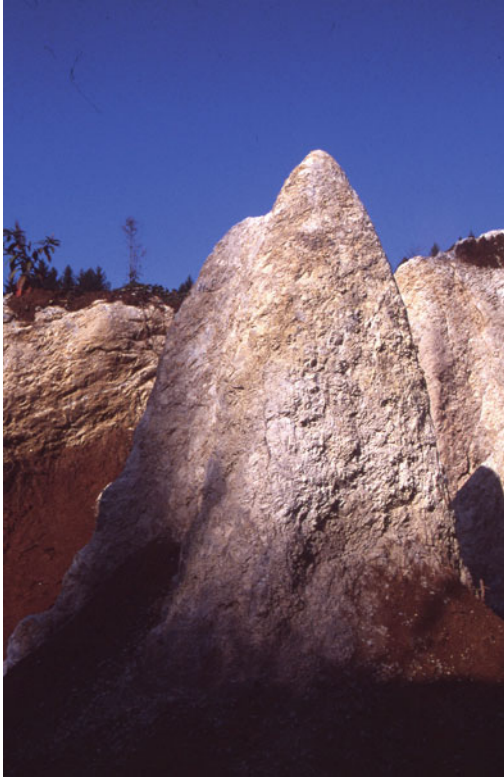
Fig. 17.4 A stone tooth

The second type of columns is represented by individual pointy and less massive columns (Fig. 17.4). Their walls are dissected by subsoil rock formations as well (Fig. 17.5).

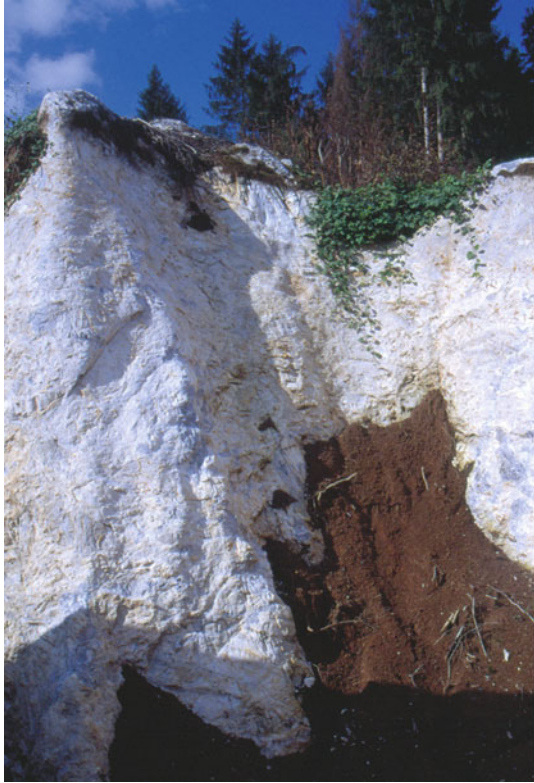
Fig. 17.6 A funnel-shaped opening of an underground flute

The most prominent rock formations dissecting columns are funnel-shaped notches (Fig. 17.6) and subsoil channels. The funnel-shaped notches at the top of larger columns measure 10 cm–2 m in diameter, feature a semi-circular shape and most frequently represent the openings of subsoil channels beneath them.

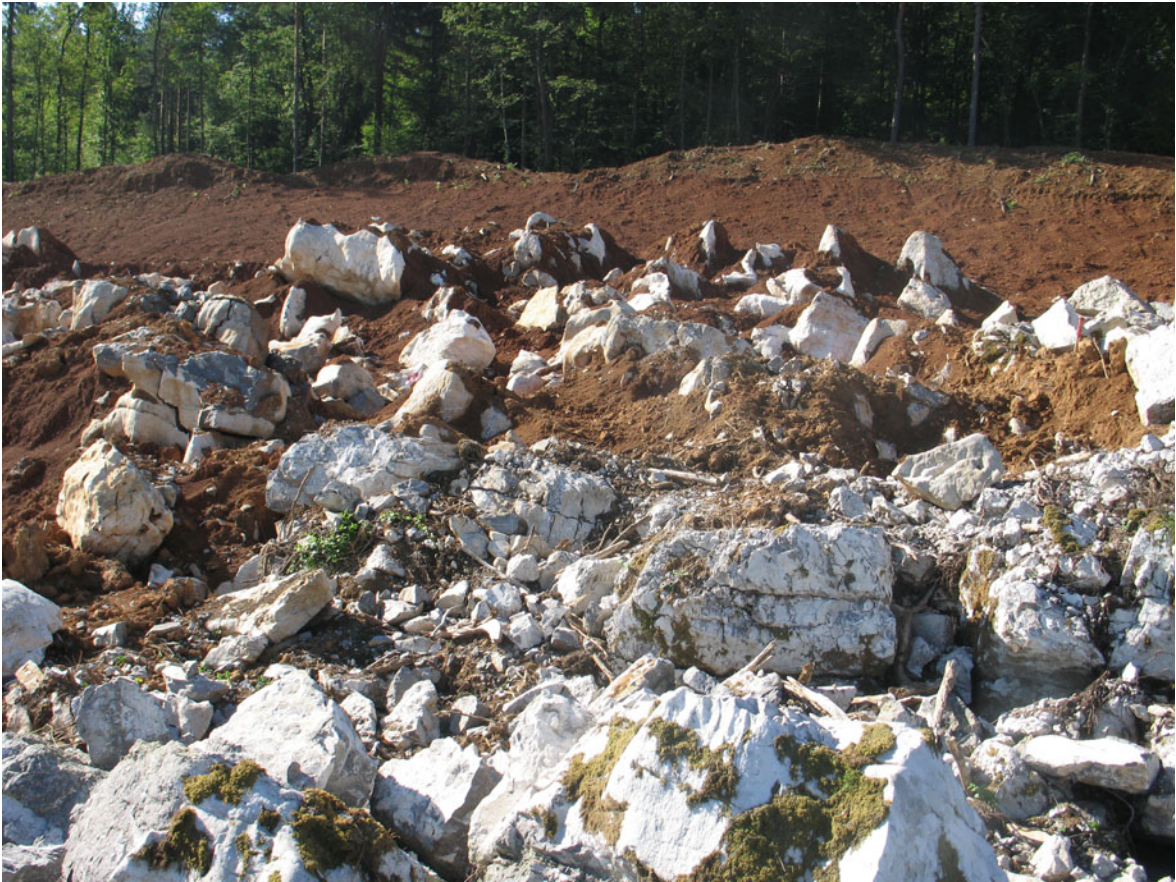
Fig. 18.2 Subsoil stone teeth

The first type of subsoil surface, which develops relatively rarely and the likes of which has not been presented in expert literature thus far, is formed on a slightly inclined and rather flat upper plane of a non-cracked rock bed. Here and there, up to 10-cm high peaks rise from it, located among the subsoil

indentations which prevail (Fig. 18.2). Between the large, well-developed and densely scattered indentations, the walls developed into a network of decimetre bumps. Their walls are dissected by horseshoe-shaped shelves, i.e. the remains of a subsoil indentation level. Upon simultaneous flowing of water down the rock, these deepened the fastest in their central part, while the edges remained hanging on several levels. The walls of some bumps are dissected by centimetre-long subsoil rain flutes, down which the water flows towards subsoil indentations and channels. The subsoil indentations either feature circular cross-sections measuring one to several decimetres, or are heavily dissected, consisting of several indentations combined into one, with diameters amounting to 1 m or even more. They are frequently connected in the direction of the rock surface slope. Larger subsoil channels, which feature semi-circular cross-sections and diameters measuring one to several decimetres, also follow the rock surface slope direction. Their bottom is usually dissected by subsoil indentations. This is actually a composite rock formation combining subsoil channels and connected subsoil indentations. Sometimes, the shape of a channel with indentations is prevalent, while other times, the formation features indentations connected so as to form a channel. The channels are prevalent on the somewhat steeper rocks, while indentations are more frequent on more gentle slopes. The rock relief undoubtedly bears traces of relatively even water percolation through alluvium and soil that

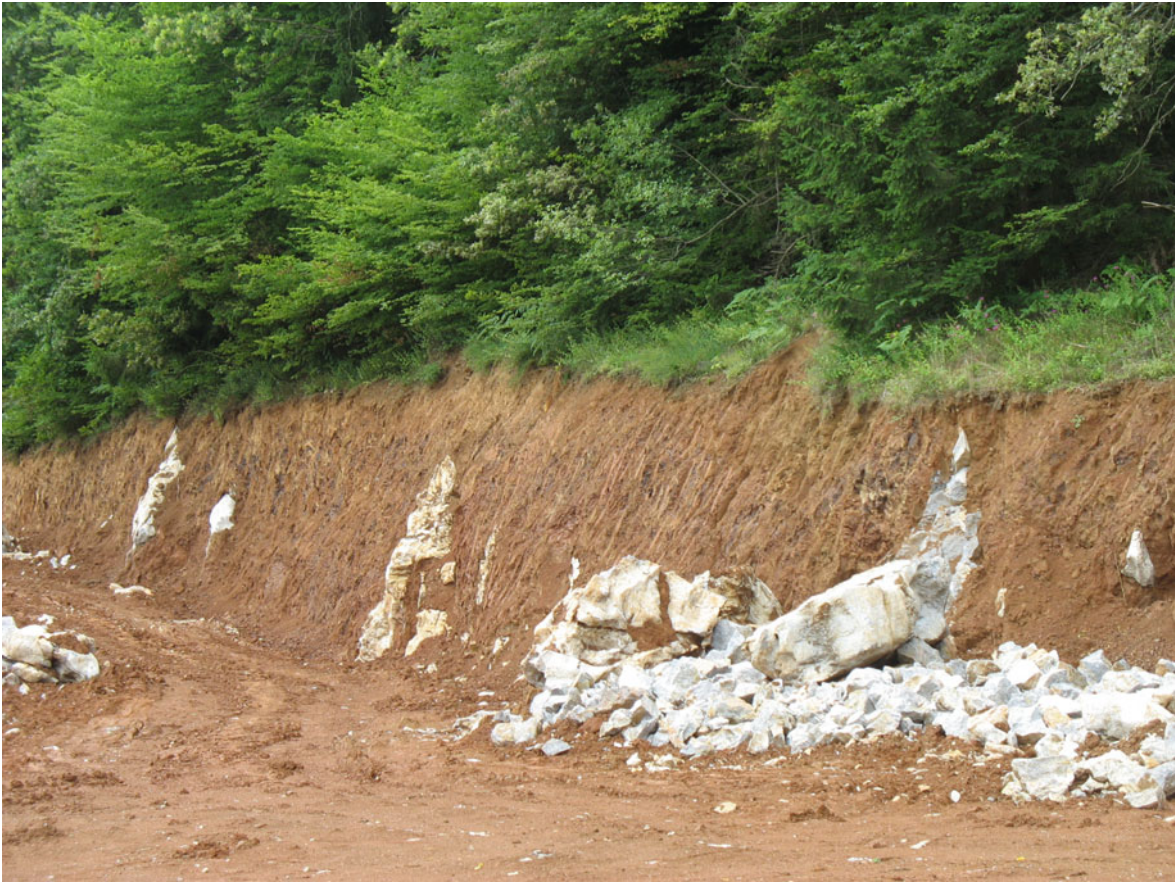
Fig. 18.3 Subsoil stone teeth within a thicker layer of soil and alluvium

Under the thicker layers of alluvium and soil, subsoil stone teeth and stone forests were formed on cracked rock (Fig. 18.3). The most extensive and prominent continuous surfaces of stone forests can be found under the thickest layers of alluvium, which prevail in notches and the lower parts of slopes. Stone columns reach the height of up to 8 m, but most of them are lower, i.e. stone teeth. The shape of stone forests and stone columns as well as the extensiveness of the latter are directed by the network of fissures that criss-crosses the rock in the vertical direction. A dense network leads to the formation of narrow and pointy stone columns, while a thinly scattered network would

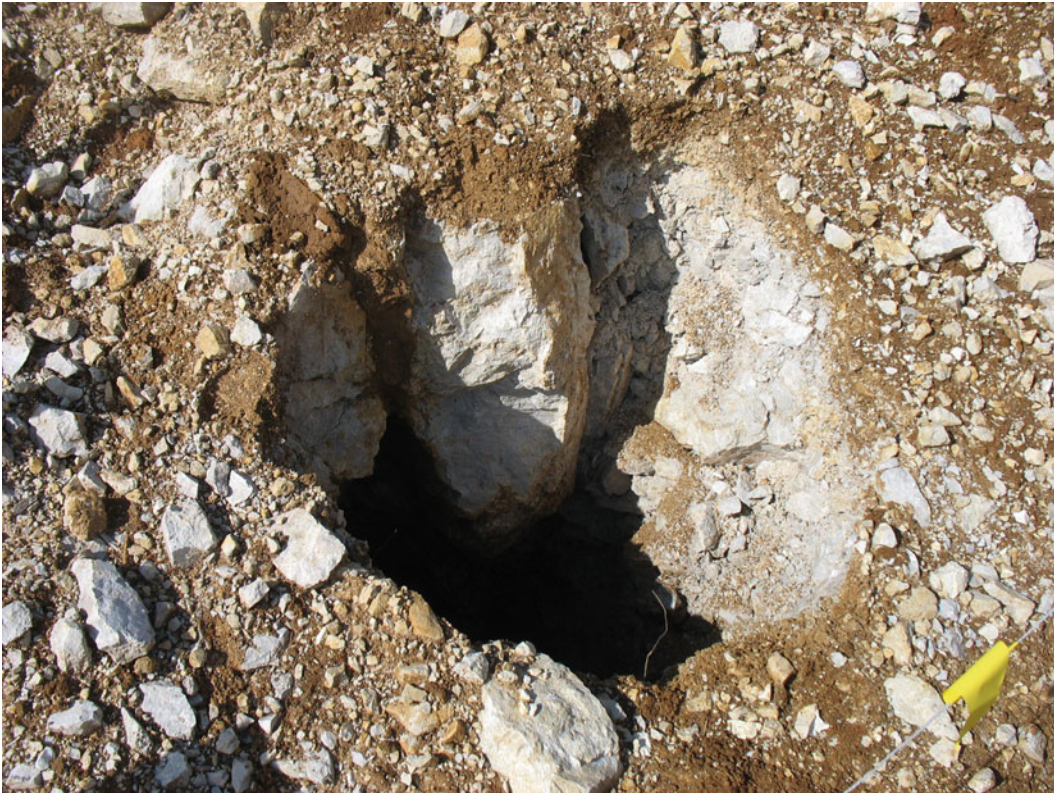
Fig. 18.5 The entrance to the shaft on the road route

The rest of the caverns are shafts (Fig. 18.5). The largest shaft is 30 m deep and 55 m long. It is a system of vertical shafts and larger fissured areas (measuring up to 8 m in length) located between them. Ten metres

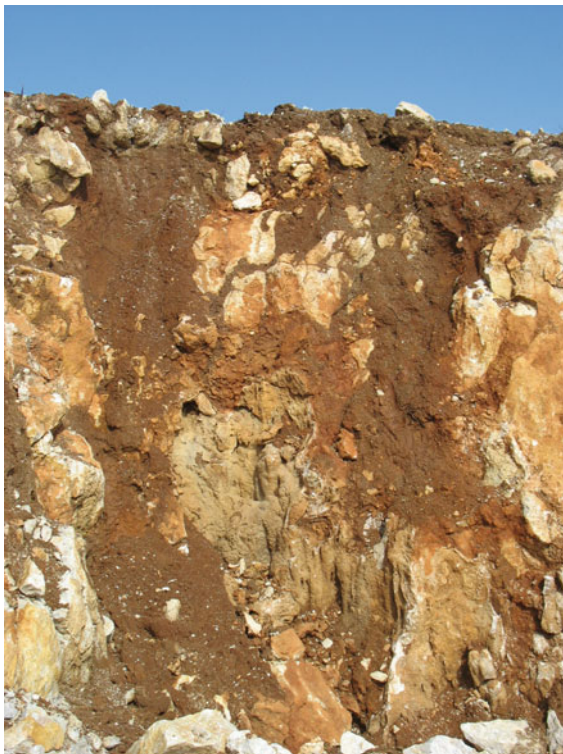
Fig. 18.6 Fissured shafts filled with fine-grained alluvium

Shafts mostly developed under fissures that dissect the (subsoil) karst surface in the shape of a letter V of varying width, and are filled with fine-grained alluvium and soil. The fissured shafts are usually up to 5 m deep and 4–5 m wide. They were mostly formed as underground shafts, which means they were filled with alluvium at least in the initial development

periods. The water percolating from the covered karst surface and dissolving the most porous parts of the rock into shafts carries fine-grained fragments and deposits them in the cavern. The cavern can be either completely or partially filled with alluvium (Fig. 18.6). Parts or entire amounts of alluvium were carried from some shafts by water. When only the lower parts of shafts are filled with alluvium, the water stagnates above the poorly permeable alluvium when the water flows are greater, partly flooding the cavern.

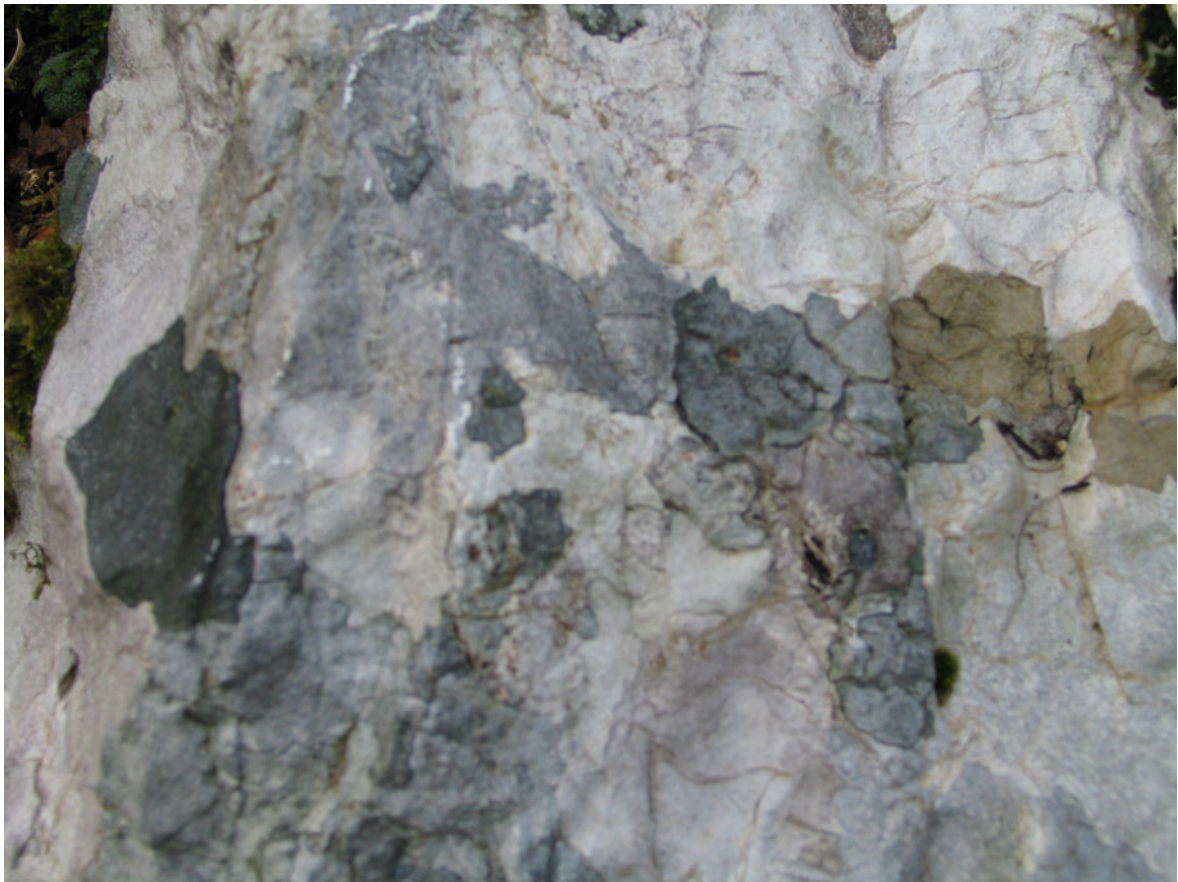
Fig. 19.2 A biocorroded surface of karren

moss, whereas lichen are more common in more sunny areas. The biocorrosion processes do not take place evenly across the entire surface, but rather selectively (Fig. 19.2). The clasts (which are probably lithologically slightly different) in the crushed and recemented rock are melted to different depths or there are various organisms on various neighbouring clasts. Especially melted due to corrosion are the contact points between individual clasts, at certain spots even several millimetres deep.

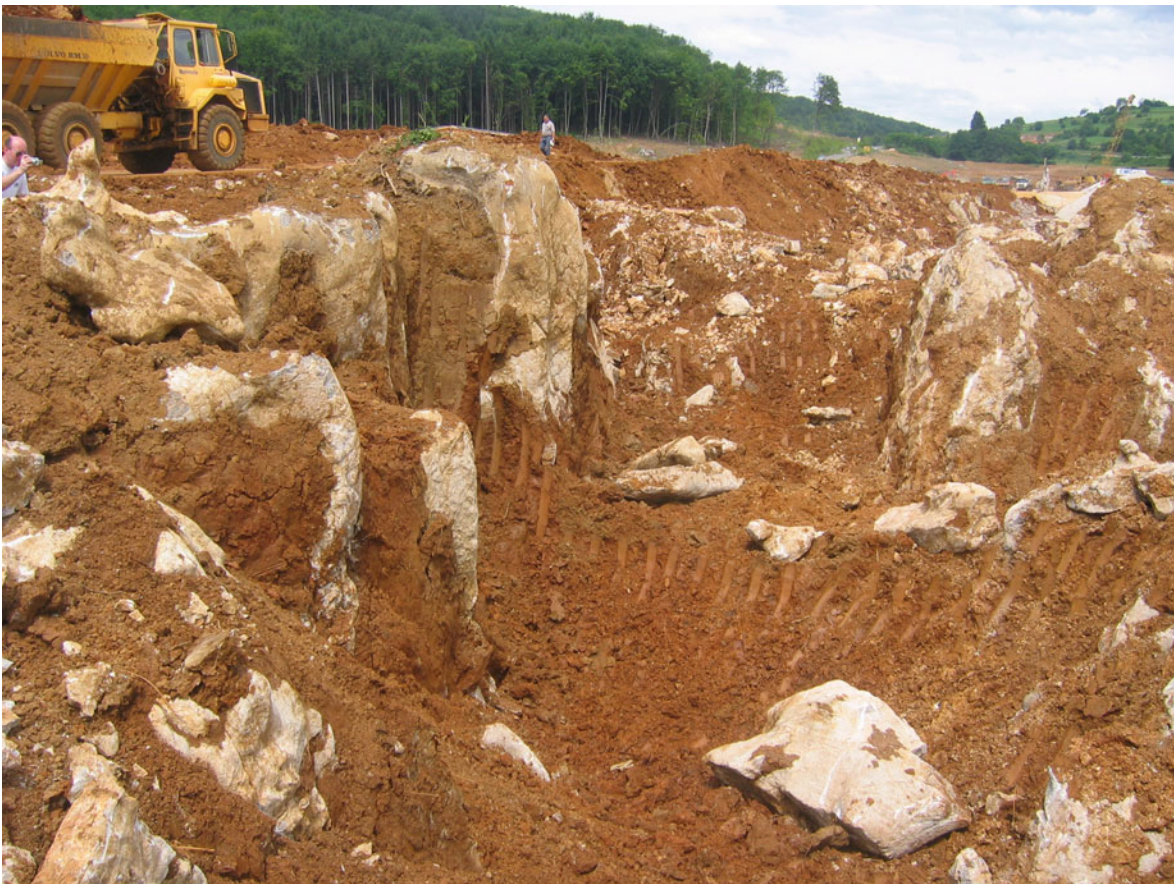
Fig. 19.3 Large surfaces of the subsoil stone forests

The relatively large areas of subsoil stone forests (Fig. 19.3) bear witness to the long-lasting underground formation of this part of the karst surface which is covered with fine-grained deposits and soil, and how this formation took place. The stone pillars are entirely covered with alluvia and soil or only their tops stick out.
