Cave and Karst Systems of the World

Cave Exploration in Slovenia

Discovering Over 350 New Caves During Motorway
Construction on Classical Karst

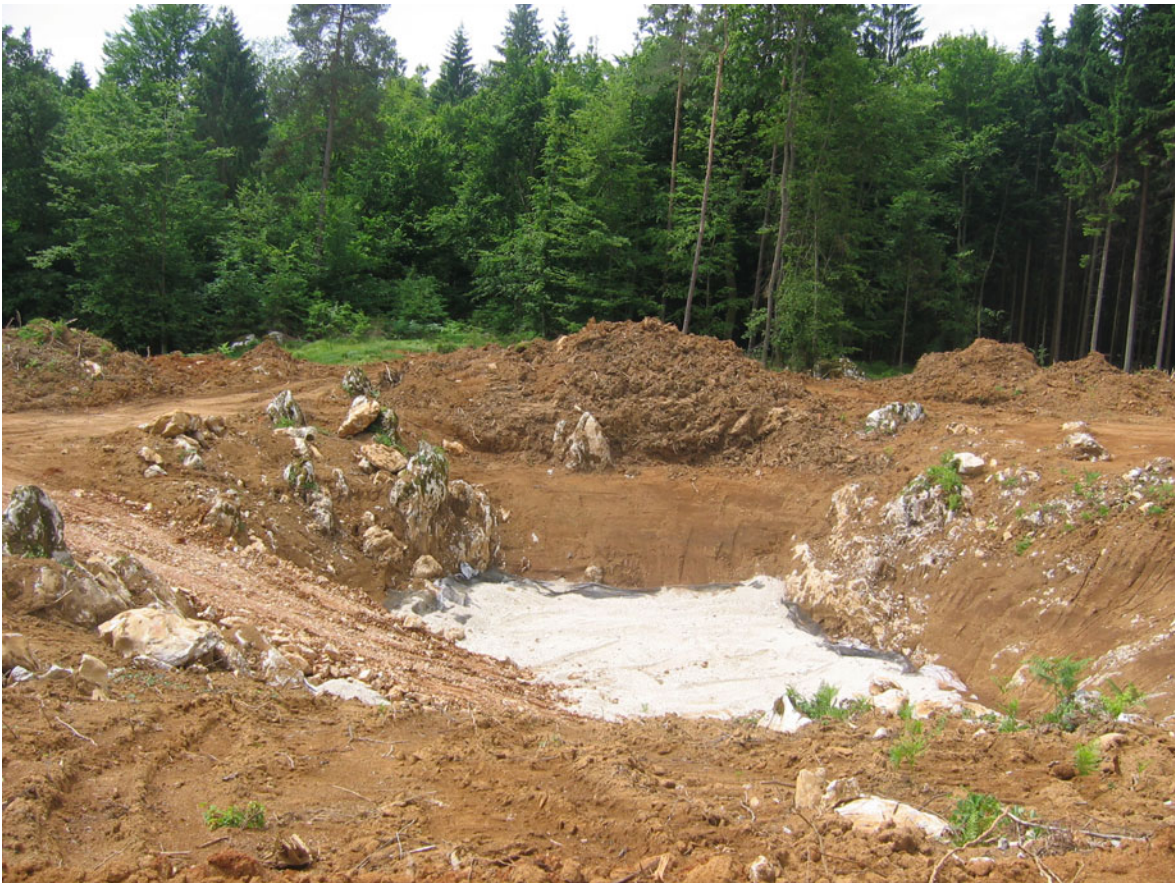
Fig. 19.4 A doline in the subsoil stone forest

The surface is intersected by smaller and bigger dolines (Fig. 19.4). The biggest of them are several tens of metres in diameter. Some are filled with grey loam, the origin of which is still being studied. On the other hand, both types of dolines are intersected by subsoil stone forests.

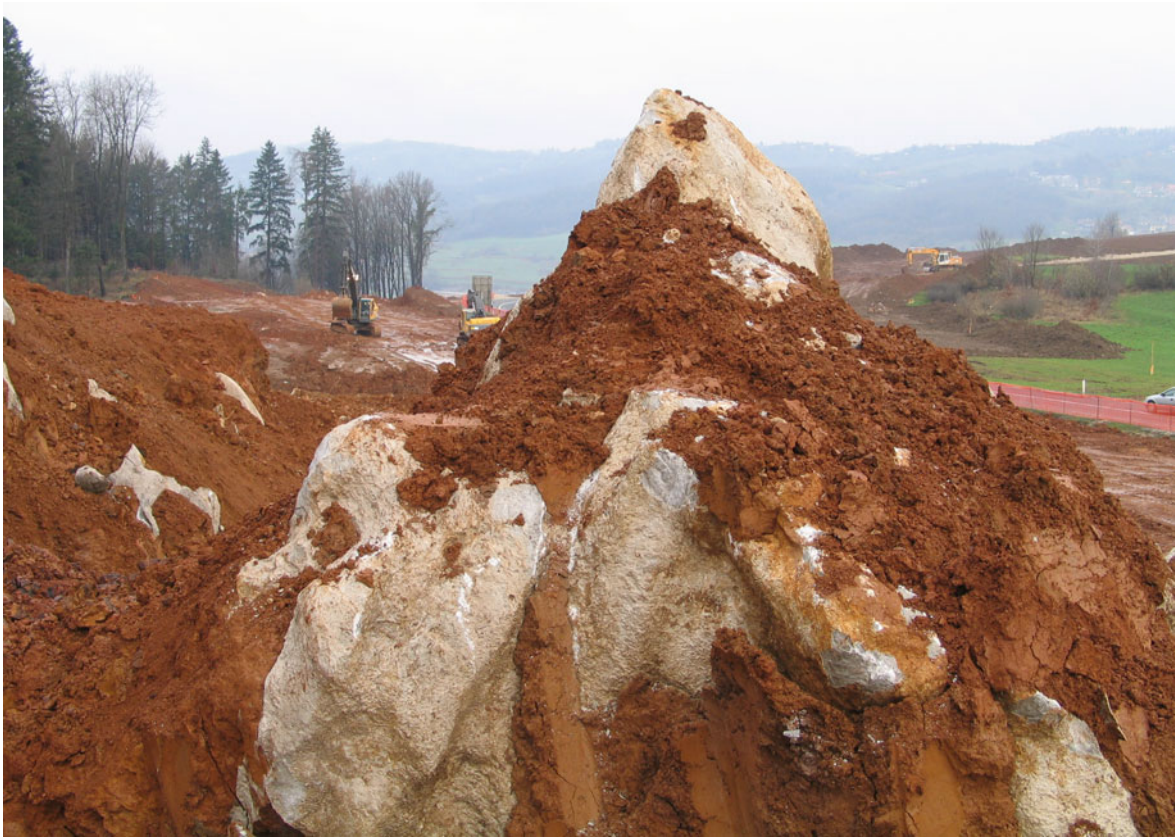
Fig. 19.5 A subsoil stone pillar with subsoil rock forms

The subsoil stone forests are made of a thick network of more or less stout and pointy pillars (Fig. 19.5) reaching 8 m, some seldom even 10 m high, while the majority tend to be lower. Narrower pillars with 1–2 m in diameter have one sharp or rounded tip at the top, whereas the stout pillars with up to 5 m or more in diameter have the tops shaped more or less like sharpened and winding ridges. Among them, there are predominantly funnel-shaped openings of vertical subsoil flutes or more or less horizontal subsoil channels.

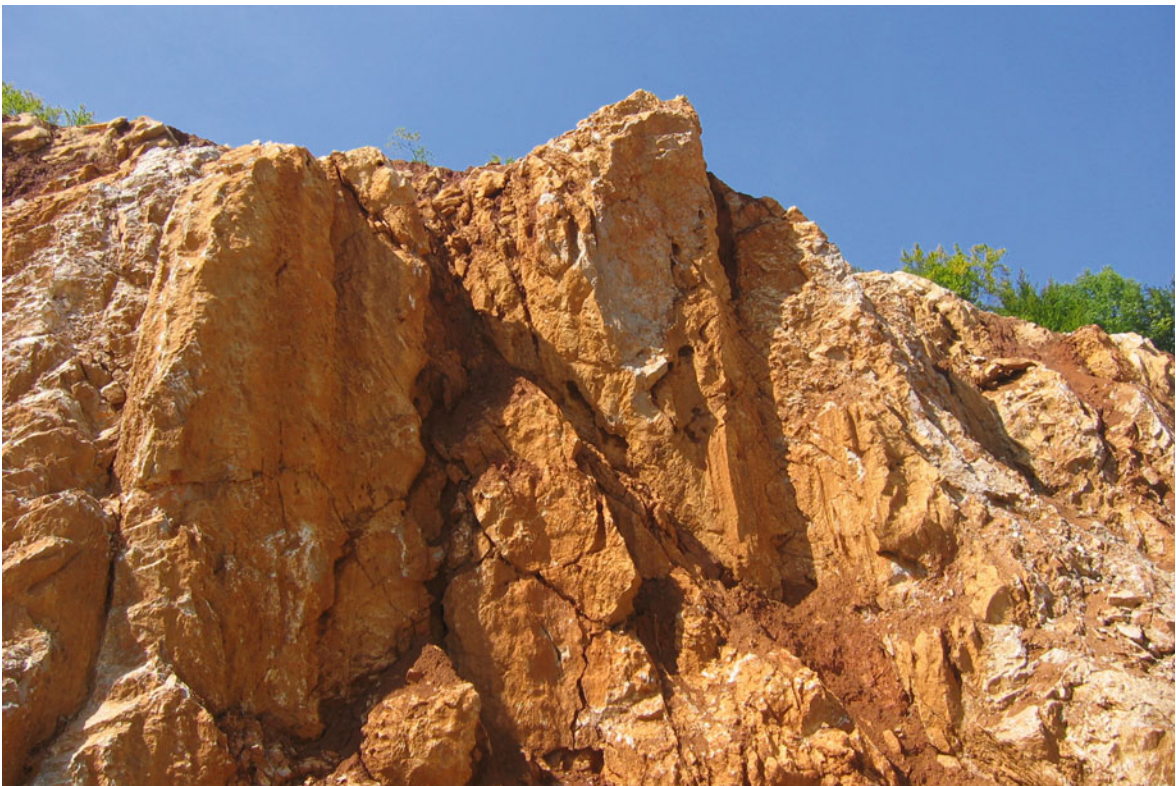
Fig. 19.6 A subsoil flute

Prevalent in the rocky relief of the pillars are subsoil rock forms (Slabe 1999; Slabe and Knez 2004) which demonstrate the gravity flow of the water from the surface. These are mostly subsoil flutes (Fig. 19.6), most commonly vertical channels 1 m or more in diameter; as determined below, the largest among these can be called underground shafts which broaden into funnel-shaped openings at the top. They accumulate water from the surface which then percolates down the rocks and flows from the soil. A cross-section of the funnel-shaped openings reveals that they come in different shapes. They can be open, semi-circular, or even nearly circular. Their shape is often the result of permeability at the contact point between the rock and the alluvium across which the water flows down. A long-lasting shaping of the opening, coupled with a poorly permeable contact point, makes the rock form dip deeper into the rock. On some rare occasions, the water managed to penetrate through the rock which led to the formation of actual funnels. If the contact point is

less permeable or when a smaller amount of water is gathering on the surface—which is, of course, common for narrower pillars whose tips protrude from the soil—smaller and winding flutes tend to form. Subsoil flutes, which generally demonstrate that the contact point between the rock and the alluvium around it is permeable, are a rare occurrence; moreover, the walls of the pillars can have elongated indentations which are an indication of waterlogging if the contact point is partly less permeable, and of an accelerated notching of the rock next to it.

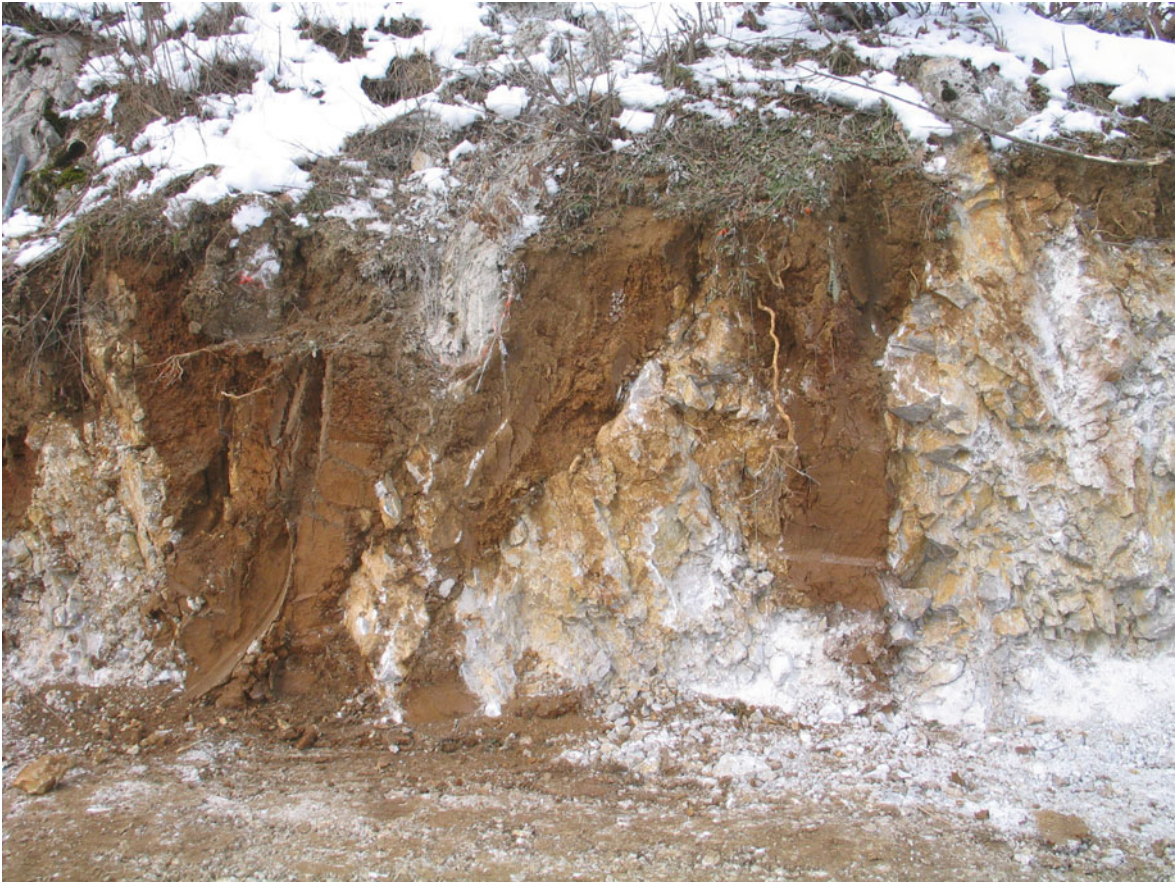
Fig. 19.9 An underground shaft filled with fine-grained alluvium

Underground shafts (Fig. 19.9) are, for the most part, vertical cavities similar to plain shafts, over which also percolates the water from the karst surface; however, they are almost entirely filled with alluvia, with only a few vertical sections that may be hollow. The water flowing through them brings in and deposits alluvium which covers the surface. Their cross-sections are more or less circular or elongated along the cracks and bedding planes. Their diameter reaches up to 2 m. Because they are filled with alluvia, they can be intersected around the rim, whereas less permeable contact points

can cause the formation of notches. Underground shafts are formed along a localized continuous flow of larger quantities of water. They can develop from subsoil flutes. Their walls have rock forms which were formed due to the contact with a fine-grained alluvium. During higher conductivity within the karst interior the underground shafts can empty out.

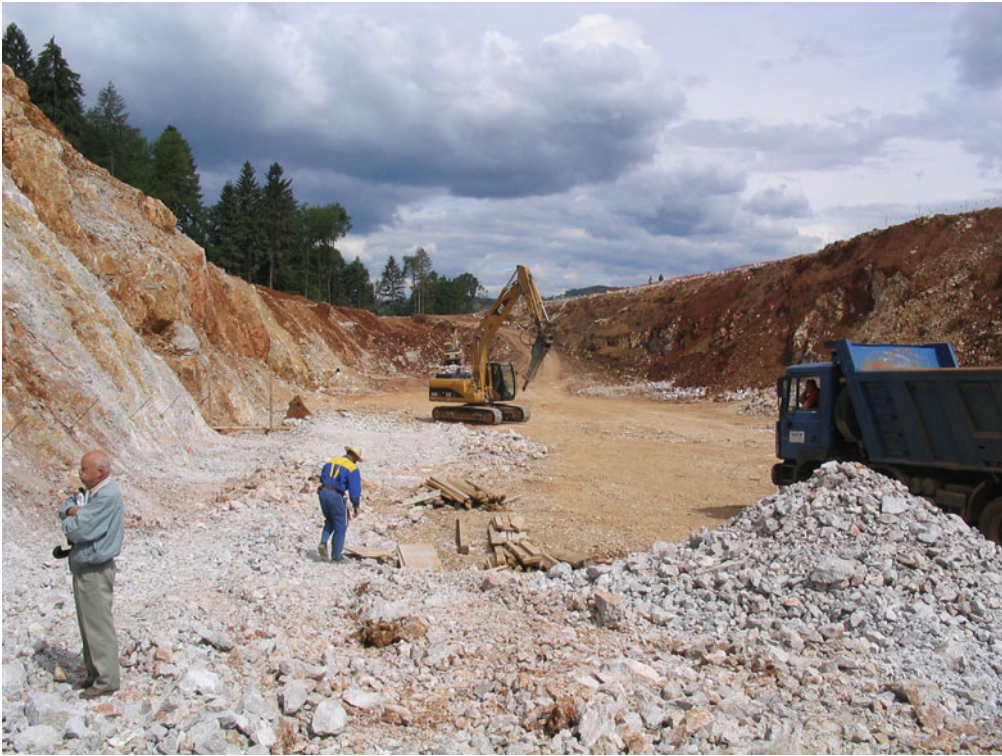
Fig. 20.2 Construction of the highway north of Novo mesto has an exposed profile of laminated grey sediments, which were covered by red soil. The profile lies behind the drilling machine in the middle of the photo

A sediment profile was taken in filled depression at Profile No. 207 (45° 50' 46.02"N; 15° 08' 59.01"E; 360 m a.s.l.) of highway construction in the section Hrastje–Lešnica, on the pass between Karteljevo and Novo mesto in the Dolenjska region (Fig. 20.1). The depression was filled with greyish laminated to thin bedded clayey deposits (Fig. 20.2), rather uncommon in the area, where reddish-brown homogenous clayey material usually covers karstified Mesozoic carbonates.

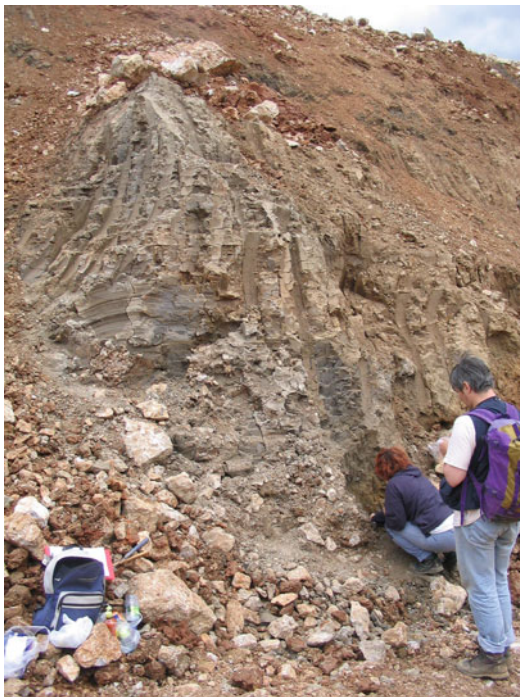
Fig. 20.3 Grey laminated sediments of the Hrastje profile

The profile of laminated sediments 383 cm thick (Fig. 20.3) was composed mostly of clays and silty clays with interbeds and bands to laminas of clayey-sandy and clayey silts. The colour of the sediments was dominantly grey, sometimes brown and beige mottled and with yellowish brown lamination (Fig. 20.4). Finds of gastropod shells, plant remains and plant roots were concentrated in the lower half of the profile (Fig. 20.5). Structures of protopalaeosols (mottled zone with plant roots and iron rich geodes—ferruginized plant roots) occurred in the same section.

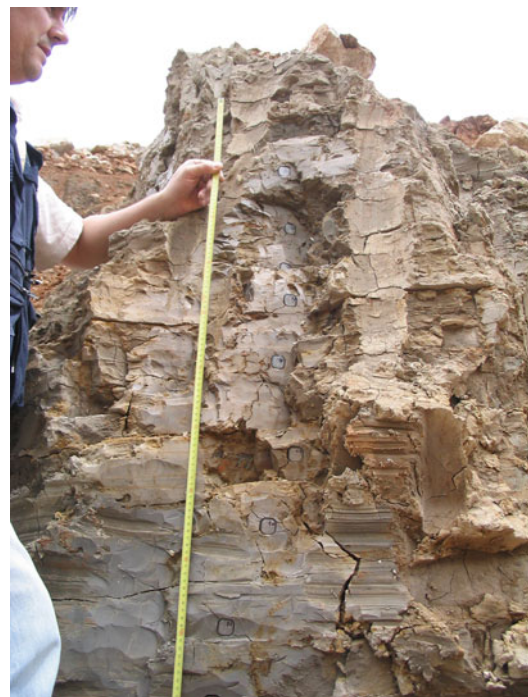
Fig. 20.4 The upper part of the Hrastje profile

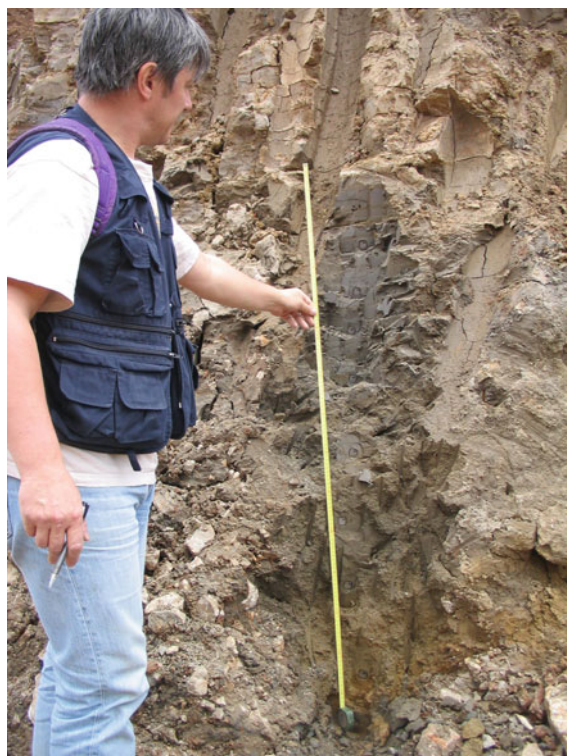
Fig. 20.5 The lower part of the Hrastje profile

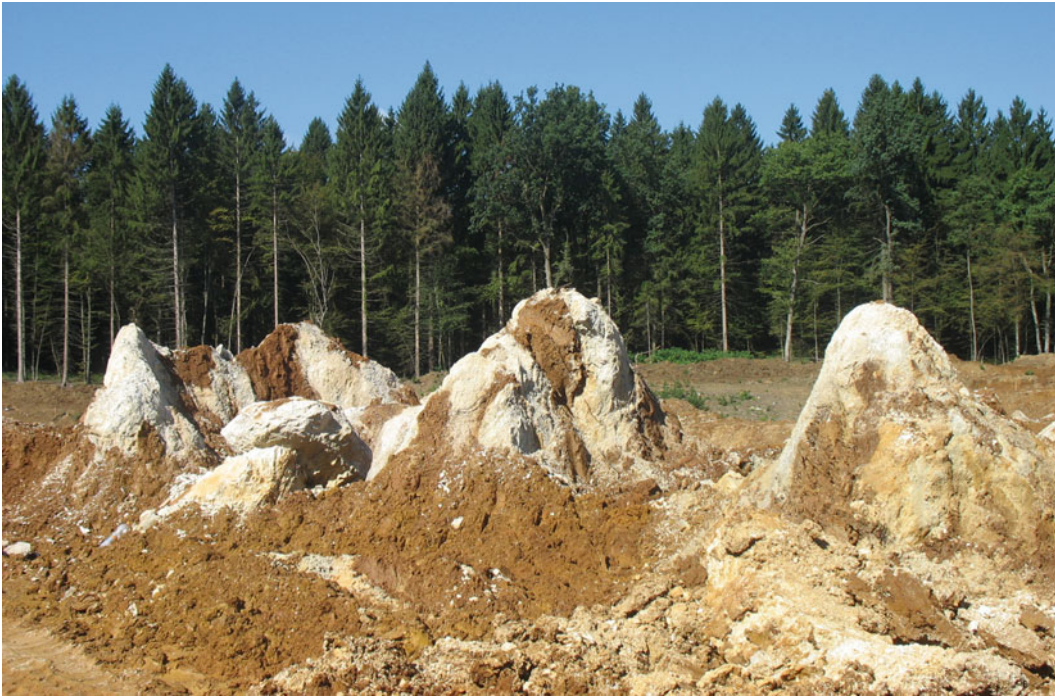
Fig. 21.1 Uncovering of a subsoil stone forest

They expand across the entire surface of the route (Figs. 21.1 and 21.2). Apart from time, their shape and size mostly depend on the characteristics of the rock. The rock is, in fact, fractured with a more or less thick

network of vertical cracks, alongside which the subsoil crevices were carved out by the water. Between them, stone pillars of various sizes have formed. The biggest among these are 10 m wide at the base and reach up to 8 m high. Most are narrower, though. Their long-lasting formation and development are evidenced by their shape which becomes narrower towards the top. Many of them have their tops either pointy or blade-shaped.

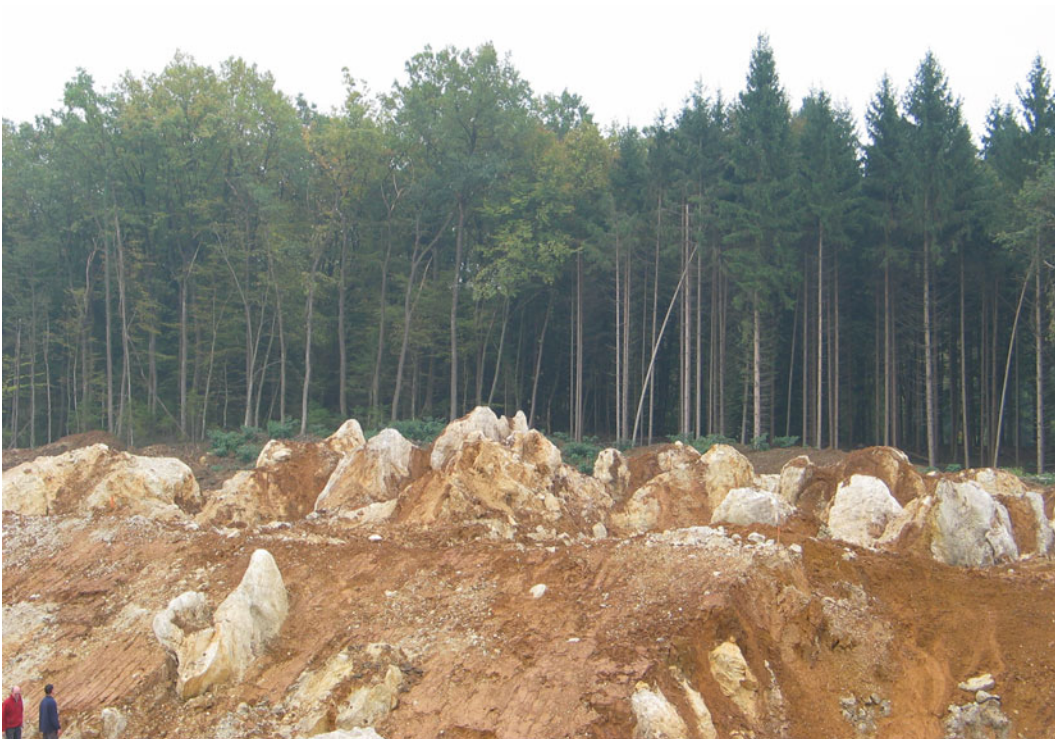
Fig. 21.2 Subcutaneous stone teeth

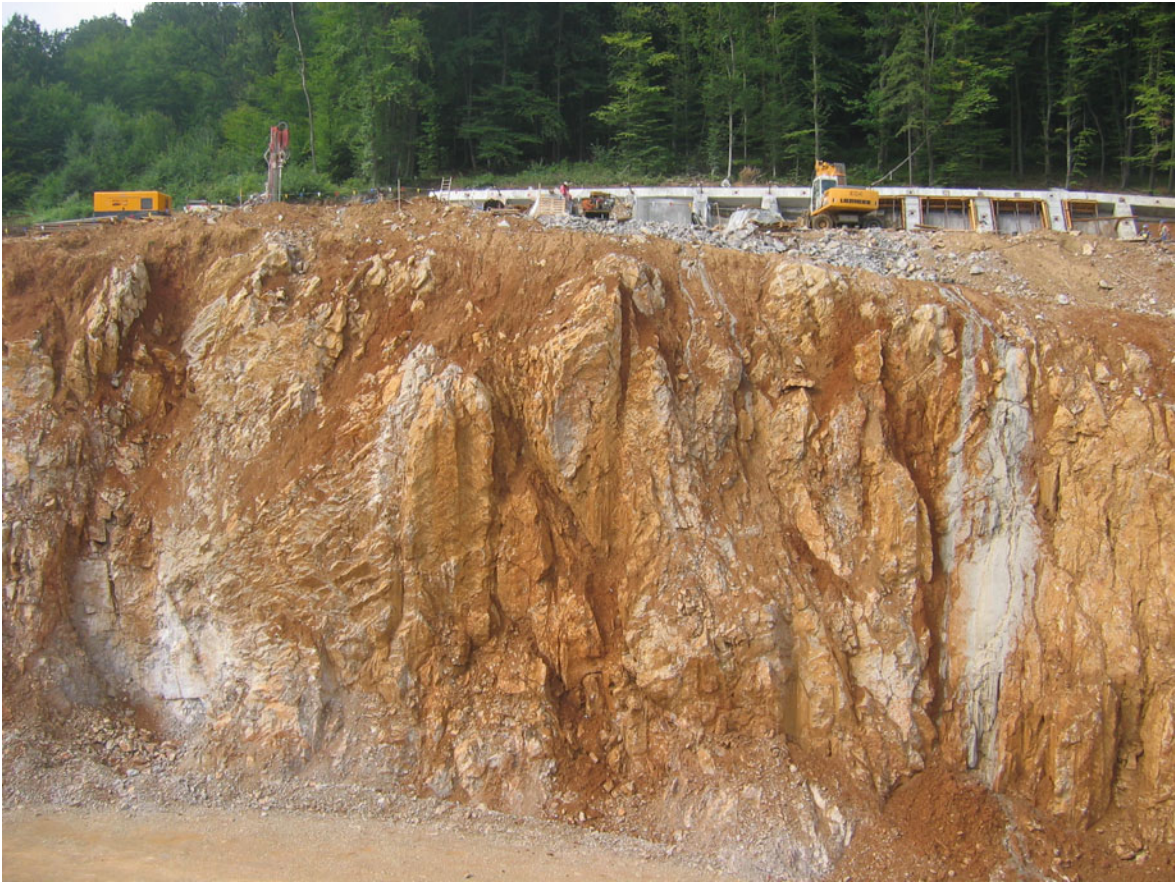
Fig. 21.3 Vertical subsoil channels on the walls of stone columns and of the shaft

Thickly fissured limestone intersects into the stone forest as well. Their shape is preserved under the surface. In fact, distinct crevices have formed alongside numerous fissures which criss-cross the rock in various directions. The rock next to them is crumbling. The rock is intersected by subsoil rock forms, i.e. flutes, tubes, notches, and niches (Fig. 21.3).

The stone pillars are intersected by subsoil rock forms. The most distinct are the more or less vertical subsoil flutes on the walls of the pillars. For the most part, they do not exceed one metre in diameter. Only a handful of pillars cutting deep into the rock and having a big funnel-shaped notch at the top tend to be bigger. Some of the larger stone pillars thus have semi-circular tops, some even have several tips, which are actually the walls of the openings of funnel-shaped notches. Smaller flutes can be winding. The water runs down the flutes at the contact between the rock and the alluvium surrounding the pillars. The second large group of subsoil rock forms, which can be found on lower sections of the stone pillars, are subsoil notches. These are semispherical notches with a circular top and open downwards. Their diameter reaches up to 1.5 m. They are mostly shallow, individual notches which formed along bedding planes or fissures, and can cut more than 1 m into the rock; some of them can

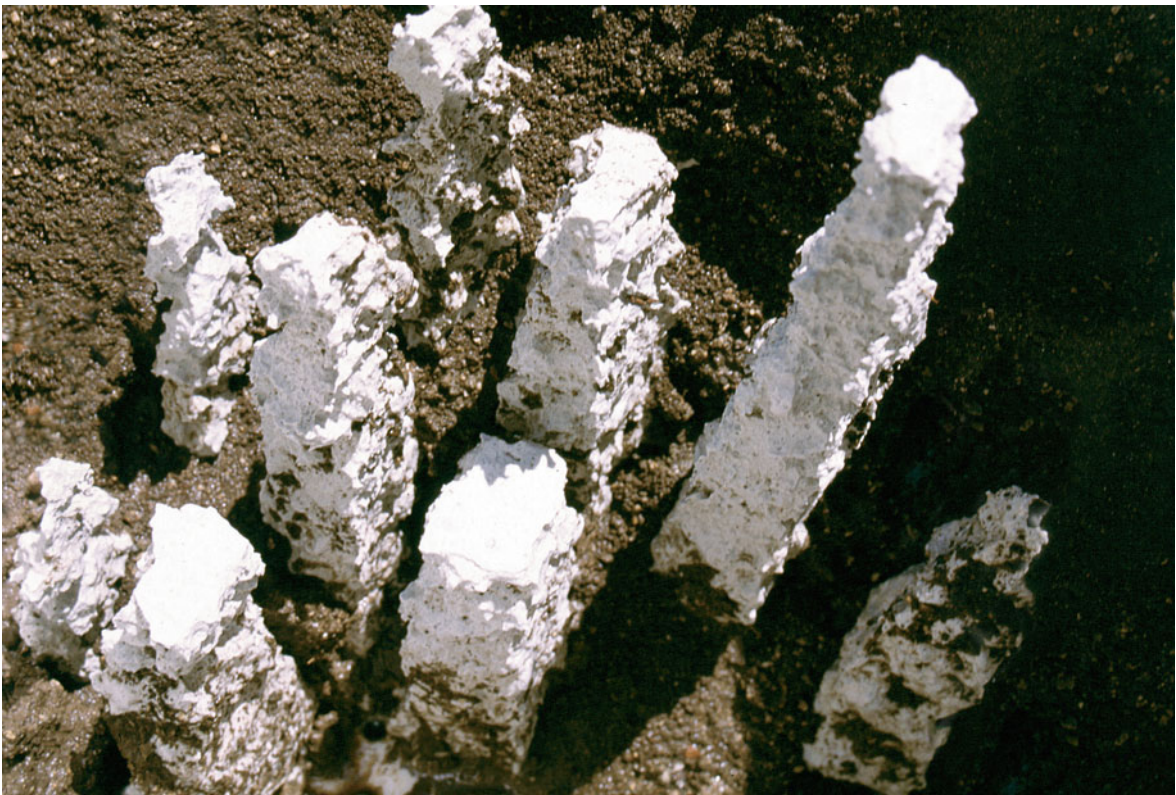
Fig. 21.5 Uncovered subsoil forest in the course of laboratory testing with gypsum

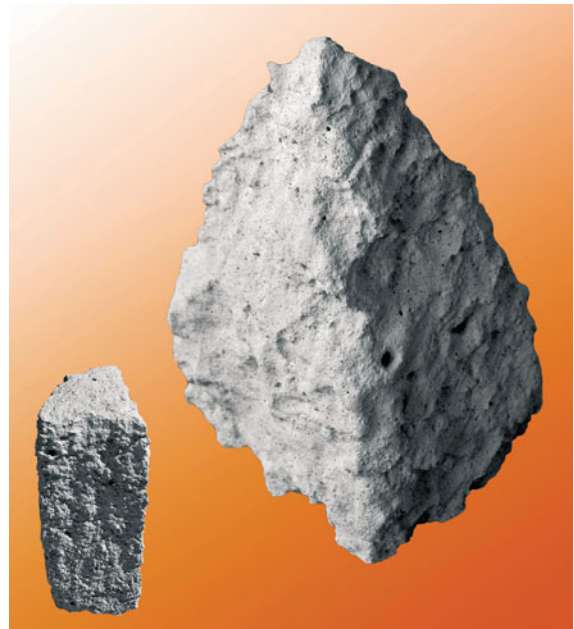
Fig. 21.6 A subcutaneously sharpened top of a gypsum column

On the last test, the somewhat larger plaster pillars (the bigger ones were 20 cm in diameter, the smaller ones 15 cm, and both were 25 cm high) were covered with a finer-grained loam which is less permeable for water (Fig. 21.6). The contact between the loam and the rock reflected this. First, subsoil shafts formed between the pillars. As a result, vertical subsoil flutes formed in the upper sections of the pillars; these flutes were a part of the shafts and had funnel-shaped openings on their tops. The openings were up to 3 cm in diameter. It seems that when the contact between the plaster and loam is poorly permeable, the water tends to find paths that are the most conductive and merges them into streams. This assumption was also confirmed by the bubbles on the surface of the water which revealed several distinct ponors. Special flutes, such as those described in the test above, formed in the lower section of the walls of the pillars and were shaped in the locally flooded zone. Anastomoses formed on the lower plane of the pillars.

The pillars were entirely pointy. The sharp side edges were preserved. With time, the rock relief became increasingly similar to that in the first test, especially on individual planes. The surface of the pillars was generally more flat, however. The new characteristics tend to remain preserved, i.e. the intersection by more or less vertical and more or less winding subsoil flutes which is due to the varying permeability through the contact point between the plaster and the loam. Higher up the walls of the pillars than on the initial tests, horizontal or leaning notches with different inclinations were preserved; this demonstrates that the crevices were almost entirely filled and the contact points between the plaster and the

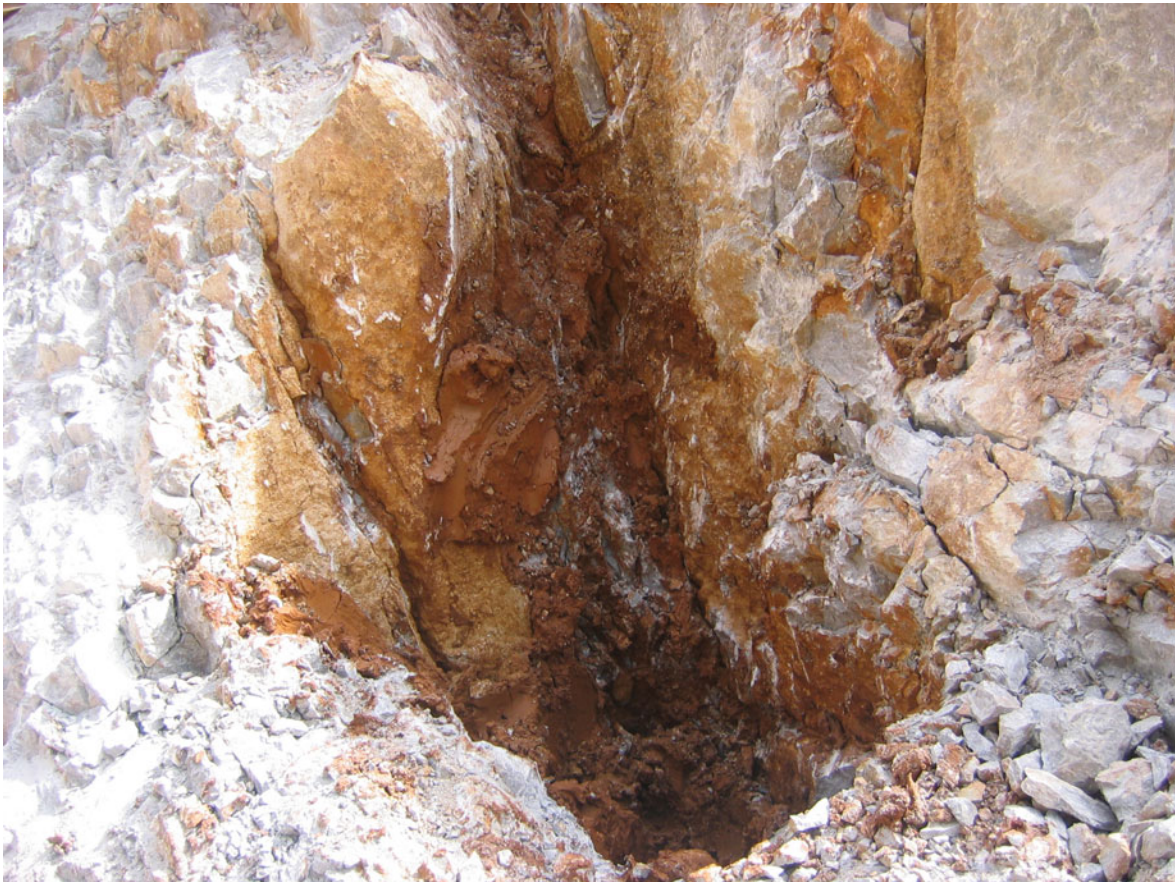
Fig. 21.7 The entrance to an underground shaft

They can be categorized into underground shafts and smaller caves (Fig. 21.7). The underground shafts form along vertical fissures, most commonly by widening the crevices between the stone pillars. They reach up to 1.5 m in diameter, have circular cross-sections, and their walls are intersected by subsoil rock forms, especially flutes and pockets. During the digging of roadcuts, they uncovered within their walls or loam soil as smaller subsidences. From some of them, the rain water washed away the alluvium.

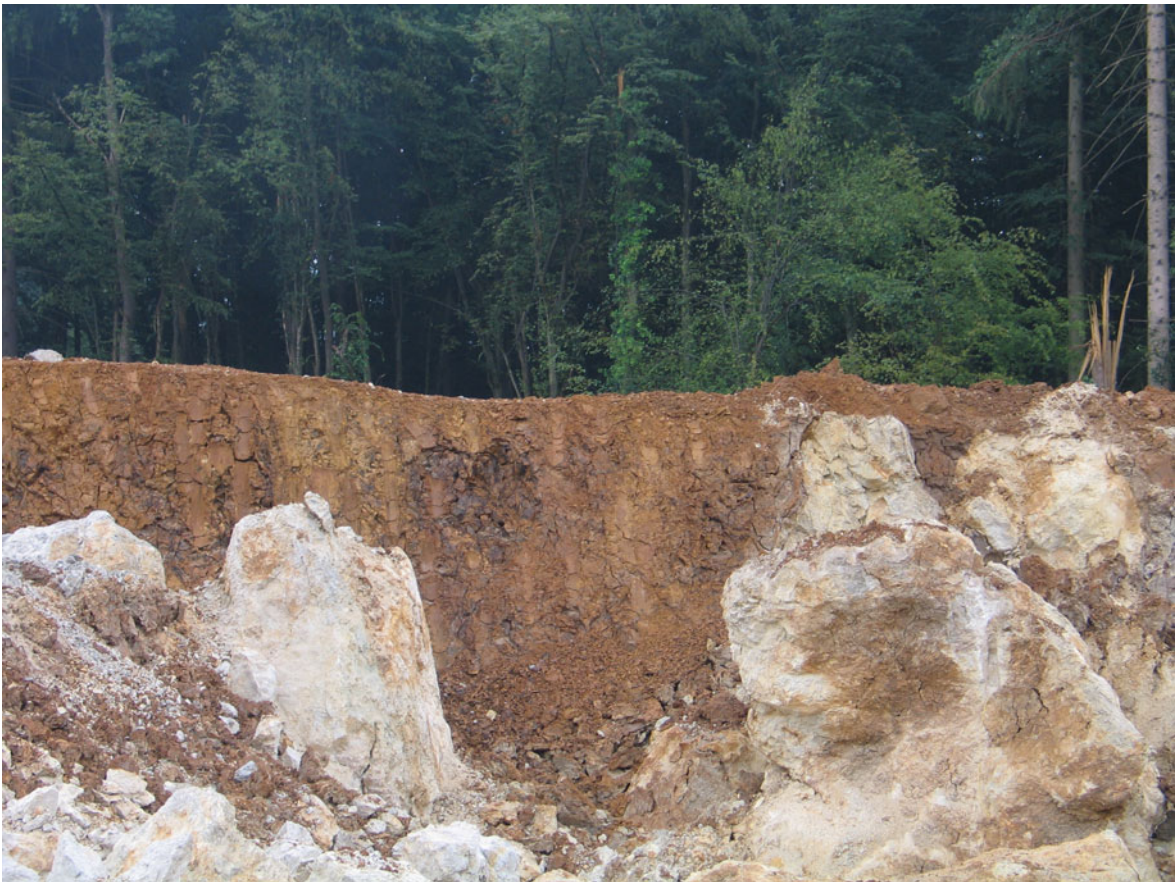
Fig. 21.8 An underground cavern filled with fine-grained alluvium

hanging flooded sections of the epikarst aquifer form. In these, the formation of the cavities with up to 1 m in diameter tends to be the most intensive. In general, the uncovered cavities crisscross the stone pillars. They are entirely filled with a fine-grained alluvium, and above-sediment flutes and anastomoses have formed on their ceiling (Fig. 21.8). The above-sediment anastomoses are common along gently sloping bedding planes as well.

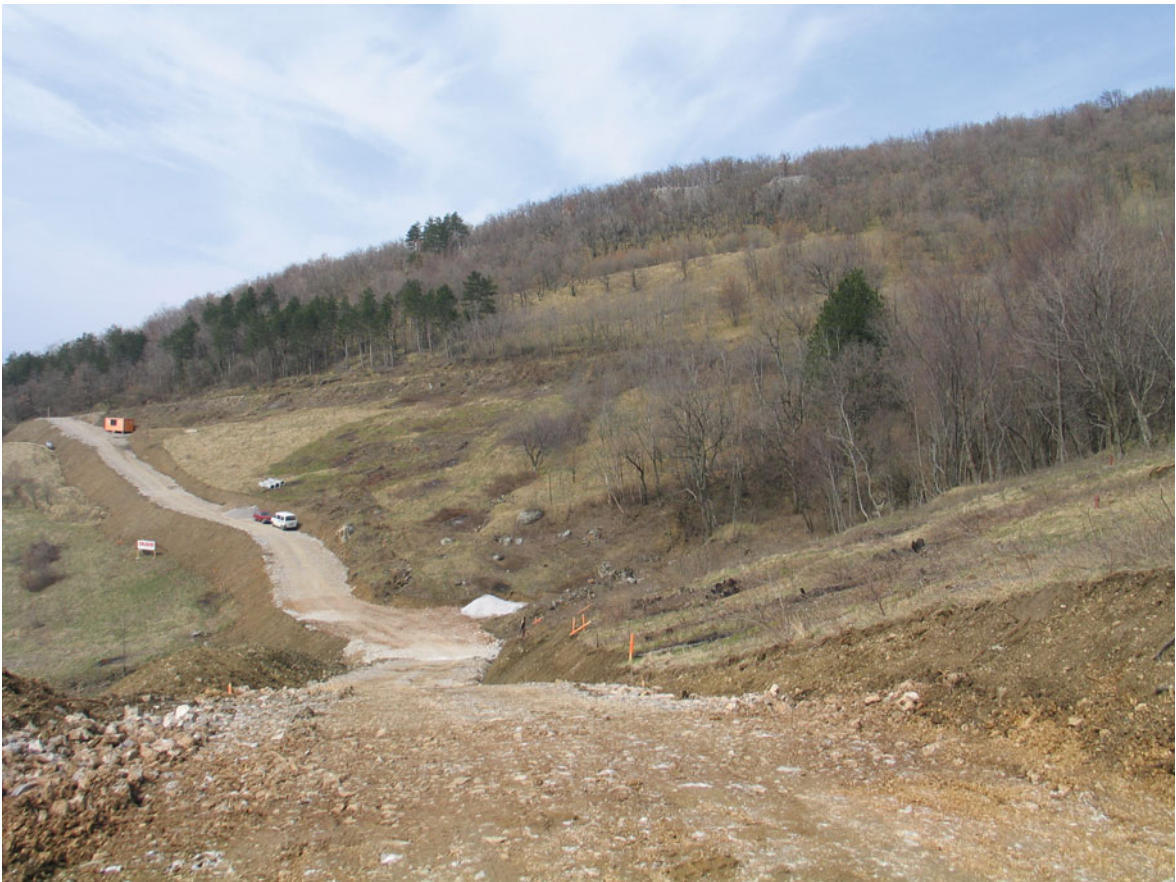
Fig. 22.2 The formation of this plateau was not affected by surface waters, whereas the underground drainage merged into an outflow as a group of springs at Vipava

Later radial movements caused the uplift of Mount Nanos and subsidence of its edge, most intensively in the area of the Vipava Valley. This allowed for the flow of water through the karst system and the formation of the surface of Mount Nanos. The formation of this plateau was not affected by surface waters (Fig. 22.2), while the underground drainage merged into an outflow as a group of springs at Vipava. Due to the low altitude of the springs, sinking streams from the northwest edge of the Pivka Basin started to flow towards the springs.

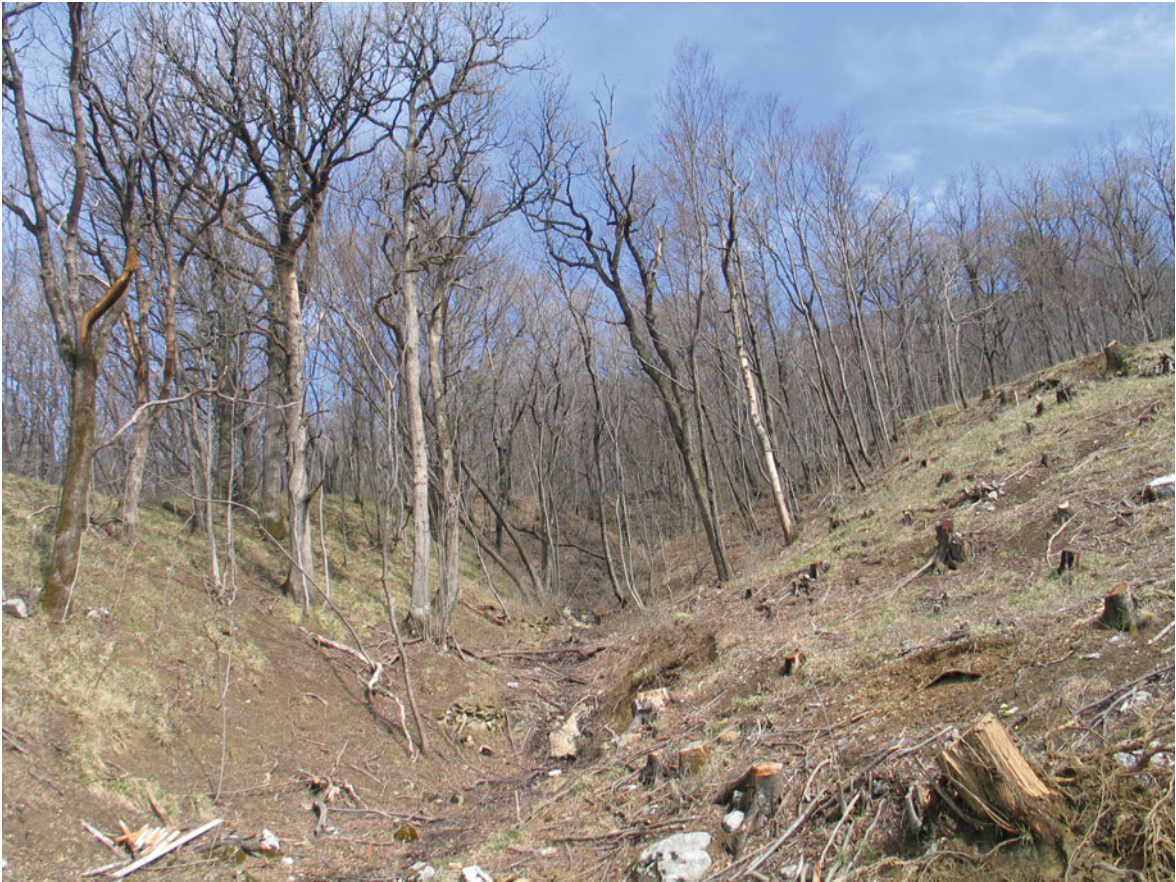
Fig. 22.3 Tributaries from the slope of Mount Nanos carrying less water have not shaped the most important valleys and have not significantly dissected the slopes

On flysch rocks at the southwestern edge of Mount Nanos, a water basin of the Močilnik Springs has emerged. The Močilnik River is characterized by its asymmetric river network which gets only the left tributaries from the flysch area of Vipavska Brda hills. These tributaries have shaped deep valleys and ravines. Tributaries from the slope of Mount Nanos carrying less water have not shaped the most important valleys and have not significantly dissected the slopes (Fig. 22.3).

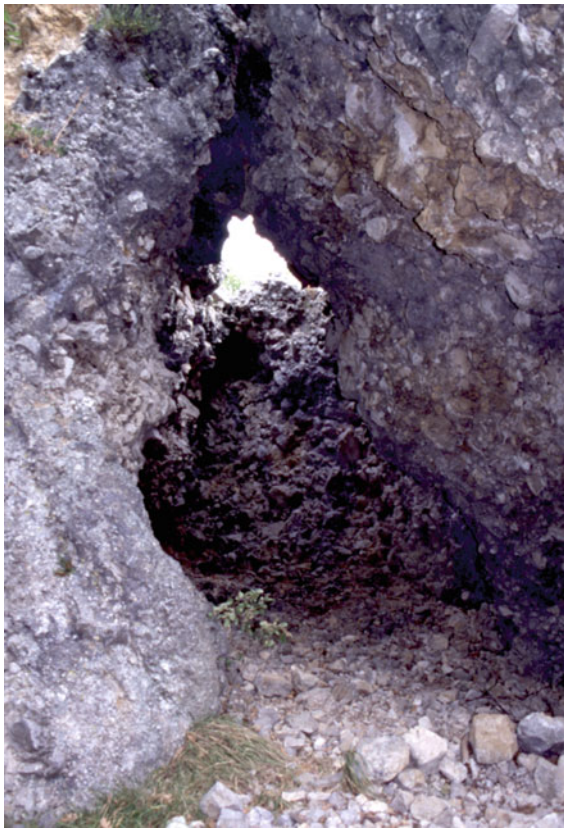
Fig. 22.4 Here and there, the sheets of limestone fragments are cemented with calcite flowstone

fragmentation, or collapses of steep slopes have covered the more gently sloped flysch part with large sheets of limestone gravel. Here and there, these sheets are cemented with calcite flowstone (Fig. 22.4).

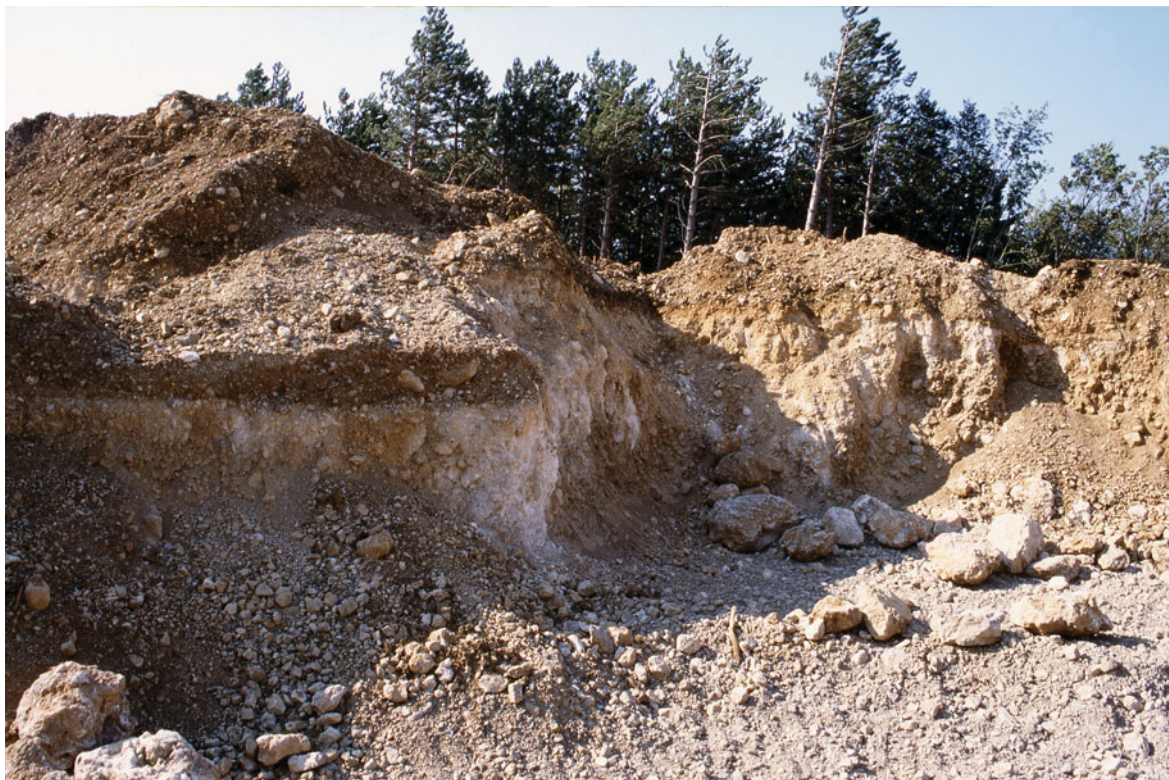
Fig. 22.5 Layers of breccia

In cross-sections of the slope exposed by cuts for the motorway, it was frequently possible to observe many layers of rubble or breccia (Fig. 22.5). Their total thickness mostly reached up to 10 m, in individual places that were exposed during the digging of the wells for the viaduct pillars even up to 25 m. Generally, the layers can be differentiated relative to the degree of cementation of rubble into breccia. Only individual layers were relatively well-cemented. The carbonate binder binds the rubble into breccia; the process first takes place around bigger rocks. In fact, the earthworks often revealed chunks of breccia several m³ in size, which were surrounded by unconsolidated or poorly unconsolidated rubble. Between the larger and smaller pieces of rubble and rock forming breccia were hollow spaces partly filled with flowstone (Fig. 22.6). The degree of cementation of breccia is therefore the consequence of the age of breakdowns, a deeper or shallow position below the surface, and characteristics of waters that percolate regularly from the surface, which is covered with a thin layer of soil and vegetation. In certain places, breccia is already uniquely karstified.

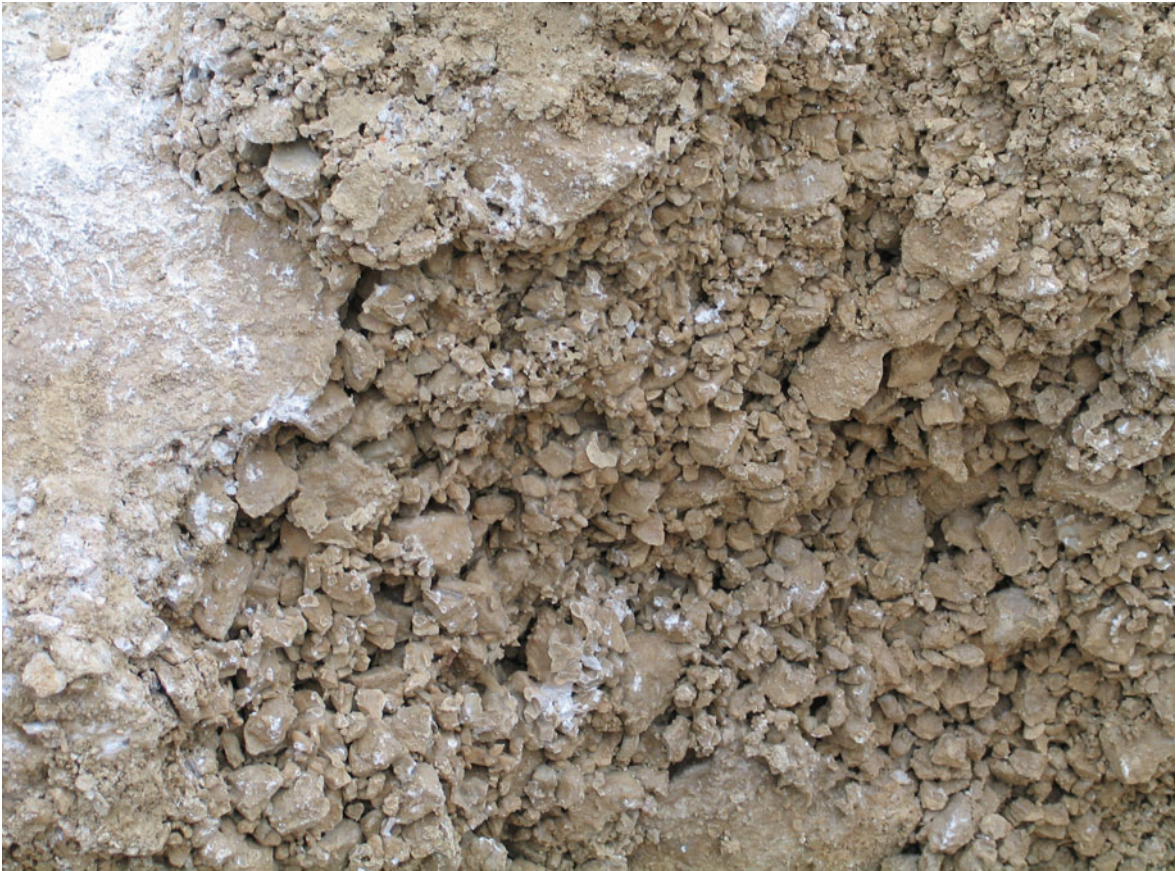
Fig. 22.6 Parts of breccia

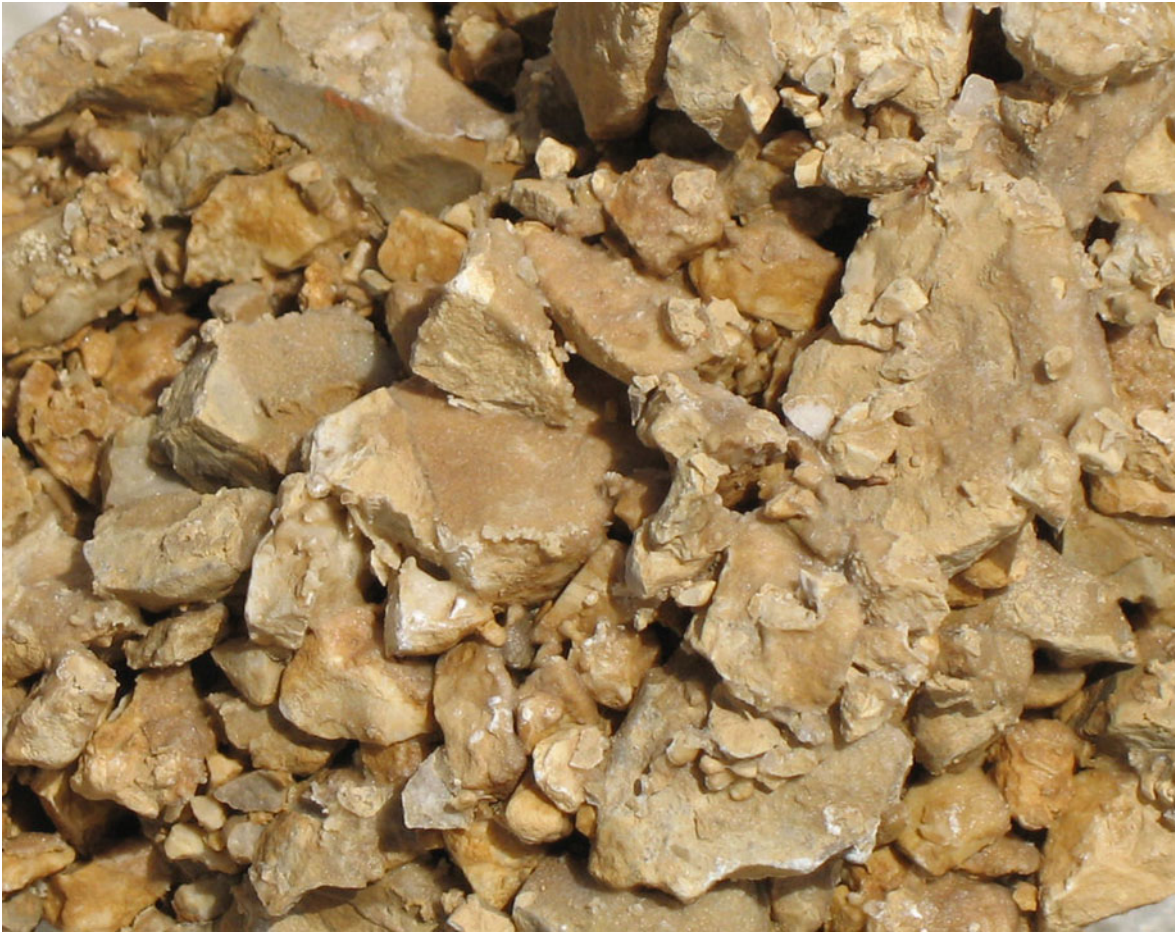
Fig. 22.7 There is almost no fine material in between breccia clasts

flowstone. There is also no fine material nested in between (Fig. 22.7). This type of breccia is very porous. Only partially porous breccias have formed where water between the clasts carried in weathered debris and fewer fine limestone clasts from the surface. In places where fine limestone fragments with the size of sand accumulated between clasts that are a few centimetres in diameter, the areas with breccia are substantially less porous. They also contain weathered debris that is bound into flowstone (Fig. 22.8). In some cases, the clasts have been bound together by the calcium carbonate in which the water deposited major quantities of weathered debris. Even in this case, breccias are poorly or almost non-porous, and the binding is of characteristic red-brown colour. In places, flowstone-covered cavities have formed between the clasts; here, the beginnings of larger calcite crystals can be observed.

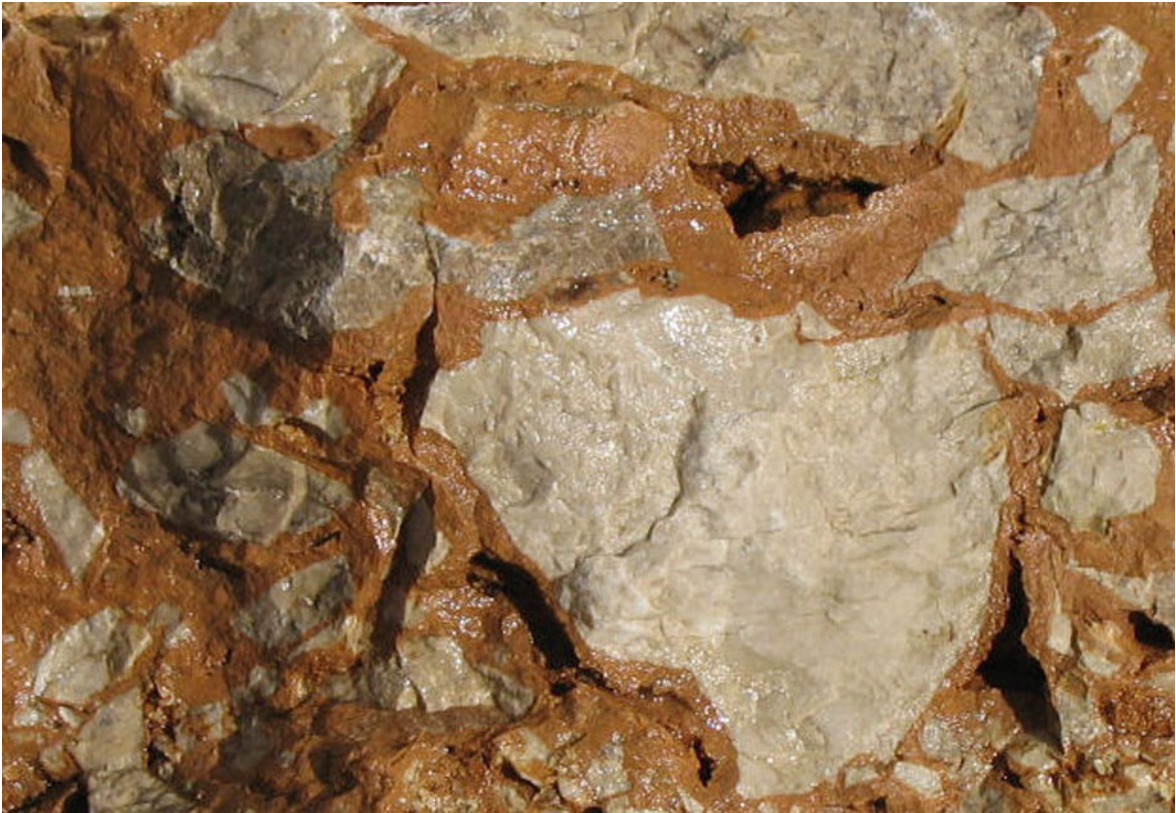
Fig. 22.8 Some breccia also contain weathered debris bound into flowstone
