Cave and Karst Systems of the World

Cave Exploration in Slovenia

Discovering Over 350 New Caves During Motorway
Construction on Classical Karst

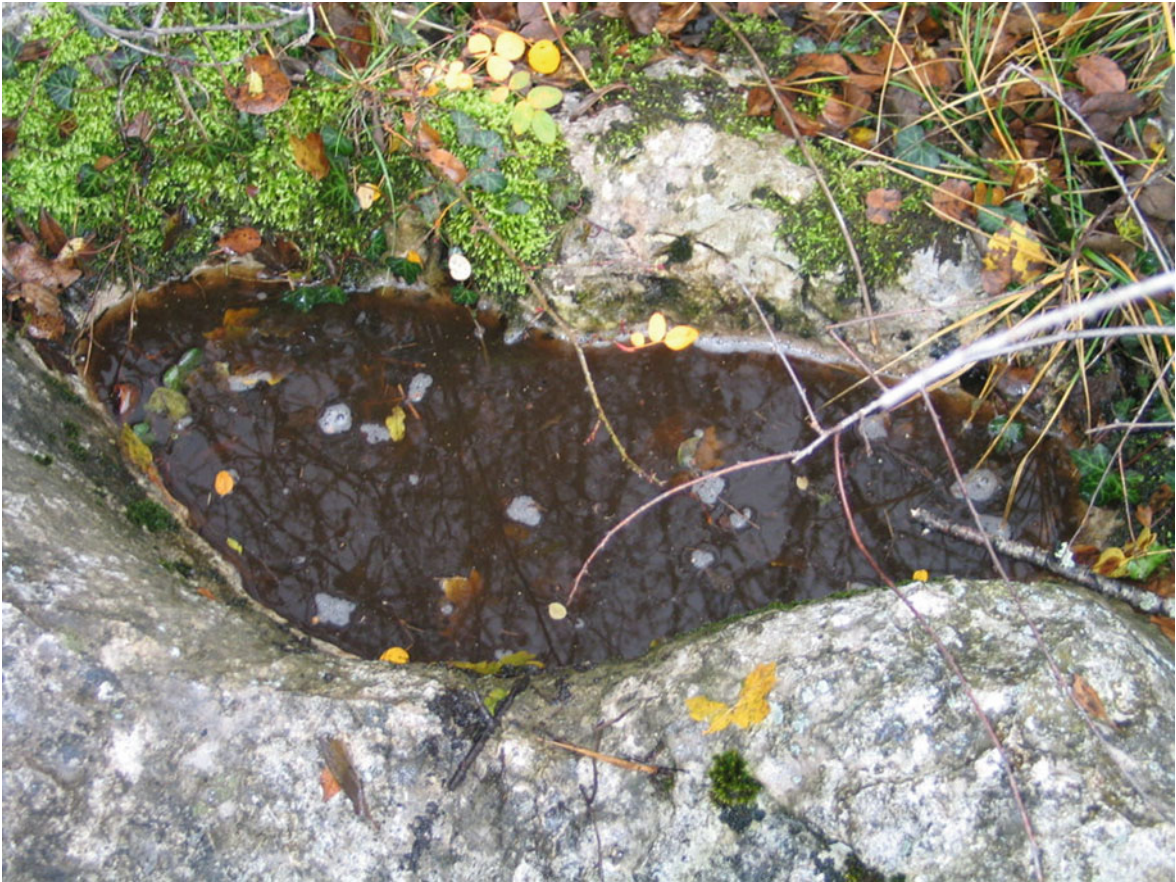
Fig. 22.9 Solution pan

The carbonate blocks on the surface have rain flutes which indicate a long-lasting shaping of the rock with rainwater. In close proximity of the route solution pans appear as well (Fig. 22.9). None of them is significantly big, although the longer axis of some solution pans is 0.8–1 m long. The majority are smaller, though.

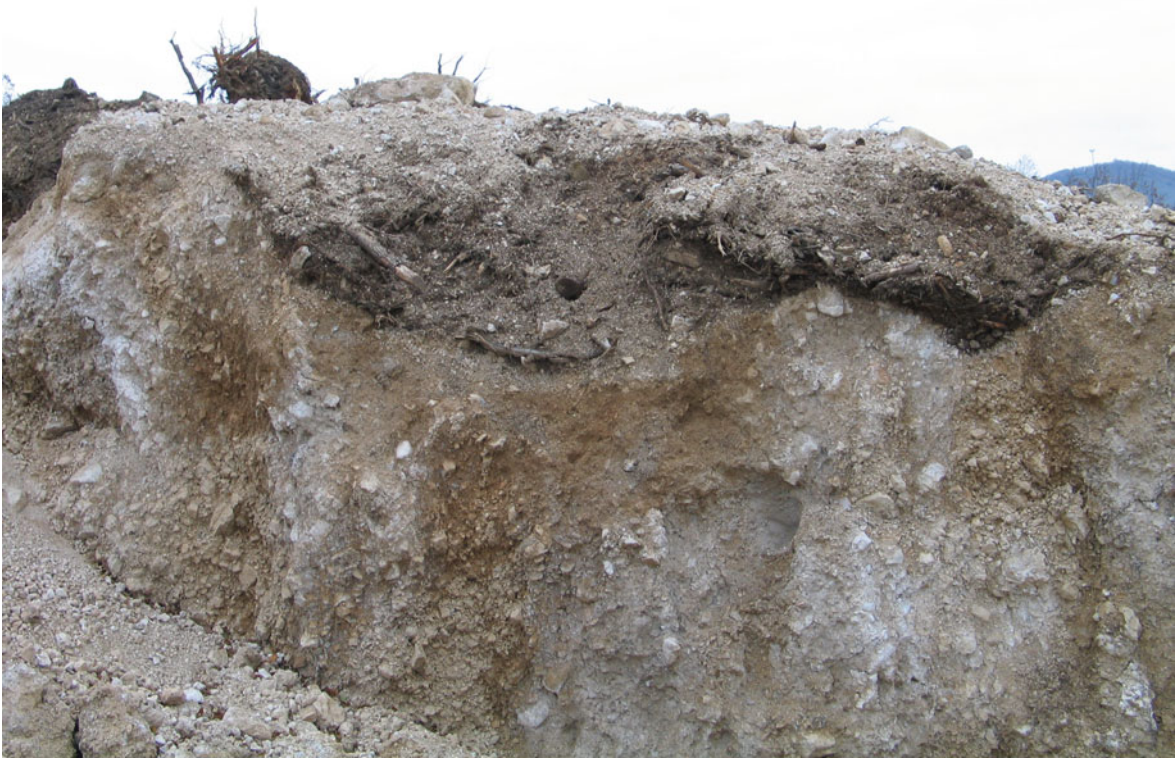
Fig. 22.10 Small dolines

In some locations, dolines have begun to form; they were formed with water that mostly dispersedly percolates from the permeable surface (Fig. 22.10). They are smaller and covered with soil which makes them

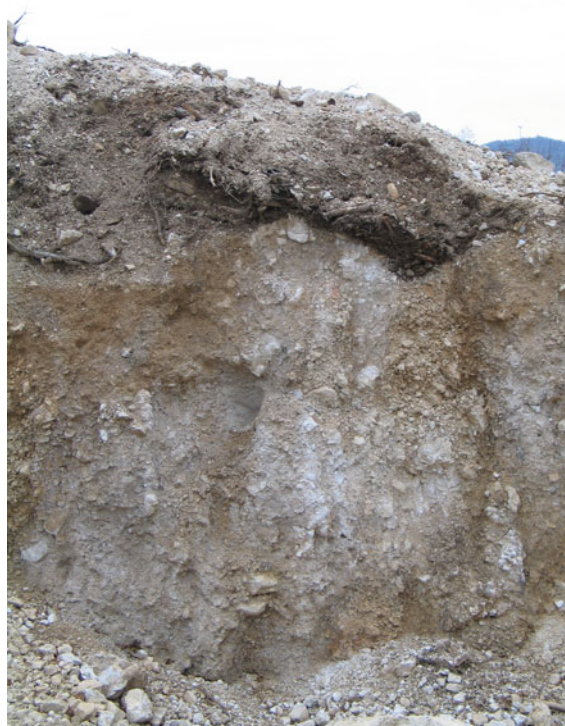
Fig. 22.11 Belt of breccia underneath a doline

less distinct on the surface. Their diameter reaches up to 3 m. Underneath, due to earthworks, of course, there are vertical, 1–2 m wide belts of uniquely washed out rubble and breccia that are clearly visible in the cross-section (Fig. 22.11). These are therefore traces of already consolidated water percolation which is also due to the rubble coagulating into breccia.

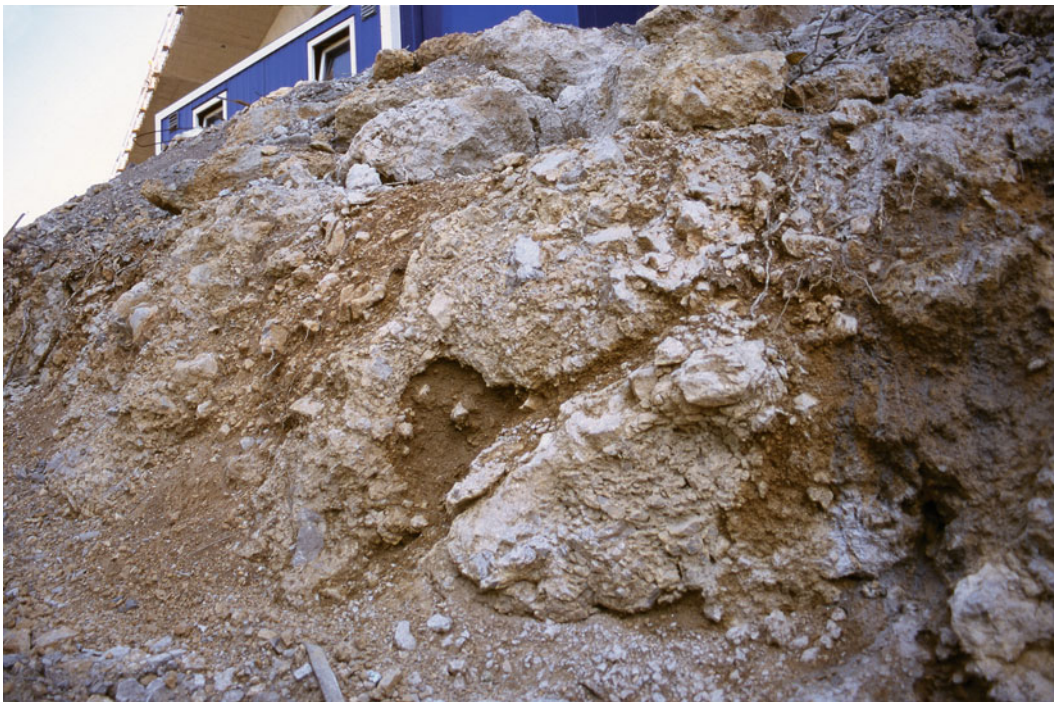
Fig. 22.12 A cavity filled with fine-grained alluvium

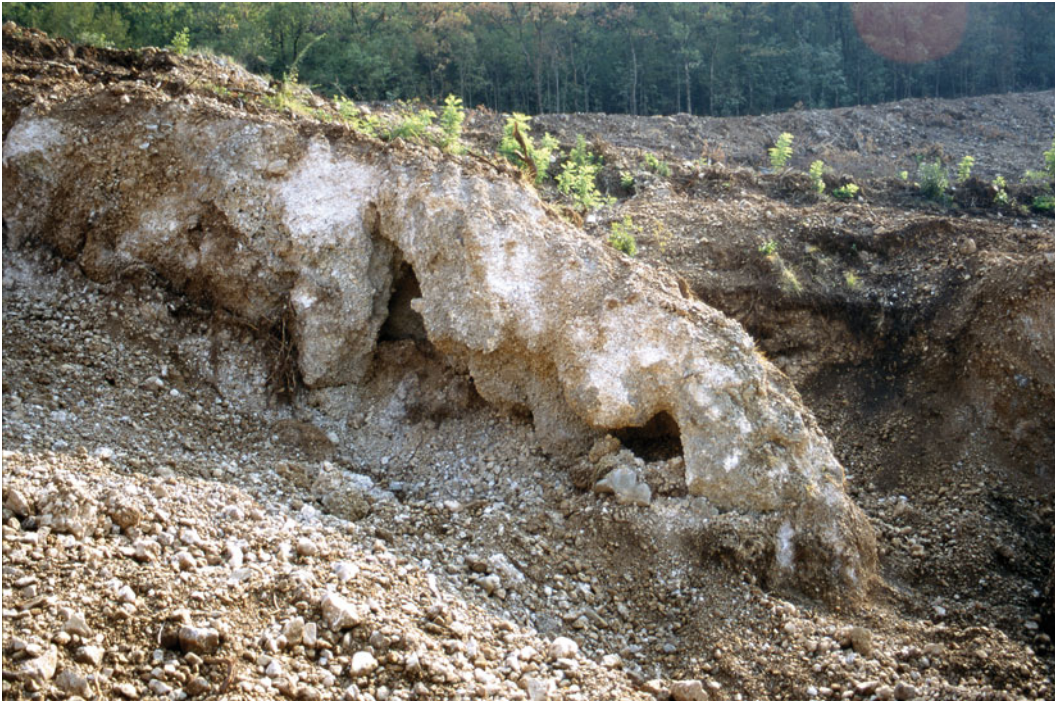
Fig. 22.14 A network of dome-shaped passages

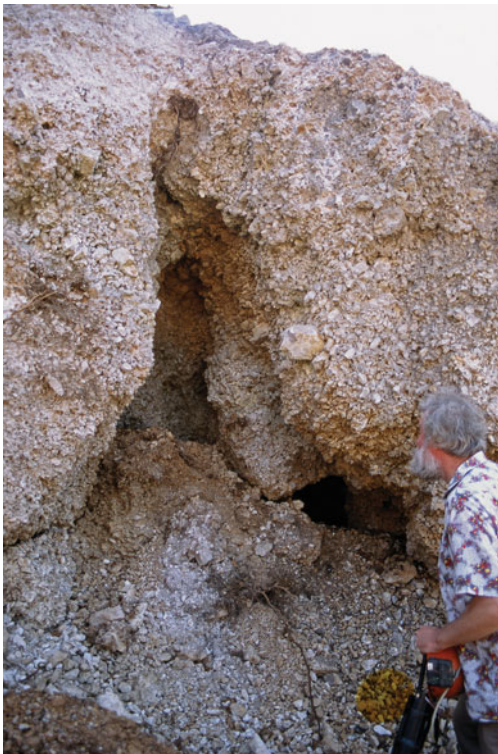
Fig. 22.15 A passage above flysch

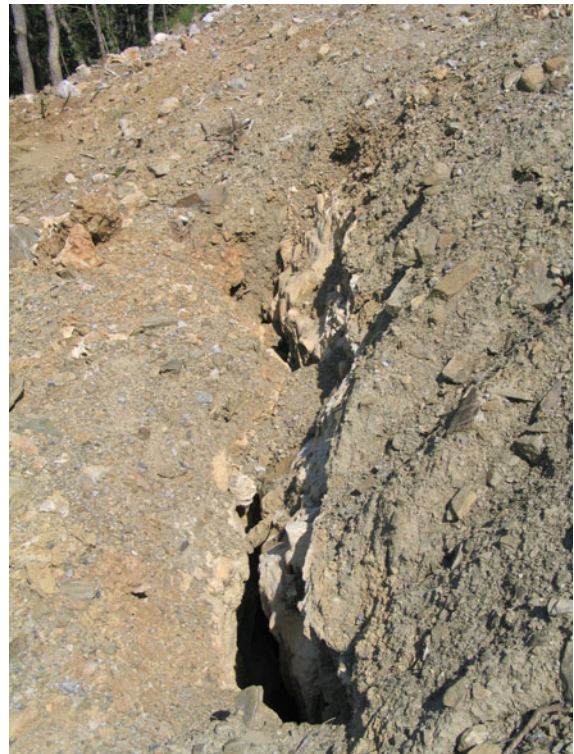
Fig. 22.16 A fissure cave

fissures they rise into domes. Along fissures which emerged due to the sliding of breccia and rubble down the slanting bedrock of frequently soggy flysch, fissure caves formed diagonally to the dip direction of the slope; some of them are very long and wide enough in places to make them accessible. Their walls are mainly covered with flowstone.

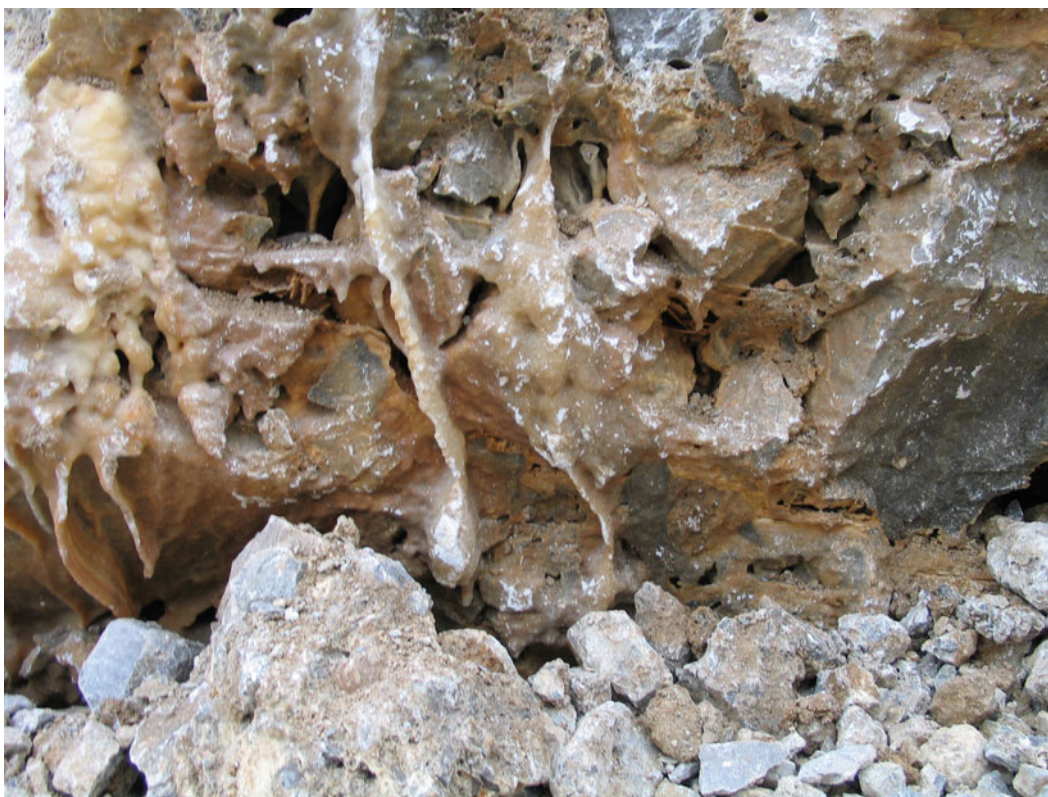
Fig. 22.17 Flowstone in breccia

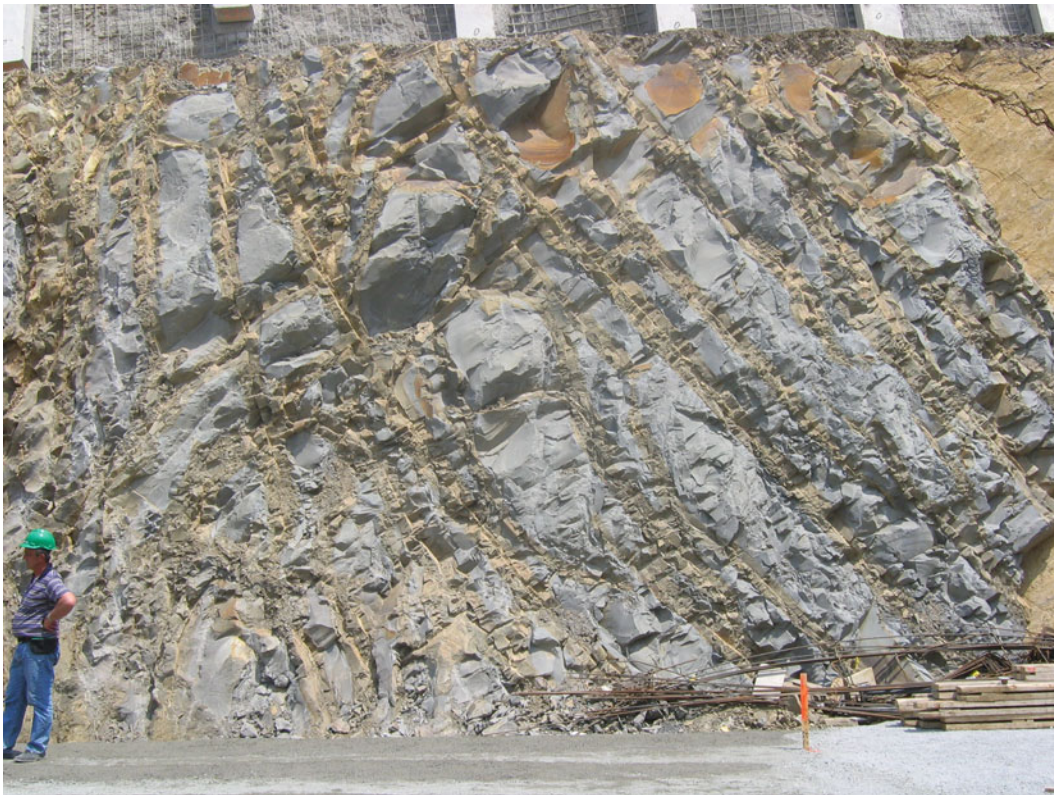
Fig. 22.18 Flysch

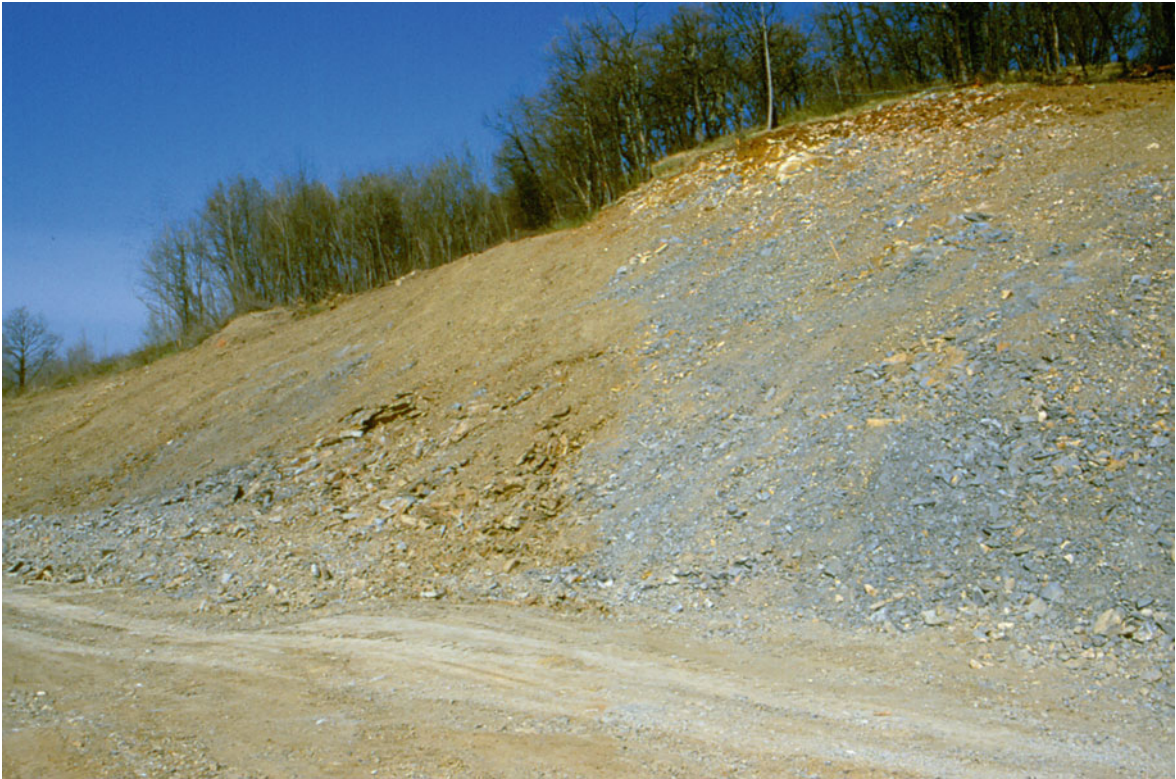
Fig. 23.1 Contact area between limestone and flysch

The bottom of the Vipava Valley is made mostly of clastic rocks and sediments of different age and origin. The motorway between Vipava and Selo initially runs across the agriculturally changed Quaternary alluvium sediments, then it crosses the slightly undulating landscape made of Lower Eocene non-carbonate and carbonate turbidites (Fig. 23.1), and in its last section it cuts across Quaternary, locally cemented talus debris (Fig. 23.2).

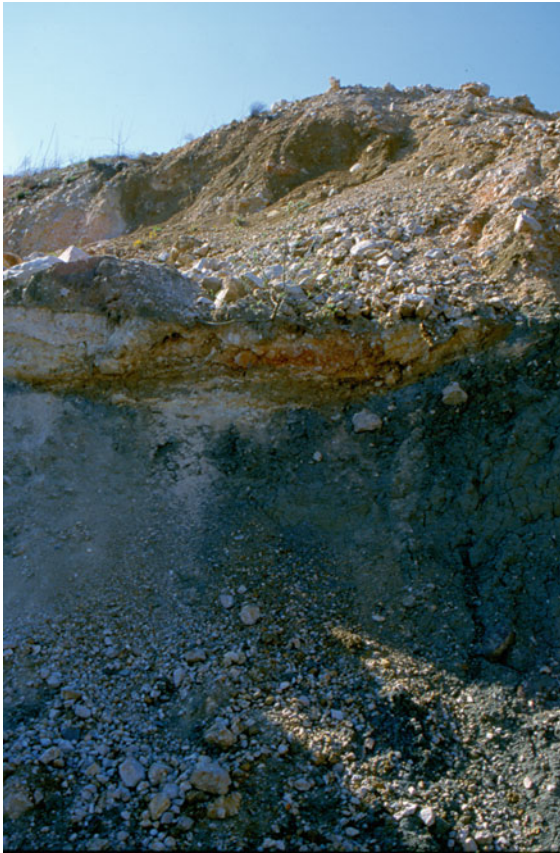
Fig. 23.2 Layers of breccia

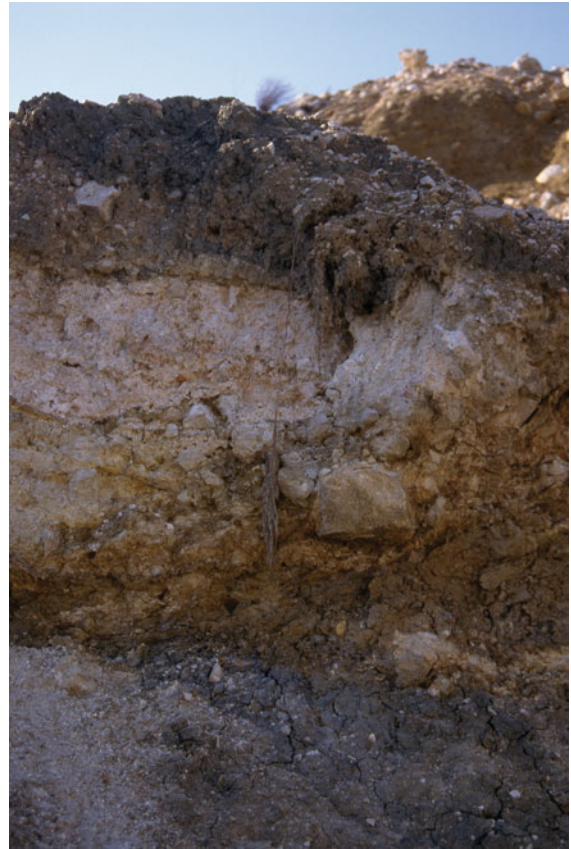
Fig. 23.3 Breccia above flysch

The Quaternary coarse-grained carbonate talus debris which, at places, features large limestone blocks, is locally cemented which is why breccia formations (Figs. 23.3 and 23.4) in between fine rubble appear “spongy”. To a lesser extent, the talus breccia of this type can be karstified.

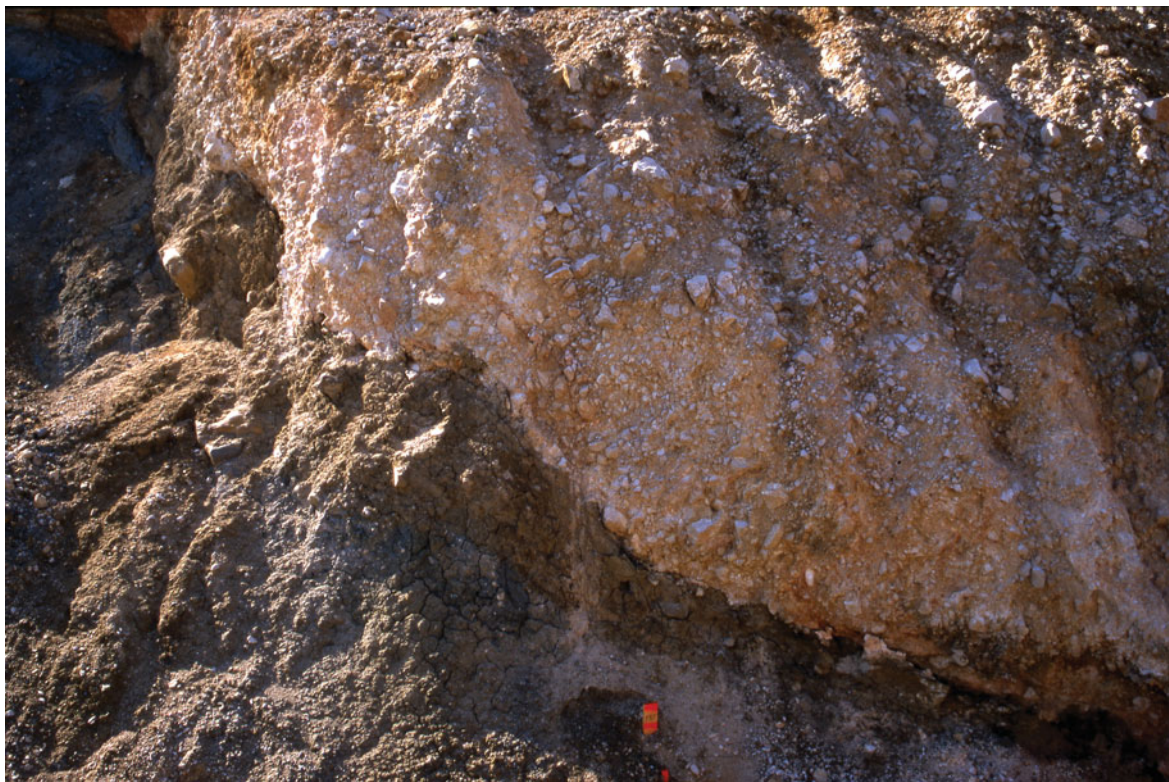
Fig. 23.4 Impermeable flysch bedrock underneath breccia

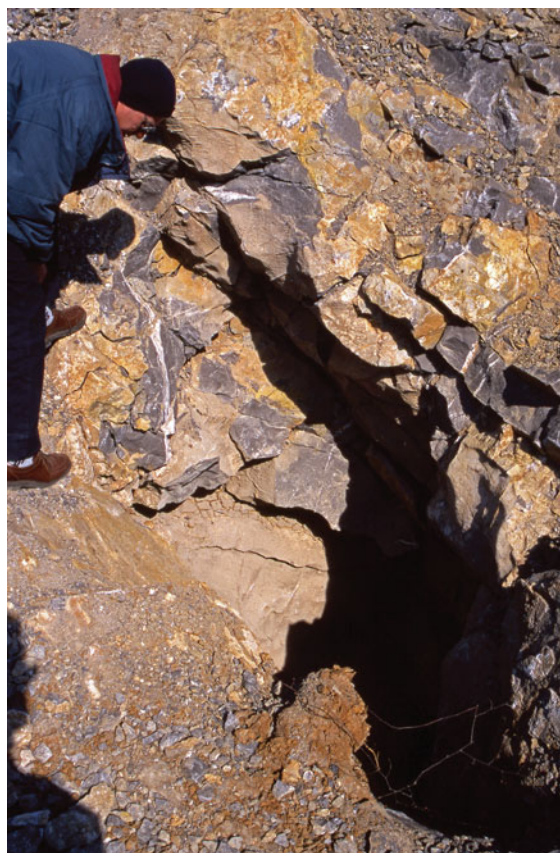
Fig. 23.6 A shaft which opened during excavation works for the roadcut

The second shaft (Fig. 23.6) is 4 m deep and up to 1.5 m wide. The bottom section of the shaft was buried due to the breakdown of rocks into it. The shaft lies in a thick-bedded limestone which lies in flysch.

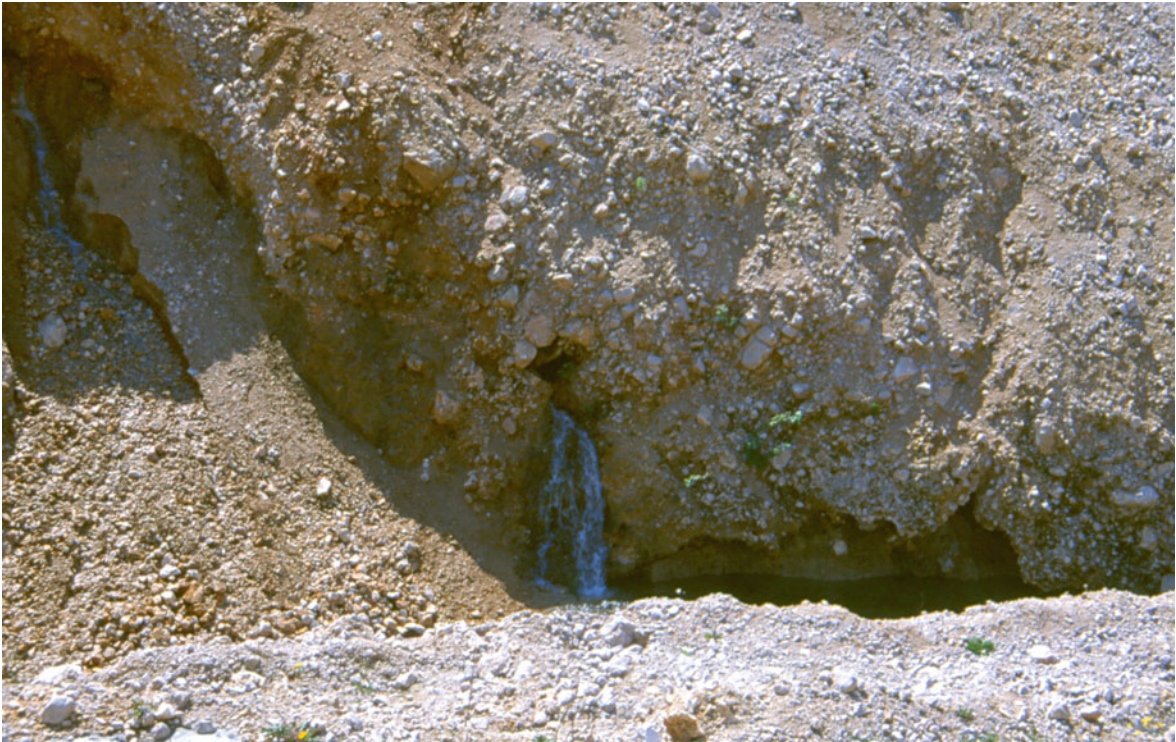
Fig. 23.7 A small passage with a water flow in breccia above the contact area with flysch

During roadcut excavation works, small cavities have formed at the contact between the upper, at places several metres thick bed of carbonate breccia, and the low-lying flysch; these cavities have a diameter of up to 0.5 m. Smaller water streams flow out from the contact (Fig. 23.7). The water that percolates diffusely through the permeable breccia therefore flows across the intertwined network of smaller cavities which formed along the contact. Moreover, two slightly larger cavities have opened as well. The larger of the two consists of several passages 1 m in diameter. The juncture of the passages is a cave 3 m wide and 1.5 m high. The circumference of the cave is crumbling since breccia is not well cemented.

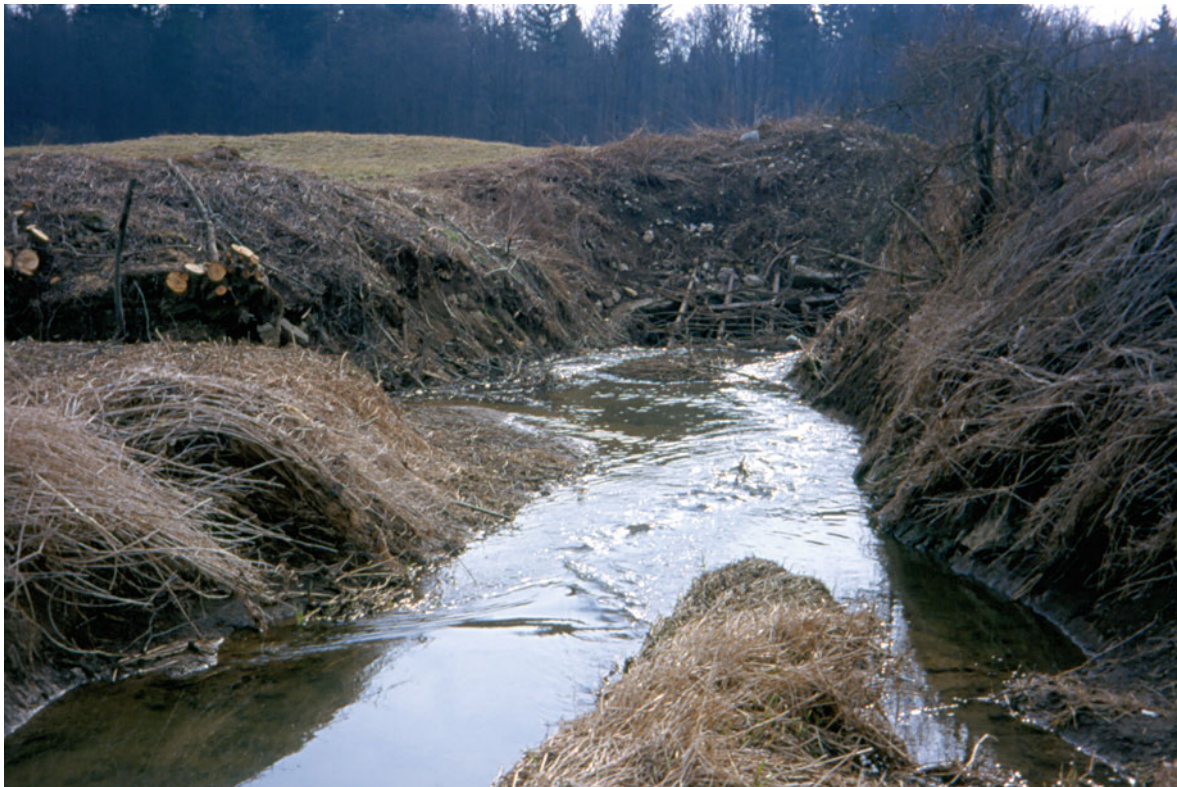
Fig. 24.2 When the water level is low, the Rupa ponor at Ponikve represents the uppermost point of the surface flow of the Temenica river

The upstream part of the Temenica River sinks at Ponikve on the karstified Jurassic limestone through numerous ponors. The activity of these ponors depends on the hydrological conditions that reflect in the river's water level. When the water level is low, the river sinks entirely into the ponor Rupa I at the altitude of 260 m (Fig. 24.2); however, when the water reaches its lowest level, the river sinks through the ponors on the right-hand side of the riverbed approx. 150 m

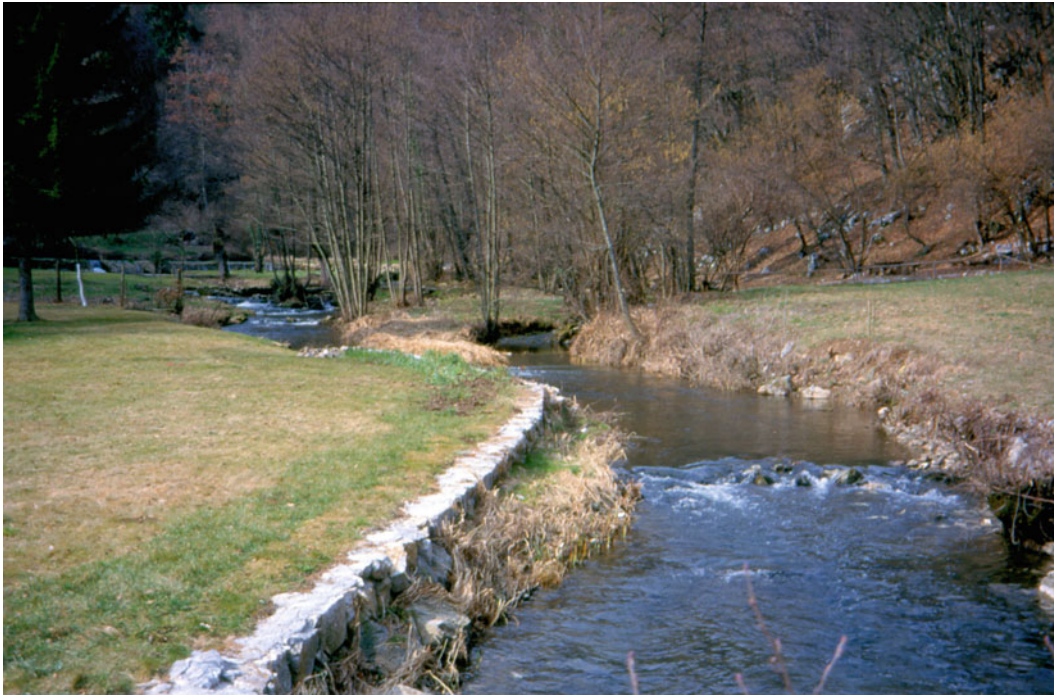
Fig. 24.3 The Zijalo springs are several permanent and intermittent springs flowing into the Temenica River

After approx. 2 km of flowing underground, the Temenica River resurfaces at the southern outskirts of Sv. Ana at the altitude of 245 m as a true headwaters with several permanent and intermittent springs, also known as the Zijalo springs (Fig. 24.3).

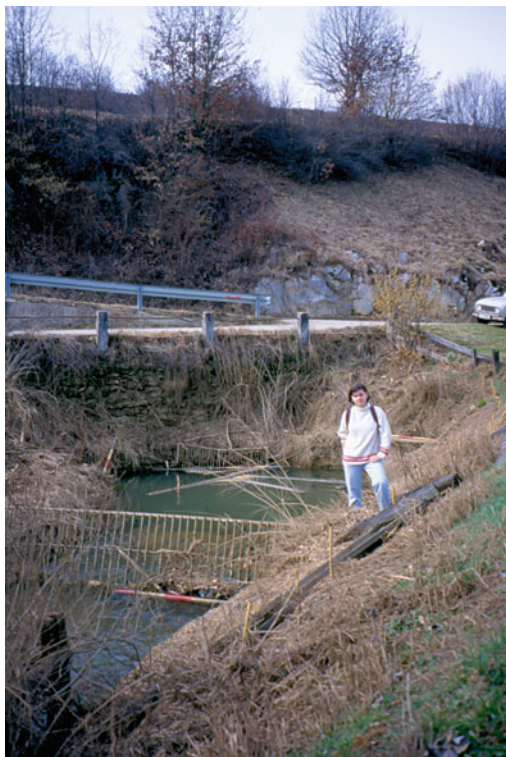
Fig. 24.4 The main ponor of the midsection of the surface flow of the Temenica River above Goriška vas

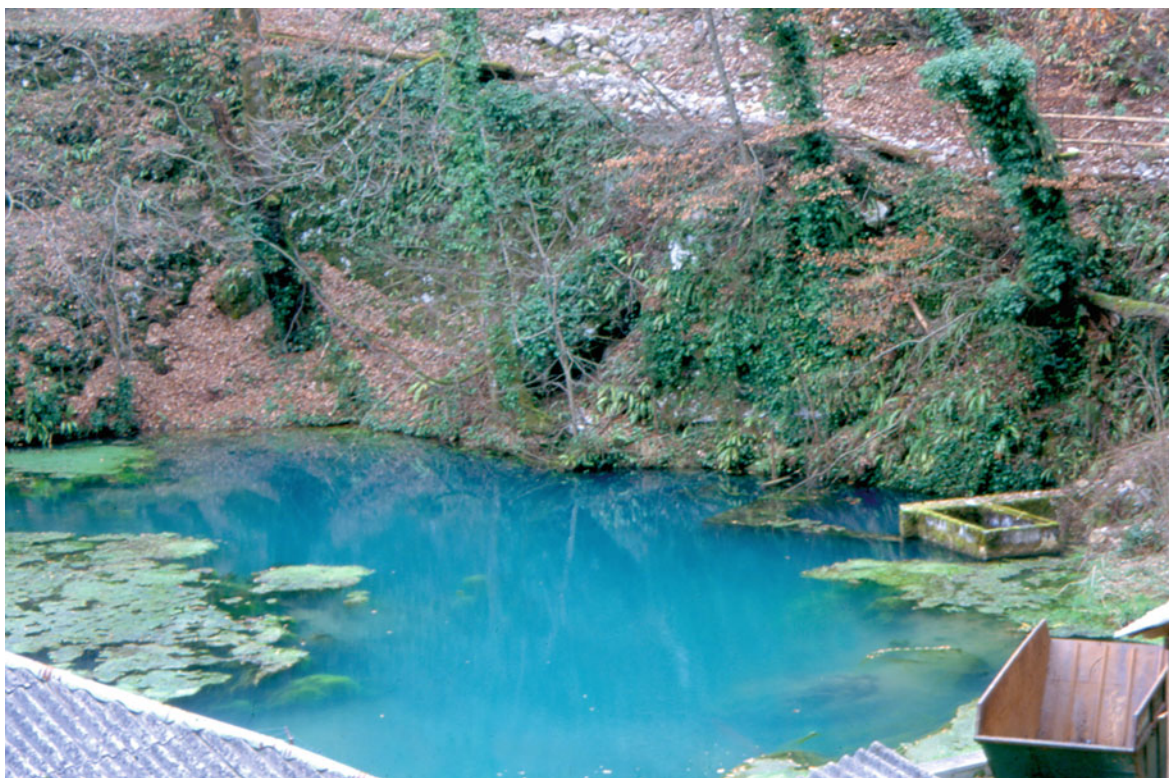
Fig. 24.5 A permanent spring of the Prečna River in the Luknja Cave

The flight distance between the ponor below the village of Goriška vas to the springs in the Luknja Cave where the Temenica River resurfaces at the altitude of 180 m, is approx. 2.5 km long. Here, the river has a new name: Prečna (Fig. 24.5). The Prečna River has one permanent spring below the Luknja Castle and a few intermittent springs, like for example the spring coming from the Jama Cave below the Luknja Castle. At Zalog, 4 km east of Novo mesto, the Prečna River flows into the Krka River.

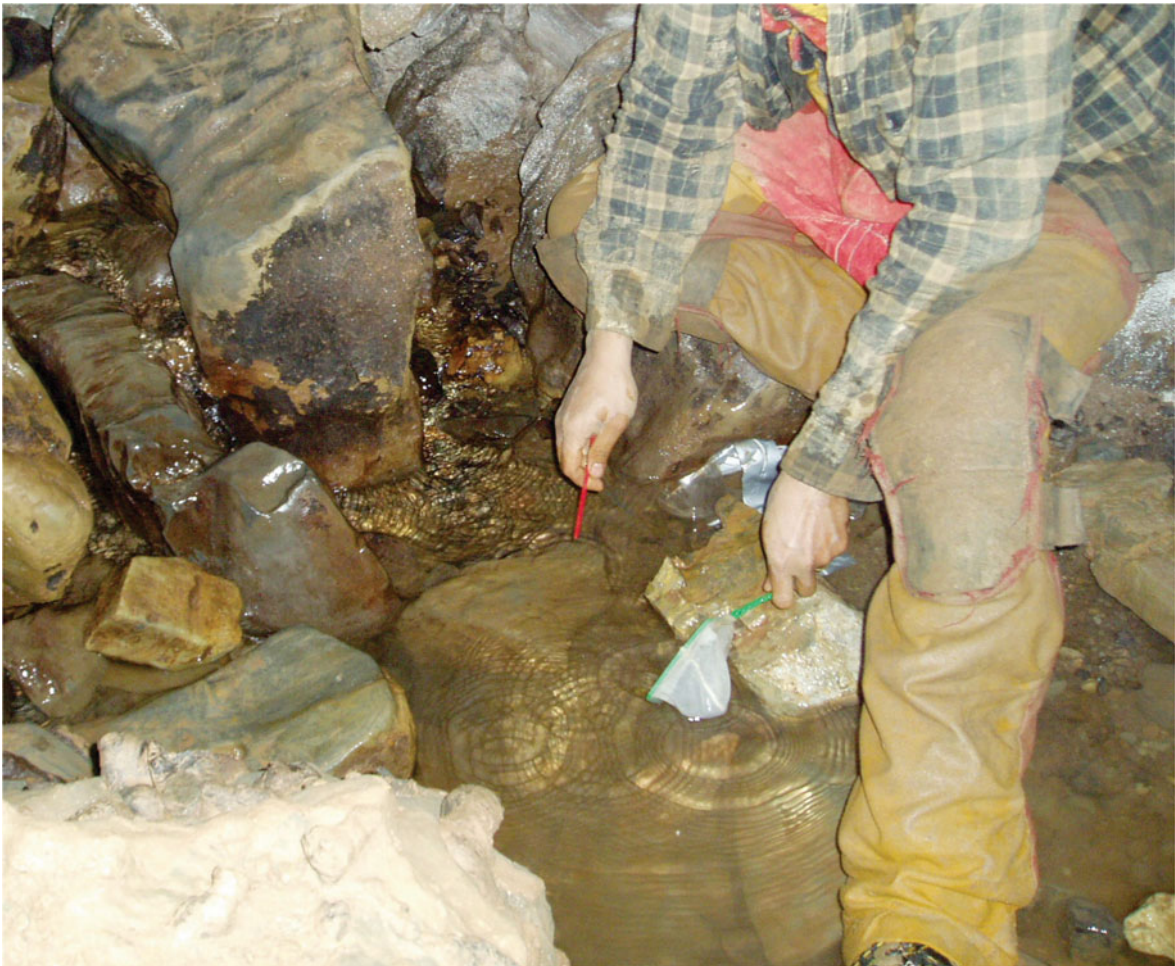
Fig. 26.1 Collecting of aquatic fauna using a fine mesh net

For studying the communities of aquatic invertebrates a simple method of filtering water through a 60 to 80 μm net can be used. The well-known planktonic or hand nets (Fig. 26.1) can be used for sampling the macroinvertebrates, whose body size exceeds 0.5 mm. For sampling smaller organisms, the so-called micro- and meiofauna with a body size between 0.06 and 0.5 mm, and for sampling in small aquatic habitats (pools, ponds), the standard sampling methods are not appropriate.

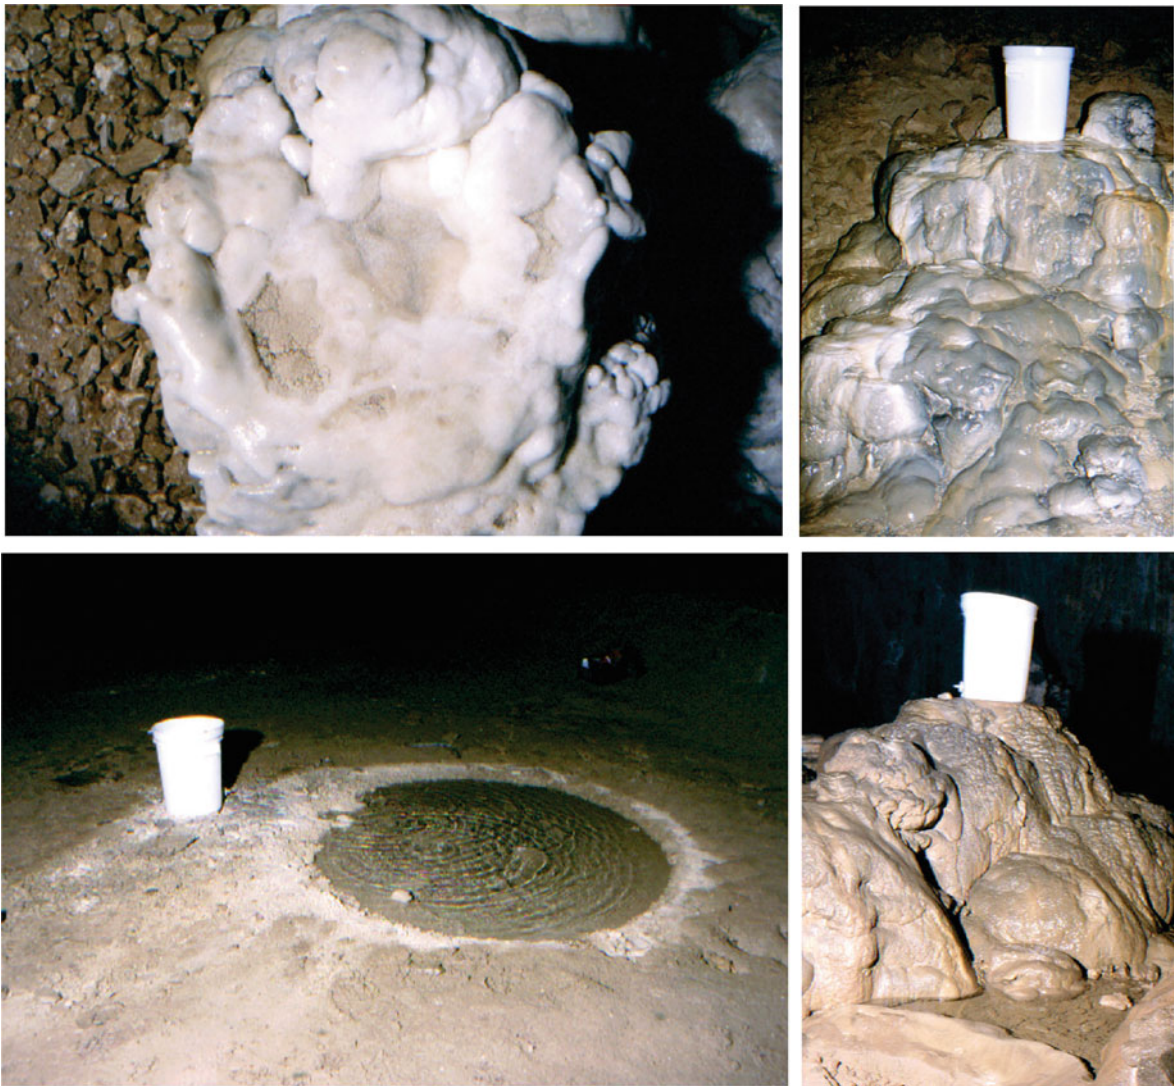
Fig. 26.2 Different types of pools filled by percolating water

Pipettes are the basic laboratory equipment and the simplest device for collecting water from very small water bodies, crevices, and small pools at the top of flowstones and from other cave formations (Fig. 26.2). Water from the pipette can be collected directly into

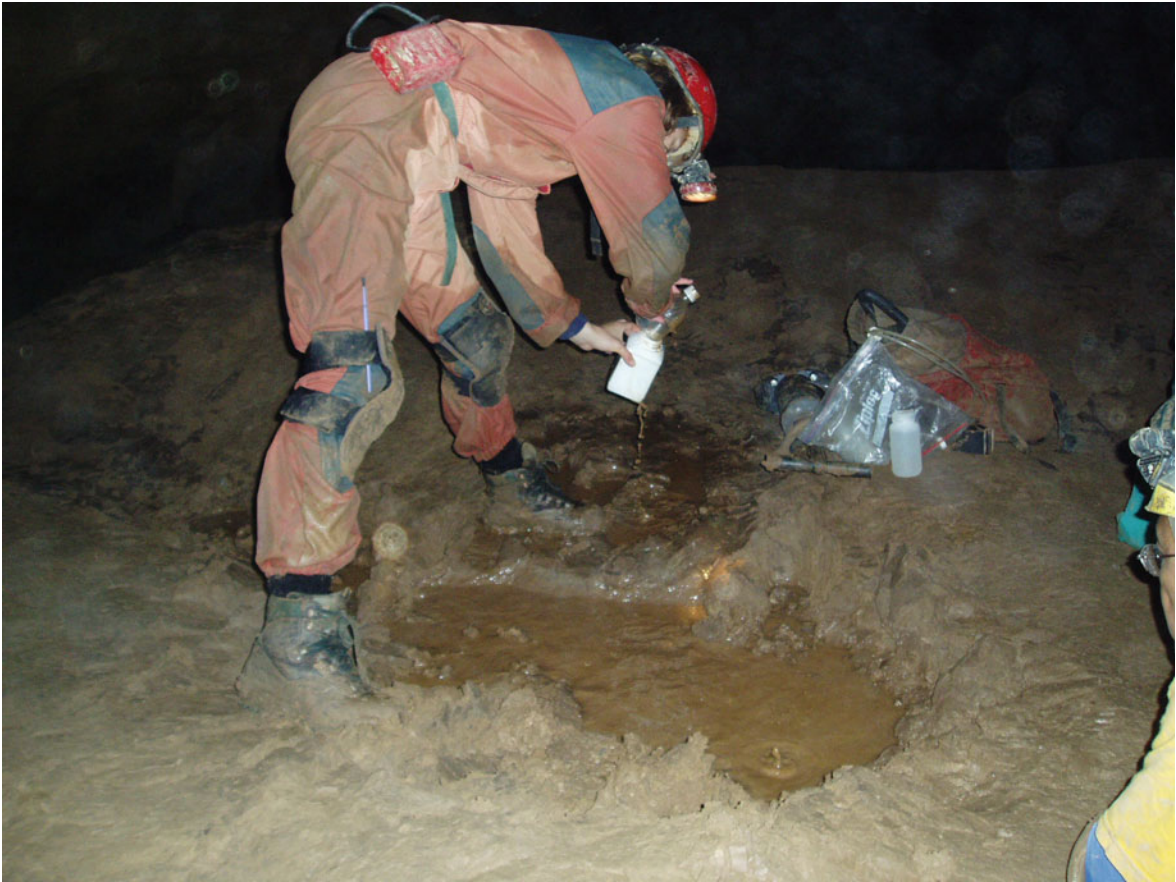
Fig. 26.3 Collecting of water from a pool and filtering through a filtering bottle

A cut plastic bottle (the cut is slightly inclined on the longitudinal axis) is very useful for sampling in small pools with clay or other sediment on the bottom and can be used on the surface or underground (Fig. 26.3). With the cut plastic bottle the bottom of the aquatic body is stirred in order to move the animals attached to the bottom into the water column. The collected water and aquatic fauna is then filtered through the filtering bottle (Fig. 26.4). The filtering bottle has holes covered with a net (60 or 80 μm) on two sides. The water from the bottle exits the net, while the animals are retained in the bottle. Afterwards the sample from the filtering bottle is emptied into a

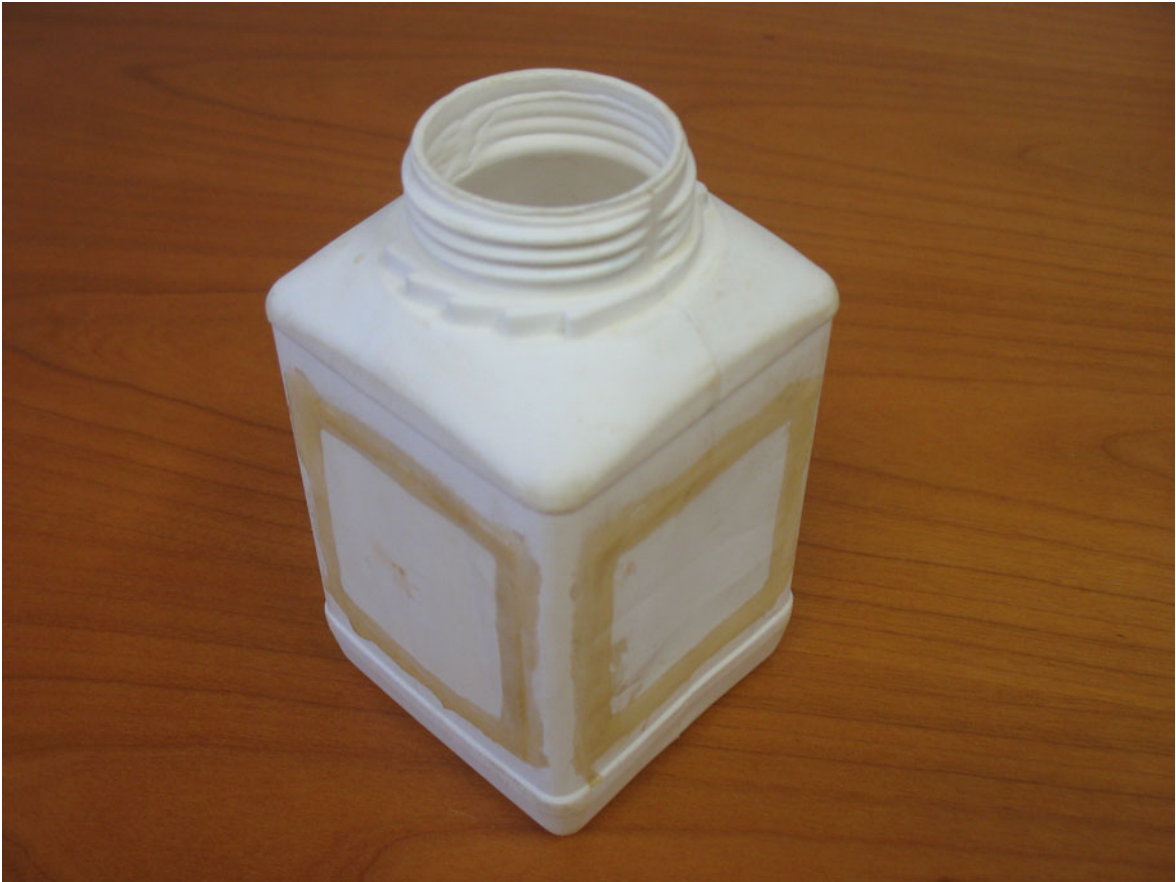
Fig. 26.4 Filtering bottle with mesh screens on the sides that allow water to pass through and retain all organisms entering via the drips

Because epikarst (see Fig. 26.9) is almost impossible to sample directly, epikarst fauna must be explored indirectly by taking samples of percolation water (Pipan 2005). Unlike most subterranean habitats, continuous, long-term sampling of epikarst communities is possible. Epikarst communities are best sampled by collection and filtration of drip water over extended periods of time. The epikarst fauna in Škocjanske jame Caves was sampled indirectly by taking samples of percolation water that drips directly from the ceiling. The water from trickles was directed into a funnel and then into a collecting container with plankton netting (Fig. 26.5). The plastic container had

holes on two sides, covered with a net of 60 μm mesh size. The collected animals and a small amount of water remained in the filtering bottle, while most of the water exited into a container. This water was used for measurements of physical and chemical parameters.

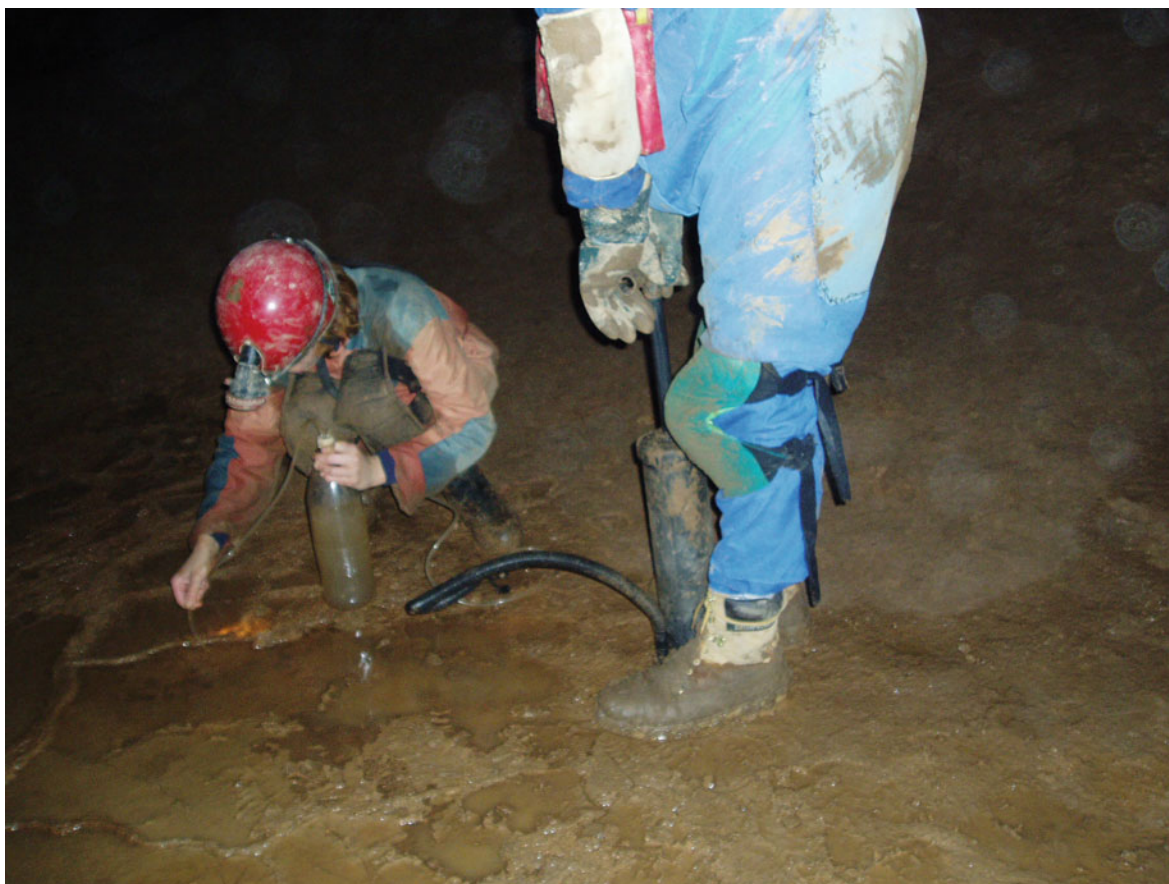
Fig. 26.6 Device for collecting fauna from small amounts of water from pools and cracks. After aspiration, the water and sediment is passed through a filtering bottle (see Fig. 26.4)

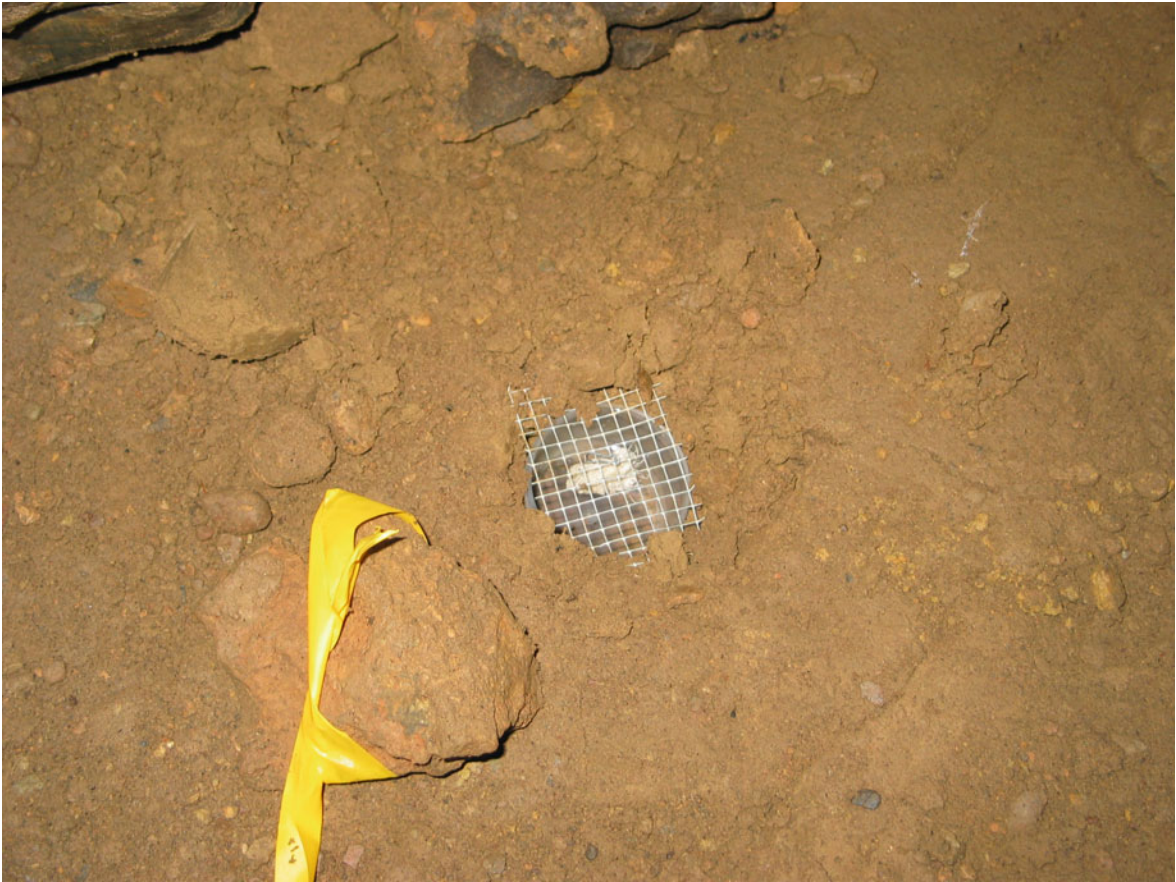
Fig. 26.12 Pitfall trap for sampling terrestrial fauna
