Cave and Karst Systems of the World

Cave Exploration in Slovenia

Discovering Over 350 New Caves During Motorway
Construction on Classical Karst

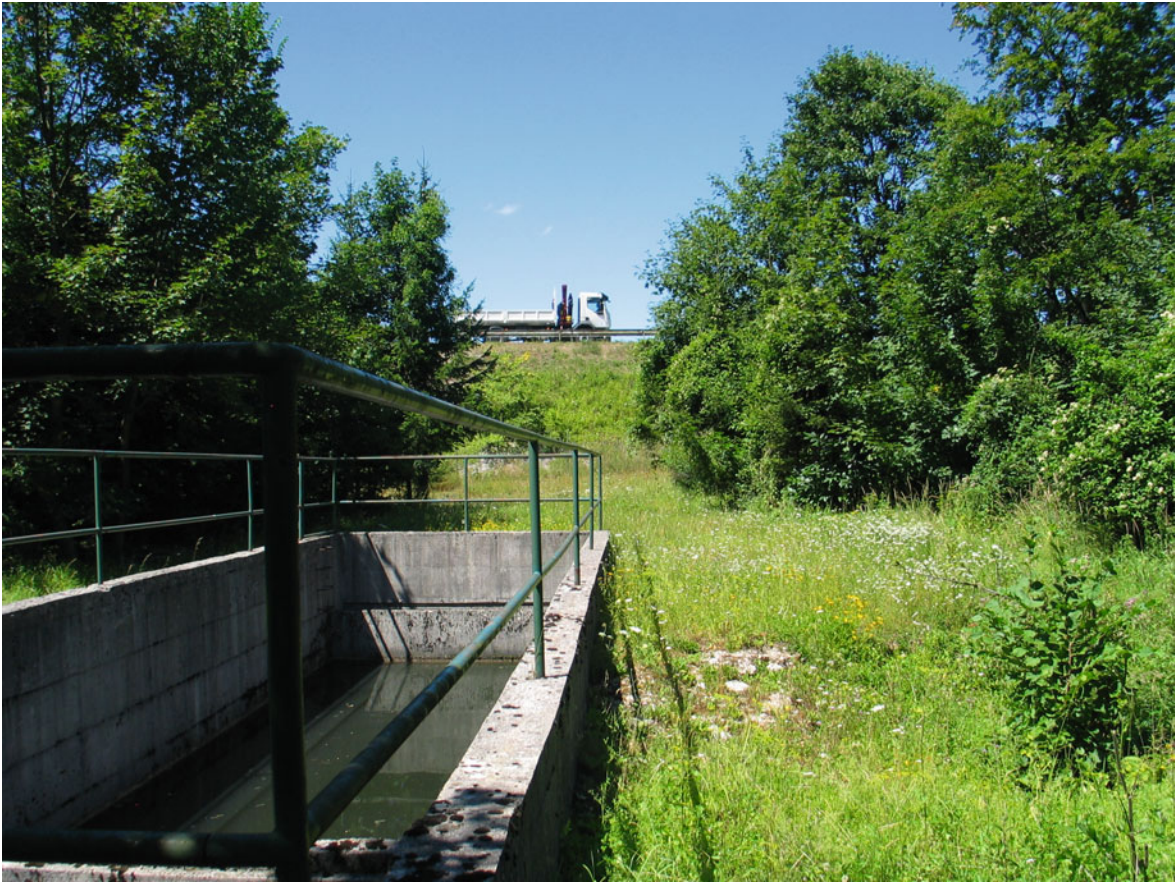
Fig. 27.1 Oil separator is a treatment facility for mechanical treatment of road drainage: sedimentation of suspended material and oil separation. It can be used for trapping spillages caused by traffic accidents

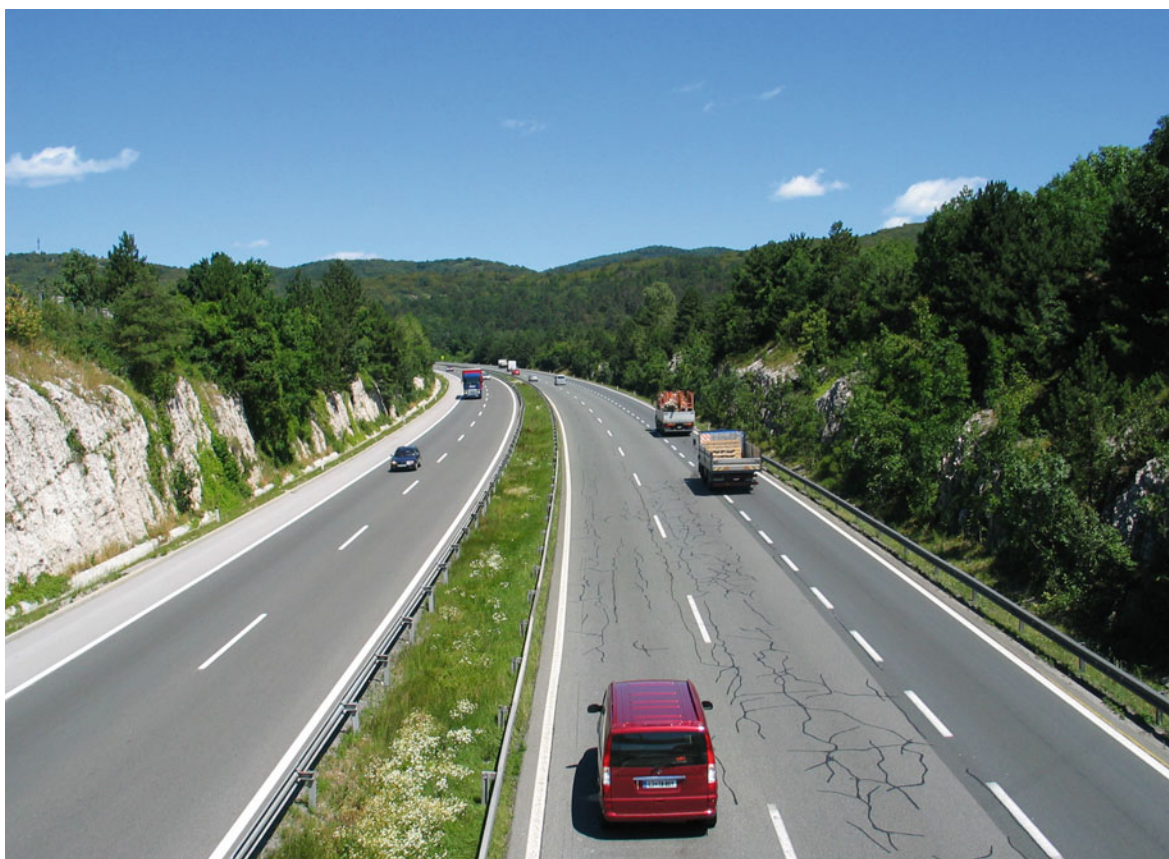
Fig. 27.2 Revealed karst rock in the roadcut of the motorway

Due to the permeability of fissured and soluble carbonate rocks in karst areas any contamination on the surface denotes a contamination of karst underground waters. Karst aquifers are supplied by precipitation percolating into the karst interior directly from the surface (Fig. 27.2), or potentially through karst sinking streams. Underground water flows back out onto the surface through karst springs, which are an important source of drinking water. Although karst rocks stand for only 7–12 % of the Earth's surface, almost a

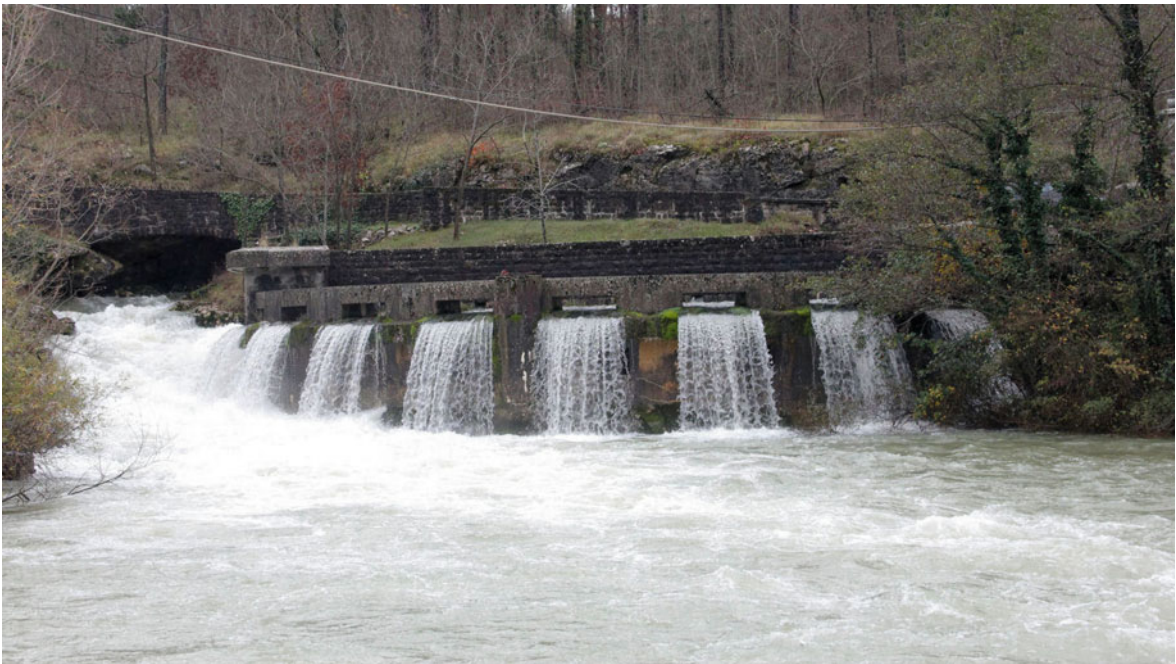
Fig. 27.4 The Spring of the Rižana River, captured in order to provide the coastal population with drinking water

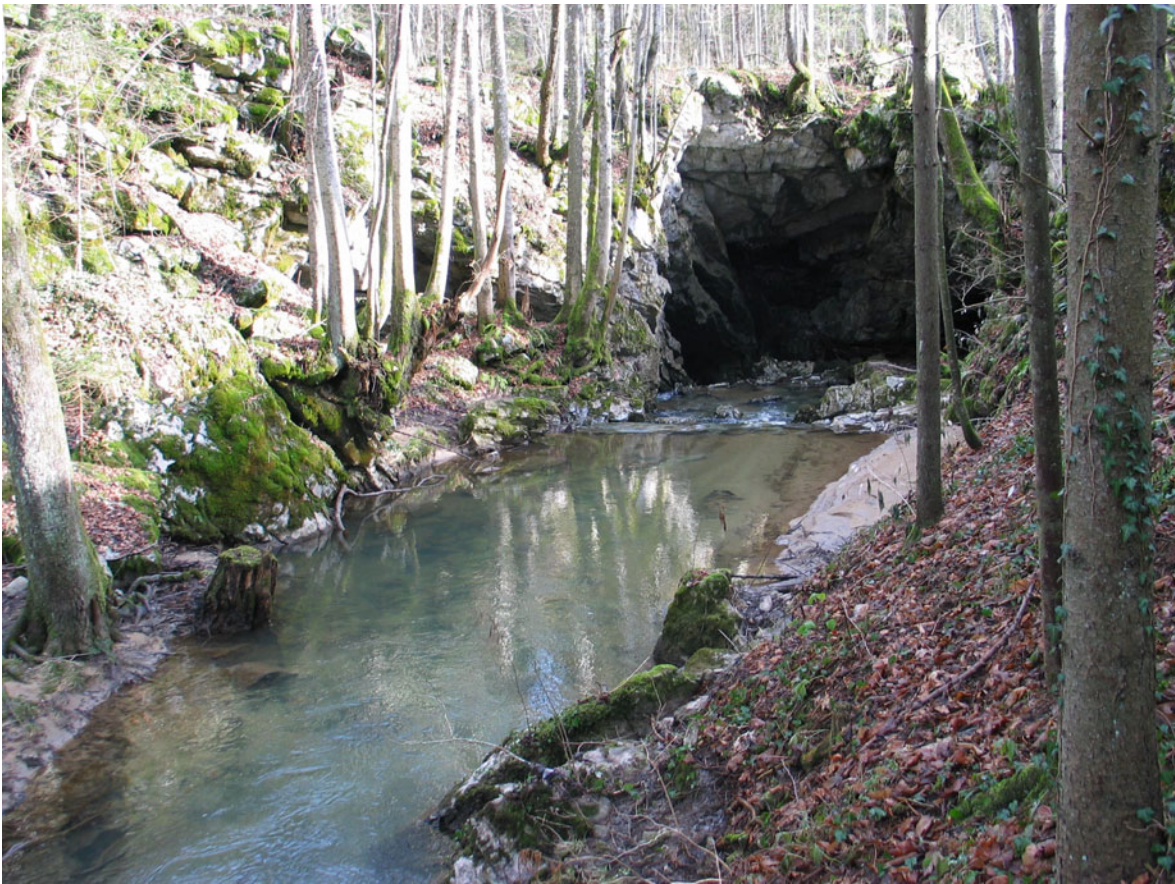
Fig. 27.6 The Tržiščica Stream sinks from the surface into a karst aquifer through the Tentera sink cave

During pumping at a warehouse for oil derivatives near Ortnek in SE Slovenia on 13 October 1998 an unknown quantity of gas oil was spilled down drainage pipes into a nearby stream, which flows into the Tržiščica Stream (Genorio 1999). The warehouse is situated in a non-karst area; however, after running on the surface for about 4 km the Tržiščica sinks at a contact with limestone through the Tentera cave into the karst underground (Fig. 27.6). After the accident this is exactly how the spilled gas oil entered the karst aquifer.

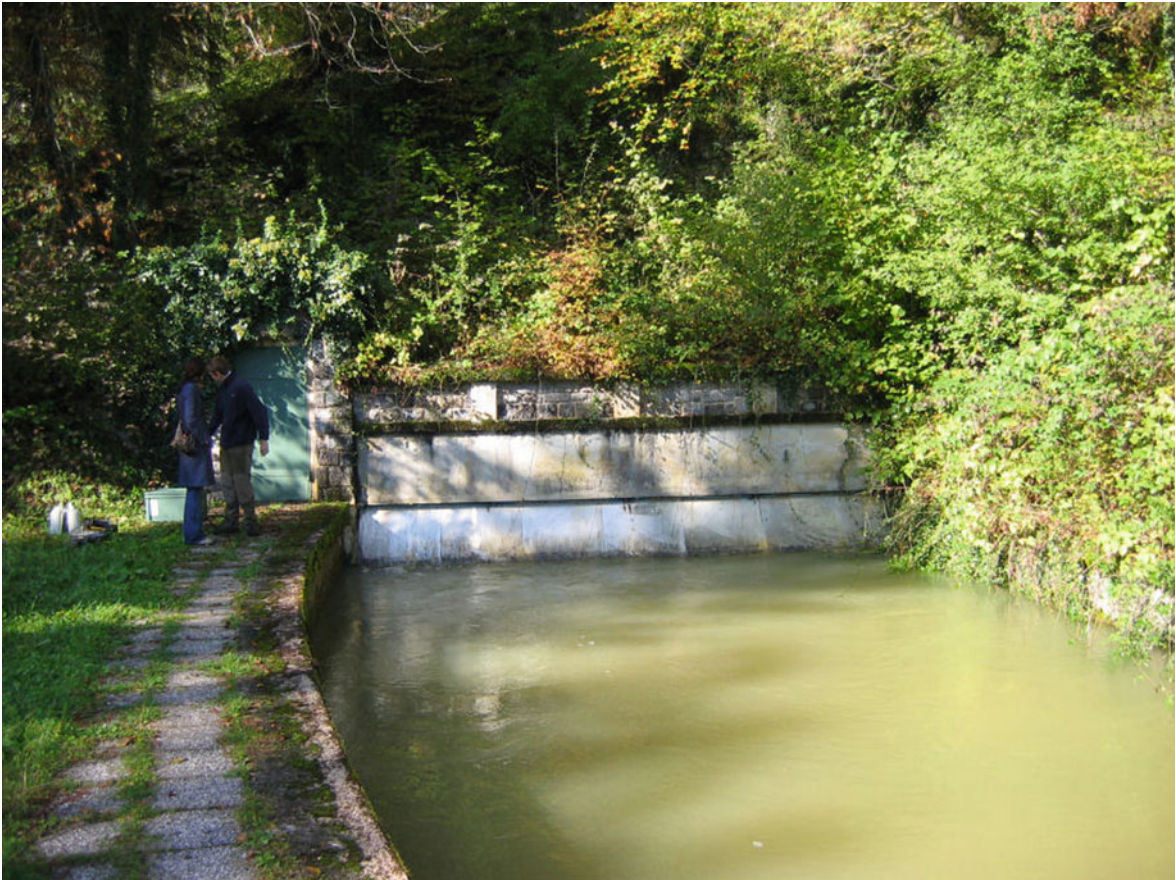
Fig. 27.7 The Globočec Spring, captured in order to provide the population of the Suha krajina region with drinking water

This karst aquifer supplies several karst springs; one of these, Globočec, has been captured for supplying the area of the Suha krajina region with drinking water (Fig. 27.7). Gas oil first appeared in this spring in a small concentration of 0.013 mg/L a good eight days after the spillage and roughly three days after heavier rain. As early as 8 h later the concentration dropped below 0.005 mg/L (the highest permissible limit for drinking water is 0.01 mg/L). After abundant precipitation on 5 November samples were taken 2 days later and merely contained the characteristic scent. Subsequent regular analyses showed pure water all the way until the end of November. In December and later on from January to March 1999 low temperatures prevailed, with relatively modest precipitation in the form of snow, which was insufficient for substances to be transferred in the karst. It was only after heavier precipitation in April 1999 that slightly increased values were again recorded for 5 h. No increase was recorded later on. When we visited the ponor of the Tržiščica in late August 1999, a year after the gas oil had been spilled, there was still a strong scent of gas oil present, as it had been adsorbed into the sediment in the riverbed.

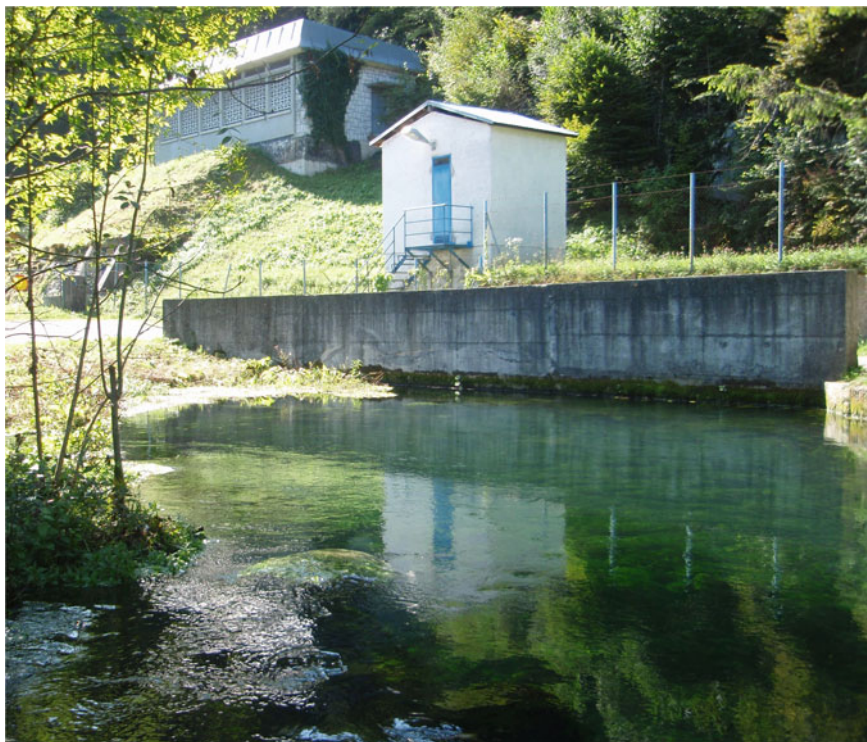
Fig. 28.1 The Malenščica Spring in Planinsko polje, captured in order to provide the population of 21,000 with drinking water

The possibility of contamination of the karst water due to the impact of the motorway in its hinterlands was demonstrated in detail on an example of the karst water source of Malenščica, which is captured to supply drinking water to a population of 21,000, mainly in the area of Postojna and Pivka (Fig. 28.1). On the southern edge of Planinsko polje (southwest region of Slovenia), there are two permanent springs, i.e. Malenščica and Unica which both flow into the Unica River (Fig. 28.2). The flow rates of the Malenščica spring range from 1.1 to 11.9 m³/s, with the mean flow rate of 6.7 m³/s. The flow rates of the Unica spring, which were measured in the 2007–2009 period, were ranging between 0.04 and 70 m³/s, with the mean flow rate of 13.3 m³/s. The recharge area of both springs are intertwined and expand across an area of over 740 km². Prevalent here are the Mesozoic carbonate rock, mostly well-karstified limestone, and to a lesser extent somewhat less permeable dolomites. The surface waters accumulate in the Pivka Basin on the Eocene flysch; at the contact area with the karst terrain, the waters sink and flow away underground towards the springs in Planinsko polje.

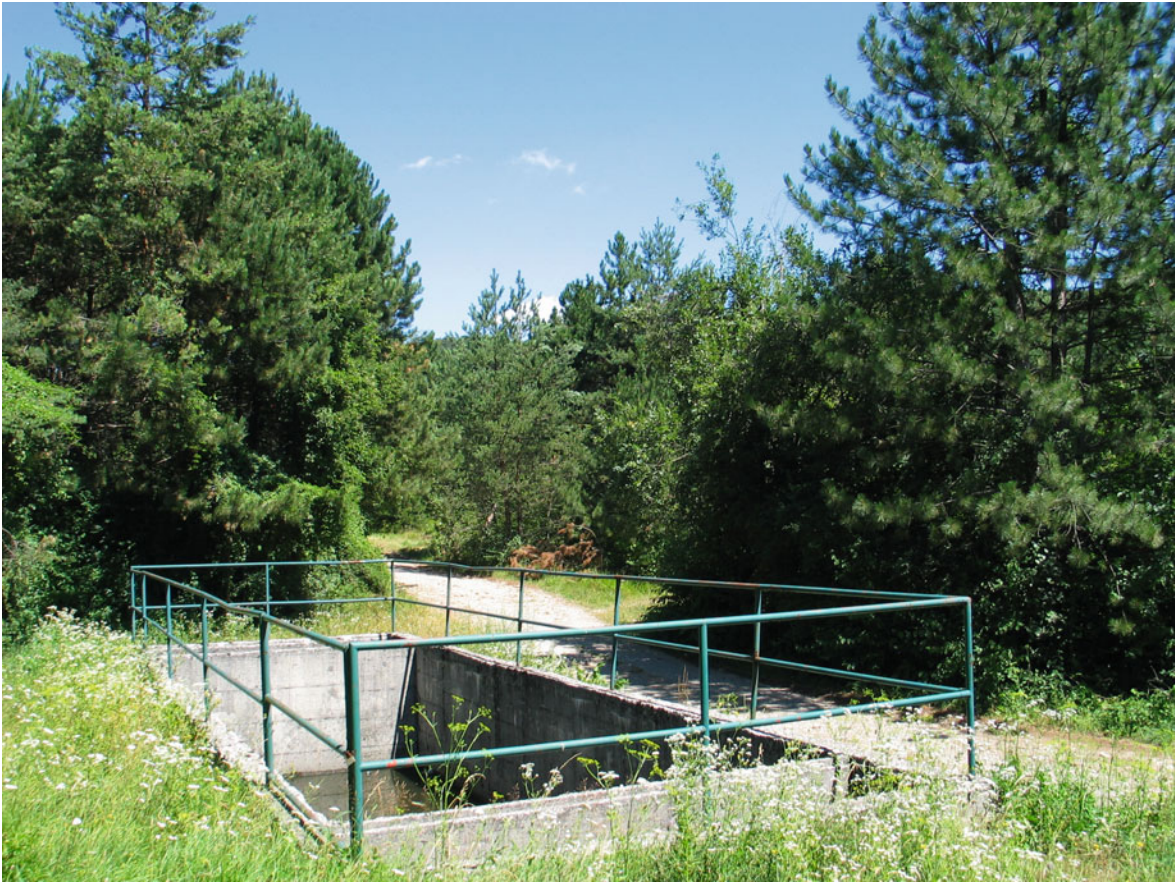
Fig. 28.3 Oil separator at the village of Stara vas

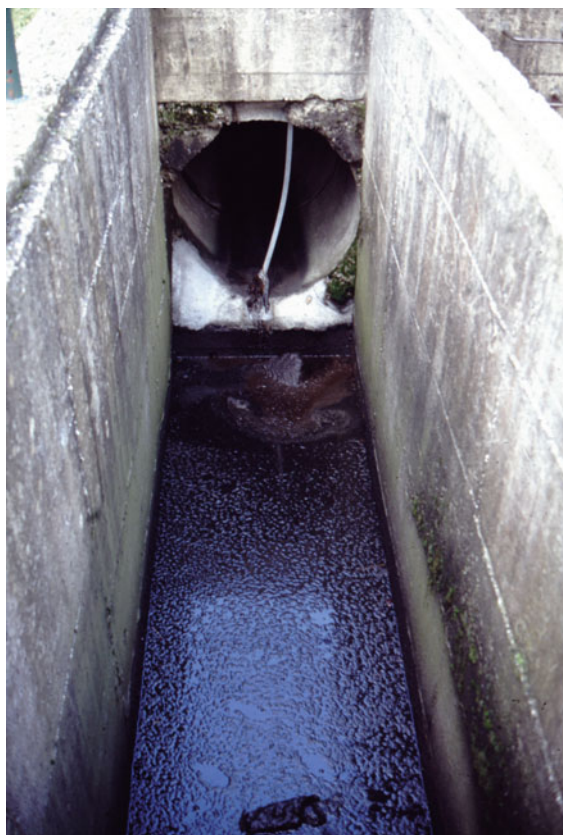
Fig. 28.4 Sampling location at the inflow leading to the oil separator

From March 1992 to January 1993, nine samples were taken from the inflow to the oil separator (Fig. 28.4) in various conditions: after a long period of drought, at the time of salting the roads, and during and after heavy rainfalls (Table 28.3).

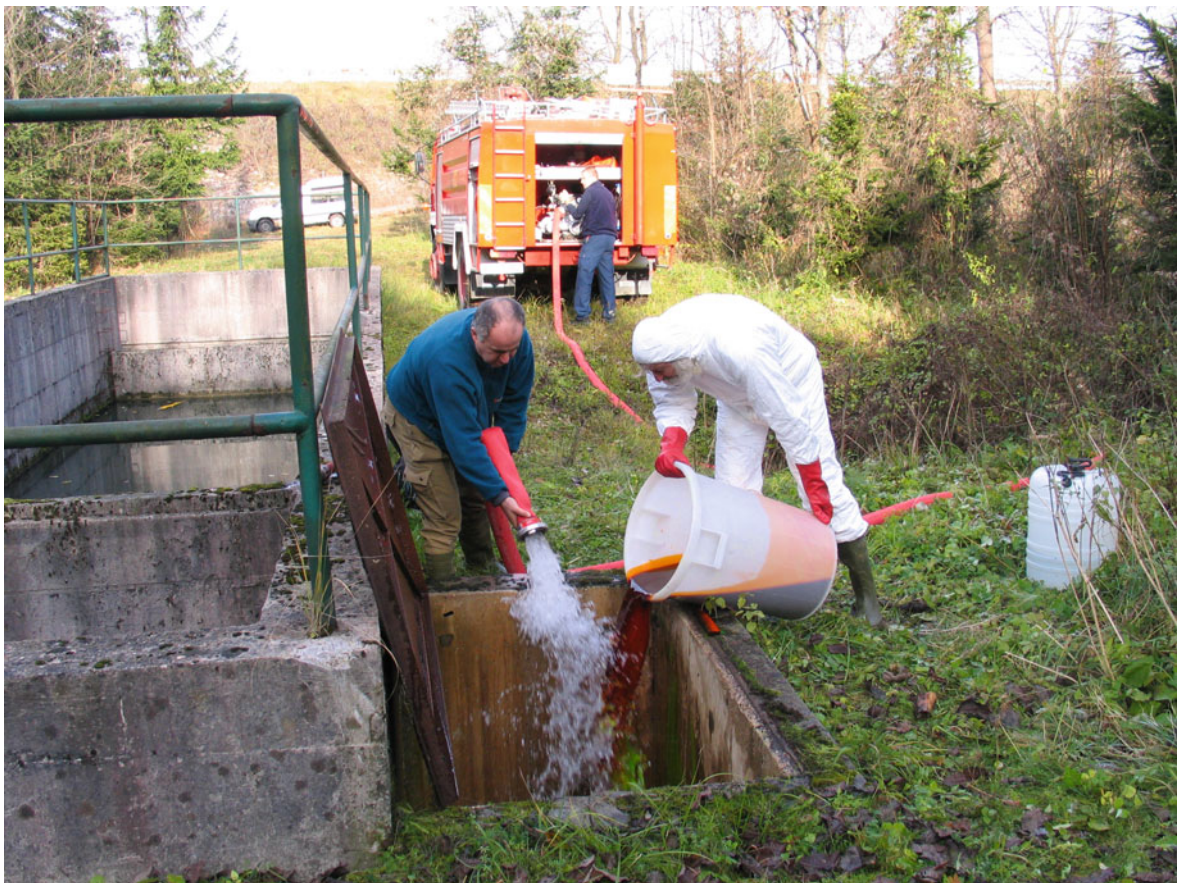
Fig. 28.8 Injection of uranine into the sinking stream of the oil separator B at Postojna

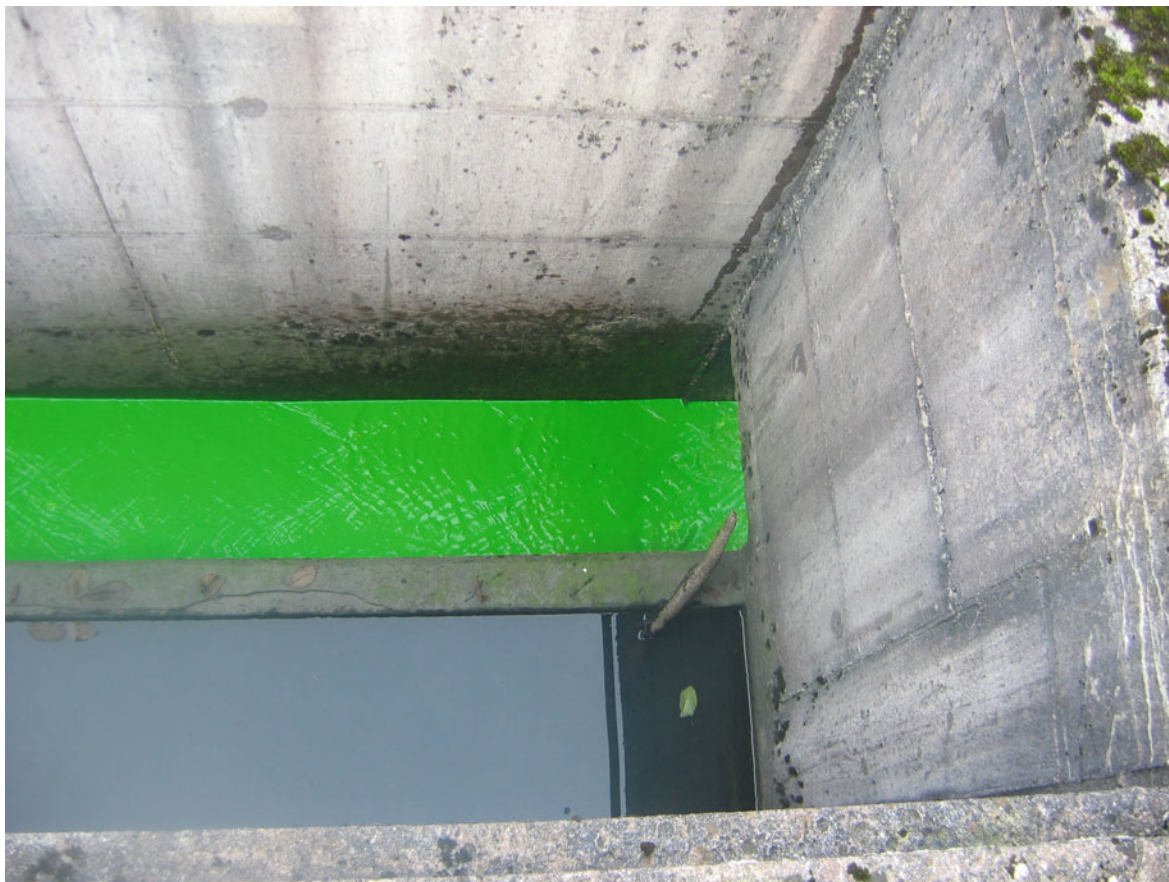
Fig. 28.9 Outflow of uranium from the sinking stream of the oil separator B at Postojna

Therefore, a tracer test was carried out on 18 November 2008 in the area of the oil separator B at Postojna, approx. 3.5 km from the source of the Malenščica spring. At 10.00 AM, at the outflow from the oil separator leading into the sinking stream, an aqueous solution containing 1 kg of the uranine tracer was injected and washed out with approx. 11 m³ of water from the tank (Figs. 28.8 and 28.9). Following the period of high water levels in the beginning of
