SINKHOLES and SUBSIDENCE

Karst and Cavernous Rocks in Engineering and Construction

Tony Waltham, Fred Bell
and Martin Culshaw

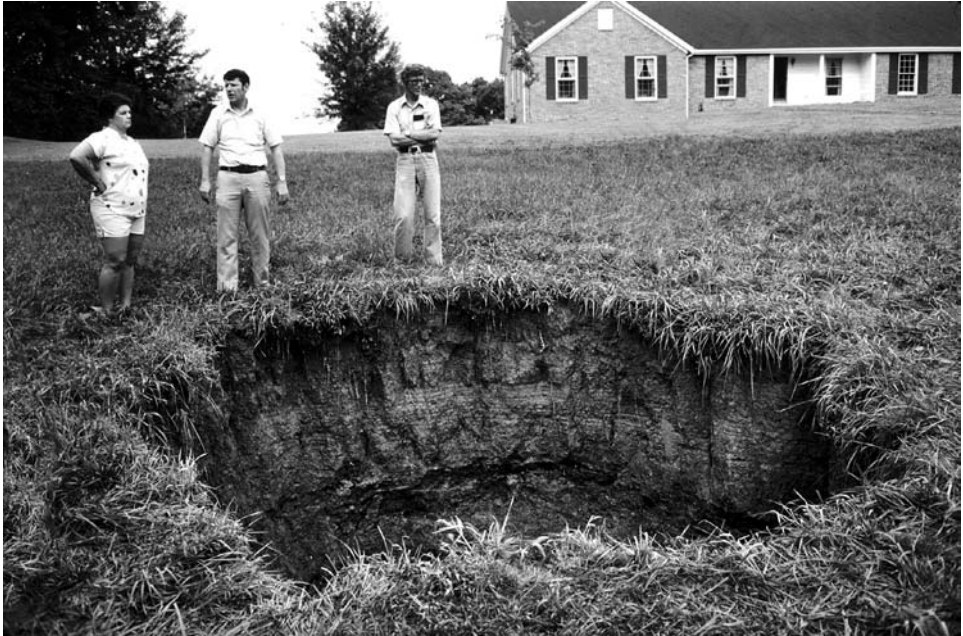
Figure 1.1. A new subsidence sinkhole in the garden of a house in Kentucky.
Photo: Art Palmer.

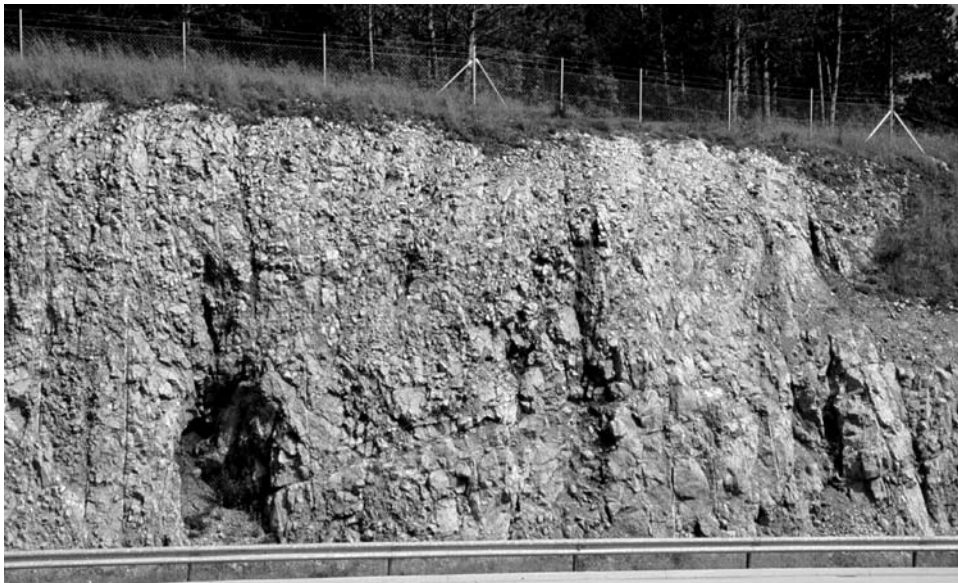
Figure 1.4. Three dissolutionally opened fissures, one with a sediment-filled cave on it, exposed in a 30-m length of cut face on the new motorway from Postojna to Trieste across the highly cavernous limestone of the Kras in Slovenia.

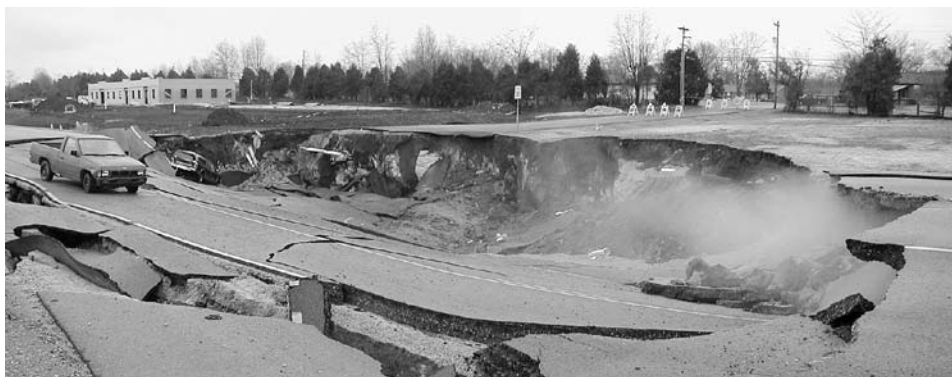
Figure 1.5. A major sinkhole collapse under an urban highway in Bowling Green, a city that stands entirely on the Sinkhole Plain of Kentucky; the fog is due to warm air rising from the breached cave early on a cold winter morning.

Sinkholes are characteristic features of karst terrain. They are classified on a basis of origin into solution, collapse, caprock, dropout, suffosion and buried sinkholes (Chapter 2). They all constitute some form of significant geohazard in karst terrains (Figure 1.5). Solution, caprock and collapse sinkholes are initiated on the rocks' inherent weaknesses, and are integral components of the cave systems that evolve beneath any karst terrain (Chapter 3). In contrast, subsidence, dropout and suffosion sinkholes develop where soil is washed down into any one of the dissolutionally opened fissures exposed at rockhead (Chapter 4). They form not by dissolution of the rock but by ravelling of the overlying soils so that a void migrates up through the soil and ultimately creates a sinkhole in the surface. A sinkhole may be 30 m across where soil has been washed into a fissure less than a metre wide. The fissure may have taken 10,000 years to reach that size by slow dissolution, but the sinkhole may develop within hours as soil collapses and suffoses through the rockhead fissure and into an open cave system below.

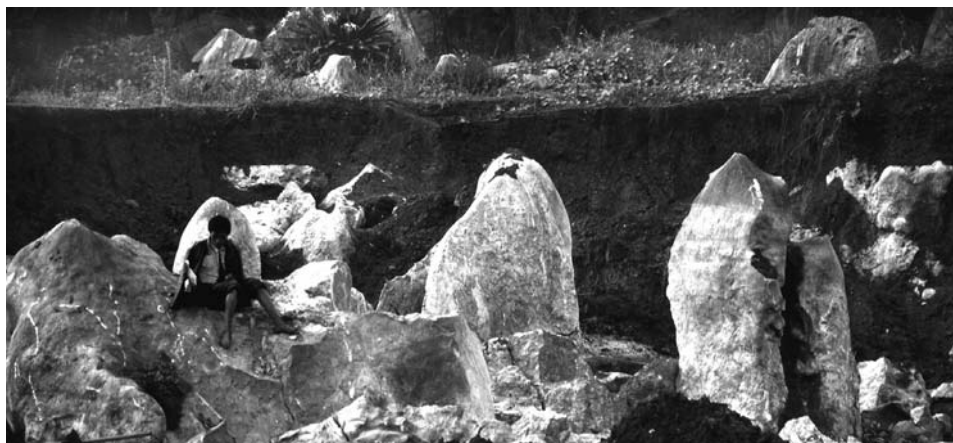
Figure 1.6. Rounded pinnacles created by subsoil dissolution eroding deep fissures to form a large form of rundkarren beneath a thick clay soil at Shilin, southern China, now exposed in excavations on a construction site.

1.6	Rounded pinnacles created by subsoil dissolution eroding deep fissures to form a large form of rundkarren beneath a thick clay soil at Shilin, southern China.	11

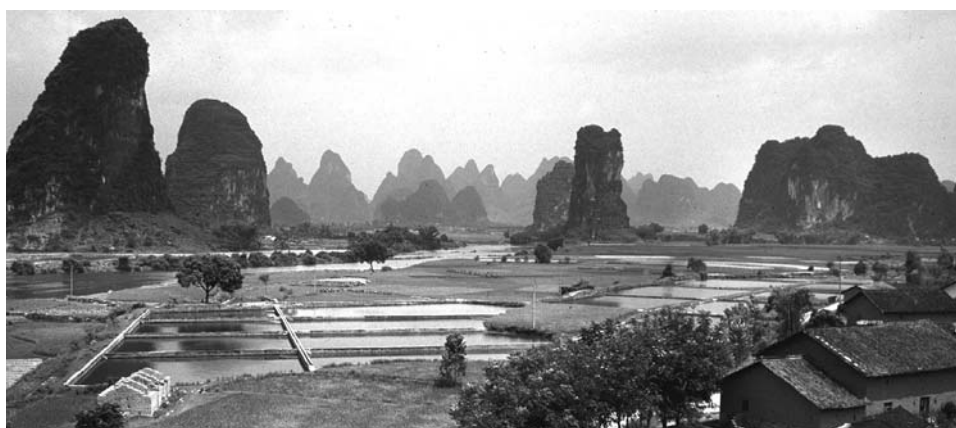
Figure 1.8. The classical fenglin tower karst near Yangshuo, in Guangxi, China; the plain between the towers has a thin alluvial cover on cavernous limestone and is the location of numerous subsidence sinkhole events.

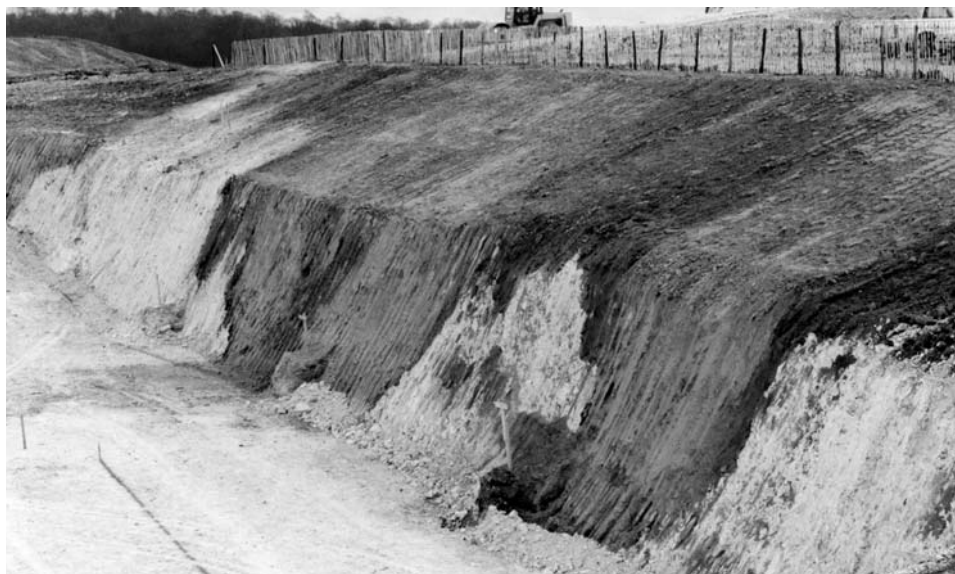
Figure 1.10. Large buried sinkholes filled with clay soils (locally known as chalk pipes) exposed in a road cutting through the chalk in southern England.

Many chalk terrains evolve into a subdued variety of fluviokarst, with dendritic systems of dry valleys largely inherited from periglacial erosion, but sinkholes are also a feature of chalk karst, as well as occurring in areas where chalk lies beneath a thin cover of clastic sediments or soils (Figure 1.10). Large, inactive sinkholes in the

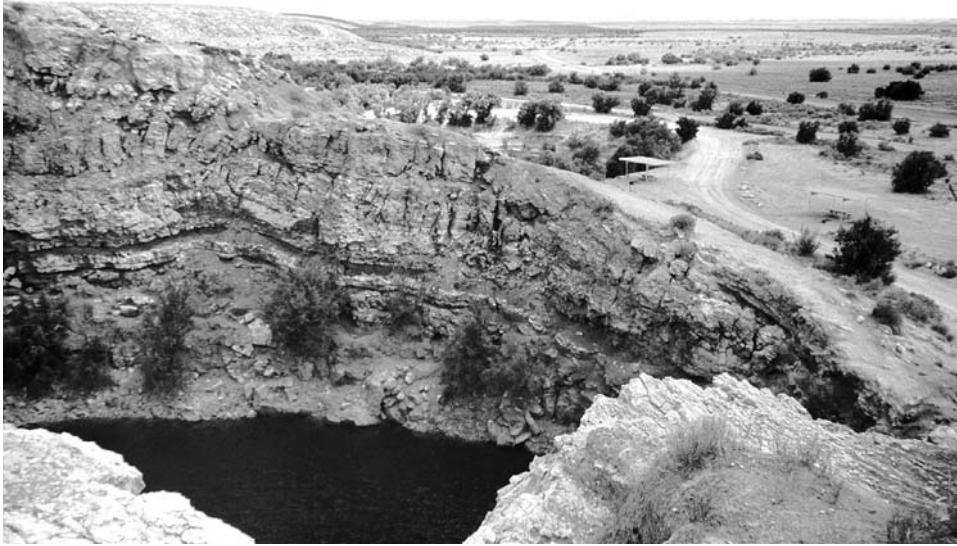
Figure 1.11. One of the collapse sinkholes that house the “bottomless lakes” at Roswell, in New Mexico, with the bedded gypsum exposed in its walls.
TW.

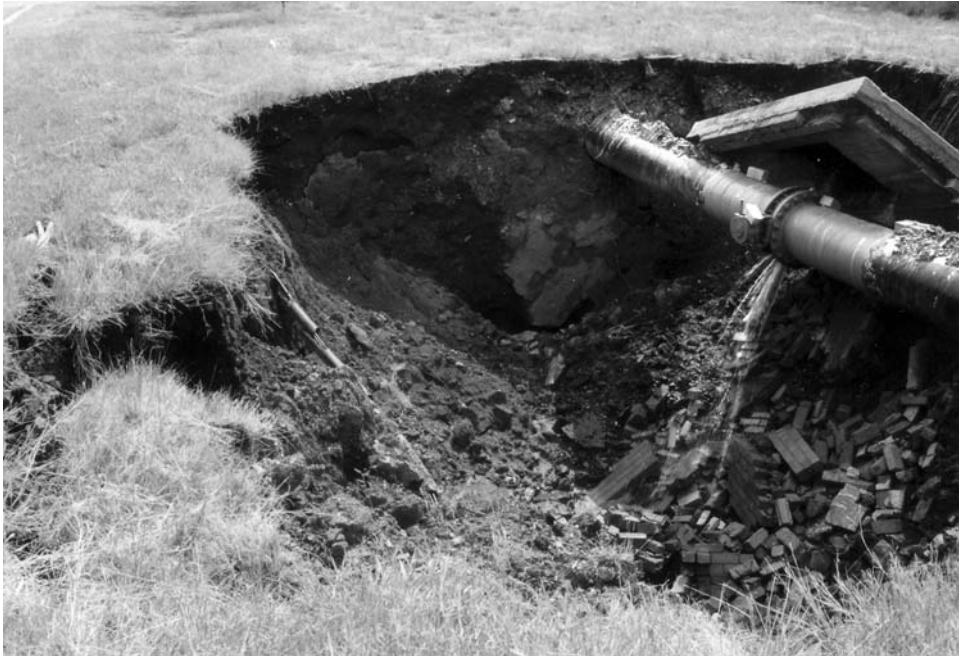
Figure 1.12. A small suffosion sinkhole that has opened up beneath a leaking pipeline in the soil-covered dolomite karst south of Pretoria, South Africa.

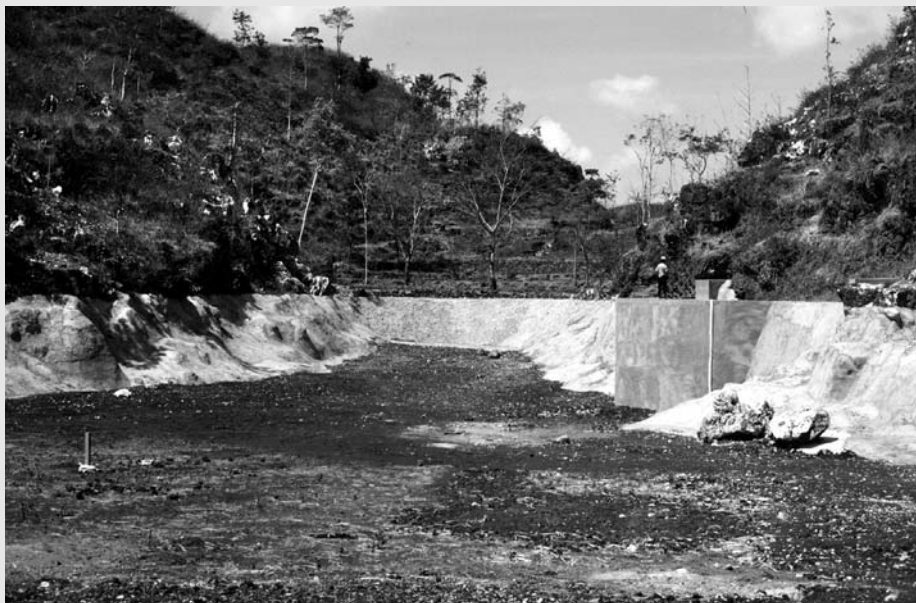
Figure 2.1.2. The Puleirang doline as modified in 1982, with its mortar-sealed slopes, graded clay floor and the concrete dam around the open sink.
TW.

Drought-season water storage is needed for the villagers. In 1982 a concrete dam was built round the open shaft, the clay floor of the doline was reworked to seal the short stream channels, and mortar was hand-placed to seal the limestone in the doline walls above the clay floor (Figure 2.1.2). In the first wet season after construction, water ponded on the doline floor, but almost immediately drained out through a new suffosion sinkhole (Figure 2.1.3). The water flowed into bedrock fissures, most of which linked across to the main shaft about 20 m below ground level. The new sinkhole through the soil was blocked with clay and mortar in the next dry season, but all bedrock fissures could not be sealed, and it failed again in the following wet season. The reservoir is now abandoned, the doline floor is used for agriculture, and all drainage sinks through the floor before reaching the lip of the shaft. Multiple fissure flows ensure that the lower parts of the shaft system are well watered in the wet season, but the dam remains high and dry. As a reservoir, Puleirang was not a success, but the site has revealed a fine example of ground conditions beneath a solution doline (or a solution sinkhole).

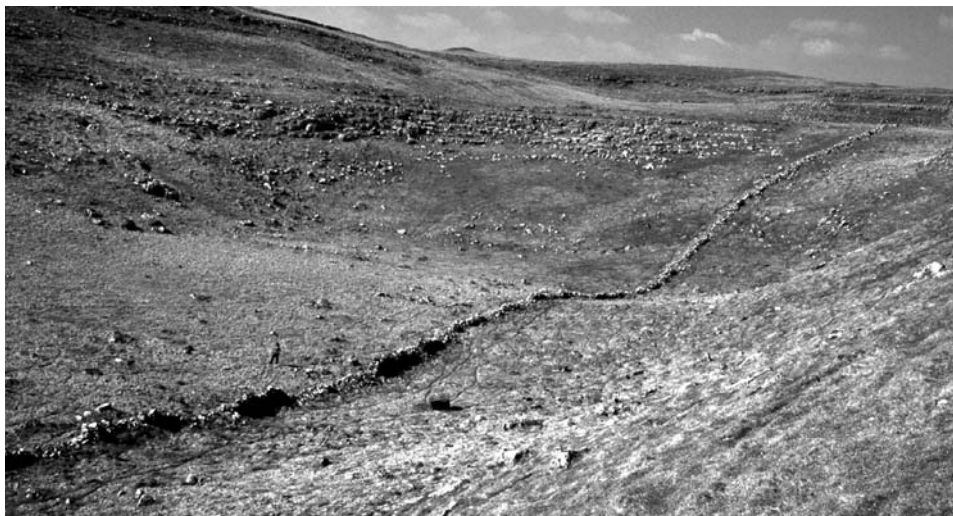
Figure 2.1. Large solution dolines in limestone above Malham in the Yorkshire Dales karst, U.K. The person is standing near the lowest point of the nearest doline, but the far doline is deeper. Neither doline has surface stream courses nor discrete sinks, and all rainfall infiltrates through the soil of the doline slopes and their wide floors.
TW.

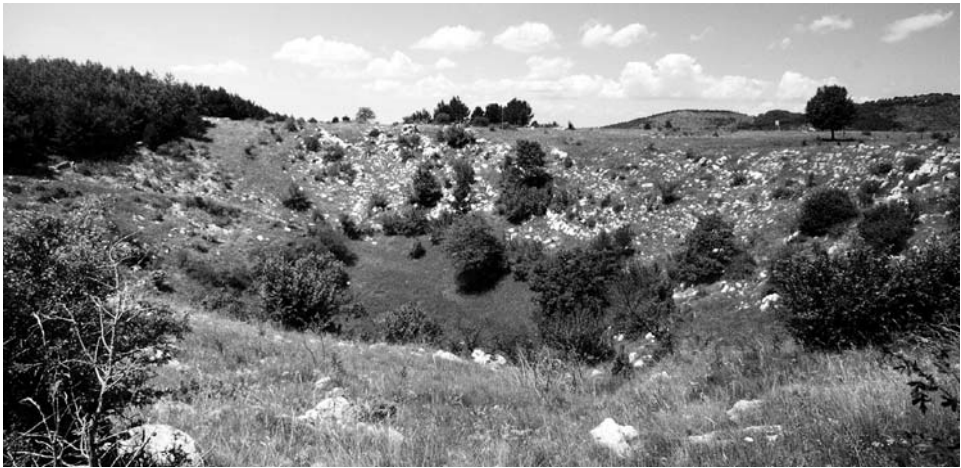
Figure 2.3. A steep-sided solution doline in steeply dipping limestone beneath an almost flat plateau surface in the classical karst of Slovenia.

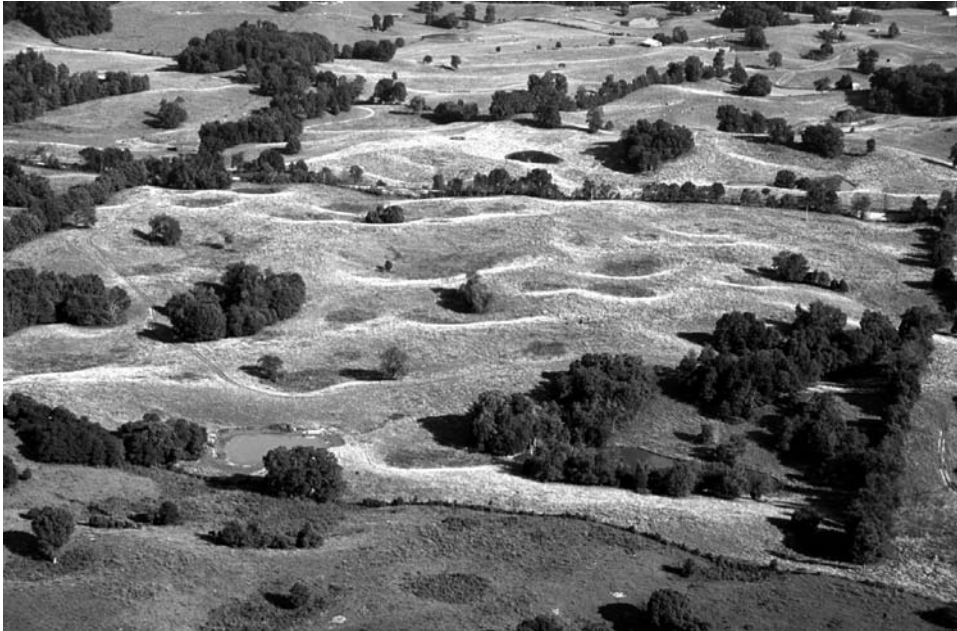
Figure 2.4. Closely packed solution dolines with polygonal inter-basin ridges in the Sinkhole Plain of Kentucky.

Where solution dolines expand across a karst surface so that they all meet their neighbours, they create polygonal karst. This is entirely occupied by polygonal dolines, each typically some hundreds of metres across, between a net of interfluvial drainage divides (Figure 2.4). As this matures by deepening of the dolines, the interfluvial nodes are left as remnant hills that take on roughly conical shapes. Within such a cone karst, many of the intervening dolines then have stellate floor shapes with blunt arms extending between the conical hills that stand along a polygonal topographic divide. Dolines in this style are also known as cockpits, after the Cockpit Country of Jamaica that consists entirely of conical hills and cockpit dolines (Figure 1.7(d)). Dayas are formed where dissolutional removal of a thin limestone caprock creates a very wide shallow solution doline (up to 1 km across but only a few metres deep) in the arid karst of the African Sahara Desert (Conrad *et al.*, 1967). Dayas have internal drainage into porous underlying rocks; some of these are insoluble sandstones, while others are calcareous sandstones where ground has subsided due to partial removal in solution. These very large dolines, cockpits and dayas, and the even larger poljes and karst basins, are major landforms where the

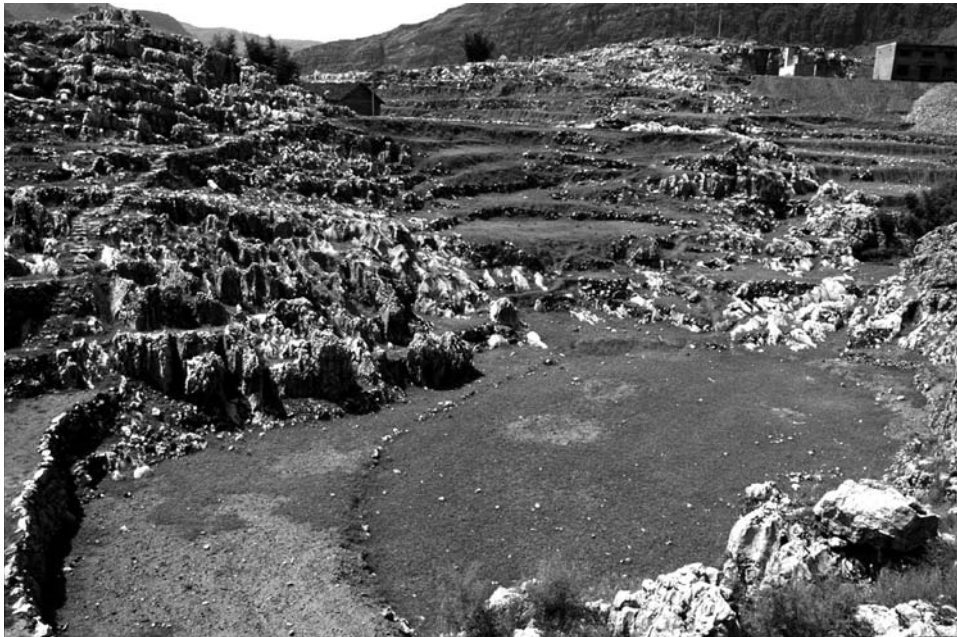
Figure 2.6. A solution doline in the Xingwen karst of Sichuan, China, where the alluviated doline floor and a narrow zone on one side have been graded by a local farmer as they offer the only soils for farming in the rocky karst terrain.
TW.

There are positive aspects to solution dolines. In mature karst, their alluviated floors offer the only ground suitable for agriculture, and thousands of families around the world survive purely by farming on doline floors (Figure 2.6). However, this land may be prone to flooding where the floor is at a level within the zone of annual fluctuation of the local water table. Seasonal flooding of deep dolines in China has been controlled by cutting drainage tunnels into neighbouring dolines at lower levels. Doline flooding is also caused by farming practices that increase soil erosion and subsequent blocking of the cave drains below the dolines, or by inappropriate urbanisation. One example of an unusual benefit of a doline is

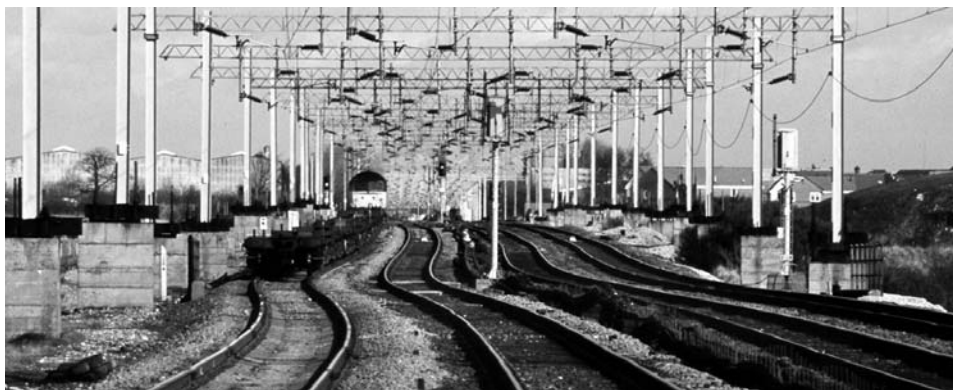
Figure 2.7. Subsidence across the active solutional depression that houses Elton Flash in the salt karst of the Cheshire Plain, U.K.; the centre of subsidence is left of the railway, causing both lateral ground strain and downward movement towards it.
TW.

Where groundwater flow patterns towards natural brine springs allow continuing salt dissolution over a limited area of rockhead, the resultant areal subsidence may be some metres deep and in the order of a kilometre across. In the English saltfield that underlies the Cheshire Plain, the Elton Flashes are active areal subsidences of this size (Waltham, 1989). These are effectively very broad solution dolines, though their dimensions are more comparable to karst basins and poljes in limestone karst. Under natural conditions of groundwater circulation, these areal subsidences on salt typically subside at rates of up to 15 mm/year. Short-term subsidence rates of up to 100 mm/year, recorded over small areas, may relate to small deep-seated collapse events within the rockhead collapse breccia. Solution mining involves various methods of pumping brine from wellfields for purposes of salt production (Waltham, 1989). One method is uncontrolled “wild brining”, where brine is abstracted from shallow wells sunk into zones of wet rockhead. This greatly increases water circulation, drawing renewed flows of aggressive fresh water onto the salt, and thereby increasing dissolution rates. While brining was taking place nearby, the Elton Flashes subsided at rates of up to 900 mm/year, necessitating ongoing engineering works on the railway that crosses them (Figure 2.7). Since the brining operations have ceased, the subsidence has reduced to the minimal rates that can be ascribed to natural dissolution in the undisturbed drainage regime.

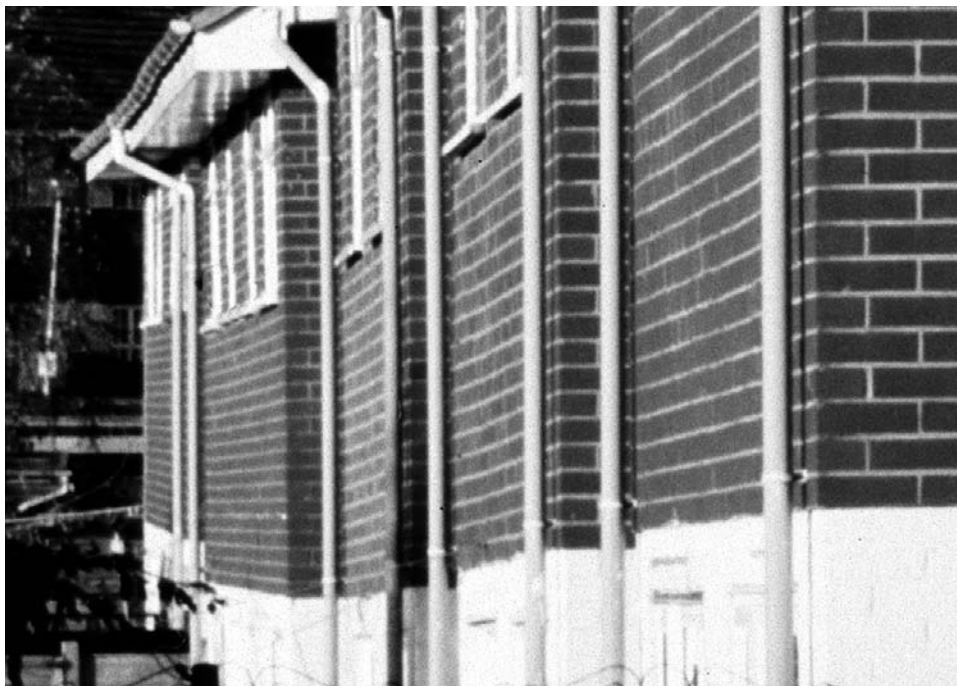
Figure 2.8. Houses in Sandbach subsided and tilted due to dissolution and removal of salt from the rockhead zone beneath 20 m of drift cover, in the Cheshire Plain, U.K.
TW.

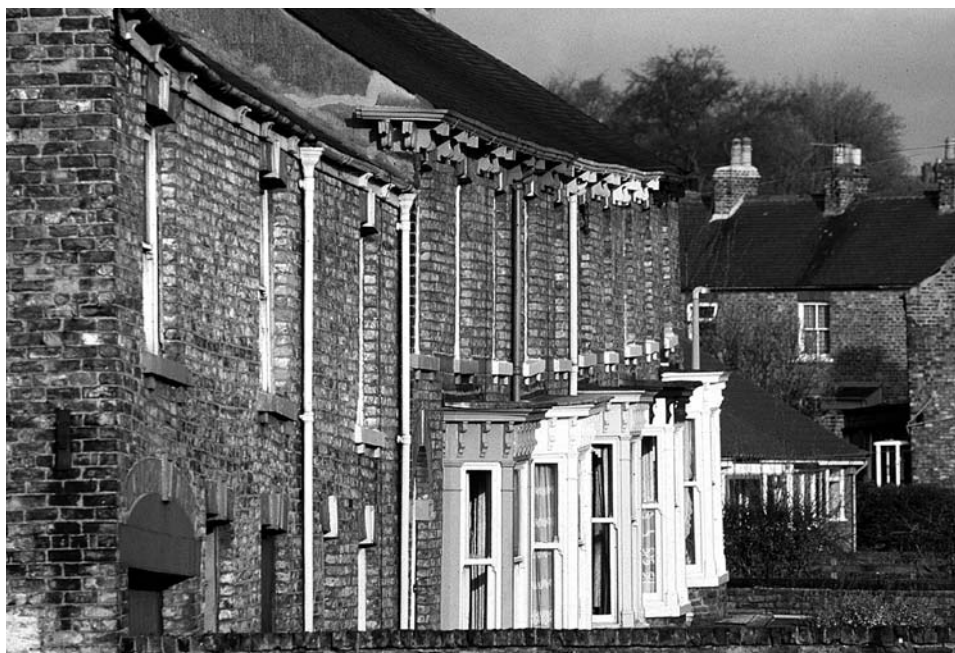
Figure 2.9. A terrace of houses in Ripon, U.K., subsided due to a combination of rockhead dissolution of gypsum and compaction of soft sediments filling an old buried solution doline. TW.

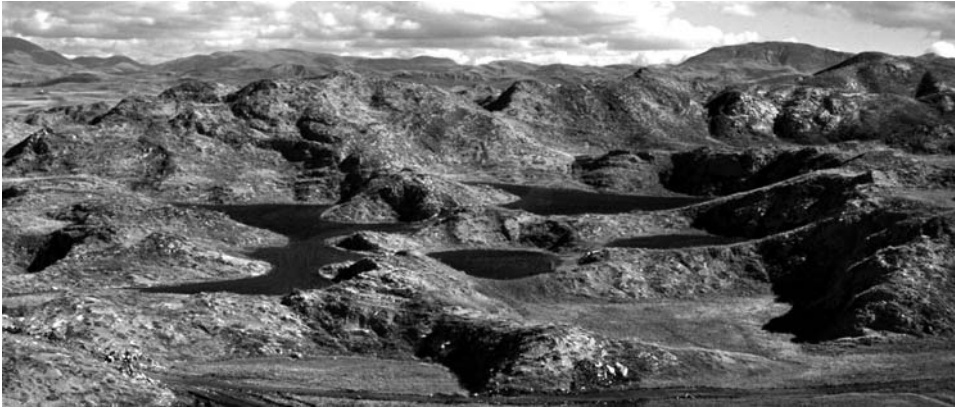
Figure 2.10. Polygonal karst with a network of solution dolines, each floored by soil that is dark where ploughed, on the gypsum outcrop near Sivas, Turkey.
TW.

Solution dolines, each 100–500 m across, can be so closely packed that they constitute very spectacular polygonal karst on some gypsum outcrops (Figure 2.10). Very fine examples are known in the dry uplands of eastern Turkey (Waltham, 2002) and Uzbekistan, where low rainfalls ensure low rates of dissolution. In wetter climates, gypsum does not survive at outcrop (and only to a limited extent at rockhead), where it is replaced by breccias of insoluble residue. In these cases, doline karst cannot evolve, but there remains a significant engineering geohazard from dissolution of the last traces of gypsum and collapses of small multiple ground cavities (Cooper and Saunders, 2002). The most extensive infrastructure damage by solution doline growth on gypsum takes place in areas of drier climates, such as Sicily, Spain (Gutierrez and Cooper, 2002) and interior U.S.A. (Rahn and Davis, 1996).

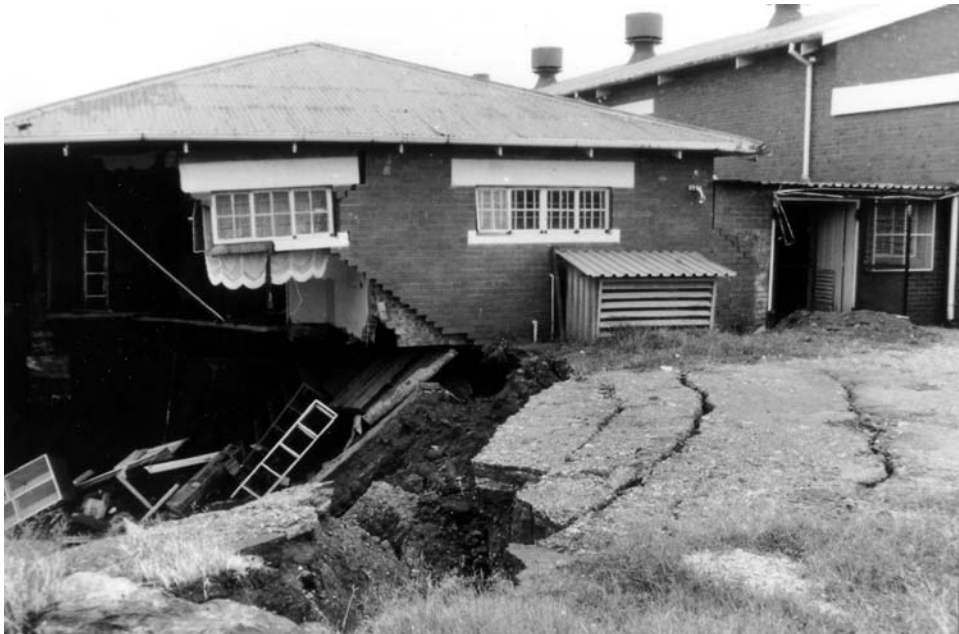
Figure 2.11. A house in Centurion, South Africa, destroyed by development of a large subsidence sinkhole when the soil beneath its foundations was washed into the dewatered underlying limestone.

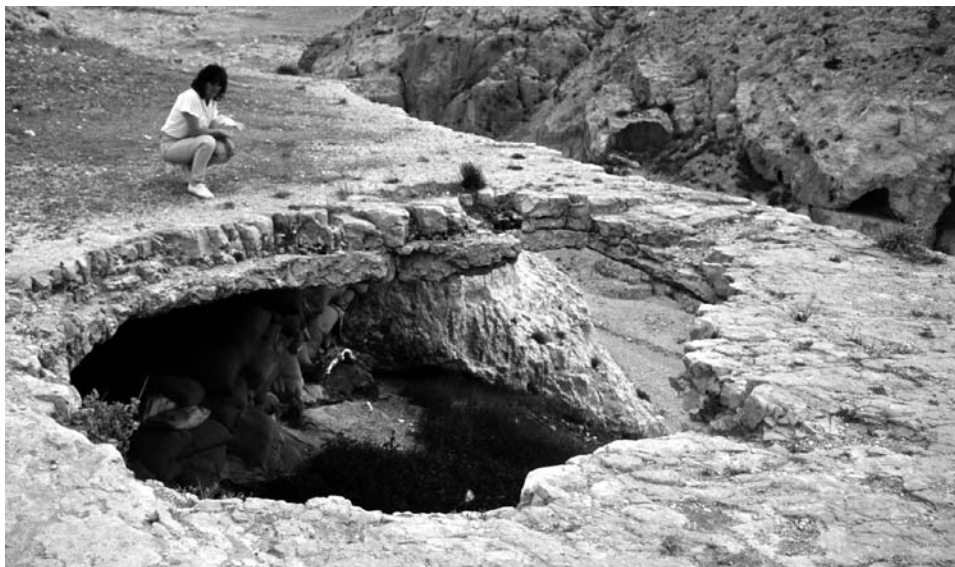
Figure 3.1. Collapse of the thin limestone roof over a small cave in the side of a wadi in Jordan; the two beds that roofed the cave, and partially survive in the entrance arch, are probably an indurated duricrust over a more easily eroded blocky limestone. TW.

The stability of a limestone cave is a function of its unsupported span and the structural integrity of its roof rock. Most caves are structurally sound; relationships between cave widths and the rock mass quality of cavernous limestones suggests that the majority of caves would require little or no support if they were regarded as engineered structures (Waltham and Fookes, 2003). A tubular tunnel dissolved out of massive limestone far beneath the surface is extremely stable. In contrast, even the smallest caves can collapse in zones of heavily fractured rock or beneath very thin roof slabs (Figure 3.1).

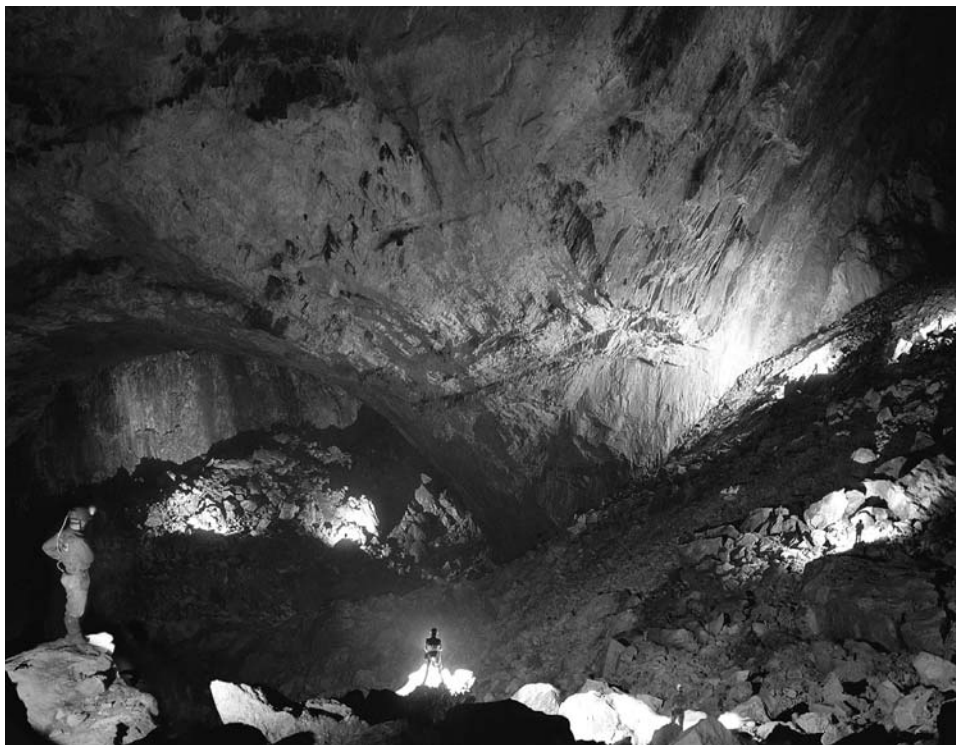
Figure 3.2. The world's largest known cavern – Sarawak Chamber, in the Mulu karst on Borneo. Eight cavers with very large flashguns just light the multiple arches that form the roof, with the far wall 300 m from the camera.

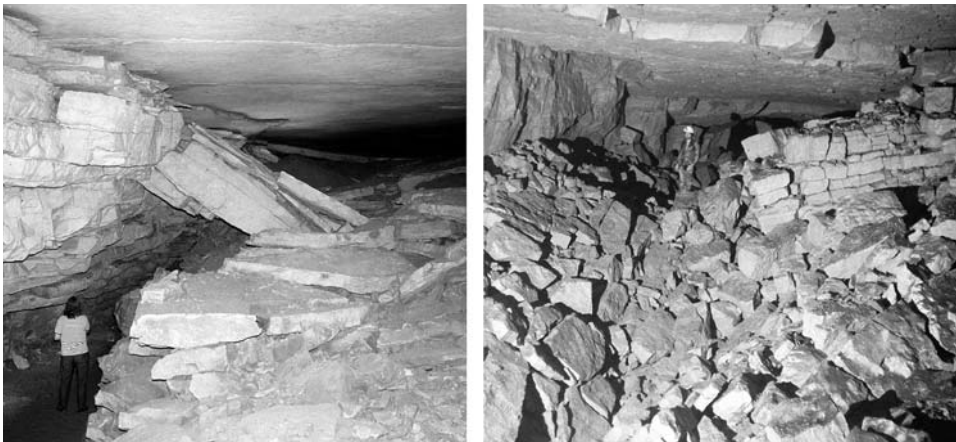
Figure 3.3. Cave passages with flat limestone roofs developed by progressive failures along bedding planes; on the left in Mammoth Cave, Kentucky, and on the right in Ogof Agen Allwedd, U.K.; in both caves the roof is some metres above the original dissolutional passage. TW.

Roof collapse by progressive roof failure is widespread in limestone caves, and can be very conspicuous in any zones of more thinly bedded limestones (Figure 3.3). These contrast with roof profiles that retain their original dissolutional features in massive limestones or within single very thick beds, and can span large voids with no sign of breakdown (Figure 3.4). The simplest analysis of a cave roof in bedded limestone is to treat the beds as beams failing under their own weight between the cave walls.

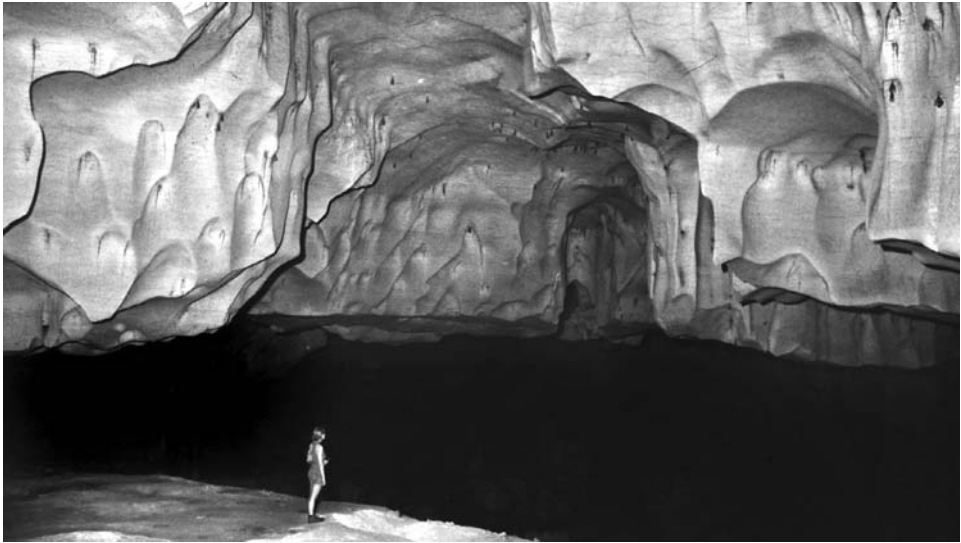
Figure 3.4. Massive limestone forming the roof of the Niah Great Cave, Sarawak, with no signs of breakdown to destroy its dissolutorial sculpture.
TW.

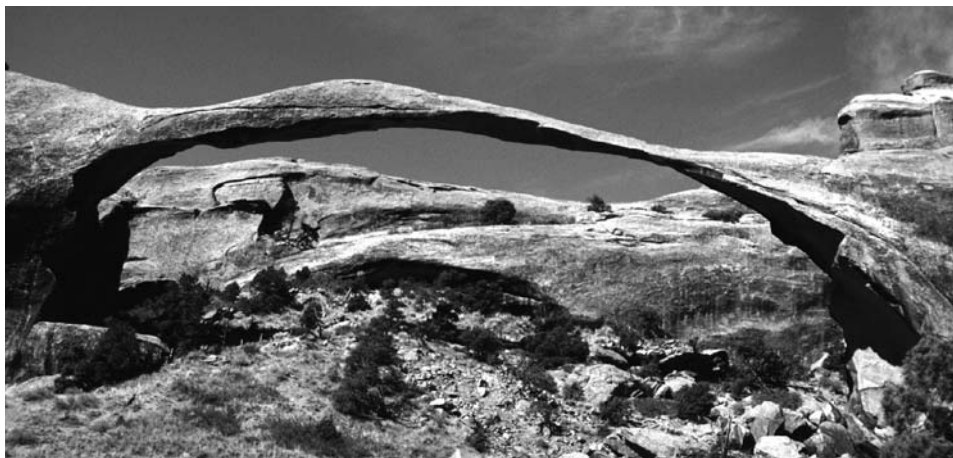
Figure 3.7. The stable, low-profile, compression arch that forms Landscape Arch in the sandstone of Arches National Park, Utah, spanning 93 m and only 5 m thick. TW.

A compression arch is much stronger than a beam in the same material, and natural arches can be very thin. The spectacularly thin Landscape Arch (Figure 3.7), in Utah, demonstrates how strong rock is under compression. It is weathered out of sandstone that is weaker than most cavernous limestones, and is not devoid of fractures. Regarded as one bed, it plots on Figure 3.5 very close to the stability limit of $L = 17d$. An arched cave roof developed by phreatic dissolution (below the water table) creates a naturally stable profile, but is rarely wider than 20 m; most large cavern roofs have arch profiles that have evolved by roof stoping within the tensile zone. A roof arch in a limestone anticline could gain strength where its blocks of rock between radiating joints perpendicular to the bedding mimic a stable voussoir arch; this is very rare in nature, but may contribute to the stability of the enormous Sarawak Chamber in the Mulu karst (Gilli, 1993).

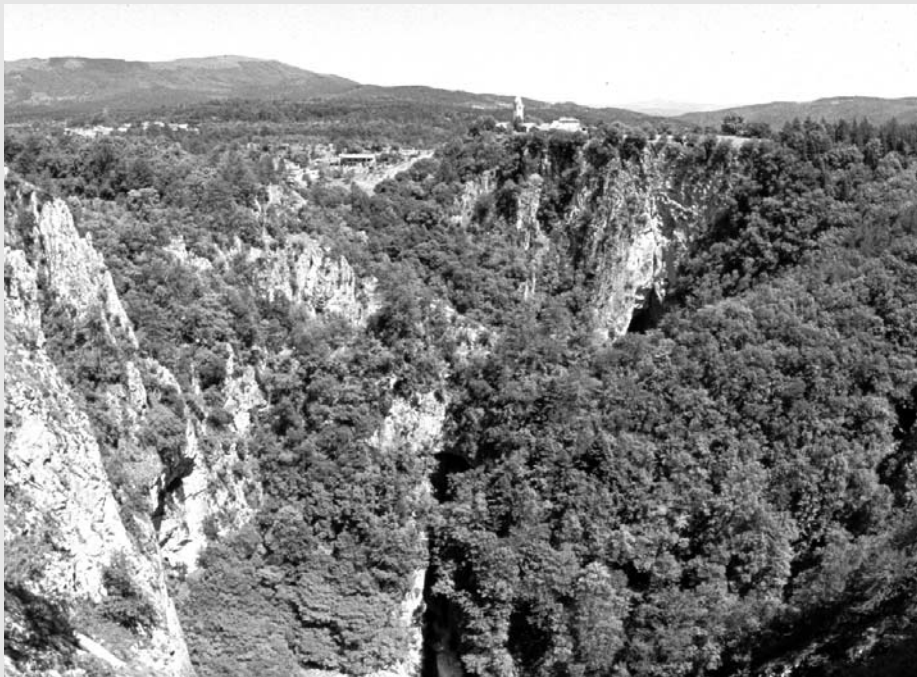
Figure 3.1.2. The view eastwards across the Velika and Mala collapse sinkholes. The village houses and church stand above the cliff that drops into the Mala sinkhole breached by the upstream segment of the Skocjan cave, and the wooded ridge in the foreground separates the two sinkholes.
TW.

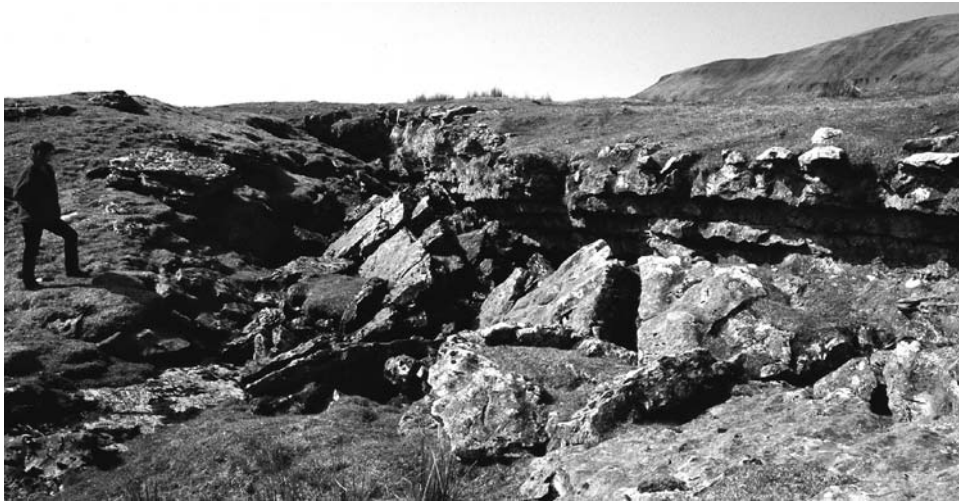
Figure 3.10. A small collapsed cave in Penyghent Gill, in the English Pennines, where a roof about 1 m thick has collapsed along the length of a low cave that was 5–10 m wide.
TW.

Total roof collapse over a length of shallow cave passage can create a very elongate collapse sinkhole lined by large slabs of undermined rock (Figure 3.10); failure of these wide caves in Penyghent Gill has created the largest area of undisturbed cave collapse in Britain (Waltham *et al.*, 1997). On a much larger scale this process can create a gorge or ravine (Figure 3.11); the Patale Chhango gorge in

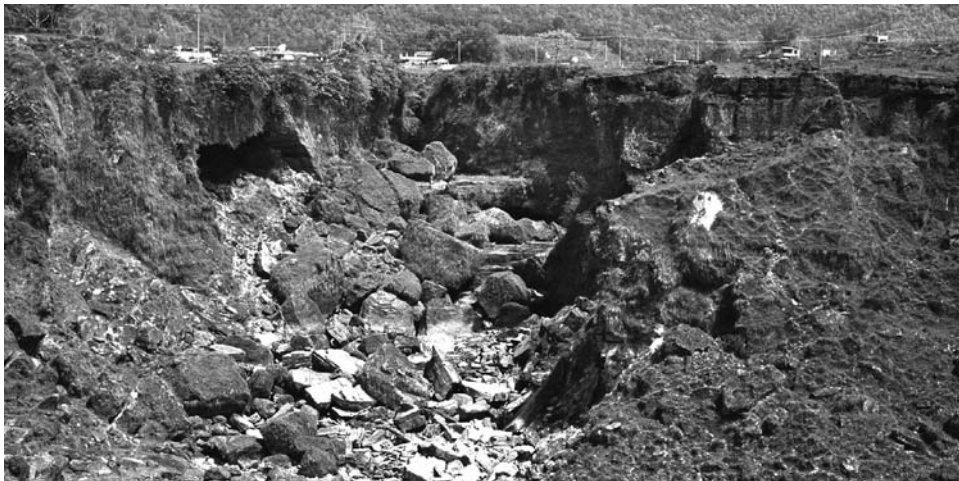
Figure 3.11. The chaos of large fallen blocks that defines the collapsed cavern at the mouth of the Patale Chhango cave in lowland Nepal; the short gorge is 55 m deep, and most of the collapse blocks are of the conglomerate that roofs the visible cave openings.
TW.

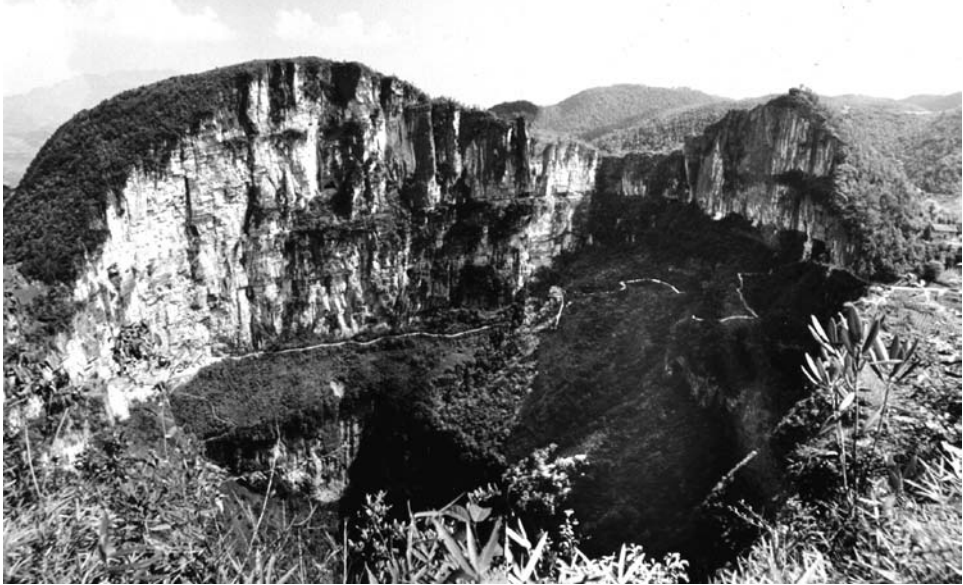
Figure 3.13. The giant collapse sinkhole of Xiaozhai Tiankeng, near Chongqing, China; the footpath winds across the wooded ledge before descending 300 m down a talus slope in the inner shaft.

The very largest collapse sinkholes are also known by the Chinese term, tiankengs (meaning *sky holes*). They are typically more than 250 m deep and wide, with vertical walls forming a large part of their perimeters, and the finest examples lie in the very mature karsts of China and New Britain. China's Xiaozhai Tiankeng is 660 m deep and 600 m across, with vertical walls above and below a sloping terrace at mid-depth (Figure 3.13); below the terrace a debris cone on one side of the hole descends to the river that crosses the floor of the tiankeng between cave passages only about 20 m wide (Senior, 1995; Zhu and Zhang, 1995; Zhu *et al.*, 2003).

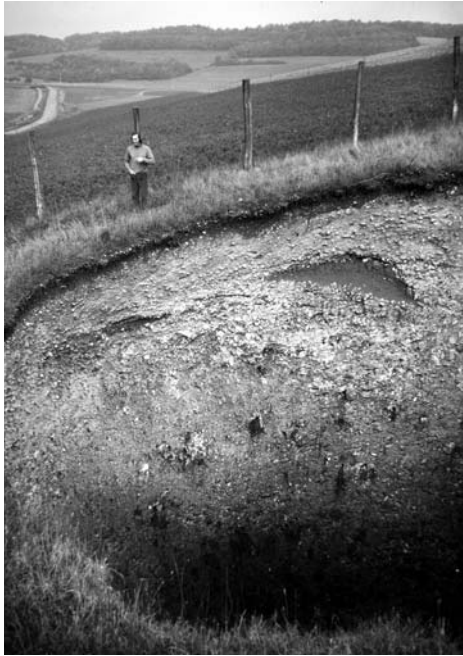
Figure 3.16. The collapse sinkhole of the Bime des Enfants in the chalk karst of northern France, 26 years after its sudden appearance.
TW.

observed collapse event created the Bime des Enfants in France's Aube department in January 1948. It left a sinkhole 16 m deep and 10 m across, with walls in typically well-fractured chalk, in a gently sloping hillside (Figure 3.16). There was no cave accessible around the edge of the mound of fallen debris, but the immediate area is distinguished by having some long stream caves with passages generally 2 m high and 1 m wide, which are large by the standards of the European chalk. The limestones of Australia's Nullarbor karst are described as chalky, and have porosities normally >25%, but they do have large cave passages slowly developed in the desert climate, and consequently have large collapse sinkholes totally unlike anything in the European chalk.

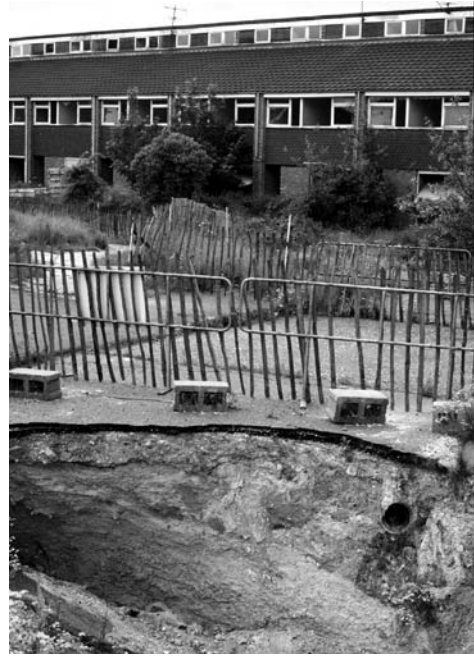
Figure 3.17. One of the collapse sinkholes formed by liquefaction failure of the chalk over old mines in Bury St. Edmunds, U.K., seven years after their failure destroyed the road.
TW.

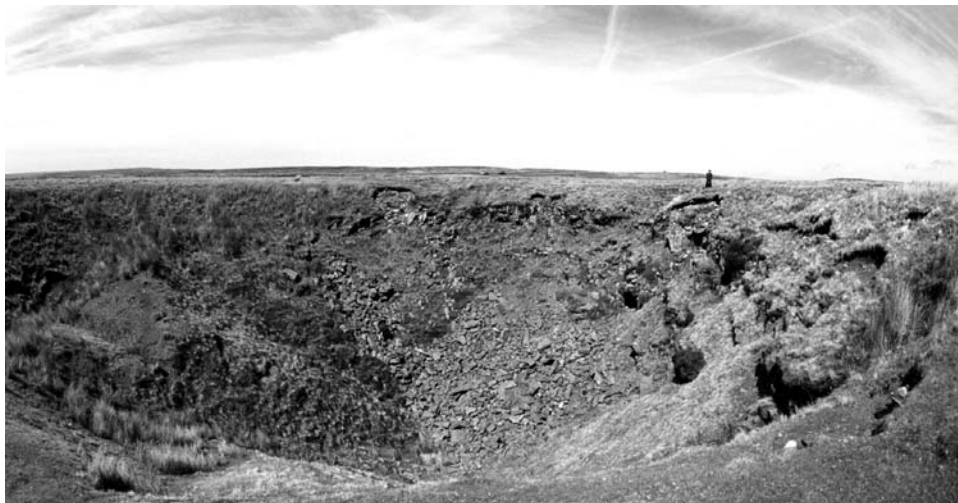
Figure 3.19. A large caprock sinkhole over the interstratal karst of Mynydd Llangattwg in Wales, U.K.; all the exposed and collapsed rock is strong gritstone, and the top of the limestone is about 10 m below the floor of the sinkhole.
TW.

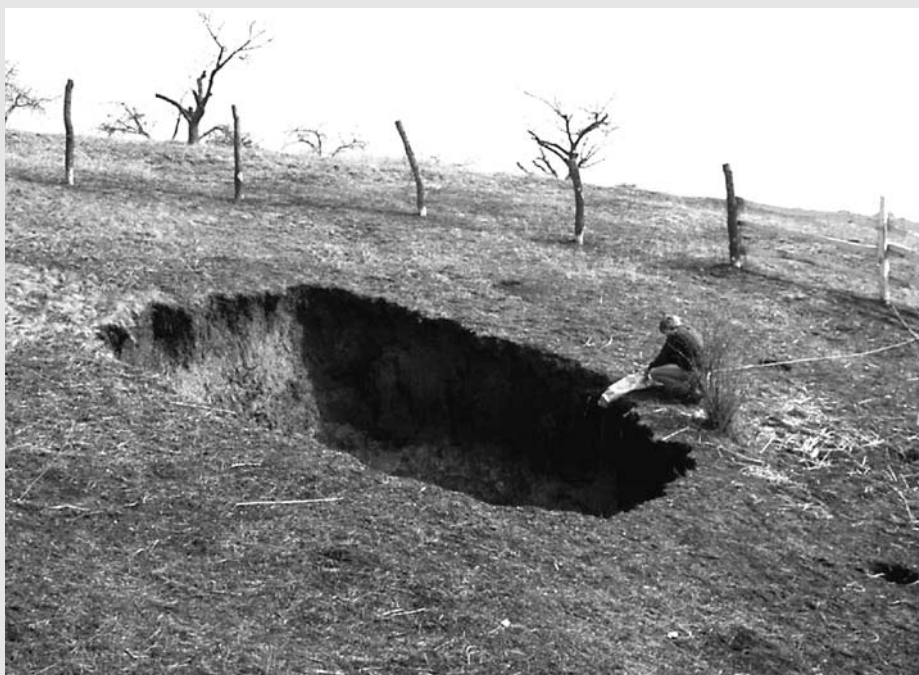
Figure 3.2.1. The freshly collapsed clay walls of the Dankivsky caprock sinkhole, Ukraine, with the way into the underlying cave lost in the darkness.

The world's most cavernous interstratal gypsum karst underlies the Dniester Valley of the western Ukraine and northern Moldova. On 11 January, 1998, a caprock sinkhole developed in a clay hillside at Dankivsky when a small instantaneous surface collapse broke through from an underlying gypsum cave. The new sinkhole was 5 m across, with vertical sides that descended 22 m to a sloping floor of fallen debris. It was in the previously unbroken grass cover of a field (Figure 3.2.1), and the collapse was heard at a farm one kilometre away. At the foot of the newly opened shaft (Figure 3.2.2), there was an opening over the debris cone and into the domed roof of a cave 9 m wide (Fig. 3.2.3). This dome had formed by wider collapse of the gypsum roof beds of a cave passage that continued about 5 m high but totally underwater where its roof was intact. The cave passage is very similar to those, just 12 km to the south, that extend for 92 km in the maze cave of Zolushka, which has been drained by pumping activity in an adjacent quarry (Klimchouk and Andrejchuk, 2003). Both the gypsum and the caprock clays are of Miocene age.

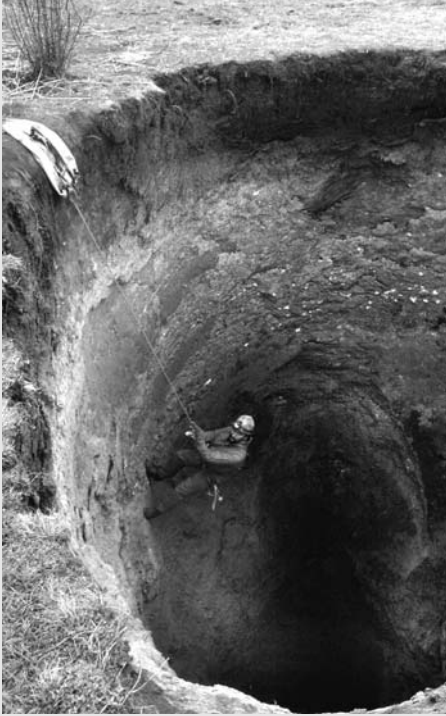
Figure 3.2.2. The grass-covered clay slope at Dankivsky broken by the new caprock sinkhole.

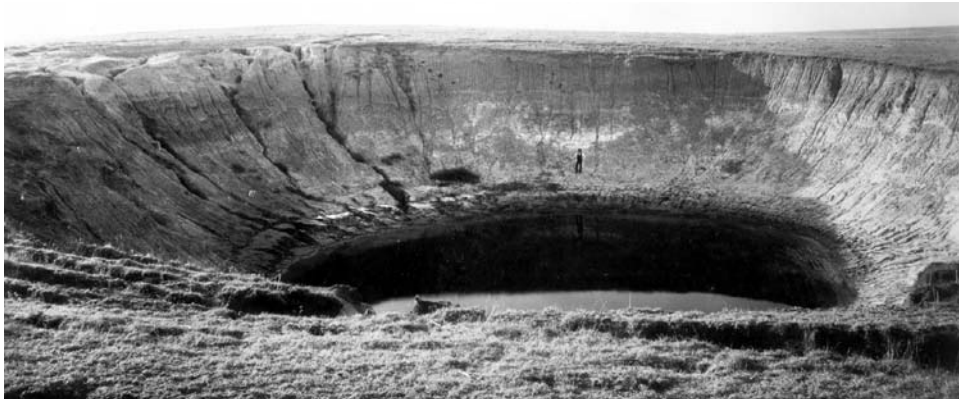
Figure 3.25. The caprock sinkhole that developed in 1879 over deeply buried salt at Meade, in Kansas.

In March 1879, a sinkhole developed catastrophically near Meade, in western Kansas (Figure 3.25). It was 52 m across, and initially 27 m deep though filled with water to within 4 m of its rim. It overlies salt at a depth of about 150 m and is clearly a caprock sinkhole, though the surface feature may have been widened by slumping of the cover soils in the manner of a subsidence sinkhole. Significantly, the salt below

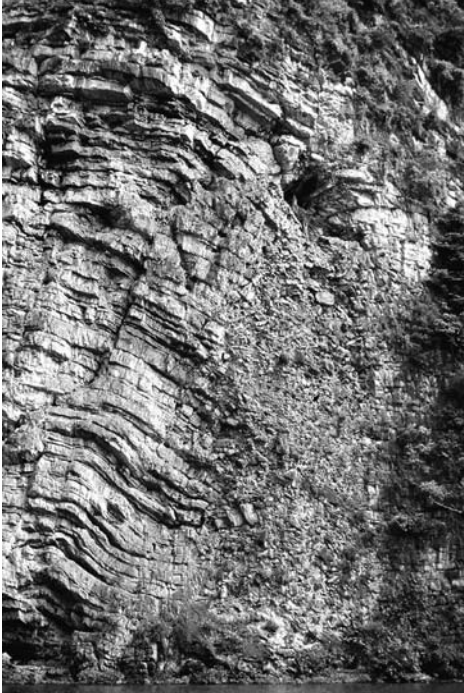
Figure 3.26. Limestone breccia pipe with an open cave at its top, exposed in the cliff of an island in Halong Bay, Vietnam. TW.
