SINKHOLES and SUBSIDENCE

Karst and Cavernous Rocks in Engineering and Construction

Tony Waltham, Fred Bell
and Martin Culshaw

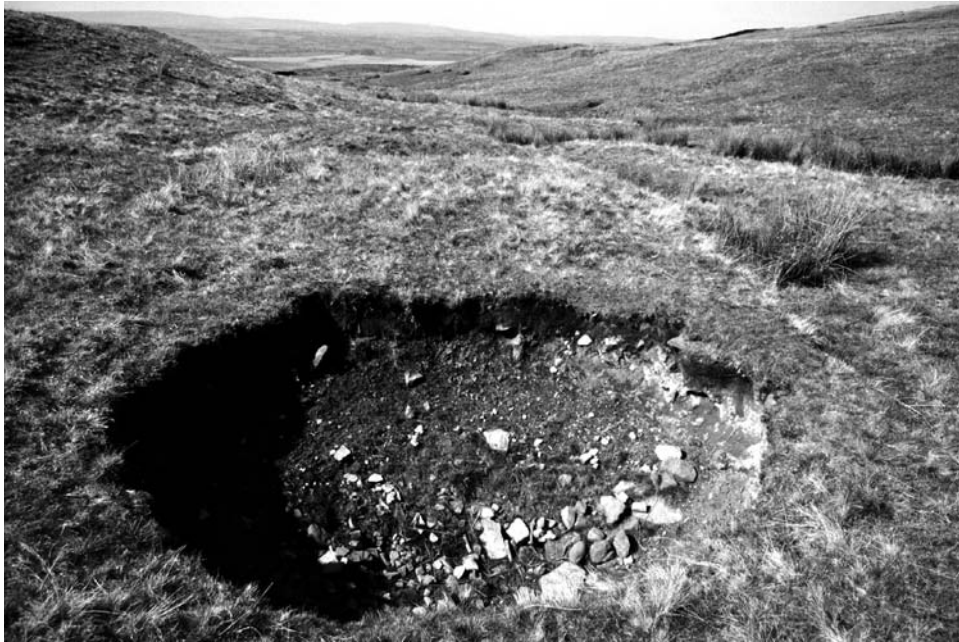
Figure 4.1. A typical small, fresh subsidence sinkhole formed in till overlying cavernous limestone in the Yorkshire Dales, U.K.; the new sinkhole is only about 3 m wide and 1 m deep, and it does not expose the limestone as rockhead is at a depth of about 3 m. TW.

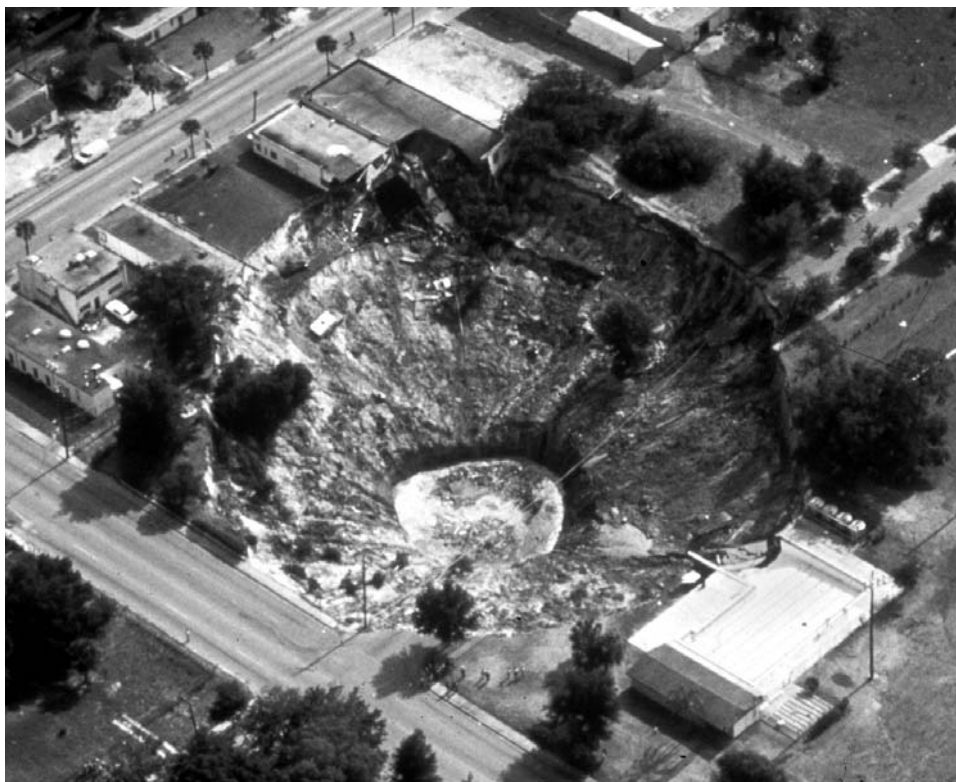
Figure 4.2. The large subsidence sinkhole in Winter Park, Florida, just after its initial dropout in May 1981; water is ponded within the steep-sided throat down through the clay soils, while the upper slopes were at the time still actively slumping back to form the wide bowl in the sand cover.

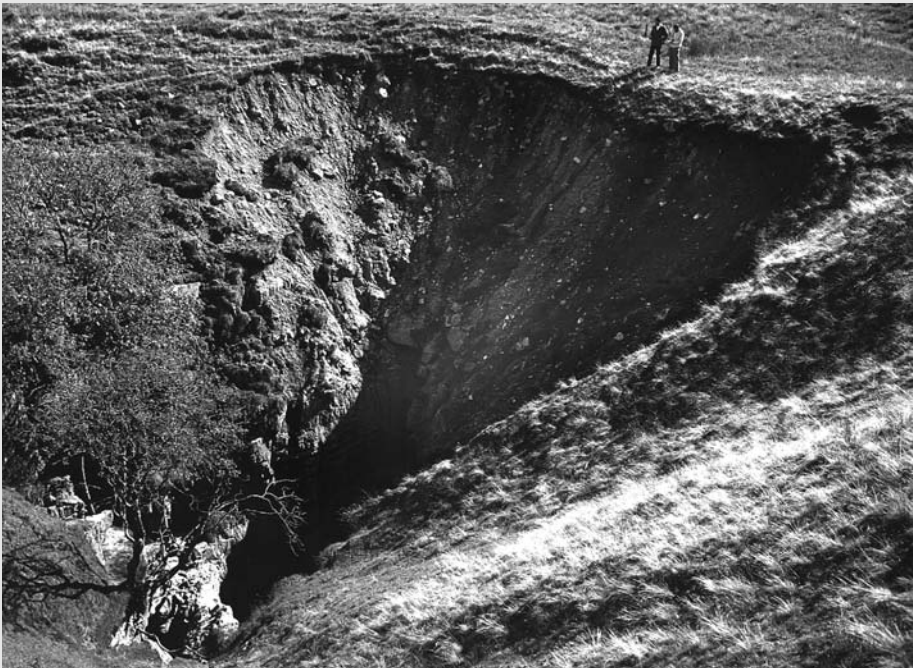
Figure 4.1.2. The subsidence sinkhole of Marble Pot, soon after its far side slumped into a newly open fissure in 1980.

Within the Yorkshire Dales glaciokarst, many of the broad limestone benches are mantled by till sediments that are pocked by thousands of subsidence sinkholes. Marble Pot is one of the larger sinkholes in the area, 40 m across and 15 m deep, and circular except for a stream trench entering on one side. A small stream drains into it, so that the underlying fissure system has evolved to be large enough to be accessible, at least in parts. This has allowed the underground features of Marble Pot and two more adjacent sinkholes to be mapped by cavers (Figure 4.1.1). If this profile had its scale adjusted so that most of the fissures were only 100–200 mm wide, it would suffice as a model for the karst morphology beneath subsidence sinkholes worldwide, where significant surface depressions appear unrelated to any visible or accessible voids in the bedrock.

Marble Pot has been developing ever since the mantle of till was left over the limestone outcrop on the retreat of the late Pleistocene glaciers about 12,000 years ago. The fissures and cave passages that constitute the constricted cave system beneath it have some earlier origins, as some of the lower passages contain stalagmite deposits that appear to be interglacial. Once the till had been deposited, seepage water (derived both from direct rainfall and small flows of allogenic surface drainage off the adjacent shale slopes) fed through to the rockhead fissures, and suffosion by this water carried sediment down into the limestone voids. The cohesive nature of the Yorkshire Dales till meant that the sinkhole then developed in a series of dropout events, each one followed by slumping of the sinkhole sides so that they flared out into the characteristic, steep, inverted cone. The most recent event was in 1980, when the whole of one side of the sinkhole failed (Figure 4.1.2). The soil all slumped into a newly opened fissure, which had been previously seen from below when cavers had looked up at a hanging choke of boulders with water dripping from between them. This temporary plug had failed during a winter storm event, and many tonnes of debris had fallen into the underlying rift. This totally choked the route down, except for the stream that could filter through the rubble and sediment.

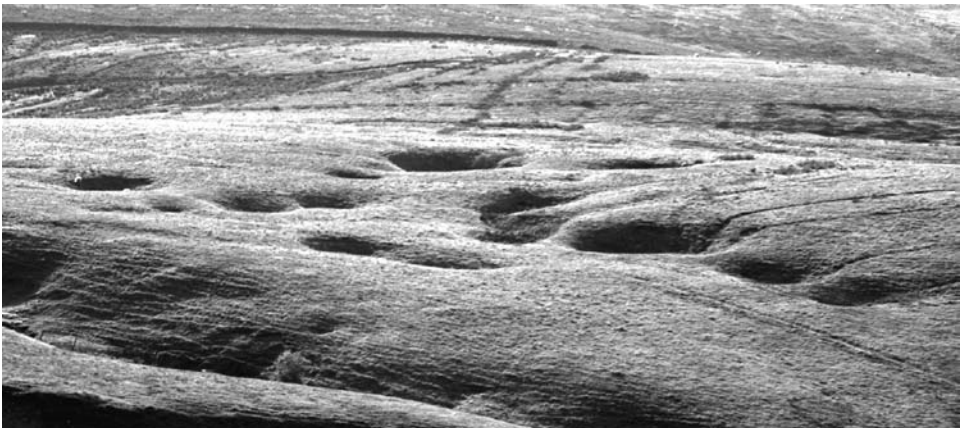
Figure 4.4. A cluster of subsidence sinkholes, locally known as shakeholes, in a patch of moraine till in the English Pennines.

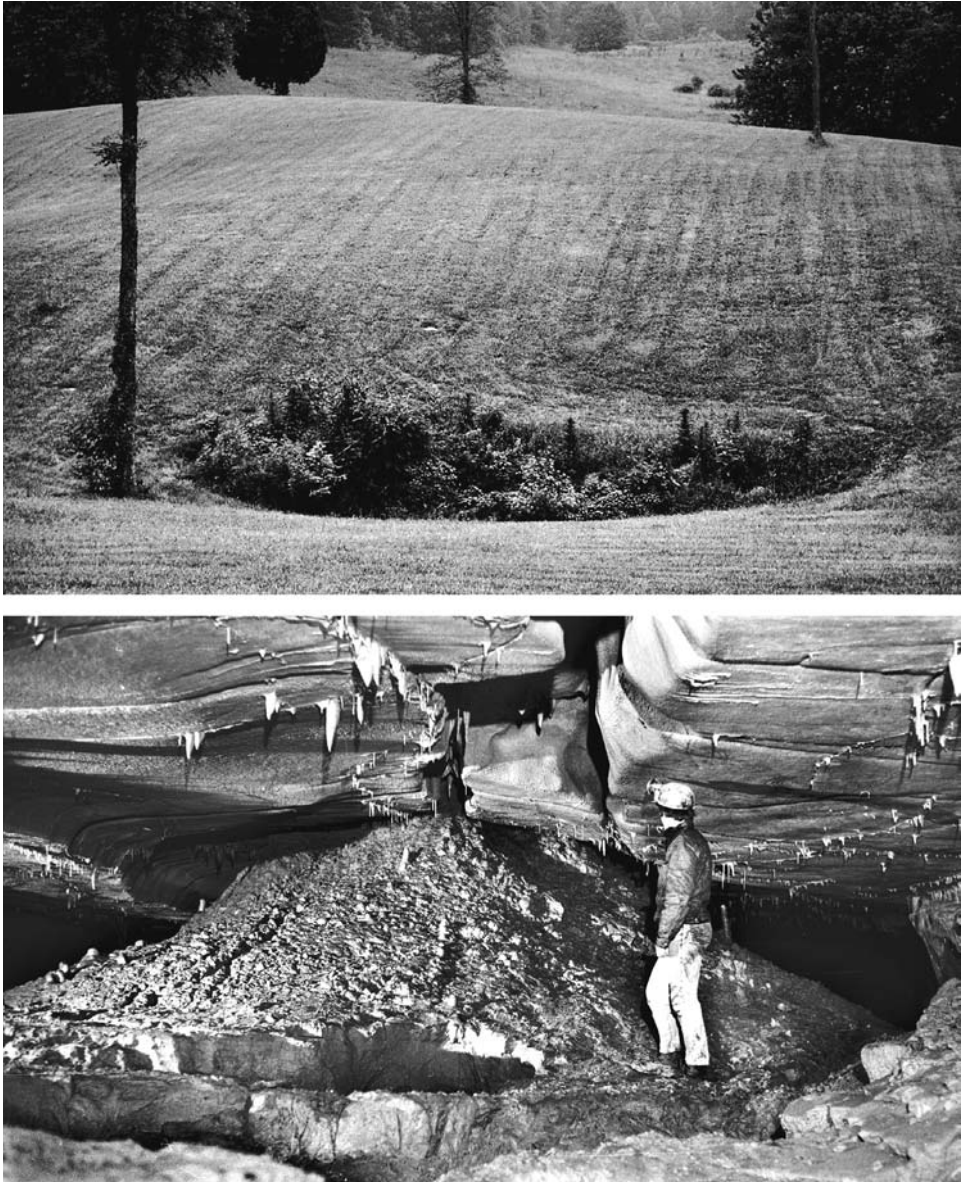
Figure 4.5. A small subsidence sinkhole in the karst of Indiana, and the cone of debris emerging from a fissure directly beneath it in Blue Spring Cave.

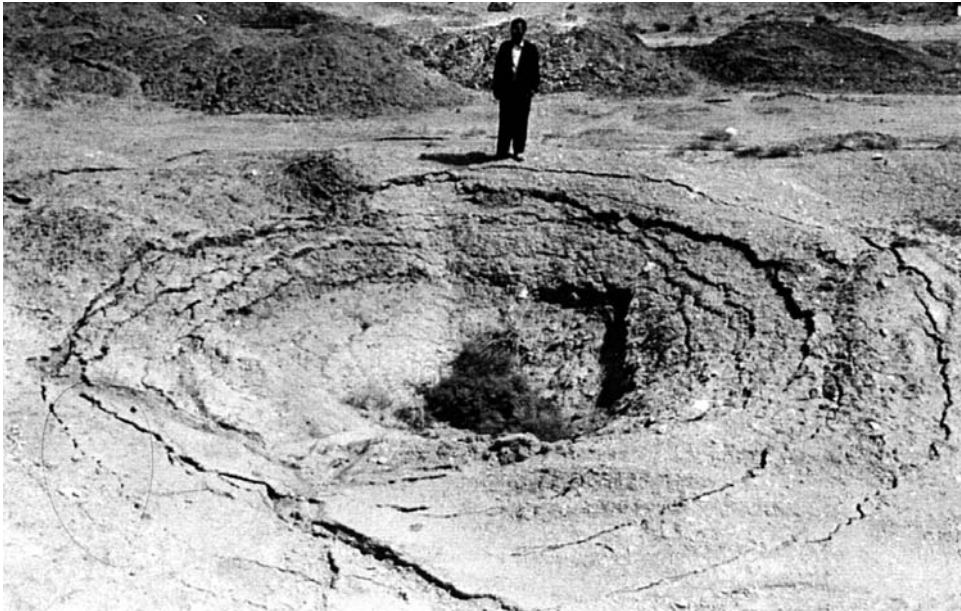
Figure 4.7. A small suffosion sinkhole newly developed in sandy soils near Kerman, Iran.
Photo: Habibeh Atapour.

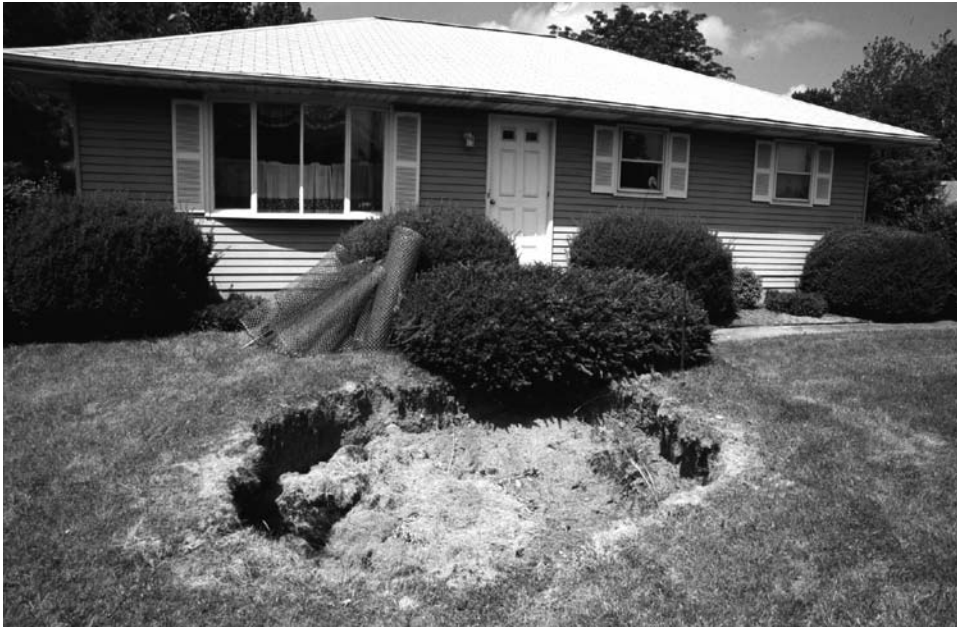
Figure 4.8. A dropout sinkhole in the front lawn of a house in Pennsylvania; the hole was originally 5 m deep but was filled with soil to prevent the sides flaring out, and the soil fill had compacted and settled by 0.7 m by the time this photo was taken.
TW.

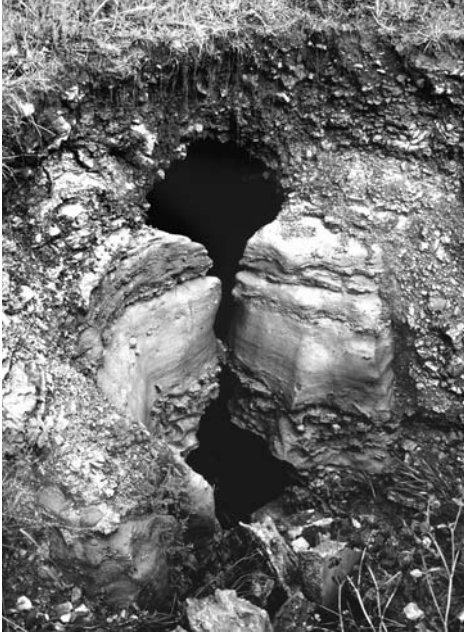
Figure 4.11. A soil arch beneath about 150 mm of cover over a cavity developed over a fissure in limestone rockhead, exposed in the side of a small collapse in Kentucky.

The critical process in the formation of dropout sinkholes is the growth, migration and failure of ephemeral soil cavities; these are widely known as regolith arches in North America. They are generally initiated at the rockhead, as soil is carried down into bedrock fissures (Figure 4.11). As more soil is lost, the cavity grows beneath an arched roof, until this becomes unstable, causing roof stoping and upward cavity migration until surface failure is induced. Sediment transport is critical to continued cavity growth, and is normally dependant on water flow rates.

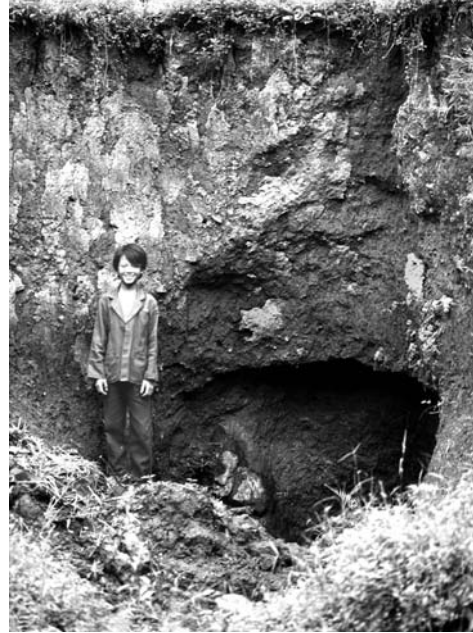
Figure 4.12. A thick soil arched over a piping cavity in the edge of a fresh dropout sinkhole in the Xingwen karst in Sichuan, China; rockhead is deeply pinnacled in this mature karst, and the edge of a limestone pinnacle is exposed just to the right of the boy's feet.

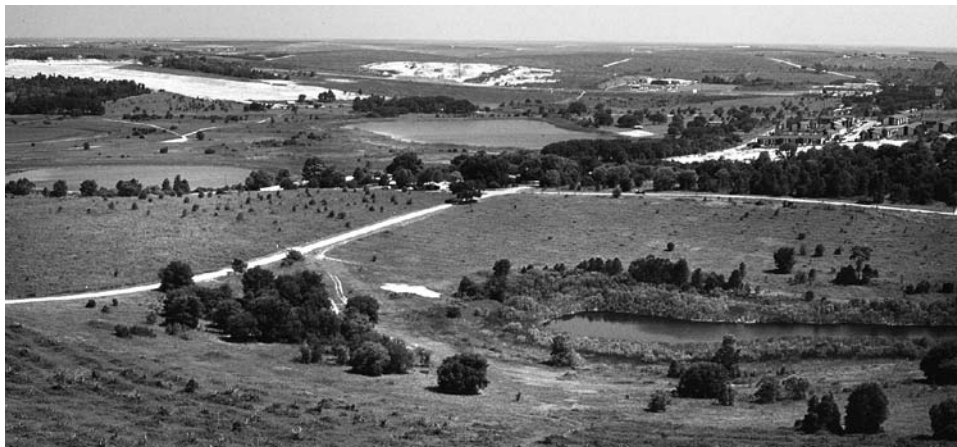
Figure 4.14. Lakes stand in many of the very old subsidence sinkholes that have degraded to wide bowls in the thick sediment cover over the limestone in the Florida lowland karst. TW.

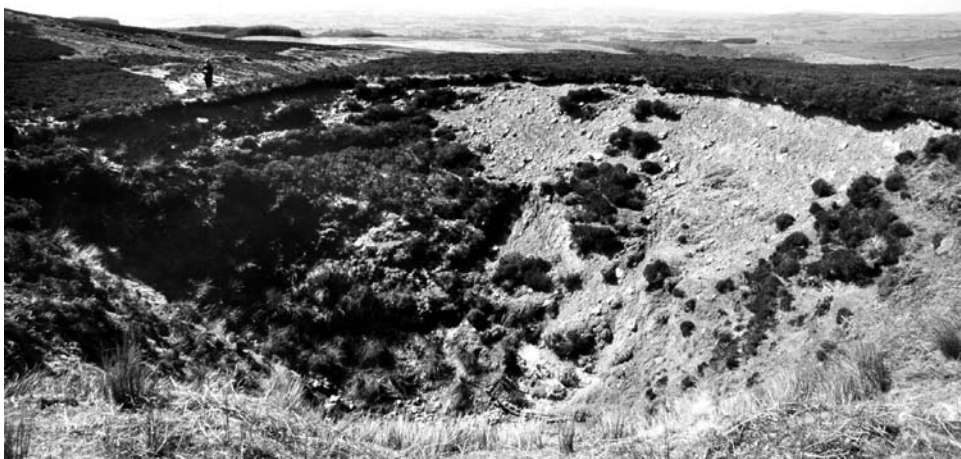
Figure 4.16. The deep and almost circular subsidence sinkhole known as Ashtree Hole that lies over a major joint in the Leck Fell limestone (see Figure 4.15).

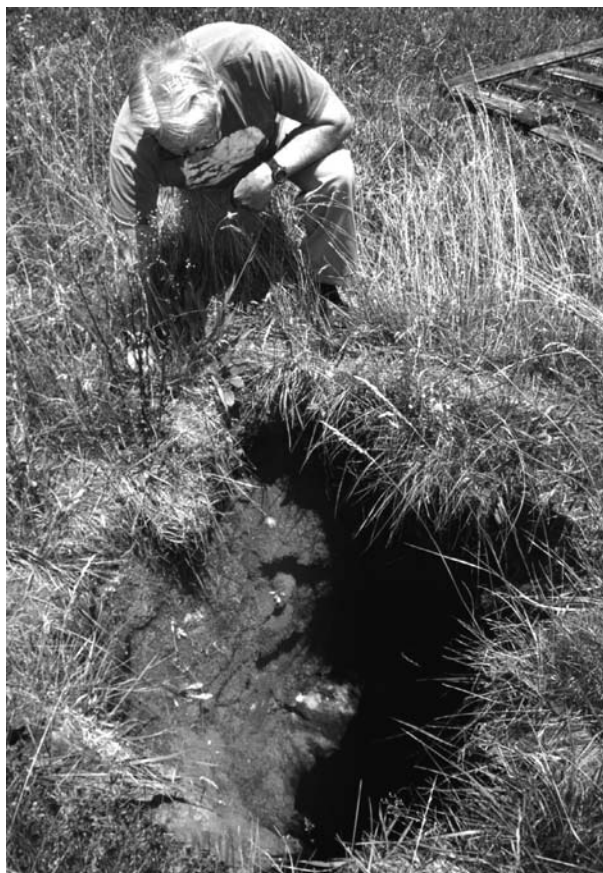
Figure 4.18. A new dropout sinkhole in the middle of a field on Kentucky's Sinkhole Plain; the top of a limestone pinnacle is just visible about 1 m down, but the open hole is 12 m deep within a fissure between the rockhead pinnacles.
TW.

Maximum depths, and therefore maximum diameters, of subsidence sinkholes are broadly limited by the thickness of soil cover in which they form. While larger sinkholes can develop in them, thicker soils still have a preponderance of smaller sinkholes, with floors or apices that do not reach down to rockhead. Also, narrow and deep dropouts can form down previously soil-choked shafts, where the lower part descends between pinnacles of bedrock capped by only a thin soil cover (Figure 4.18). Overall, cover thickness is not a good predictor of sinkhole size

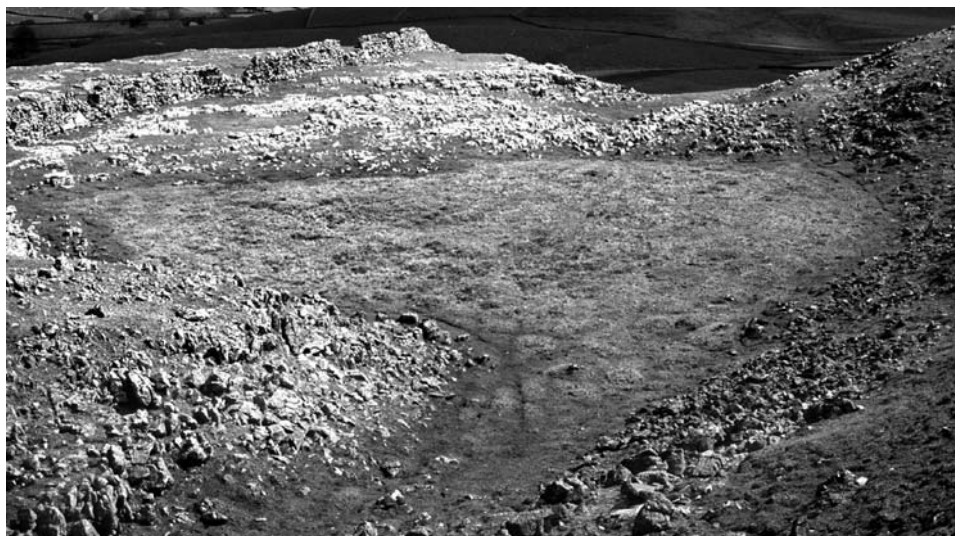
Figure 5.1. Buried sinkhole within the bare limestone pavements of Ingleborough in the English Pennines; the patch of soil overlies an unconsolidated soil fill of a depth that is unknown but likely exceeds 20 m.

Filled and buried sinkholes can occur as isolated features in any type of rockhead morphology; they can break the profile of glaciated rockheads that may be otherwise very uniform (in karst of class kI or kII), and can also occur within terrains of exposed limestone where a patch of soil may either rest on the limestone surface or may be the top of a deep fill in a buried sinkhole (Figure 5.1).

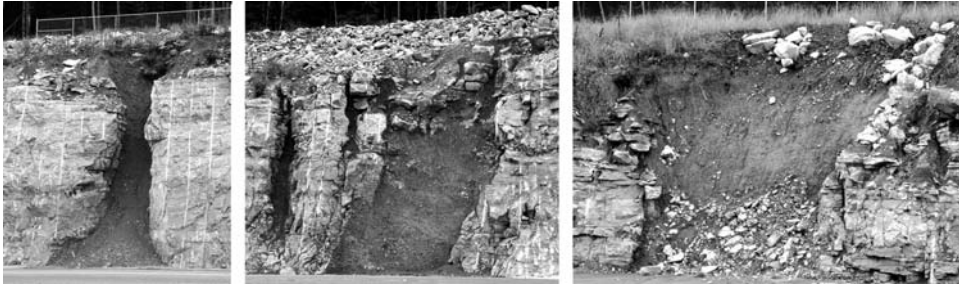
Figure 5.2. Various profiles within some of the buried sinkholes exposed in a single road cut, about 7 m deep, through a limestone hill outside Huntsville, Alabama.

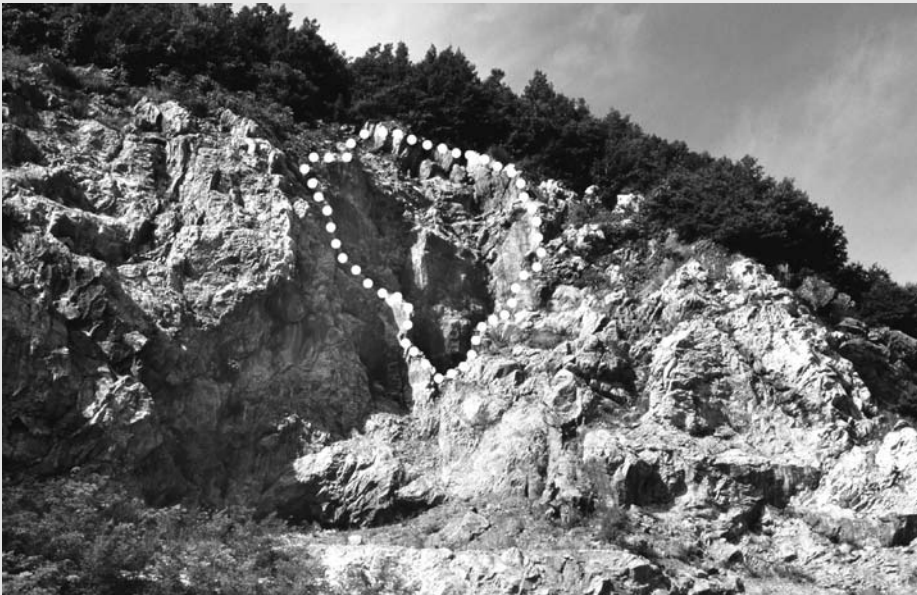
Figure 5.1.2. The upper bench of the Chunglim quarry, with the subsoil outcrop of the now-empty buried sinkhole picked out by the dotted line. Entrances to the mine workings are almost hidden behind the debris barriers piled up on the main bench at the foot of the picture.

The mountains of eastern South Korea contain steeply folded bands of limestone and dolomite that are locally eroded into moderately mature karst of classes kII and kIII. Some outcrops are pitted with large solution sinkholes. Rockhead relief is generally 3–5 m, with many small, buried and filled sinkholes. The buried sinkhole in the Chunglim valley was intersected at depth by a large heading in a limestone mine, and consequently its morphology is well exposed. The hillside profile was transformed by the benches of an open quarry, but working continued underground to follow the material of highest quality. The upper hillside is thickly wooded, with scattered small pinnacles of limestone rising through the thin cover of clay and loess soil. Mine tunnels, each 7 m high and wide, were driven into solid rock, but one heading collapsed when it breached the buried sinkhole nearly 25 m below the steep hillside (Figure 5.1.1). The soil fill within the sinkhole then ran into the mine, blocking the heading with a cone of loose debris, and the slope above is now scored by the gaping hole of the empty sinkhole (Figure 5.1.2).

The buried feature appears to have been about 20 m in diameter at the surface, and tapered to about 7 m across at the depth of the mine roof. Its soil fill was a mixture of red–brown clay, silt, rounded pebbles and angular limestone blocks. Details of the soil-filled fissures and any open cavities below this depth were obscured by the collapse and its consequent debris pile, though a solutionally opened cave extends for a few metres to one side (Figure 5.1.3, right of the person). When the soil was emptied from the sinkhole into the mine beneath, slices and blocks of rock came away from the unsupported walls. This left the nearly planar backwall (Figure 5.1.3, left of the person), that has since been washed clean by rainfall, and is revealed as a major joint that had been previously opened by dissolution, and may or may not have once been filled with in-washed soil. The original sinkhole appears to have developed in a zone of joints that strike roughly parallel to the hillside contours, but this degree of fracturing is normal in the well-folded limestones of Korea.

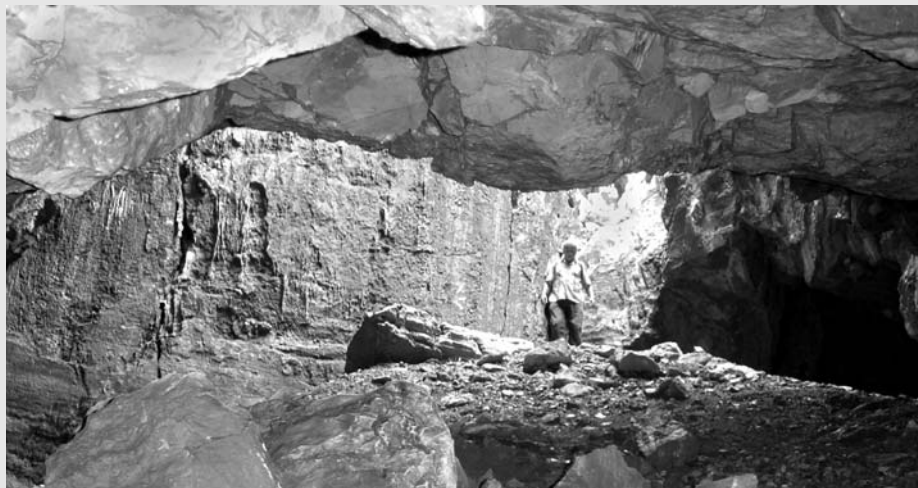
Figure 5.1.3. Looking up the debris pile, from the Chunglim mine tunnel into the open daylight shaft that is the emptied buried sinkhole; the shadowed roof of the mine is scored by narrow soil-choked fissures around the perimeter of the old filled sinkhole.

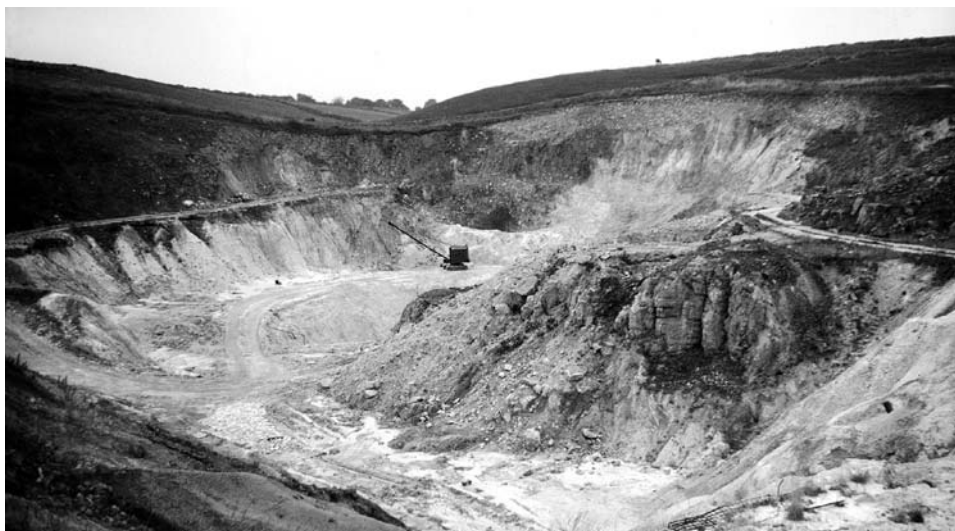
Figure 5.5. A large buried sinkhole in England's southern Pennines, exposed after its fill was extracted as a valuable source of refractory minerals; scale is indicated by the old excavator. TW.

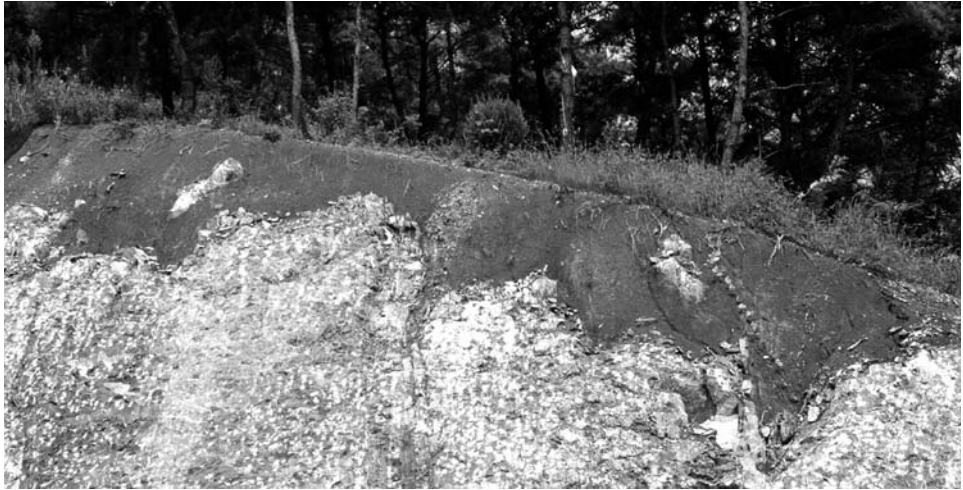
Figure 5.6. Two small limestone “floaters” within a red, clay-rich soil above a rockhead of only modest relief exposed in a new road cut in Korea.
TW.

A feature of many borehole explorations in karst is the revelation of sections of sound limestone core followed by soil, unconsolidated sediment or open voids at greater depths. Where not matched by comparable core records in adjacent boreholes, these records are commonly described as “floaters” and interpreted as isolated blocks of limestone within the soil profile (Figure 5.6). But these apparent floaters may represent a variety of features. Possibilities include transported limestone boulders, limestone blocks in a collapse zone, limestone bedrock with caves at multiple levels or a single large cave with ledges and notches in its walls (Tan, 1987). Fallen or detached pinnacles should be added to this list. These floaters are sometimes referred to as corestones, but this is misleading as they are not residual blocks surrounded by their own weathering products. Transported boulders are very unlikely at most sites, but collapse blocks are likely to occur in many buried sinkholes. All floaters must be regarded as potentially unstable. However, many of them eventually prove to be extensions of solid bedrock. These may offer stable load-bearing rock if they are thick enough (Chapter 7) and are continuous to bedrock on three or four sides, but are unstable if they are rock projections cantilevered out from one side only. Further investigations are normally required to elucidate valid 3-D ground models (Figure 5.7), on which sound engineering decisions can be based.

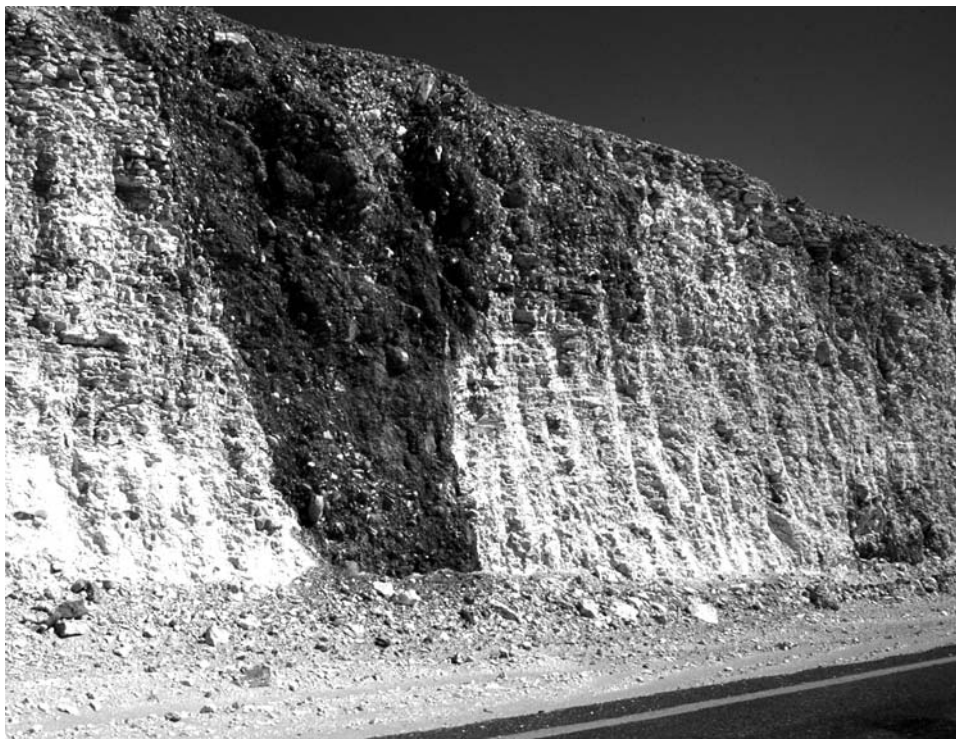
Figure 5.8. An ancient buried sinkhole bisected by a road cutting in the limestone of Egypt's Kharga Plateau; much of the cohesive fill remains in place in the modern dry environment. TW.

Buried sinkholes are a widespread geohazard for foundations and may also diminish integrity of shallow cut faces (Figure 5.8). Most close downwards into narrow fissures, but some larger filled caves (often known as pipes) continue to great depth. At a depth of nearly 100 m, the heading of the Dodoni Tunnel in northern Greece breached a filled sinkhole 1.5 m in diameter (Marinos, 2001). Its saturated fill ran into the heading, and a sinkhole 3 m across opened on the surface above. The fact that 1,200 m³ of fill entered the heading indicates that it was emptied from an unknown and more extensive system of caves and fissures, as its volume far exceeded that of a single narrow pipe.

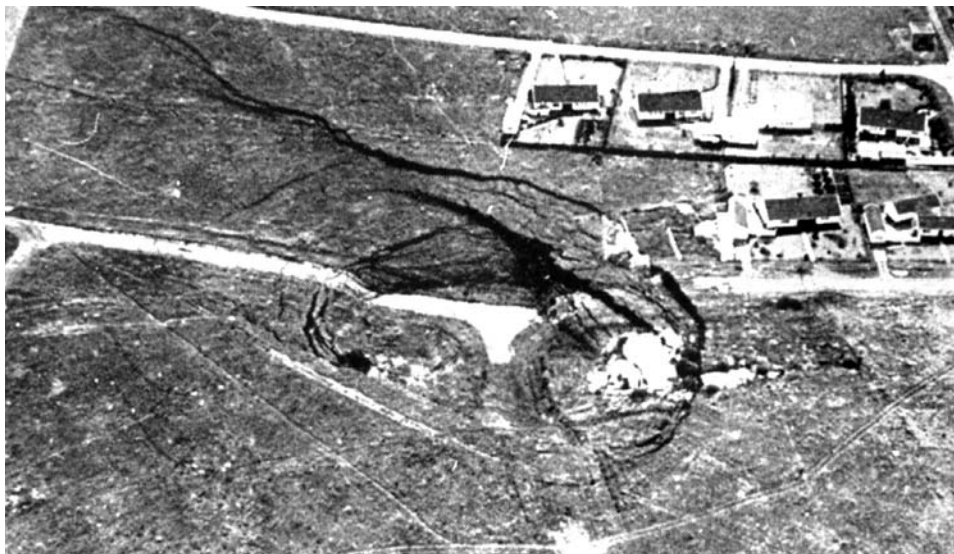
Figure 5.11. The compaction sinkhole known as Schutte's depression, when it was active during de-watering of the Rand karst of South Africa.

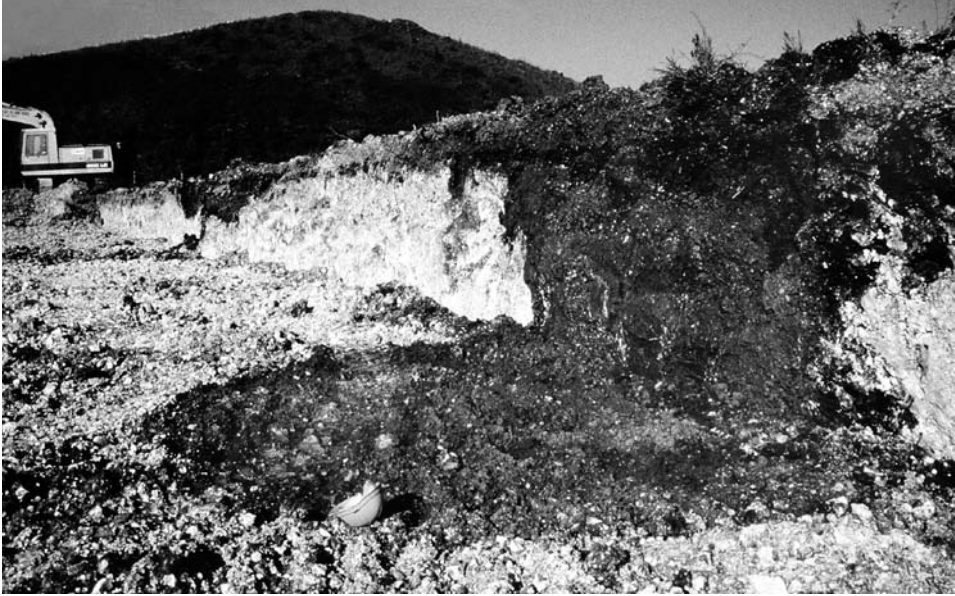
Figure 5.13. A single clay-filled pipe in chalk, exposed in both plan and profile on a building site in southern England.

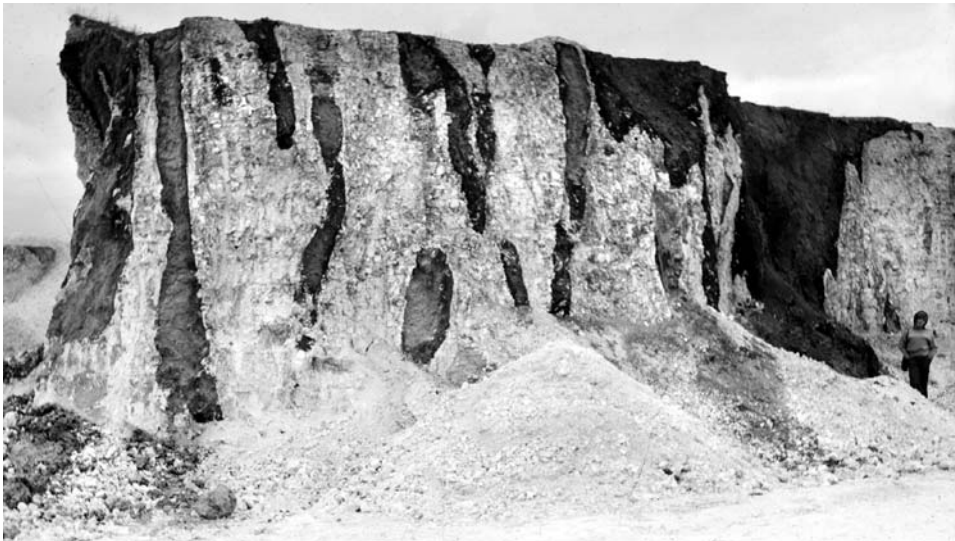
Figure 5.14. A cluster of clay-filled pipes in chalk exposed in a quarry in the English Chilterns. TW.

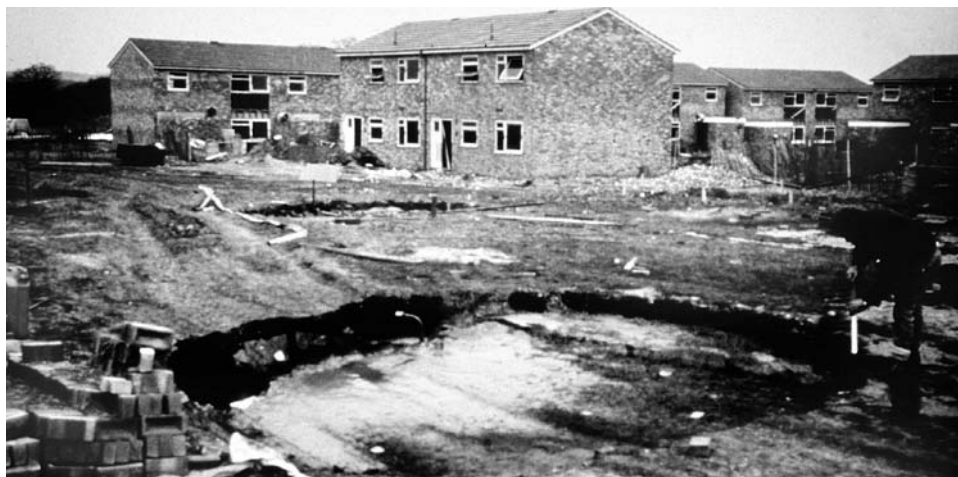
Figure 5.15. Subsidence of about 300 mm over a chalk pipe whose fill was disturbed by construction activity on a site in the English Chiltern Hills.

Pipes in chalk karst constitute a significant geohazard in that they occur as scattered, hidden, unstable ground features. A building site of about 2 ha, in England's Thames Valley, recorded 27 subsidence features and 15 zones of loose soil undermined by suffosion (Edmonds, 1988). Each feature was 2–10 m across, and lay over either a buried sinkhole or a pipe. They were all revealed during construction activity on the site, when loss of soil cover, imposed loading and drainage disturbance are prime triggers that renew either compaction or suffosion of the sinkhole and pipe fills. Most such subsidence events are little more than inconveniences on construction sites (Figure 5.15), and most are small enough that subse-

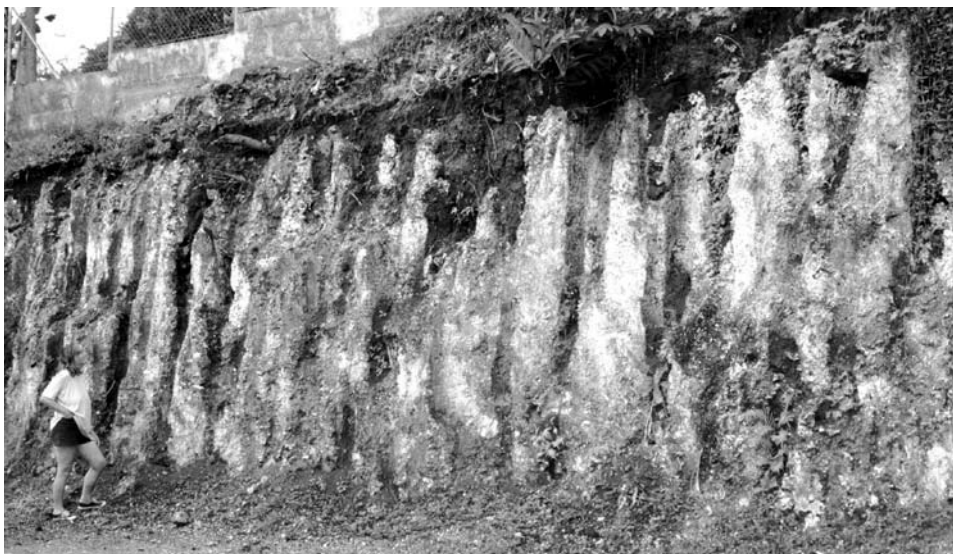
Figure 5.16. Closely spaced pipes within a soft raised limestone on Efate Island, Vanuatu; some of the soil fills have been washed out since the face was exposed on a building site. TW.

Though pipes are a characteristic feature of chalk, comparable features occur in other soft limestones, notably the young reef rocks that form the raised terraces of many tropical islands (Figure 5.16). Rapid dissolution in these environments creates narrow vertical shafts that take rainwater, until they are filled by in-washed soil to form pipes in prematurely mature karst. They then become just one more variety of buried sinkhole that can provide geohazards for engineering works in karst terrains.

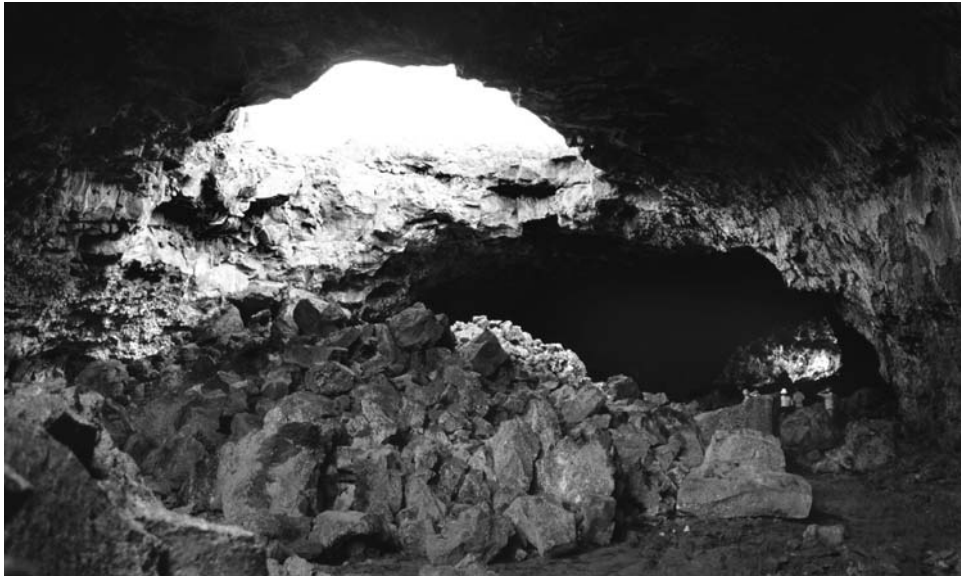
Figure 6.1. Breakdown pile beneath the sinkhole entrance to Indian Tunnel, a lava tube 20 m wide beneath a roof less than 5 m thick in the Craters of the Moon lavafields, Idaho; people on the right indicate the scale.
TW.

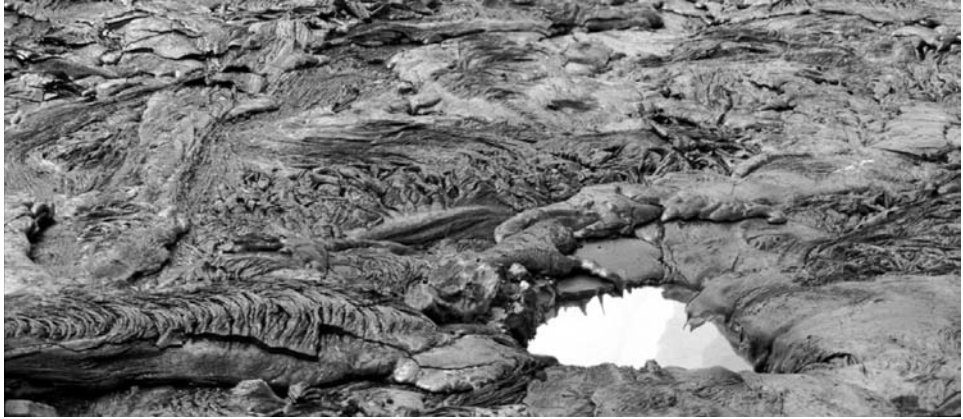
Figure 6.2. A skylight into an active lava tube on the Kilauea volcano, Hawaii; the open hole is just a few metres across, and the failed basalt crust is less than a metre thick.
TW.

Many active lava tubes have only very thin roofs of chilled basalt, and the flowing lava may be exposed in its tube by small roof collapses that form skylights (Peterson *et al.*, 1994). These are essentially collapse sinkholes, but are distinguished by the absence of fallen roof debris – which has been carried away by the lava or has melted into it. Though some active tube roofs are dangerously fragile (Figure 6.2), they constitute no engineering hazard, as construction works are neither required nor advised on an active lava flow.

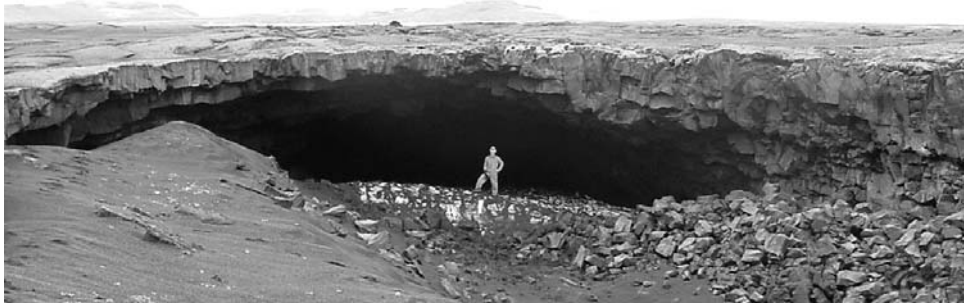
Figure 6.4. The entrance to the Flothellir lava tube in Iceland where a very thin roof has collapsed across a very wide span.

The stability of the rock forming the roof of a lava tube depends on the rock thickness, the unsupported width over the tube and on how the roof was formed (Figure 6.4). Tubes formed by injection might be at a depth of tens of metres, but most open tubes lie only 1–5 m below the ground surface. The width of a lava tube is commonly anything up to about 10 m. A minority of wider caves are recorded; Manjang Gul, on Korea's Cheju Island, has a single tunnel that is 15–25 m wide along some kilometres of its length, but this is exceptional, and most of it lies beneath solid rock more than 10 m thick.

Figure 6.6. Plan and profile of the Flothellir lava tube within the basalts formed during the 1783 eruption from the Laki fissure, Iceland; the photograph in Figure 6.4 is of the entrance to the southern cave from the middle collapse.

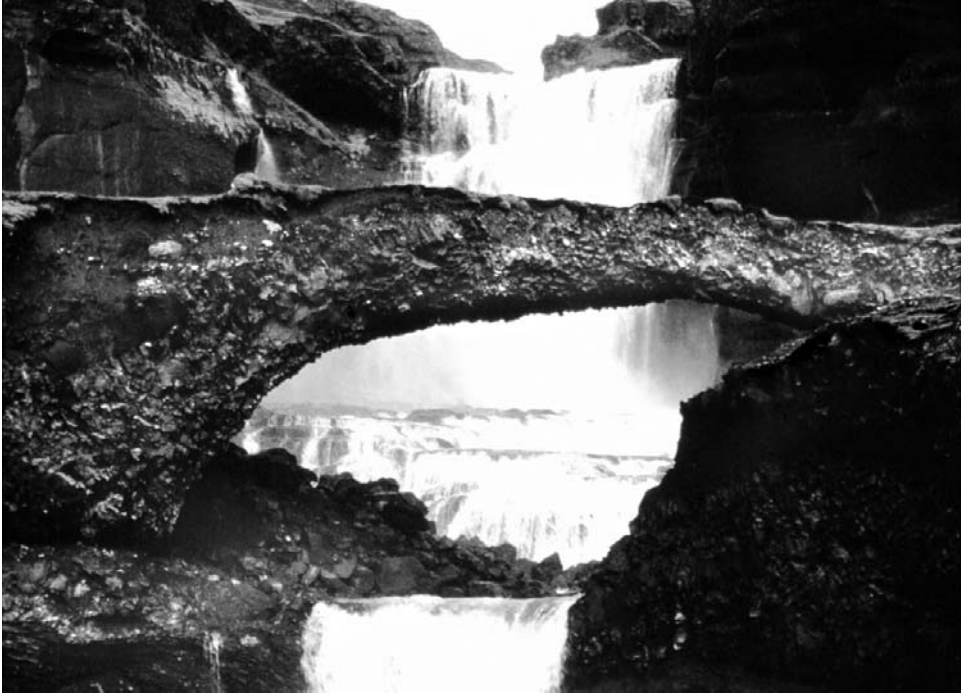
Figure 6.5. The thin basalt arch across the Ofaerufoss waterfall, before its collapse in 1993. Photo: John Middleton.

The winter of 1993 saw the collapse of the often photographed basalt arch across the Ofaerufoss waterfall in Iceland (Figure 6.5). Though it was an erosional feature created by river scour of a scoriaceous horizon, this arch had the proportions of a lava tube roof, with a low arch about 2 m thick across a span of about 14 m, giving it a cover ratio of 7 : 1. Though it collapsed without any imposed load, its rock was significantly broken as it was formed of a mass of pahoehoe toes and partly welded blocks, and it was therefore much weaker than many lava tube roofs formed of more homogeneous basalt.

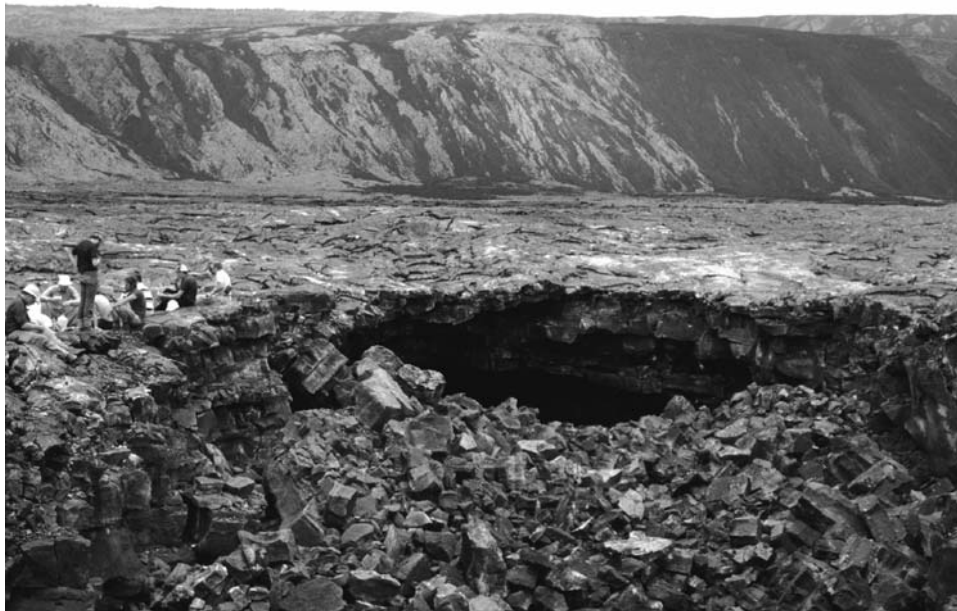
Figure 6.7. Newly collapsed sinkhole entrance to the lava tube of Apua Cave only 3 m below the basalt surface in Hawaii.
TW.

Skylights that form in active lava tubes, and large areas that deflate and subside as lava drains out from beneath them, are structural features of young basalt lava. Some tubes also collapse as or soon after their lava drains out, to form sharply defined “valleys” across outcrops of very recent basalt. The notable geohazard on basalt is created by the collapse sinkholes that develop where rock collapses into open tubes long after the eruption activity has ceased. A large proportion of tubes have thin roof spans that must be regarded as only quasi-stable, even prior to any weakening of the rock by subsequent weathering. It is significant that the entrances to most of the thousands of lava tube caves known around the world are through natural collapses, where their roof rocks have failed without any imposed load. Most collapses pre-date recorded observations, but the two entrances to Apua Cave, in lava flows formed on Hawaii in 1973, were only found after they had collapsed during a minor earthquake in 1975 (Figure 6.7). Apua Cave is about 15 m wide and lies about 3 m below the surface, indicating a cover ratio of 5:1, but it is not known if roof stoping had reduced this ratio prior to the collapse. There would appear to be significant numbers of sites on recent basalt lavas where ground is waiting to collapse over open tubes, and will readily collapse under any loading imposed by engineering activity.

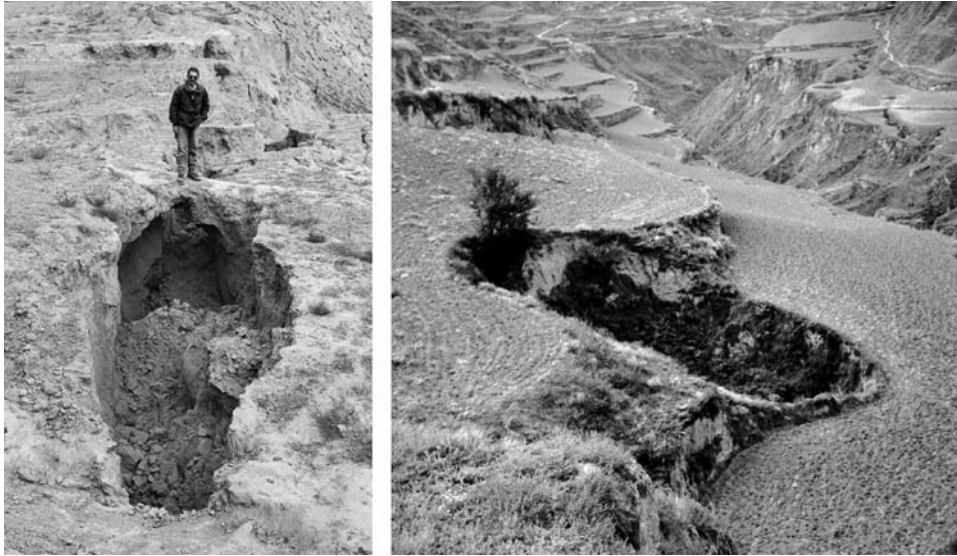
Figure 6.11. Sinkholes in the loess terrain near Lanzhou, China – a recent small collapse over a youthful pipe, and a larger old collapse further from the terrace edge.

In any soil terrain where piping is observed, there is the possibility of sudden collapse of the ground at the upper end of unseen pipe systems. The soil arches are so

weak that they are likely to collapse naturally due to continuing piping and erosion. They have negligible bearing capacity, and any that already exist are likely to collapse under the disturbance and loading of construction traffic. New pipes and sinkholes may be formed during single or multiple rainstorm events, within the lifetime of an engineered structure. It is therefore essential to control surface drainage and ensure that opportunities for rainwater infiltration are eliminated from development sites.

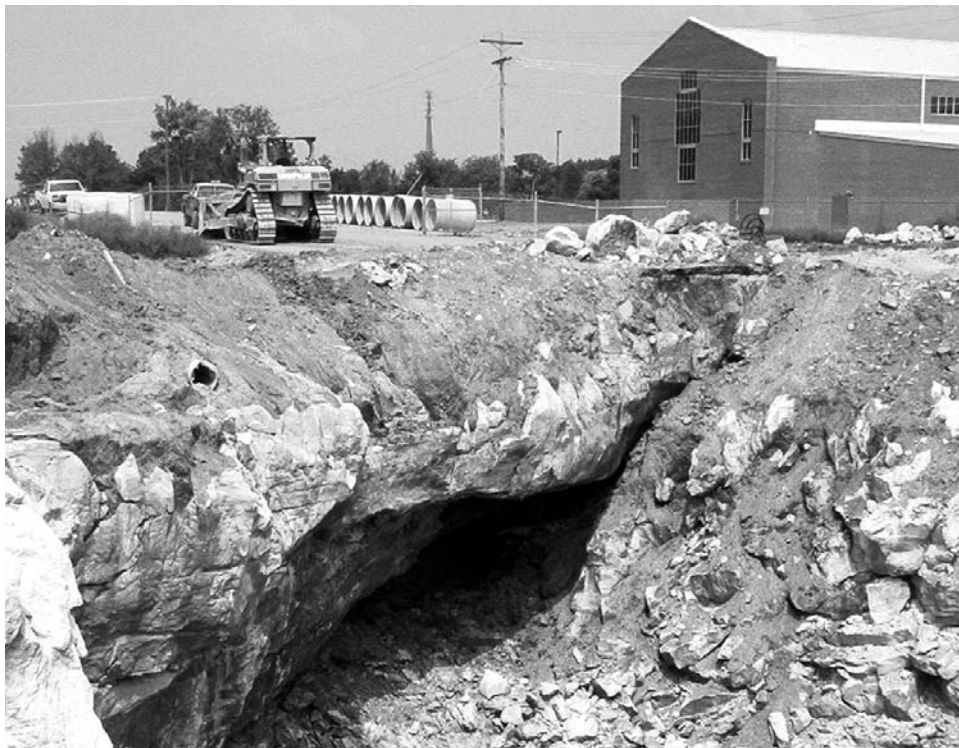
Figure 7.1. Fractured rock around the margin of the new collapse sinkhole that destroyed Dishman Lane in Bowling Green, Kentucky, in 2002.

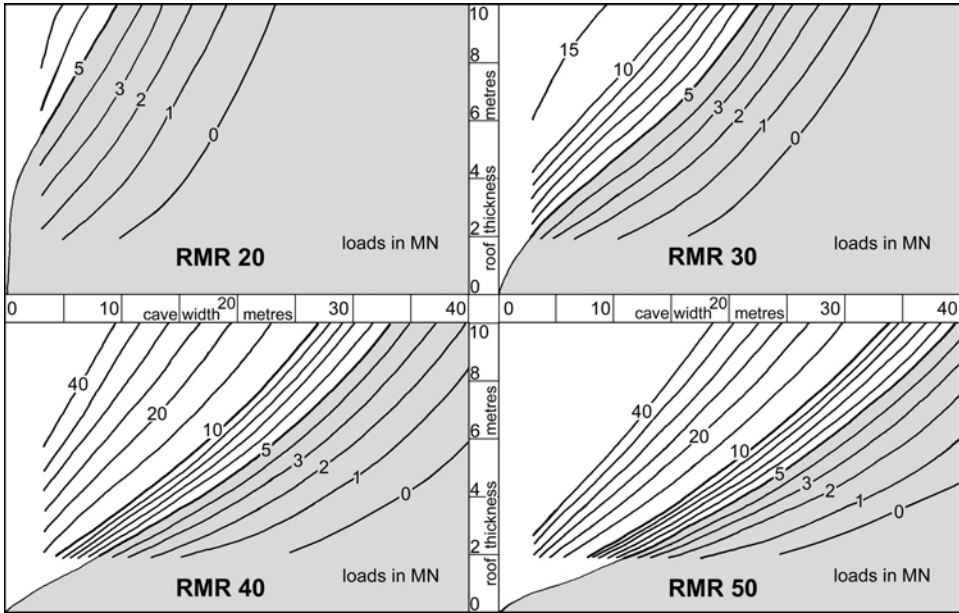
Figure 7.3. Nomograms that relate failure loads to cave width and roof thickness in ground of various rock mass ratings; loads are applied to foundation pads 1 m^2 on the surface directly above the caves; the shaded areas represent situations with respect to cave width and roof thickness where loading of 1 MN on the pad leaves a factor of safety < 5 , and are therefore considered unsafe.
