SINKHOLES and SUBSIDENCE

Karst and Cavernous Rocks in Engineering and Construction

Tony Waltham, Fred Bell
and Martin Culshaw

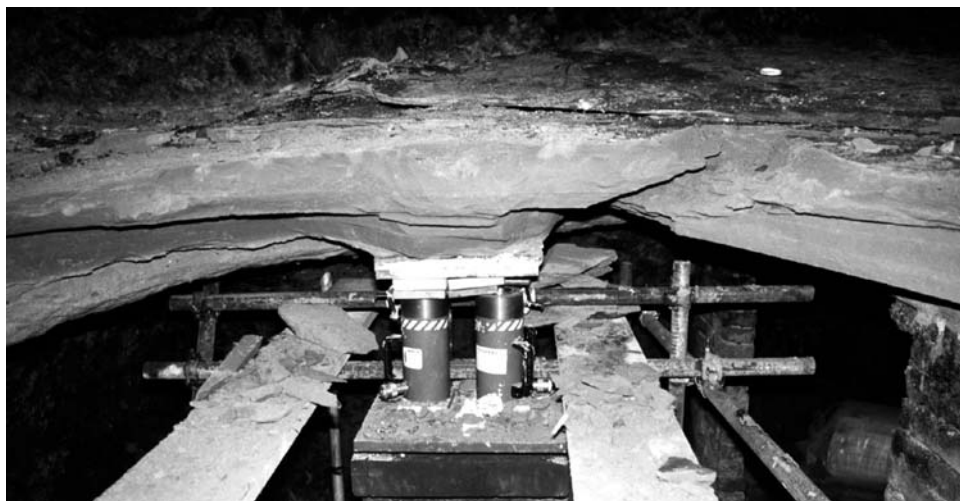
Figure 7.6. Broken rock in a cave roof loaded to failure; a full-scale test (by loading upwards on hydraulic jacks) on homogeneous sandstone in Nottingham, U.K. TW.

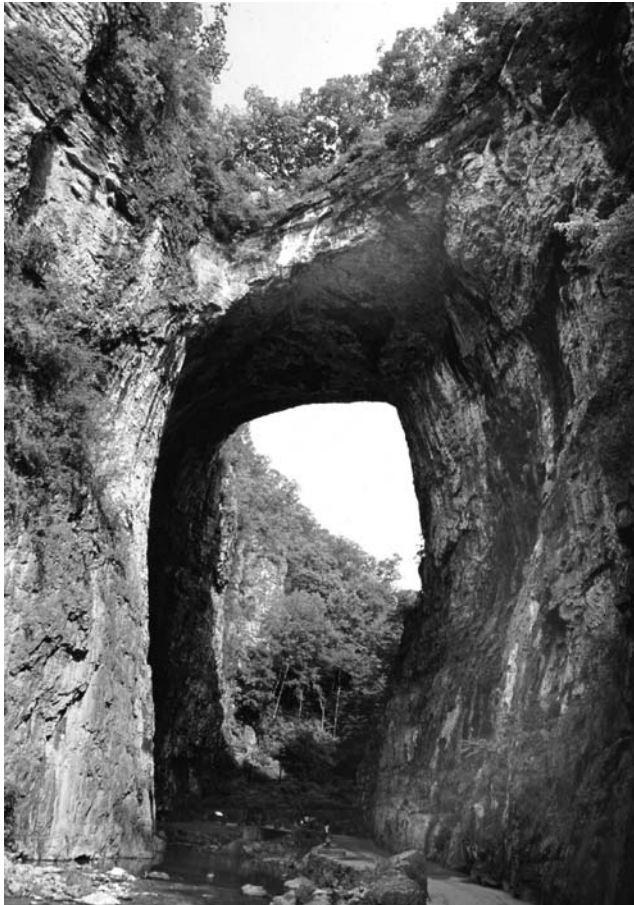
Figure 7.8. Natural Bridge, Virginia, with a road over its thin but stable arch.
TW.

Natural Bridge, in Virginia, is effectively a very short cave that is about 27 m wide with a roof thickness of 14 m ($t/w = 0.5$) of thickly bedded strong limestone (Figure 7.8). It has carried a two-lane highway for a hundred years and shows no sign of distress. A main road in Iceland crosses over the lava tube of Raufarholshellir where it is about 10 m wide under a basalt roof just 4 m thick ($t/w = 0.4$). When the cave was found (from a nearby entrance) long after the road was built, concerns led to checking it for movement and roof breakdown, but none was found over some years of monitoring, and the cave and road are now regarded as stable. In Hungary, the urban sprawl of Budapest includes roads and buildings that stand over some 30 km of known cave, much of which lies at shallow depths and where no collapse has ever been recorded.

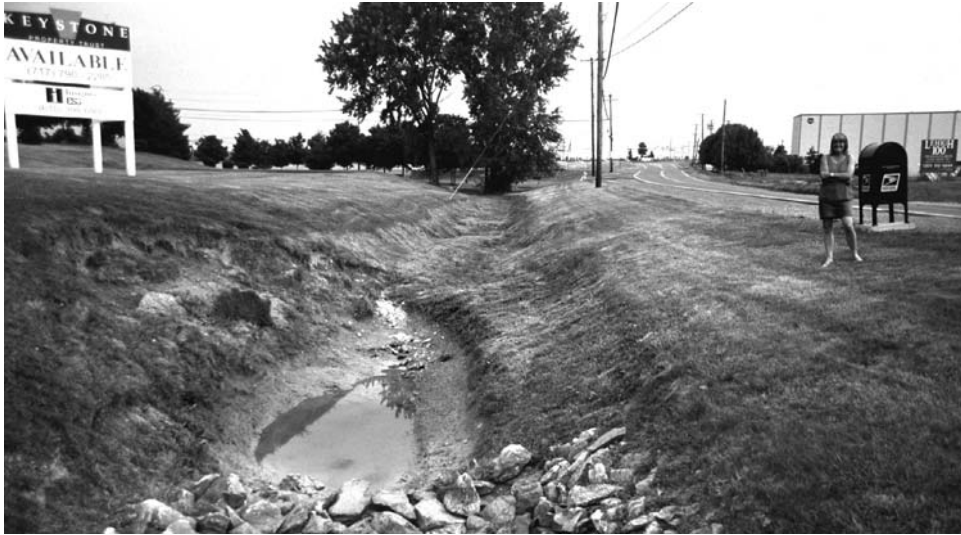
Figure 8.1. Early stages of a sinkhole developing in the untreated soil floor of a ditch beside a Pennsylvanian highway; it is temporarily choked with clay, while the riprap in the foreground was placed to prevent erosion at a culvert outlet.

Unlined drainage ditches are a major source of problems in karst regions, and many develop sinkholes soon after their construction. By their very existence, they concentrate water flow at sites that previously took only direct rainfall infiltration. Run-off from an airport runway in Pennsylvania was fed into an unlined gully that is now broken into a series of large sinkholes (White *et al.*, 1986). Ditches on low gradients are traditionally left unlined along transport corridors. Seepage losses from unlined ditches accounted for 14 out of 54 severe sinkhole collapses along China's railways (many of the others were induced by water table decline; Guo, 1991), and also for 49 out of 72 sinkhole events along Tennessee's highways, where only 4 sinkholes developed along the lined ditches (Moore, 1988). Seepage into any unseen rockhead fissure can carry soil from beneath a ditch floor; by the time surface subsidence is apparent (Figure 8.1) it will require remediation to prevent potentially destructive expansion, when it may then be turned into a stable outlet to bedrock (Chapter 11). Though many unlined ditches do keep sinkhole initiation away from the actual road or railway, concrete-paved ditches can prove cost-effective in sinkhole-prone karst (Moore, 1988).

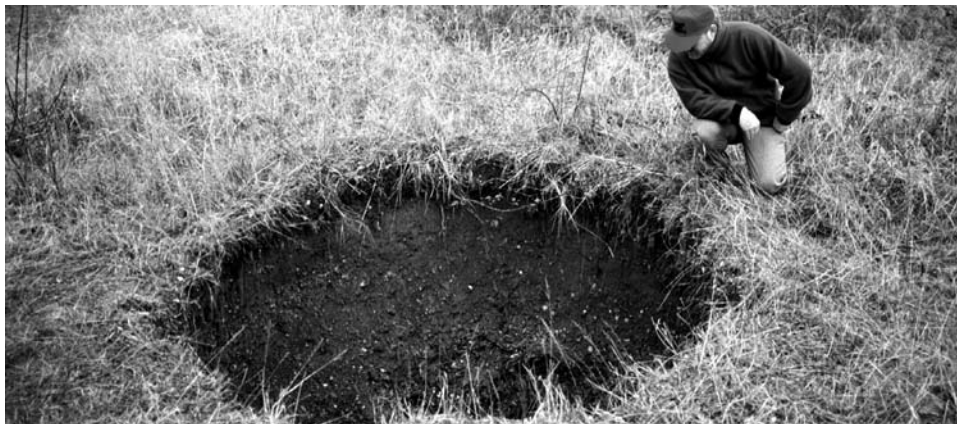
Figure 8.2. One of the cluster of subsidence sinkholes induced by a broken water main on the English chalk downs; there was no surface flow, but the dropouts developed above suffosion points in the soil over bedrock fissures.

A leaking water main is a very effective means of supplying water to a soil and thereby initiating a subsidence sinkhole as both water and soil are lost into bedrock fissures. A mains failure under a rural road on the South Downs, in England, created about 80 dropout sinkholes in adjacent fields within a few hours (McDowell and Poulson, 1996). There was no surface flow, as the water spread through the cover of loose sands and gravels until it found outlets in pipes and fissures within the underlying chalk. Some of the dropout failures occurred within minutes, suggesting that

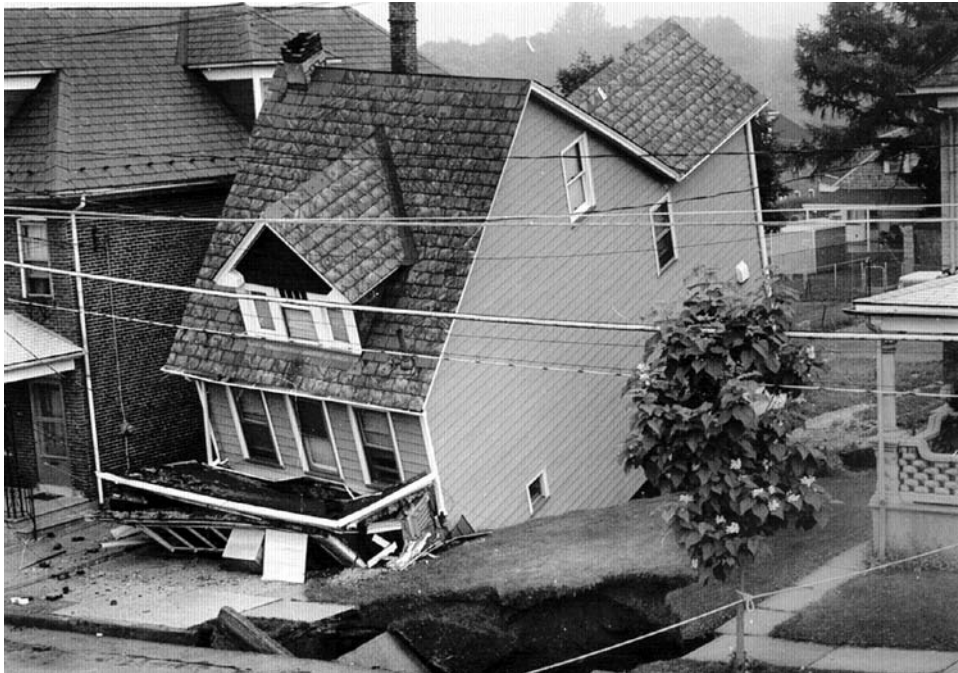
Figure 8.3. Terminal damage to a timber-frame house in Phillipsburg, New Jersey, caused when sinkholes developed underneath it and under the sidewalk after a water main burst beneath the street.

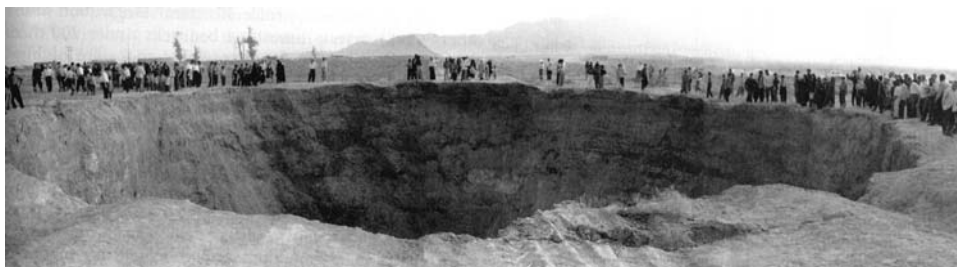
Figure 8.5. The very large subsidence sinkhole that developed in 1998 in irrigated farmland near Ekhtiyarabad, southern Iran.

Land irrigation may be a necessary and planned recharge of water to the soil, but it can have disastrous side-effects where the soil overlies cavernous rockhead. Small subsidence sinkholes are common in ploughed and irrigated farmland in karst regions all round the world, but their economic impacts are generally small, and could not justify stopping the irrigation except in the smallest of sinkhole-prone areas. An unusually large sinkhole opened in a pistachio field that was kept well irrigated in the desert lands just west of Kerman in Iran (Figure 8.5). It formed in alluvial soils more than 40m thick, and though the groundwater pumping was causing steady water table decline, the irrigation recharge onto the surface appears to have been the critical factor in the sinkhole's very rapid collapse (Atapour and Aftabi, 2002). Dissolution of gypsum horizons within the alluvium sequence may have aided growth of large soil cavities, whose dramatic collapse was then marked by

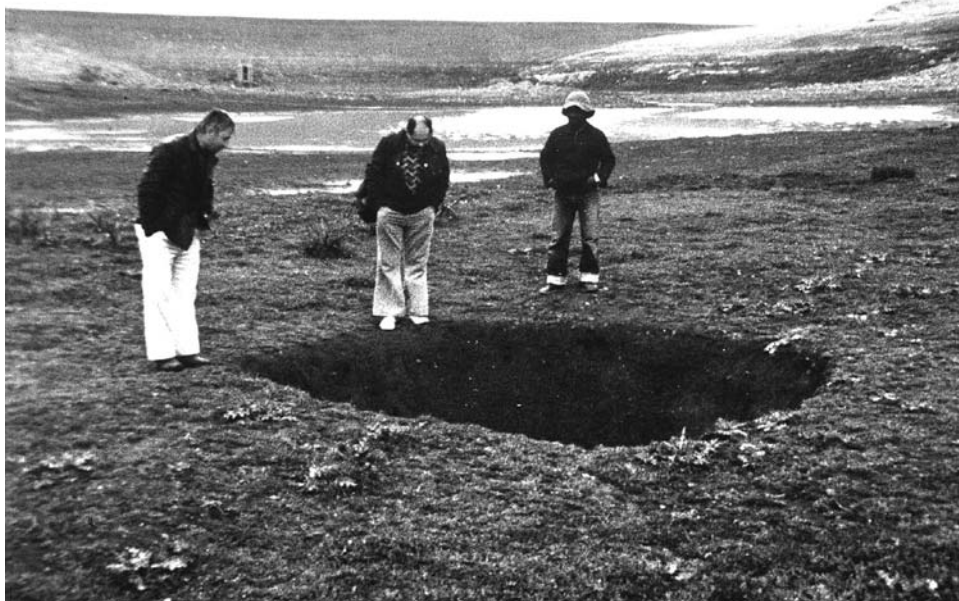
Figure 8.6. The Karrubah sinkhole, in Libya, that formed beneath the waters of the short-lived reservoir impounded by the Marj dam, visible in the distance.

Nearly all these reservoir losses on karst create subsidence sinkholes entirely within the soil profile, but the massive through-flows of escaping water can scour out buried features and expose open solutional voids that reach deep within the bedrock. Shortly after the Al Marj dam was built on karst in the Jabal Akhdar (Green Mountains) of northeastern Libya, its reservoir was filled during a major rain storm. Local people gathered in celebration, only to see a huge whirlpool develop in the middle of their new lake, which was soon completely empty. Sinkholes left on the ex-reservoir floor included a vertical open shaft, down through 1 m of soil and 26 m of limestone to a rubble choke (Figure 8.6). This sinkhole appears to have developed when a previously filled shaft within the bedrock was washed out from below, where the main water flow (from the whirlpool) had entered through a side fissure 20 m down. Collapse of limestone bedrock is rare beneath a reservoir, but some measure of dissolution and subsequent rock collapse must occur during a catastrophic reservoir drainage event that occurs on gypsum.

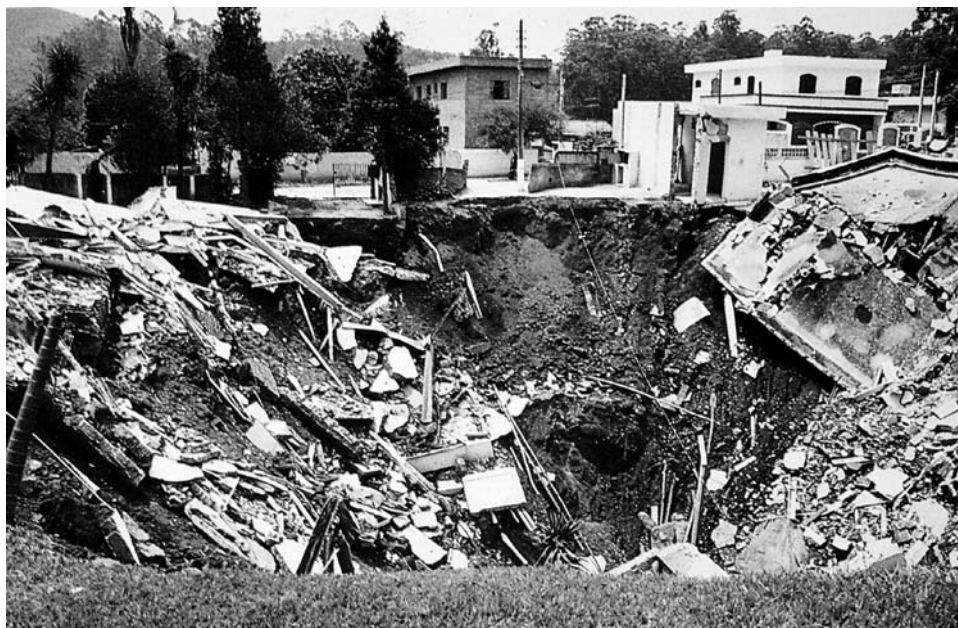
Figure 8.7. Collapse of a house in Cajamar, Brazil, in 1986 over a sinkhole induced in a thick soil cover by excessive groundwater abstraction at a nearby industrial site.

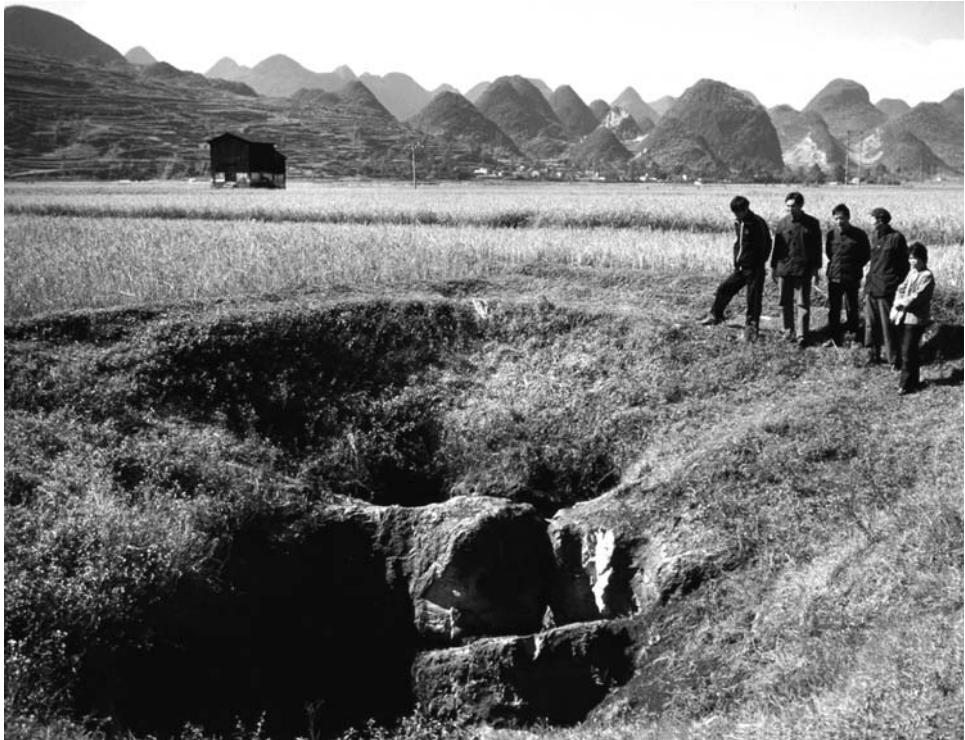
Figure 8.9. A subsidence sinkhole induced by water table decline as groundwater was pumped through the well house visible beyond, in the Shuicheng karst basin, China. The crest of a limestone pinnacle is exposed in the sinkhole only a metre below the original ground level. TW.

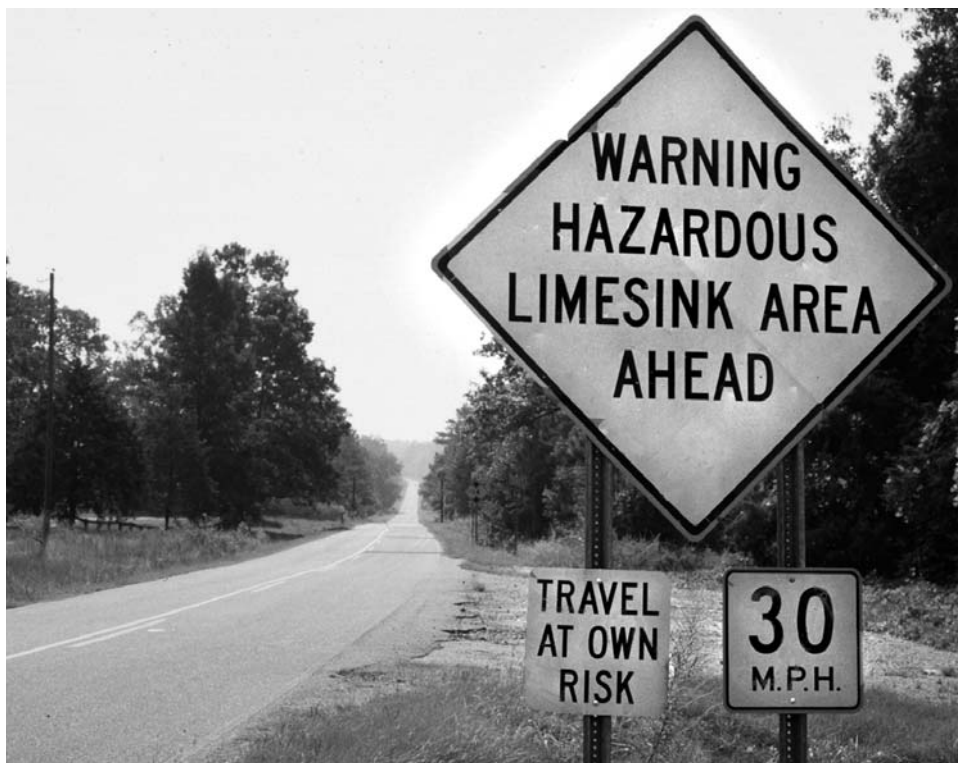
Figure 8.11. Road signs that warn of the ongoing hazard to a road across Alabama's Dry Valley, where sinkholes are induced in the soil by de-watering at a nearby limestone mine. TW.

down and still above rockhead, but the dropout occurred just a few months after a quarry 2 km away commenced working on a new lower level (Sowers, 1996).

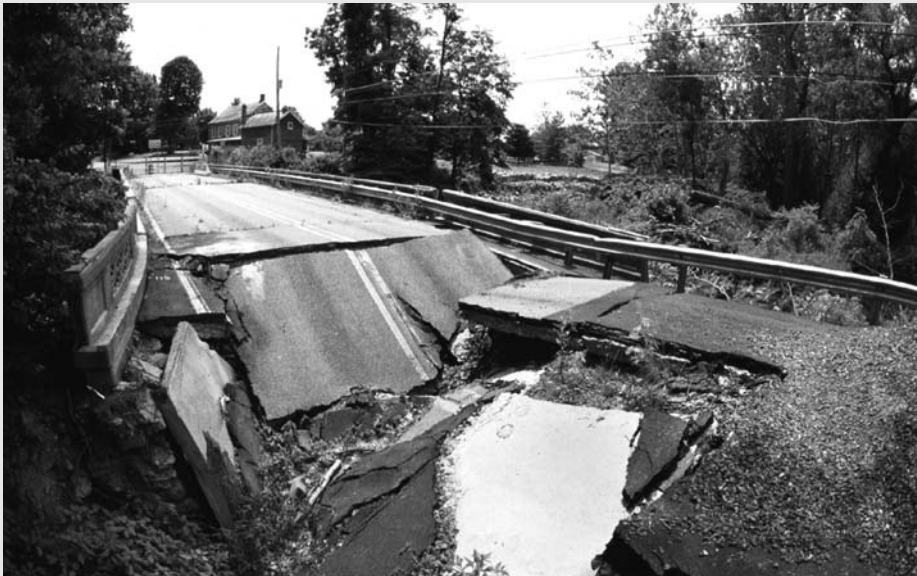
Figure 8.2.2. The bridge that carried Tatamy Road over Bushkill Creek, destroyed by an expanding and ever-changing cluster of sinkholes.
TW.

A nearby limestone quarry stays dry by pumping out water at a mean rate of $2\text{ m}^3/\text{s}$. The quarry floor is about 50 m below the level of the adjacent small river, Bushkill Creek (Figure 8.2.1), which now loses all its water into its bed until it is replenished by the quarry pumping outfall. Water pours out of at least two open cave passages in the quarry wall, and also seeps out along certain bedding planes. A cone of depression (mapped at 5.6 km^2 but probably now larger) created by the pumping has caused a number of sinkholes to appear around the quarry. One sinkhole in the river bed downstream of the quarry diverted a major flow into the far end of the quarry, and was soon sealed, as the quarry pumping was merely re-circulating the same water. The quarry company plans to line about 1,200 m of the river bed to prevent new leakages, but 80 sinkholes have been recorded along 2.5 km of the Bushkill Creek.

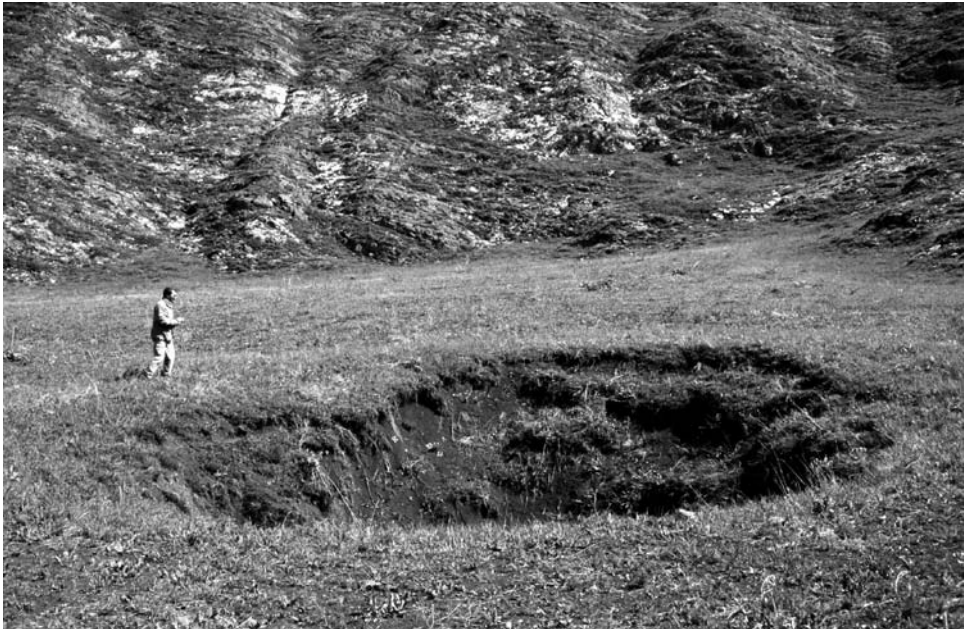
Figure 9.1. New subsidence sinkholes in thick soils are the most widespread hazard in karst terrains, and the likelihood or potential for their development is one of the prime tasks of ground investigations in karst.

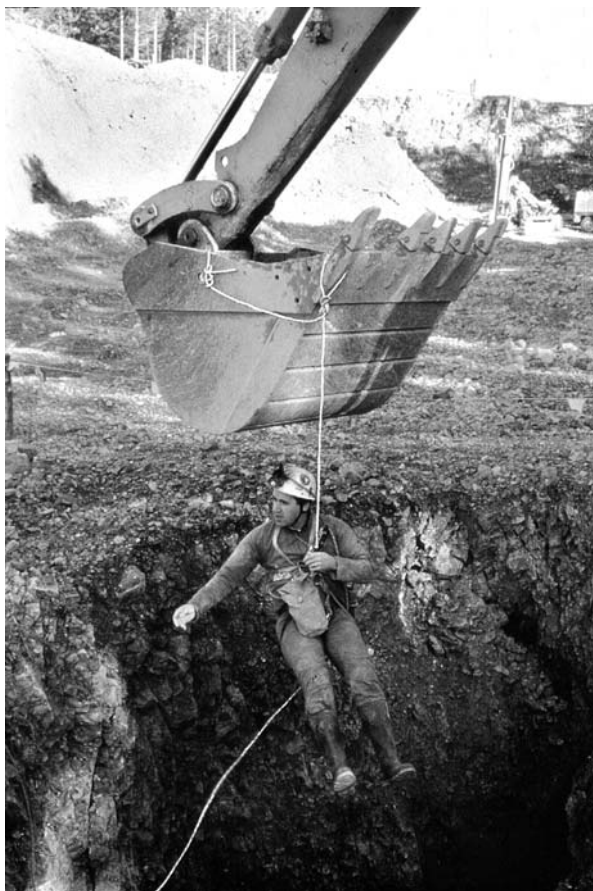
Figure 9.7. Direct exploration: an engineering geologist, who is also an experienced caver, abseils from an excavator bucket into a sinkhole that collapsed into an open cave during road construction in Slovenia.

Among the various methods of direct investigation, there is an extra option that is specific to karst, because its ground voids are commonly large enough to be physically explored by a person. Though cavities in soil may be so unstable that direct entry is unsafe, caves in bedrock limestone may be perfectly safe for exploration by competent cavers, preferably by those with experience in exploration, mapping, geology and engineering (Figure 9.7). Physical examination and mapping are undoubtedly the most cost-effective means of investigating any mature cave passage or cave system that happens to lie beneath a construction site.

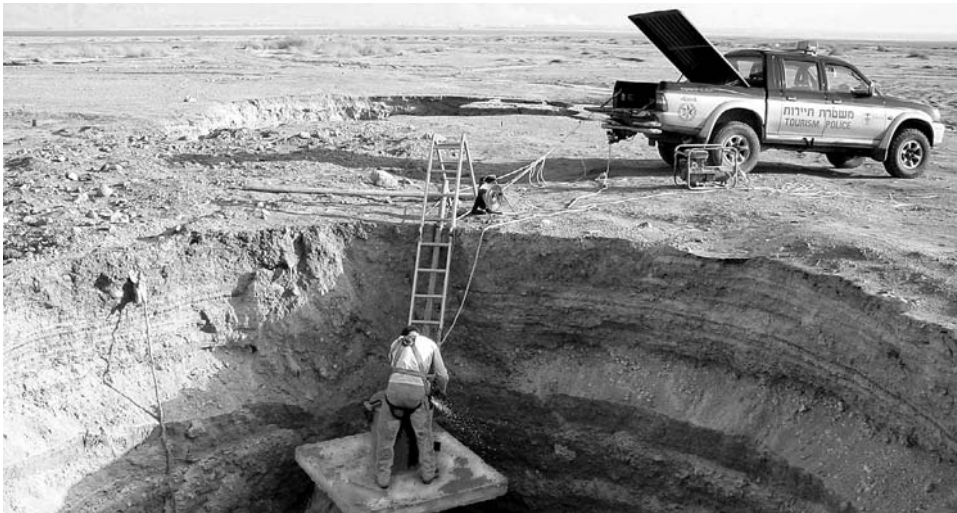
Figure 9.8. A man standing on the collar of a borehole that had dropped into a sinkhole over salt in the Israeli desert near the Dead Sea; though dissolution, cave development and sinkhole formation were already active in the area, the location of this sinkhole was determined by the borehole that was drilled to investigate the subsidence problem.

Rock is only penetrated by rotary drilling. This can produce an intact core inside a bit armoured with diamond or tungsten carbide. Alternatively, probing (or destructive drilling) simply bores a hole without retaining any rock core, and relies on flushed cuttings and penetration rates to interpret the ground conditions. Probing is quicker and cheaper, and is generally adequate for simple cavity searches in karst bedrock, once strata control has been established by a smaller number of cored holes. All rock drilling requires the use of a flushing medium to cool the drill bit and to bring cuttings to the surface. Loss of drilling fluid can be a valuable indicator of sinkholes or caves, especially where the fluid escapes through a narrow fissure that drains into an adjacent cave missed by the borehole. Uncased boreholes can be inspected by means of cameras or echo-sounders, especially where they penetrate a void. Rotary holes that breach an open or water-filled cave may have to be terminated where a steeply inclined cave floor prevents the drill biting in to continue the hole; if deeper exploration is required, it is often cost-effective to drill a second hole. Flush loss does not create a hazard in limestone, as it may only wash loose sediments out of any caves and is unlikely to induce any sinkhole failure. However, care is needed when drilling in salt due to the possibilities of very rapid dissolution, either by the normal water flushes or by chemically aggressive groundwater that is able to flow from another aquifer via the new borehole. Drilling in salt can use a brine flush, and all boreholes in salt and gypsum should be sealed after use; failure to complete the latter may lead to new sinkhole development shortly afterwards (Figure 9.8).

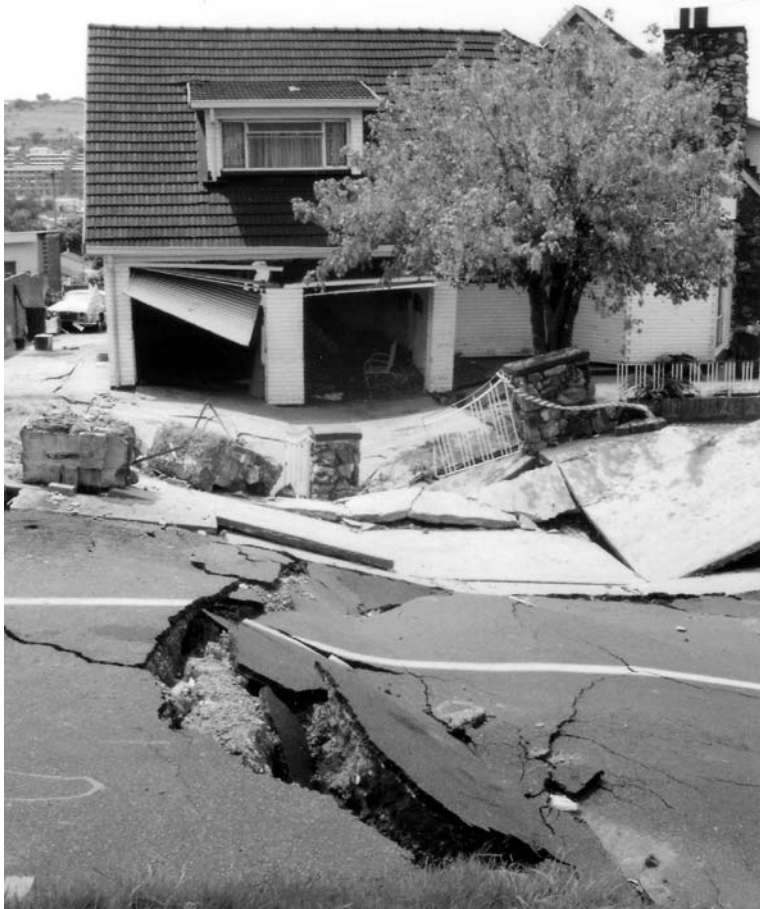
Figure 10.8. A house and road destroyed by sinkhole development in Centurion, South Africa, during a period of water table decline within the underlying dolomite aquifer; major costs will have to be borne, wholly or partly, by the home owner, his insurance company, the highways authority and perhaps by whoever was responsible for the groundwater abstraction. Photo: Fred Bell.

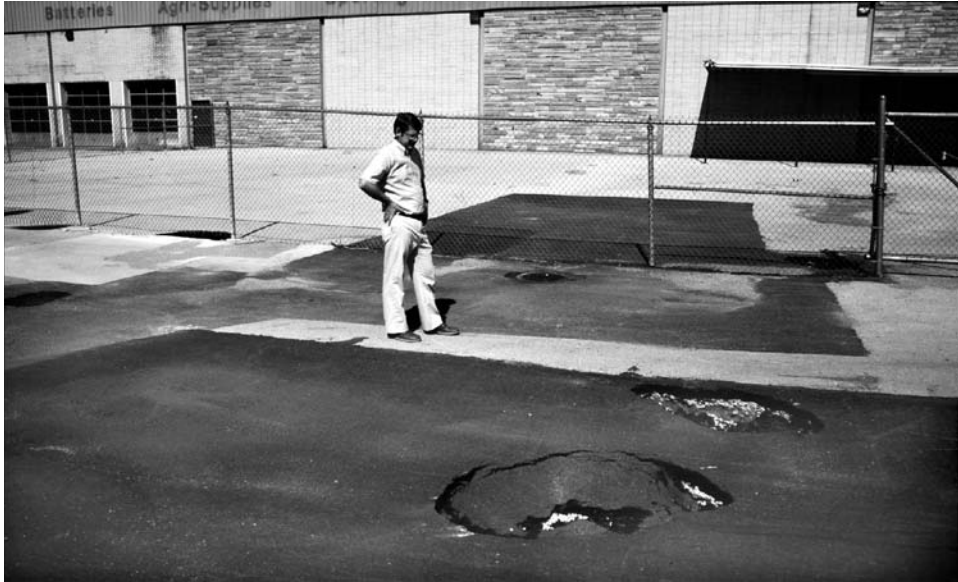
Figure 11.4. A small sinkhole that has been repeatedly filled, without proper treatment, under a much-patched parking lot in Bowling Green, Kentucky.
TW.

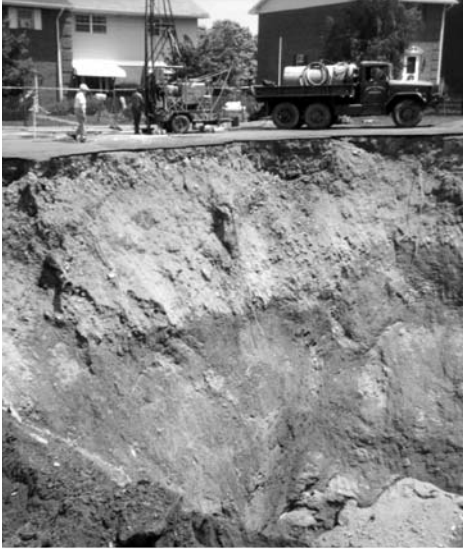
Figure 11.7. The unstable sides of the Macungie sinkhole, in Pennsylvania, below an investigation drill-rig that found rock head at a depth of 30 m.
Photo: Percy Dougherty.

More successful, and only marginally smaller, was the repair of a caprock sinkhole under a road in the town of Macungie, also in Pennsylvania (Dougherty and Perlow, 1988). This sinkhole opened up to 26 m across and 13 m deep, though the karstic dolomite is 30 m down beneath its cover of shale and soils (Figure 11.7). It occupied the site of a large sinkhole containing a pond, which had been filled with mixed soil and rubbish, and then forgotten, when it was in farmland about 20 years before the road and houses were built over it. The repair was based on experience at the nearby Saucon Valley sinkhole (which had occurred 30 months previously, and at the time had its first repair intact). The throat was choked with 800 m³ of large dolomite boulders (up to 1 m in size) tied with a lean-mix concrete (Figure 11.8), though the bedrock fissures could not be exposed because adjacent apartment blocks prevented any deeper or wider excavation of the unstable hole (Figure 11.9). This conical plug was capped with a reinforced concrete slab 900 mm thick (Figure 11.10), before soil was placed to restore grade. The replaced road remains stable today, with only the slightest of settlement – which can be ascribed to compaction of the soil fill.

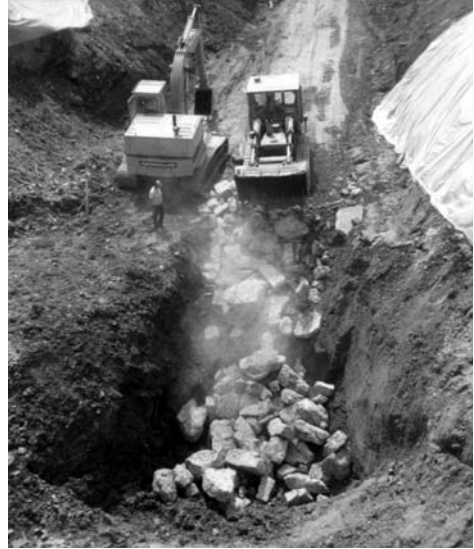
Figure 11.8. Chunk rock being placed at the lowest exposed point in the Macungie sinkhole.
Photo: Percy Dougherty.

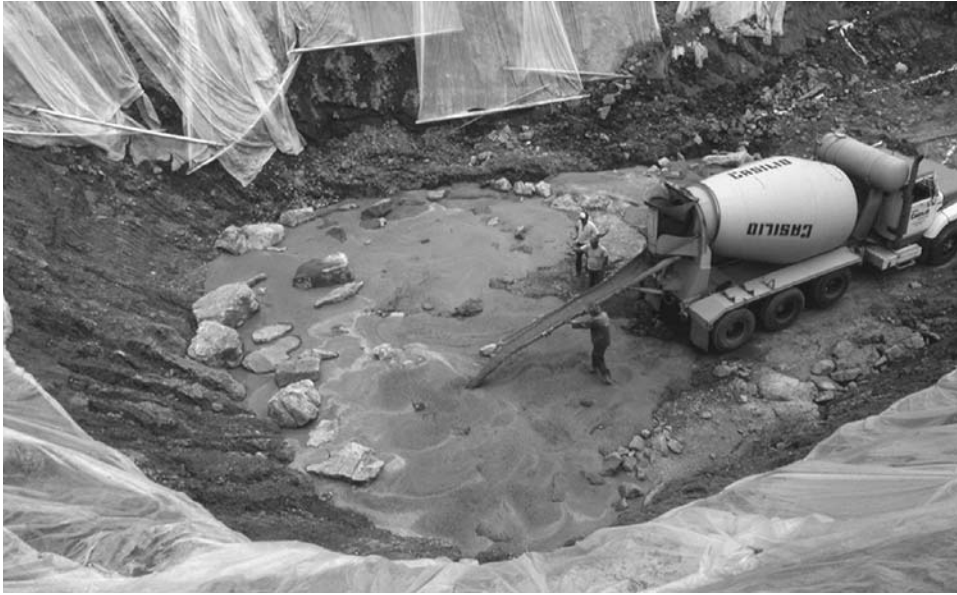
Figure 11.10. Pouring the last of the concrete into the plug of chunk rock in the Macungie sinkhole, before rebar was laid as reinforcement to a cast concrete cap.

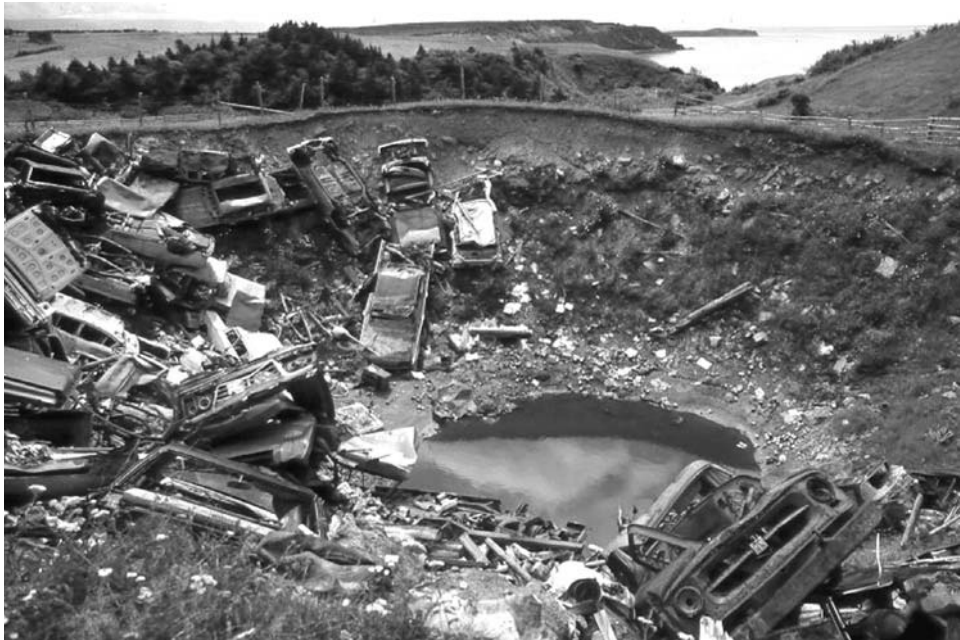
Figure 11.12. Uncontrolled landfill in a small subsidence sinkhole in the covered karst of Newfoundland, Canada.

numerous sinkholes around the world are filled with uncontrolled waste of all kinds (Figure 11.12). Under any attempt at control, engineered liners would prove excessively uneconomical in most sinkholes, if they were intended to achieve long-term stability. Even if a liner could be installed in a sinkhole, leachate drainage is impossible without expensive maintained pumping.

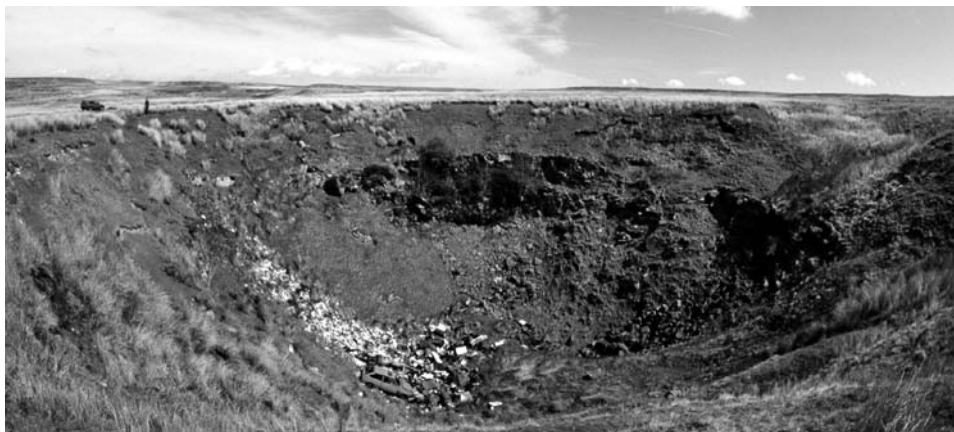
Figure 11.13. Fly-tipping of waste in a deep caprock sinkhole that is conveniently adjacent to a moorland road across the Llangattwg interstratal karst, U.K.
TW.

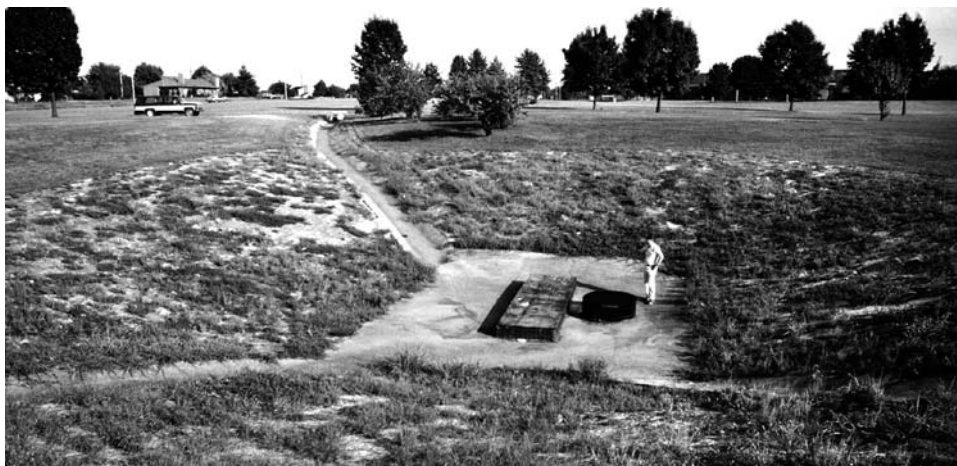
Figure 12.1. A shallow sinkhole in Bowling Green, Kentucky, engineered to take storm-water drainage from an urban area directly into an underlying limestone cave without eroding the soil cover.

In most terrains of polygonal karst, storm drainage cannot be completely removed, and it must be directed into available sink points within the natural sinkholes. Selected sinkholes can be engineered to behave as retention ponds (Figure 12.1), as topography generally limits the scope for built retention ponds. These and all other sinkholes may require engineering of their internal sinks so that they become efficient disposal wells that transfer drainage directly to the karst conduits; they must avoid imposing flows through the soil cover that could promote development of new subsidence sinkholes (Figure 8.4). Failure to maintain the drainage outlet can allow frequent flooding of the sinkhole, which may be acceptable in agricultural land or in car parks (Figure 12.4) but cannot be tolerated where buildings are placed.

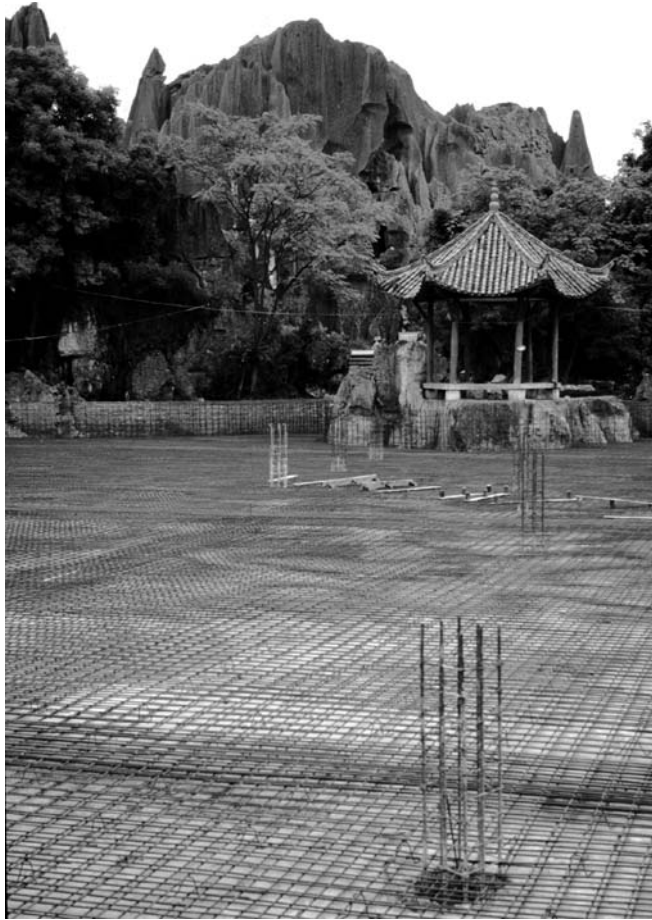
Figure 12.2. Double weldmesh reinforcement for a concrete slab, cast as foundations for an ornamental lake with a bridge and pagoda, on deep soils over pinnacle karst at Shilin, southern China.

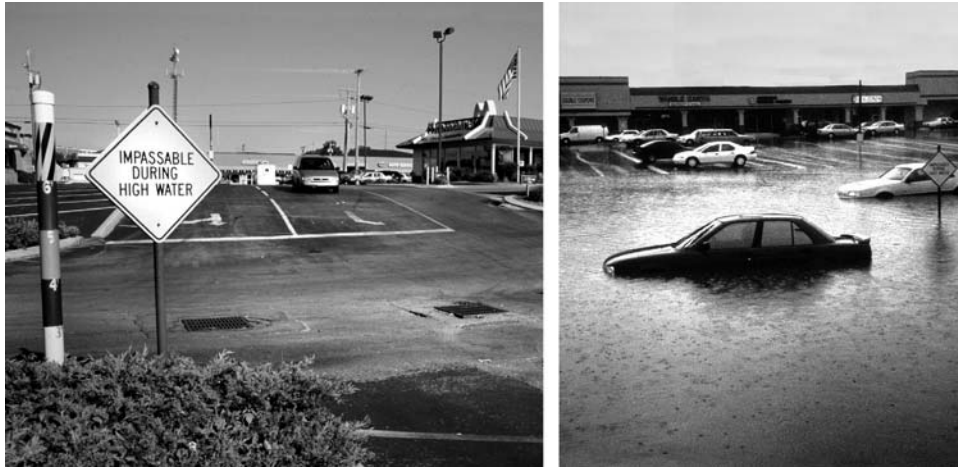
Figure 12.4. A shallow sinkhole within a car park in Bowling Green, Kentucky; drains within the road surface carry storm water directly into the limestone, but their limited capacity makes flooding inevitable after heavy rainstorms.

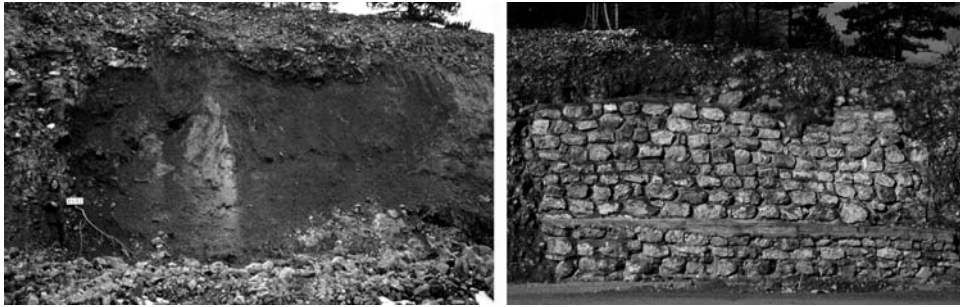
Figure 12.6. A sediment-filled cave in the wall of a road cutting in Slovenia, seen when it was first exposed and later with a masonry wall across its sediment fill.

1997; Knez and Slabe, 2002b). Caves exposed in the sides of road cuttings were walled up to avoid rock fall (Figure 12.6).

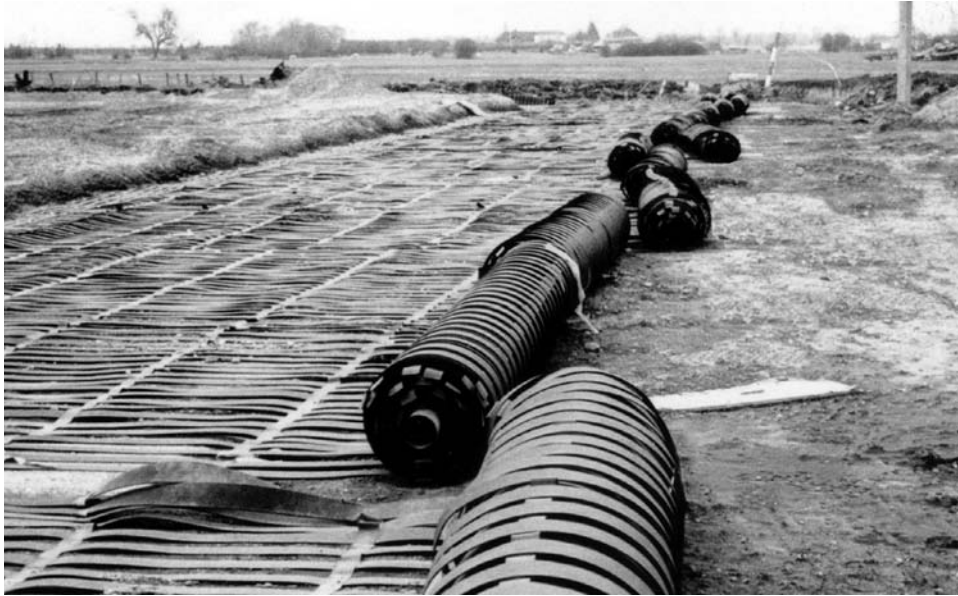
Figure 12.7. Heavy paralink geogrid being rolled out onto a road sub-base as a protection measure against sinkhole development in the underlying soil.
TW.

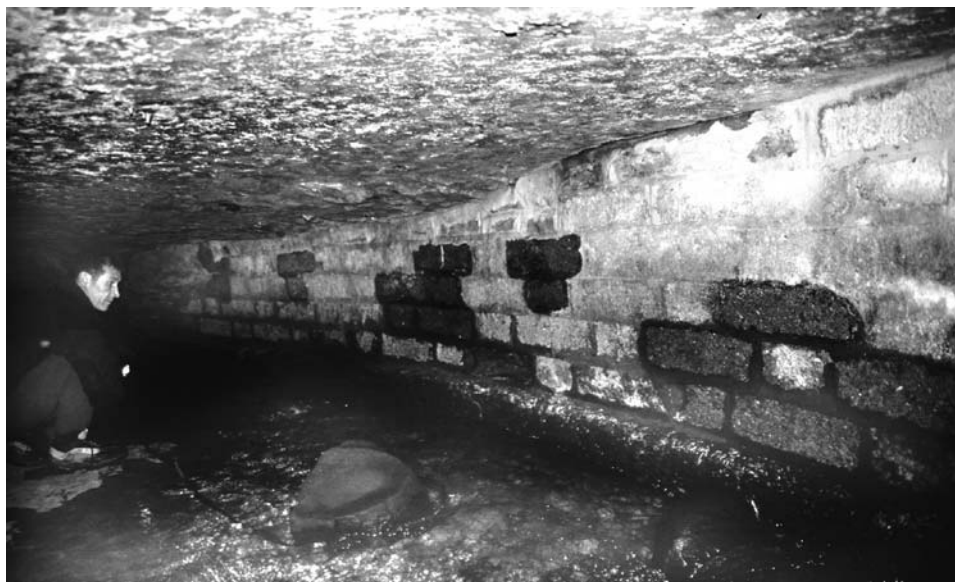
Figure 12.13. A masonry wall built beside the underground stream inside the St. Augustine's Cave in Ireland in order to reduce the unsupported span beneath a main road that stands on a concrete slab.

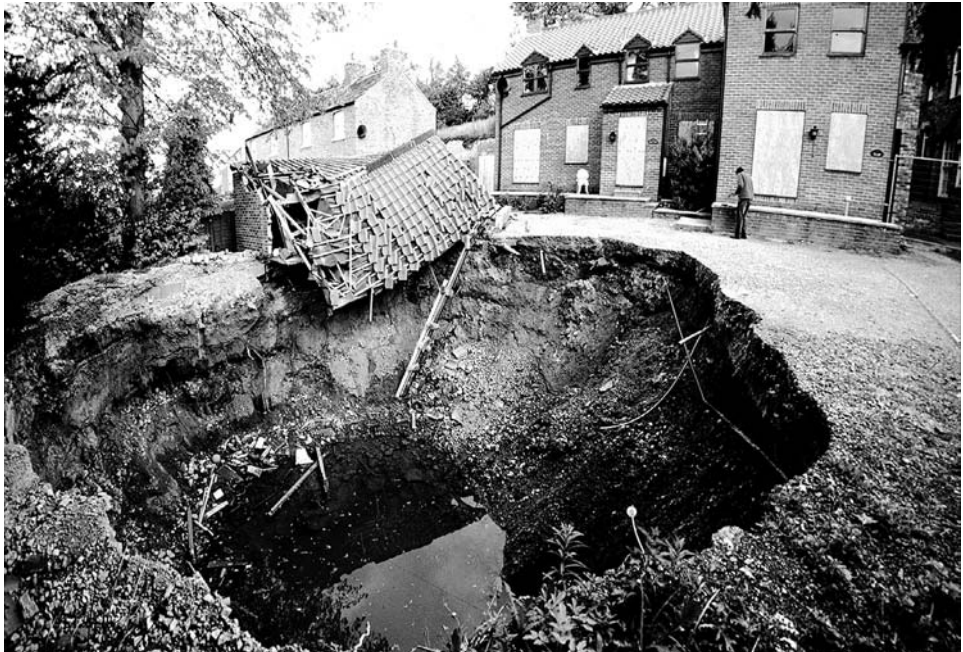
Figure 13.1.1. The open sinkhole that collapsed in front of the house on Ure Bank Terrace, Ripon.
TW.

On Wednesday 23rd April 1997, a large and sudden sinkhole subsidence occurred immediately in front of Field View, a house on Ure Bank Terrace, in the small Yorkshire town of Ripon, U.K. Overnight this hole continued to grow, thereby demolishing two garages, leaving a crater 10.7 m across and 6.2 m deep, and threatening the house that had already sustained minor damage (Figure 13.1.1). The adjacent local road was closed, and photographs of the subsidence appeared on television and in the newspapers. It was the latest collapse on a site that had been subsiding since at least 1856, when the Ordnance Survey map showed a pond at that location (Cooper, 1986). An earlier smaller collapse (subsequently filled in) had already demolished two garages, and it was estimated that the total vertical amount of collapse (ignoring minor subsidence) had been about 21 m over the previous 30 years and at least 24 m in the past 150 years (Cooper, 1999). The site

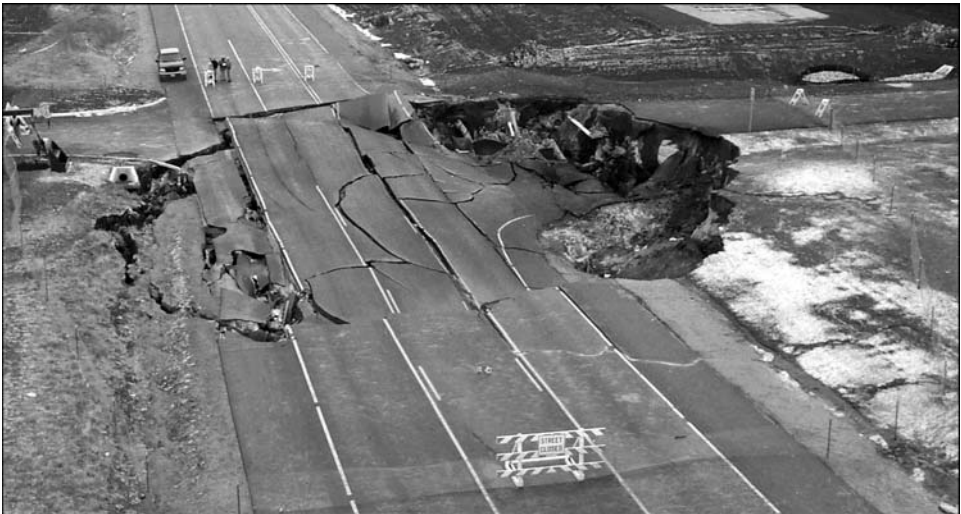
Figure 13.2.1. Aerial view of the collapse sinkhole in Dishman Lane, Bowling Green, seen looking towards the south-east

On a cold afternoon in February 2002, in the southern part of Bowling Green, Kentucky, rush hour traffic on Dishman Lane halted abruptly. A sinkhole 60 m across suddenly collapsed, dropping the road by 5 m. No-one was injured, but four cars were stranded on the subsided road. The cause was a catastrophic collapse of the main passage of State Trooper Cave (Figure 13.2.1), and the subsequent repairs to the road took nine months at a cost of a million dollars.

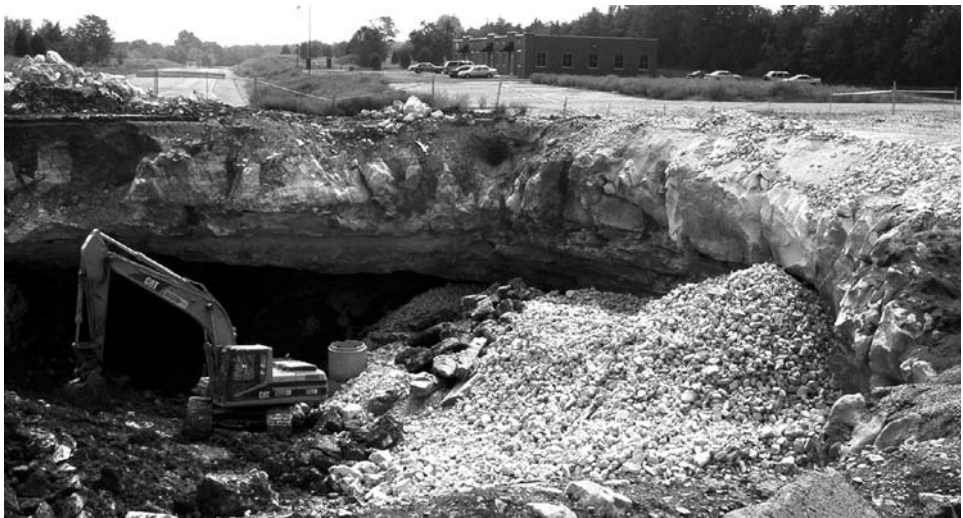
Figure 13.2.4. The edge of the collapse zone under Dishman Lane, showing the deeply fissured limestone rockhead beneath the red clay soil cover.

The ceiling of the downstream passage could not be seen as the new debris pile sealed off that part of the cave. The roof of the upstream cave passage appeared to be intact, with about 7 m of overburden rock and soil (Figure 13.2.4), and the room's southwestern wall appeared to be the stable original, rather than a freshly broken new surface. The entire rim of the new hole in the cave roof appeared to be along fresh breaks, as did all of the new breakdown blocks that lay over the old debris pile. Some of the new breakdown was coated with soil and sediment from above.

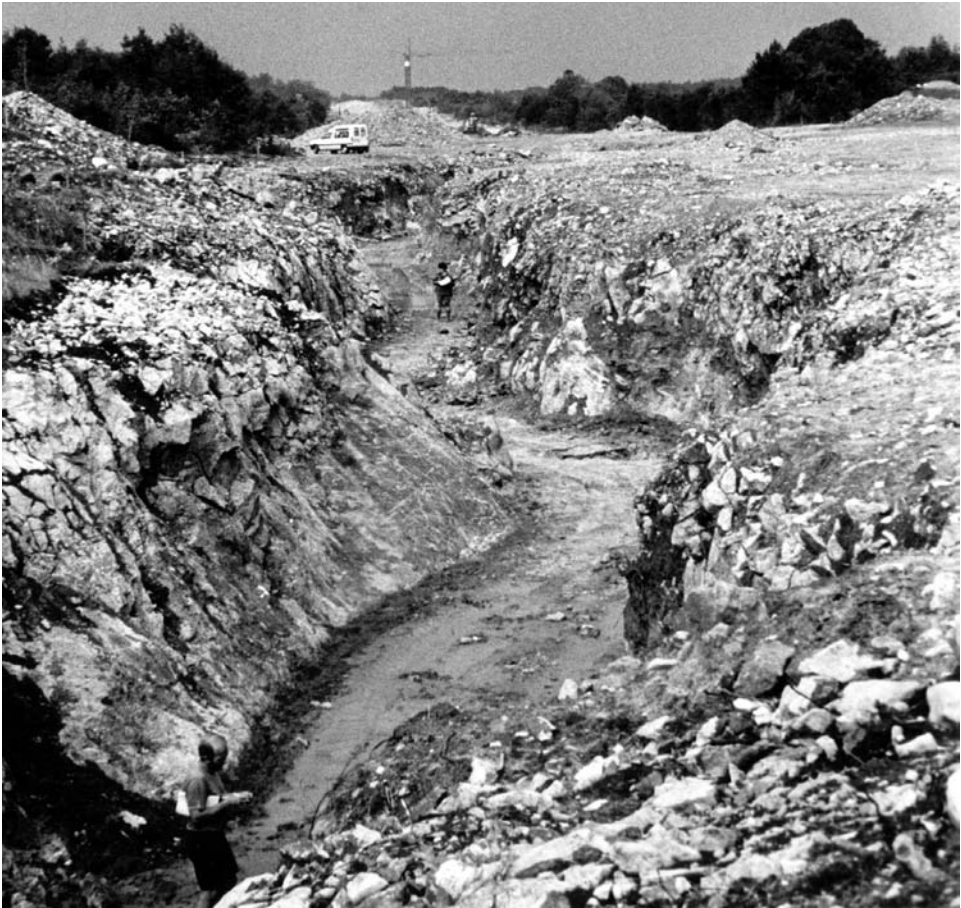
Figure 13.3.2. Large unroofed cave passage that lay parallel to the karst surface, near Divača, seen after its sediment has been removed in preparation for road construction.

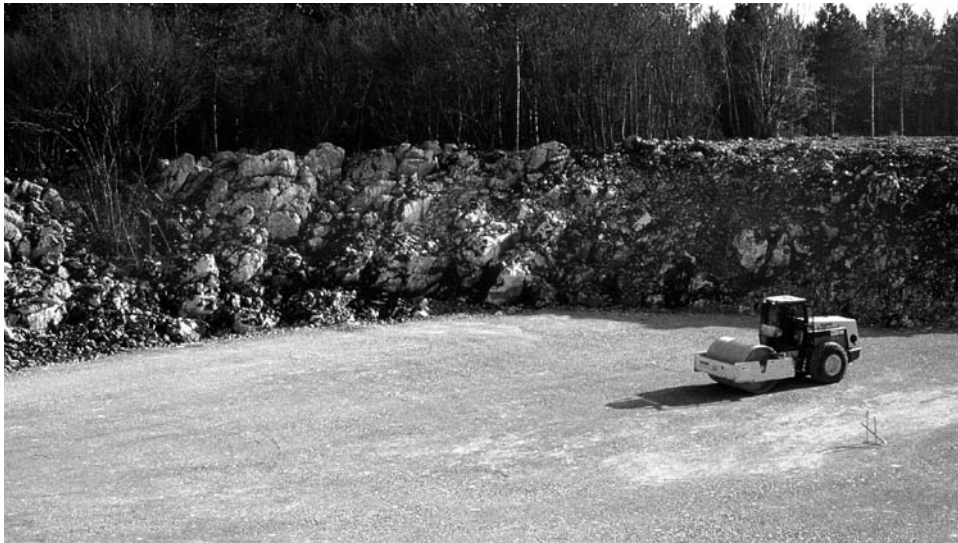
Figure 13.3.3. Compacting a graded fill placed inside a large sinkhole that had previously been filled with loose soil, near Divača.

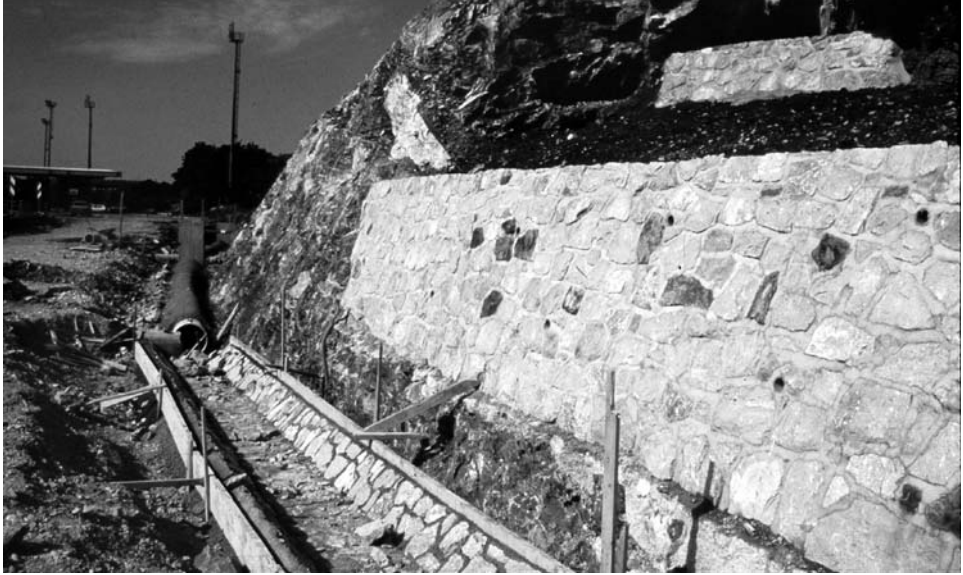
Figure 13.3.5. Construction of an impermeable roadbed through a cutting where a breached cave has been walled off, along a motorway to Italy.
