SINKHOLES and SUBSIDENCE

Karst and Cavernous Rocks in Engineering and Construction

Tony Waltham, Fred Bell
and Martin Culshaw

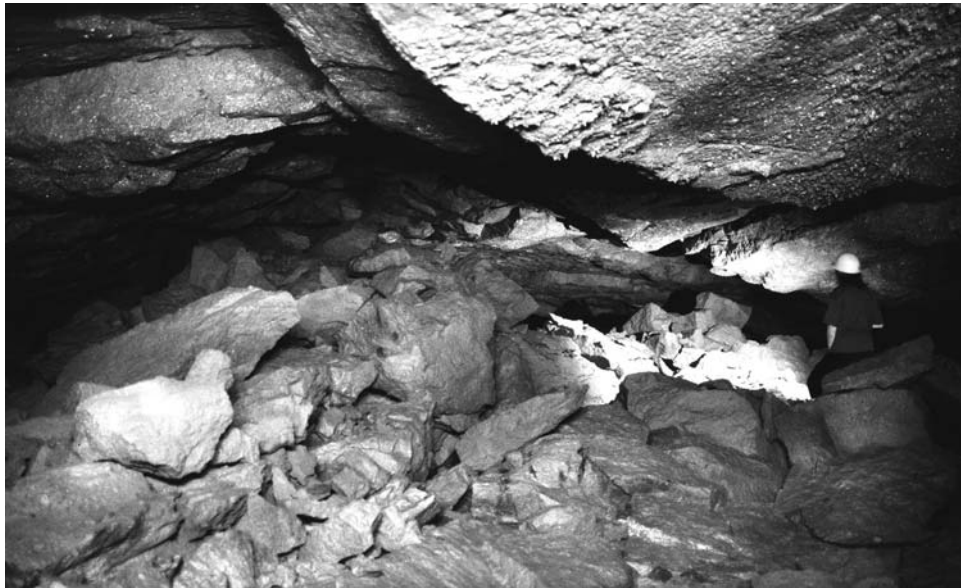
Figure 13.4.3. The collapse zone down-flow of the road, with part of the original tube roof surviving on the right.
TW.

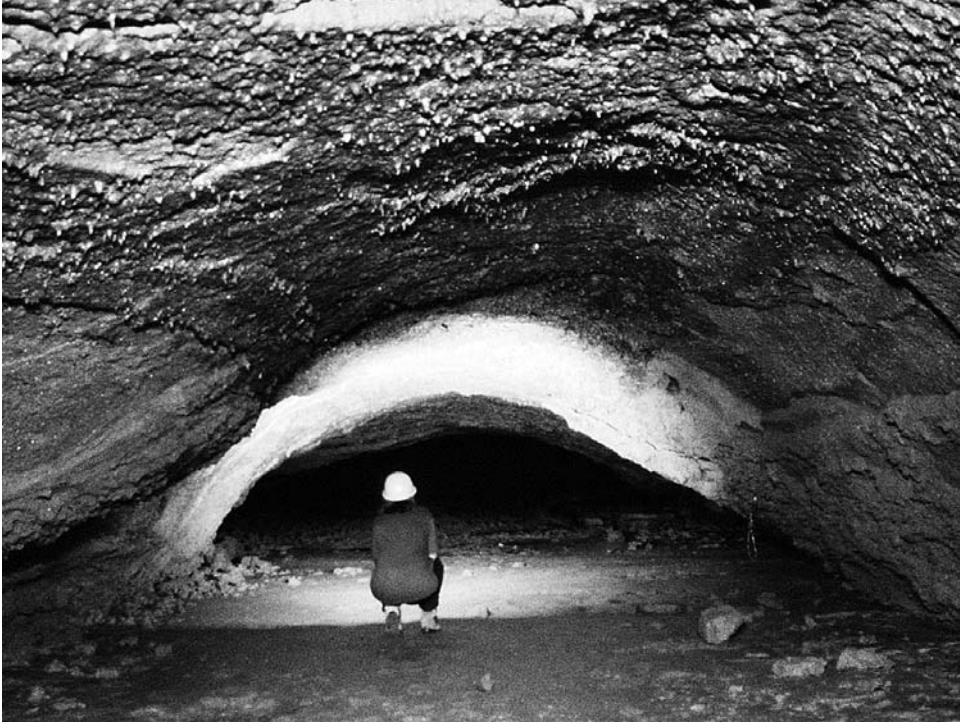
Figure 13.4.4. The stable arch roof in sound basalt where the Sung Gul lava tube lies directly beneath the main road.
TW.

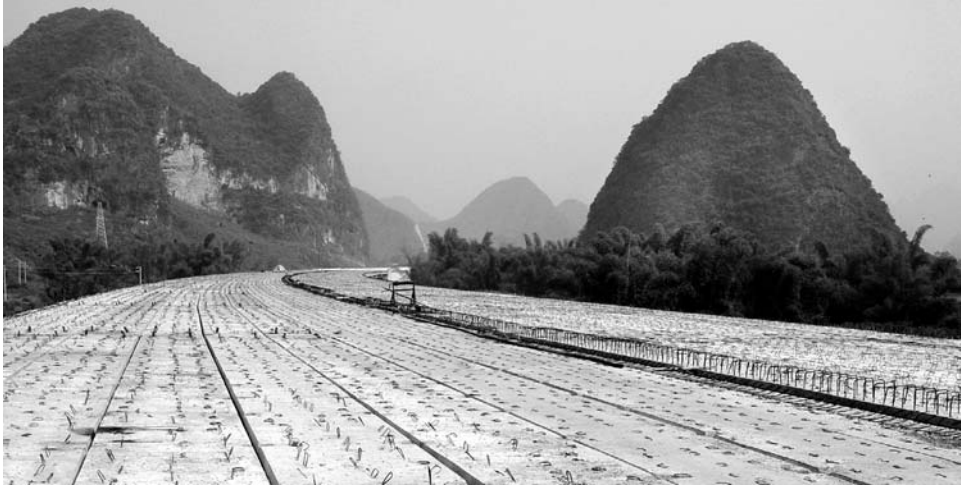
Figure 13.5.1. The deck of a long viaduct with piled piers carrying the Shui-Nan Highway over difficult karst ground between steep conical hills in the fengcong karst.
Photo: Mingtang Lei.

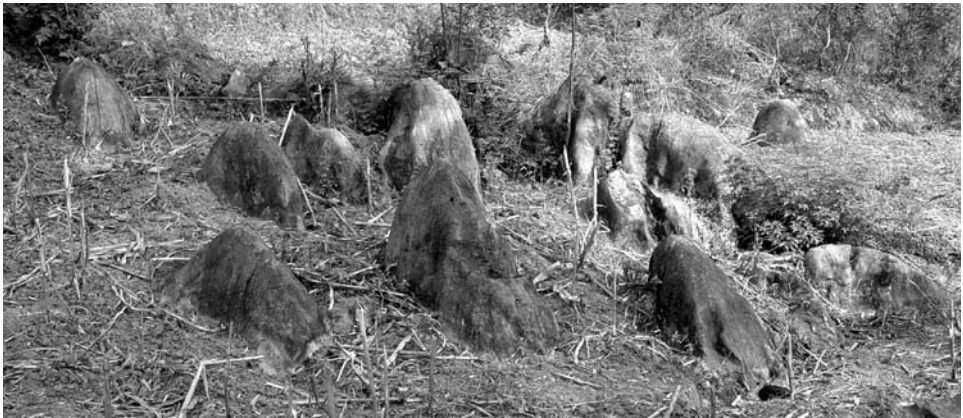
Figure 13.5.2. Stone teeth – the tops of bedrock pinnacles projecting through the soil cover – are widespread in the Disu karst of Guangxi.
Photo: Mingtang Lei.

An important section of the new road from Chongqing south to Zhanjiang, is the Shui-Nan Highway, between Hechi and Nanning (both in Guangxi). Its total length is 236 km, and this includes more than 10 km through a karst valley within the catchment of the famous Disu underground river system. This is a basin of mature karst with numerous well-developed stream sinks, large solutional dolines, open shafts, sinkholes of all types and dry valleys. Potential karst collapse (by development of new sinkholes) creates a serious risk to the highway construction. Consequently, measures to prevent collapses have been incorporated during construction of the 10 km of highway at greatest risk. This section of the Shui-Nan Highway site lies along a valley whose floor width is generally only 300–1,200 m, with tall conical hills of mature fengcong karst on each side (Figure 13.5.1). Karst features developed within the limestone of the road corridor include solution sinkholes, collapse sinkholes, dry and blind valleys, open fissures, open shafts, flooded shafts (cenotes) and stream sinks (ponors). The valley floor is distinguished by a karst rockhead that is deeply fretted between tall pinnacles, some of which project through the soil surface as stone teeth (Figure 13.5.2). The extensive cover of alluvial soils contains numerous subsidence sinkholes.

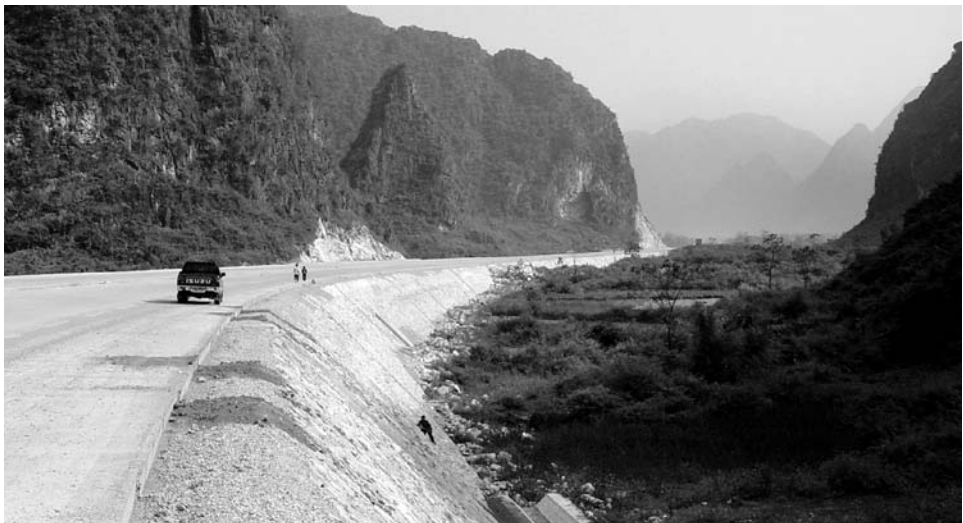
Figure 13.5.3. A rock fill embankment that required considerable ground treatment to carry the Shui-Nan Highway through the Disu karst.

Rock filling was selected as the main subgrade type for the sections of the highway over karst (Figure 13.5.3). After excavating the soils, fissures and depres-

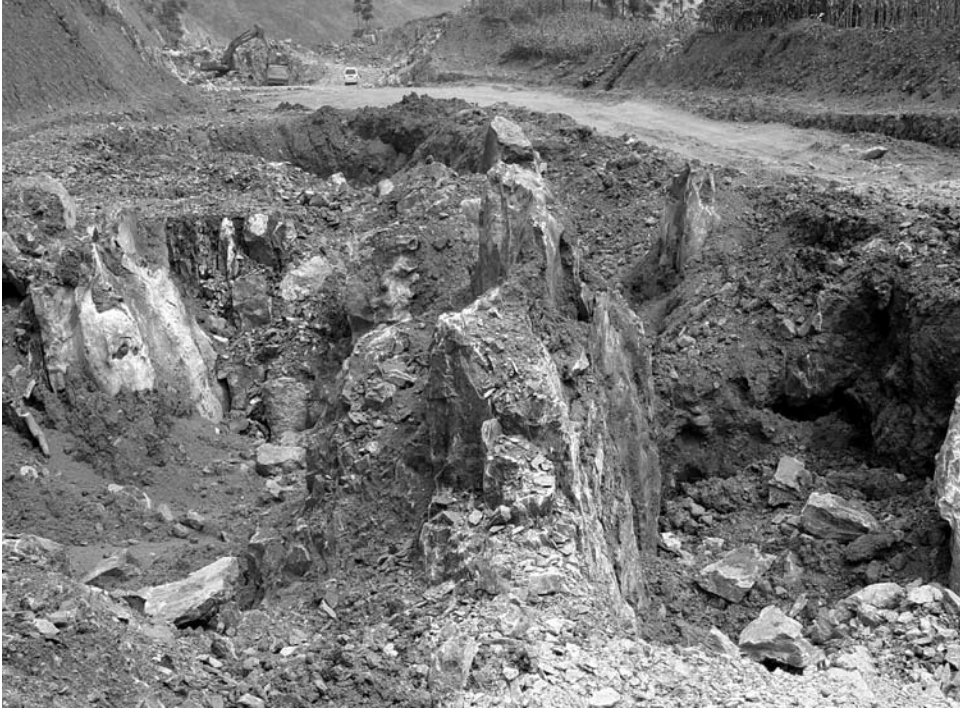
Figure 13.5.5. Excavating the soil fill from fissures and hollows between elongate, bladed pinnacles in the karst rockhead, before building the Shui-Nan Highway.

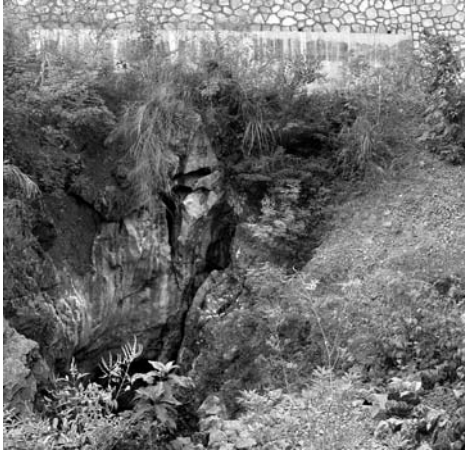
Figure 13.5.6. A concrete slab spanning wide and deep fissures in exposed limestone, with hand-placed stone facing on the road embankment above.

Where soil thickness is less than 3 m and karst fissures are commonly wider than 1 m, the soil is first cleaned out from all the fissures and hollows between the bedrock pinnacles (Figure 13.5.5), and the spaces are backfilled up to the main rockhead level, using coarse rubble with grain size decreasing gradually upwards. A raft of reinforced concrete 1 m thick is then placed across the pinnacles and the intervening fill (Figure 13.5.4(c)), and fill is placed over the raft to reach roadbed level (Figure 13.5.6).

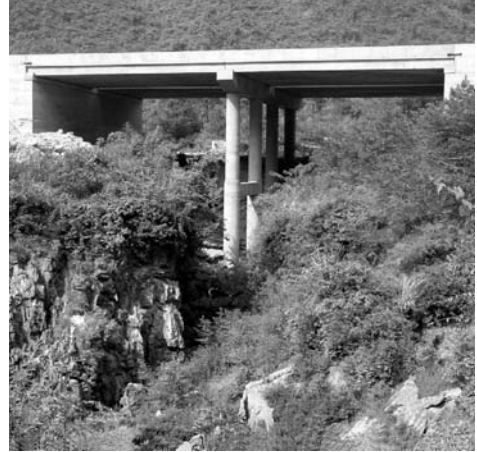
Figure 13.5.7. Piers stand on piles founded on sound bedrock to carry the Shui-Nan Highway over a section of difficult karst ground.

Where soil thickness is less than 3 m over a very complex rockhead consisting of wide fissures between pinnacles commonly taller than 10 m, bridges with piled foundations set onto sound bedrock are used to span the karstic openings (Figure 13.5.7). Such conditions have required construction of a number of long low viaducts in place of rock-fill embankments (Figure 13.5.1).

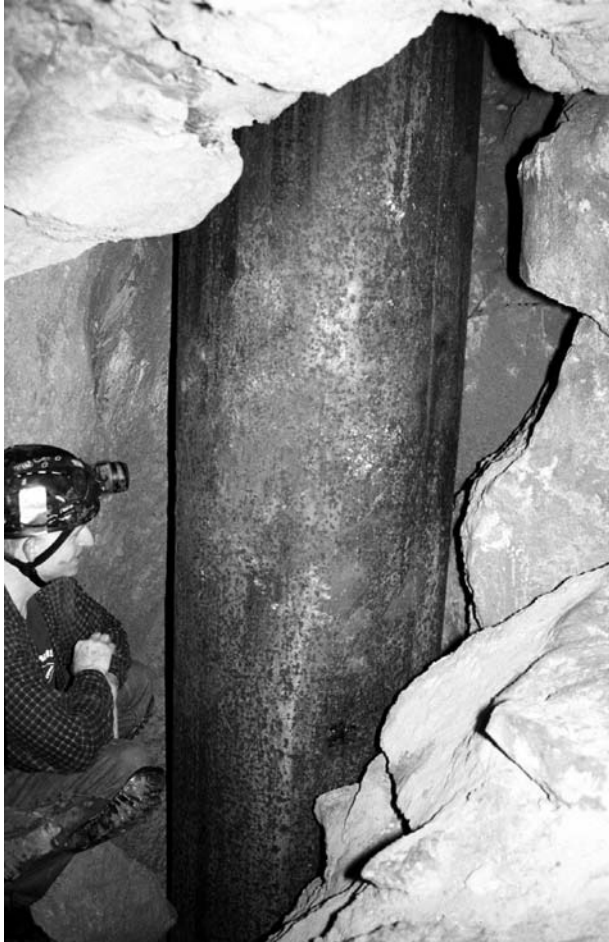
Figure 13.6.4. A caisson that supports the Courthouse in Huntsville, passing through the major zone of karstic breakdown along the northern side of Big Spring Cave. TW.

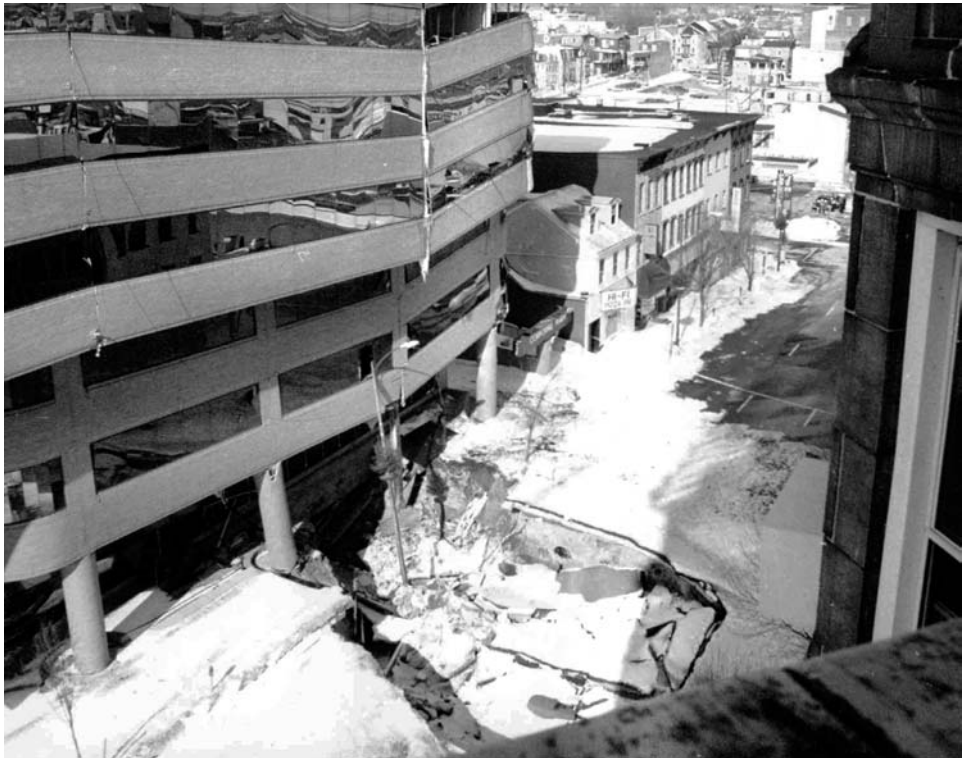
Figure 13.7.1. The newly collapsed sinkhole in Seventh Street, with the conspicuous sag in the Corporate Plaza building above it.

In February 1994, the redevelopment efforts of the City of Allentown came to an abrupt halt when a large sinkhole opened in Seventh Street and undermined the Corporate Plaza office building and an adjacent multi-story car park. Corporate Plaza, the crown jewel of downtown revitalisation, was a seven-story, modern office building with over 10,000m² of office space occupied by over 400 employees. The building was a complete loss, resulting in an insurance claim of \$8 million and several legal actions (Figure 13.7.1).

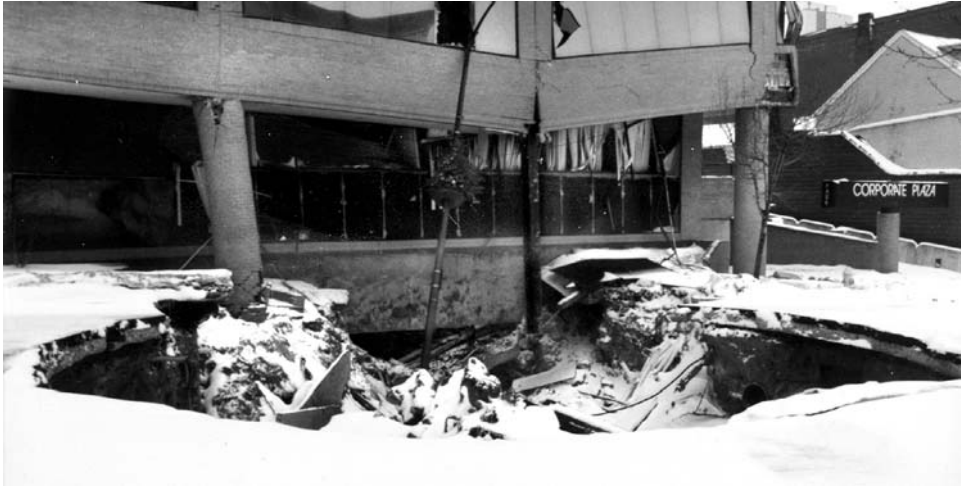
Figure 13.7.3. The Seventh Street facade of Corporate Plaza damaged by the collapsing sinkhole. The column on the left is damaged over its subsided column base, exposed except for a thin cover of snow and debris. The column in the centre has its steel stanchion hanging from the building's frame after all its footing has dropped into the sinkhole and its brick cladding has fallen away. The corner column, on the right is almost undisturbed. Photo: Percy Dougherty.

The mid-street sinkhole continued to enlarge, so that it extended beneath the supports of the Corporate Plaza building, causing extensive damage to its Seventh Street facade. By daybreak the sinkhole was 5 m deep and 15 m across (Figure 13.7.2). One of the support columns for the building was undermined and a V-shaped bow had developed in the lower floors of the building facade. By noon, three columns along the Seventh Street frontage were engulfed by the sinkhole. Each of these had stood on spread footers that had been totally undermined; the brickwork columns had disintegrated and the internal steel stanchions were left suspended from the building's frame (Figure 13.7.3). In addition, the northwestern corner of the building sagged 3 m into a second sinkhole, which also damaged an adjacent multi-story car park (Figure 13.7.4). Damage was so extensive that the City of Allentown forced the evacuation of the Corporate Plaza and issued a demolition order. The entire building was demolished 23 days later in a spectacular implosion (partly funded by the sale of souvenir bricks and a lottery to trigger the detonation). Three more buildings across Seventh Street, and on the alignment of the two new sinkholes, were also damaged and were subsequently demolished.

In hindsight, it is apparent that the extensive damage resulted from the building having been placed on spread footings when it was constructed in 1986. Prior to construction, 21 test borings had been taken to depths of 9–13 m on a grid at 15-m centres. No bedrock or voids were encountered along the northern side of the site, so the engineering report recommended a flexible steel-frame structure bearing on spread footings (Leddin, 1994). Concrete column bases 2,500 mm across were founded on soils 1,500–1,800 mm below the ground surface. Had the columns been founded on bedrock, the building would have survived the sinkholes that developed within the soil.

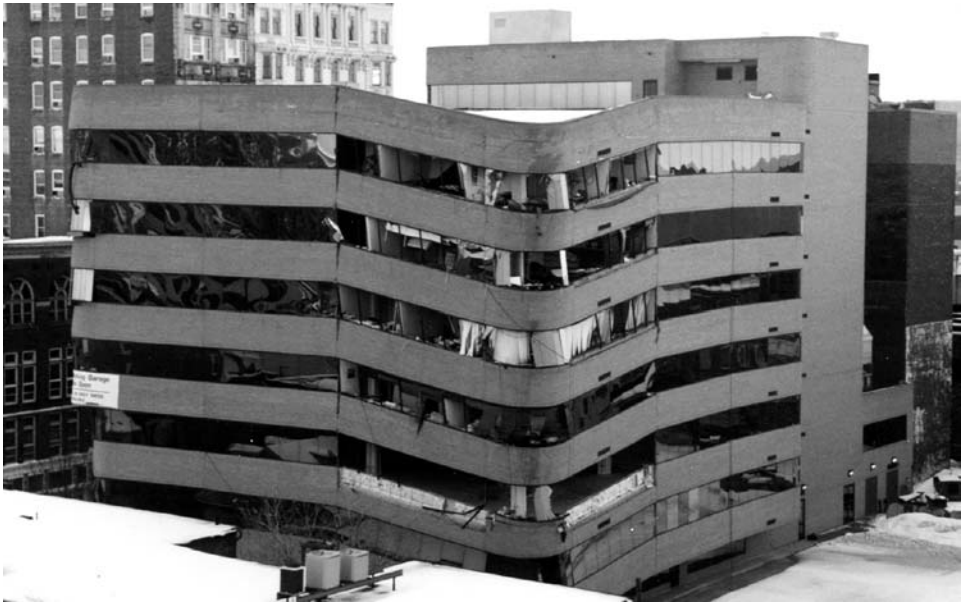
Figure 13.7.4. Subsidence of the northwestern corner of the Corporate Plaza where the second sinkhole developed. Photo: Percy Dougherty.

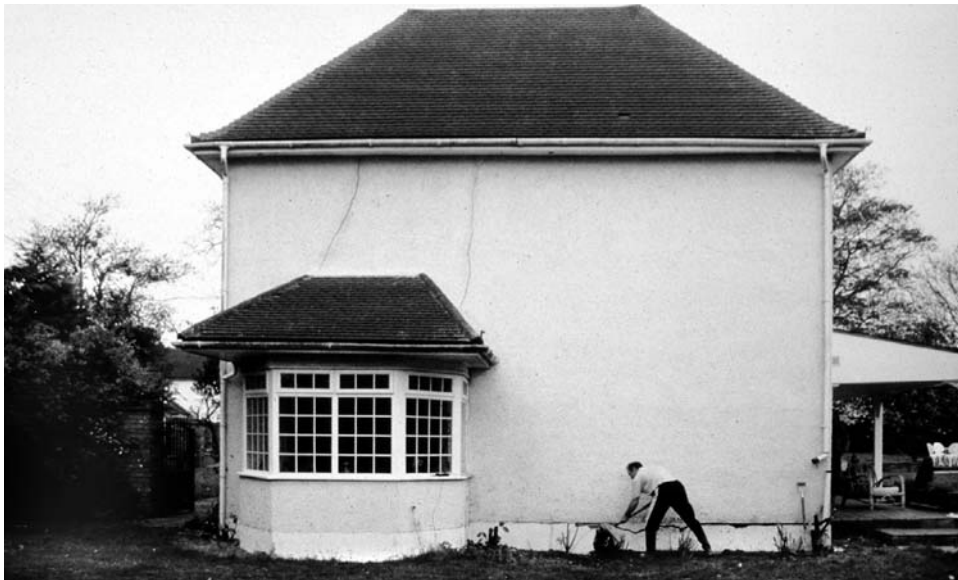
Figure 13.8.2. The west end of the house extension, showing the new open break where the floor has dropped away from the wall, and also cracks in the higher part of the wall where it is failing in cantilever.

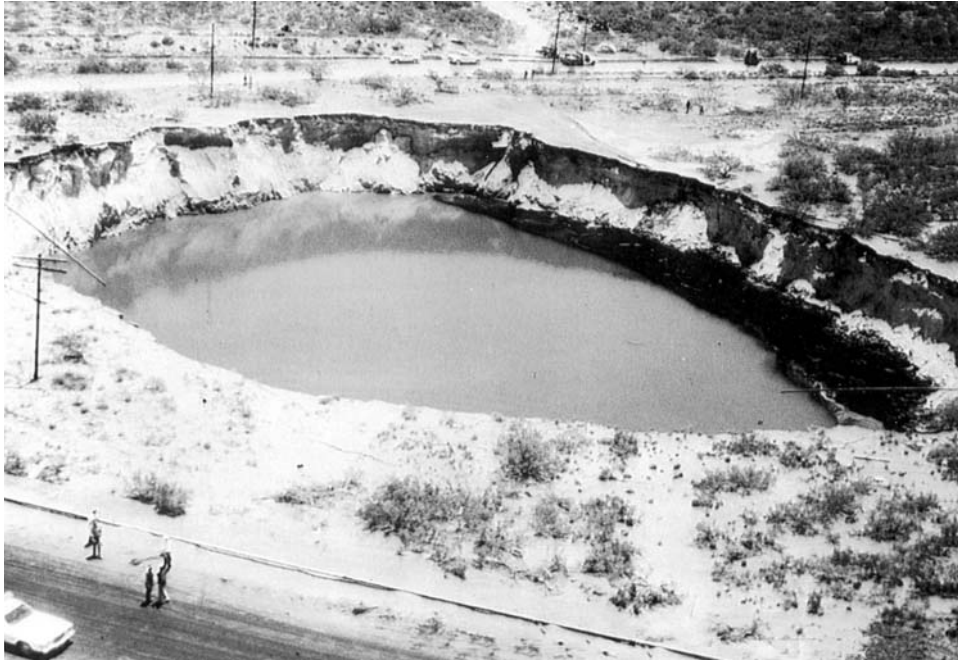
Figure 13.11.2. Aerial view of Wink Sink #1 in June 1980, when it was 110 m across.
Photo: Robert Baumgardner, Jr.

Wink Sink #1 formed on 3 June, 1980, and within 24 hours had expanded to a maximum width of 110 m (Figure 13.11.2); two days later, the sinkhole was 34 m

deep, with a volume estimated at about $159,000 \text{ m}^3$ (Baumgardner *et al.*, 1982; Johnson, 1989b, 1998; Johnson *et al.*, 2003). The abandoned Hendricks oil well 10-A (drilled in 1928) was incorporated within the sinkhole, and a second oil well was later plugged and abandoned because of its proximity to the new hole. It appears that Wink Sink #1 formed where a dissolution cavity in the salt had migrated upward by successive roof failures, thereby producing a collapse chimney filled with brecciated rock (Figure 13.11.3). The original dissolution cavity had developed in the Salado, between 400 and 660 m beneath the ground surface at the sinkhole.

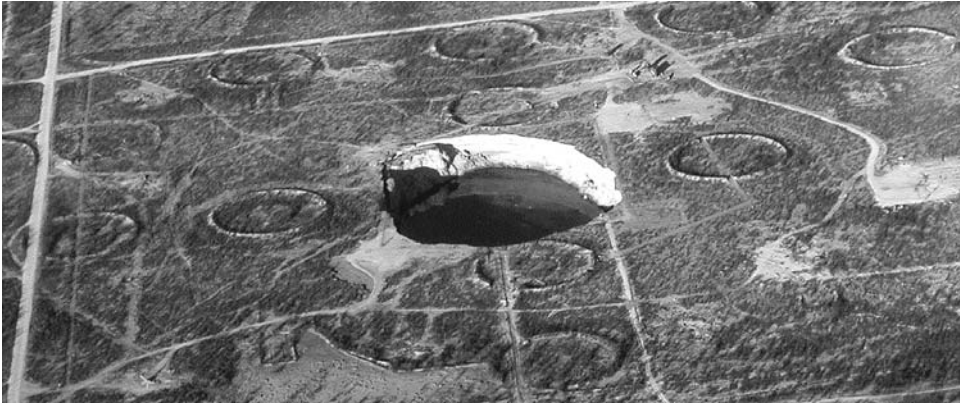
Figure 13.11.4. Aerial view of Wink Sink #2 in March 2003; the sinkhole is about 185 m across, with its 240 m length foreshortened, and each circular earth berm is about 100 m in diameter.

Wink Sink #2 is centered on the site of a former water-supply well, the Gulf WS-8 (Johnson *et al.*, 2003). This well was completed in September 1960, drilled into the Capitan Reef, to a total depth of 1,092 m. It met the top and base of the Salado Formation at depths of 412 m and 686 m, so the Salado salt is 274 m thick. There are not yet sufficient data to assess the specific relationship of Wink Sink #2 to the Gulf WS-8. However, it may be similar to Hendricks 10-A in that the well could have been a conduit for unsaturated water to reach the Salado salt beds, where a solution cavity was created and then migrated upward to cause collapse of the land surface.

Remediation engineering of major sinkholes, such as the Wink Sinks, is difficult. The sinkholes generally are too large and unstable for backfilling or for other

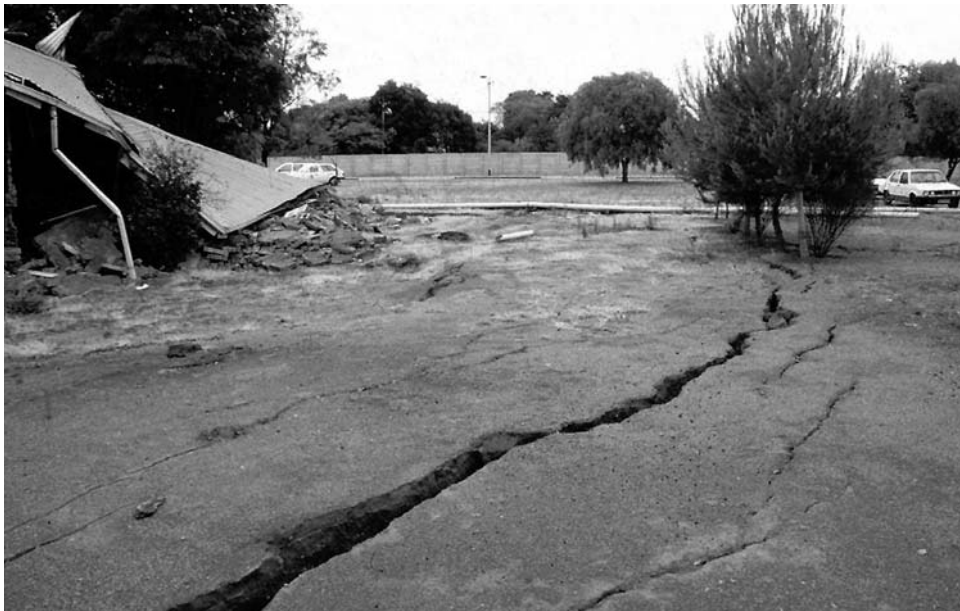
Figure 13.12.2. Ground fissures around the subsidence feature adjacent to the northern end of the Centurion warehouse after it finally collapsed in November 1994.

However, no further action was taken by the property owner until May 1994, by which time the building was severely cracked and the subsidence feature also threatened an important access road north of the warehouse. In light of the continuing subsidence, an additional geotechnical investigation was conducted. This incorporated a gravity survey on a grid spacing of 30 m, as well as the drilling of a further eight air-percussion boreholes (some inclined towards the centre of subsidence), accurately delineating the buried depression and confirming the karstic nature of the rockhead topography. It was also found that the voids within the soil inside the rockhead depression had enlarged significantly, due to compaction and suffosion of the wad into rockhead fissures, especially beside the dolomite pinnacles. The cavernous condition of the soil caused moderate to total air loss and poor sample recovery during drilling all the new boreholes. Fast-flowing, foul-smelling water was encountered at a depth of 7 m in borehole #11 west of the subsidence feature (Figure 13.12.1). Inspection of fire hydrants at the warehouse and further north revealed that a water main west of the building appeared to be damaged. Application of the Method of Scenario Supposition (Buttrick *et al.*, 2001) showed that the northern portion of the warehouse was a high-hazard site (class VIII) for development of karstic instability features with diameters greater than 10 m (Table 10.5). This assessment was based on the gravity survey results, on drilling records from the sites of both the damaged warehouse and several nearby structures and on the known subsidence history of the area.

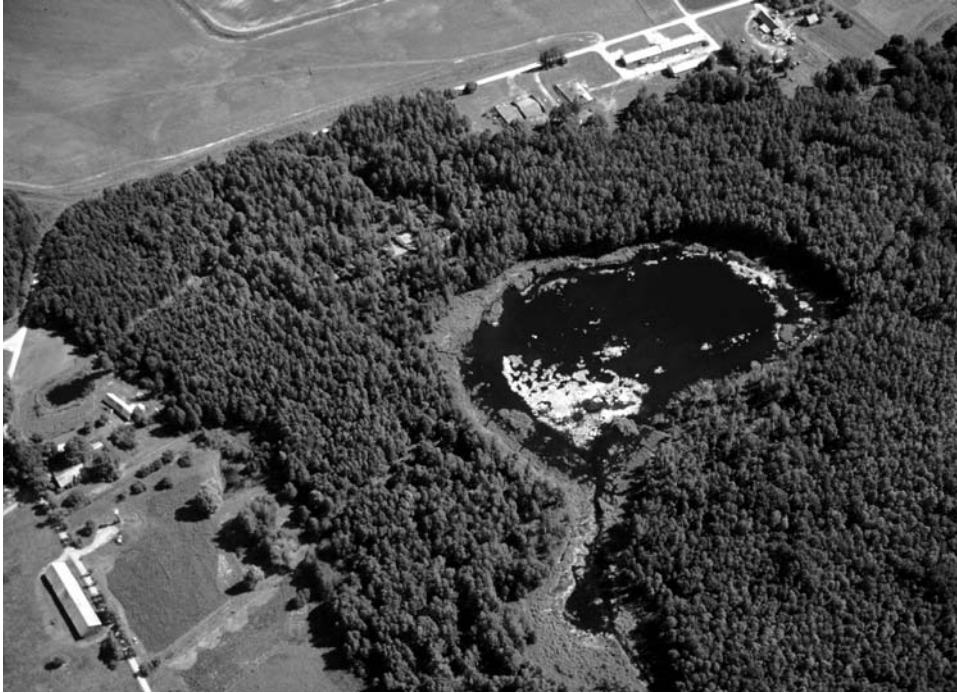
Figure 13.13.1. A large, old, flooded sinkhole in woods surrounded by farmland near Birzai on the soil-covered gypsum karst.

More than 8,500 sinkholes of different shapes, sizes and diameters occur in the active gypsum karst, which has an area of about 400 km² (Paukštys and Karise, 1998). Some 87% of the sinkholes have diameters of 10–50 m, and 93% are less than 5 m in depth. Some sinkholes are open to depths of about 40 m. Most sinkholes are dry, but some open to the water table, where they are filled with water (Figure 13.13.1). Some clusters of sinkholes have coalesced to form subsidence basins now occupied by small lakes; the most notable is Lake Ilgasis (Long Lake) 1,100 m long and 200 m wide across a belt of 30 sinkholes. Karst springs occur along valley sides, and were focal points for settlements in the past. Only one cave is known in the gypsum karst region, but other old caves have collapsed.

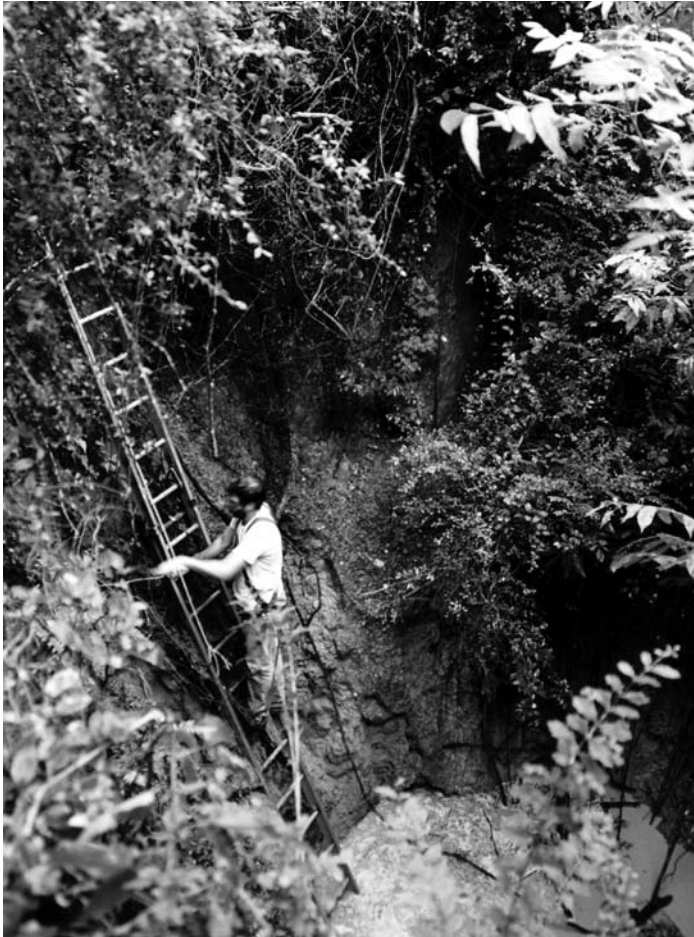
Figure 13.14.2. The main sinkhole soon after its discovery in the woodland of Weeks Island.
Photo: Jim Neal.

sinkhole gradually deepened and was actively enlarging. It was recognised that the site should be closed, with the oil transferred elsewhere, and decommissioning began in 1994. Anxiety over the threat of an oil spill from the mine increased when a second sinkhole was shortly noticed nearby; but this one was only about 4 m wide and 3 m deep.

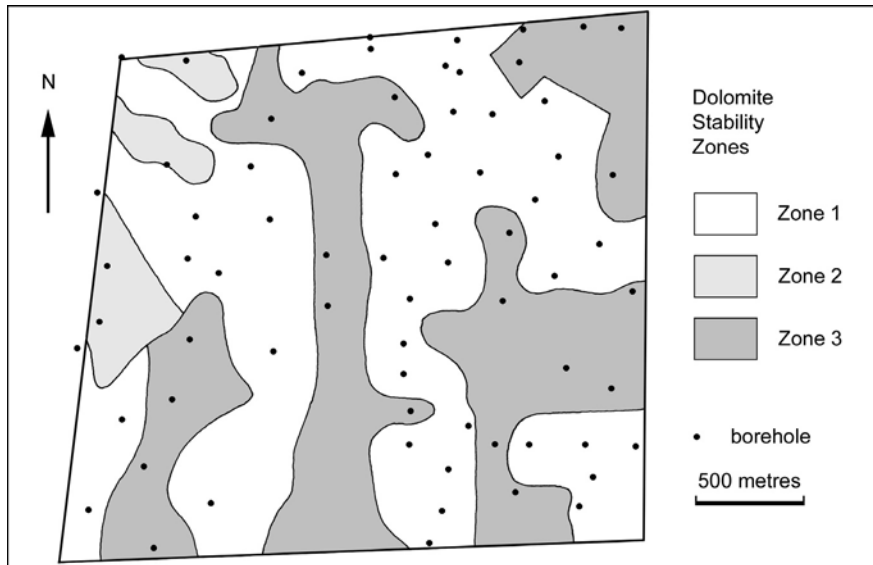
Figure 13.15.3. Division of the Simunye site into three zones with respect to stability and potential sinkhole hazards over the karst dolomite.

The Simunye site was broadly divided into areas of distinctive karst morphology (Figure 13.15.3) that were largely reflected in the maps of gravity contours and

This zone is identified by the areas of high gravity and their immediate surrounds that have gentle gravity gradients. Areas with steep gravity gradients are eliminated from the zone due to the propensity for sinkhole formation on steep rockhead gradients. The dolomite rockhead lies mainly above the original water table. The zone includes small sub-areas where rockhead is below the water table in areas of gentle gravity gradients, where minimal potentially compressible soil materials are recorded below the water table and where Karoo shale overlies the dolomite. Karoo shale, colluvium and alluvium constitute a large proportion of the karst cover, and these residual and reworked materials typically have permeability values of the order of 1×10^{-7} to 1×10^{-9} m/s.

Voids in dolomite bedrock lie at depths in excess of 30 m. Very large sinkholes could therefore be formed if the soil cover was fully mobilised, but these are considered as very rare, and none has been observed in this setting. The water table decline occurs within the dolomite bedrock, and therefore has minimal negative impact on the overlying soils; soil mobilisation potential due to groundwater drawdown is assessed as low (NSH < 0.5 , where NSH = number of new sinkhole occurrences per km² per year). Ingress of water to initiate subsurface erosion or

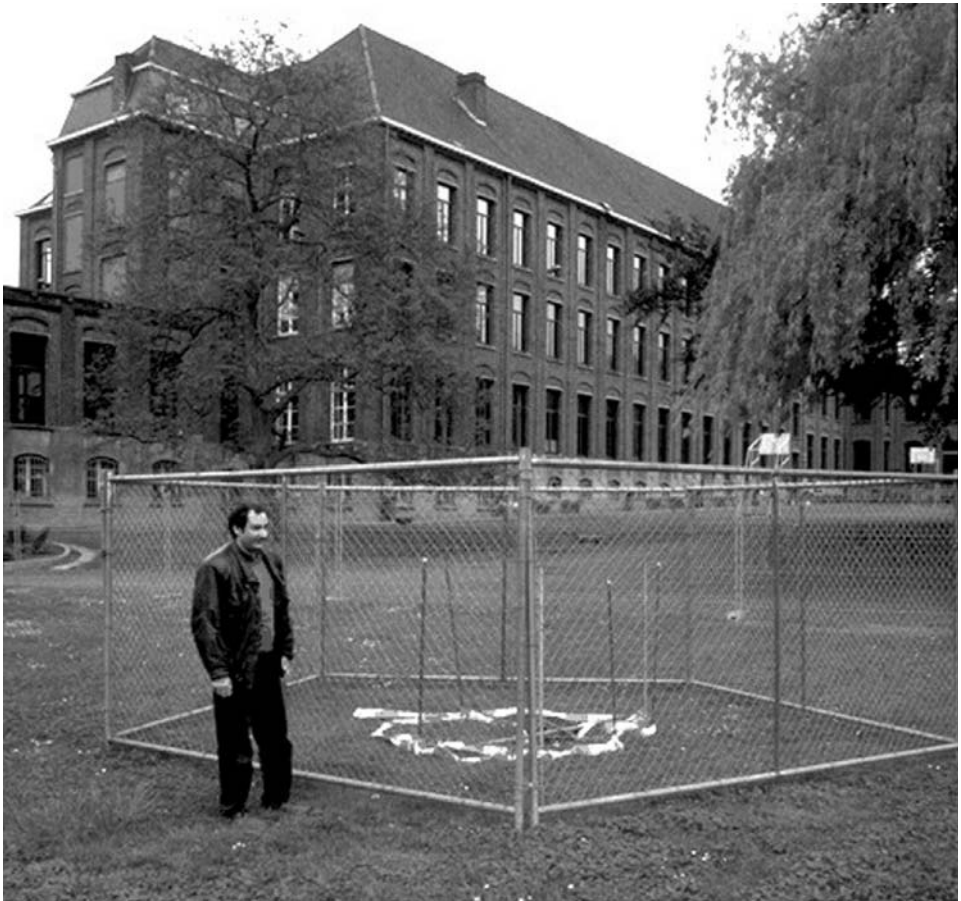
Figure 13.16.1. The building under investigation near Tournai, with a fence surrounding a small subsidence sinkhole in the foreground.

In an area where collapses had already occurred, there was serious concern over the structural stability of a public building nearly 100 years old and four floors high (Figure 13.16.1). It was standing on conventional foundations less than 5 m deep on the Cretaceous marls. A number of sinkhole collapses, each 2–3 m across, have occurred under and around the building in the last five years. One of these, 2.0 m wide and 1.7 m deep, occurred below the lift shaft during former remediation works, while others caused floor failures between the foundation elements. An investigation was therefore conducted beneath the building foundations, in order to establish the ground conditions and map the complex topography of the buried rockhead. This was essential to identify problematic zones, and then to design proper and effective remediation.
