# **The Nalco Guide to Boiler Failure Analysis**

**Nalco Chemical Company**

**Robert D. Port**

**Harvey M. Herro**

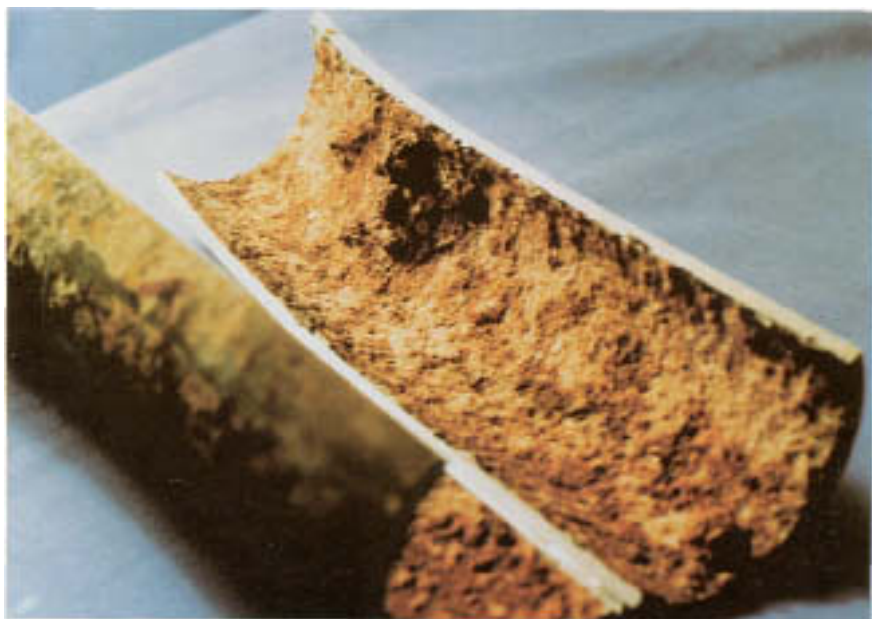
Steaming does not often occur in economizers. Deposits are usually iron-rich. The iron oxide is produced in the preboiler system or is formed in the economizer itself (Figs. 1.4 and 1.5).

**Figure 1.4** Thick layer of friable iron oxide in an economizer tube. Most iron was carried into the economizer from the preboiler system.

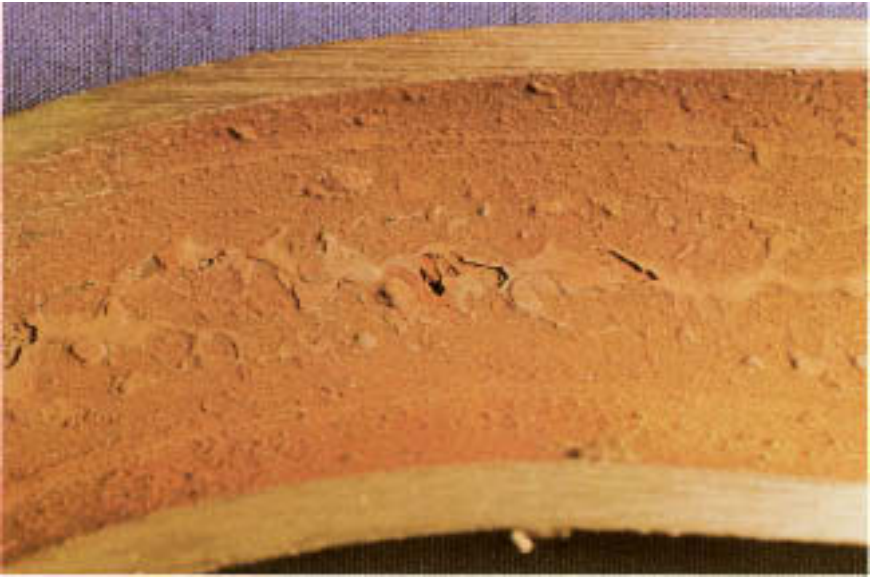
**Figure 1.5** Fragmented hematite layer on an internal surface of an economizer. Most oxide was formed in place, but some was moved as fragments and chips.

Hematite formation, on the other hand, is favored at somewhat lower temperatures and higher oxygen concentrations. Hematite is a binder species that tends to accumulate and hold other materials in the deposit. Hematite can be red if formed where oxygen concentrations are high. Hematite usually is present in economizers in conjunction with oxygen corrosion (Fig. 1.5).

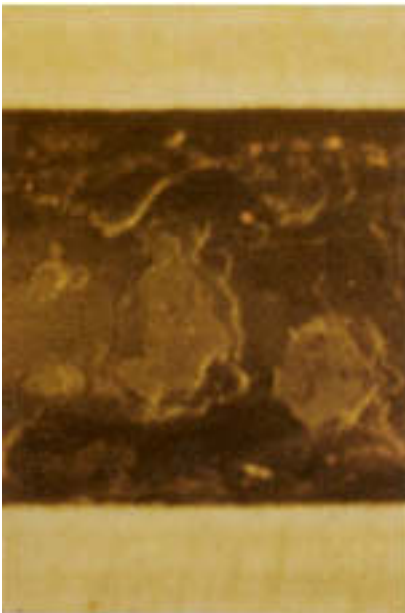
**Figure 1.6** Exfoliated magnetite patches in a tube from the primary superheater of a utility boiler. Magnetite chips can be carried into turbines and cause severe damage (see Fig. 1.7).

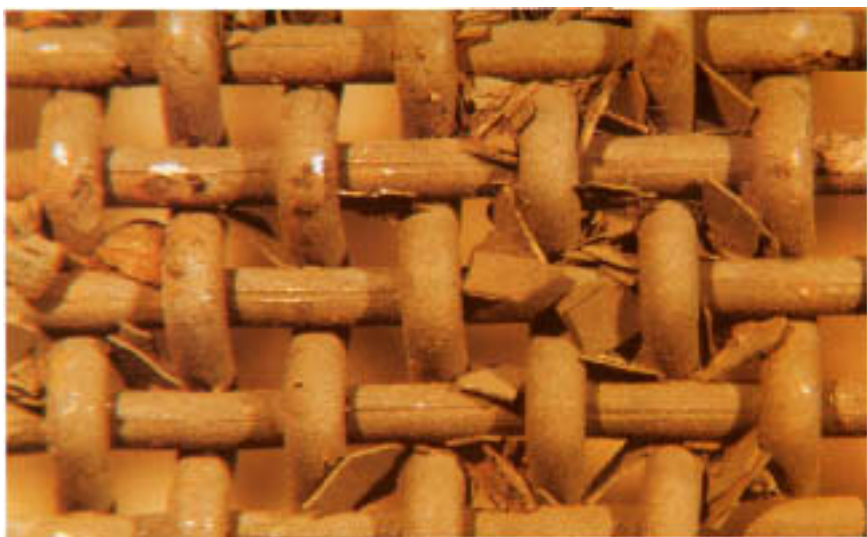
**Figure 1.7** Fine-mesh turbine inlet screen. Pieces of exfoliated oxide from superheater tubing are wedged into screen openings. (Magnification: 7.5 $\times$ .)

Approximately 10% of the fine screen openings were plugged with magnetite chip scale. Small exfoliated chips had been blown through the superheaters and had lodged in the screen (Fig. 1.7). A few rocks and cutting-torch spatter beads were also trapped. The coarse screen caught magnetite chips as thick as 0.010 in. (0.025 cm) and as wide as 0.15 in. (0.038 cm). The side of the coarse screen facing steam flow was hammered and peened by impact with flying projectiles.

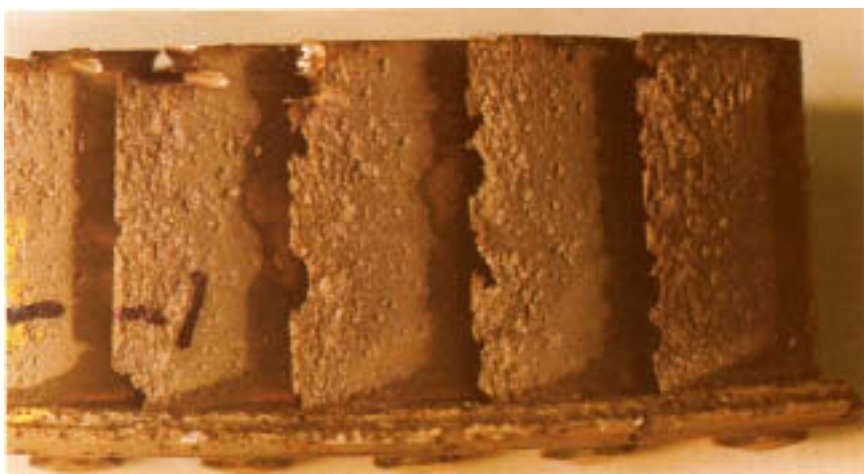
deposited on turbines. If chlorides and sulfates are present, hydration can cause severe corrosion due to hydrolysis (Figs. 1.8 and 1.9).

**Figure 1.8** Severely corroded blades from high-pressure condensing stage of a turbine. Deposits were removed to reveal attack.

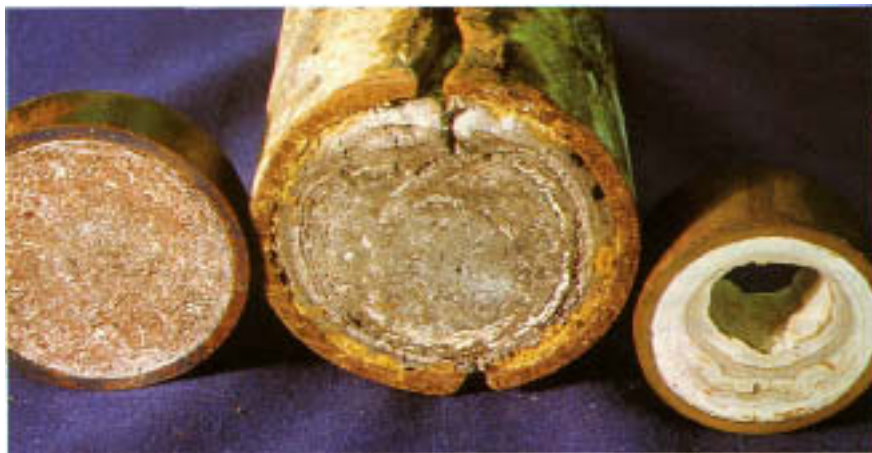
**Figure 1.10** Tube sections virtually plugged with deposits. The tube on the right is from a low-pressure boiler and is fouled with almost pure calcium carbonate. The center tube contains silicates, phosphates, and other compounds; fouling occurred on standby service. The section on the left is reddened by almost 20% elemental copper. Such heavy deposition can occur only when internal pressures are low. Otherwise rupture would occur.

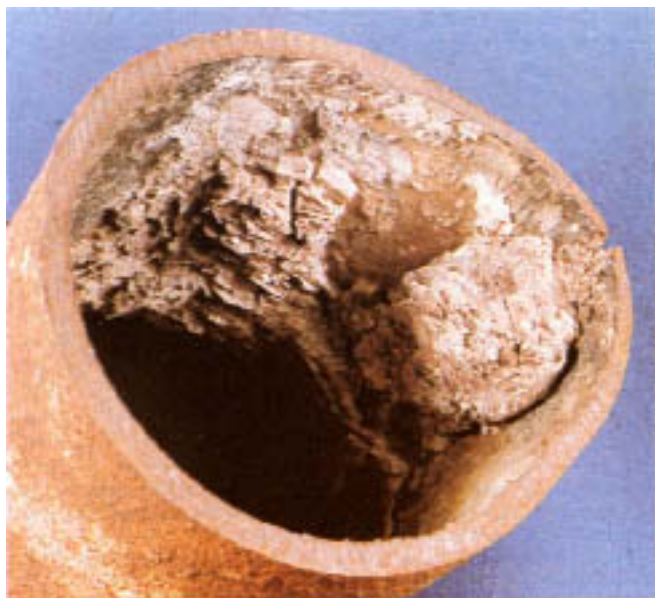
**Figure 1.11** Sodium hydroxide-rich deposit on fire side of wall tube from 600-psi boiler. Note the bulge due to long-term overheating.

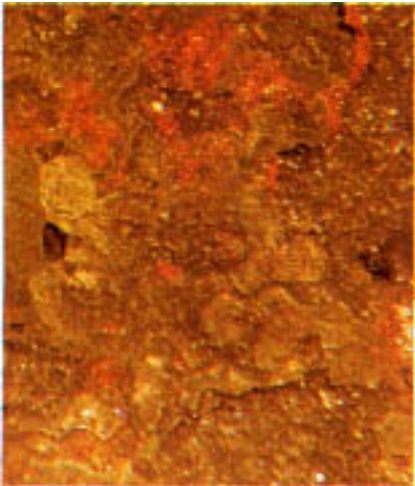
Figure 1.12 Elemental copper on wall tube from a high-pressure utility boiler.

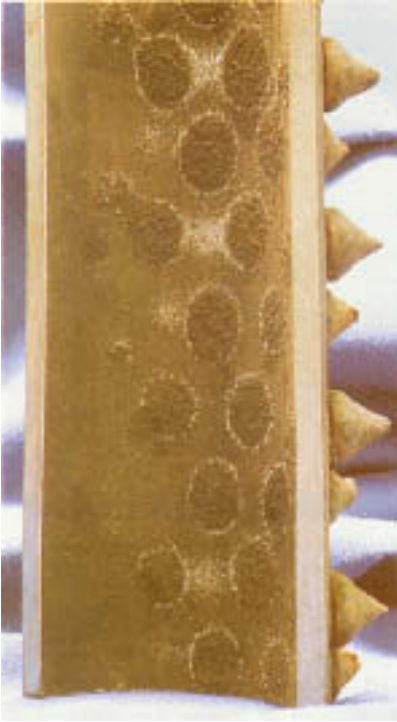
**Figure 1.14** Spots of particulate iron oxide deposit mirroring stud locations on a wall tube of a recovery boiler. The studs, if exposed, concentrate heat, causing higher rates of steam generation and deposition. Note the white deposits of sodium hydroxide encircling each powdery magnetite spot.

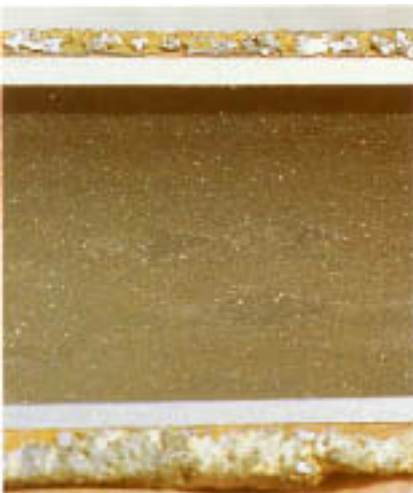
**Figure 1.15** Sparkling black magnetite crystals on internal surface of a wall tube. Crystals are formed by precipitation on surfaces, or are transported from preboiler areas.

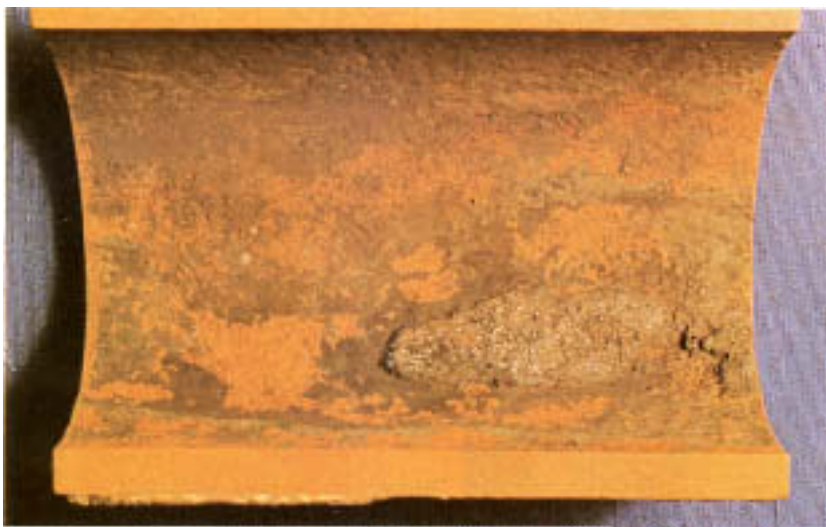
**Figure 1.16** Patch of sparkling magnetite crystals associated with caustic corrosion site. Such crystals are often found near sites of acid and caustic corrosion.

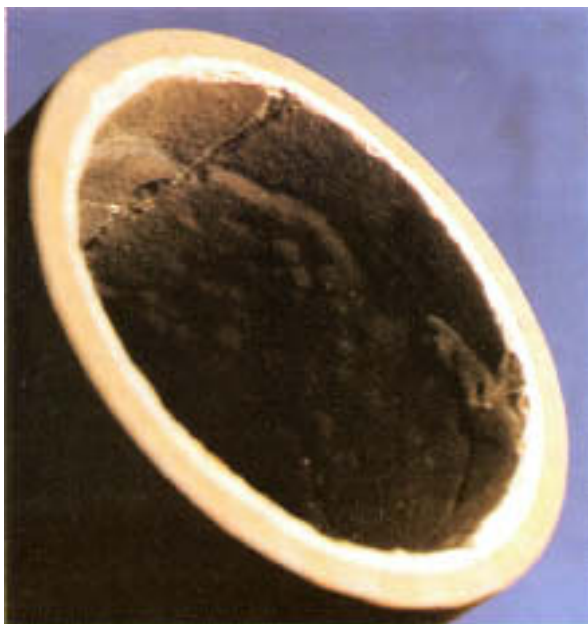
**Figure 1.17** Calcium carbonate deposit (see Fig. 1.10).

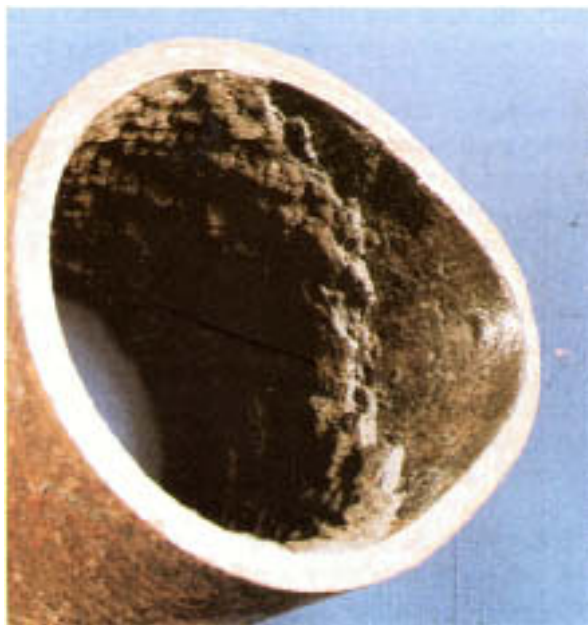
**Figure 1.18** Analcite formed by carryover of alum from clarifiers. Note how the deposit has spalled from the bulge.

( $\text{Na}_2\text{O} \cdot \text{Fe}_2\text{O}_3 \cdot 4\text{SiO}_2$ ), or sodalite [ $\text{Na}_2\text{O} \cdot 3\text{Al}_2\text{O}_3 \cdot \text{SiO}_2 \cdot 2\text{NaCl}$ ] can be evidence for steam blanketing, since intermediate sodium compounds are soluble. Analcite frequently forms if alum is carried over from clarifiers (Fig. 1.18).

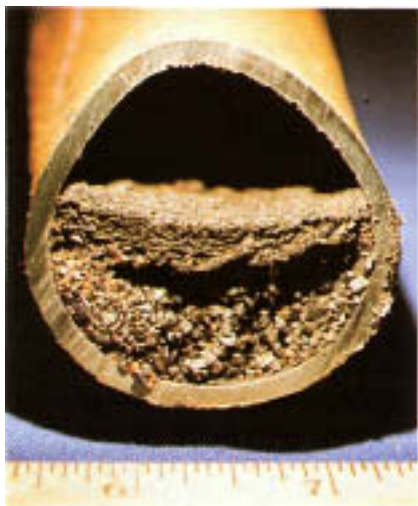
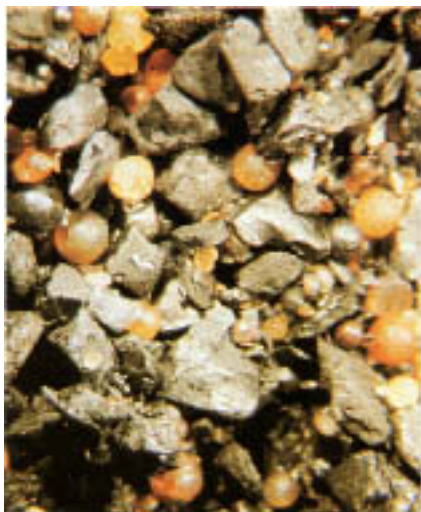
During removal of failed economizer tubes, heavy internal deposits were found unexpectedly. Internal surfaces of some economizer tubes were partially lined with an irregular layer of soft, flaky iron oxide. Underlying oxides were black. A 1-in.-thick layer of friable material accumulated at the tube bend is shown in Fig. 1.19. Close observation revealed that the accumulated material consisted of anthracite particles and resin beads (Fig. 1.20). The deposit had been transported from a disintegrated resin bed. The metal surface beneath the deposit was gouged and thinned.

The accumulated deposit retarded coolant flow, yet overheating could not occur because flue-gas temperatures were too low (about 550°F, or 288°C). Deviations from nucleate boiling beneath the deposit did occur, leading to concentration of sodium hydroxide and associated corrosion (see Chap. 4, “Caustic Corrosion”).

**Figure 1.19** Anthracite and resin beads beneath a stratified iron oxide layer.

**Figure 1.20** Anthracite and resin beads. (Magnification: 7.5 $\times$ .)

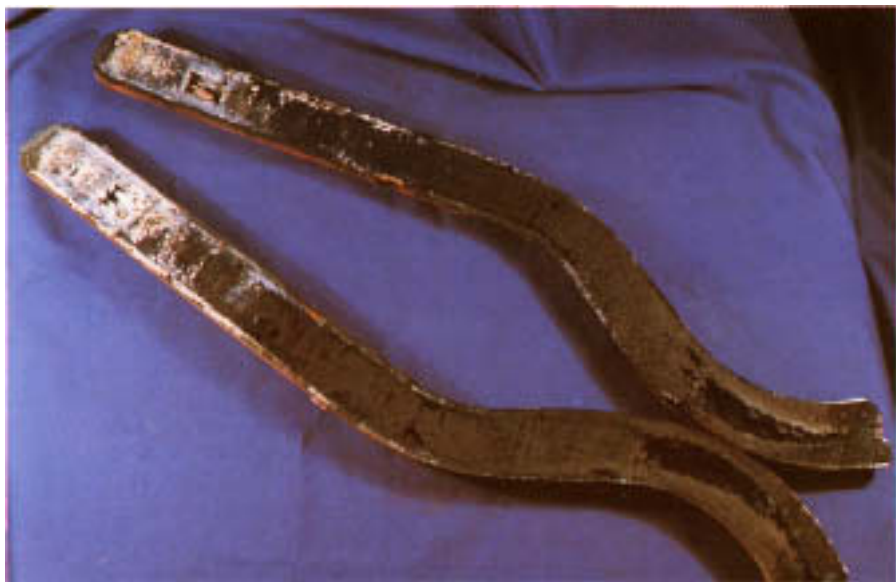
A 2-ft section of superheater-tubing stub end was plugged solid with deposits that were still soaked with water when the tube was split. Sections were gently heated for 3 days to dry the deposit in situ. After drying, white deposits became visible at the end of the stub (the lowest tube point in service) (Fig. 1.21).

**Figure 1.21** Longitudinally split stub end from a superheater outlet. The tube is plugged with deposits. The white material is sodium hydroxide and sodium carbonate concentrated at the bottom of the stub end. The black material is mostly magnetite.

and 7% sodium hydroxide and sodium carbonate by weight. Small amounts of sulfur, chlorine, phosphorus, chromium, and manganese were also detected. At the stub end, about half the deposit was sodium hydroxide and sodium carbonate.

Deposits were caused by chronic contamination of attemperation water and/or carryover of boiler water into the superheater header from the steam drum. Water was converted to steam and left solids behind. Solids accumulated during a considerable period in stagnant, low-flow regions like stub ends.

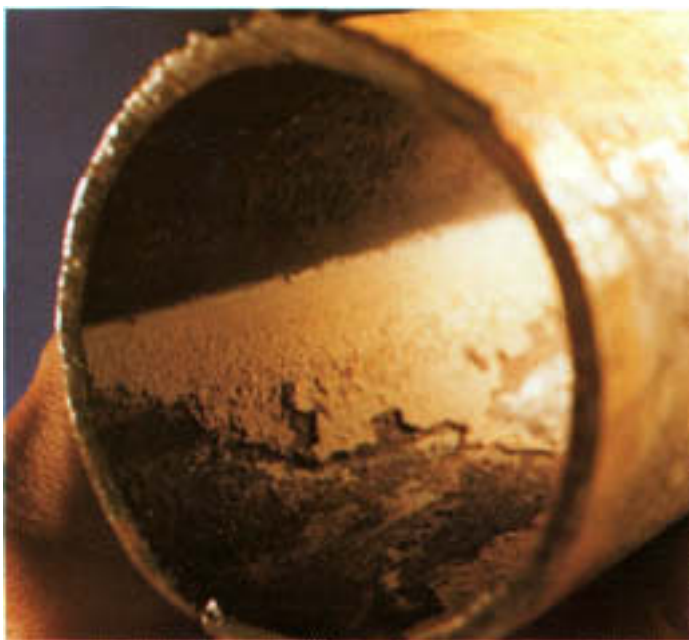
The crossover tube contained a small bulge and rupture. A white, friable deposit layer having a density of 16 g/ft<sup>3</sup> (17 mg/cm<sup>3</sup>) was present on hot-side internal surfaces; 1 g/ft<sup>3</sup> was present on the cold side. Deposits were bounded on both sides by sharp borders (Fig. 1.22). The borders indicate the steam-blanketing terminus. Deposition took place during a brief episode of high fire-side heat input. High heat input resulted in overheating and eventual failure.

**Figure 1.22** Deposit layer on the internal surface of the hot side of a crossover tube. Some deposit spalled off at a shallow bulge. Note the sharp boundaries indicating the terminus of steam blanketing.

Deposits consist of basic calcium phosphate (hydroxyapatite), sodium aluminum silicate hydrate, magnetite, magnesium silicate, and small amounts of other materials. Some alum was carried over from clarifiers. Firing practices and water clarification were reviewed and changed appropriately.

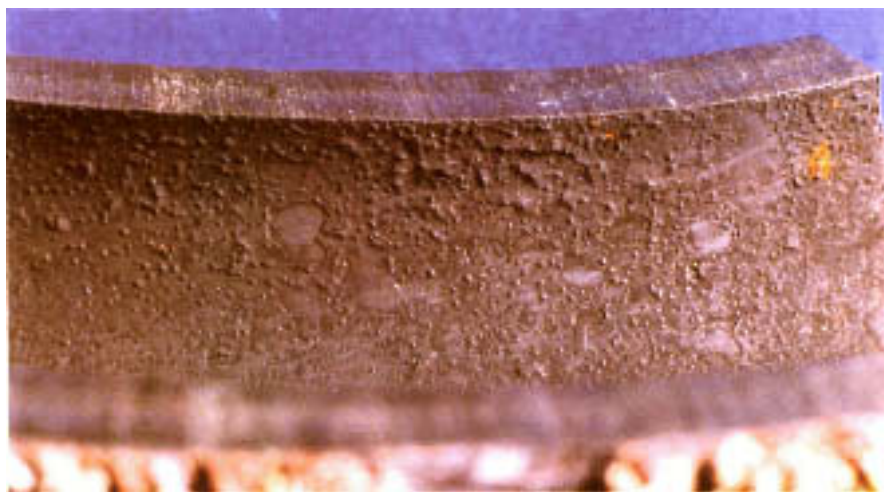
A pendant U-bend section of the superheater was removed from service because of fire-side metal loss associated with slagging. When the internal surface was examined, severe blistering of the magnetite layer was found (Fig. 1.23). Spalling of the magnetite layer had occurred. Although such spalling can lead to turbine erosion, none was detected.

**Figure 1.23** Magnetite blisters on the internal surface of a U-bend in a primary superheater. Note that the magnetite has spalled in places.

fluctuating thermal stresses. Stresses can become large when tubes are slagged. Furnace-gas channeling and "laning" can produce hot spots. The fracturing of slag, perhaps during soot blowing, can cause rapid surface-temperature variations. It is not established that soot blowing alone can cause exfoliation.

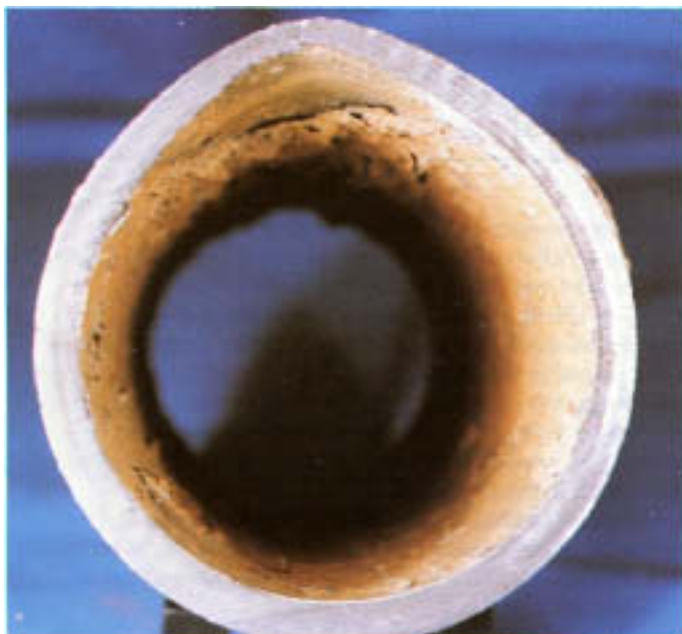
One of the seventy-four target-wall tubes was bulged and ruptured. A thick, friable, tan deposit layer covered the internal surface (Fig. 1.24). The hot-side deposit weight was 100 g/ft<sup>2</sup>, while the cold-side weight was 82 g/ft<sup>2</sup>. Deposits contained calcium carbonate, calcium silicate, calcium phosphate, and magnesium silicate hydroxide.

The boiler was fired intermittently at up to 90,000 pounds (40,900 kilograms) of steam per hour for over 1 year [design was 75,000 lb/h (34,000

**Figure 1.24** Cross section of bulged target-wall tube. Deposits are heavy on both hot and cold sides. Most deposits are phosphates, silicates, and carbonates.

kg/h)]. Fuels were switched between natural gas and No. 6 fuel oil until 1 month before failure, when oil was used exclusively. Original burners were replaced with larger burners.

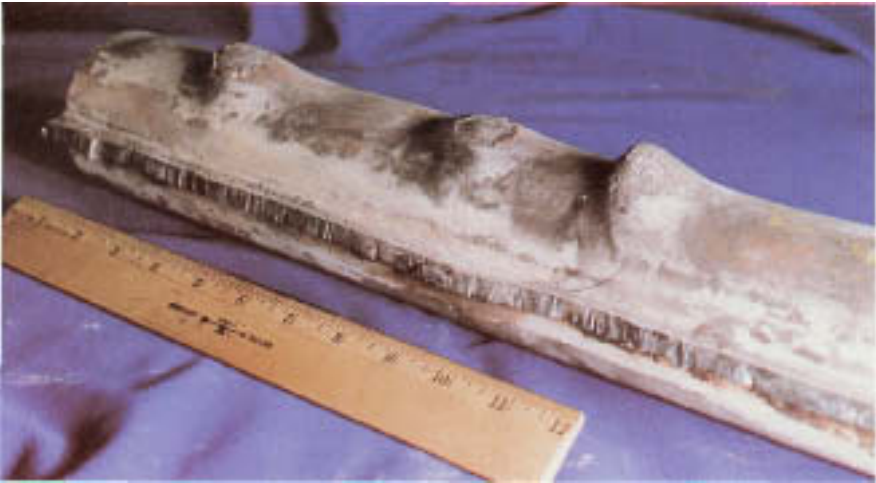
**Figure 2.2** Multiple, abrupt bulges on the hot face of a waterwall tube of a recovery boiler.

The tube has a series of several prominent bulges longitudinally aligned along the hot-side crown (Fig. 2.2). Thick layers of hard, tenacious iron oxide cover each bulge, except where spalling has dislodged the oxide. Internal surfaces on the hot side are covered with spongy, porous deposits, which cover a hard, black magnetite layer. The back wall at the same elevation saw many failures. The boiler had frequent load swings and was operated intermittently.

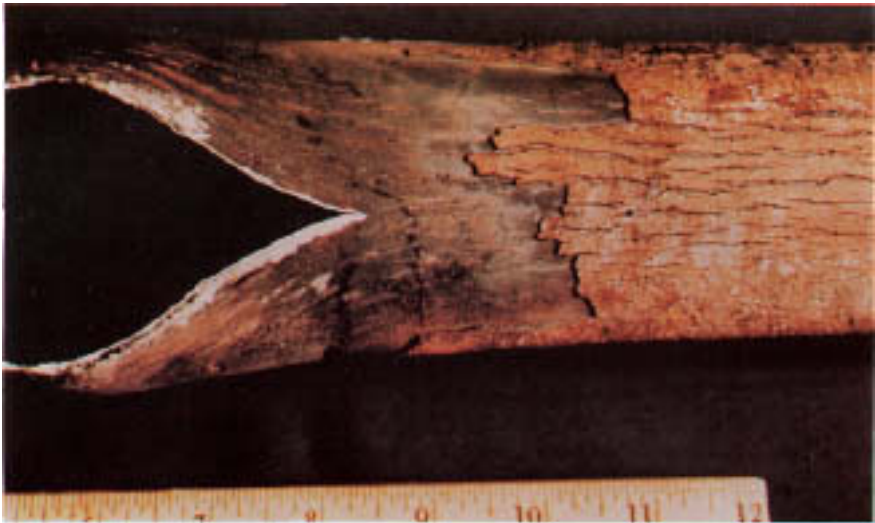
**Figure 2.5** Thermally deteriorated metal on failed wall tube of a utility boiler. Note the spalled and cracked oxide resembling tree bark caused by expansion of tube during bulging and thermally induced stresses.

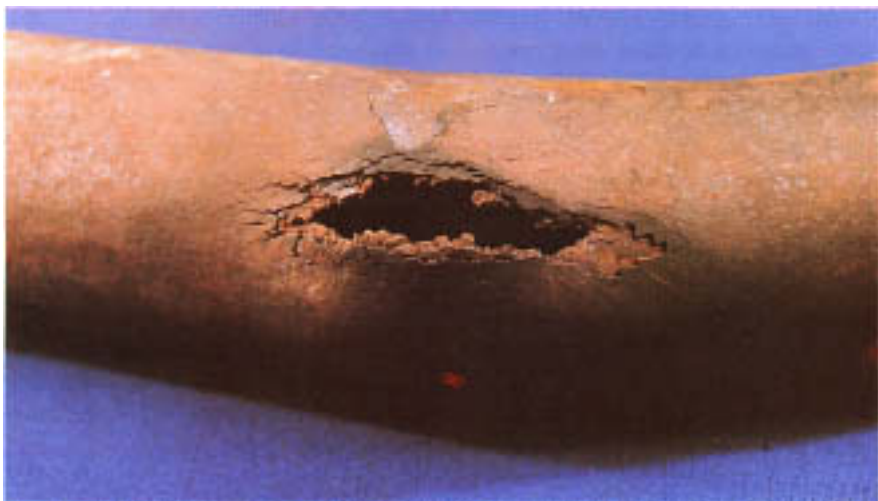
**Figure 2.7** A small, ragged creep rupture at the apex of a bulge. Note the small secondary fissures and the relatively thick rupture edges.

in metal during overheating. Often a small longitudinal fissure will be present at the apex of a heavily oxidized bulge (Fig. 2.7). In other cases, the rupture will be larger and have a fish-mouth shape (Fig. 2.8). The rupture will usually have blunt and slightly ragged edges. Similar, but smaller, longitudinally oriented ruptures and fissures may exist nearby.

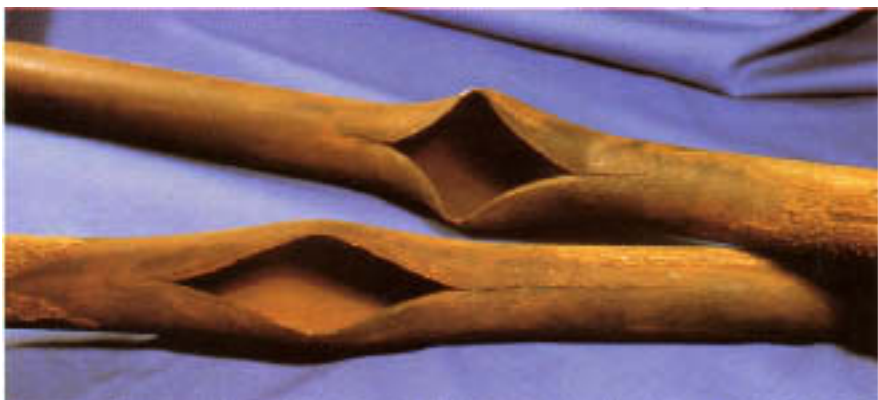
**Figure 2.8** Two superheater tubes from a utility boiler [1400 psi (9.7 MPa)], failed by creep. Note the fish-mouth ruptures. Compare with Fig. 2.7.

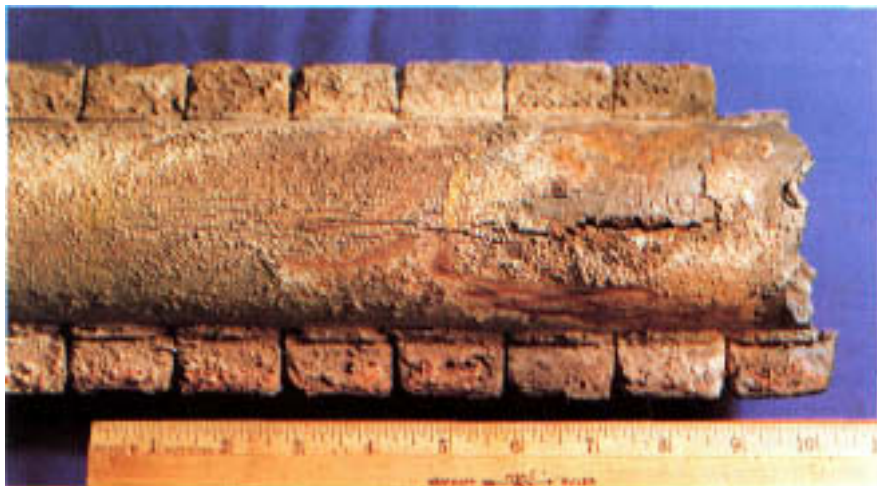
Longitudinal fissures and thick-walled, ruptured bulges were present along the hot side of this section (Fig. 2.12). Surfaces are covered with an irregular tan slag layer, and the external surface near the through-fissure is checkered. The rupture and fissuring were caused by very long-term exposure of the metal to temperatures between 850 and 1050°F (454 and 566°C). Evidence suggests that exposure to these temperatures may have been occurring for several years. Overheating was caused by excessive heat input relative to coolant flow rate.

**Figure 2.12** Longitudinal fissures along hot side. Note the through-fissure at the bulge apex.

Nearby tubes showed similar, although less severe, attack. Deposits on hot-side internal surfaces were less than  $20 \text{ g/ft}^2$  ( $22 \text{ mg/cm}^2$ ). The boiler had been cleaned 3 years prior to failure.

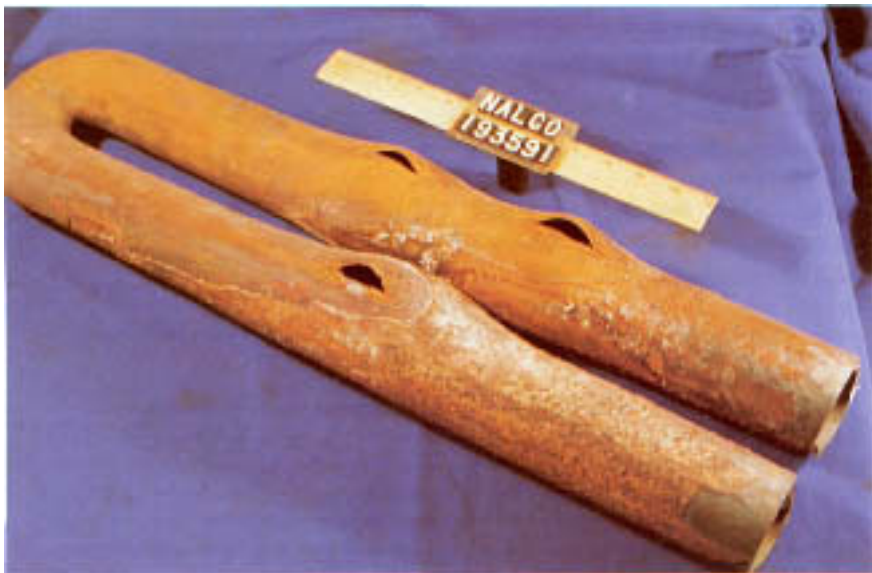
Three large bulges are present on the pendant legs of this U-bend section. Each bulge is ruptured at its apex. The legs expanded to about a 2½-in.

**Figure 2.13** Bulged and ruptured superheater U-bend. The legs are slightly expanded.

(6.4-cm) outer diameter from their 2¼-in. (5.7-cm) original value. Bulges are shown in Figs. 2.13 and 2.14. Internal surfaces are free of significant deposits, while external surfaces are covered with a tenacious, fragmented oxide layer. Eighteen tubes were similarly affected. This boiler operates on waste heat from a slab furnace.

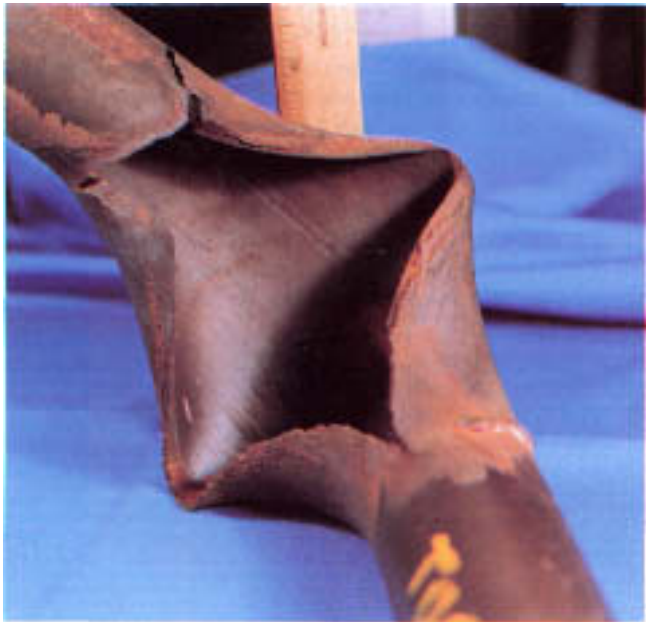
The section contains a massive, thick-walled, longitudinal rupture just above a circumferential weld. The rupture occurred immediately downstream of the weld. The tube was bent into an “L” by the burst. The rupture terminates at one end in a pair of thick-walled transverse tears (Fig. 2.15). A thick, tenacious magnetite layer covers external surfaces, except those near the

**Figure 2.15** Massive thick-walled fracture caused by creep. Note the circumferential weld just below the failure. The tube is torn and bent to a 90° elbow by the violence of the rupture.

rupture, where the oxide has cracked and spalled. Elemental copper and spotty deposits are present on internal surfaces.

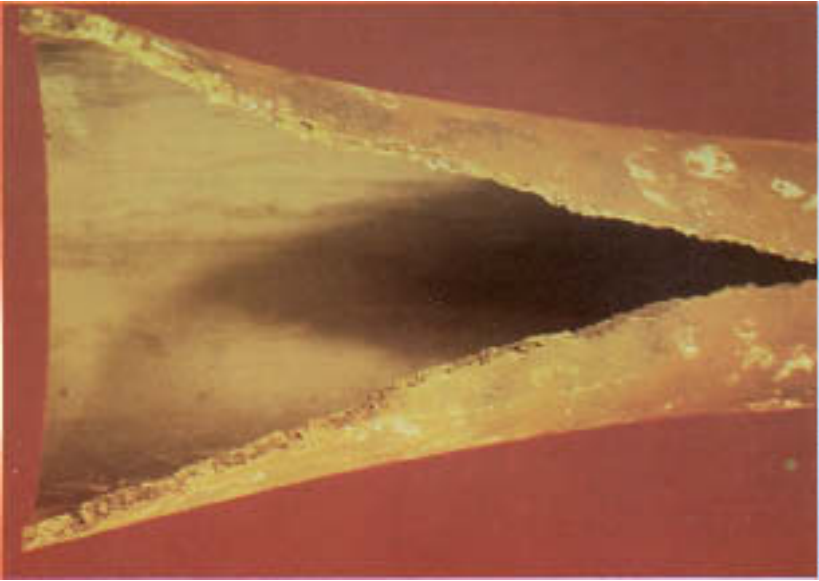
**Figure 3.1** Longitudinal rupture in a superheater tube caused by partial pluggage upstream of failure, which in turn caused short-term overheating. Note the thick-walled rupture edges. Virtually identical tube circumferences are present at the rupture and away from the burst. Such failures often occur when temperatures exceed 1350°F (730°C).

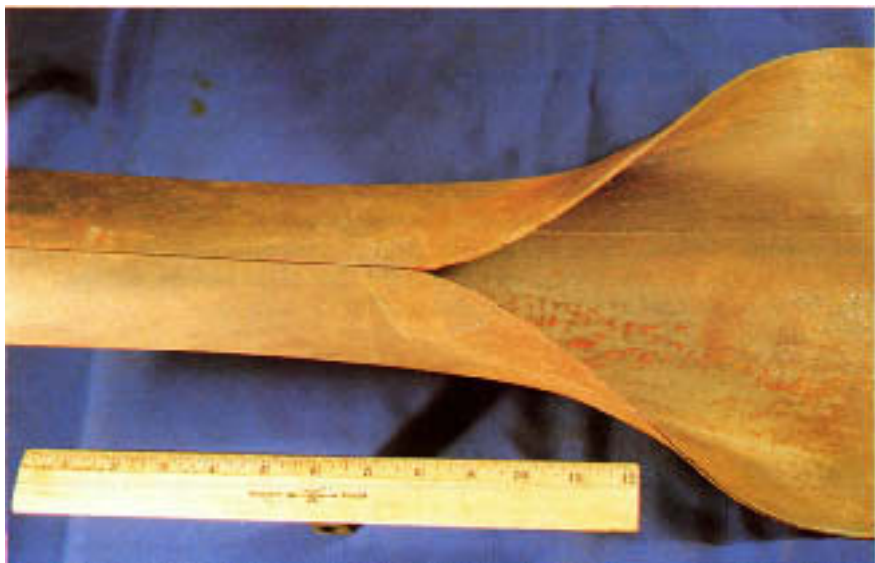
A massive thin-lipped longitudinal rupture is present. A thin, straight through-fissure runs longitudinally down the tube from the corner of the rupture mouth (Fig. 3.6). Internal surfaces are smooth, except for shallow mandrel markings. A thin, uniform layer of light-colored deposits is present away from the rupture.

Failure was caused by severe overheating resulting from coolant starvation. A minor defect (mandrel marking) guided the rupture line but was not a significant contributing factor to failure.

**Figure 3.6** Longitudinal fissure running from the edge of a large, wide-open rupture.

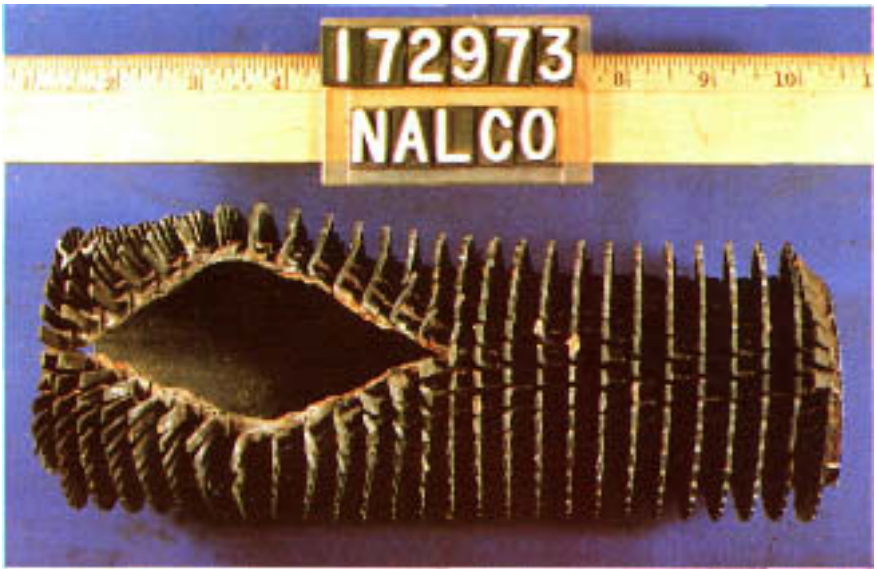
A rupture  $4\frac{1}{4}$  in. (10.8 cm) long by  $1\frac{1}{2}$  in. (4.1 cm) wide is present at a bulge (Fig. 3.7). A thick, black layer of thermally formed oxide is present on both internal and external surfaces and is thicker along the hot side. Deposits containing sodium, calcium, silicon, and iron are present in the tube. Deposit loading is  $38 \text{ g/ft}^2$  ( $41 \text{ mg/cm}^2$ ). Carryover of boiler water into the superheater due to water-level excursions and foaming was common. The boiler had never been cleaned.

Temperatures of waste-heat gases ranged from  $1200$  to  $1800^\circ\text{F}$  ( $650$  to  $980^\circ\text{C}$ ). The tube failed during several other tube failures. Tubes nearby

**Figure 3.7** Large, wide-open rupture in a superheater tube of a waste-heat boiler. The tube experienced long-term overheating followed by a brief episode of short-term overheating when nearby tubes ruptured.

failed as a result of long-term overheating (creep rupture), while others failed as a result of short-term overheating. It was determined that the section had been mildly overheated for a considerable period, but had failed during a brief episode of severe overheating when temperatures exceeded 1350°F (730°C). The short-term overheating probably occurred because of coolant starvation, caused by leakage from other failed tubes upstream.

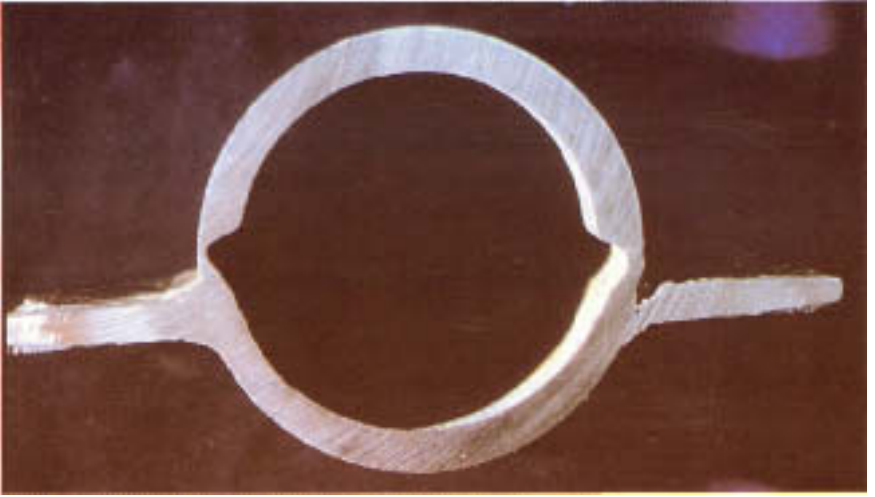
**3. Evaporation at a waterline.** Where a waterline exists, corrosives may concentrate by evaporation, resulting in gouging along the waterline. In horizontal or slanted tubes, a pair of parallel longitudinal trenches may form (Fig. 4.4). If the tube is nearly full, the parallel trenches will coalesce into a single longitudinal gouge along the top of the tube (Fig. 4.5). In

**Figure 4.4** Caustic gouging along a longitudinal waterline. (Courtesy of National Association of Corrosion Engineers.)

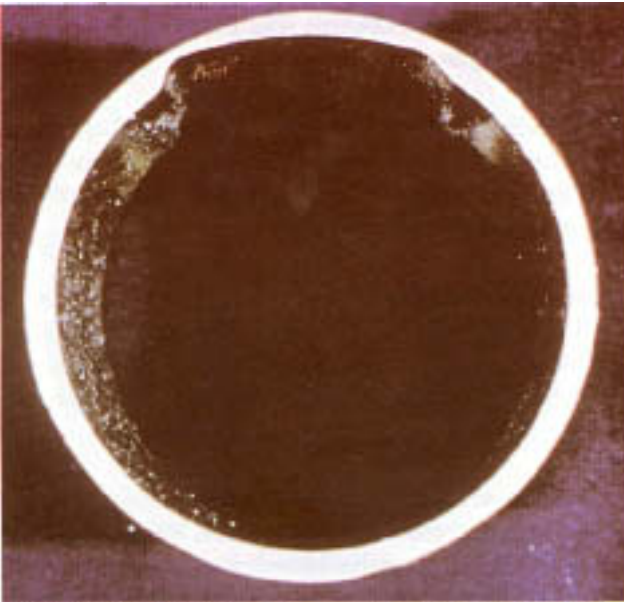
**Figure 4.5** Caustic gouging resulting from evaporation at a waterline riding along the crown of the tube. (Courtesy of National Association of Corrosion Engineers.)

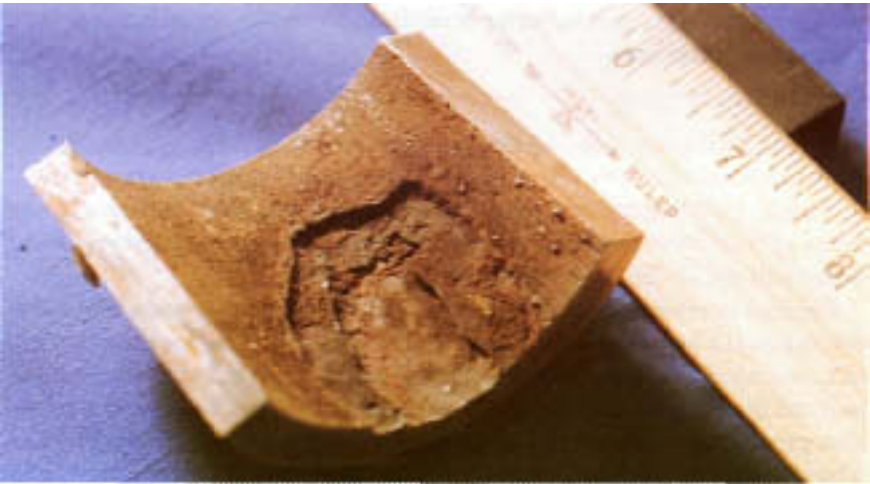
Numerous caustic attacks on the back wall of a cyclone-fired boiler (Fig. 4.6) were all observed within a month. This type of attack had occurred once previously. This boiler was acid-cleaned every 18 to 24 months. The gouge was noted 1 year after the last acid cleaning.

Visual examinations disclosed hard layers of black, crystalline corrosion products covering the attack site. Measurement revealed a 42% reduction in tube-wall thickness. Microstructural examinations disclosed moderate overheating in the gouged region. Evidence revealed that DNB, rather than deposits, was responsible for caustic concentration in this case. Overfiring during start-up and low flow rates of the feedwater were suspected.

**Figure 4.6** Region of caustic gouging along internal surface.

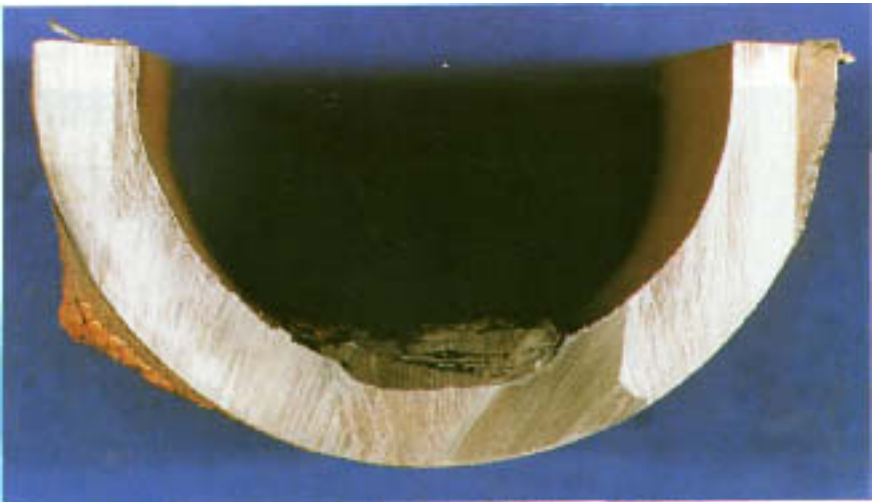
Visual examinations disclosed a thickened patch of hard corrosion products adjacent to one bend (Fig. 4.7). Perforation of the wall had not occurred, but transverse cross sections cut through the site revealed substantial metal loss (Fig. 4.8).

**Figure 4.8** Cratered region beneath patch of iron oxides.

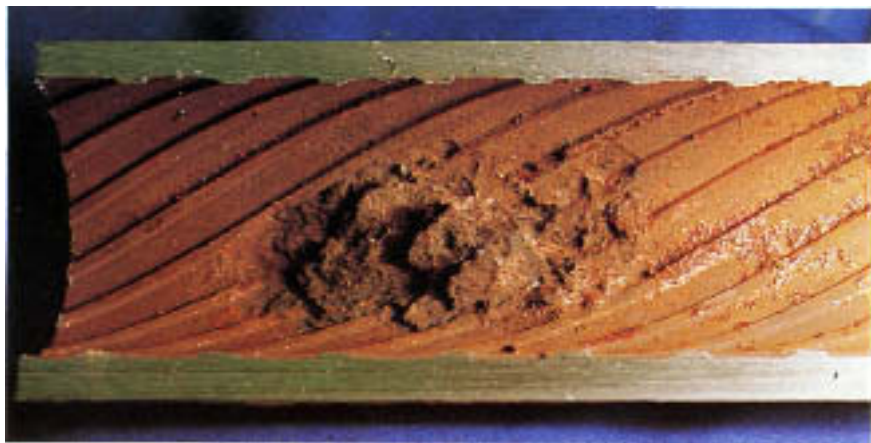
Figure 4.9 illustrates the appearance of the internal surface in the area of leakage. A small perforation of this rifled tube was observed in the center of a large, elliptical area of metal loss (Fig. 4.10). This area has a smooth, rolling metal-surface contour covered with a thick, irregular mound of coarsely stratified iron oxides. The rest of the internal surface had suffered no metal loss.

Since deposits were not present and evidence of a waterline was not observed, it can be assumed that concentration of the caustic material was caused by highly localized nonnucleate boiling (DNB). The rifling of the internal surface is designed to induce swirling of the water to prevent nonnucleate boiling and steam/water phase stratification. It is surprising, therefore, to find severe caustic gouging in this tube design.

**Figure 4.9** Thick, irregular mound of hard iron oxides covering perforation.

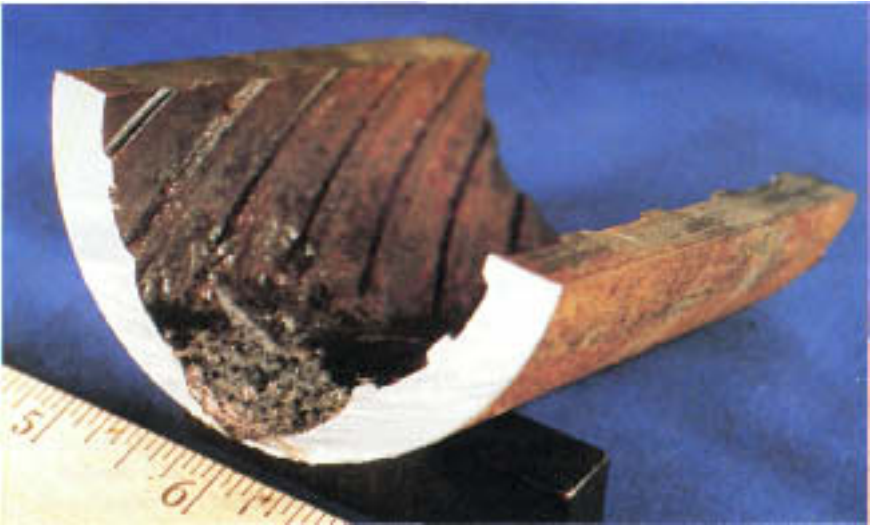
**Figure 4.10** Perforation at bottom of crater.

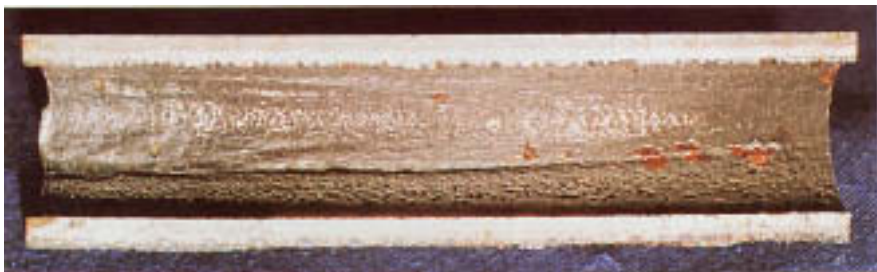
A massive longitudinal perforation was evident on this tube section. The failure resulted from wall thinning on the internal surface. Metal loss was localized to the top of the tube and the area of metal loss was approximately 19 in. (48.3 cm) long (Fig. 4.11).

Examination revealed a distinct groove along the top of the internal surface; this groove diminished gradually in both depth and width as the tube assumed a vertical orientation. Vertical surfaces were not corroded. The groove surface was very smooth, slightly rolling in contour, and covered with a uniform coating of black iron oxide. The surface at the perimeter of the groove was marked by a dense population of deep, hemispherical pits that

**Figure 4.11** Groove approximately 14 in. (35.6 cm) from perforation.

The grooving resulted from the concentration of sodium hydroxide due to steam accumulation and channeling along the upper horizontal and slanted regions of the internal surfaces. In addition to the important contribution of the tube's horizontal and slanted orientation, the accumulation of steam resulted from a condition of either excessive heat input in this region or impaired coolant flow through these tubes. This problem might be corrected by reducing heat input in this part of the boiler or by increasing water velocity through these tubes.

These types of failures have also been prevented through the use of rifled tubes. Closer control of the chemical program for the boiler water also might eliminate this type of failure.

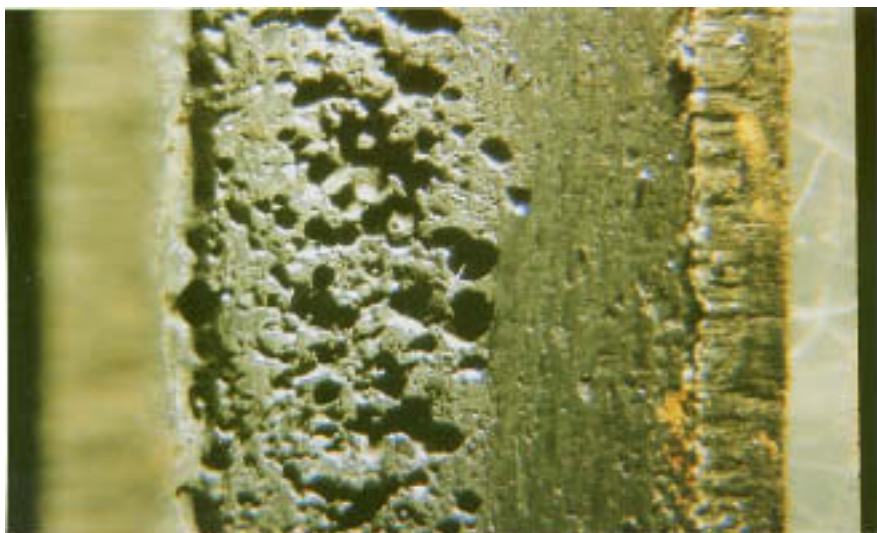
existed in a distinct band along the sides and at each end of the groove (Fig. 4.12).

**Figure 4.12** Band of hemispherical pits adjacent to groove. (Magnification: 6.5X.)

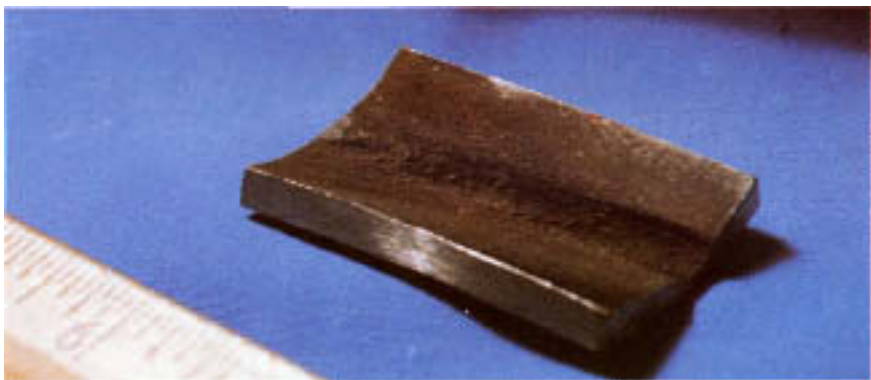
**Figure 4.13** Grooved window section cut from inner bend.

Visual examinations revealed a longitudinal groove on the internal surface along the top of the tube (Fig. 4.13). Perforation had not occurred, but as much as 60% of the tube wall had been corroded.

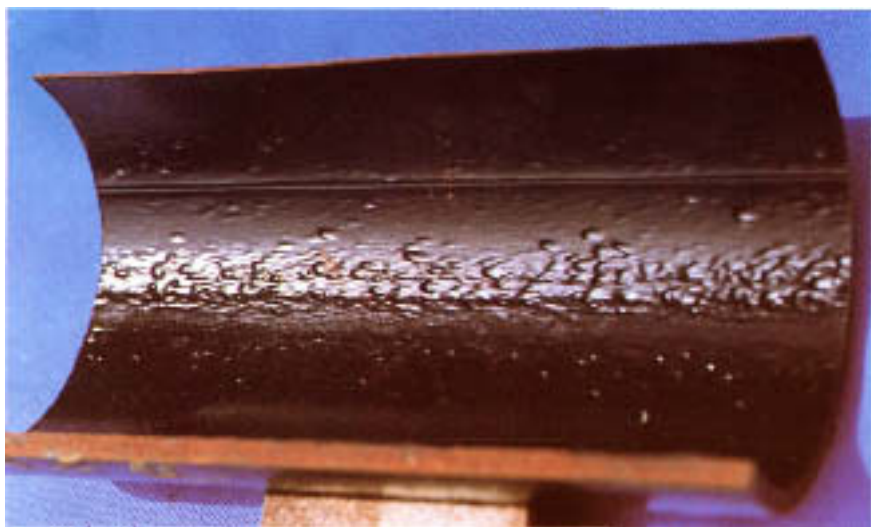
Surfaces attacked by chelants are typically very smooth and featureless. In situations where there is sufficient fluid velocity, the surfaces may have a smoothly rolling contour marked by “comet tails” and horseshoe-shaped depressions (Fig. 5.1). These features are aligned with the direction of flow. The metal surface will be uniformly covered with a submicroscopic film of

**Figure 5.1** Comet-tail and horseshoe-shaped depressions.

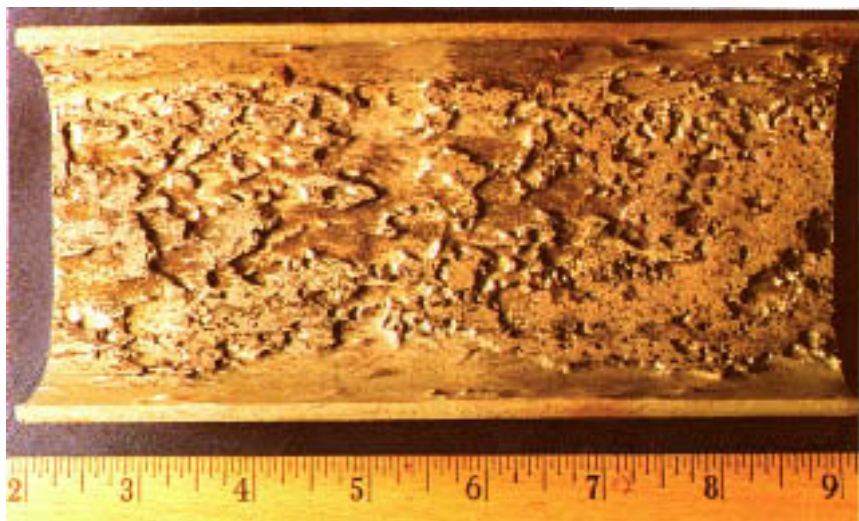
**Figure 5.2** Chelant corrosion altered by the presence of excessive oxygen.

metal loss (Fig. 5.2). Some observers have reported that attack by chelants has given a jagged roughness, similar to that resulting from attack by a strong acid.

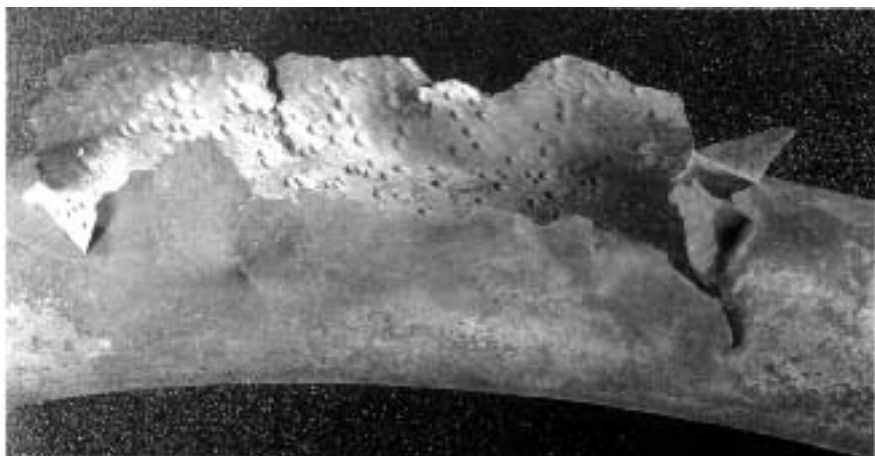
**Figure 5.3** Tube rupture after severe metal loss by chelant corrosion. (Courtesy of National Association of Corrosion Engineers.)

The massive rupture of the wall tube (Fig. 5.3) was the first to occur in the boiler. The edges of the rupture are very thin, and a population of horseshoe-shaped depressions oriented in the direction of flow can be seen along the wasted internal surface. Microstructural examinations revealed that overheating had not occurred.

The rupture occurred on the cold side of the tube. The insulation installed to protect the cold side of this tube apparently had been dislodged by steam impingement from a leaking superheater tube. Hot furnace gases that reached the unprotected back side of the tube caused unstable film boiling and concentration of chelant from the boiler water.

The combination of concentrated chelant and fluid velocity caused the thinning of the internal surface apparent in Fig. 5.3. Thinning of the tube wall in this manner continued until stresses imposed by normal internal pressure exceeded the tensile strength of the thinned tube wall.
