# **The Nalco Guide to Boiler Failure Analysis**

**Nalco Chemical Company**

**Robert D. Port**

**Harvey M. Herro**

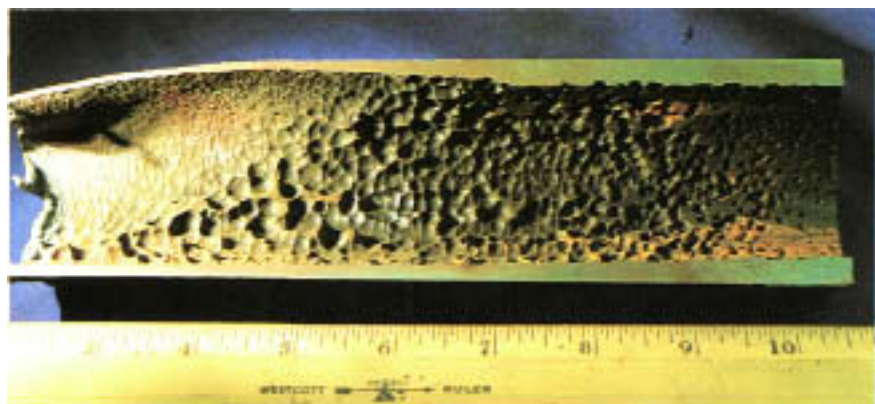
Failure of a section adjacent to the tube, illustrated in Fig. 5.4, occurred during hydrotesting. Severe internal wastage was confined to 6 to 9 in. (15.2 to 22.9 cm) of tube length in each of four adjacent tubes. Metal loss within the affected region varied. In areas of severe metal loss the appearance was smooth and wavelike. Discrete, isolated pits were evident in areas of moderate metal loss.

The highly localized attack on this section illustrates the importance of velocity and turbulence in an erosion-corrosion process involving chelants. Metal loss is severe in regions of turbulence at the inlet end of the tube from the header. The attack moderates with distance along the tube, until it ceases altogether where laminar flow is established. The chelant alone was not sufficiently aggressive to cause corrosion. Rather, metal loss resulted from the synergistic interaction of the chelant with localized turbulence.

**Figure 5.4** Chelant corrosion on internal surface of inlet end.

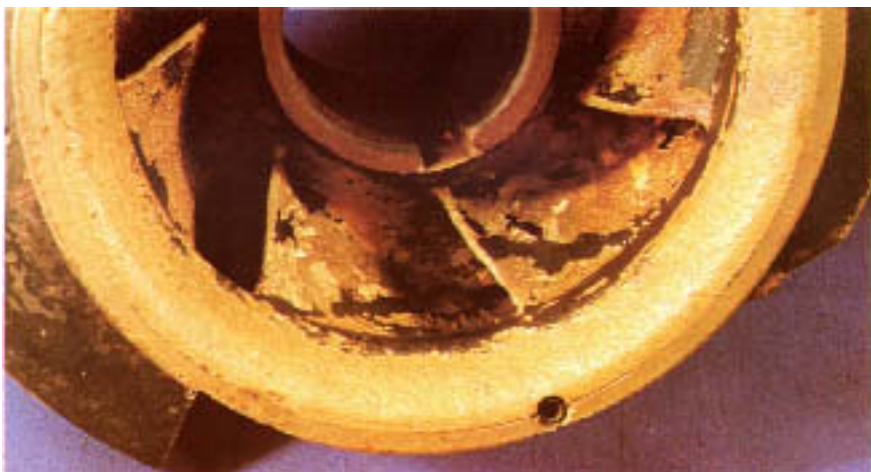
This impeller, illustrated in Fig. 5.5, was removed from the fifth stage of a feedwater pump. Broad areas of general wastage are apparent. Areas of metal loss are confined principally to regions of high turbulence such as the vane edges and discharge throat. Horseshoe-shaped depressions are visible in some regions.

**Figure 5.5** Chelant corrosion on feedwater pump.

Close examination of wasted surfaces under a low-power stereoscopic microscope revealed dendrites and other microstructural features of the casting. Chelants are aggressive toward copper and copper-based alloys and should be fed well downstream of copper-alloy impellers.

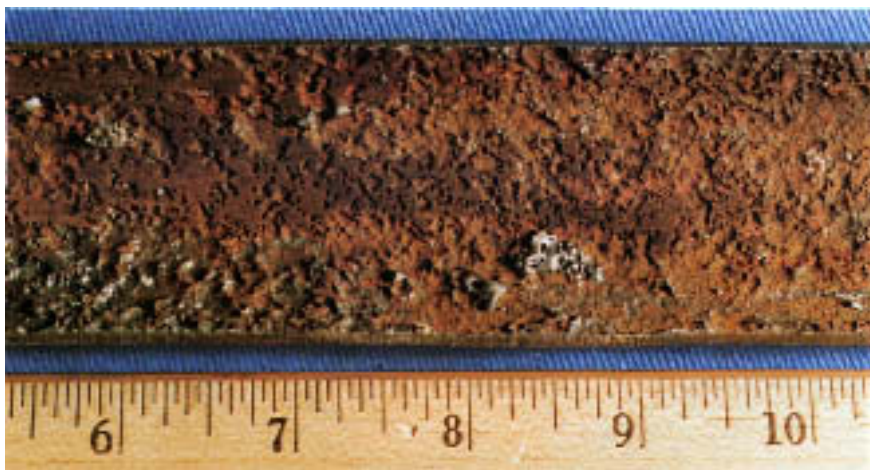
Figure 5.6 illustrates the appearance of the internal surfaces of 12 adjacent downcomer tubes that have suffered severe internal corrosion. Although the same water-treatment program had been utilized for this boiler for 17 years, this corrosion occurred within a period of 7 months.

The affected tubes were located at one end of the boiler, within 9 in. (22.9 cm) of the feedwater line in the steam drum. It is surmised that feedwater was short-circuiting through the affected area.

**Figure 5.6** Internal surface of downcomer tube.

This type of failure can be prevented by gaining control of dissolved oxygen. Preventing short-circuiting of the feedwater is also a solution to this type of corrosion.

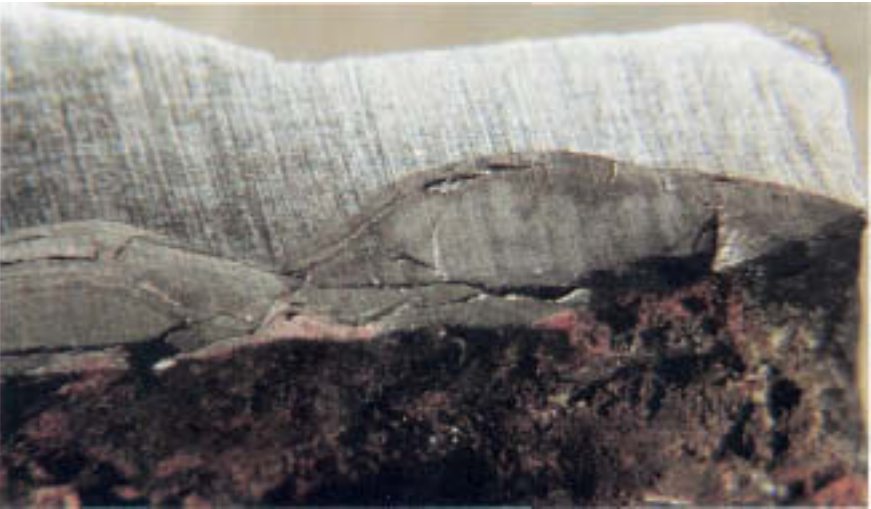
**Figure 6.2** Deep gouge on internal surface. (Magnification: 7.5X.)

Figure 6.2 illustrates the extent and appearance of the gouging. The crater was filled with thick, hard, iron oxides and elemental copper. (Most gouging had occurred downstream of circumferential welds.)

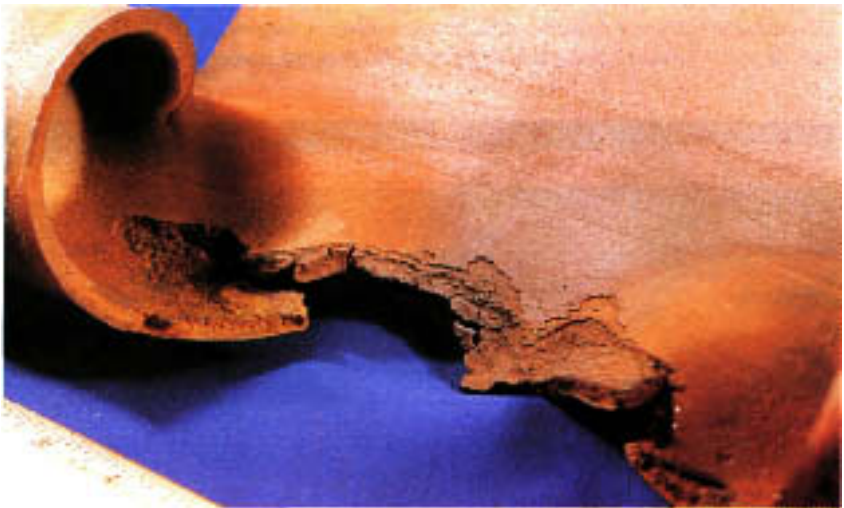
Figures 6.3 and 6.4 illustrate the massive rupture that occurred in a distinct zone of deep metal loss along the internal surface of this tube. Surrounding areas of the internal surface were unaffected and quite smooth.

**Figure 6.4** Metal loss at the origin of rupture.

Microstructural examinations revealed extensive hydrogen damage in the tube wall immediately below the gouged zone.

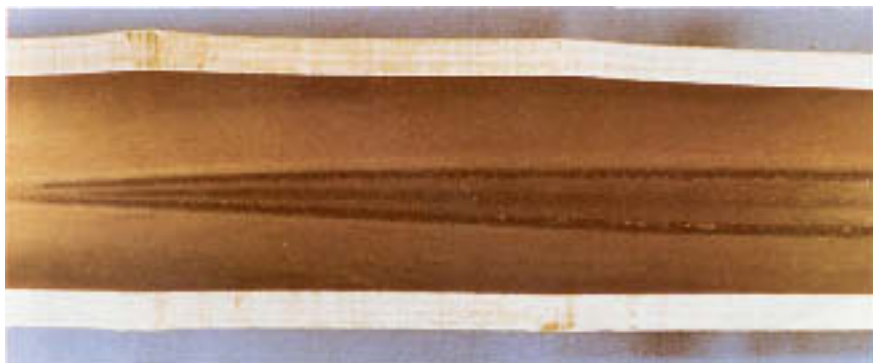
Figure 6.5 illustrates one of many tubes that had sustained similar severe corrosion. Grooves were located along the top (crown) of each tube. The convergence of the groove, apparent in Fig. 6.5, marked the position where the slanted tube assumed a vertical orientation. Metal loss was not observed downstream of this point.

**Figure 6.5** Convergence of groove.

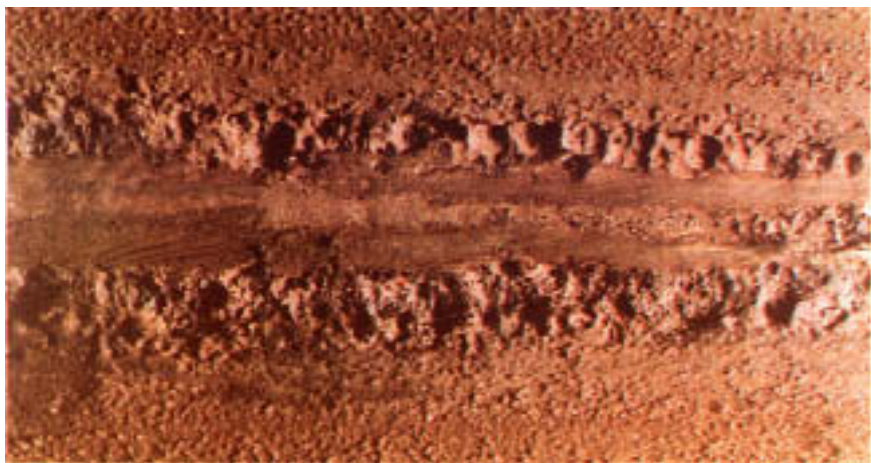
Corroded areas were covered with black, powdery deposits (Fig. 6.6). These deposits covered a second layer of light-colored material that was

**Figure 6.6** Appearance of deposits covering groove.

directly on the metal. The light-colored material was present only in corroded regions. On either side of the groove a hard coating of protective magnetite covered the smooth internal surface. The contour of the corroded surface following removal of the deposits and the light-colored material is shown in Fig. 6.7.

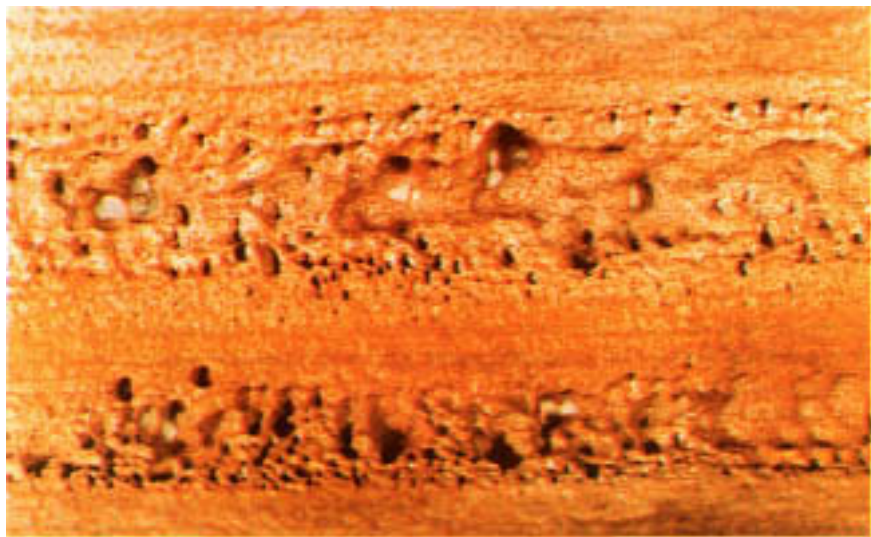
**Figure 6.7** Contour of groove after deposit removal. (Courtesy of Electric Power Research Institute.)

Microstructural analyses revealed that the grooved tube wall had sustained mild overheating. Analyses of the substances covering corroded surfaces revealed that the light-colored material on the metal surface was highly crystalline and was composed of iron and phosphorus. X-ray diffraction studies of this material revealed iron phosphate and sodium iron phosphate.

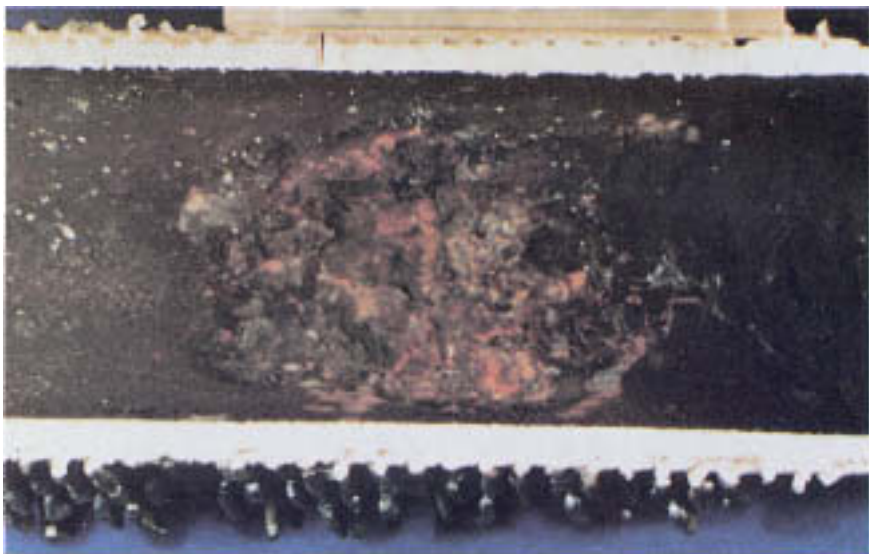
Corrosion was a recurrent problem in the economizer of this gas-fired boiler. Failures occurred only in the hot end of the economizer at the beginning of the finned area (Fig. 6.8). Heat fluxes in this area were 40% higher than design values.

Corrosion formed a large elliptically shaped gouge covered with a thick, irregular layer of hard, dark iron oxides. Microstructural examinations of the iron oxides covering this gouge revealed a laminated structure typical of low-pH gouging.

Nonnucleate boiling in this area of the economizer (caused by excessively high heat fluxes) furnished the means for concentrating corrosive, low-pH substances. The source of the acid-producing salts was undetermined, but may have been caused by leakage of sodium chloride from the regeneration of a water softener.

**Figure 6.8** Gouging along internal surface opposite fins.

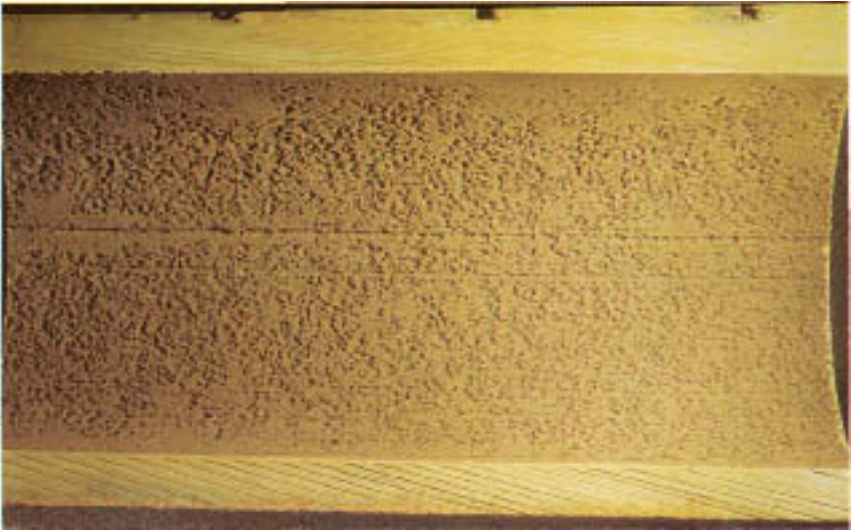
Attack of any metal surface of a boiler by strong acid is generally unmistakable. The surface usually has a rough or jagged appearance, depending on the severity of the attack (Figs. 7.1 and 7.4). A close examination will disclose discrete pits, which are frequently undercut. On boiler tubes, the pits will frequently be aligned longitudinally along the tube wall (Fig. 7.1).

**Figure 7.1** Acid corrosion on the internal surface of a wall tube. (Courtesy of Electric Power Research Institute.)

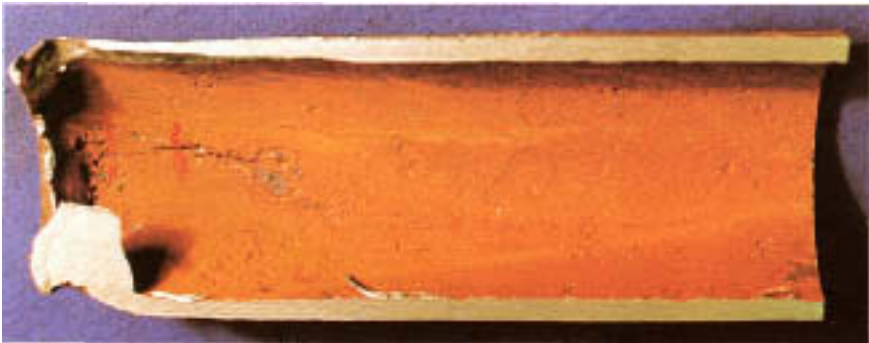
Following an acid cleaning of the boiler, the damage apparent in Figs. 7.5 and 7.6 was observed. Close visual examinations of these tubes revealed very fine, discontinuous fissures running longitudinally down the internal surfaces. These fissures, which appeared to coincide with a series of faint mandrel marks, were deeper at the end that had been rolled into the drum. The tube illustrated in Fig. 7.6 also shows deep transverse fissuring where it had been rolled into the drum. Examination of cross-sectional profiles of tube surfaces revealed they were jagged, undercut, and free of normally present iron oxides.

Attack by strong mineral acid is responsible for the delineation and deepening of mandrel marks running down the bore of the tube, as well as for the development of deep fissures near the end of the tubes that had been rolled into the drum. The delineation and deepening of the mandrel marks is associated with residual stresses in the metal at these sites from the tube-fabrication process. The presence of deep fissures of various orientations at the ends rolled into the drums is associated with residual stresses resulting from the tube-rolling process. Strong mineral acid characteristically attacks

**Figure 7.5** Longitudinal fissures near rolled end.

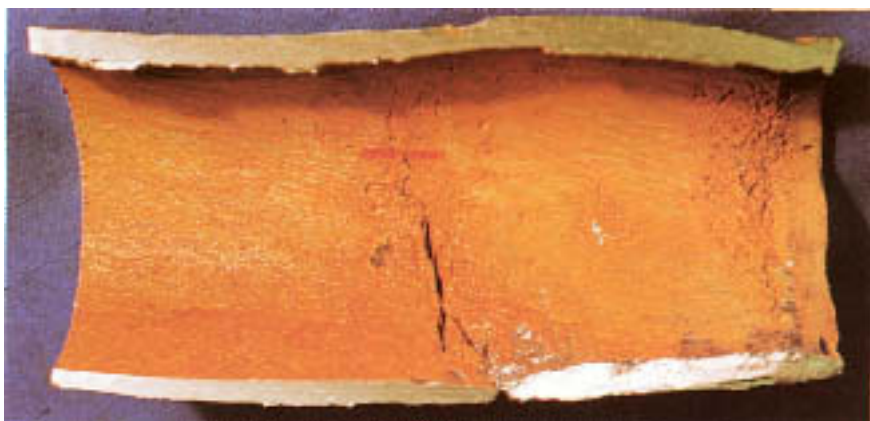
**Figure 7.6** Transverse fissures near rolled end.

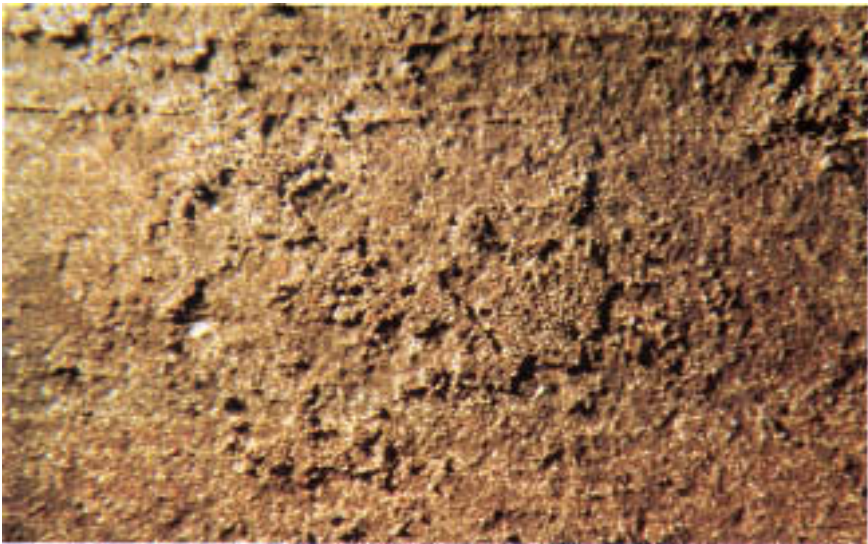
Attack by citric acid is illustrated in Fig. 7.7. Visually, the surface has an etched, bright metallic appearance. Close examination reveals irregular islands of uncorroded metal, which, in this case, stand 0.005 in. (0.12 mm) above the surrounding corroded surface. Essentially the entire internal

**Figure 7.7** Appearance of attack by citric acid. (Magnification: 7.5X.)

surface, both hot and cold sides, was similarly affected. This condition is consistent with attack during acid cleaning.

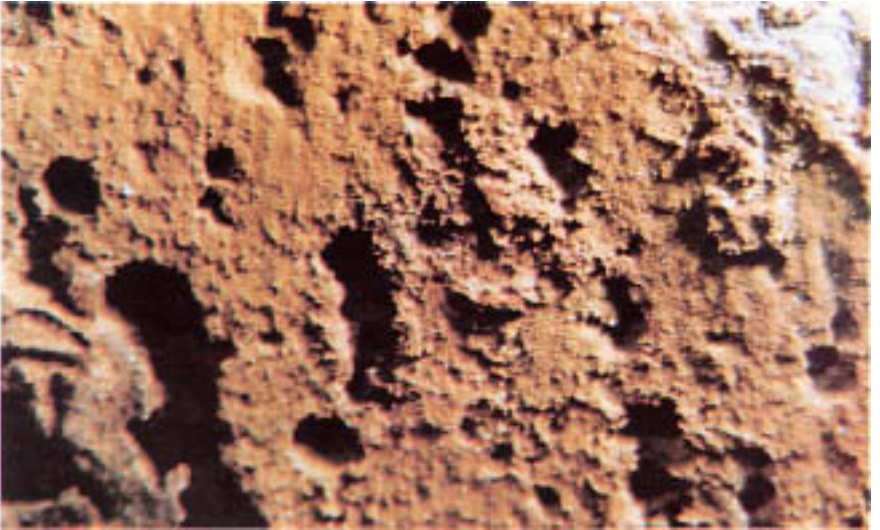
A number of fairly deep, overlapping pits were observed in a circumferential zone along the internal surface opposite circumferential welds on the external surfaces of the tubes (Fig. 7.9). Other areas of attack were noted in regions where welds were not present (Fig. 7.10). Attack in these areas was more pronounced along the tube seam.

**Figure 7.10** Acid corrosion along internal surface. (Magnification: 7.5X.)

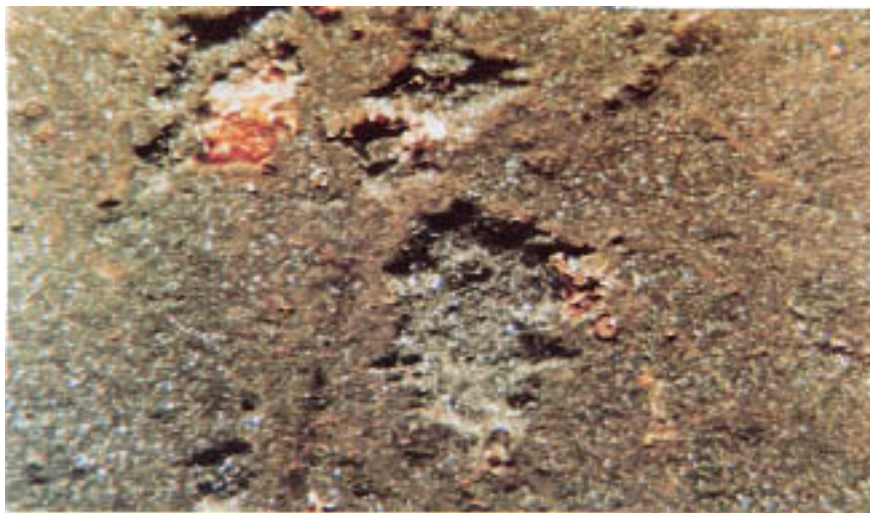
Visual examinations of belly-plate surfaces revealed shallow patches of irregular metal loss on all top and bottom surfaces. The sites of metal loss tended to be aligned in parallel rows. Figure 7.11 illustrates the appearance of the metal loss, although a thin coating of iron oxide tends to soften the normally sharp edges.

This case illustrates the importance of supporting observations in establishing low-pH corrosion as the cause of metal loss. Figure 7.11 lacks the classical, jagged, undercut surface profile normally associated with attack by a strong acid. However, the following additional observations strongly support the diagnosis:

- Alignment of attack sites in parallel rows oriented in the rolling direction of the steel from which the plate was fabricated
- Preferential attack of welds and tube ends in the steam drum
- Jagged, undercut, cross-sectional profiles of belly-plate surfaces apparent in metallographic examinations

**Figure 7.11** Metal loss from strong acid. (Magnification: 7.5X.)

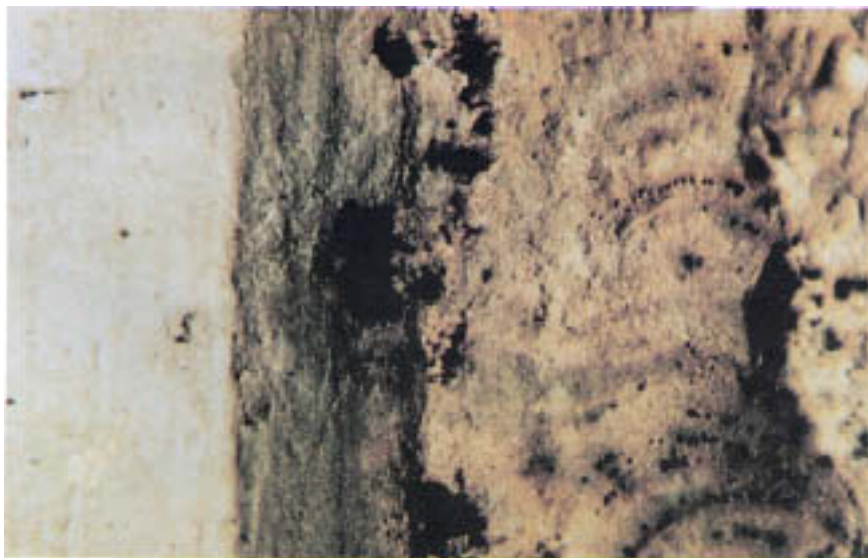
Close examination of the internal surfaces of the welds revealed highly localized areas of corrosion, which produced jagged, undercut surface contours typical of attack by strong mineral acid (Fig. 7.12).

Open crevices, pores, and pits in weld areas are sites where acid may survive neutralization steps following acid cleaning. Acid corrosion can enlarge and deepen these sites, resulting in eventual perforation of the tube wall at the weld.

**Figure 7.12** Acid attack along weld on internal surface. (Magnification: 7.5x.)

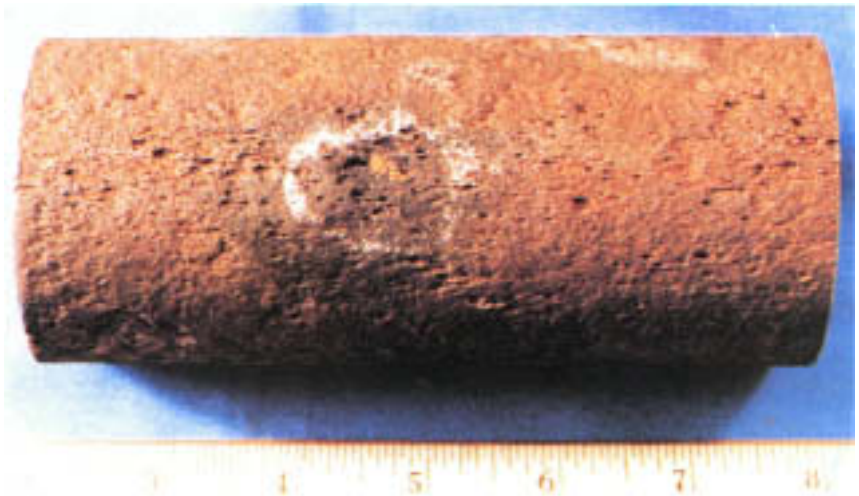
Hydrotesting following acid cleaning of the boiler revealed several leaking tubes. Examination of one of the leaking tubes revealed profuse pitting (Figs. 7.13 and 7.14). External surfaces were covered with a film of brown iron oxides.

Although some pitting may have occurred as a result of excessively high oxygen levels in the boiler water during idle times, the primary mode of attack was insufficiently controlled exposure to strong mineral acid during acid cleaning. Note the large population of pit sites, the general deterioration, and the appearance of fine longitudinal fissures characteristic of attack by a strong acid (Fig. 7.13).

**Figure 7.13** Acid corrosion on the external surface of a fire tube.

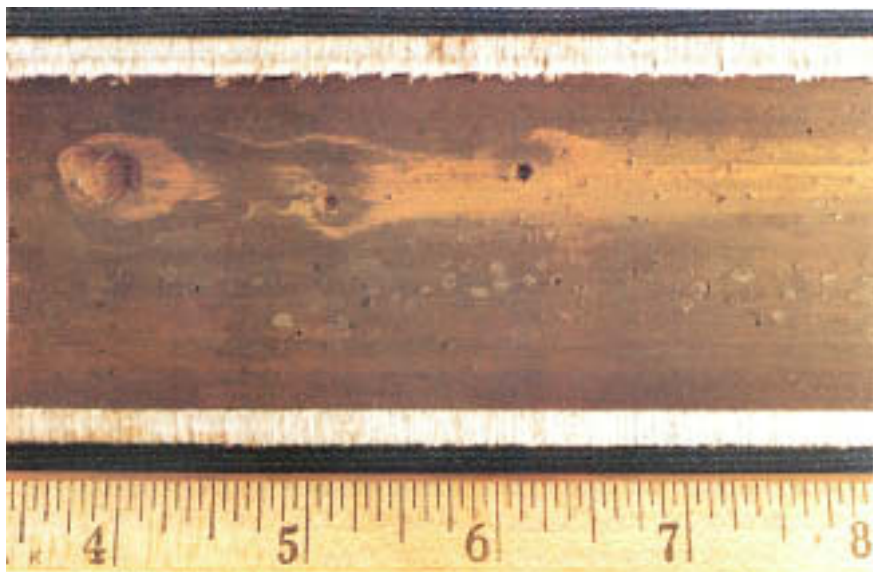
**Figure 8.1** Oxygen pits in section of superheater tube. (Courtesy of Electric Power Research Institute.)

The oxygen pits illustrated in Figs. 8.1 and 8.4 were discovered during a hydrotest of a recovery boiler that had been in wet lay-up over the summer. The superheater section had been in dry lay-up under a nitrogen blanket.

Gravity-induced drainage of corrosion products from sites on vertical sections is apparent in Fig. 8.1. Elliptical rings surrounding the pit on the horizontal portion of the pendant section indicate that a pool of condensate had been present (Fig. 8.4). Close examination under a low-power stereoscopic microscope revealed contraction cracks in the protective magnetite at the pit sites. It is apparent that, despite the precautions of dry lay-up, the tube had been exposed to condensed moisture and atmospheric oxygen.

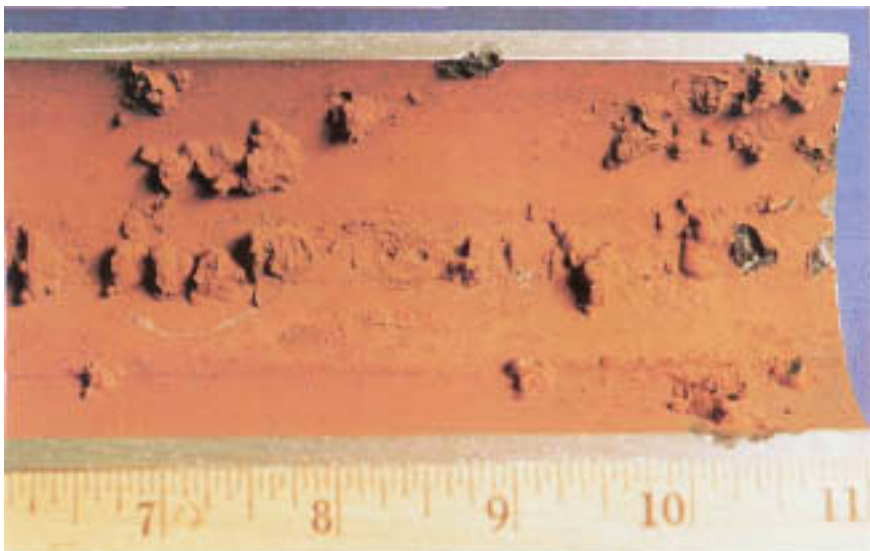
**Figure 8.2** Caps of iron oxide covering pit sites.

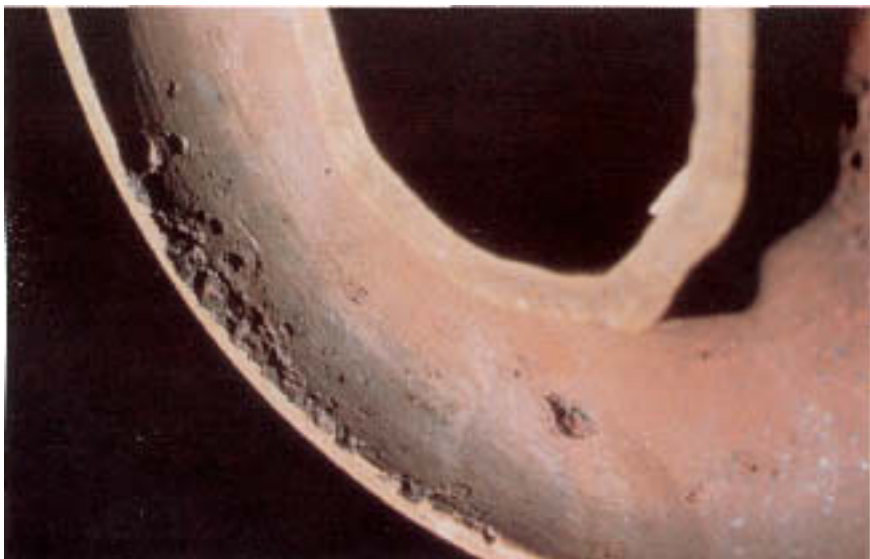
For example, moisture condensing on the walls of an idle superheater tube will dissolve atmospheric oxygen. Fractures in the protective magnetite are caused by contraction stresses as the superheater is cooled to ambient temperatures. The fracture sites furnish anodic regions where oxygen-containing moisture can react with bare, unprotected metal. The result may be deep, distinct, almost hemispherical pits (Fig. 8.1), which may be covered at times with caps of corrosion products (Fig. 8.2). Frequently, pitting will occur at the bottom of U-shaped superheater pendants where moisture can accumulate (Fig. 8.3).

**Figure 8.3** Oxygen pits along bottom of superheater pendant. (Courtesy of National Association of Corrosion Engineers.)

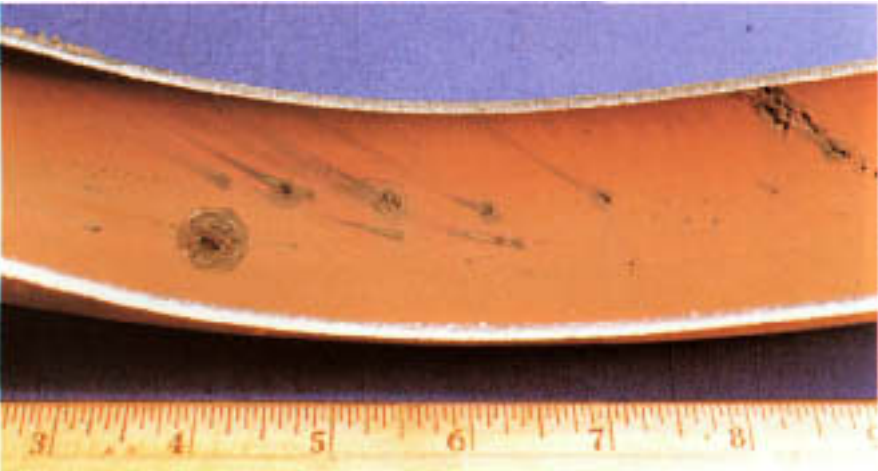
Figures 8.5 through 8.7 illustrate typical oxygen pitting resulting from an improperly executed wet lay-up. Inadequate feed of oxygen-scavenging chemicals, and/or failure to maintain proper water circulation, may have been responsible.

Gravitationally induced drainage of corrosion products is apparent in Fig. 8.5. This is evidence of stagnant or very low flow of water during lay-up. Significant water flow would have reoriented the drainage lines in the direction of water flow. Typical knoblike mounds of iron oxide corrosion products (tubercles) are shown in Figs. 8.6 and 8.7.

Figure 8.5 Oxygen pits on internal surface.

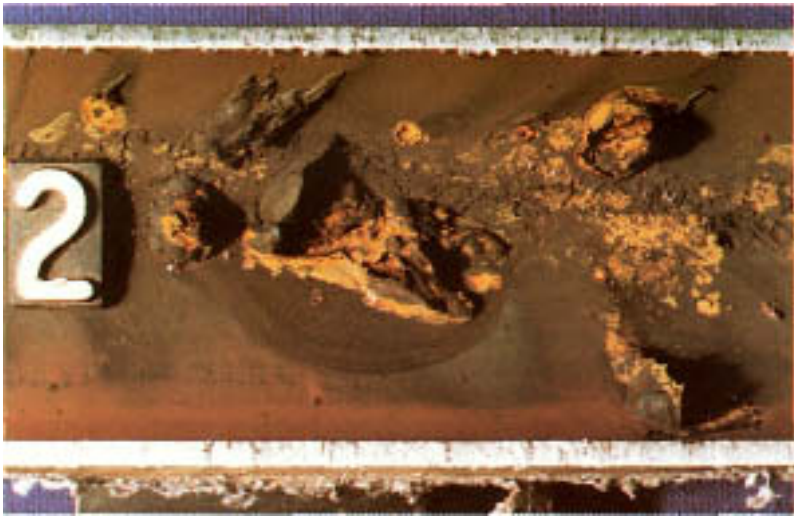
**Figure 8.6** Tubercles covering oxygen pits.

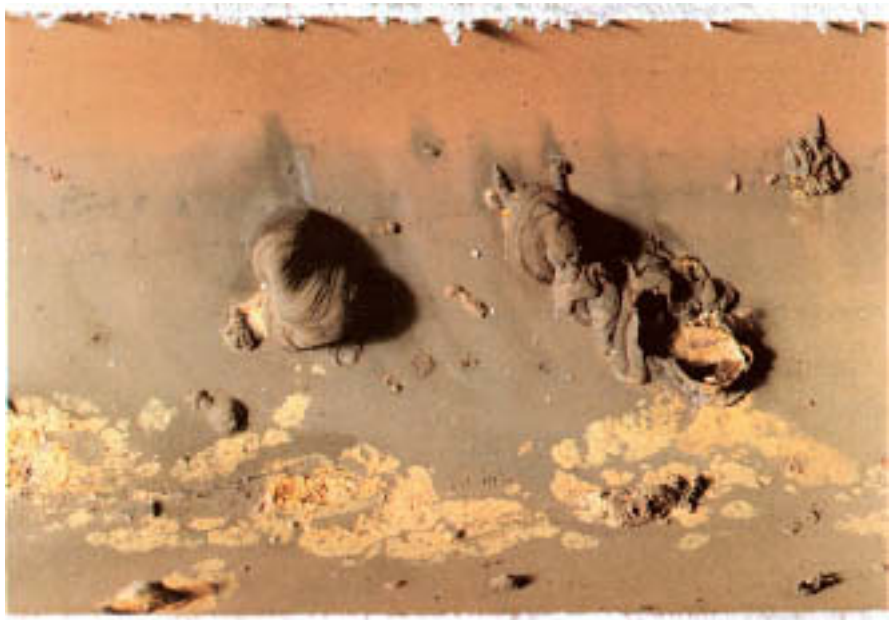
**Figure 8.7** Tubercles covering oxygen pits.

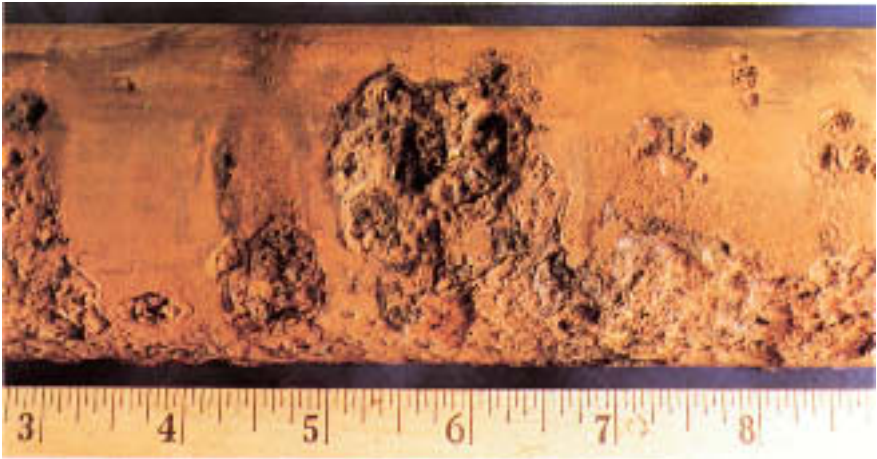
Figure 8.8 illustrates the external surface of a fire-tube boiler that has sustained severe oxygen corrosion. Interruptions of oxygen-scavenger feed lasting as long as 1 week had occurred. It is probable that the pitting initiated and progressed during these interruptions. Deposits, which can also induce pitting (deposit corrosion), were not present on the tube.

**Figure 8.8** Oxygen pitting on the external surface of fire tube.

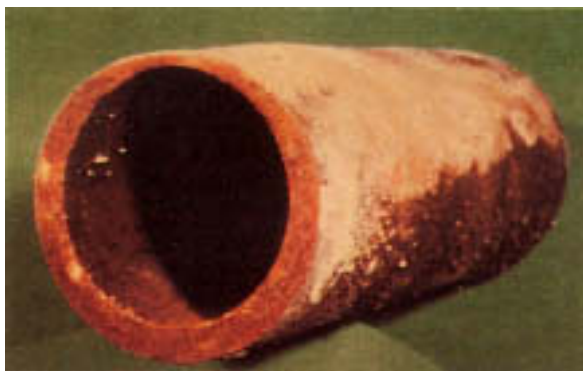
Figure 9.4 illustrates the appearance of oil-ash corrosion on a low-alloy steel tube. A section of a stainless steel reheater tube that has suffered oil-ash corrosion is illustrated in Fig. 9.5. Figure 9.6 illustrates the deterioration of a stainless steel tube at an attachment. The attachment, which protruded into the gas stream, acted as a heat-transfer fin, causing metal temperatures at its base to increase. Severe oil-ash corrosion resulted wherever the metal temperature exceeded 1100°F (593°C).

**Figure 9.4** Wall thinning from oil-ash corrosion. Corrosion rates of 30 mil/y (0.76 mm/y) have been observed. (Courtesy of Electric Power Research Institute.)

The first step in combating oil-ash corrosion is chemical analysis of both the fuel and ash to determine whether corrosive constituents are present. It is also important to know the fusion temperature of the ash. Annual surveys of tube-wall thickness using ultrasonic testing can give early warning of impending problems. If tube failure occurs, a wall-thickness survey can determine the extent and severity of the problem.

Elimination of oil-ash corrosion is accomplished by controlling the critical factors that govern it. First, if fuels containing very low quantities of vanadium, sodium, and sulfur cannot be specified, then recommendation of a fuel-treatment additive to prevent the formation of low-melting eutectics may be necessary. The use of magnesium compounds has proven to be

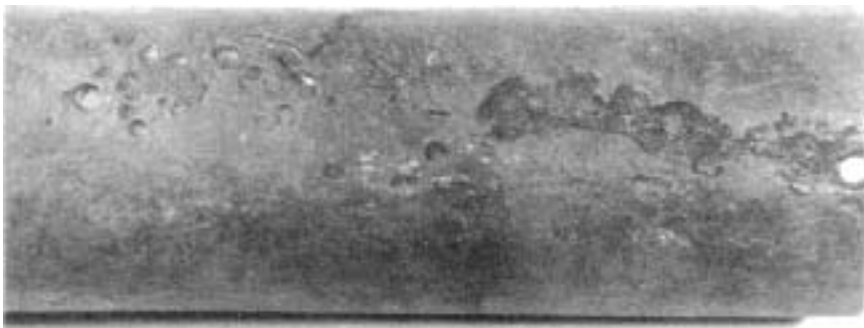
**Figure 9.5** Oil-ash corrosion on stainless steel reheater tube. (Courtesy of John Wiley and Sons, *Metallurgical Failures in Fossil Fired Boilers*, by David N. French, New York, 1983.)

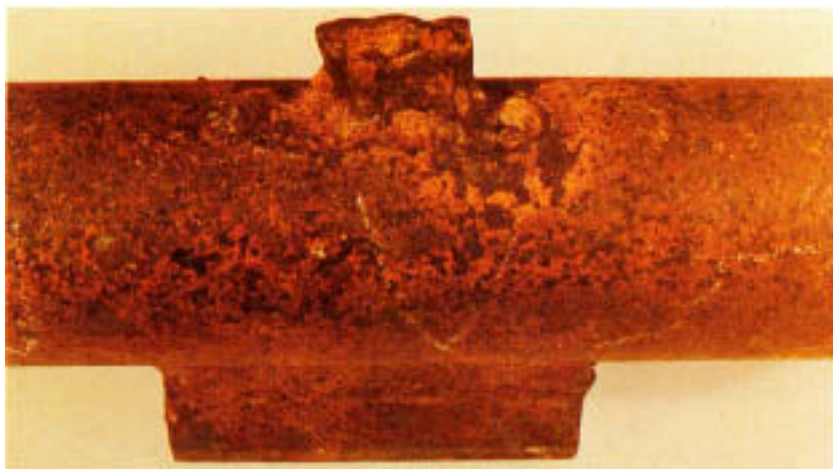
**Figure 9.6** High-temperature corrosion at the base of an attachment (top of photograph) on a stainless steel reheater tube. (Courtesy of Electric Power Research Institute.)

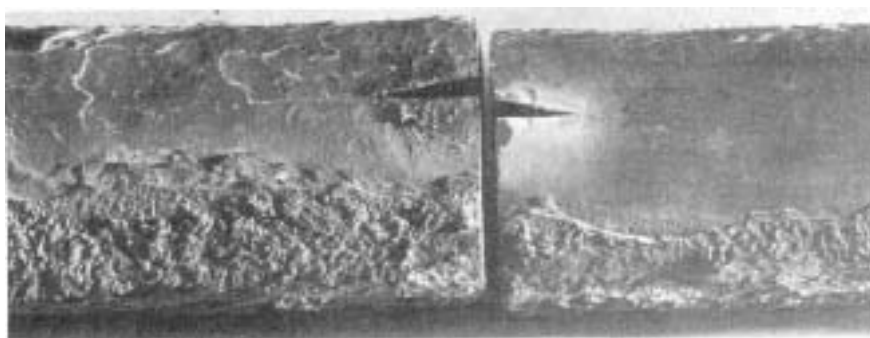
Coal-ash corrosion is identified by slag buildup on the tube wall and the associated metal loss. Austenitic stainless steel tubes may exhibit a pock-marked surface appearance. Low-alloy carbon steel tubes typically show a pair of flat zones of metal loss that are located on both sides of the leading face of the tube at orientations of 30 to 45°. Corroded surfaces have a grooved or roughened appearance (Fig. 10.1).

**Figure 10.1** Superheater tube (ASME SA-213, grade T22) that ruptured due to thinning by coal-ash corrosion. (Reprinted with permission of American Society for Metals Handbook, vol. 10, 8th ed., Metals Park, Ohio, 1975, p. 537.)

If corrosion is known to have occurred, ultrasonic thickness surveys are useful for determining the extent and severity of the attack. If corrosion is not severe, economic solutions may include periodic tube replacement, specification of thicker tube walls, use of thermal spray coatings, or pad welding. The use of stainless steel shields over affected areas has extended tube life.

Where coal-ash corrosion is severe, cladding of tubes with a resistant alloy may be required. To date, fuel additives have not been economically successful in combating coal-ash corrosion.

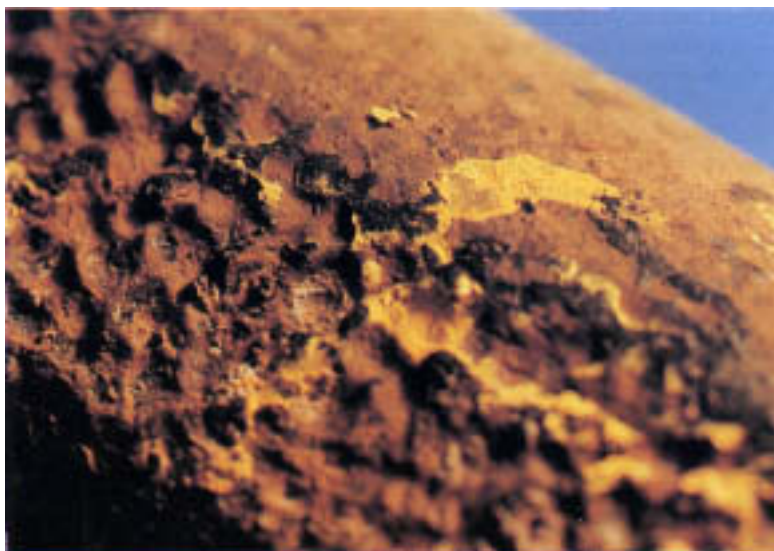
The boiler from which the tubes illustrated in Figs. 10.4 and 10.5 were removed had experienced chronic corrosion problems in the outlet pendants of the secondary superheater. Ten separate failures had occurred over a 3-year period. The boiler was operated continuously.

The tube submitted for analysis had not failed, but had sustained a 1-in.-wide (2.5-cm-wide) band of severe corrosion along one side of its external surface. Measurement indicated a reduction in tube-wall thickness of 0.085 in. (2.2 mm).

**Figure 10.4** Contour of external surface in corroded zone. Note pockmarked surface appearance characteristic of attack on stainless steel.

Microstructural examinations revealed solidified eutectics of slag covering the external surface in the corroded zone. Chemical analysis of material covering the corroded region revealed large amounts of iron, sulfur, and potassium, as well as components of fly ash.

Evidence from visual, microstructural, and chemical analyses identified the wastage as coal-ash corrosion resulting from the formation of complex alkali sulfates at the metal surface.

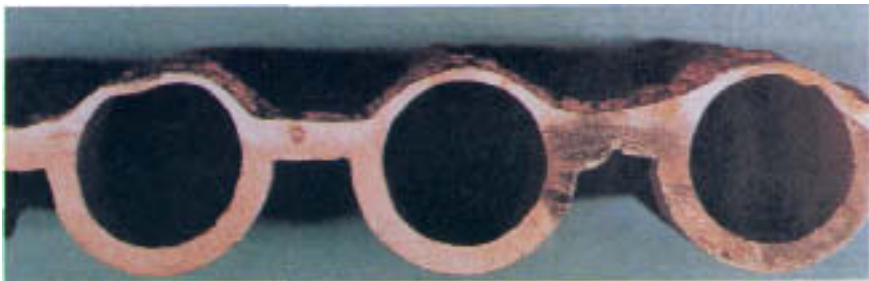
Waterwall–fire-side corrosion is frequently characterized by metal loss along the crown of the tube and may extend uniformly across several tubes in a particular location (Fig. 11.2). Corroded regions may be covered by abnormally thick layers of iron oxide and iron sulfide corrosion products. At times, flow patterns of the liquid pyrosulfates are apparent in regions of metal wastage.

**Figure 11.2** Severe fire-side metal loss on waterwall tubes. (Courtesy of Electric Power Research Institute.)

Since the critical factors governing this form of deterioration relate to combustion characteristics, reduction or elimination of this problem can be realized by making appropriate changes in the combustion process. Changes might consist of improving burning efficiency by grinding coal to a finer, more uniform size; balancing fuel supply to individual burners; adjusting burners to prevent flame impingement; and increasing and redistributing secondary air.

Experience has shown, however, that only marginal improvement in combustion can be expected from these corrections. A furnace modification may be necessary to achieve substantial improvement. To date, fuel additives have not been economically successful in combating waterwall-fire-side corrosion.

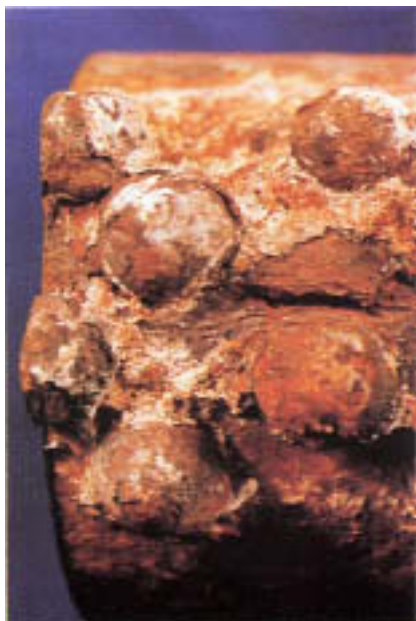
Six tube failures of the type illustrated in Fig. 11.3 occurred over a period of several weeks. Only roof tubes had failed.

Visual examination of the external surface of one of the tubes revealed a deep, longitudinal fissure at the base of a stud (Fig. 11.3). This surface was covered with a hard, tenacious, light-colored slag. Chemical analysis of this fire-side slag revealed 42% sulfur and 18% sodium. The pH of a 1% slurry of the deposit was 2.9.

Microstructural examinations revealed no thermal alteration of the tube metal. However, deep, intergranular fissures filled with a complex sulfate eutectic were observed originating on the external surface.

**Figure 11.3** Longitudinal fissure adjacent to stud; fissure was caused by the combined effects of stresses imposed by internal pressure and the presence of a molten phase.

Visual and microstructural examinations, coupled with chemical analysis of the slag, revealed that the cracking apparent in Fig. 11.3 resulted from penetration of molten sodium pyrosulfate along grain boundary pathways of the tube-wall metal during boiler operation. Stresses imposed by normal internal pressure acted synergistically with the molten slag to produce the intergranular penetration. Microstructural examinations reveal that this attack was localized to a small region around the primary crack.

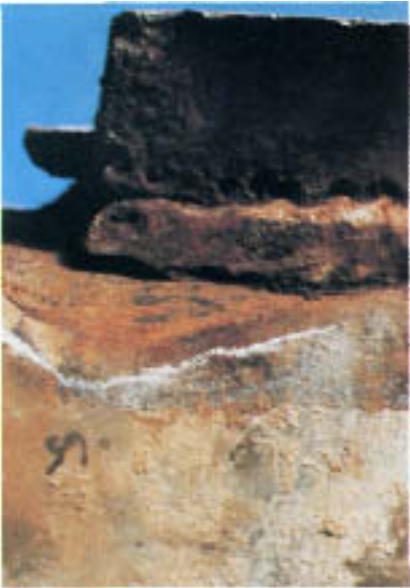
Figure 11.4 shows metal loss from the external surface near a longitudinally oriented fin. Metal loss was confined to an elliptical region centered on the fin. The stainless steel cladding as well as some underlying carbon steel was corroded away.

**Figure 11.4** Metal loss around a fin resulting from exposure of a stainless steel-clad tube to a molten sodium salt.

Mitigation of this problem requires redesign of tube openings so that seals are tight to flue gas. In addition, crevices where corrosive substances can concentrate must be eliminated.

Repair of damage is most successful when weld overlays of high-nickel stainless steels and thermal spray coatings are used.

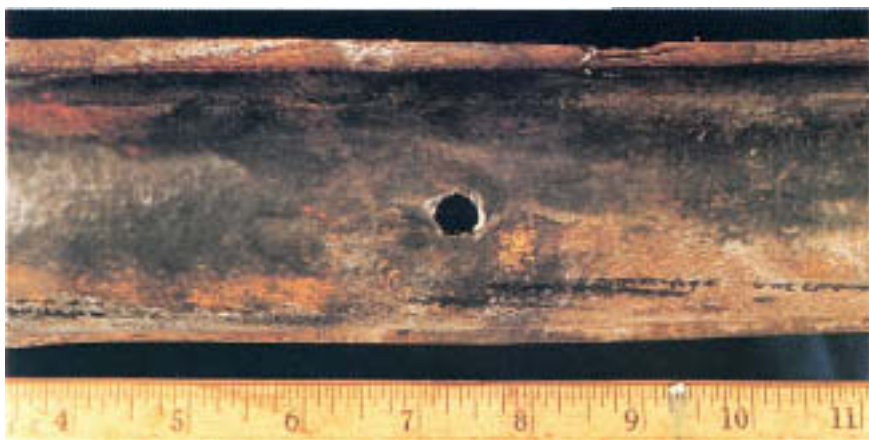
The corrosion apparent in Figs. 11.5 and 11.6 occurred over a very small area of the wall at a position 40 ft (12.2 m) above the floor and 4 ft (1.2 m) above oil guns. A failure of this type had not occurred previously.

**Figure 11.5** Perforation in a region of severe metal loss.

The  $\frac{3}{8}$ -in. hole in Fig. 11.5 is centered in a region of severe external corrosion along the crown of the tube. The corrosion has produced deep, broad depressions, which give the surface a rolling contour. Microstructural examinations revealed no evidence of overheating.

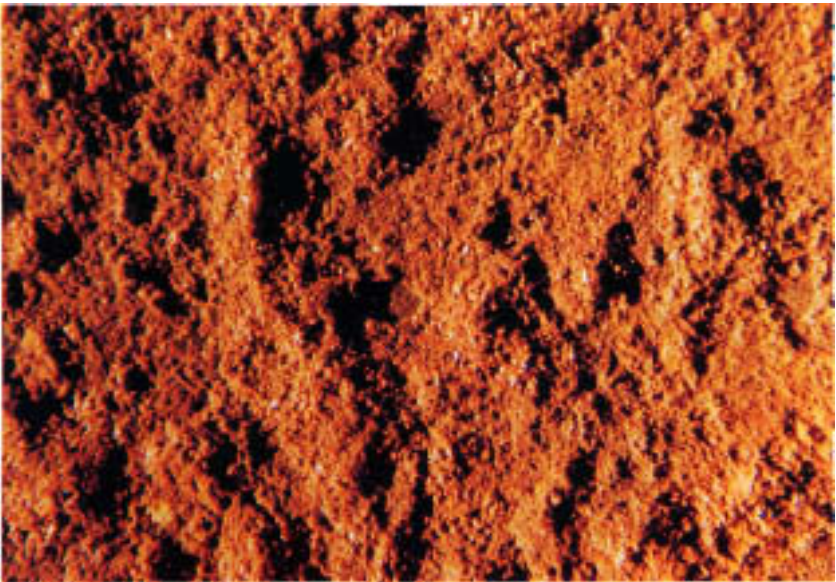
Figure 12.3 is a close-up photograph of the external surface of an economizer tube that has sustained general corrosion. Note the pockmarked contour. Corrosion occurred in regions of the economizer where sulfuric acid condensed from the flue gas. Such condensation, if it occurs, generally affects the tubes at the end of the economizer where feedwater enters—i.e., the end where metal temperatures are lower.

**Figure 12.3** Pockmarked contour of economizer tube exposed to condensed sulfuric acid. (Magnification: 7.5 X.)

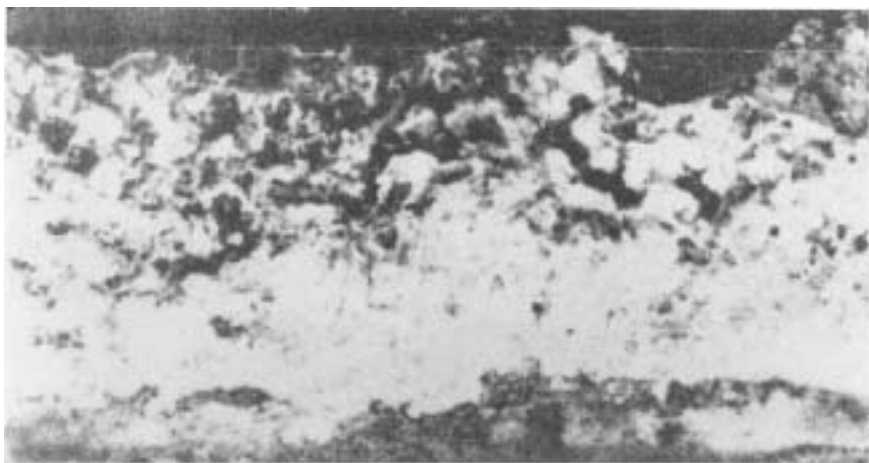
**Figure 13.1** Heavy ash buildup on fire side of boiler tube. (Reprinted with permission from Daniel P. Hamilton, "Preventing Dew-Point Corrosion during Boiler Shutdown," *Plant Engineering*, July 22, 1982, p. 73.)

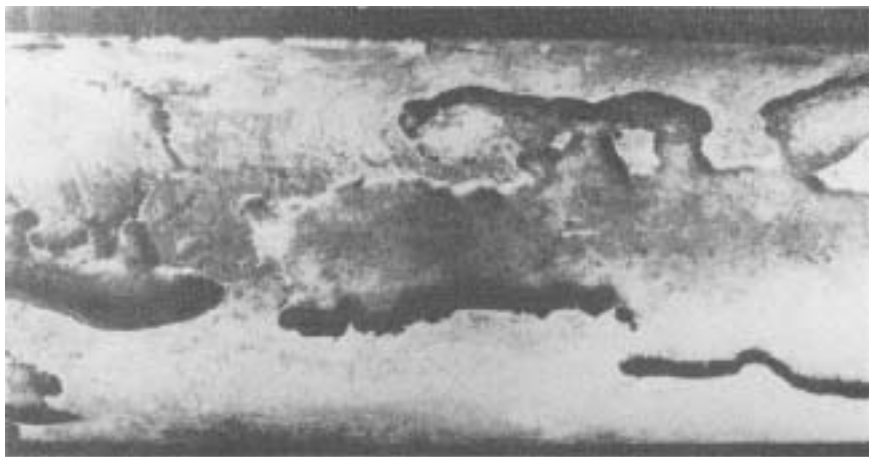
Once deposits are removed, simple visual inspection should disclose the occurrence of dew-point corrosion (Fig. 13.2). Typically, metal attack will

**Figure 13.2** Severe, localized corrosion apparent after deposit removal. Areas adjacent to the deposits remain uncorroded. (Reprinted with permission from Daniel P. Hamilton, "Preventing Dew-Point Corrosion during Boiler Shutdown," *Plant Engineering*, July 22, 1982, p. 73.)

be confined to surfaces that were covered with the sulfurous ash deposits. The attack often produces well-defined regions of metal loss and leaves islands of metal relatively intact.

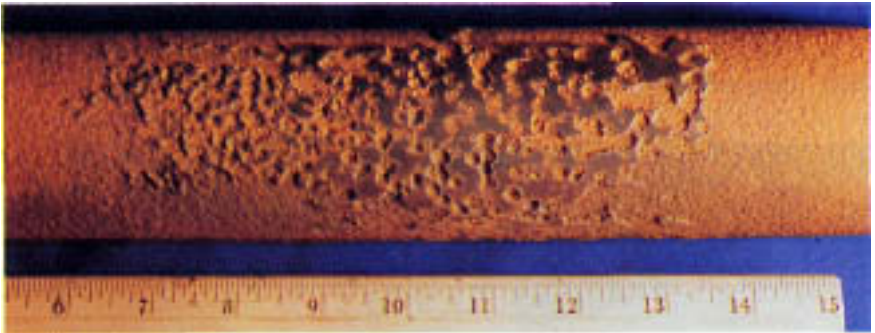
Measurement revealed a reduction in tube-wall thickness of approximately 20%. The corroded surface is rough, but smooth islands of the original surface remain.

Microstructural examinations revealed no evidence of attack of the external surface by high-temperature slag. The corrosion occurred during idle periods. An inadequate water wash of the boiler can leave corrosive, sulfur-containing, acid-producing salts. The remaining salts, coupled with moisture, are capable of producing the type of corrosion apparent on this tube.

**Figure 13.6** Corrosion resulting from inadequate water washing of external surfaces.

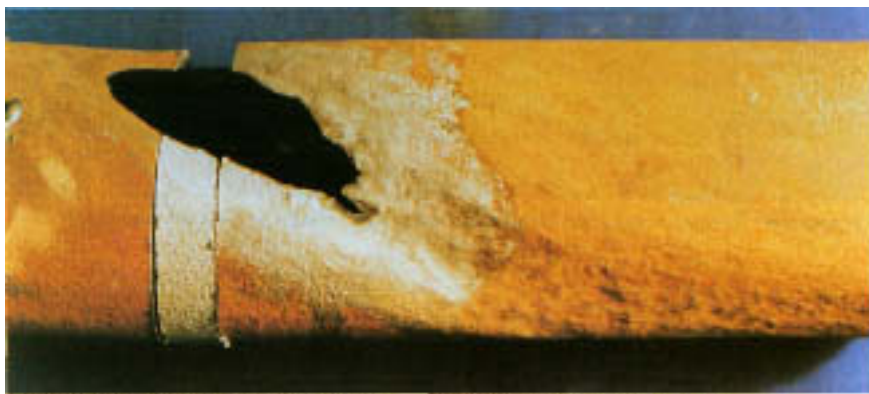
The tube illustrated in Fig. 13.7 was one of several similar tubes discovered during a fire-side inspection. The tube was positioned at a 45° angle in the boiler. The massive, perforating groove was oriented vertically. It was observed that the groove was directly aligned with water dripping from the economizer section above.

Incomplete washing of highly corrosive deposits in the air preheater furnished a source of highly corrosive water, which corroded every tube in its drip paths. Tubes in both the economizer and the boiler proper were affected.

**Figure 13.7** Grooving and perforation of a slanted tube resulting from corrosive water dripping from above.

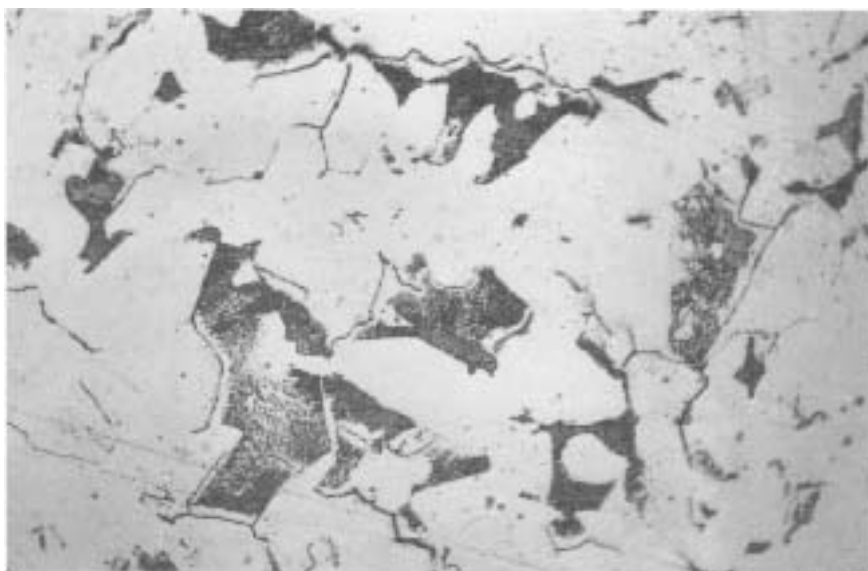
**Figure 14.1** Discontinuous intergranular microcracks resulting from methane formation in the grain boundaries. Note decarburization of adjacent pearlite colonies (dark islands). (Magnification: 500X.)

Since neither molecular hydrogen nor methane is capable of diffusing through the steel, these gases accumulate, primarily at grain boundaries. Eventually, gas pressures will cause separation of the metal at its grain boundaries, producing discontinuous intergranular microcracks (Fig. 14.1). As microcracks accumulate, tube strength diminishes until stresses imposed by boiler pressure exceed the tensile strength of the remaining, intact metal. At this point a thick-walled, longitudinal burst may occur (Fig. 14.2). Depending on the extent of hydrogen damage, a large, rectangular section of the wall frequently will be blown out, producing a gaping hole (Fig. 14.3).
