# **The Nalco Guide to Boiler Failure Analysis**

**Nalco Chemical Company**

**Robert D. Port**

**Harvey M. Herro**

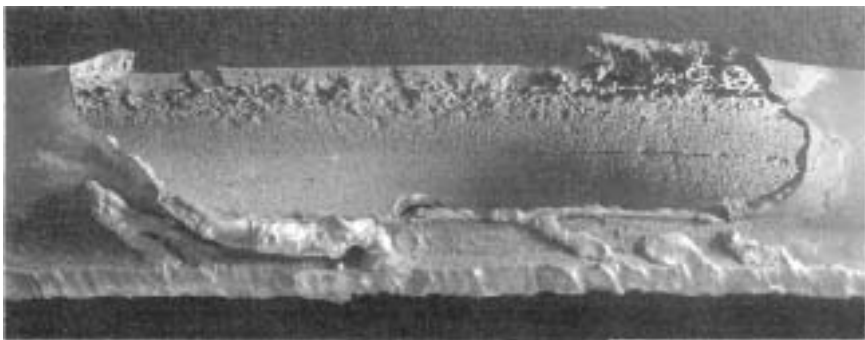
**Figure 14.3** Large wall section blown out of a hydrogen-damaged tube from a 2075-psi (14.3-MPa) boiler. Note zone of gouging along fracture line. (Courtesy of National Association of Corrosion Engineers.)

The boiler from which the section illustrated in Fig. 14.3 was taken is a forced-circulation unit that produces 2½ million pounds (1,134,000 kilograms) of steam per hour. The boiler had been in peaking service for 2 years.

Failures were recurrent in the nose section and roof tubes. An acid cleaning of the boiler was conducted. The failure shown in Fig. 14.3 is one of several that occurred after the acid cleaning.

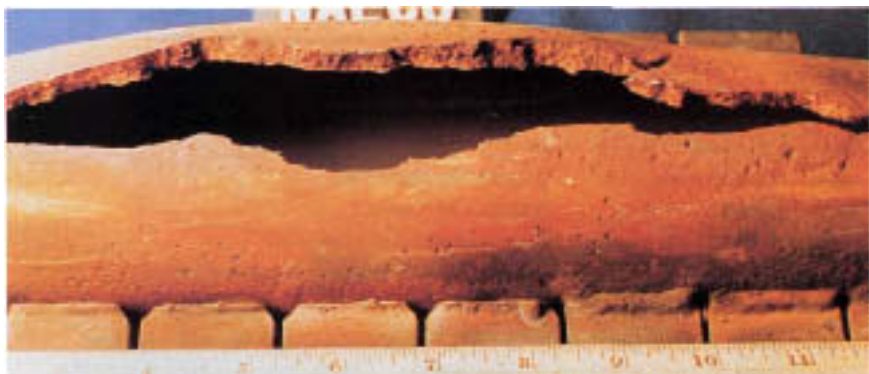
The thick-walled rupture shown in Fig. 14.5 is one of numerous similar failures recurring in both the nose-arch section and roof tubes, requiring this area of the boiler to be rebuilt. The boiler is in peaking service.

**Figure 14.5** Thick-walled rupture.

Examination of the microstructure revealed no thermal alteration. Numerous randomly oriented intergranular microcracks were present in the tube wall just below the corroded region.

Localized DNB resulted in concentration of sodium hydroxide, which caused deep caustic gouging at this site. The hydrogen damage and resulting fracture were a direct consequence of the caustic gouging.

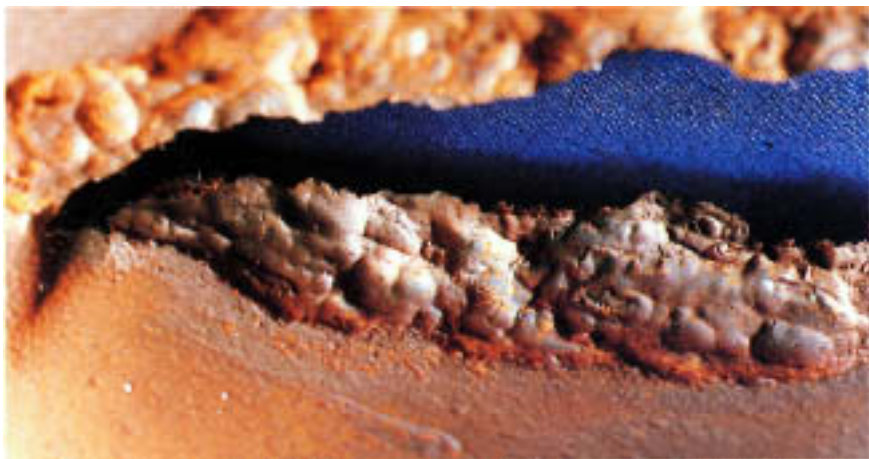
The rupture coincides with a distinct zone of deep metal loss on the internal surface (Fig. 14.6). The wavelike contour of the corroded region is covered with black iron oxide.

**Figure 14.6** Smooth, wavelike contours of internal surface resulting from caustic gouging.

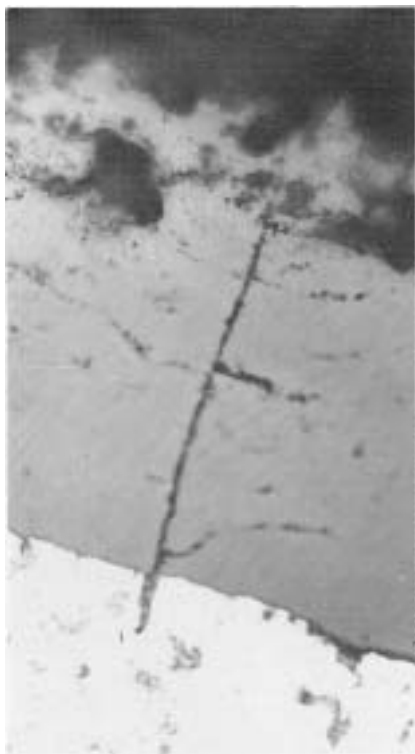
**Figure 15.1** Incipient corrosion-fatigue crack formed at base of cracked layer of iron oxide. (Magnification: 400X. Etchant: Picral.) (Courtesy of National Association of Corrosion Engineers.)

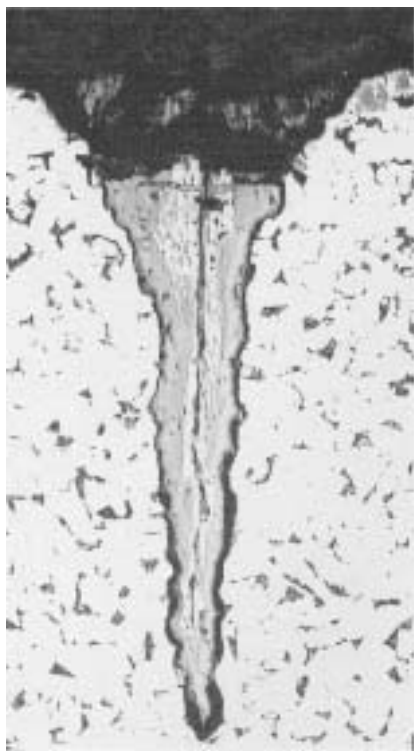
**Figure 15.2** Mature corrosion-fatigue crack. (Magnification: 200X. Etchant: Nital.) (Courtesy of National Association of Corrosion Engineers.)

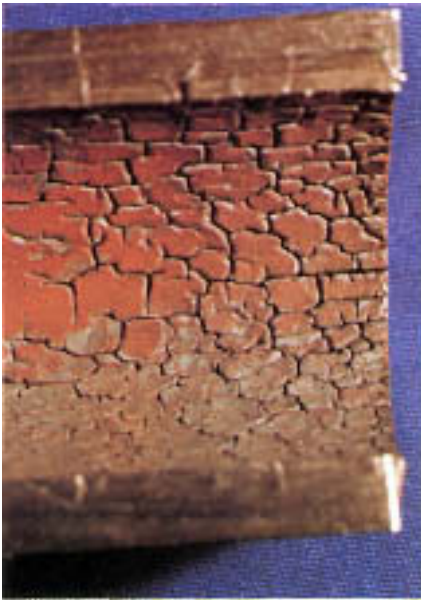
Deep, cross-hatched cracks and fissures are located in a distinct zone around one end of the internal surface of the drain line (Figs. 15.6 and 15.7). Cracks and fissures are not present in areas away from this end.

Microstructural examinations revealed classic thermal-fatigue cracks propagating through the wall. Evidence of mild overheating was also observed.

**Figure 15.6** Thermal-fatigue cracks on internal surface.

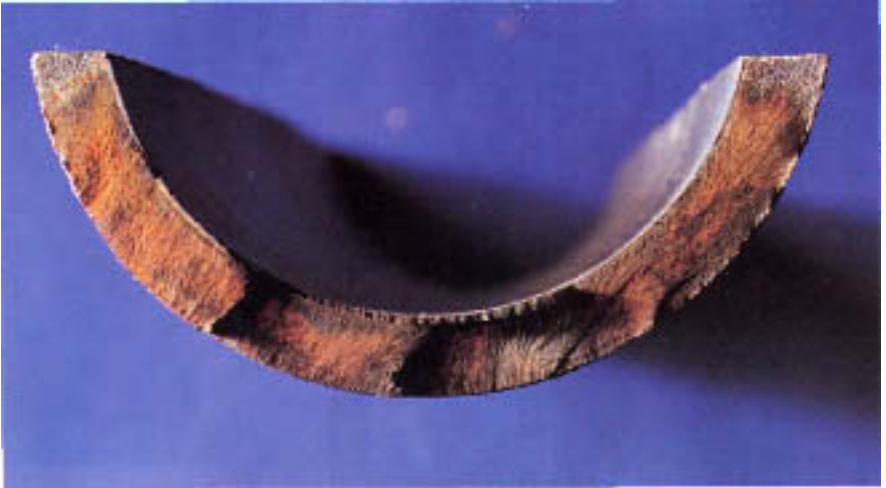
The thick-walled circumferential fracture shown in Fig. 15.10 was the first superheater failure in this boiler. Close visual examinations of both internal and external surfaces adjacent to the fracture revealed secondary cracks (Fig.

**Figure 15.10** Brittle fracture face resulting from corrosion fatigue.

15.11). Microstructural examinations of the tube wall confirmed the presence of families of unbranched transgranular cracks near the fracture both internally and externally. The circumferential orientation of the cracks reveals that the stresses responsible were cyclic bending stresses, possibly caused by thermal expansion and contraction of the tube.

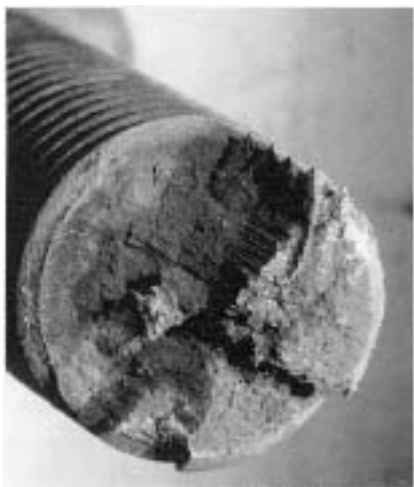
**Figure 16.1** Steam drum bolt that failed by caustic stress-corrosion cracking. Note the typical brittle character of the fracture. (*Courtesy of National Association of Corrosion Engineers.*)

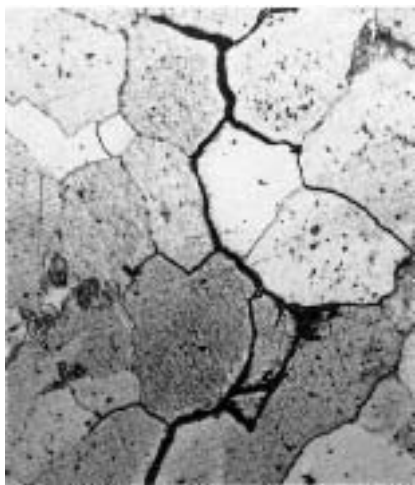
Gross attack of the metal is not necessary for this phenomenon and, in fact, does not characteristically accompany it. The combination of concentrated sodium hydroxide, some soluble silica, and tensile stresses will cause continuous intergranular cracks to form in carbon steel (Fig. 16.2). As the cracks progress, the strength of the remaining intact metal is exceeded, and a brittle, thick-walled fracture will occur.

**Figure 16.2** Caustic stress-corrosion cracking: continuous intergranular cracks running through a tube wall. (Magnification: 500X.)

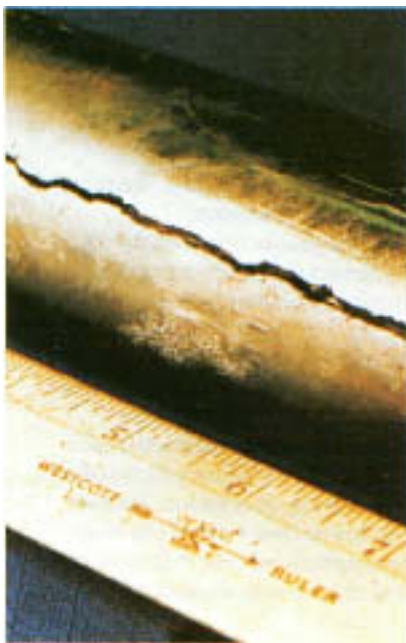
Figure 16.3 shows one of several stainless steel soot-blower lines that had cracked. Failures of this type can be quite dangerous, since steam can be released into occupied areas.

Close visual and microstructural examinations revealed that the cracks originated on the external surface. Microstructural examinations also revealed severe cold working of the metal.

**Figure 16.3** Extensive longitudinal crack in a stainless steel soot-blower line. Note that the crack edges have spread apart.

Elemental analysis of substances covering the crack face revealed the presence of chlorine.

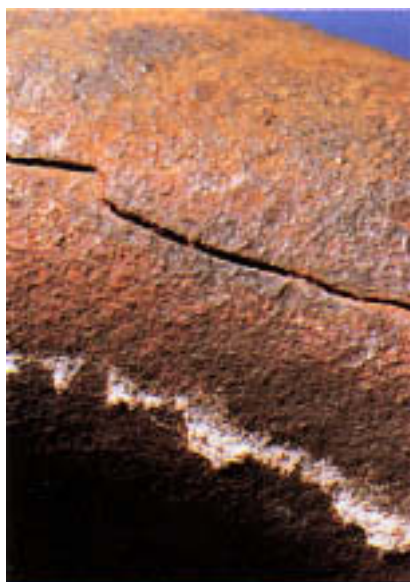
A section of an economizer tube having a 90° bend at its midpoint contains a pair of thick-walled cracks on opposite sides of the tube (Fig. 16.4). The tube had an oval rather than a circular cross section through the bend, and the cracks were located at opposite ends of the long axis of the oval.

Microstructural examinations revealed that the cracks originated at the bottom of shallow pits. The cracks exhibited branching as they propagated through the tube wall. Crack paths were principally across the metal grains (transgranular).

Stress-corrosion cracking in carbon steels requires the joint action of concentrated sodium hydroxide and tensile stresses. The sodium hydroxide apparently concentrated beneath porous iron oxide deposits that were present on the internal surface. The presence of crystalline magnetite indicates exposure to concentrated sodium hydroxide. The shallow pits acted as stress concentrators, elevating the normal stress level. In addition, stresses from internal pressure would be highest along the narrow ends of the oval cross section, where the cracks formed. The longitudinal orientation of the cracks reveals that internal pressure provided the stresses necessary for stress-corrosion cracking.

**Figure 16.4** Longitudinal crack along the side of a 90° bend in an economizer tube. A similar crack is located along the opposite side.

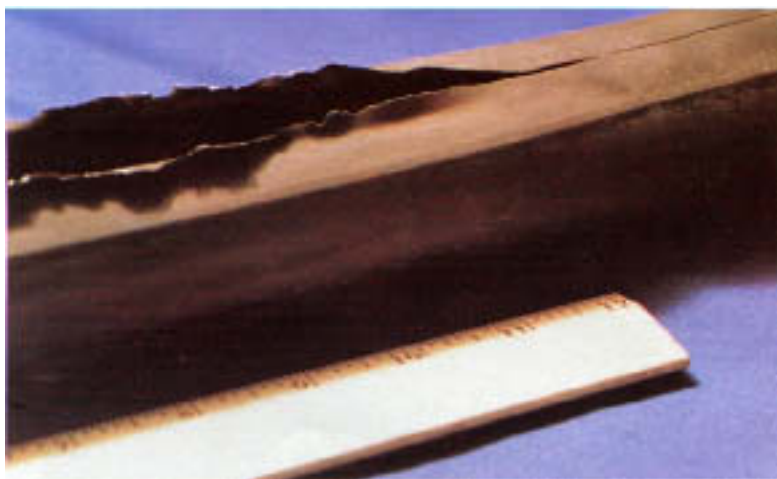
**Figure 17.2** Tube rupture caused by a misdirected soot blower. Rupture edges are thin and ragged because of tearing of the wasted steel in the eroded zone. The tube surface is light gray and shiny as a result of erosion of the normally present fire-side oxides and deposits.

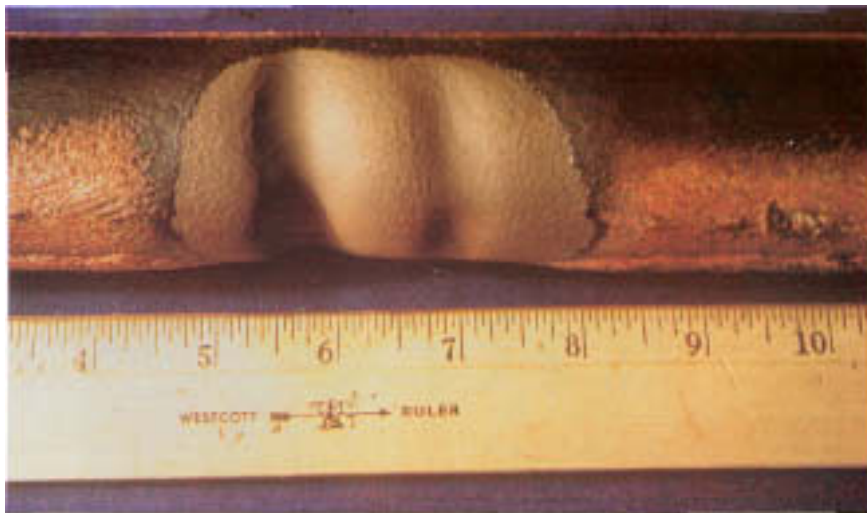
**Figure 17.5** Utility superheater tube cut by steam leaking from an adjacent tube that failed at a manufacturing defect. Note the smoothly undulating surface and removal of red and black oxides and deposits in the wasted area.

A series of failures of superheater tubes occurred almost 2 years after extensive retubing. Nearby tubes contained forming defects present as deep fissures. These fissures opened in service, causing steam cutting of adjacent tubes (Fig. 17.5).

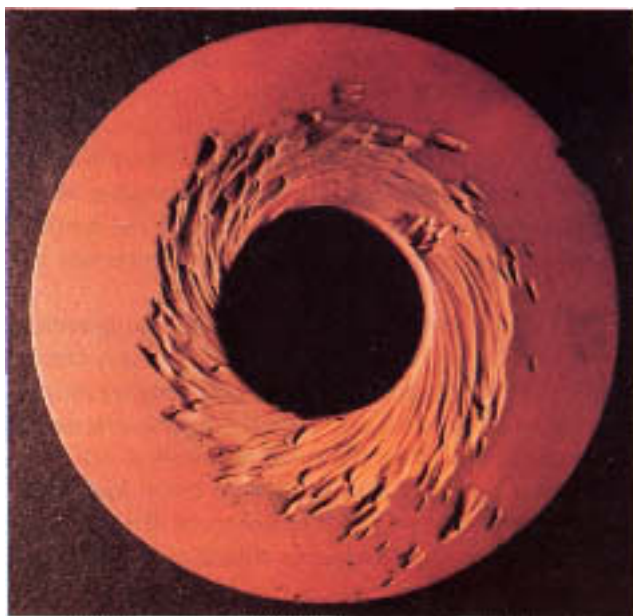
**Figure 17.9** Feedwater-pump spacer eroded by turbulent high-speed water. Flow patterns are obvious.

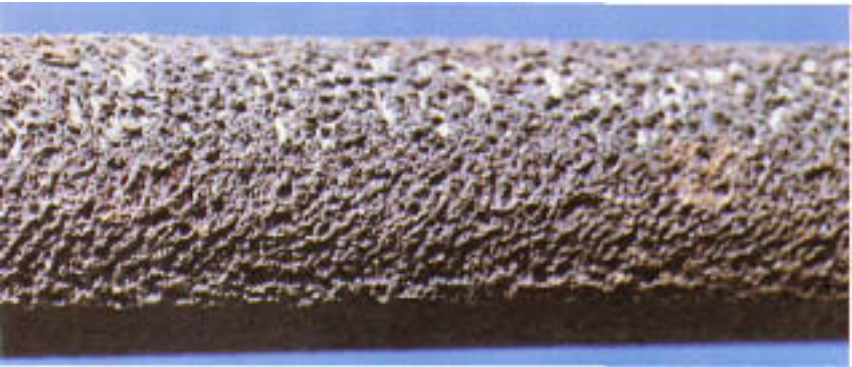
**Figure 17.13** Erosion on mild steel turbine drain line. Surface is festooned with small, conical projections pointing toward the direction of impingement.

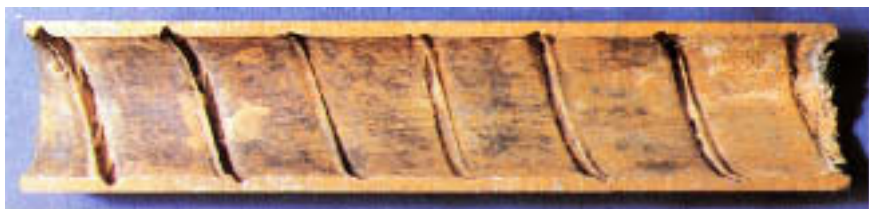
A longitudinally split section of flue-gas cooler used to preheat boiler feedwater contained helical grooves on internal surfaces (Fig. 17.14). Some grooves penetrated the tube wall, producing helical cracks, while other grooves went only one-third of the way through the wall. Grooves were undercut in the direction of gas flow.

Erosion occurred along a helical coil inside the tube. The helix was used to increase turbulence and eliminate deposits. High-velocity flue-gas flow became sufficiently turbulent at the helix to cause erosion failures.

**Figure 17.14** Spiral grooves cut into internal surface of flue-gas cooler by erosive gas flow. A spiral, stainless coil present inside the tube caused increased localized turbulence.

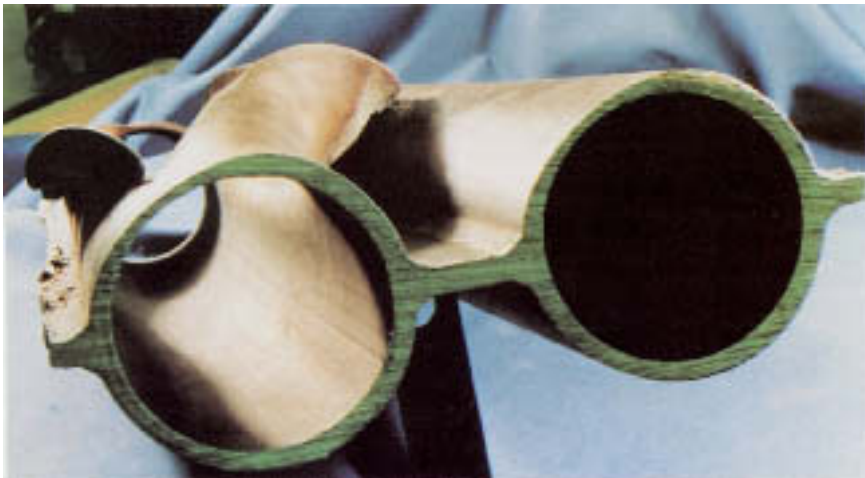
The section has a massive longitudinal rupture in a zone of severe metal loss from external surfaces (Fig. 17.16). Failure was caused by external-surface erosion. Microstructural examination revealed that hard particulate matter (sand) was entrained in bed gases. Impingement of sand against the tube reduced wall thickness, resulting in severe thinning. Rupture occurred when internal pressure exceeded the yield strength of the thinned tube.

The forced-draft fan maintained a 60- to 70-in. (15- to 17.5-cm) pressure head of water to fluidize the bed. No refractory or other surface protective devices such as studs or wear bars were present at the failure site.

**Figure 17.16** Ruptured division-wall tube from fluidized-bed boiler. Attack was caused by sand abrasion in the bed.

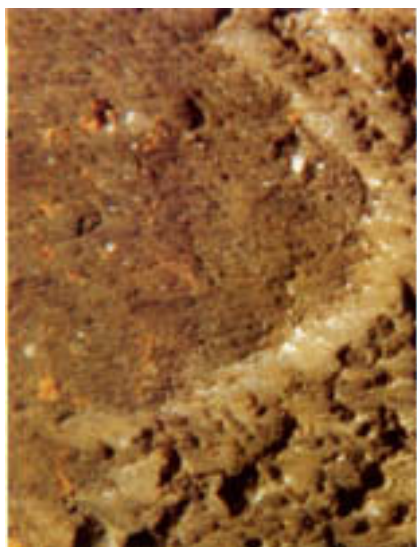
Internal surfaces were covered in some areas with a smooth, black magnetite layer. Severe metal loss was present in large, distinct patches (Fig. 17.17). The metal loss produced smooth, mildly rolling contours free of deposits or corrosion products. Flow-oriented striations were present at the perimeter of the affected area (Fig. 17.18).

**Figure 17.18** Erosion patterns at edge of wasted area. As in Fig. 17.17. Note flow patterns. (Magnification: 7.5X.)

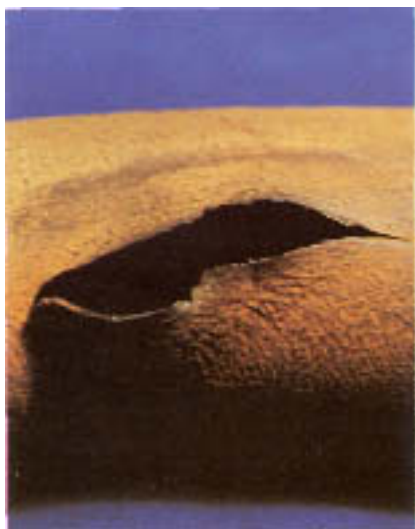
Substantial thinning of the external surface of the tube wall is present at the inner curvature of a bend in an economizer tube. A ragged rupture perforates the wall in a zone of severe thinning (Fig. 17.19). Away from the rupture, surfaces are relatively unattacked.

The rupture was caused by erosive wall thinning. Normal internal pressures could no longer be contained at the eroded site and the tube ruptured.

Erosion was caused by impingement of hard particulate matter entrained in flue gases. There was evidence of mild cold-end corrosion on all external surfaces.

**Figure 17.19** Rupture in an economizer tube caused by severe localized external-surface erosion associated with particulate matter entrained in flue gas.

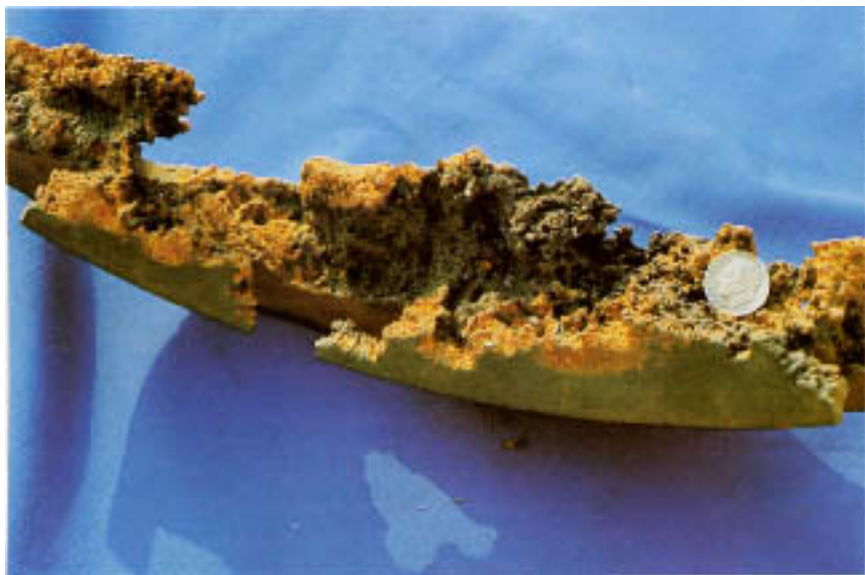
Alloy composition also influences attack. Soft, ductile metals and brittle, low-strength alloys such as gray cast iron are easily attacked (Fig. 18.2). Alloys such as chromium stainless steels are resistant to attack in many environments.

**Figure 18.2** Pump-housing section severely attacked by cavitation. Material of the pump-housing section is gray cast iron.

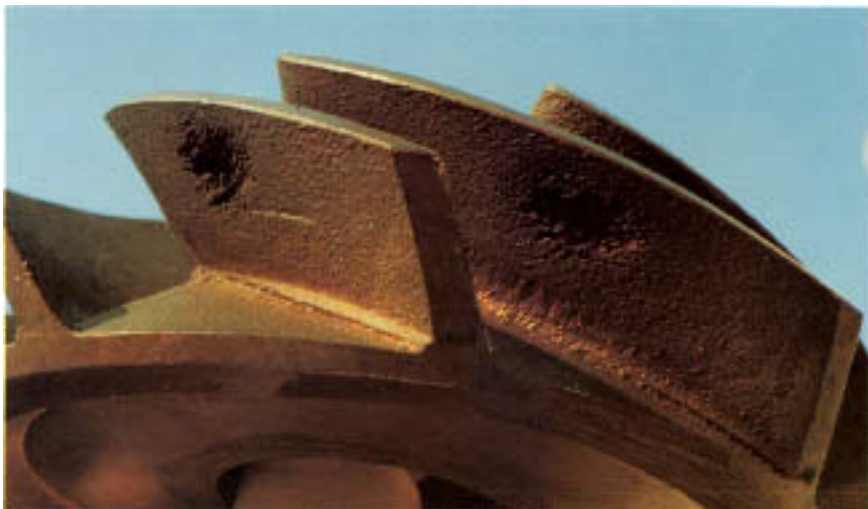
A striking feature of cavitation damage is the localized nature of attack. Wastage is most severe on pump impeller vanes near the outer periphery where impeller speed, and presumably turbulence, is highest (Fig. 18.3). Attack is most severe on trailing vane edges, where low-pressure areas are formed (Fig. 18.4). Pump shafts, for example, can be attacked locally where surfaces are exposed to turbulent conditions (Fig. 18.5). Adjacent surfaces are usually only lightly polished or apparently totally free of damage. Edges, corners, and projections all intensify turbulence, provide bubble-nucleation sites, and become preferred damage regions.

**Figure 18.4** Vane damage on low-pressure sides of small, special-purpose, bronze feedwater-pump impeller. Some vanes have been penetrated.

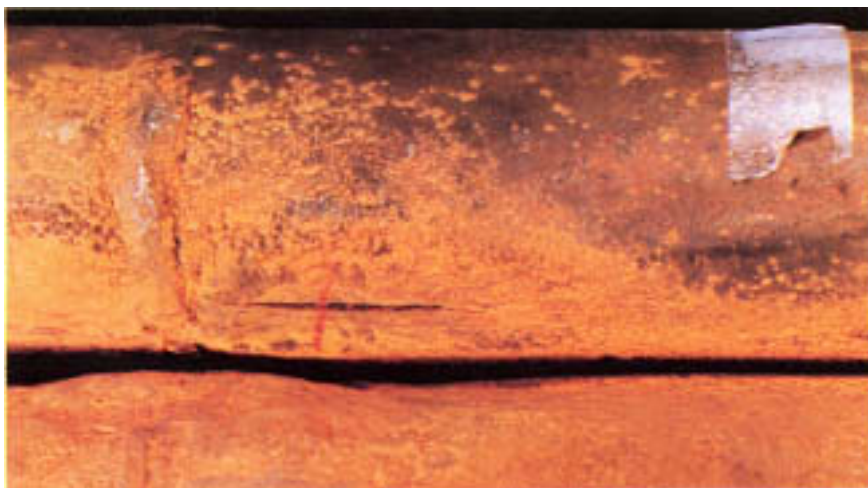
The longitudinal tube rupture apparent in Fig. 19.2 is 1½ in. (3.8 cm) long. Both visual and microstructural examinations reveal that the rupture occurred along a weld seam. Seam contours were clearly visible along the length of the tube.

Examination of cross sections taken at a distance from the through-wall rupture reveals that the unfused weld seam penetrates 40% of the tube-wall thickness, and is lined with dense iron oxide (Fig. 19.3). This is a weld-seam defect that occurred during tube manufacturing. An acid cleaning of the boiler caused the cavernous metal loss apparent near the surface in Fig. 19.3. External metal loss on the adjacent tube due to erosion from steam and water escaping from the through-wall rupture is apparent in Fig. 19.2.

**Figure 19.2** Seam defect (top tube). External metal loss on the bottom tube is the result of erosion from mixed steam and water escaping through the rupture.

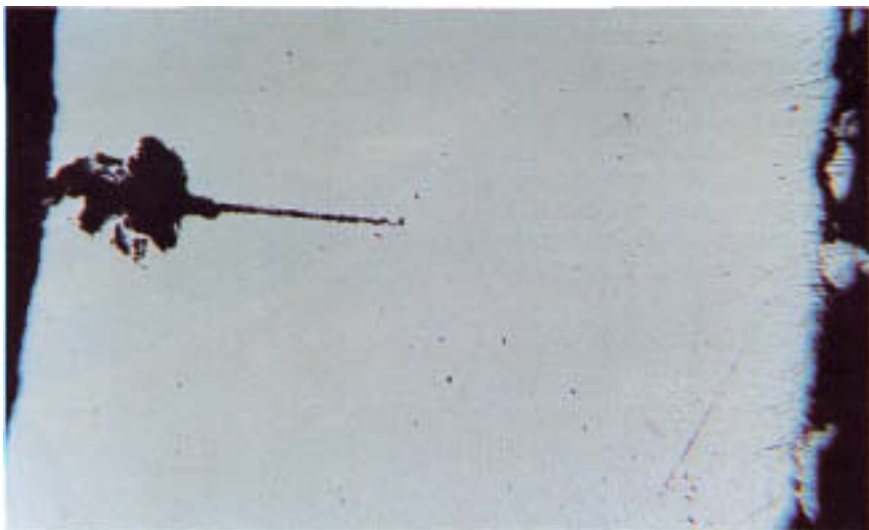
**Figure 19.3** Cross-sectional view of weld-seam defect originating on the internal surface. Note enlargement of opening due to past acid cleaning of the boiler. (Magnification: 20 $\times$ .)

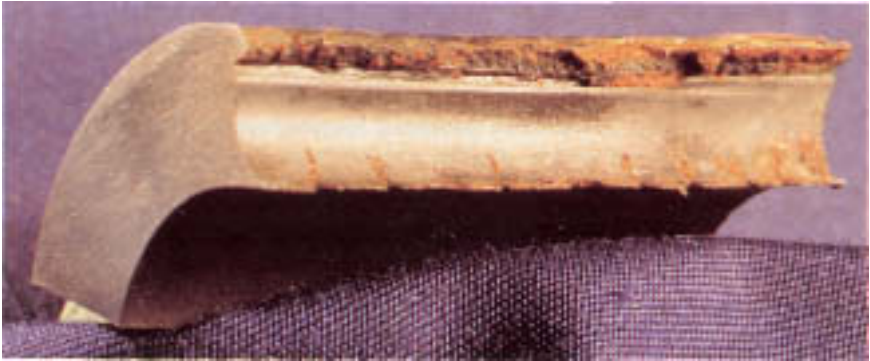
The failure illustrated in Fig. 19.6 is an 8-in.-long (20.3-cm-long), thick-walled fracture that originated on the internal surface (Fig. 19.1). Examination of the fracture face reveals a very smooth contour curving toward the external surface (Fig. 19.7). The extent of this smooth area is approximately 60 to 80% of the tube-wall thickness and runs 18 in. (45.7 cm) of the tube length. The fracture is covered with a very uniform layer of black iron oxide. The remaining 20 to 40% of the fracture surface adjacent to the external surface is irregular and lacks a distinct iron oxide covering.

**Figure 19.7** Smooth curved contour of defect. (Courtesy of National Association of Corrosion Engineers.)

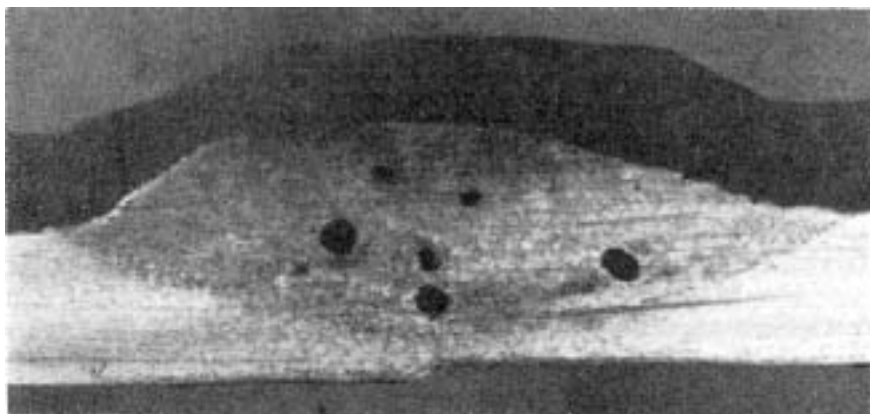
*Identification.* Porosity refers to the entrapment of gas bubbles in the weld metal resulting either from decreased solubility of a gas as the molten weld metal cools, or from chemical reactions that occur within the weld metal (Fig. 20.1). Generally, porosity is not apparent from the surfaces of the weldment. The distribution of pores within the weldment can be classified as *uniformly scattered porosity*, *cluster porosity*, or *linear porosity*. Porosity near surfaces seems to have a significant effect on mechanical properties of the weld.

**Figure 20.1** Cross section through weld showing severe porosity. This weld had been in low-pressure service for 40 years without failure. (Magnification: 2X.) (Reprinted with permission from Helmut Thielsch, *Defects and Failures in Pressure Vessels and Piping*, New York, Van Nostrand Reinhold, 1965.)

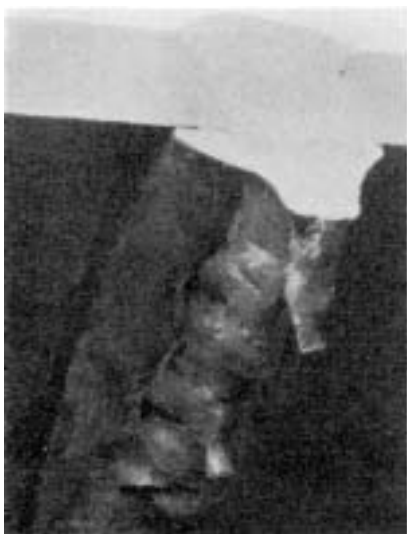
**Identification.** The term *excess penetration* refers to disruption of the weld bead beyond the root of the weld. This disruption can exist as either excess metal on the back side of the weld, which may appear as “icicles” (Fig. 20.3), or concavity of the weld metal on the back side of the weld, sometimes referred to as “sink” (Fig. 20.4).

**Figure 20.3** Burnthrough resulting in icicles on the underside of a butt weld. (*Reprinted with permission from Helmut Thielsch, Defects and Failures in Pressure Vessels and Piping, New York, Van Nostrand Reinhold, 1965.*)

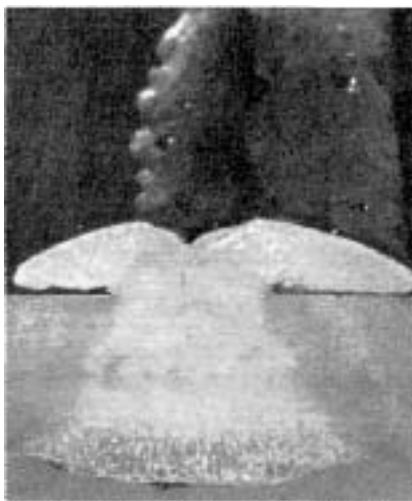
**Figure 20.4** A burnthrough cavity formed on the backing ring of a tube weld. (*Reprinted with permission from Helmut Thielsch, Defects and Failures in Pressure Vessels and Piping, New York, Van Nostrand Reinhold, 1965.*)

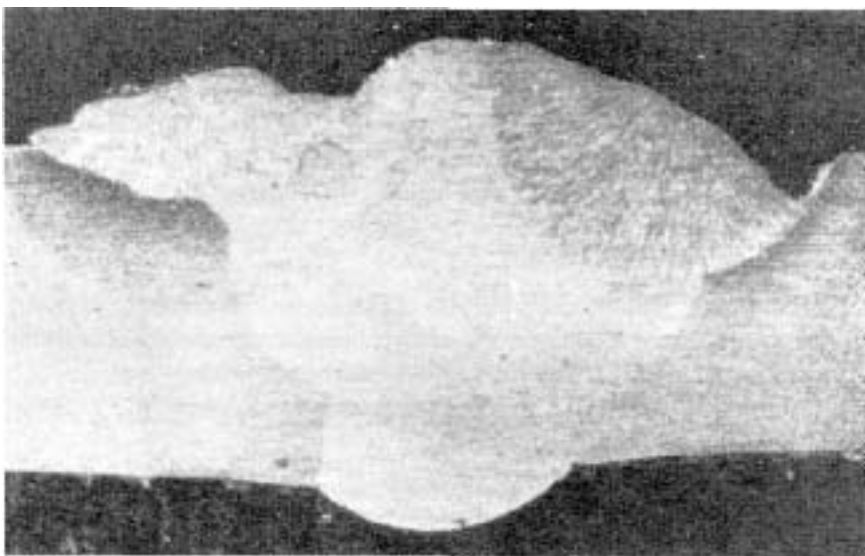
**Figure 20.5** Cross section of welds containing severe undercut. (Magnification: 1.5 $\times$ .) (*Reprinted with permission from Helmut Thielsch, Defects and Failures in Pressure Vessels and Piping, New York, Van Nostrand Reinhold, 1965.*)

*Identification.* The term *undercut* refers to the creation of a continuous or intermittent groove melted into the base metal at either the surface (toe of the weld) (Fig. 20.5) or the root of the weld. Depending upon depth and sharpness, undercutting may cause failure by either mechanical or thermal fatigue.

**Elimination.** Serious undercutting may be repaired either by grinding or by depositing additional weld metal. Undercutting is generally caused by using excessive welding currents for a particular electrode or maintaining too long an arc.

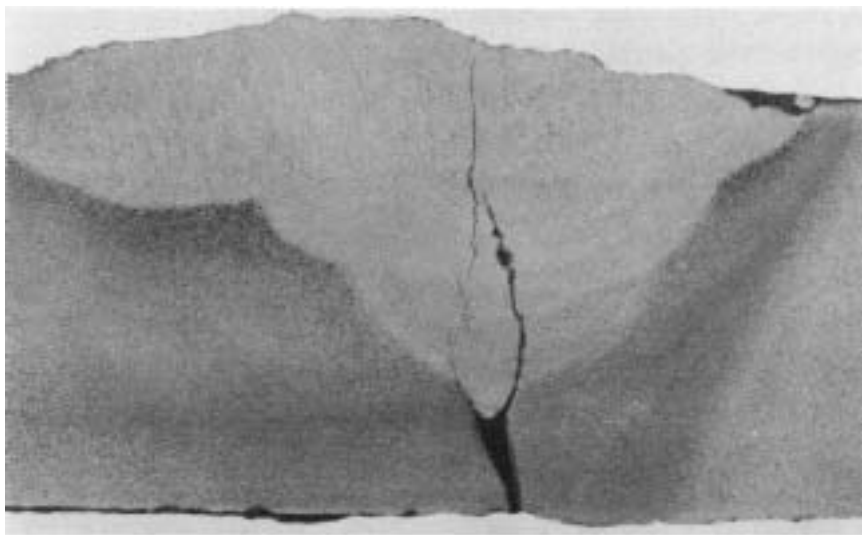
**Figure 20.6** Lack of penetration in the root of a butt weld in a boiler feedwater line. Sodium hydroxide concentrating in the resulting crevice led to caustic stress-corrosion cracking. Note fine cracks emanating from crevice. (Reprinted with permission from Helmut Thielsch, *Defects and Failures in Pressure Vessels and Piping*, New York, Van Nostrand Reinhold, 1965.)

joint (Fig. 20.6). It usually applies to the initial weld pass, or to passes made from one or both sides of the joint. On double-welded joints, the defect may occur within the wall thickness (Fig. 20.7).

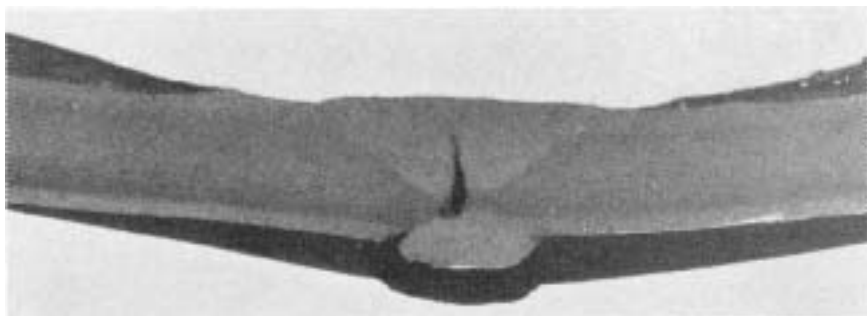
**Figure 20.7** Cross section of circumferential butt weld. (Reprinted with permission from Helmut Thielsch, *Defects and Failures in Pressure Vessels and Piping*, New York, Van Nostrand Reinhold, 1965.)

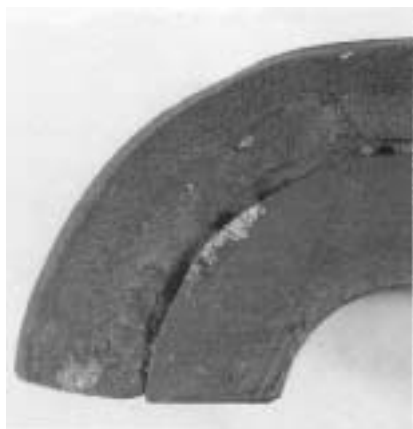
The tube illustrated in Figs. 20.9 and 20.10 had been welded to the finishing-superheater outlet header in the penthouse. The specimen shows a brittle fracture at the weld, which apparently popped out of the header after the failure. Similar fractures had not occurred previously, but several additional cracked and leaking welds were discovered upon the inspection associated with this failure. The boiler was base-loaded and in continuous service except for yearly maintenance outages.

Visual examination of the weld and the fracture face revealed that large areas of the weld root were unfused. Radial striations on the fracture face originated at the unfused region.

The specimen had failed at the weld that joined the tube to the header. Cracks initiated at the weld root, where incomplete fusion had occurred, and propagated from this region by a corrosion-fatigue mechanism. The unfused portion of the weld formed sharp crevices, which acted as stress-concentration sites that locally elevated normal stresses.

**Figure 20.9** Cross section of tube showing weld metal (top of tube).

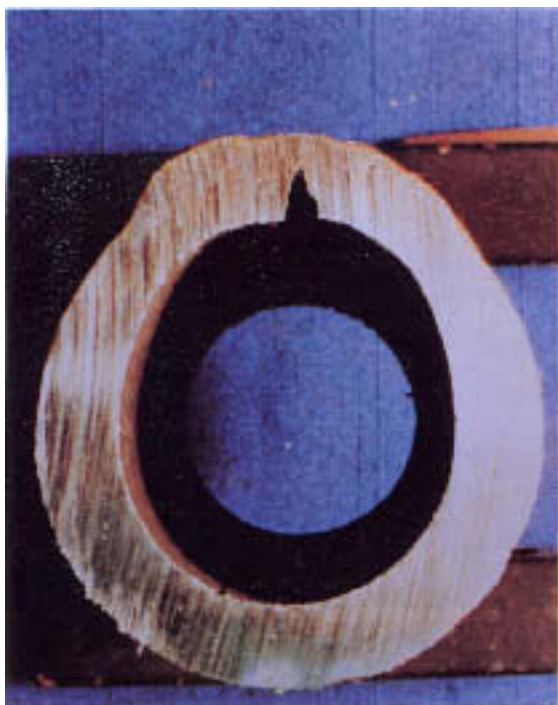
The boiler from which the tube illustrated in Fig. 20.13 was taken had experienced recurrent overheating failures in the areas around the cyclone burners and the furnace floor. The boiler had been in peaking service for the last 6 years.

**Figure 20.13** Profile of tube wall showing unfused fissure remaining after weld repair.

Failures were repaired by patch-weld overlays. The illustration indicates that the weld metal has not penetrated through the tube wall, leaving the thick-walled fissure caused by the in-service overheating unfused. These fissures operate as stress-concentration sites. Consequently, under the combined influence of normal service stresses and high operating temperatures, creep cracks (see Chap. 2, “Long-Term Overheating”) formed at the tip of the fissure. Failure of the weld-repaired tube wall was imminent.

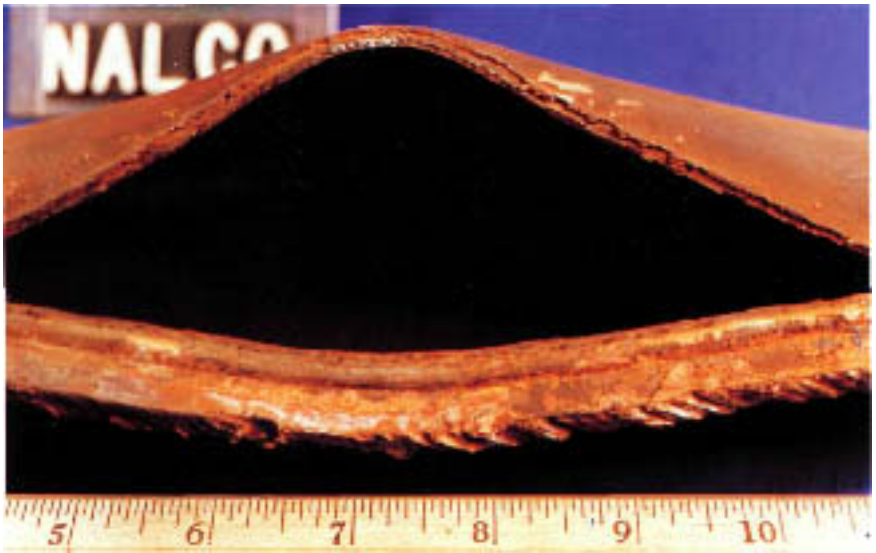
Fig. 20.14 illustrates a massive fracture along the weld bead attaching the membrane to the tube wall. Microstructural examinations revealed an aligned chain of graphite nodules in the heat-affected zone immediately adjacent to the weld bead. The fracture had occurred through this chain. The proximity and alignment of the graphite nodules provided a weak plane where a fracture could readily propagate due to stresses imposed by internal pressure. This tube section had been exposed to metal temperatures in excess of 850°F (454°C) for a very long period of time.

**Figure 20.14** Massive fracture along weld bead resulting from weld-related graphitization. (Courtesy of National Association of Corrosion Engineers.)

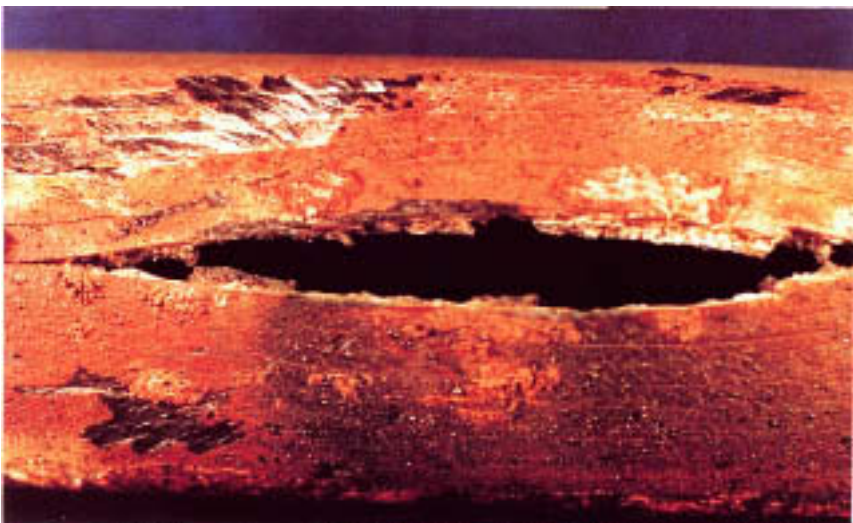
The thick-walled rupture shown in Fig. 21.3 is one of many similar failures that occurred sporadically in this section of the boiler. The boiler is presently base-loaded, but had been in peaking service previously.

Microstructural examinations of the metal revealed a dense population of graphite nodules and spheroidal iron carbides in the tube wall. Intergranular oxidation was apparent at all surfaces.

The failure of this tube is a direct result of operation in an environment that exceeded the thermal stability of the metal. A low-alloy steel tube (SA-213 T22) that had been butt-welded to the ruptured tube did not fail and had sustained only mild thermal deterioration.

**Figure 21.3** Thick-walled rupture in a reheater tube. Note fissures on external surface aligned with the rupture.

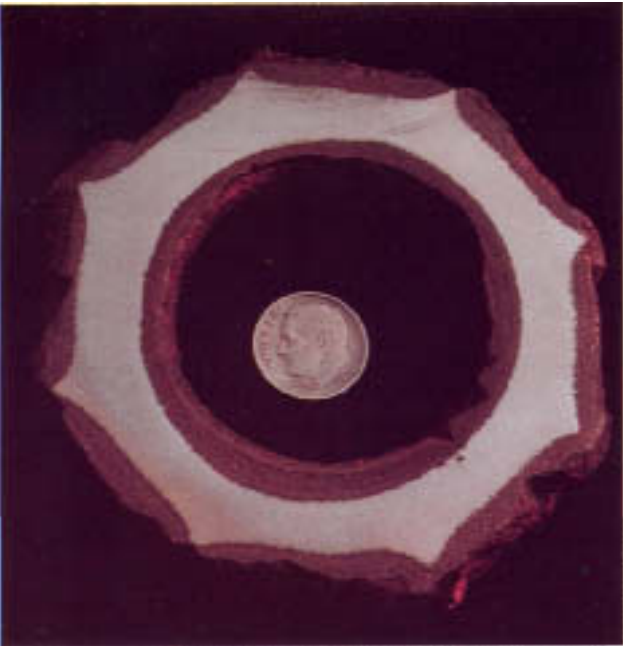
**Figure 22.1** Pump impeller severely attacked by graphitic corrosion. Material of the impeller is gray cast iron. Note the gray areas on both internal and external surfaces where the metal has been converted to rust and graphite.

Cast iron is converted to a soft mixture of iron oxides and graphite (Figs. 22.1 and 22.2). Pieces of corrosion product smudge hands and can be used to mark paper, just as if the corroded material were lead in a pencil (Fig. 22.3). Attack is often uniform, with all exposed surfaces corroded to roughly the same depth (Figs. 22.4 and 22.5). If localized deposits are present, especially those containing sulfate and chloride or other acidic species, corrosion may be confined to pockets. When attack is severe or prolonged, the entire component is converted to corrosion product. Surface contour and appearance are often preserved. Attack is usually not apparent until surfaces are probed or stressed.

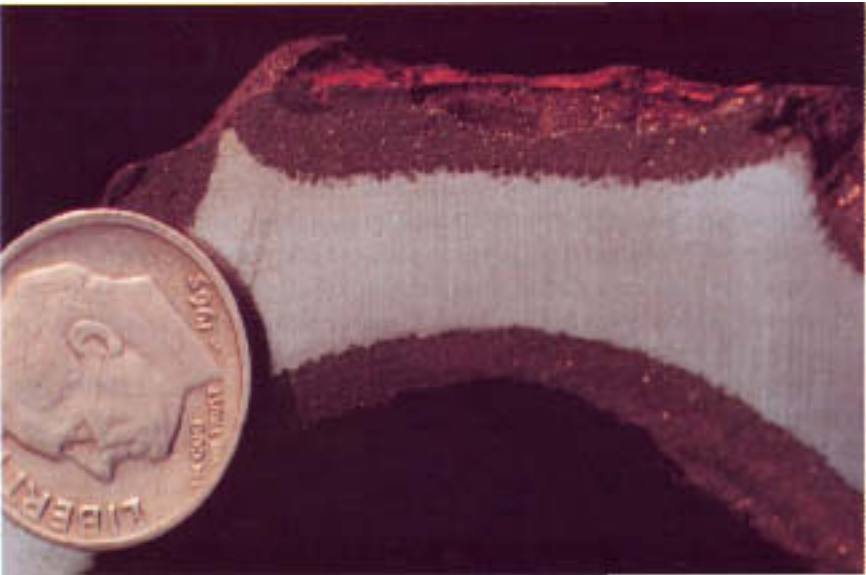
**Figure 22.2** Note how uniformly metal is converted to corrosion product. Impeller vanes were lost in service because the graphitically corroded metal is brittle.

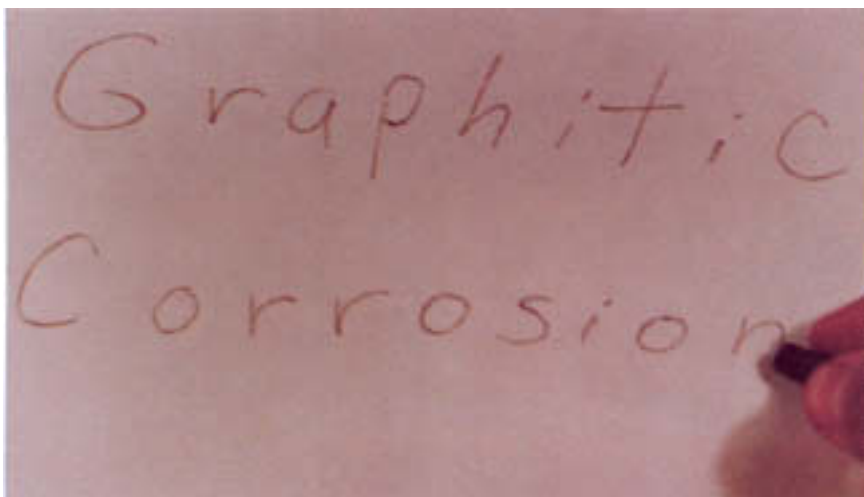
**Figure 22.3** Fragment of graphitically corroded, gray cast iron pipe is used to write on paper, as if it were a lead pencil. The corrosion product is graphite flakes intermixed with rust.

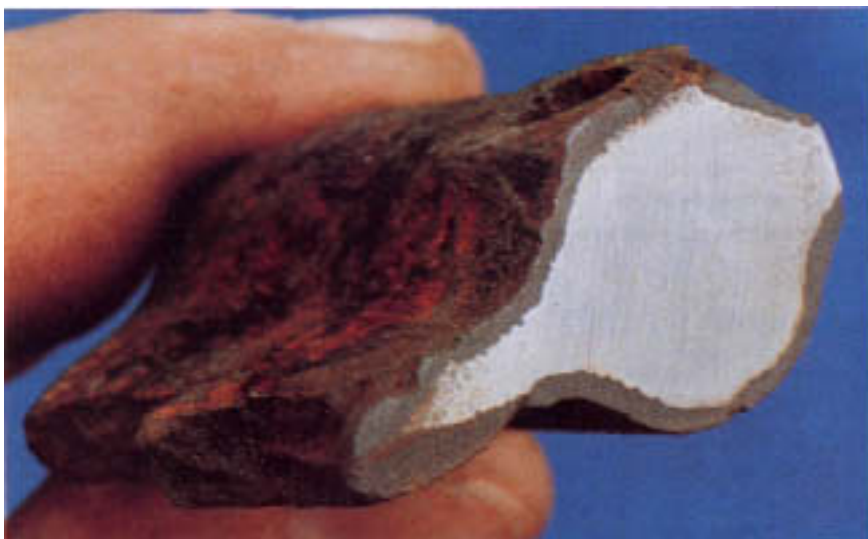
**Figure 22.4** Graphitically corroded valve butterfly. Original surface contours are preserved. Edges, which were completely converted to brittle corrosion product, have broken.

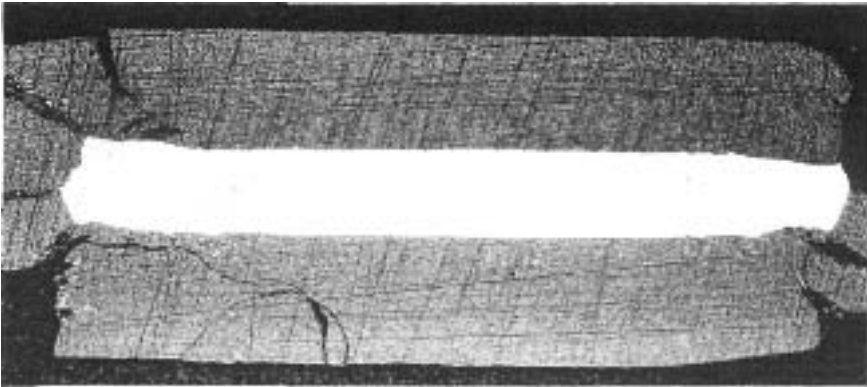
*Destannification* (loss of tin) can occur in gunmetal and some phosphor bronzes. This is especially the case in steam environments and in hot feedwaters. Monel steam strainers have been attacked when exposed to steam containing sulfur compounds at elevated temperatures (Fig. 23.3).

**Figure 23.3** Cross section through a corroded Monel metal steam strainer. The dark area consists of oxides, sulfides, and elemental copper (Magnification: 15X.)

A Monel turbine steam strainer was discovered to contain many broken elements. The metal was converted to oxide, sulfide, and elemental copper (Fig. 23.3). The deteriorated metal consisted of numerous elemental copper
