# Lessons Learned in Aircraft Design

The Devil is in the Details

Dr. Jan Roskam

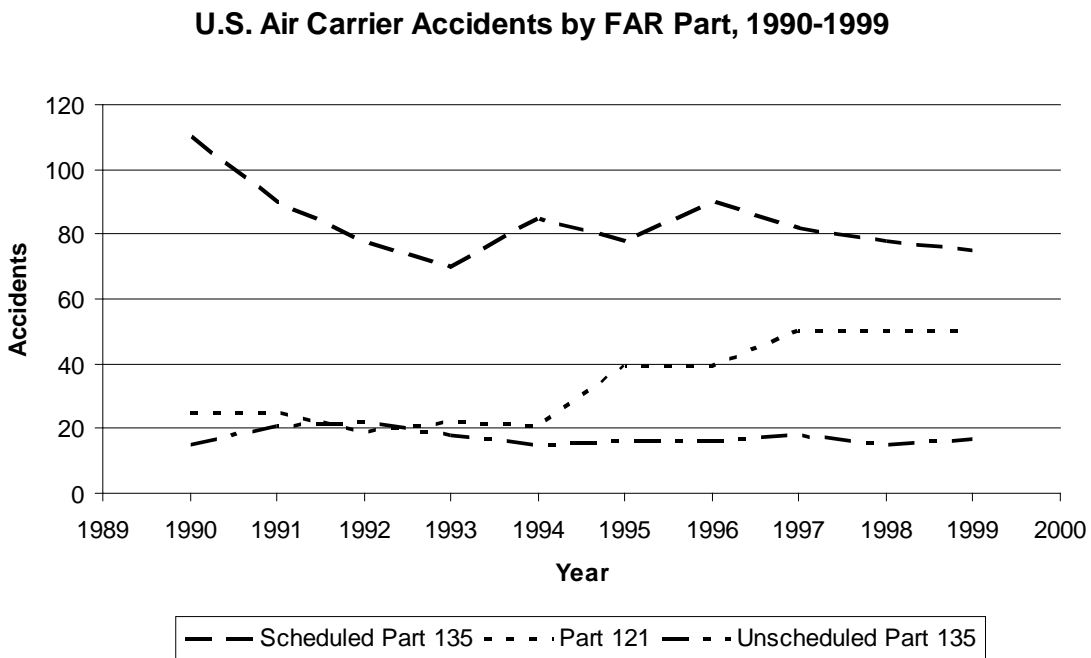
Figure 1.1 Part 121 and Scheduled Part 135 Accident Rates over a Ten Year Period (Ref. 1.1)

In 1999 there were 51 accidents with Part 121 aircraft, 13 with scheduled Part 135 and 73 with unscheduled Part 135 aircraft. In total there were 137 accidents. Figure 1.1 shows a comparison of Part 121 and scheduled Part 135 accidents during the period 1990-1999.

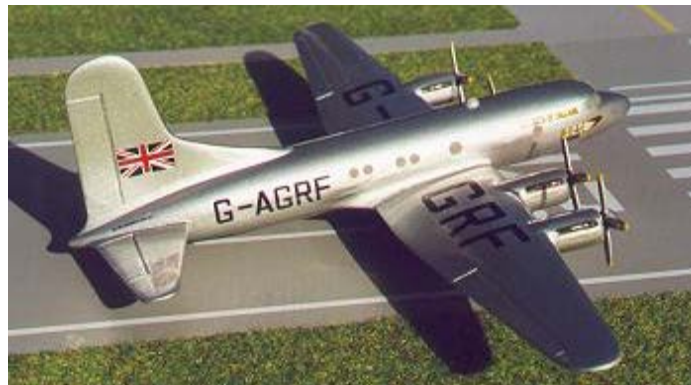
*Figure 2.2 Model of AVRO Tudor 2 (Courtesy [www.collectorsaircraft.com](http://www.collectorsaircraft.com))*

In 1950 an AVRO Tudor 2 (Figure 2.2) crashed on an approach to landing.

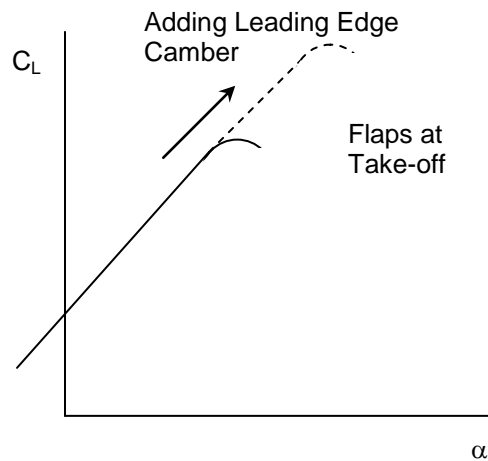
*Figure 2.5 Effect of Leading Edge Camber on the Stall Angle of Attack*

In the case of the Comet, DeHavilland cambered the wing leading edge of the Comets down a bit to prevent wing stall during excessive take-off rotation. Added camber extends the stall angle of attack to a higher value as shown in Figure 2.5.

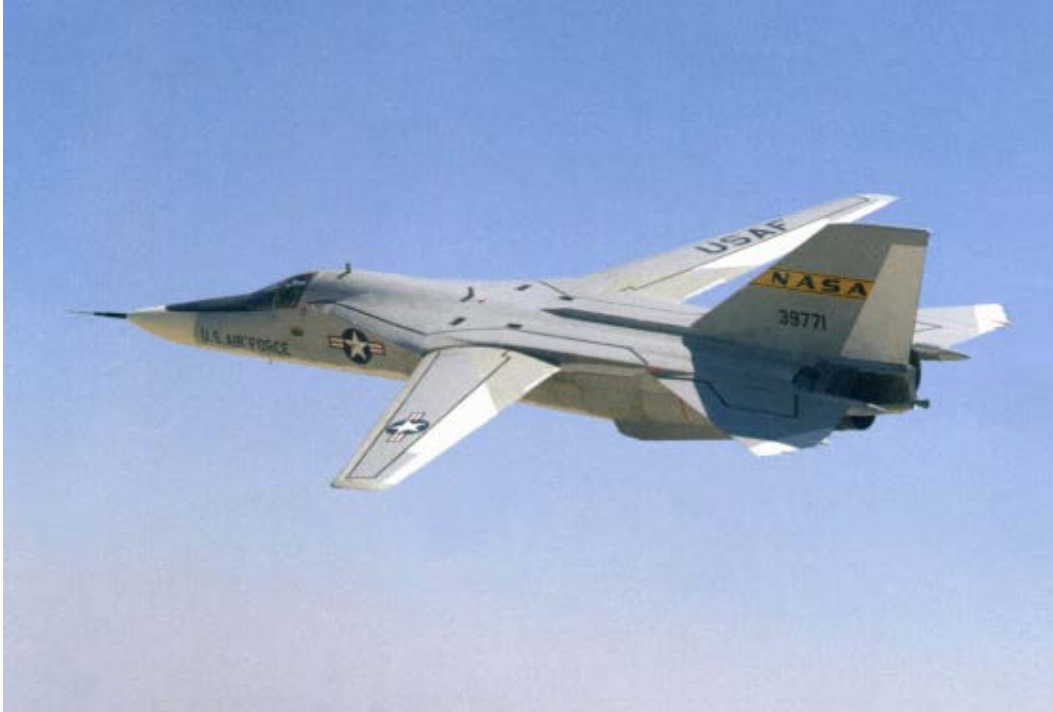
*Figure 2.10 General Dynamics F-111A (Not accident aircraft, Courtesy NASA)*

In 1964, to celebrate the first flight of the F-111A (Figure 2.10), the management of the Fort Worth division of General Dynamics invited some top brass for a special demonstration.

The F-111A made a successful demonstration flight and landed, as usual, with the wings swept forward and the big Fowler flaps deployed. When approaching the ramp area the test pilot thought that there was insufficient space between two of the parked airplanes for him to taxi through with the wings swept forward. Therefore, he engaged the wing-sweep system to sweep the wings aft. Crunch, crunch, crunch: the Fowler flaps were crushed against the side of the fuselage. All this in front of all the brass. Very embarrassing.

The cause was not that the pilot did what he did. The cause was the design engineers not foreseeing this event and designing a simple device which disables the wing sweep mechanism when the flaps are down.

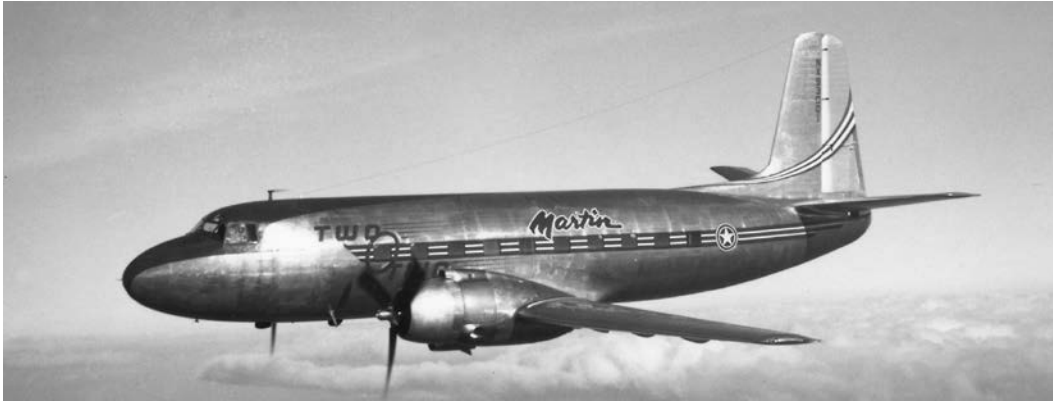
*Figure 3.2 Martin 202, Before Dihedral Modification (Not accident aircraft, Courtesy Stan Piet)*

In 1948 a Northwest Airlines Martin 202 (Figure 3.2) lost a wing while flying close to a thunderstorm over the state of Minnesota. All 37 persons on board were killed.

Another Northwest Martin 202 that flew through the same storm about one hour after the accident airplane landed with a crack in a wedge shaped forging which was used in the structural connection between the inboard wing and the outboard wing.

During early flight testing of the airplane (Figure 3.2) it was found that there was insufficient dihedral effect (i.e. negative rolling moment due to sideslip). This was corrected by increasing the geometric dihedral angle of the outboard wings. To enable this from a structural viewpoint, wedge shaped, forged fittings were inserted at the spars of the wing. The fittings were designed with fairly sharp edges in areas of high stresses leading to local stress concentrations which in turn led to early cracking. Figure 3.4 shows a perspective view of this fitting and its installation in the wing.

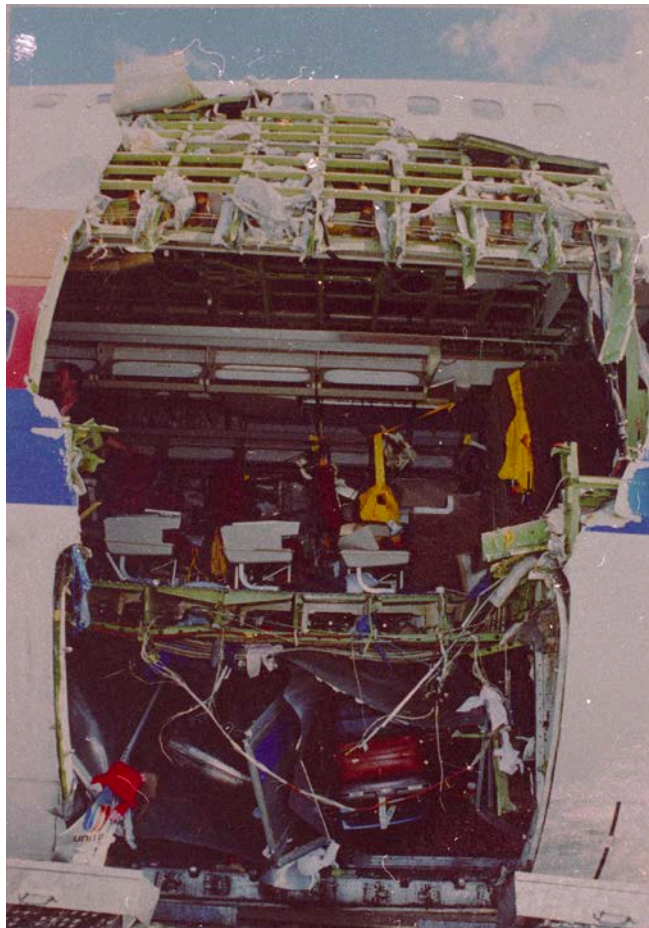
When a picture (Figure 3.30) of the damage done to the side of the airplane is examined, one is drawn to conclude that the door hinge structure, once the door opened in flight, tore a large part of the passenger cabin skin open, more or less like a sardine can.

*Figure 3.30 Damage Done by a Cargo Door Opening in Flight (Courtesy NTSB)*

No matter how careful cargo door latching mechanisms are designed and inspected there continue to occur incidents with such doors. It appears to the author that a design criterion for the door hinge structure should be to fail without opening the skin of the airplane. Designers should consider this in future designs.

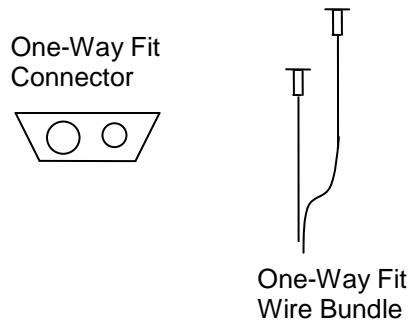
*Figure 4.16 Suggested Diagram for One-way Fit of Critical Wiring*

Wire bundles for critical items in the flight control system should be designed for a one-way fit. Figure 4.16 suggests two ways of accomplishing this.

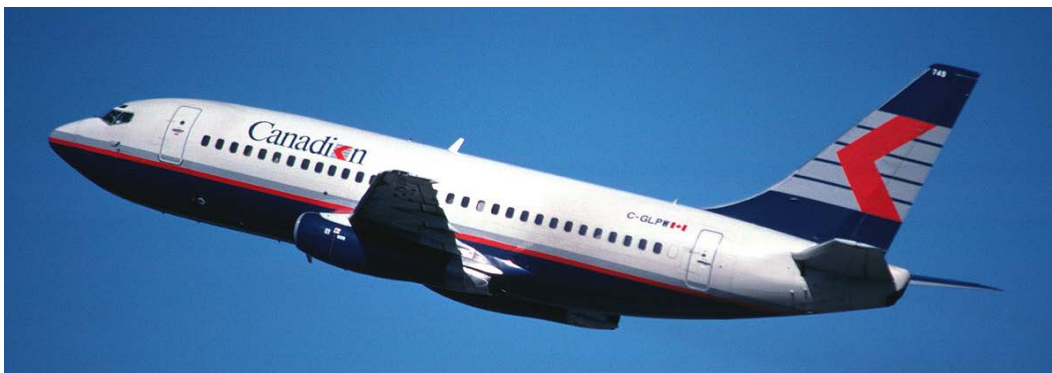
*Figure 4.40 Boeing 737-200 (Not accident aircraft, Courtesy G. Helmer)*

The 737 has two elevator trim tabs, one on each side. Each tab is 90 inches long and is attached to the elevator at 4 hinge points about 27 inches apart. The section between the first and second hinge points had broken off and was not found. The remaining small inboard section of the tab, with the control horn, broke free from the first hinge and was held to the elevator only by the attachment to the control rod. The outboard section was still attached by the remaining three hinges. Marks on the hinges indicated that this section was probably oscillating rapidly through

its full range of movement. The tab oscillations in turn caused the elevator to oscillate which is the vibration felt by the crew.

The investigation of the remaining tab (Ref. 4.33) indicated that the outer layers of the composite surface material had disbonded from the honeycomb core. This weakened the tab enough for the aerodynamic loads to cause it to fail in flight. The remaining tab portion was sent to Boeing for a detailed analysis. Boeing engineers concluded that the tab damage was consistent with damage inflicted by a ground vehicle bumping into the tab.

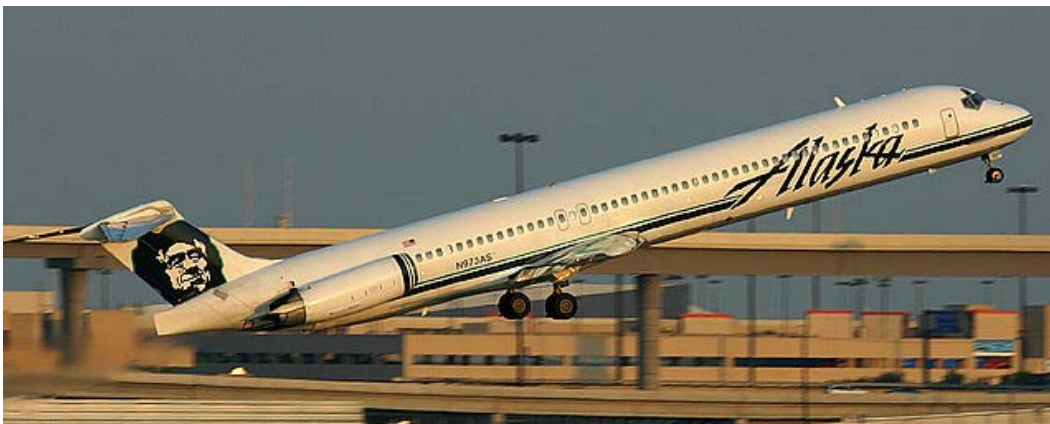
*Figure 4.41 McDonnell-Douglas MD-83 (Not accident aircraft, Courtesy Tim Perkins)*

The cause was established to be a stripping of the threads in the stabilizer jack-screw acme-nut. This failure allowed the horizontal stabilizer to move leading edge up to a very large angle making the airplane uncontrollable in pitch. The NTSB report (Ref. 4.34) cites lack of lubrication due to lapses in required maintenance of this system as the primary reason for this failure.

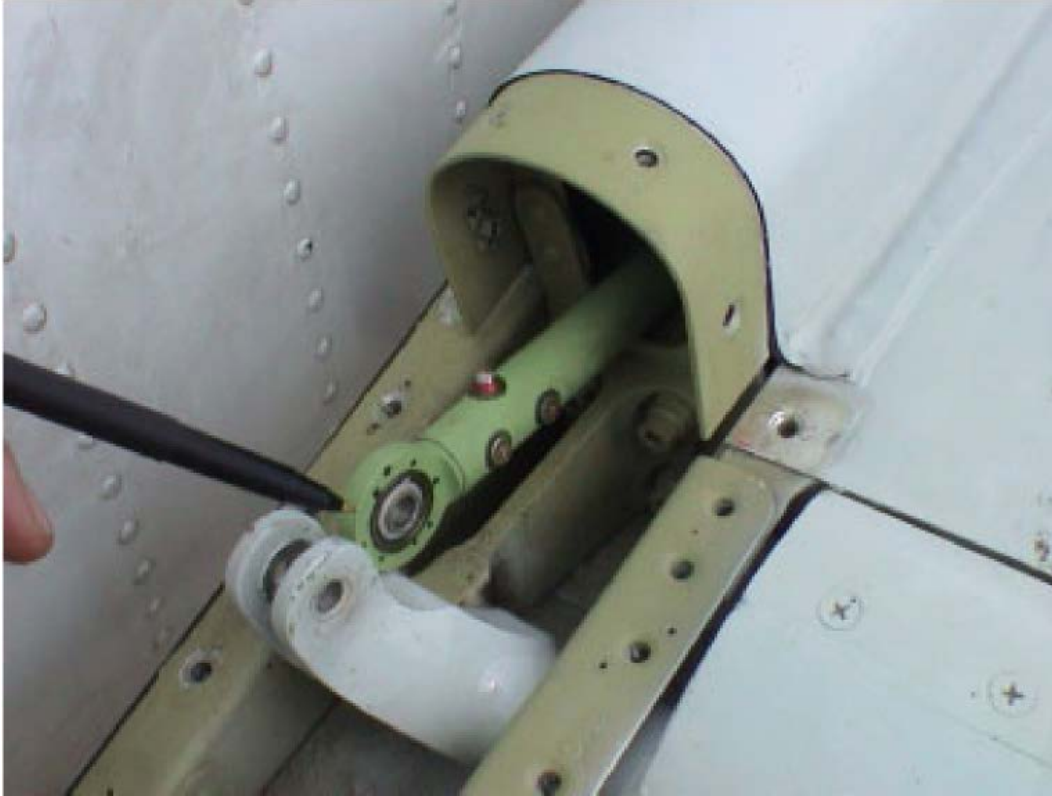
*Figure 4.44 Photograph of the Right Elevator Control Tab Pushrod Contacting the Crank Fitting on a Test Airplane (Courtesy NTSB)*

Figure 4.44 shows the right elevator control tab pushrod contacting the servo-tab crank fitting on a test airplane to demonstrate the effect.

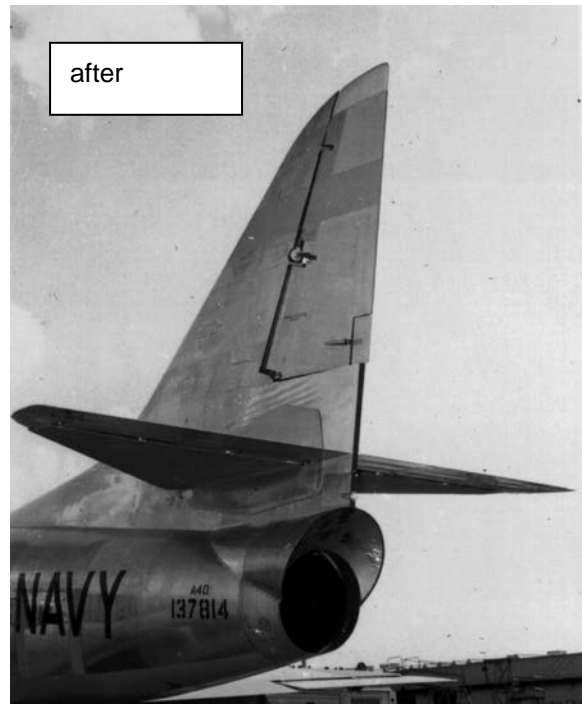
Figure 5.7 Sugar-scoop fairing as installed on the Douglas A4D Skyhawk (Courtesy San Diego Aerospace Museum)

The problem was traced to massive flow separation between the exhaust and the lower part of the vertical tail. The solution was the addition of a so-called “sugar-scoop” as shown in the “before-after” pictures of Figure 5.7.

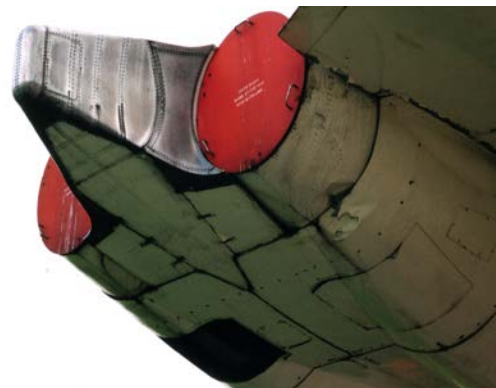
*Figure 5.18 Modified Exhaust Configuration  
(Courtesy J. Hieminga)*

Figure 5.18 shows the exhaust fairing, known as the “beavertail”, added to the airplane. This “beavertail” added to the rear end in between the exhaust resulted in significantly lower cruise drag (nine drag counts!).

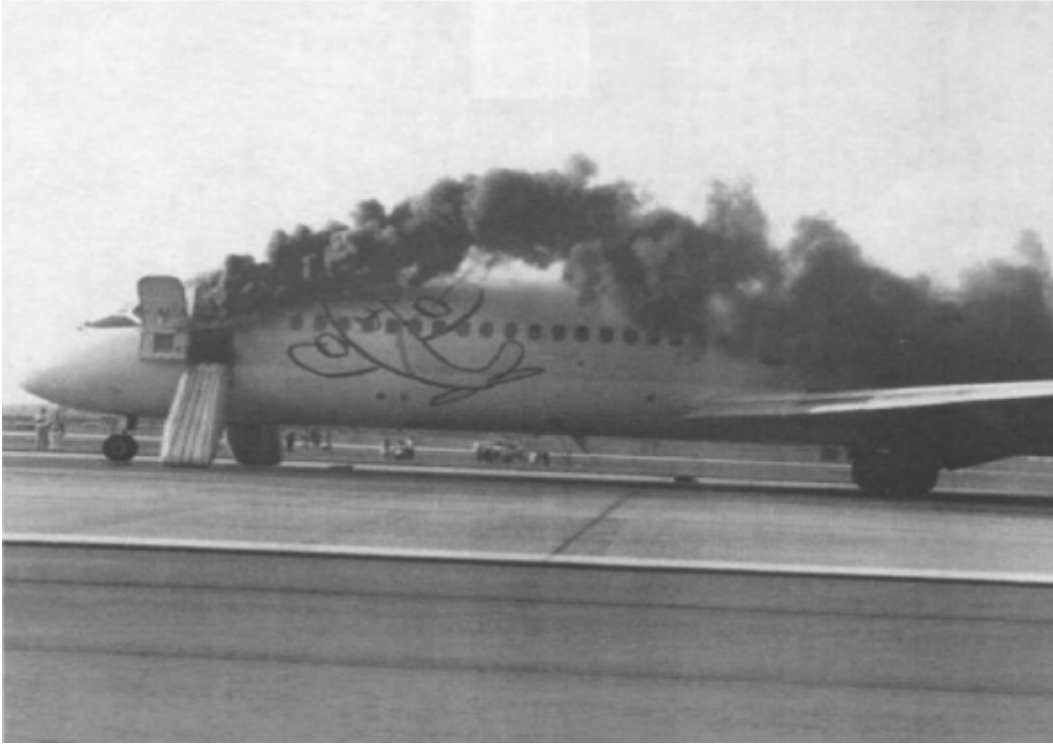
*Figure 5.28 DC-9-32 after Uncontained Engine Failure (Courtesy NTSB)*

As a result of the uncontained engine failure, engine fragments penetrated the airplane cabin, severing the right main fuel line and causing the release of pressurized fuel inside the cabin.

Sparks which were probably generated by steel engine fragments contacting galley components ignited a fire that spread through the airplane cabin and destroyed the fuselage of the airplane.

Figure 5.28 shows the airplane after evacuation.

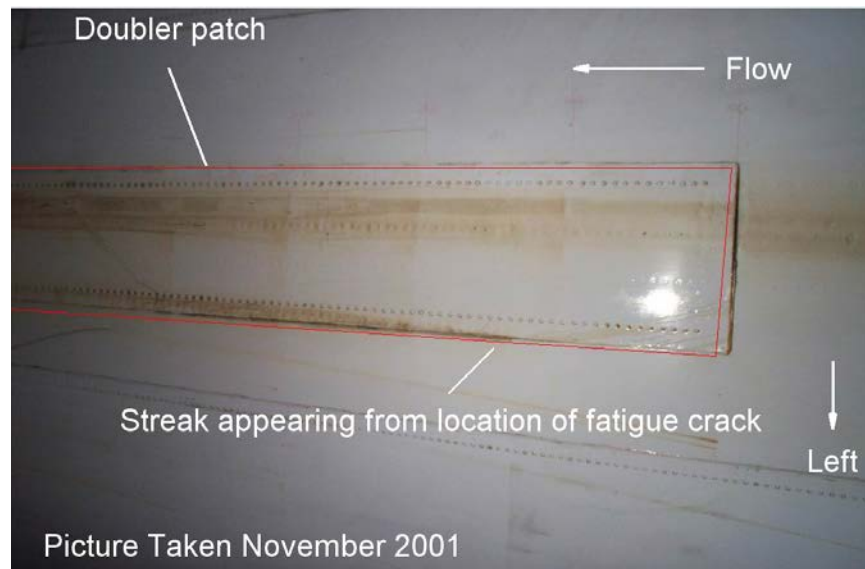
Figure 7.24 Repair Doubler Showing Streaks Emanating from Fatigue Crack (Courtesy Republic of China Aviation Safety Council)

Figure 7.23 shows the general location of the tail strike repair doubler at the bottom of the lower rear fuselage. Figure 7.24 shows a close-up of the repair doubler. It apparently covered a fatigue crack from which air leaked from the pressurized fuselage. Streaks emanating from such doublers are often signs of underlying fatigue cracks which can only be visually detected by a periodic bilge inspection.

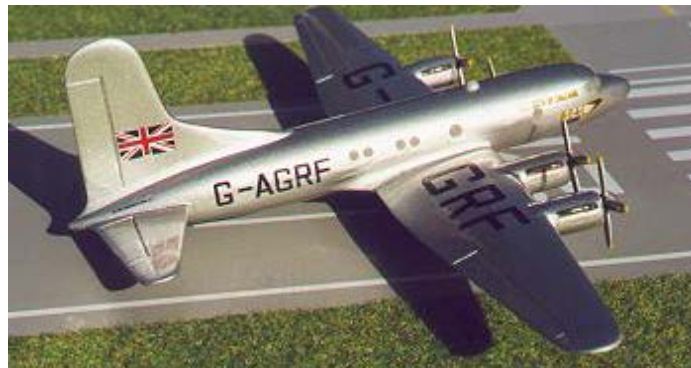
*Figure 8.2 Model of the AVRO Tudor 1 with Modified Vertical Tail  
(Courtesy [www.collectorsaircraft.com](http://www.collectorsaircraft.com))*

A very much larger vertical tail with higher aspect ratio and a slightly larger horizontal tail were installed as shown in Figure 8.2.

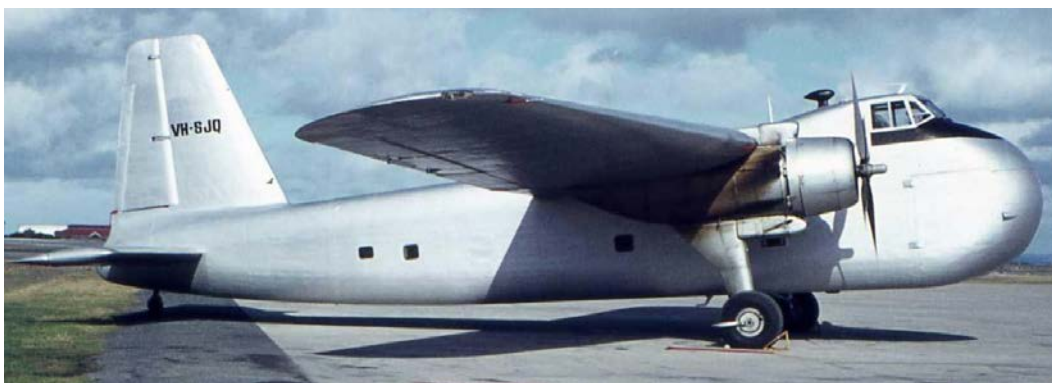
*Figure 8.3 Early Version of the Bristol Freighter (Not accident aircraft, Courtesy John M. Wheatley)*

In May of 1949 a Bristol Freighter airplane crashed into the sea. At that time the cause of the crash was not established. All on board were lost. In March of 1950 another Bristol Freighter crashed during a single-engine climb under circumstances similar to the earlier crash (Ref. 8.3, pp 337-338). Figure 8.3 shows an early picture of the Bristol Freighter (note the absence of the dorsal fin).

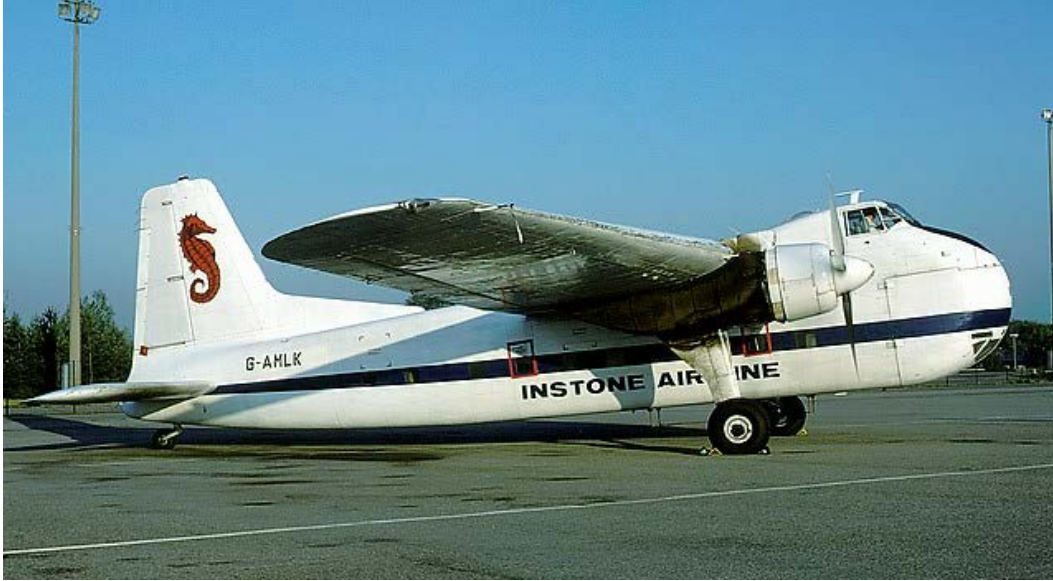
Figure 8.5 Bristol Freighter with Dorsal Fin (Courtesy E. Marmet)

The problem was eliminated by the addition of a dorsal fin to the airplane. Figure 8.5 shows an example of the Bristol Freighter with the added dorsal fin.

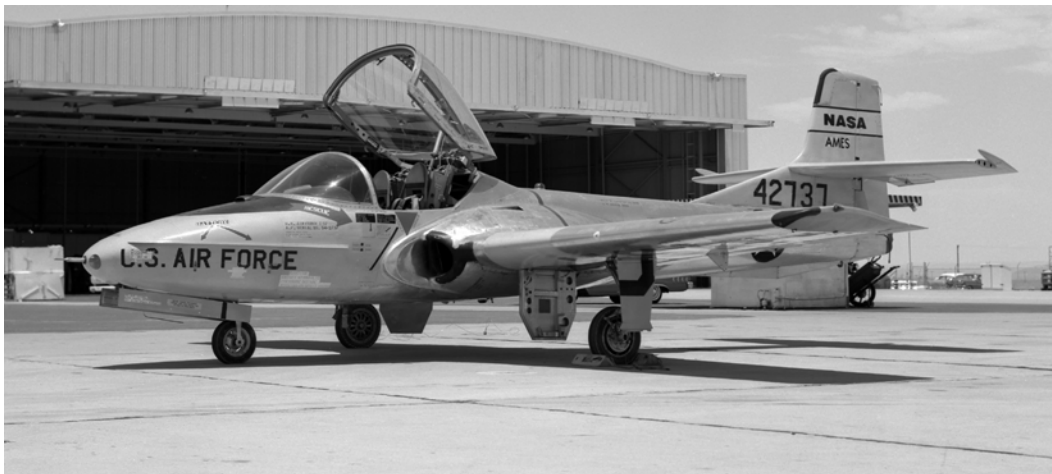
*Figure 8.15 Cessna T-37 with Nose Mounted Spin Strips (Courtesy NASA)*

It was conjectured that the problem was caused by the rudder not being effective in spin recovery. The head of the aerodynamics department, Harry Clements, suggested that a flat strip of aluminum wrapped around the nose of the airplane might break up the flow around the nose at high angle of attack. This could reenergize the air flowing toward the rudder, and just might provide enough rudder control power to allow spin recovery.

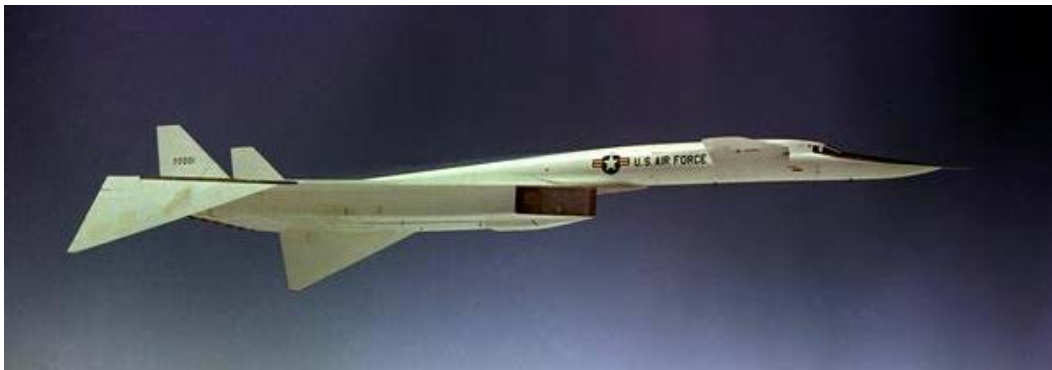
*Figure 8.19 North American XB-70A with Wing Tips Folded (Courtesy Department of Defense)*

Solution 2 would have been practical but was not implemented because of the early service withdrawal. The airplane that was intended to follow the B-58, the North American XB-70A (Figure 8.19) was equipped with fold-down wingtips for this reason.

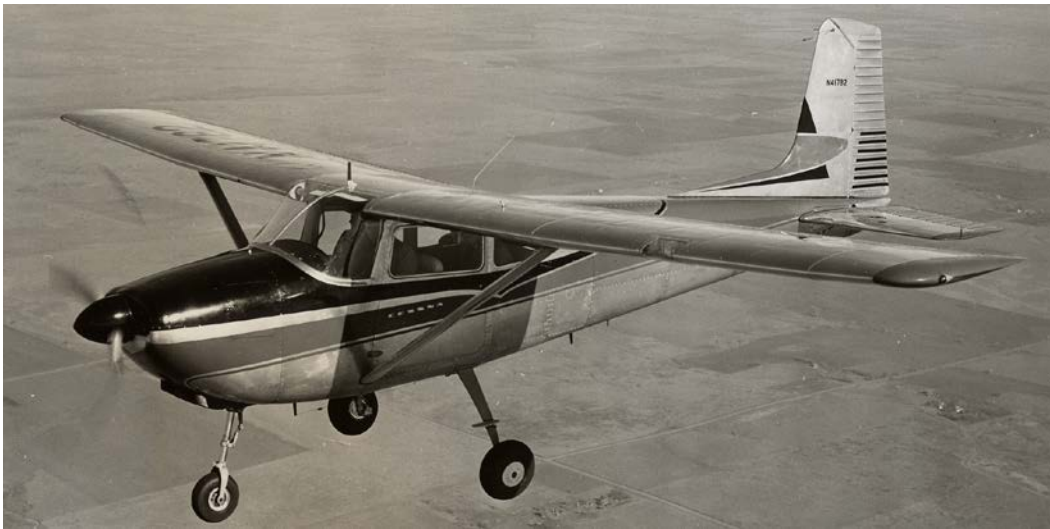
*Figure 8.20 Cessna 172 with Unswept Vertical Tail (Courtesy Cessna)*

The following material was adapted from Ref. 8.9. In 1957 the Cessna 172 had an unswept vertical tail as shown in Figure 8.20.

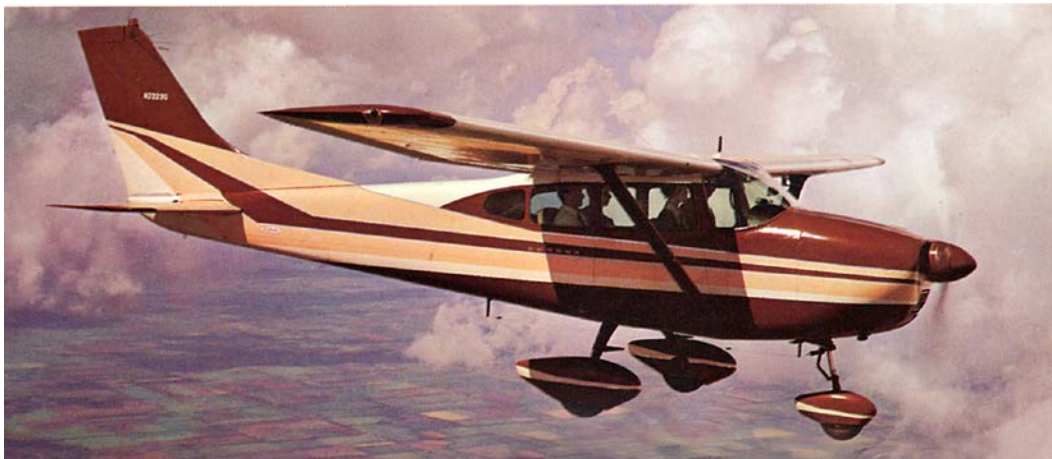
*Figure 8.23 Cessna 172 with Swept Vertical Tail (Courtesy Cessna)*

I briefed the marketing director on my results and he took my data back to the Commercial Division and managed to convince the decision-making hanchos that they should adopt the swept tail. That fall, Cessna proudly announced the “new swept look” for the 172 model. It improved sales by 30% and the swept tail became a standard feature on other Cessna models (Figure 8.23).

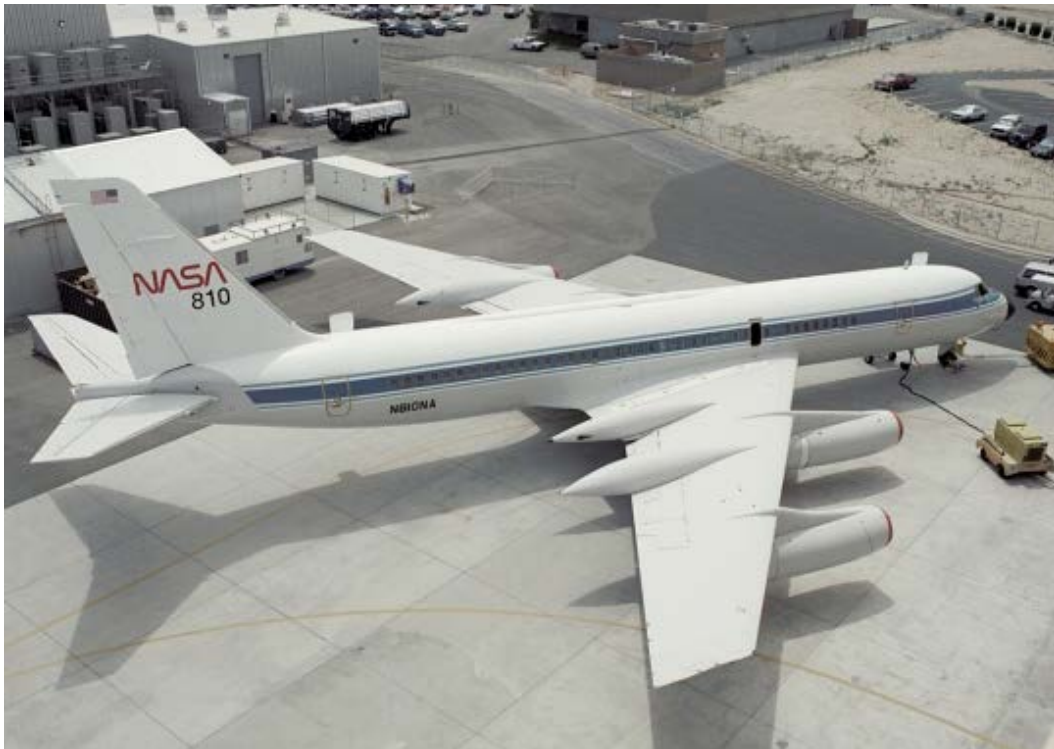
*Figure 8.24 Convair 990 Coronado (Courtesy NASA)*

The Convair 990 (Figure 8.24) was designed to be a jet transport with a cruise Mach number of  $M=0.91$ . For 1958 that was a very tall order.

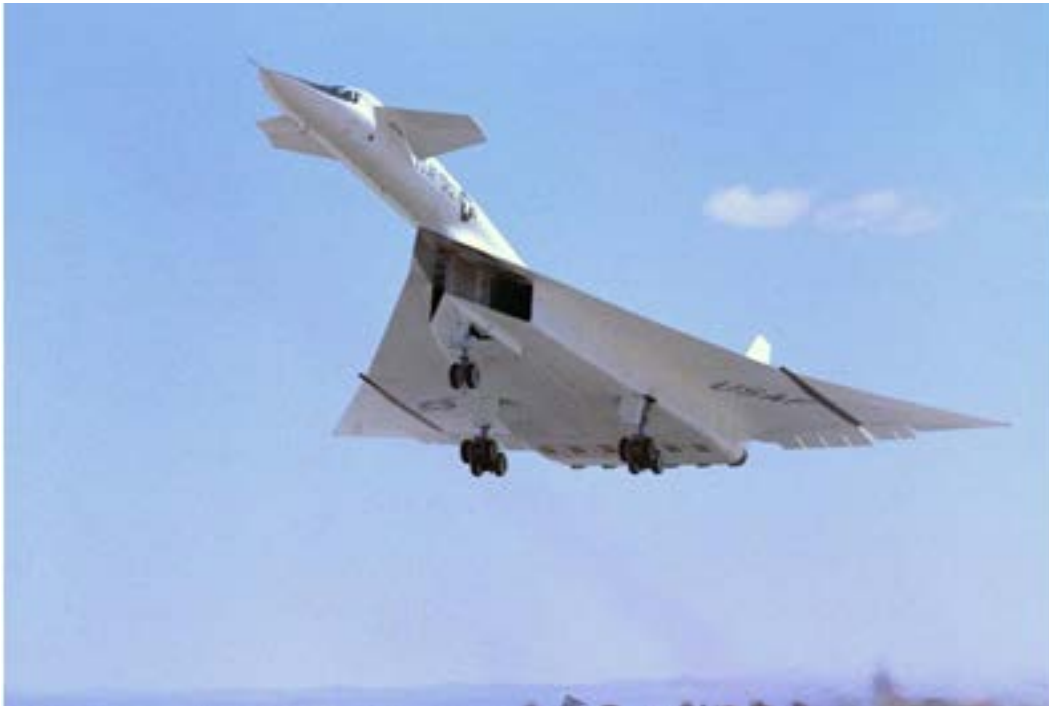
*Figure 8.32 North American XB-70A (Courtesy NASA)*

In 1965, during several test flights at high altitude the XB-70A (Figure 8.32) was observed to have a directional “snaking oscillation”.

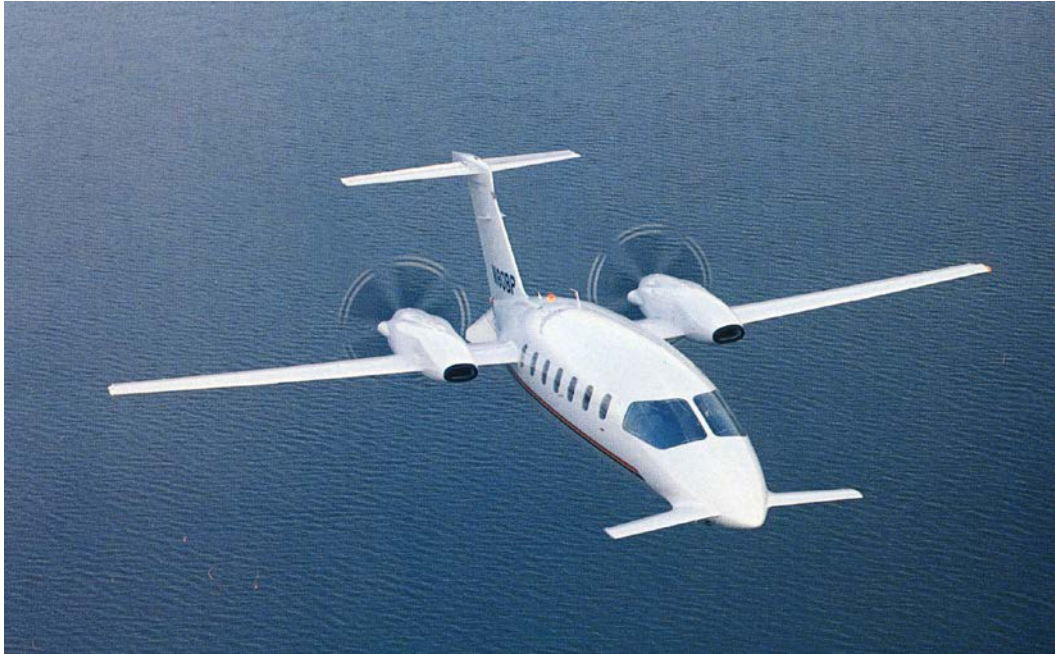
*Figure 8.40 Piaggio P-180 Avanti (Courtesy of Piaggio)*

My first of many visits to Piaggio resulted in a lot of consulting engineering work on the Piaggio P-180 Avanti (Figure 8.40). The Avanti configuration had been evolved by Piaggio's Director of Engineering, Dr. Mazzoni and his design team. Their big question to me was: which is the better approach: VATLIT or P-180? It did not take me and my own design team in the USA long to determine that the Piaggio approach was the superior one. One very clever aspect of their three-surface approach was the structural and aerodynamic synergism that was achieved:

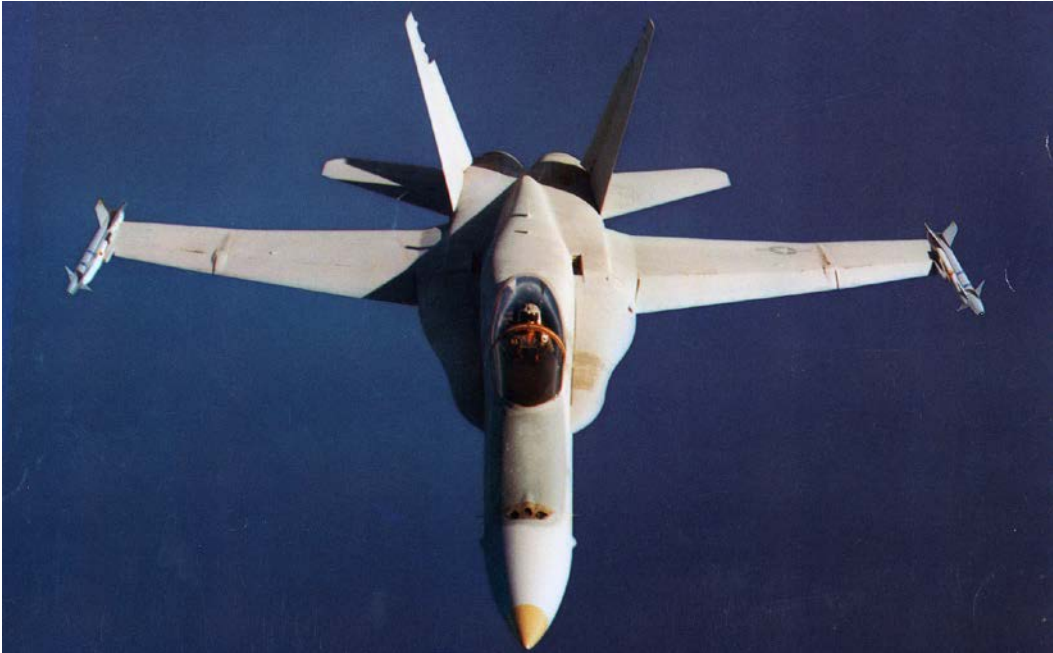
*Figure 8.41 Early Version of the McDonnell-Douglas F-18, Hornet (Courtesy Boeing)*

In 1978, when the first F-18 fighter (Figure 8.41) was flight tested at Patuxent River, MD, it became evident that the airplane would not rotate at the predicted take-off rotation speed. This made the field performance of the airplane for land based applications unacceptable.

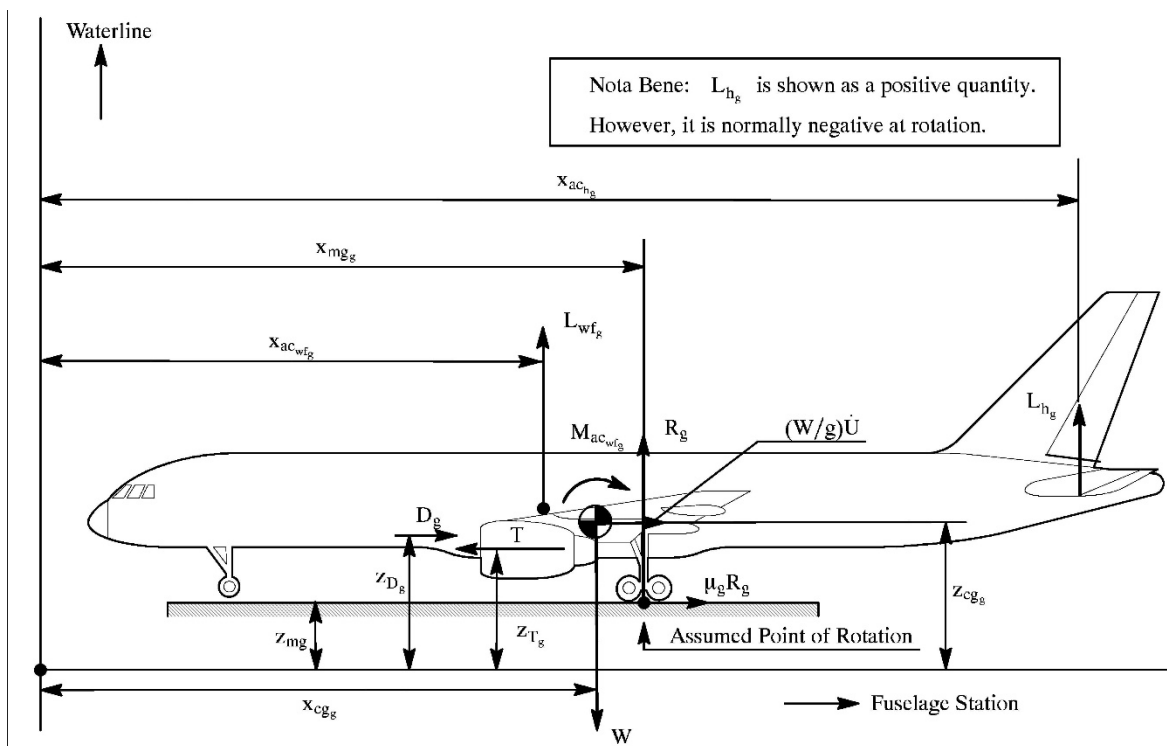
Figure 8.43 Forces and Moments Acting on an Airplane at Initiation of Take-off Rotation

I suggested that he send me a copy of their tail-sizing report and include the work done on the take-off rotation. When the report arrived it contained a side-view of the airplane with all forces and moments which act on the airplane drawn in. Figure 8.43 shows what such a side-view drawing should be like (albeit for a different airplane).

Engineers should understand Newton's Laws before tackling problems relating to airplane dynamics. Also this: note the subscript "g" associated with all aerodynamic forces and moments in Figure 8.43. This means that those forces and moments must be evaluated in the presence of the ground ("ground effect"). See also Section 8.16.

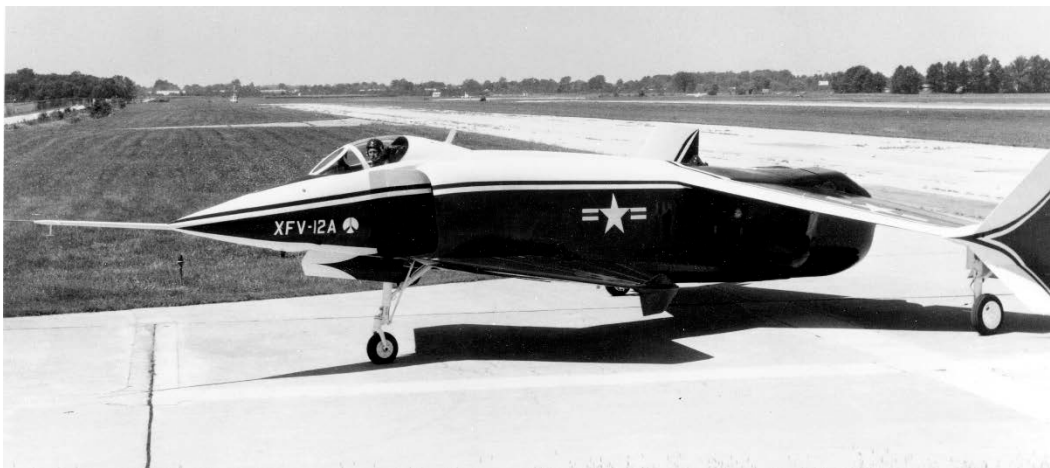
*Figure 8.45 Prototype of the XFV-12 (Courtesy San Diego Aerospace Museum)*

As it turned out, the system was not able to do this either. The project was cancelled. Figure 8.45 shows one of two prototypes which were built.

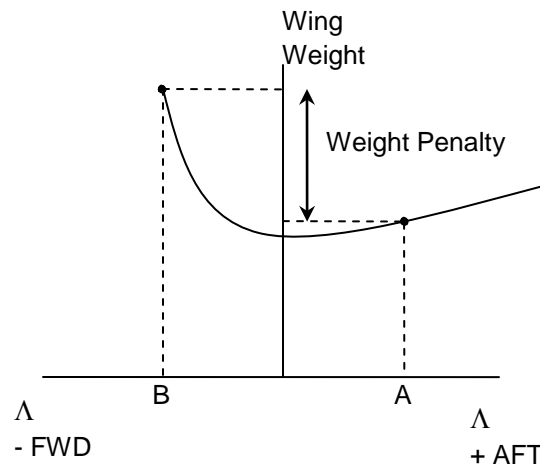
Figure 8.47 Generic Wing Weight Trend with Sweep Angle

Based on these assumptions a methodology was produced for arriving at trade studies, showing the effect of wing aspect ratio and sweep angle on wing weight. The results were dramatic, and showed that very large weight penalties were associated with forward swept wings. A generic trend of these data is shown in Figure 8.47.

As can be seen from Figure 8.47 the weight penalty of the forward swept wing is very large compared with the aft swept wing. It turned out that this report put the nail in the coffin of the forward swept wing until the 70's.

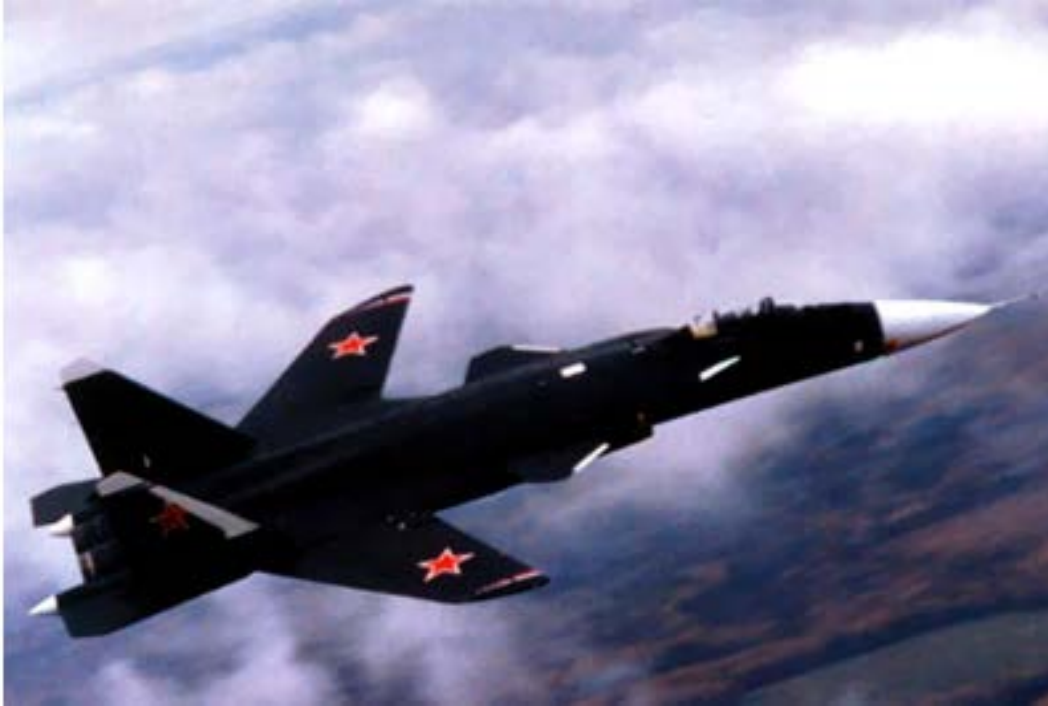
*Figure 8.48 Sukhoi S-37 Berkut (San Diego Aerospace Museum)*

4. From a cross-sectional area distribution point of view, a forward swept wing has a lower wave drag than an aft swept wing. This effect becomes important in fighter aircraft. This is one of several reasons why Sukhoi used a forward swept wing on the Sukhoi S-37 Berkut of Figure 8.48.

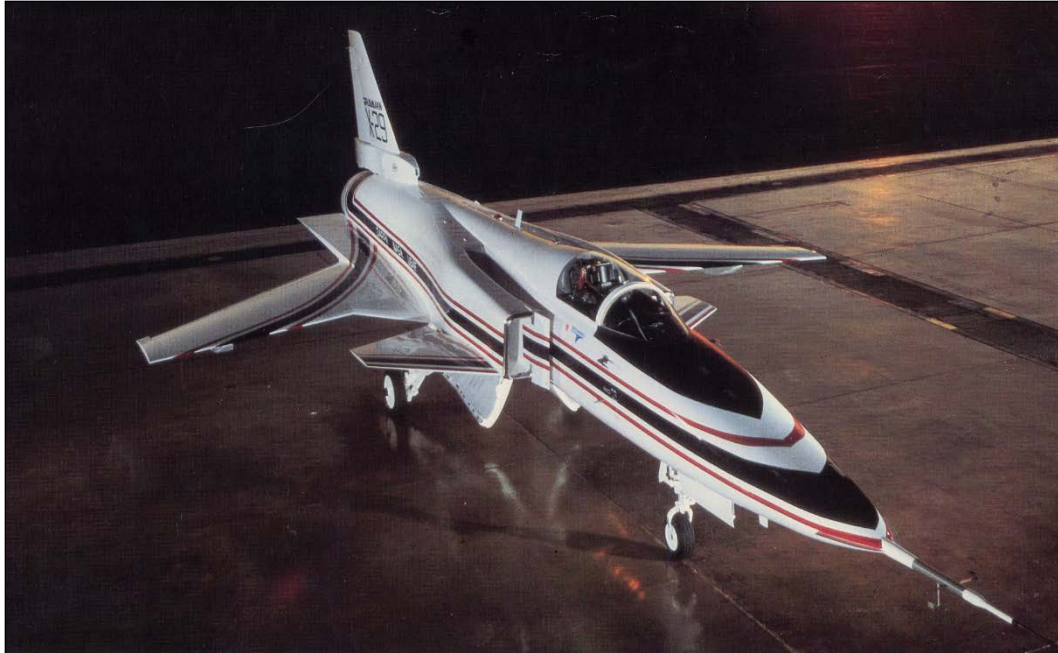
*Figure 8.49 Grumman X-29 (Courtesy Grumman)*

1. By using composite materials the homogeneous, isotropic assumption is no longer correct. This allows the tailoring of material properties to any particular requirement. In a forward swept wing, one would orient the fibers in such a manner that torsional stiffness is enhanced while sacrificing some bending stiffness. This method was used in the manufacturing of the wings of the X-29 (Figure 8.49).

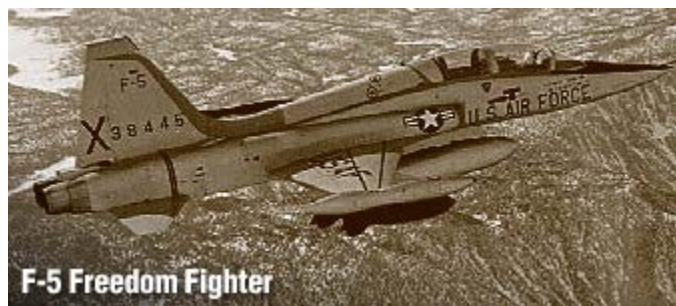
*Figure 8.52 Northrop F-5 with Local Tip-tank-to-wing Area Ruling  
(Courtesy U.S. Air Force)*

Figure 8.52 shows the local area ruling applied to that intersection. The figure also shows the very pronounced area ruling applied to the wing-fuselage intersection.

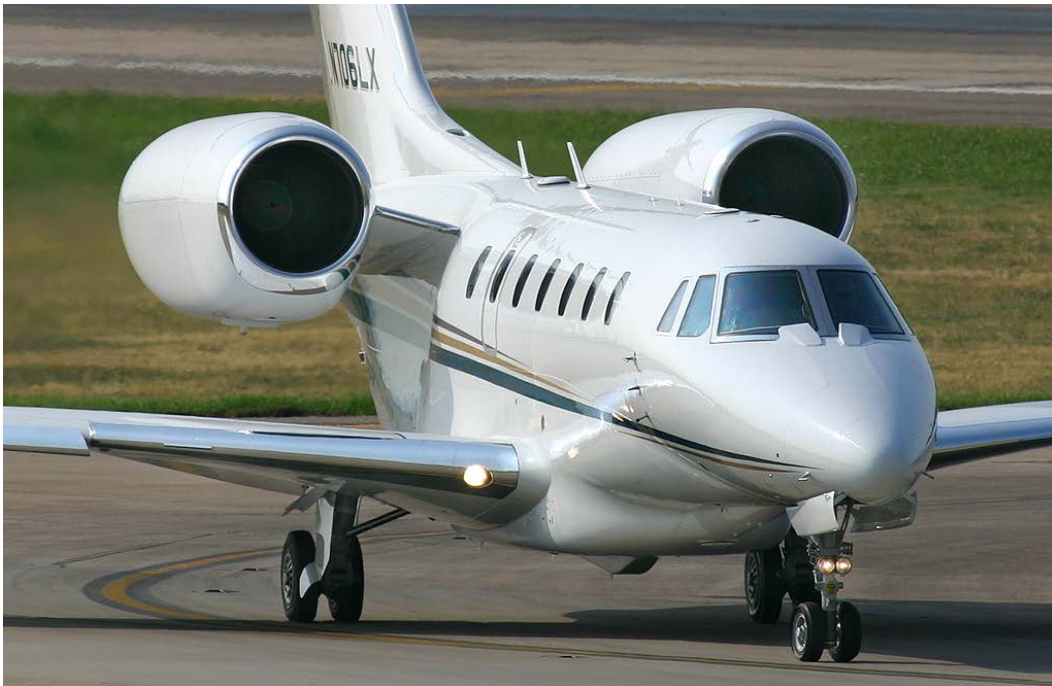
*Figure 8.54 Cessna Citation X (Courtesy Tim Perkins)*

This airplane, in 2004 the fastest subsonic commercial airplane, required very extensive area ruling in the nacelle-fuselage area to obtain acceptable transonic drag characteristics. CFD applications had identified the need for this during early design and subsequent wind tunnel testing confirmed this. Figure 8.54 shows the extensive area ruling in the nacelle-fuselage area.

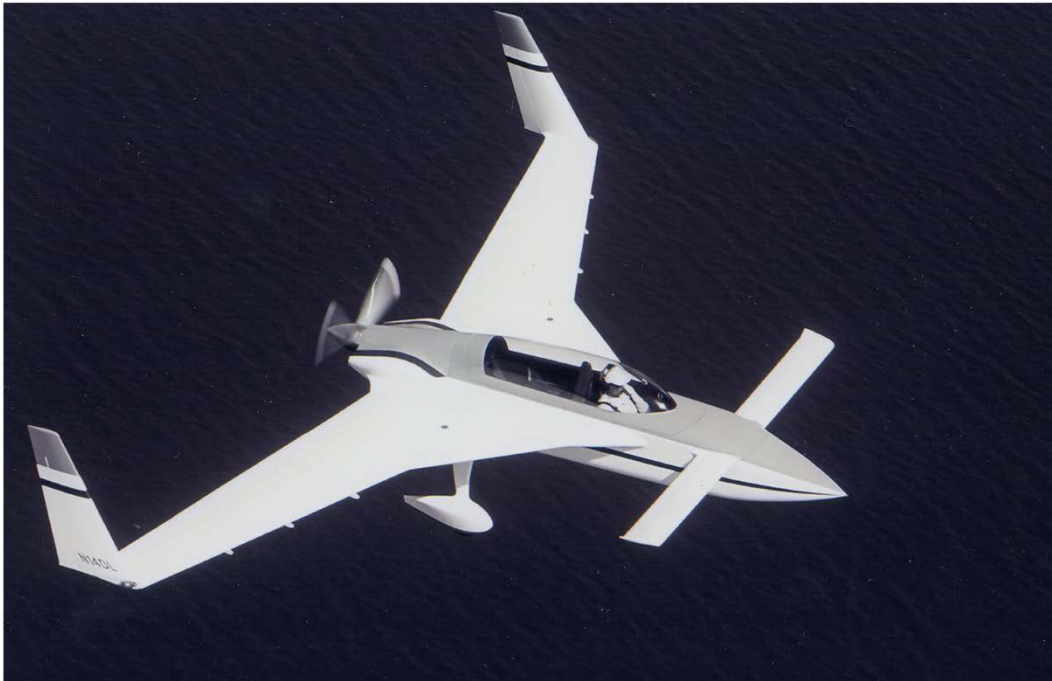
*Figure 8.56 Rutan Varienze (© 1999, EAA, Mark Schaible)*

A preferred solution is to avoid the problem by using the pusher propeller configuration as was done in the Rutan Varienze of Figure 8.56.

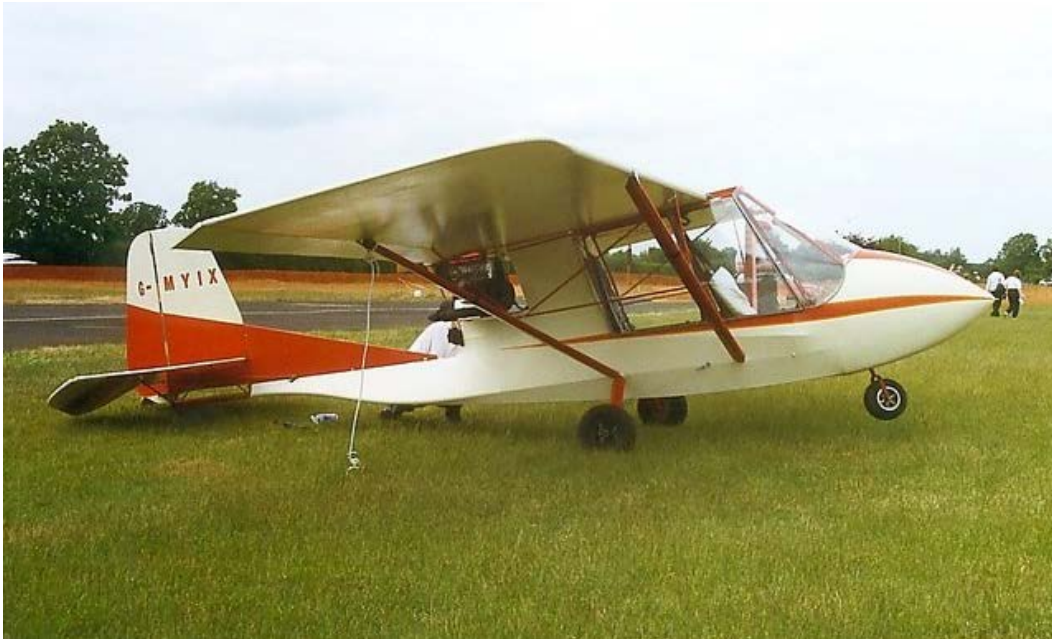
*Figure 8.57 Quad City Challenger (Not Accident Airplane, Courtesy A. Brown)*

Examine Figure 8.57. Most experienced airplane designers would agree that the airplane probably lacks adequate directional stability because of the large amount of side-surface area ahead of the c.g. and the relatively small vertical tail. Close examination of Figure 8.57 shows that there are no side doors (open cockpit). Therefore, air will be able to flow through the side openings on one side and out the other side. The effect of that is to effectively reduce the destabilizing side area forward of the c.g.
