# Lessons Learned in Aircraft Design

The Devil is in the Details

Dr. Jan Roskam

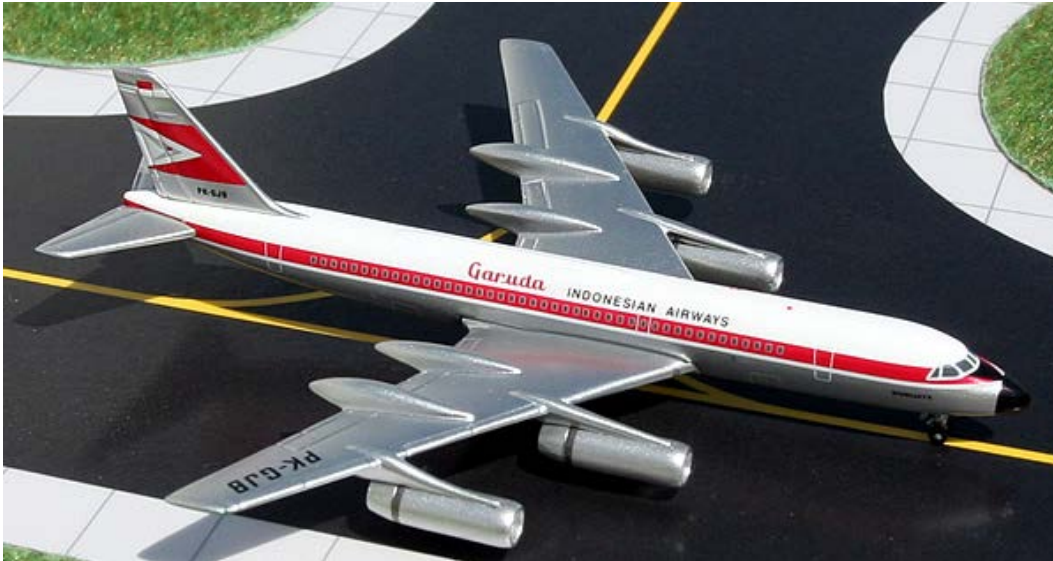
*Figure 9.3 Model of Convair 990 (Courtesy geminijets.com)*

It turned out that the transonic drag rise was much more rapid than predicted and with the help of NASA, aerodynamic modifications were made in the form of the trailing edge anti-shock bodies, seen in Figure 9.3. Even with this the cruise drag was higher than predicted and only 37 were manufactured.

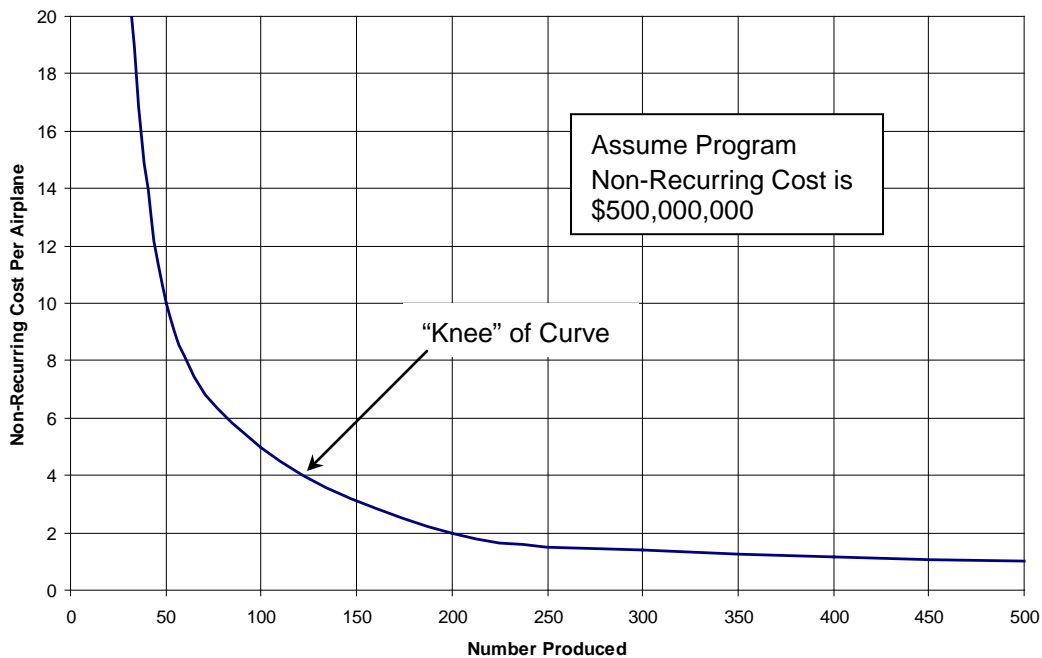
*Figure 9.4 Non-recurring Cost per Airplane versus Numbers Produced*

A simple way to look at an affordable unit cost per airplane is to consider Figure 9.4. In this figure the assumption is made that the total non-recurring cost is \$500,000,000. The cost

contribution per unit produced obviously varies hyperbolically with the number of airplanes built. Figure 9.4 shows that if the market price of an airplane is, say \$40,000,000 and the unit cost to produce (including all engines, avionics and customer equipment) is \$38,000,000 then it takes at least 250 airplanes produced to break even. That general area of the curve is referred to as the “knee” of the curve.

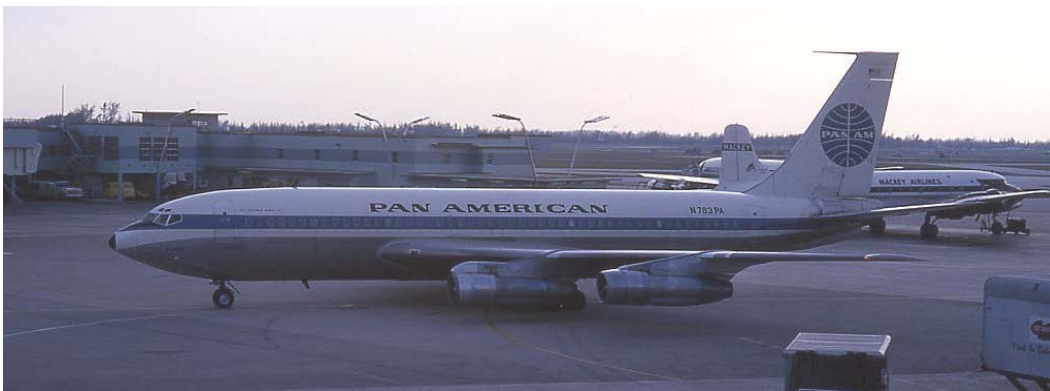
*Figure 9.11 Boeing 720 (Courtesy D. Schulman)*

The airplane was aimed at shorter stage lengths with fewer passengers than the 707 and a much lower empty weight was critical to its success. This was achieved by shortening the fuselage. The inboard wing sweep angle was increased and full span Krueger flaps were fitted to the leading edge. A major reduction in weight was achieved by the incorporation of 7075ST skin panels.

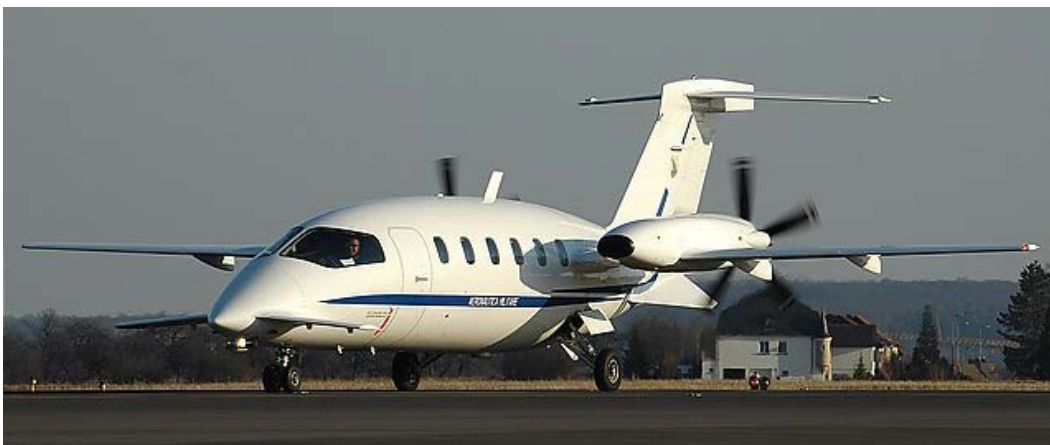
The Piaggio P-180 Avanti (Figure 9.14), not unlike any new airplane type, was rather expensive to develop.

*Figure 9.14 Piaggio P-180 Avanti (Courtesy L. Willems)*

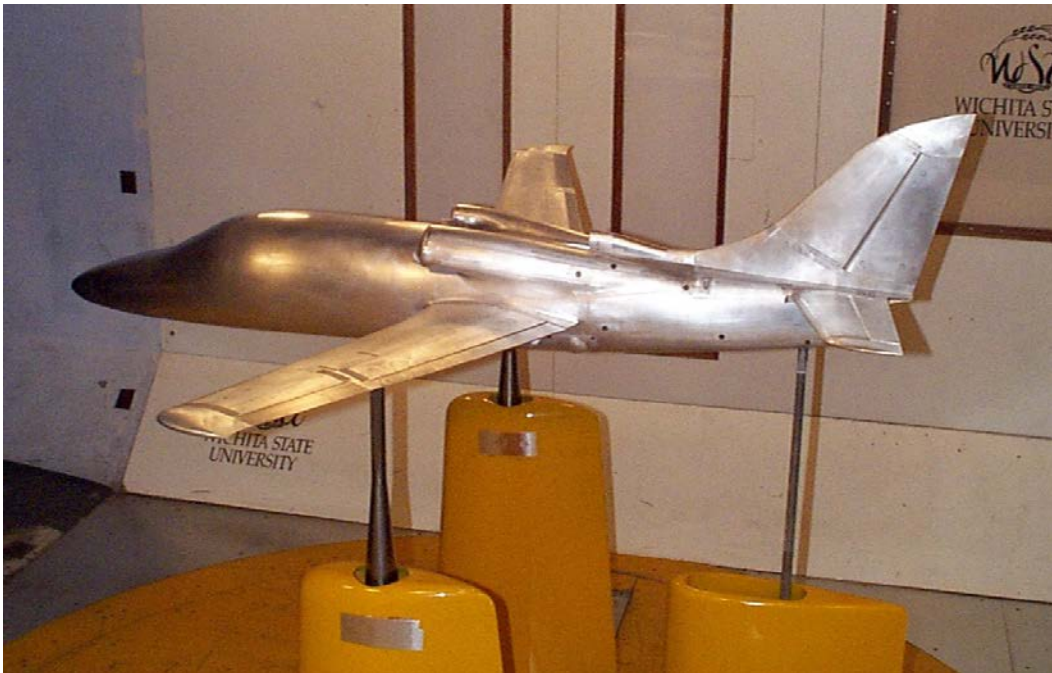
The VisionAire Vantage airplane (Figure 9.15) was envisioned as a single pilot, single engine, low cost business jet that would take advantage of the well-established reliability of the P&W Canada JT-15D turbofan engine.

*Figure 9.15 Wind Tunnel Model of VisionAire Vantage*

In 1998 DARcorporation was given a contract to conduct a series of wind tunnel tests on a model of the Vantage airplane to determine the cause of the various short-comings in flying qualities. The tunnel test clearly showed that the test pilots were correct in their assessment. The test results were summarized in a memo written to VisionAire management outlining which modifications should be made to the airplane.

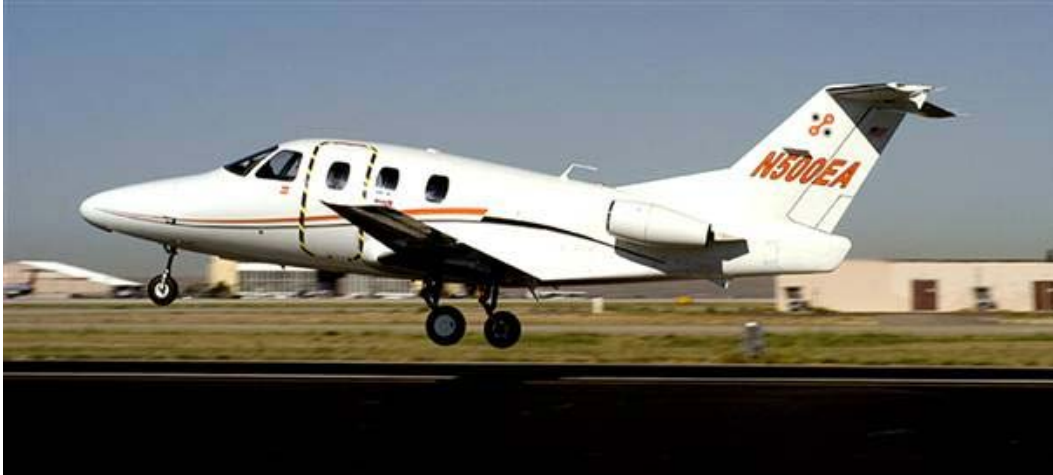
Eclipse Aviation of Albuquerque, New Mexico was formed in 1998 to develop the Eclipse 500 (Figure 9.16) with Williams EJ-22 engines. These engines were not certified nor had they been flight tested when detail design of the Eclipse 500 began.

*Figure 9.16 Eclipse 500 with Williams EJ-22 Engines (Courtesy Eclipse Aviation)*

The first flight was a disappointment in that it showed that the engines did not meet expectations. Eclipse then cancelled its contract with Williams and switched to Pratt & Whitney PF610F engines flat-rated at 900 lbs of thrust. These engines were undergoing flight certification testing in 2004. A variant of that engine was also selected by Cessna to power the Mustang jet.

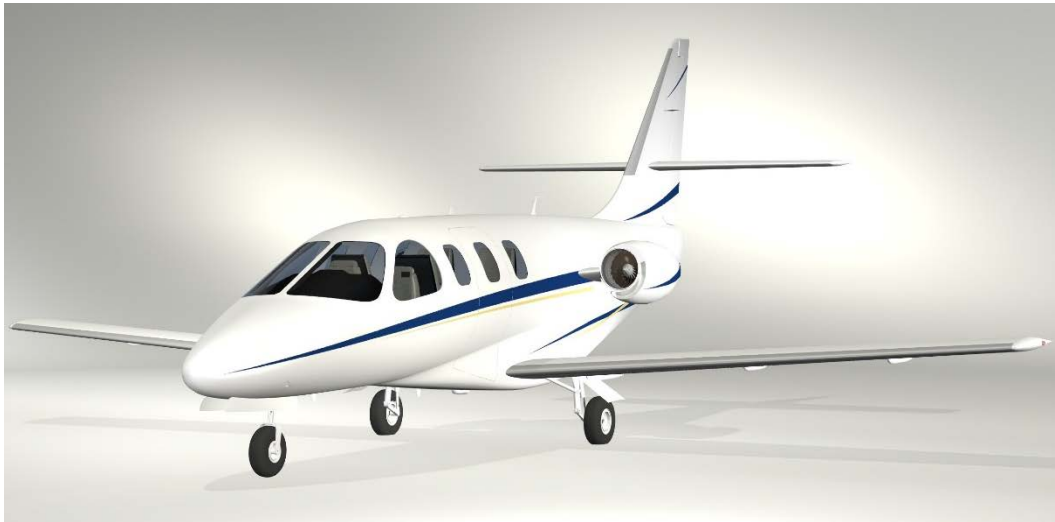
The Safire Aircraft Company was formed in 1998 to develop the Safire Jet shown in Figure 9.17. Financing was available only for basic engineering development.

*Figure 9.17 Safire S-26 Jet (Courtesy Safire Aircraft)*

The airplane was originally designed to be powered by the Agilis TF-800 turboprop engine, a new, uncertified engine being developed by a new company. A wind tunnel test was run which identified a number of minor problems which needed to be solved.

In due course it became evident that no assurances about the viability of the Agilis engine could be given and a switch was made to Williams FJ-33 engines which were certified in 2004. The change in engines caused a change in the rear fuselage as well as the empennage and another wind tunnel test was accomplished to make sure that the airplane could be certified. By that time the company had run out of money, a new financing package could not be put together and the future of this program is in doubt.
